CORROSION OF THE VOLATILITY PILOT PLANT
INOR-8 HYDROFLUORINATOR AND NICKEL 201
FLUORINATOR DURING FORTY FUEL-PROCESSING
RUNS WITH ZIRCONIUM-URANIUM ALLOY

ORNL-3623

Chemical Technology Division

MARCH 1965

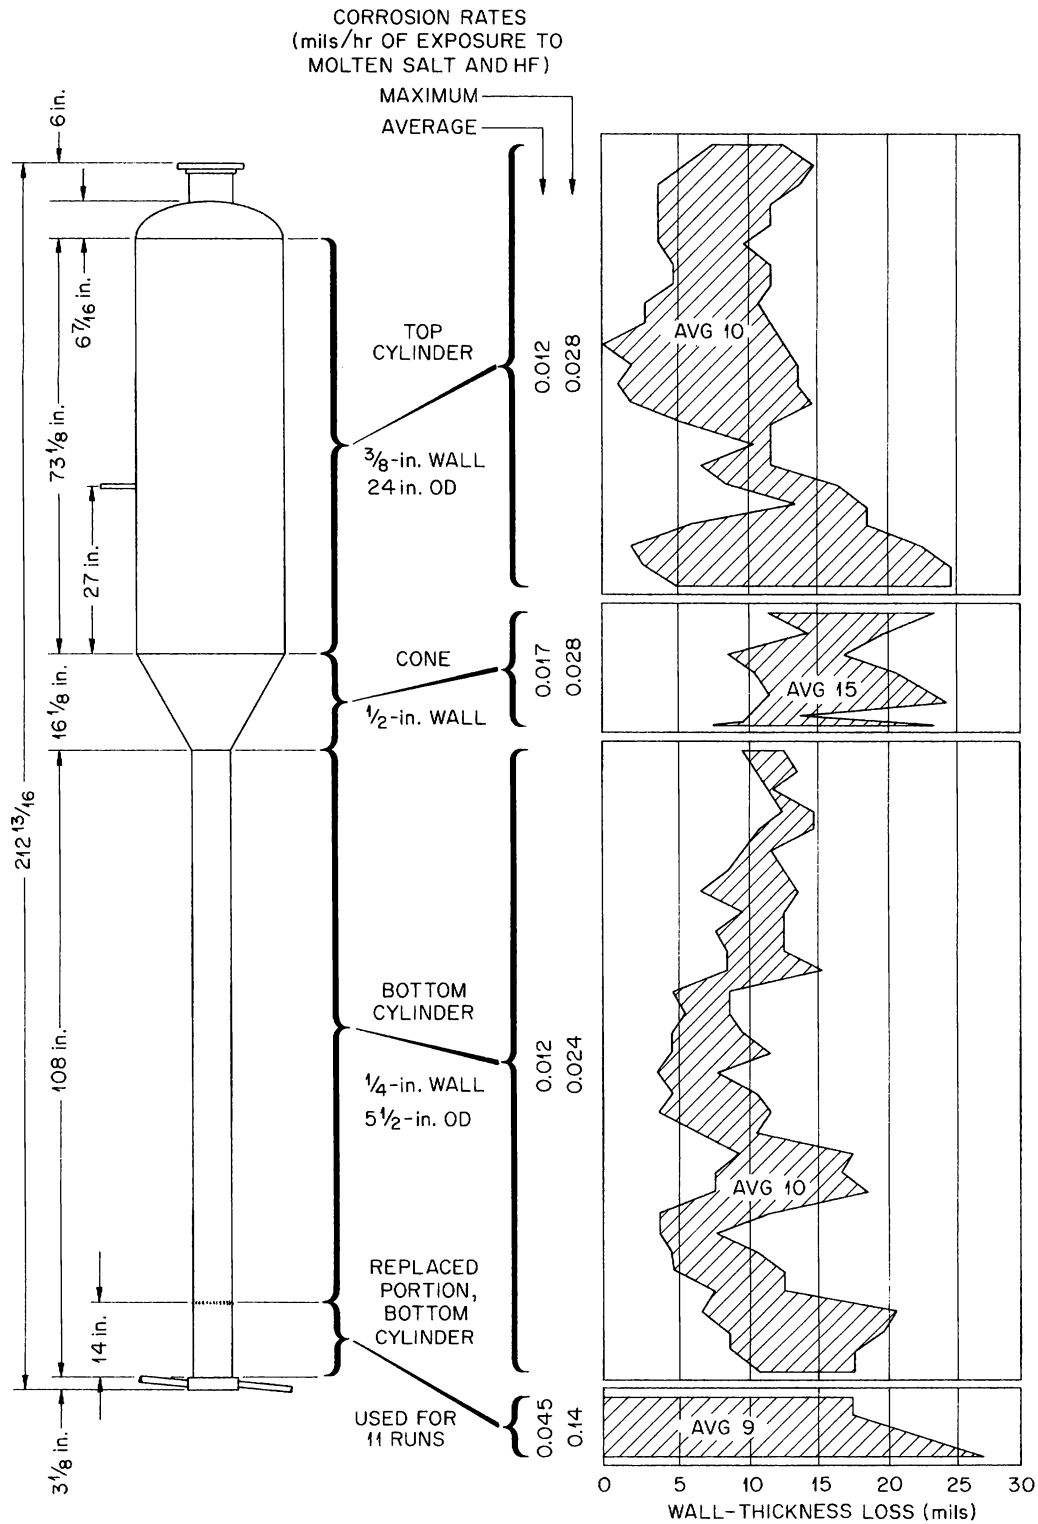
After 40 runs, the 24-in.-diam cylindrical and conical section had a maximum thickness loss (excluding pits or cracks) of 25 mils and an average attack of about half the maximum. The small cylindrical section, excluding the bottom 14 in., had a comparable loss, with a maximum of 21 mils and an average of 10.3. In this section, the maximum corrosion rate since the fourteenth run appears to have reached a rate of about 0.024 mil/hr, based on HF exposure, and 6.7 mils/month based on salt-residence time. Measurements made of the 3/8-in. instrument lines removed after 21 runs agree well with the above rate (excluding the bottom 6 in.). Corrosion rates measured at various times showed more variation in the cone and large cylinder than in the small cylinder, possibly because of the smaller number of readings taken in those areas. However, a maximum rate of about 0.028 mil/hr of HF exposure and 8.1 mils/month of salt-residence time appears fairly consistent with previous measurements in the cone and large cylinder since the fourteenth run. The maximum corrosion rates for the hydrofluorinator after 40 runs are given in Table 5.

Fig. 2. Hydrofluorinator Wall-Thickness Loss During Forty Zirconium Processing Runs.

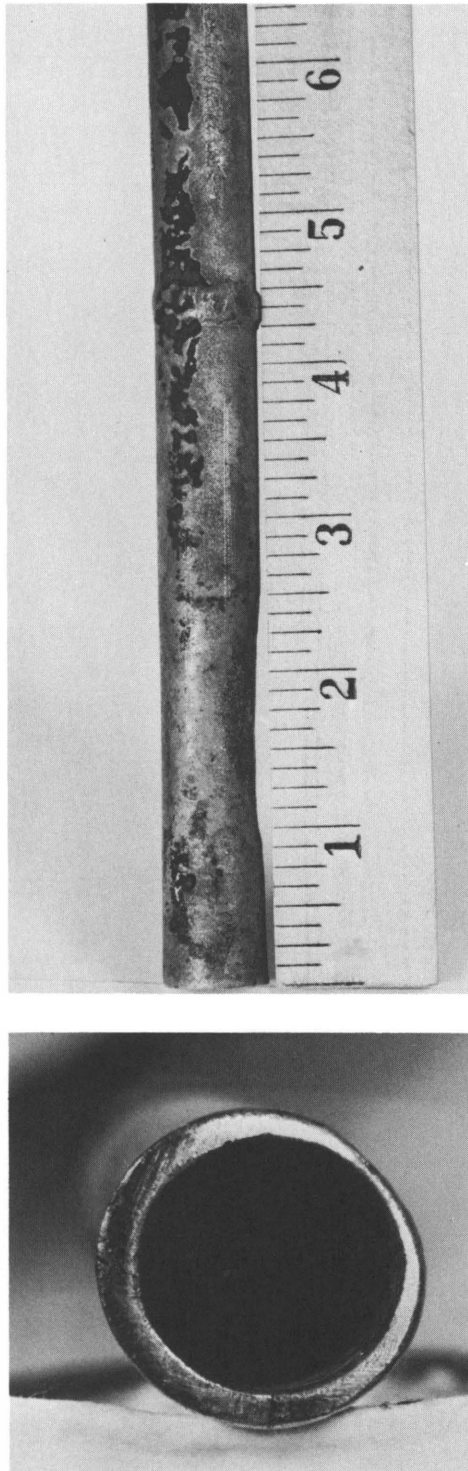
14 runs indicated corrosion rates comparable to those for the upper portion of the section. After 21 runs, the lower section showed a maximum attack of 18 mils (0.036 mil/hr of HF exposure), compared with a maximum of 13 mils (0.026 mil/hr of HF) for the upper portion. An instrument line removed at this time showed a maximum wall-thickness loss of 50 mils (0.10 mil/hr of HF) at a location about 1-1/2 in. above the distributor plate (Fig. 3). A thermocouple well removed at the same time showed a maximum loss of 26 mils (0.05 mil/hr of HF) at about the same location. This corrosion occurred in the vicinity of a clip that held the lines against the vessel wall. The higher corrosion rate at this location was apparently due to turbulence of the HF-salt mixture at that point since the upper section of the line showed only normal losses.

Fig. 3. Corrosion of an Instrument Line Removed From the Bottom of the Hydrofluorinator After Twenty-one Runs.

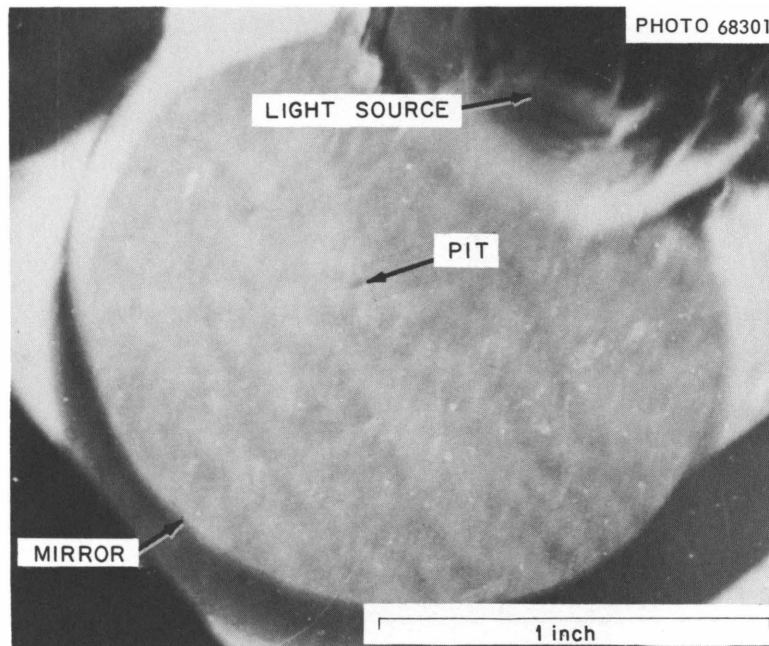
surface of the 5-1/2-in.-diam section and the lower part of the cone section were inspected. This was done with a Questar telescope and mirrors. A few pits were seen in the 5-1/2-in.-diam section, such as the one shown in Fig. 4. The largest pit was estimated to be no more than 20 mils in diameter or 20 mils deep. Several small fissures were seen in the conical section, running upward from the lower weld. These fissures (Fig. 5) were estimated to be not more than 10 mils wide, and they did not appear to be very deep. Welds in the lower part of the hydrofluorinator appeared to be in good condition. No areas of extensive pitting or cracking were seen.

Fig. 4. A Pit Observed in 5-1/2-in.-OD Section of the Hydrofluorinator After Forty Runs.

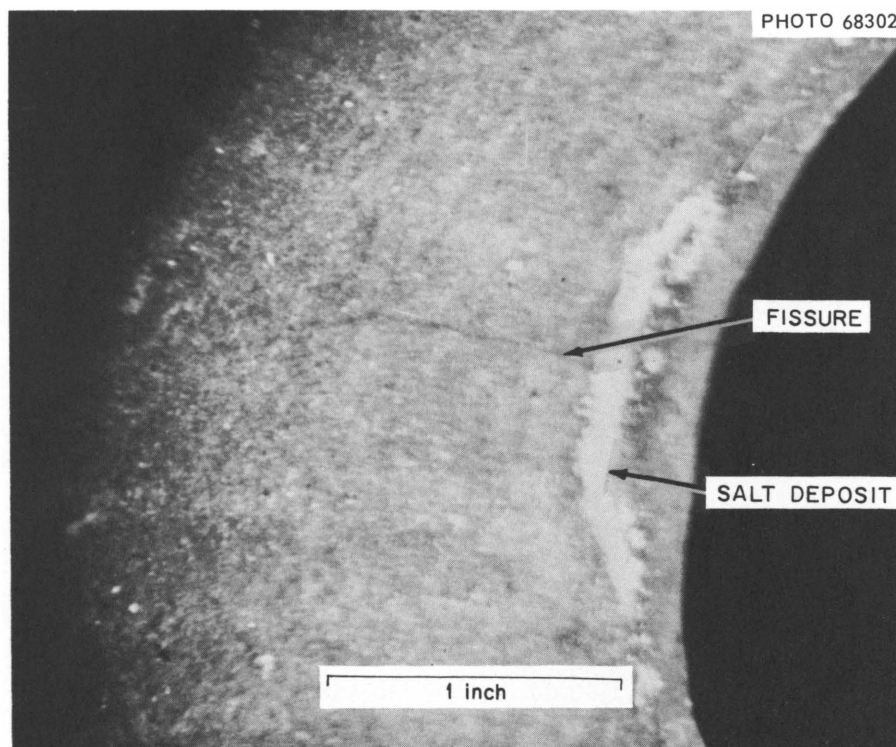
Fig. 5. Fissure in the Conical Section of the Hydrofluorinator After Forty Runs.

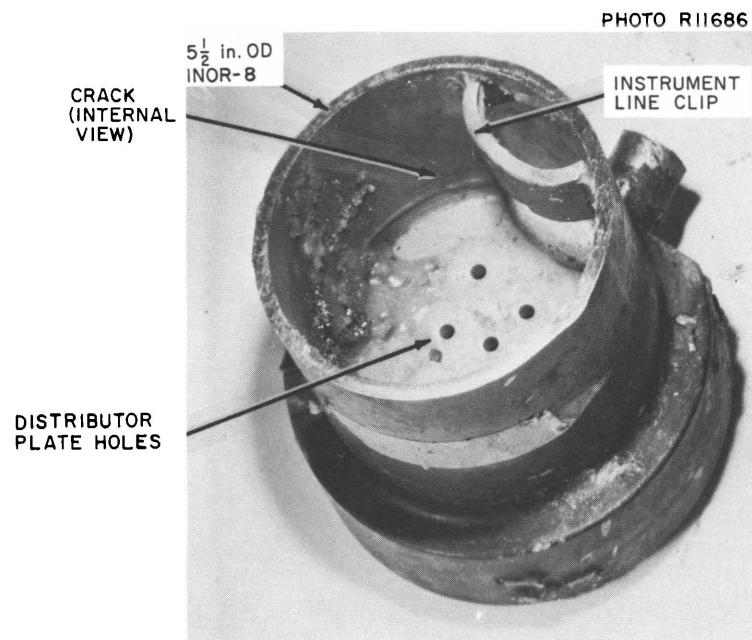
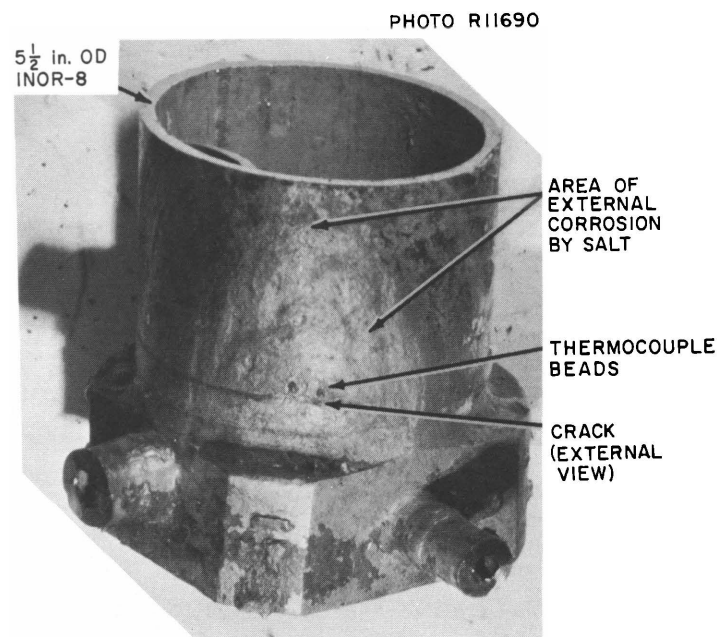
After run T-11 (29 runs) the hydrofluorinator was decontaminated, and a visual inspection was made of the exterior. This examination revealed a salt leak in the 5-1/2-in.-OD section of the vessel just above the girth weld joining the distributor plate to the 5-1/2-in. section. The crack, shown in Fig. 6, occurred in the heat-affected area of two stainless-steel-sheathed thermocouple weld beads. The leakage was through two intersecting cracks. The horizontal crack was 1-1/8 in. long and was located between the thermocouple heads and the girth weld at the distributor plate. The vertical crack was 3/8 in. long and was between the two thermocouple heads. Both cracks were intergranular and appeared to have originated at the exterior. Only a small quantity of salt had leaked through the crack and covered about a 6-in.-diam circle on the exterior. The exterior of the hydrofluorinator and the thermocouples in the area of the leak were severely corroded, as is normal with metals in contact with molten fluorides in air. Since thermocouple failure occurred during run R-1, presumably the crack

Fig. 6. Lower Section of Hydrofluorinator After Failure by Cracking (After Twenty-nine Runs).

also occurred then, and the salt sealed the crack sufficiently to permit continued operation.

The lower 17 in. of the hydrofluorinator was removed for metallurgical examination.¹¹ No gross bulging was found in the bottom section, and test specimens removed from this section showed no loss of tensile strength or brittleness of the INOR-8. However, chemical analyses indicated that it apparently was from an INOR-8 heat (SP-26) known to be susceptible to weld cracking.¹² Other intergranular cracks, up to 65 mils deep, were found on the exterior surface below the lower girth weld. Apparently the leak resulted from the effect of the thermocouple bead welds and the girth weld on substandard INOR-8, susceptible to weld cracking.

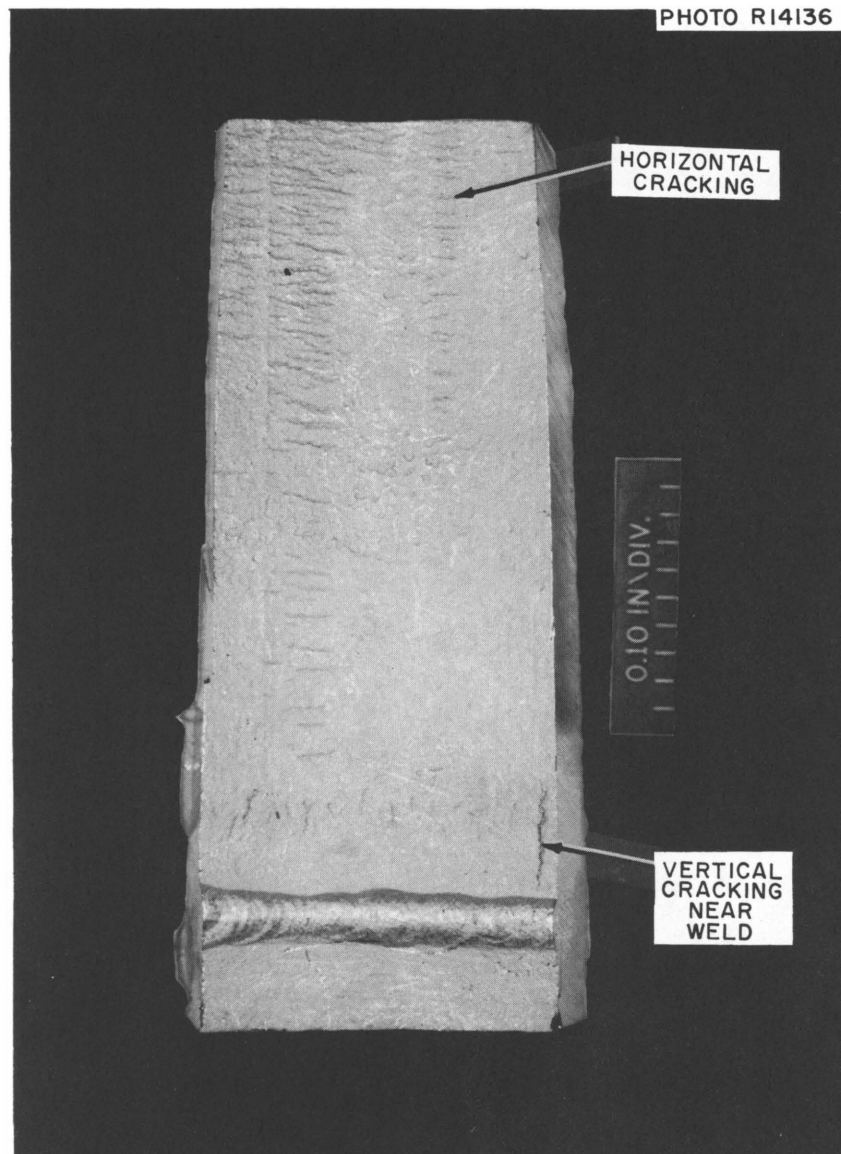
Many cracks between 10 and 40 mils deep were found on the inside surface of the vessel near the leak. These cracks, shown in Fig. 7, were classified into two groups. The first consisted of cracks perpendicular or adjacent to welds and were apparently associated with weld stresses. The second group contained horizontal cracks aligned in vertical rows throughout the lower 12 in. of the vessel. The horizontal cracks may have resulted from the rolling operation used in fabrication.

Fig. 7. INOR-8 Specimen Removed From the Bottom Section of the Hydrofluorinator After Twenty-nine Runs.

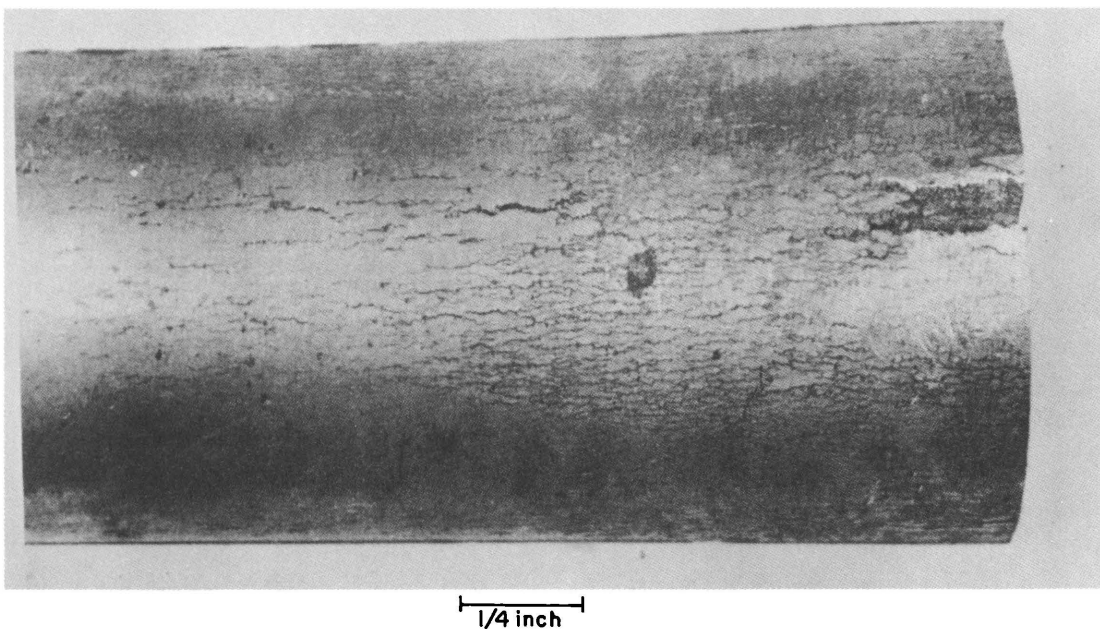
A rupture occurred after TU-6 (13 runs) in the 1-in.-OD adapter at the junction between the salt-transfer line and the bottom of the hydrofluorinator. This was the area where the freeze valve was formed. In addition to the rupture there were many other cracks on the outer surface (Fig. 8). Metallography revealed that the rupture and other cracks were intergranular and that they originated on the outside, indicating that they were caused by salt expansion.¹³ Apparently this was a result of salt melting in the center of the freeze valve before the salt at each end became molten. The adapter was replaced temporarily until after TU-7, at which time 3-in.-long adapters were installed in both the salt transfer and HF inlet lines. The shorter adapter allowed more uniform heating, and no further difficulties were experienced. Portions of these 3-in.-long adapters were examined metallographically after they had been used for 15 runs (after T-11) and found in good condition.

Fig. 8. Cracking Due to Salt Expansion in an INOR-8 Adapter on the Hydrofluorinator HF Inlet Line.

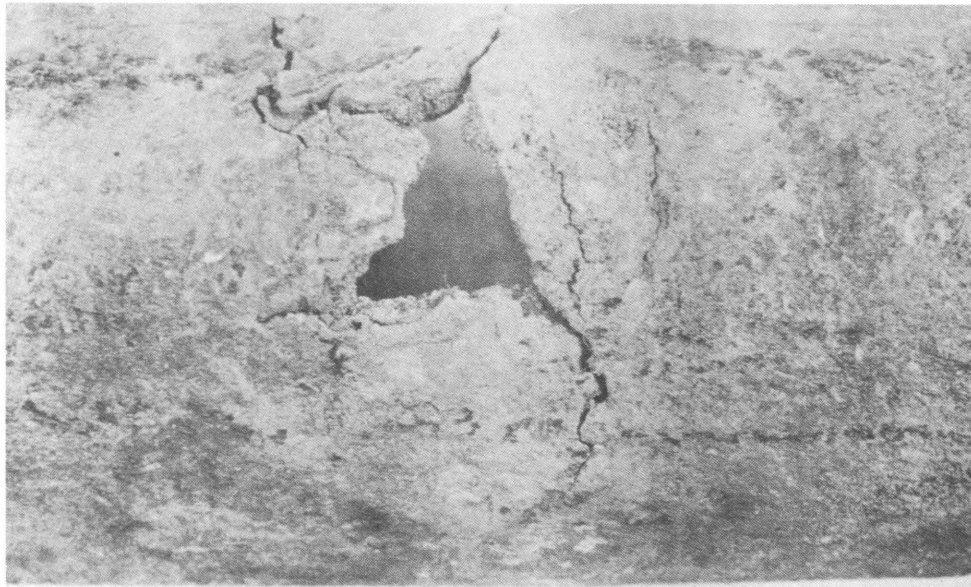
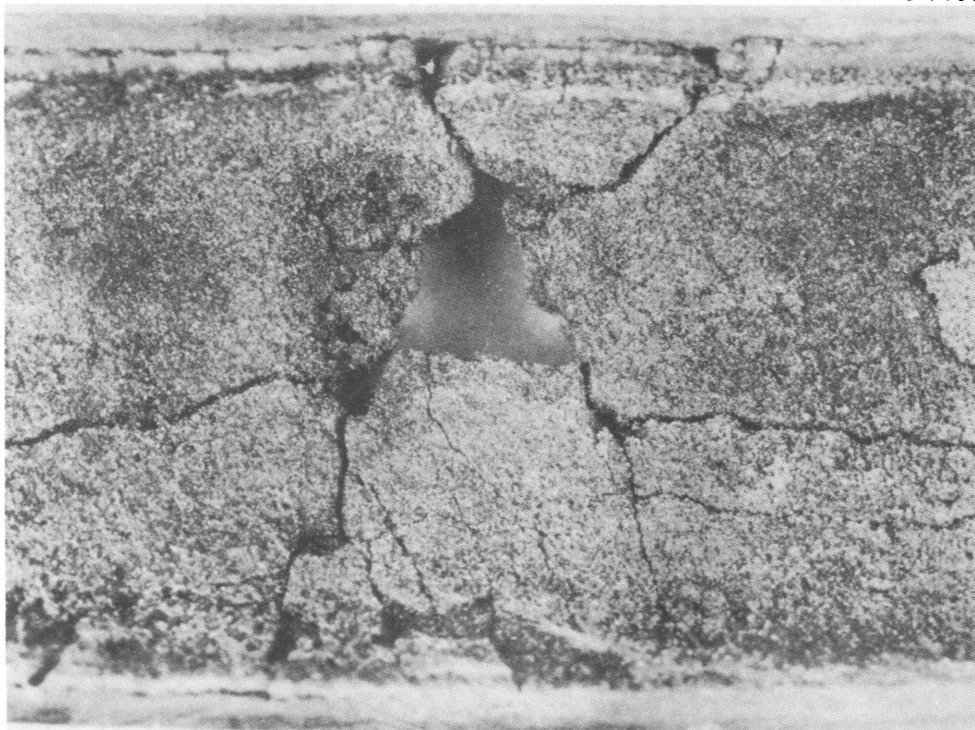
Originally, all three autoresistance-heated lines that entered the hydrofluorinator were made of 3/8-in. sched-40 Inconel pipe. After TU-7 (14 runs) a leak developed in the HF line about 2 ft from the hydrofluorinator. Figure 9 shows a section of pipe in which the leak occurred. Metallography revealed that chromium and iron had been leached from the Inconel pipe in the vicinity of the leak. Leaching occurred all along the pipe but was less severe at greater distances from the hydrofluorinator.¹³ Thinning of the pipe wall by corrosion apparently caused localized overheating (750°C maximum temperature) and even greater corrosion.

1/4 inch
Outside of pipe

1/4 inch
Inside of pipe

Fig. 9. Corrosion of Inconel Pipe in the Hydrofluorinator HF Inlet Line.

than the HF line; however, there was indication of metal loss, particularly in the areas closer to the vessels. The Inconel piping in the three auto-resistance-heated lines attached to the hydrofluorinator was replaced with INOR-8 pipe after TU-7 (14 runs).

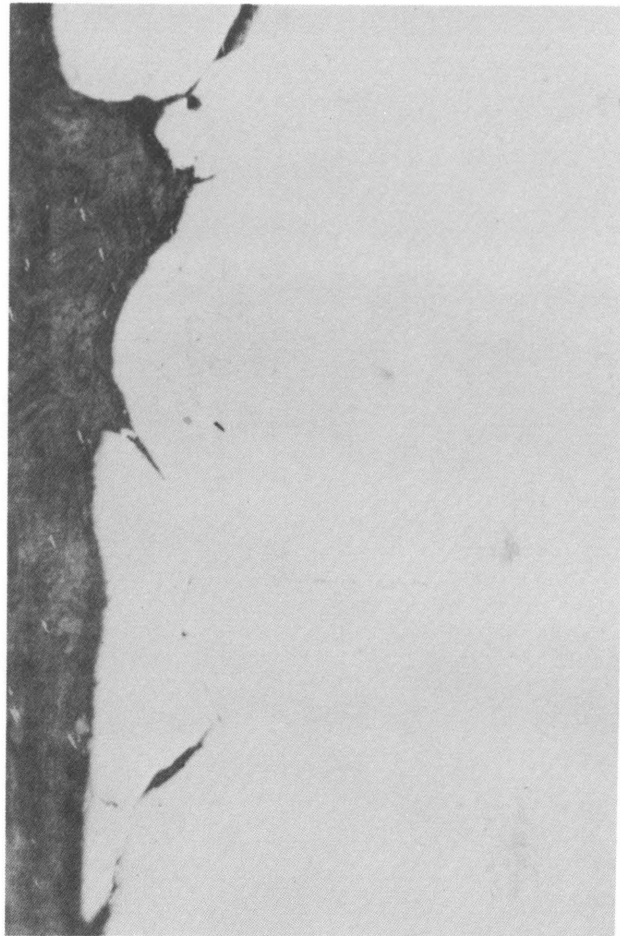
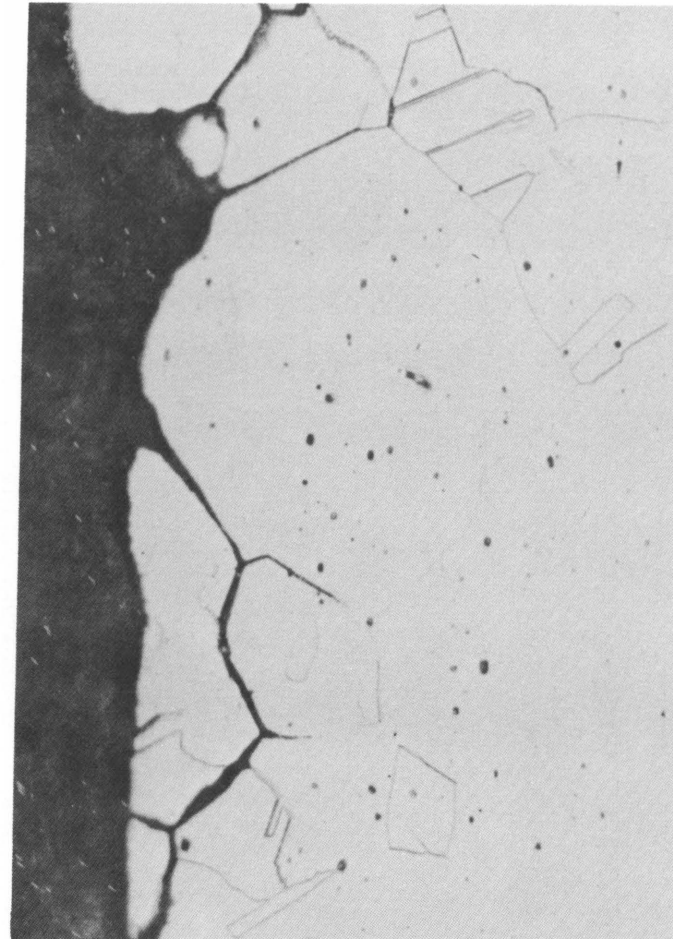
Fig. 11. Grain-Boundary Modification of Nickel 201 Specimens Removed From the Fluorinator Wall After Twenty-nine Runs.

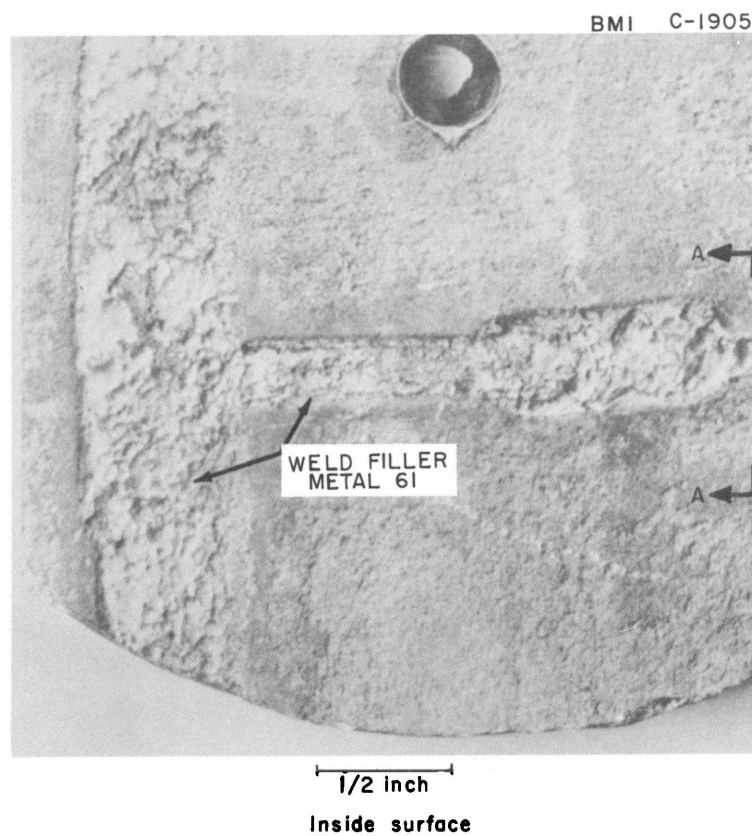
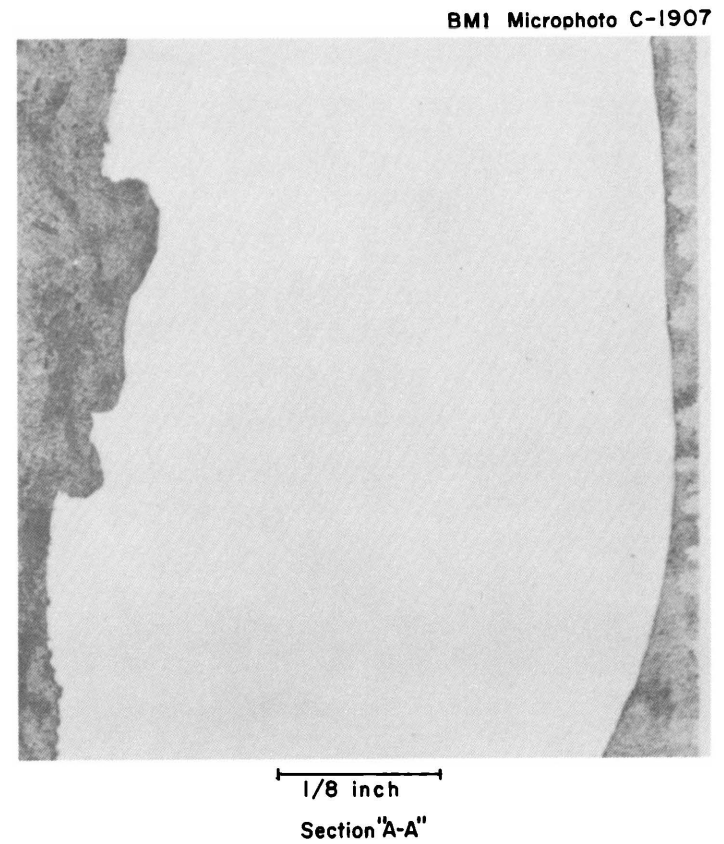
However, an examination of the fluorinator after the cleaning following run T-11 (29 runs) revealed that the weld filler metal 61 had been selectively attacked. This attack on a specimen cut from the fluorinator is shown in Fig. 12. The weld metal was removed to a depth of about 40 mils, but, as shown in Fig. 12, the thickness of the remaining weld metal was still about the same as that of the vessel wall. Weld metal loss was fairly uniform throughout the vessel, and gamma radiography of the welds in the lower section indicated that there were no areas of extensive penetration.

Studies were made at BMI⁹ and ORNL⁸ to determine the cause of the selective attack on weld filler metal 61. At BMI, corrosion specimens made from the fluorinator wall, as well as prepared specimens, were exposed to alternating cycles of boiling 0.1 M $\text{Al}(\text{NO}_3)_3$ —0.01 M HNO_3 and 5-2-2 wt % NaOH - H_2O_2 - $\text{NaC}_2\text{H}_4\text{O}_6$ at room temperature. The results of this exposure, given in Table 16, indicate that the $\text{Al}(\text{NO}_3)_3$ - HNO_3 is more corrosive to both Nickel 201 and weld filler metal 61 than is the caustic-peroxide-tartrate. Initial corrosion rates in the $\text{Al}(\text{NO}_3)_3$ - HNO_3 during the first 3 hr were considerably higher than later rates. The use of caustic-peroxide-tartrate appears to increase corrosion by subsequent treatment with $\text{Al}(\text{NO}_3)_3$ - HNO_3 . Neither the prepared corrosion specimen of Nickel 201 welded with filler metal 61 nor the filler metal 61 corrosion specimens indicated selective attack by the decontaminating solution. However, the weld filler metal 61 specimen removed from the fluorinator was selectively attacked, as shown in Fig. 13. Based on these studies, it was concluded that the weld filler metal 61 attack was caused by the aluminum nitrate-nitric acid cleaning solution used after run T-11.

Fig. 12. Section of the Fluorinator Wall Showing Corrosion of the Weld Filler Metal 61 After Twenty-nine Runs and 3 Aqueous Cleanings.

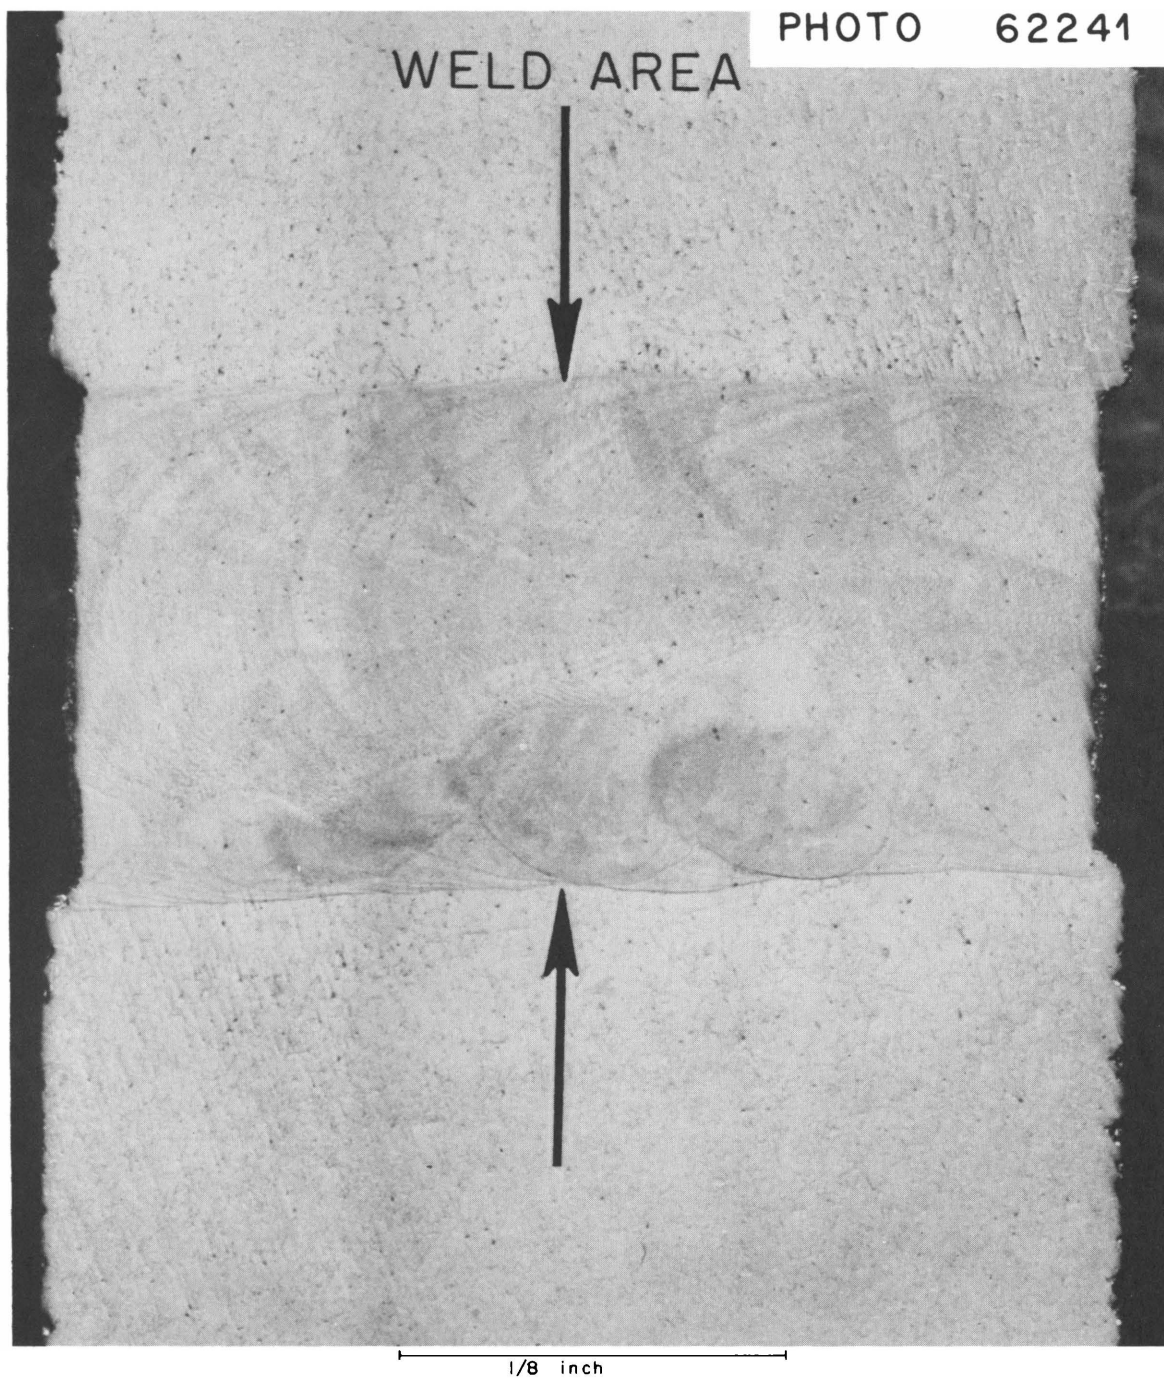
Fig. 13. Selective Corrosion of Weld Filler Metal 61 by Aqueous Cleaning Solutions. Vertical faces were flat before exposure to solutions.

The reason is not known for the difference between the corrosion rate for the weld filler metal 61 from the fluorinator specimen and that for the prepared specimens (which did not show selective attack of the weld filler metal 61). Analyses of the fluorinator welds gave a typical weld filler metal 61 composition. The larger ratio of Nickel 201 to weld filler metal 61 in the fluorinator, compared with that for the corrosion specimen, may have increased the weld filler metal 61 attack in the fluorinator by galvanic corrosion.⁸

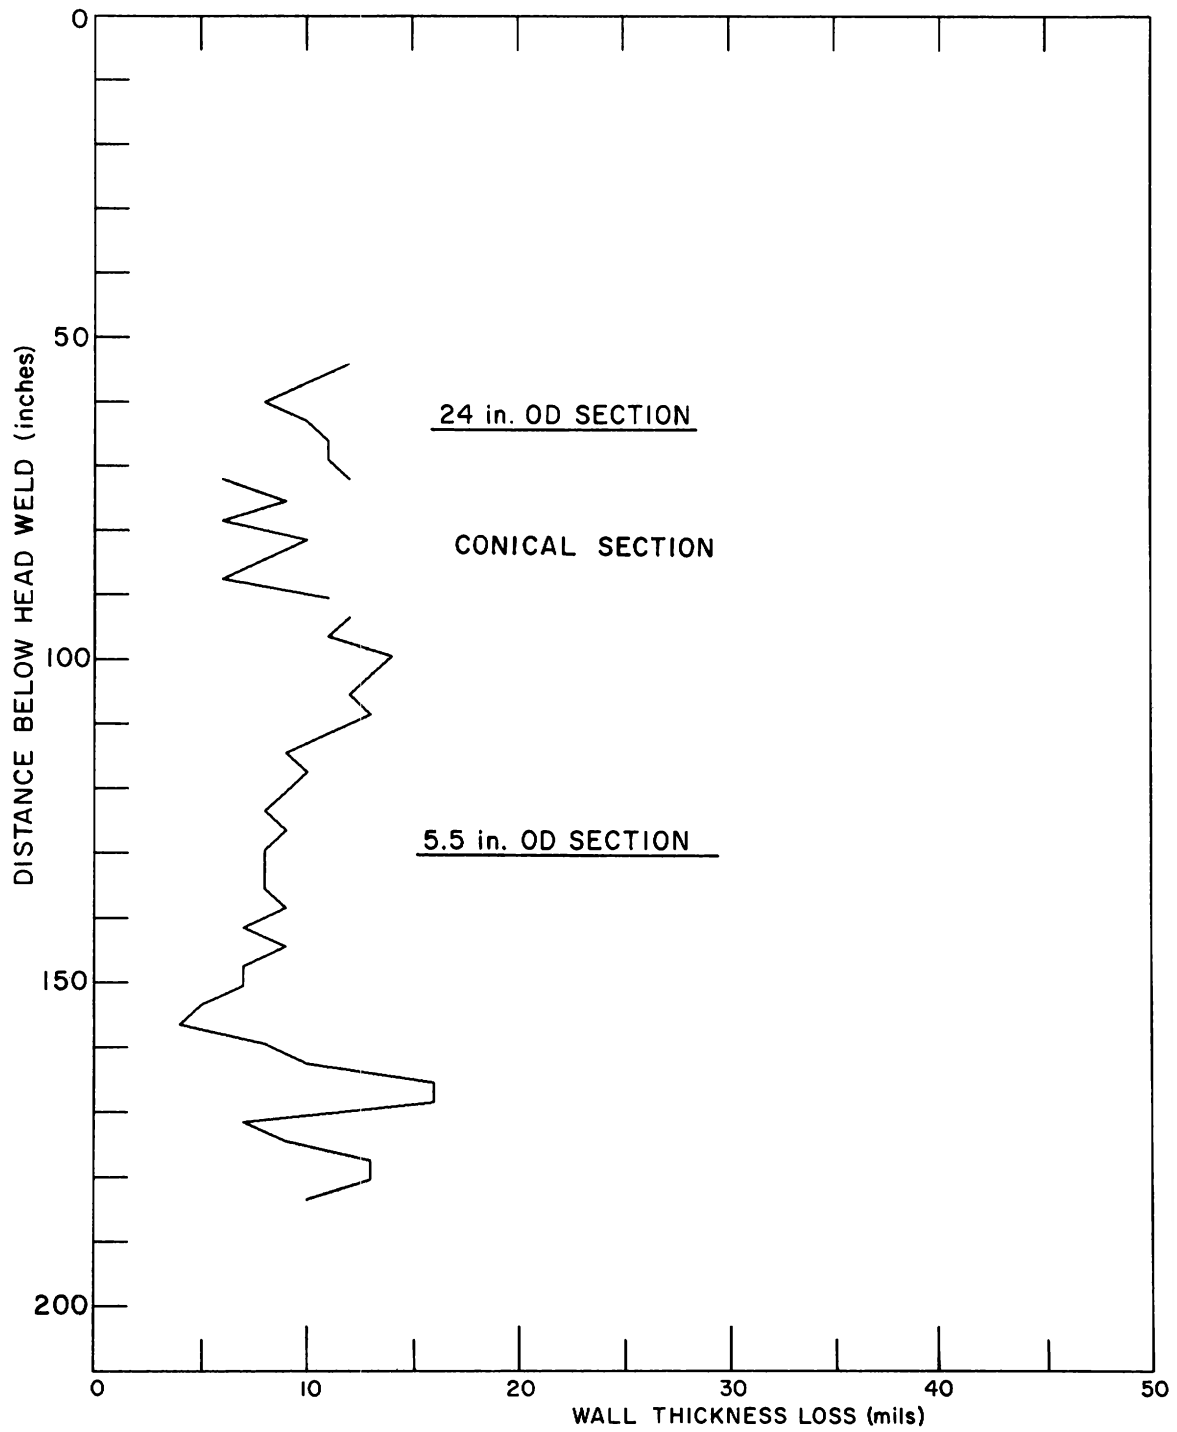
gross loss and does not include other attack, such as pitting or cracking, which will be discussed later. Since there was from 10 to 20 mils of variation in wall thickness of the same nominal-size material used in the hydrofluorinator wall, thickness losses were determined by subtracting the final value from the initial thickness measured at approximately the same point. Figure 2 is a profile of the gross metal loss after 40 runs. A profile of the loss after 29 runs is given in Fig. 2A in the Appendix.

Fig. 2A. Hydrofluorinator Wall-Thickness Losses After 29 Runs.

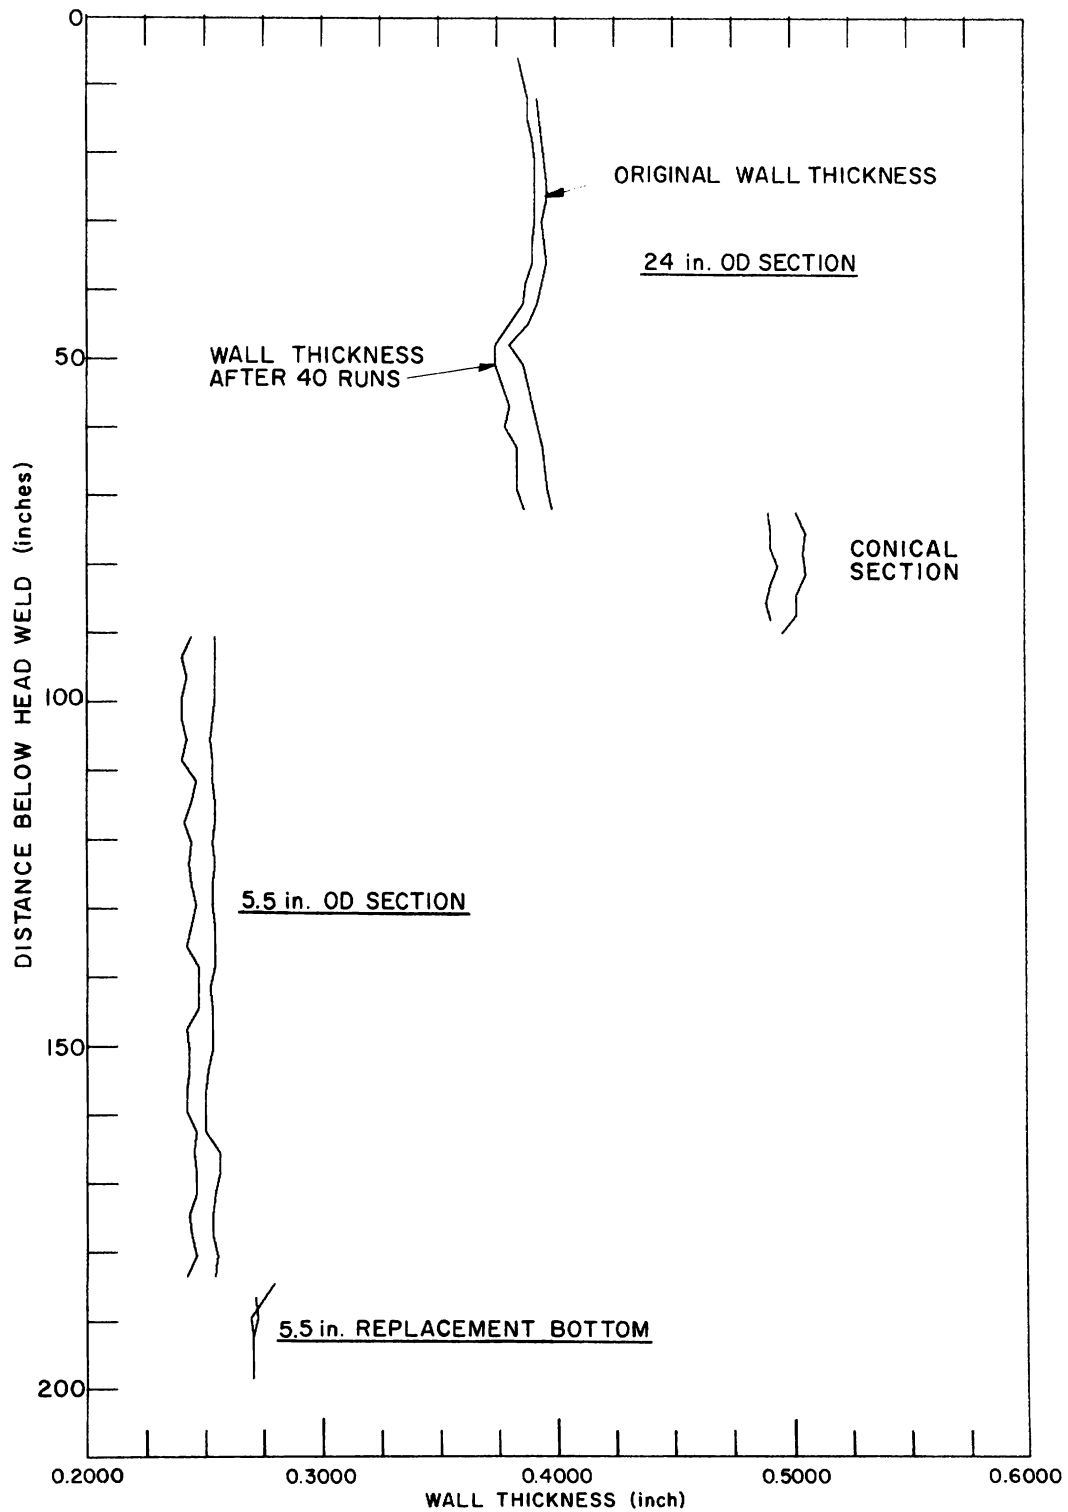
Fig. 3A. Hydrofluorinator Wall-Thicknesses Before and After 40 Zirconium Runs (North Wall).

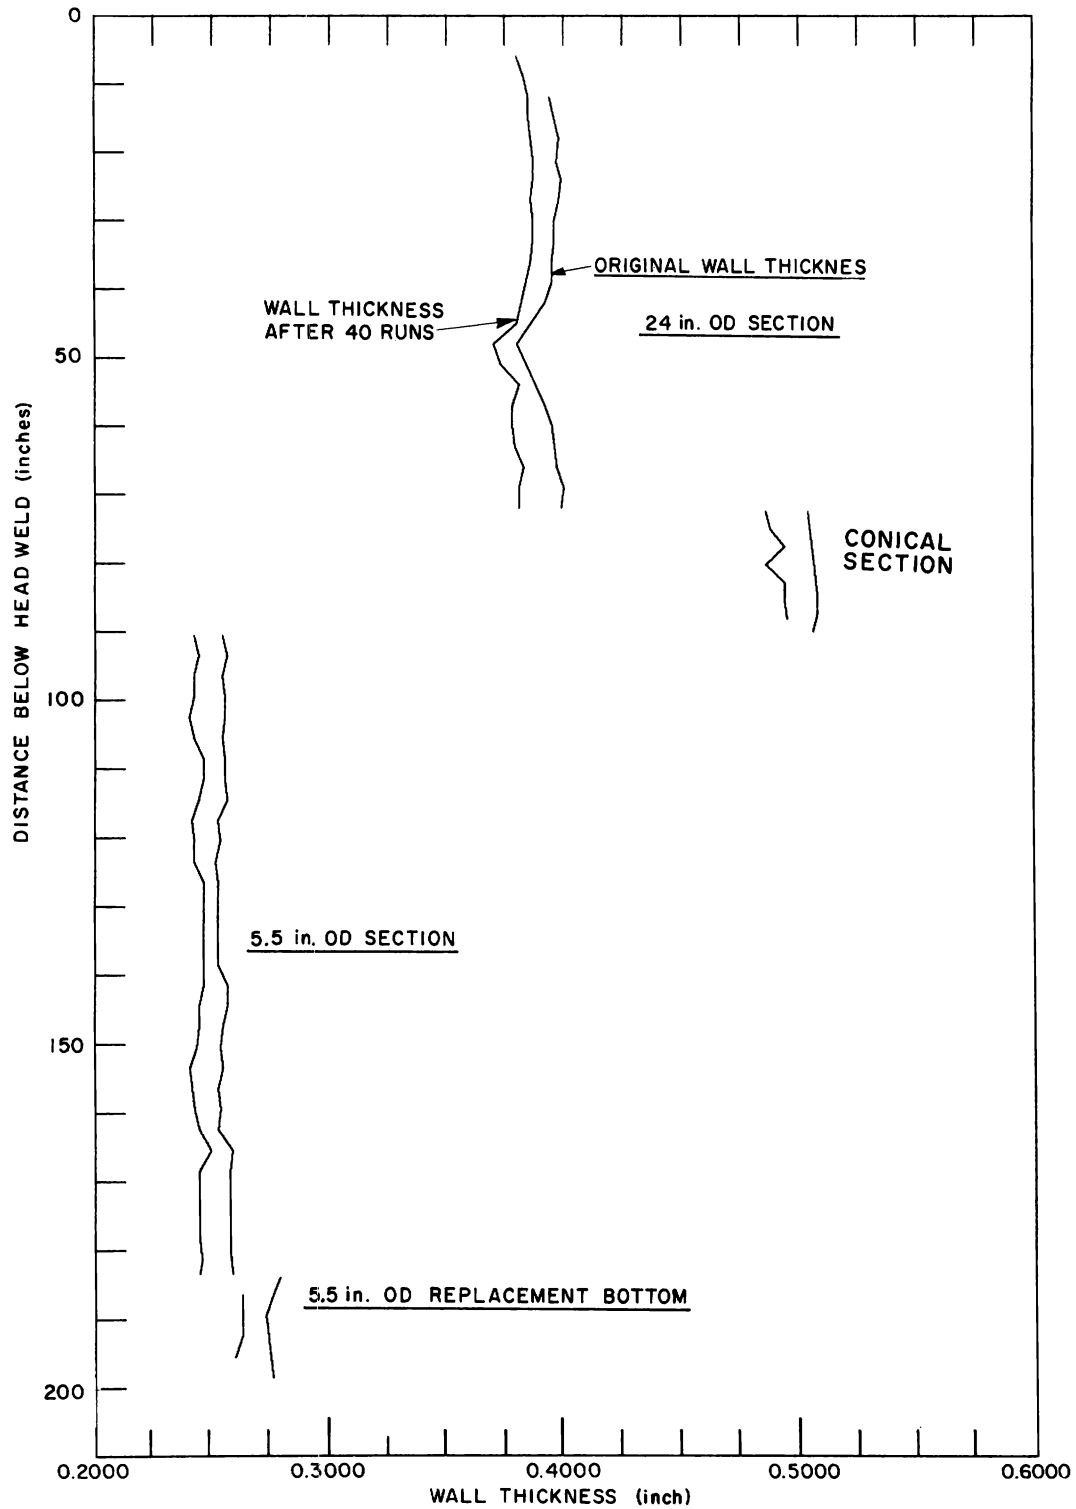
Fig. 4A. Hydrofluorinator Wall Thicknesses Before and After 40 Zirconium Runs (South Wall).

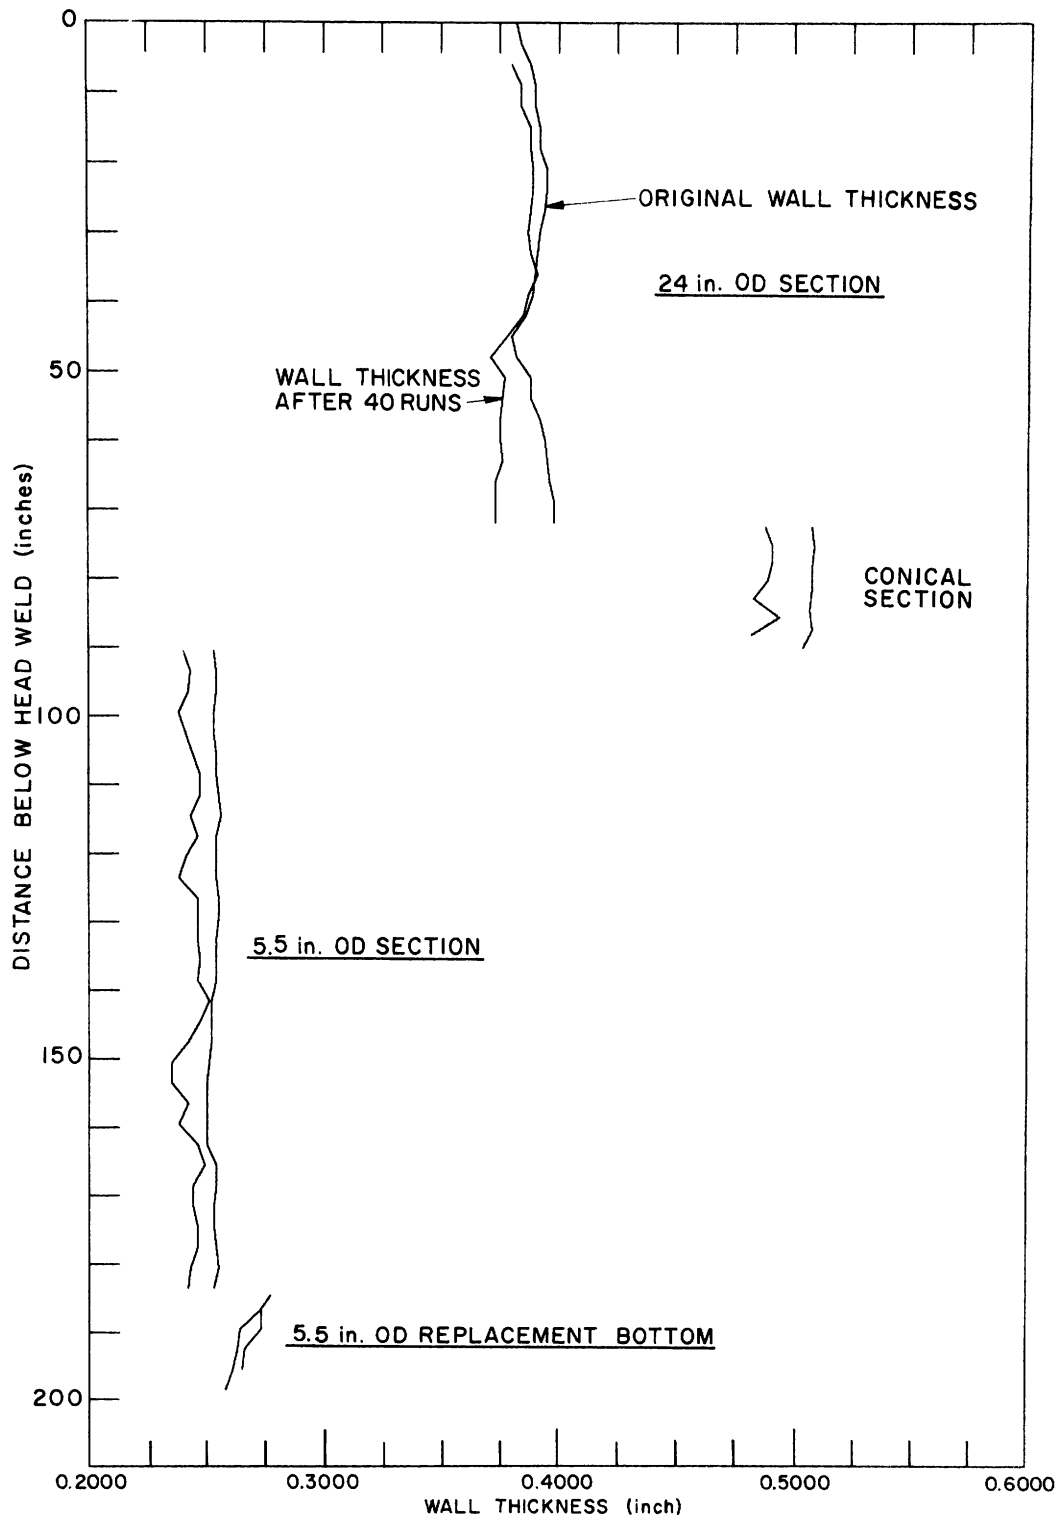
Fig. 5A. Hydrofluorinator Wall-Thicknesses Before and After 40 Zirconium Runs (East Wall).

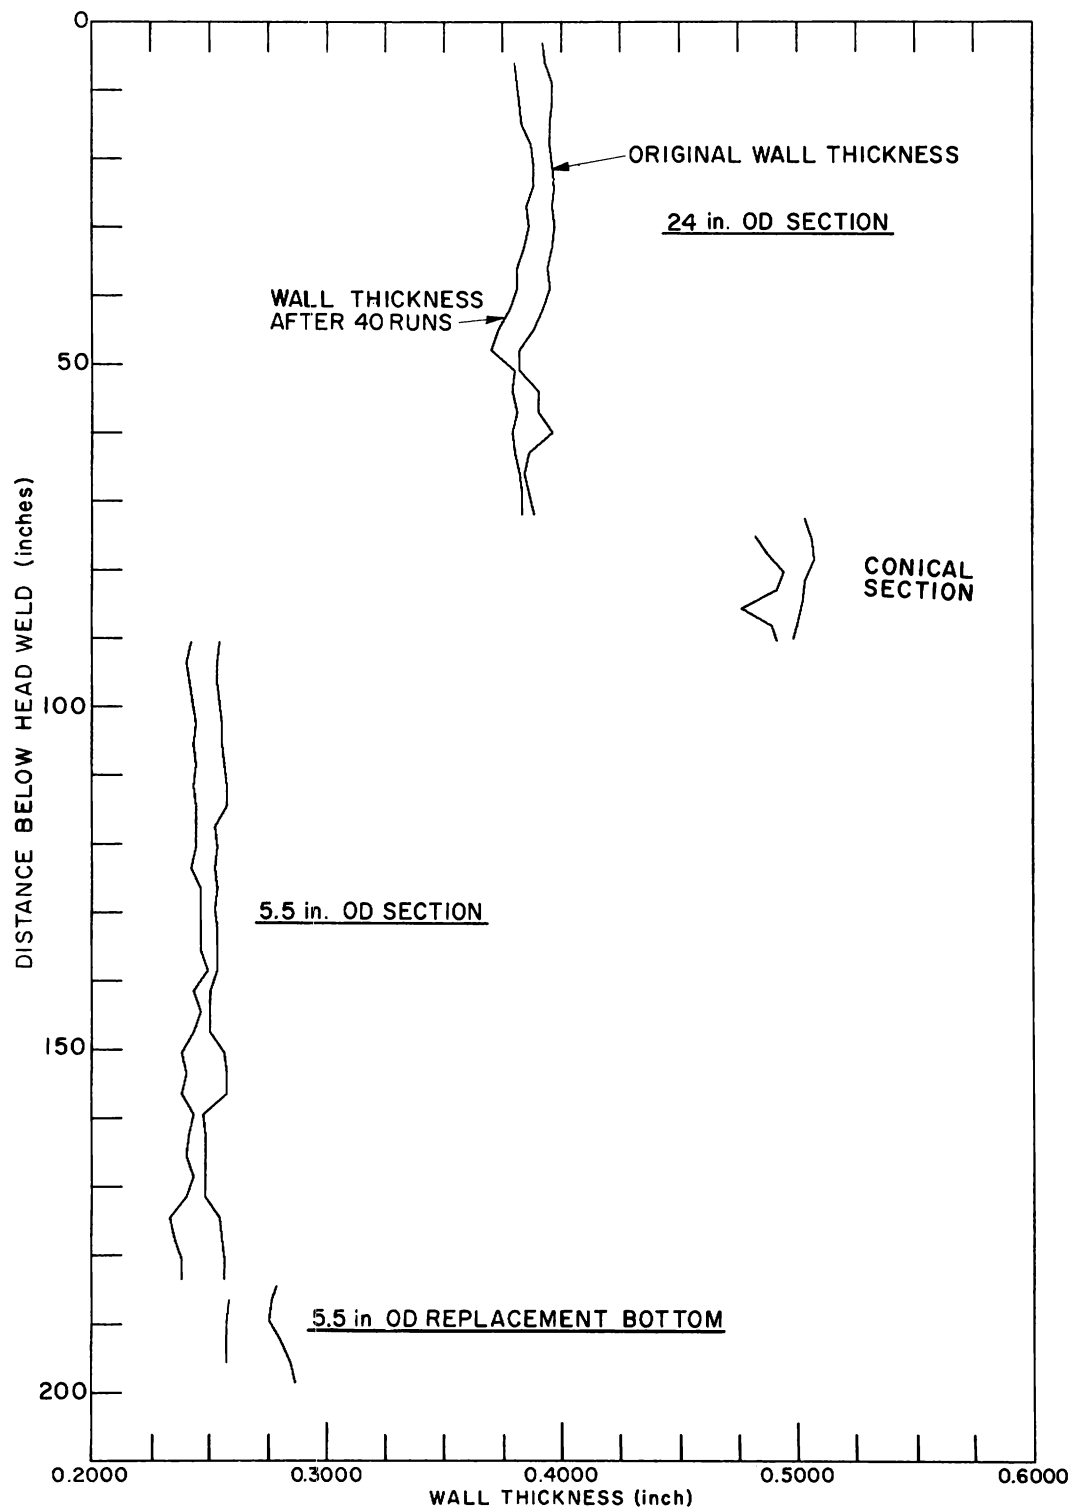
Fig. 6A. Hydrofluorinator Wall Thicknesses Before and After 40 Zirconium Runs (West Wall).
