# $\begin{array}{c} \text{IN-REACTOR MONITORING} \\ \text{OF ZIRCALOY-2 PRTR PRESSURE TUBES,} \\ \text{PART III} \end{array}$

JULY 1963 - NOVEMBER 1963

P. J. Pankaskie

Materials Development
Reactor and Fuels Research and Development Operation
Hanford Laboratories

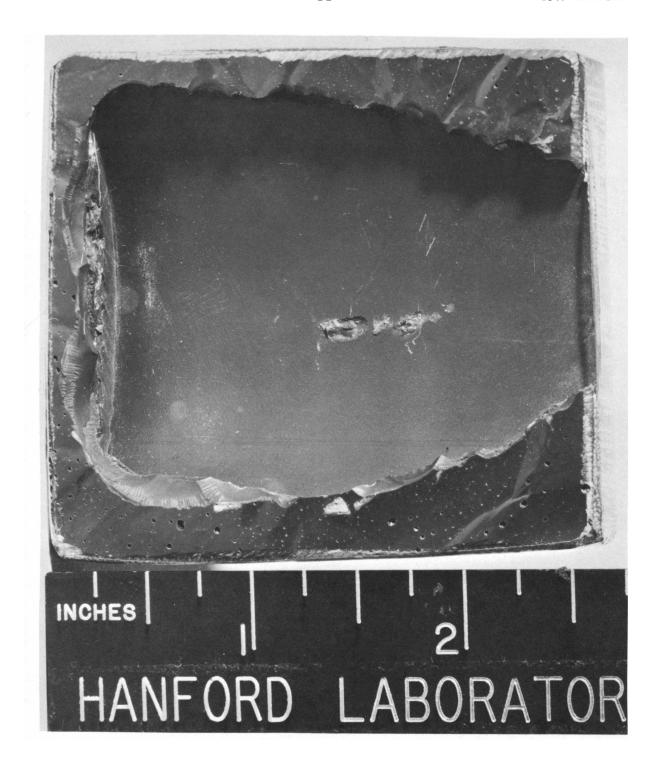
#### FIGURE 2

The pressure tubes from Process Channels 1358 and 1558 were discharged during this reporting period for suspected defects. Figure 2 shows a positive replica of the suspected defect found in Process Channel 1358. In-reactor measurements showed this suspected defect to be about 0.5 mm (0.020 in.) deep, 3 mm (1/8 in.) wide, and 6 mm (1/4 in.) long. Destructive examinations confirmed these measurements. The origin of this suspected defect is not now known. Its location in the pressure tube does not correspond to fuel element end brackets, spiral wire rod or bundle wraps, or fuel element bands. Hence, it does not appear that this suspected defect originated from fretting action.

Suspected Defect Inside Tube in Process Channel 1358  $\sim 2-1/2 \,\mathrm{X}$
