EVALUATION OF FAILED HOT GAS ISOSTATIC PRESSED FUEL RODS

C. J. Baroch

March 20, 1963

Vallecitos Atomic Laboratory
General Electric Company
San Jose, California

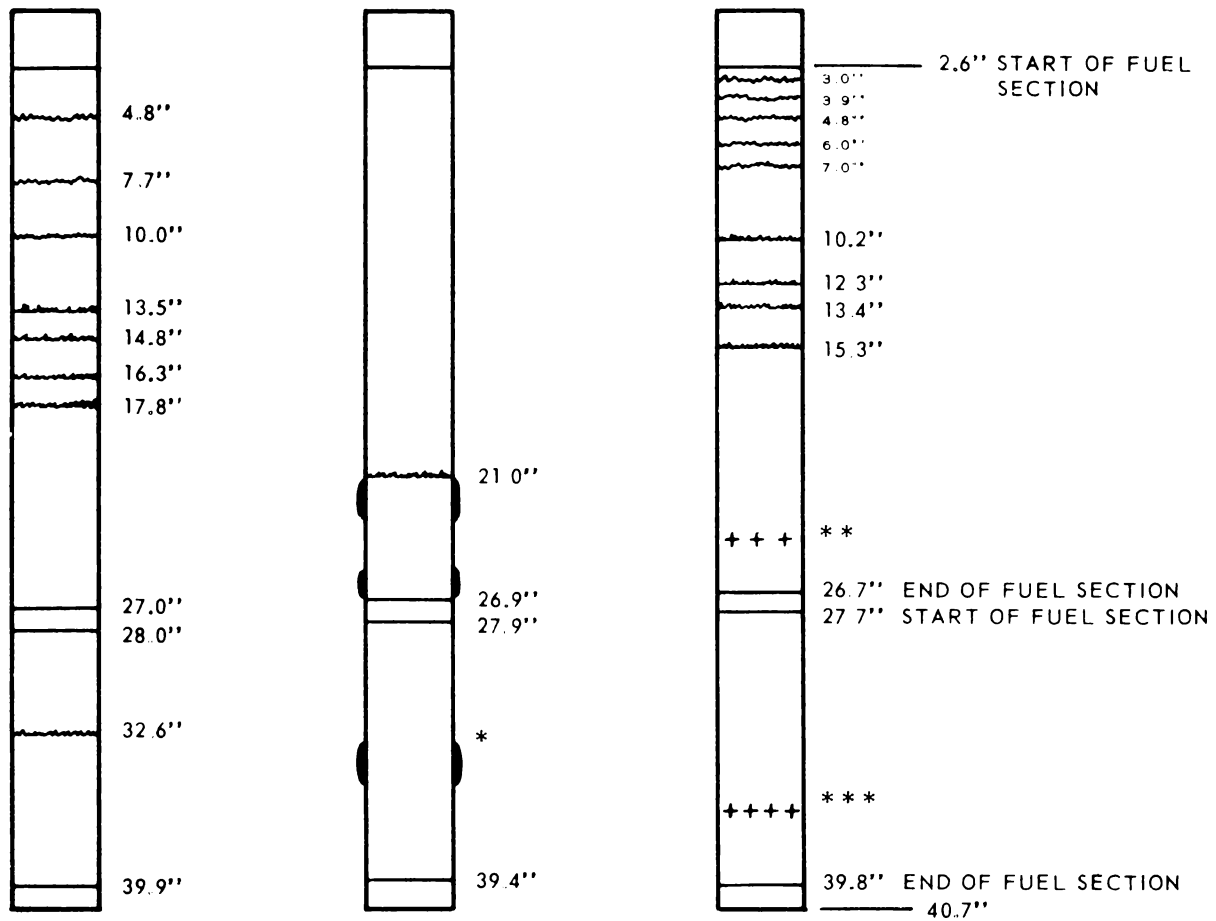
Figure 8. Location of Fractures in the BMI Rods

Several segments of the fuel rods and the BMI-2 rod were visually examined to determine the course of the failures. During handling, the BMI-2 rod also fractured in one location. The BMI-1 and BMI-4 rods were reassembled to determine the location of the fractures. Gamma scanning of the fuel rod segments was used to aid in the reassembly of the rods and to insure that the reassembly was correct. The location of the fractures was then determined by measurement made by gamma scan and the reassembled rod. A sketch of the three fuel rods and the approximate location of the failures are shown in Figure 8.

- * AREA OF ABNORMAL INCREASE IN DIAMETER
- ** ARTIFICIAL FRACTURE IN AREA NOT EXHIBITING RED BROWN CORROSION PRODUCT
- *** ARTIFICIAL FRACTURE IN AREA EXHIBITING A RED BROWN CORROSION PRODUCT

A 24-inch section of the BMI-4 rod which did not contain any visible fracture was subjected to a bending test to determine whether there were any other areas of weakness in the rod. The rod was supported at both ends and positioned at an angle of about 45 degrees with the horizontal. A downward force was applied at the center of the rod with the "slaves" and the rod broke with very little force being applied in an area exhibiting a reddish brown corrosion product. The test was repeated on the remaining 20-inch section and the rod broke this time in the middle in an area not exhibiting the reddish brown corrosion product. The downward force required to cause this fracture was estimated to be about 15 pounds. The location of these fractures are shown in Figure 8.

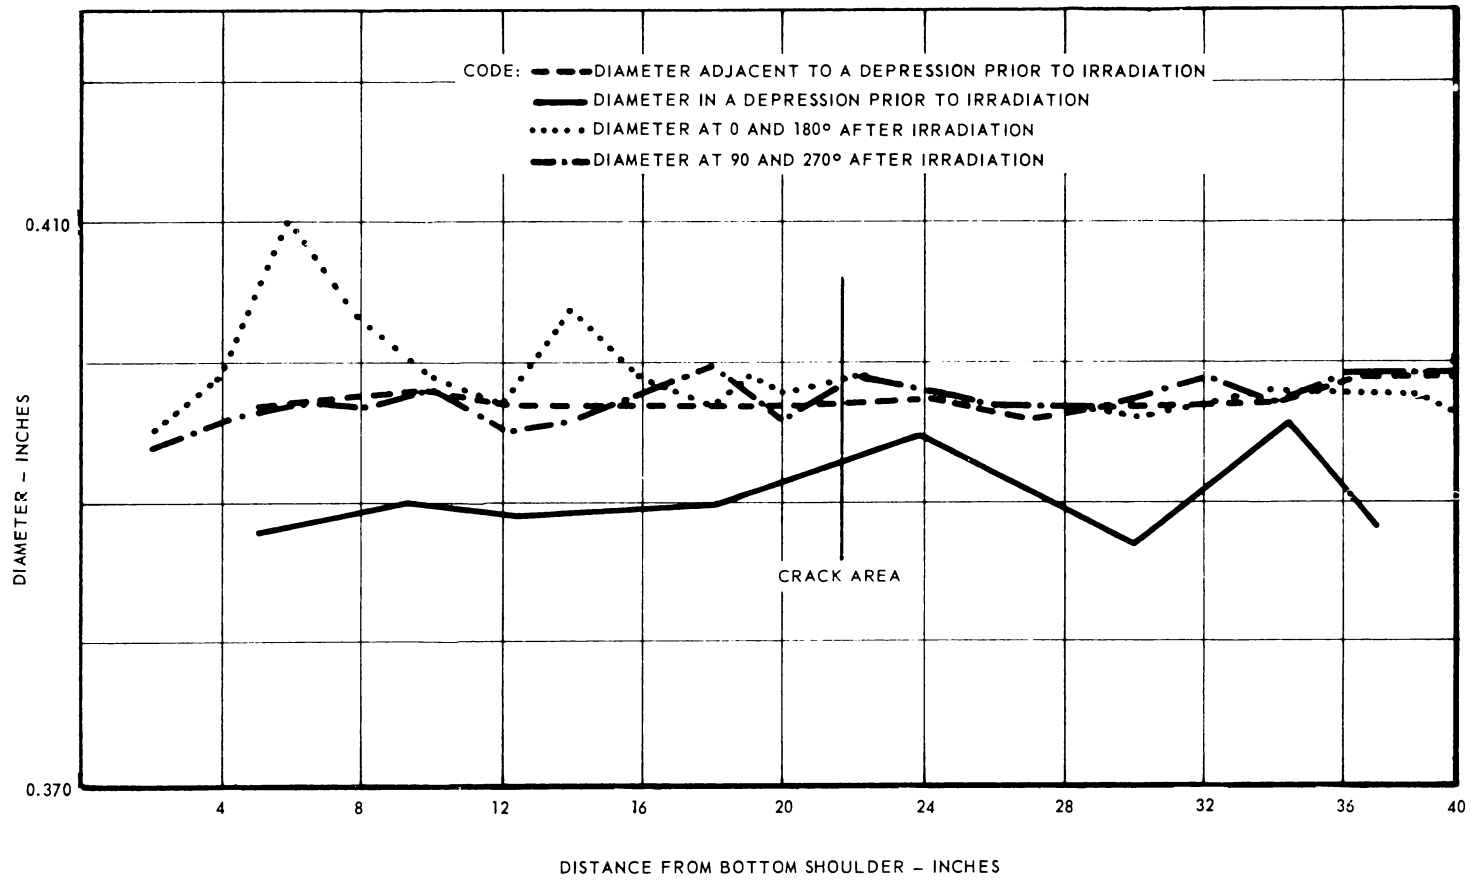
Figure 9. Pre- and Post-Irradiation Measurements of BMI-2 Rod

Diametral and longitudinal measurements were taken of the BMI-2 rod as well as diametral measurements of the 3-inch segment of BMI-1 rod. A plot of the diameter of the BMI-2 rod after irradiation along the length at two different radial angles is shown in Figure 9. This figure also includes the pre-irradiation measurements. At two locations there has been some increase in the diameter of the BMI-2 rod, but there was no increase in the diameter of the 3-inch segment of BMI-1 rod. Whether the increased diameter is actually caused by swelling of the rod, by surface irregularities prior to irradiation, or by deposition of a corrosion product was not determined. Measurement of the rod after cleaning with a wire brush, however, did not result in any significant change in the diameter of the rod. The longitudinal measurements which were made are of insignificant value because of the difficulty in precisely matching the fracture faces. Photographs of the failed BMI rods are shown in Figures 10 through 12. Front and rear views of the fracture in BMI-2 rod are shown in Figure 10. The appearance of three different fractures from unidentified fuel rods is shown in Figure 11. A close-up view in the area of the connector pin of BMI-4 rod is shown in Figure 12.

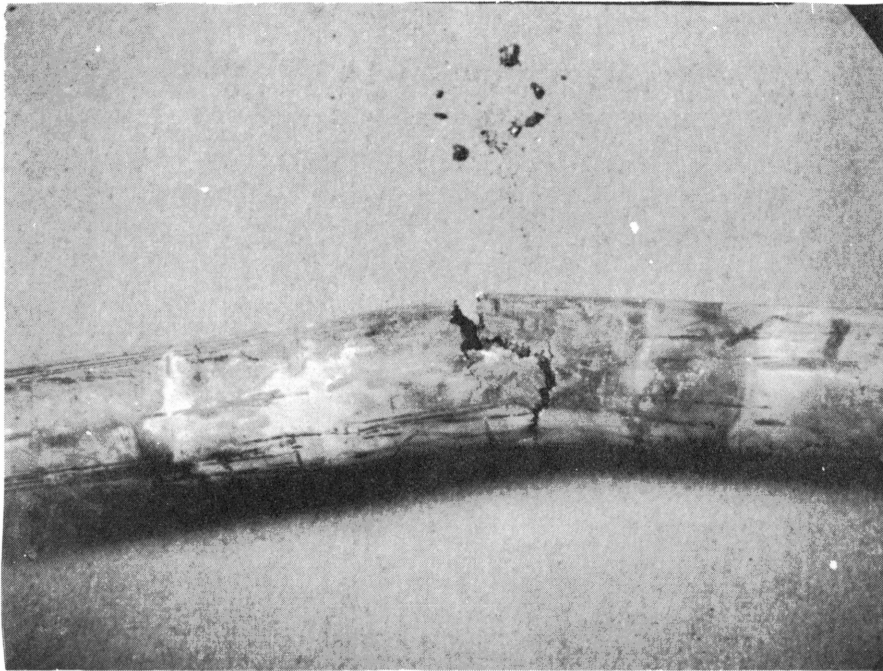
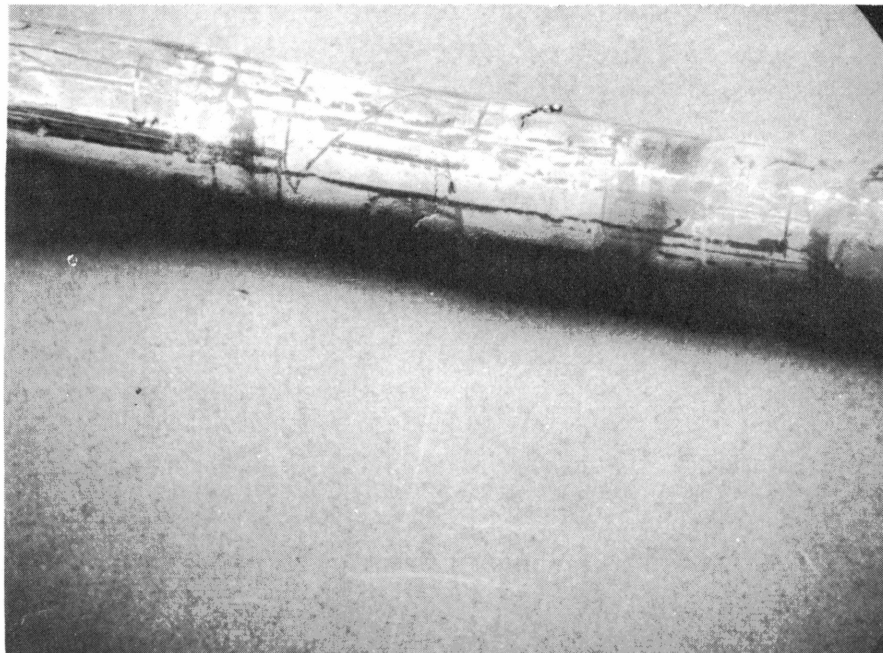
FIGURE 10 LONGITUDINAL VIEW OF FAILURE IN BMI-2 ROD. NOTE THE DARK COLORED DEPOSIT SURROUNDING THE FRACTURE AREA, PARTICULARLY ON THE FRONT SIDE

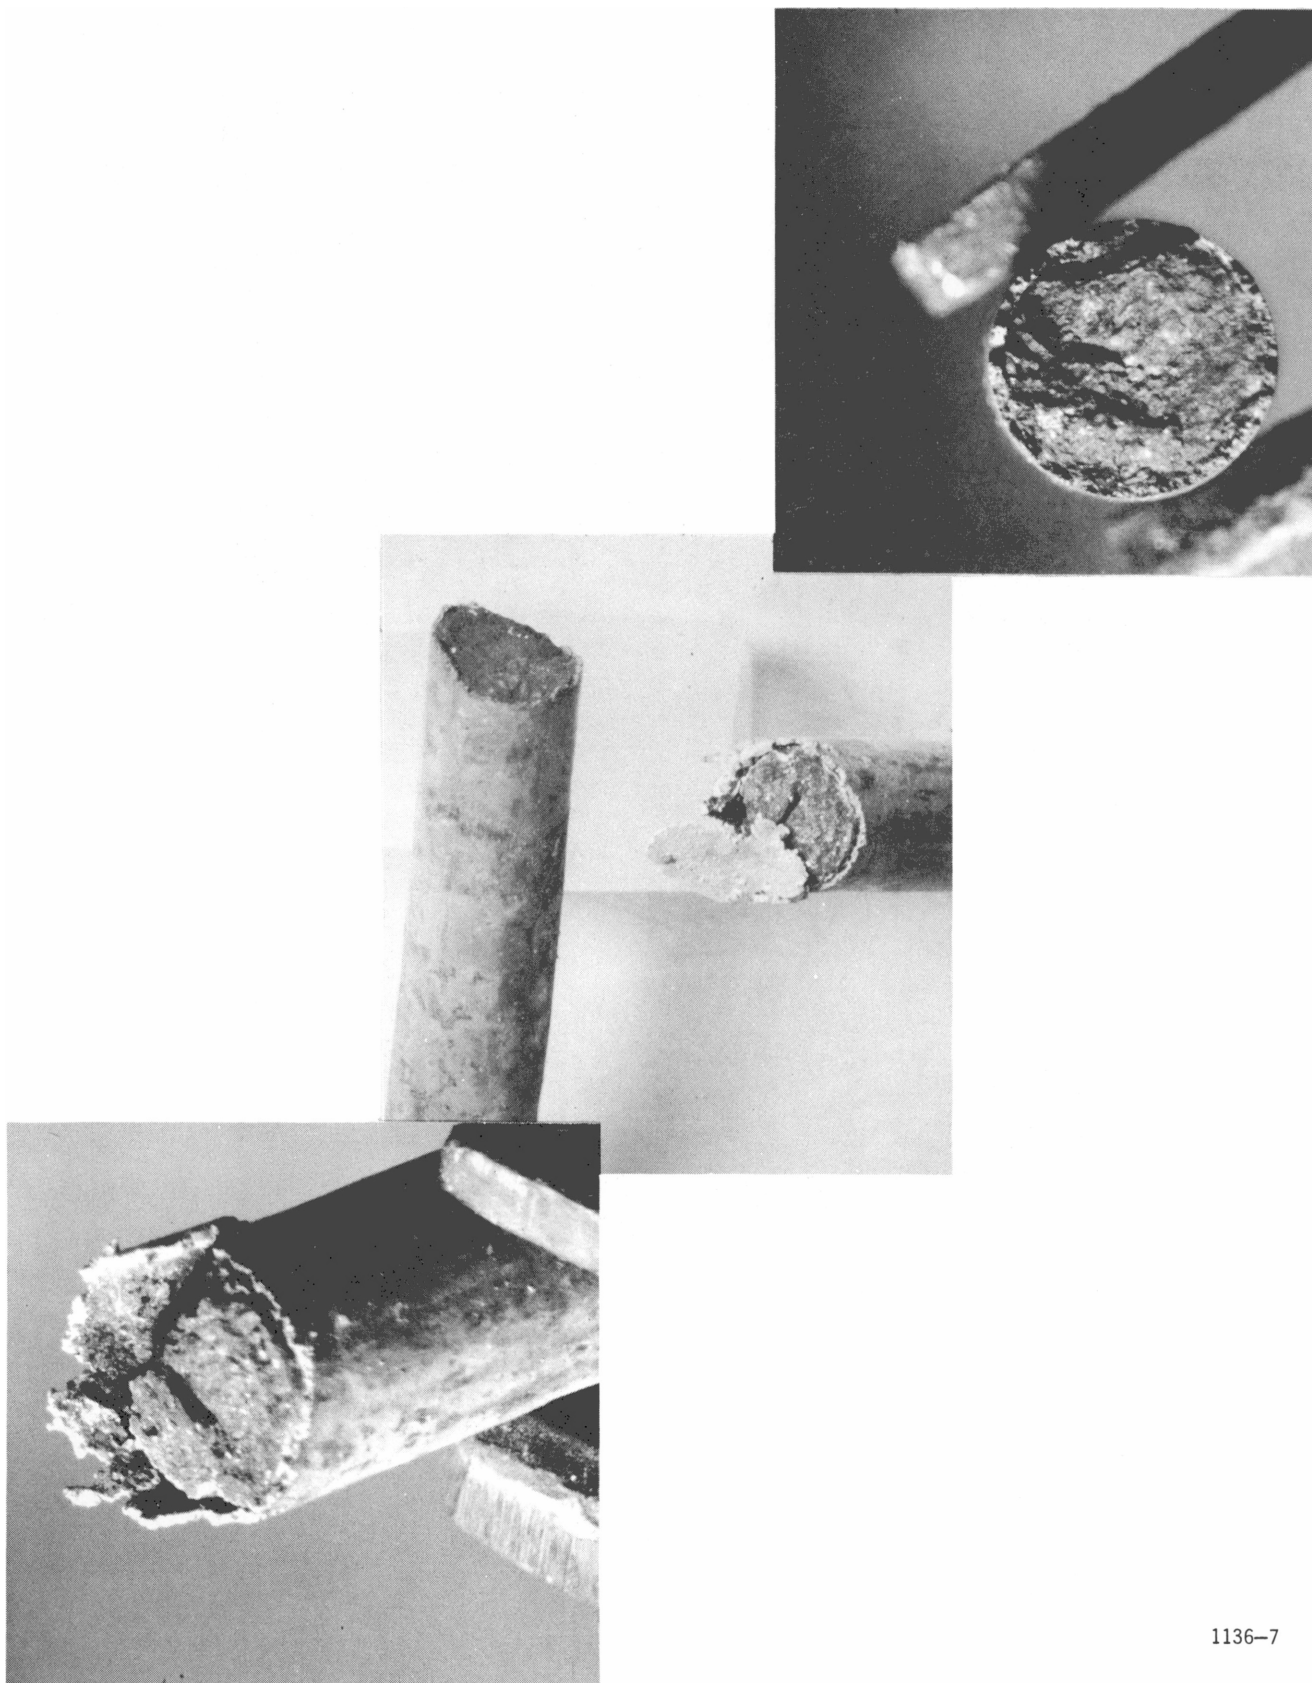
FIGURE 11 APPEARANCE OF THREE DIFFERENT FRACTURES FROM AN UNIDENTIFIED BMI ROD

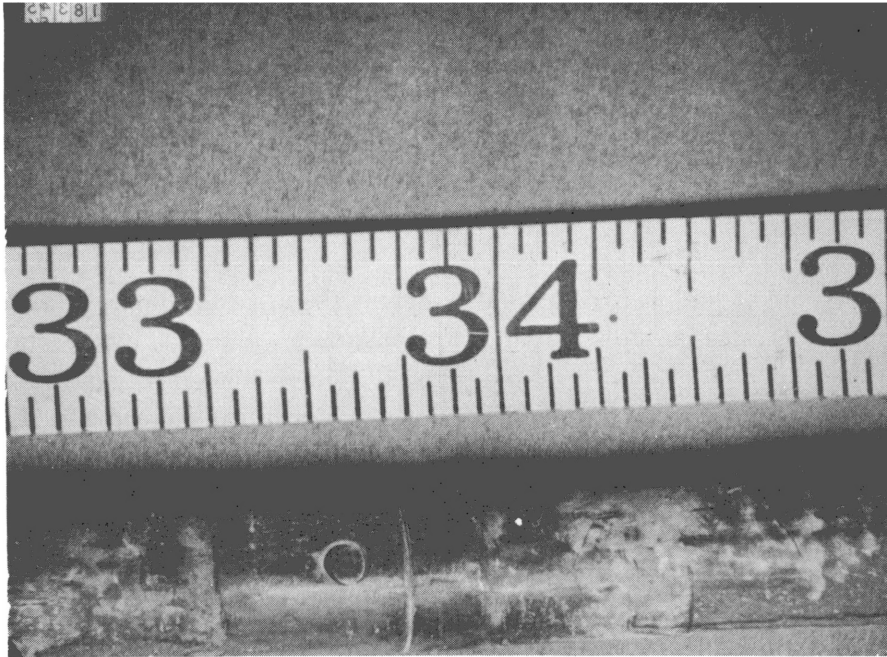
FIGURE 12 CLOSE UP OF PIN AREA OF BMI-4 ROD. NOTE THE CLEAN APPEARANCE FOR ABOUT 1/2 INCH ON EACH SIDE OF THE PIN.

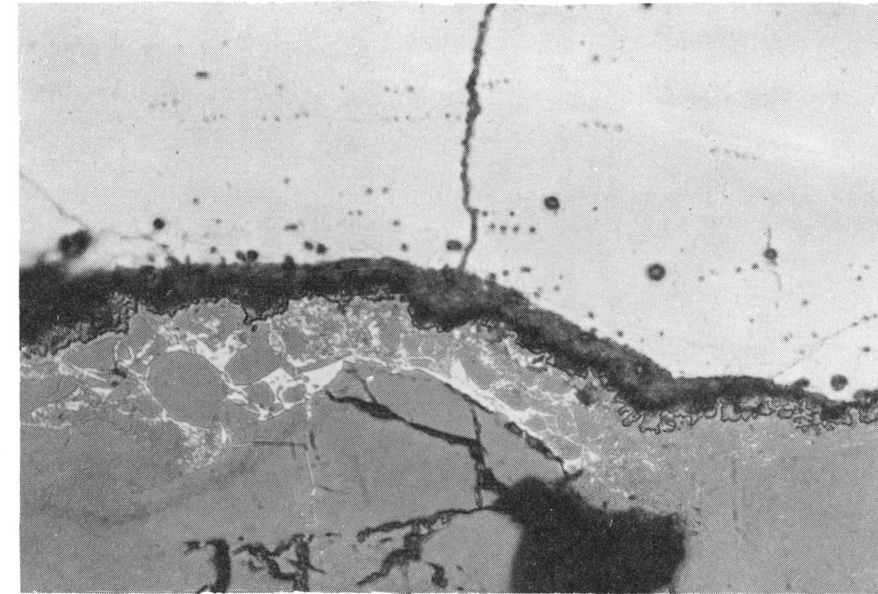
Figures 13 through 18 are some of the photographs taken during the metallographic examination. A reaction zone between the UO_2 and stainless steel and permeation of the UO_2 by the stainless steel as indicated by the presence of a metallic phase in the UO_2 are shown in Figure 13. The appearance of the clad on both the inside and outside surfaces are shown in Figure 14. Large amounts of grain boundary precipitate, hair line cracking, and large grain size in the stainless steel clad from a non failure area are also shown in Figure 14.

COMMENTS: NOTE THE REACTION ZONE BETWEEN THE UO_2 AND CLAD AND THE METALLIC PHASE IN THE FUEL.

FIGURE 13 EVIDENCE OF REACTION BETWEEN UO_2 AND CLAD

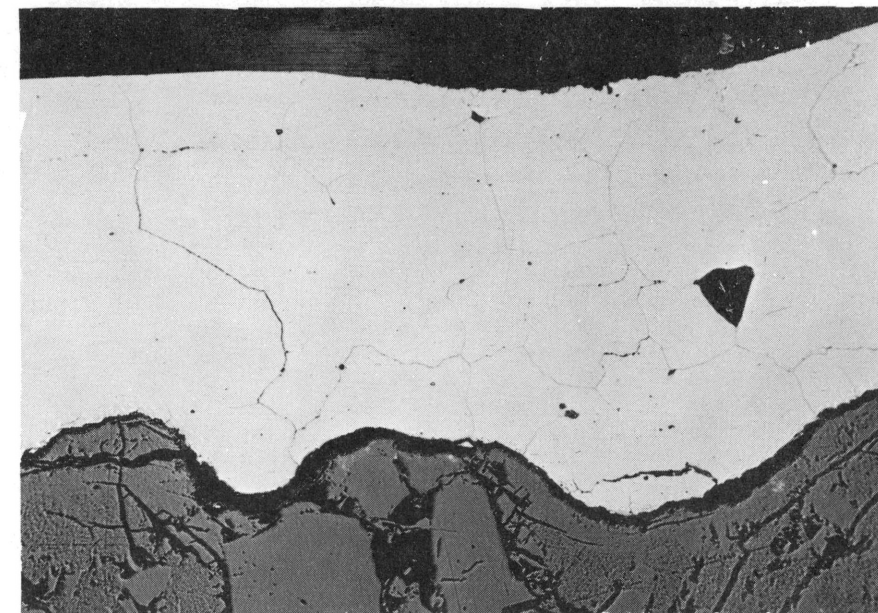
COMMENTS: NOTE THE HEAVY GRAIN BOUNDARY PRECIPITATE, HAIR LINE CRACKS, DISTORTED CLADDING, AND PENETRATION OF CLAD INTO UO_2 .

FIGURE 14 APPEARANCE OF AS-POLISHED CLAD IN NON-FAILURE REGION

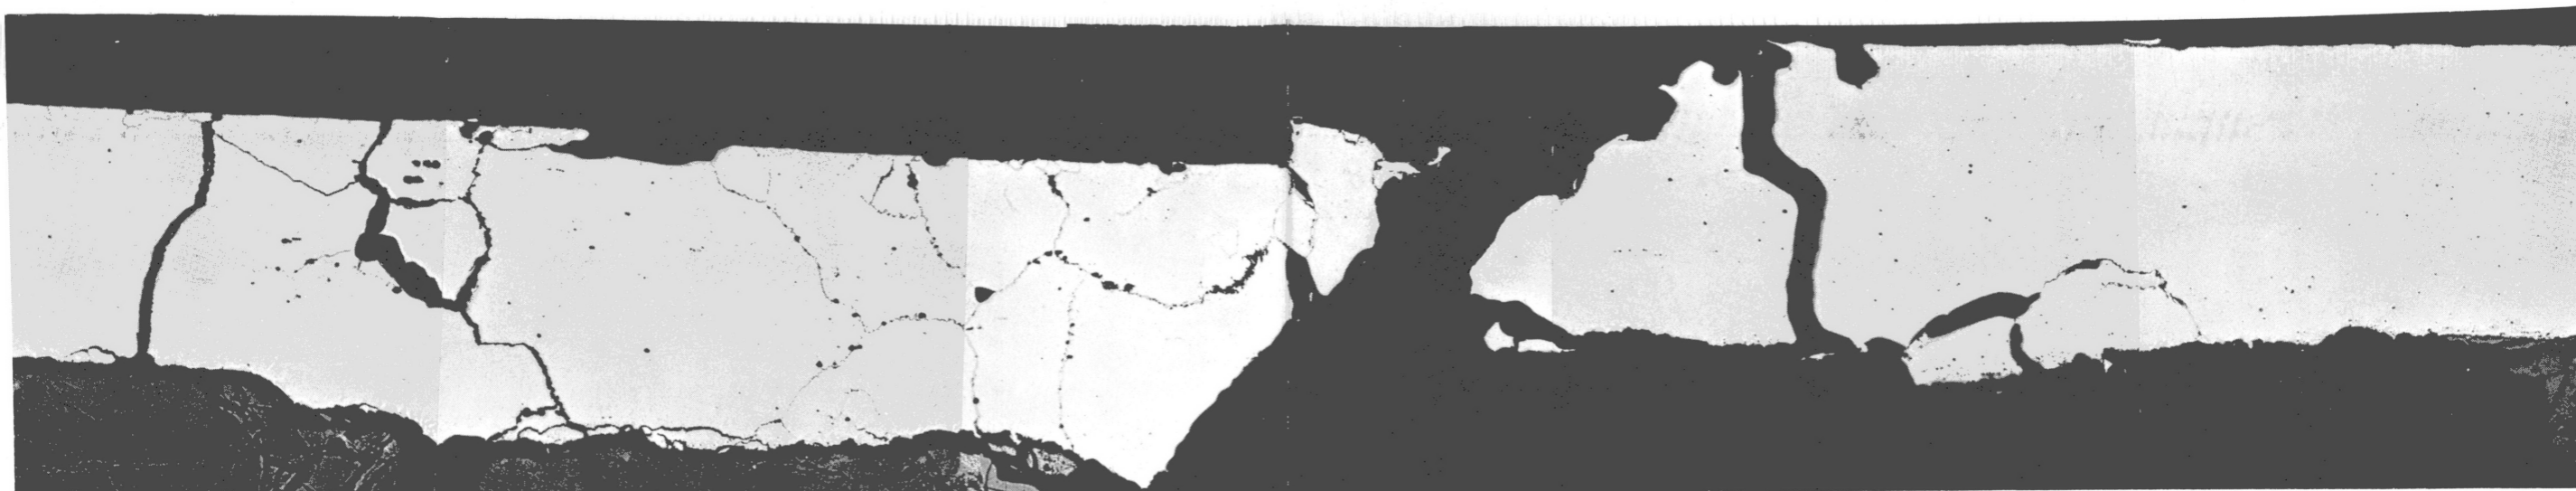
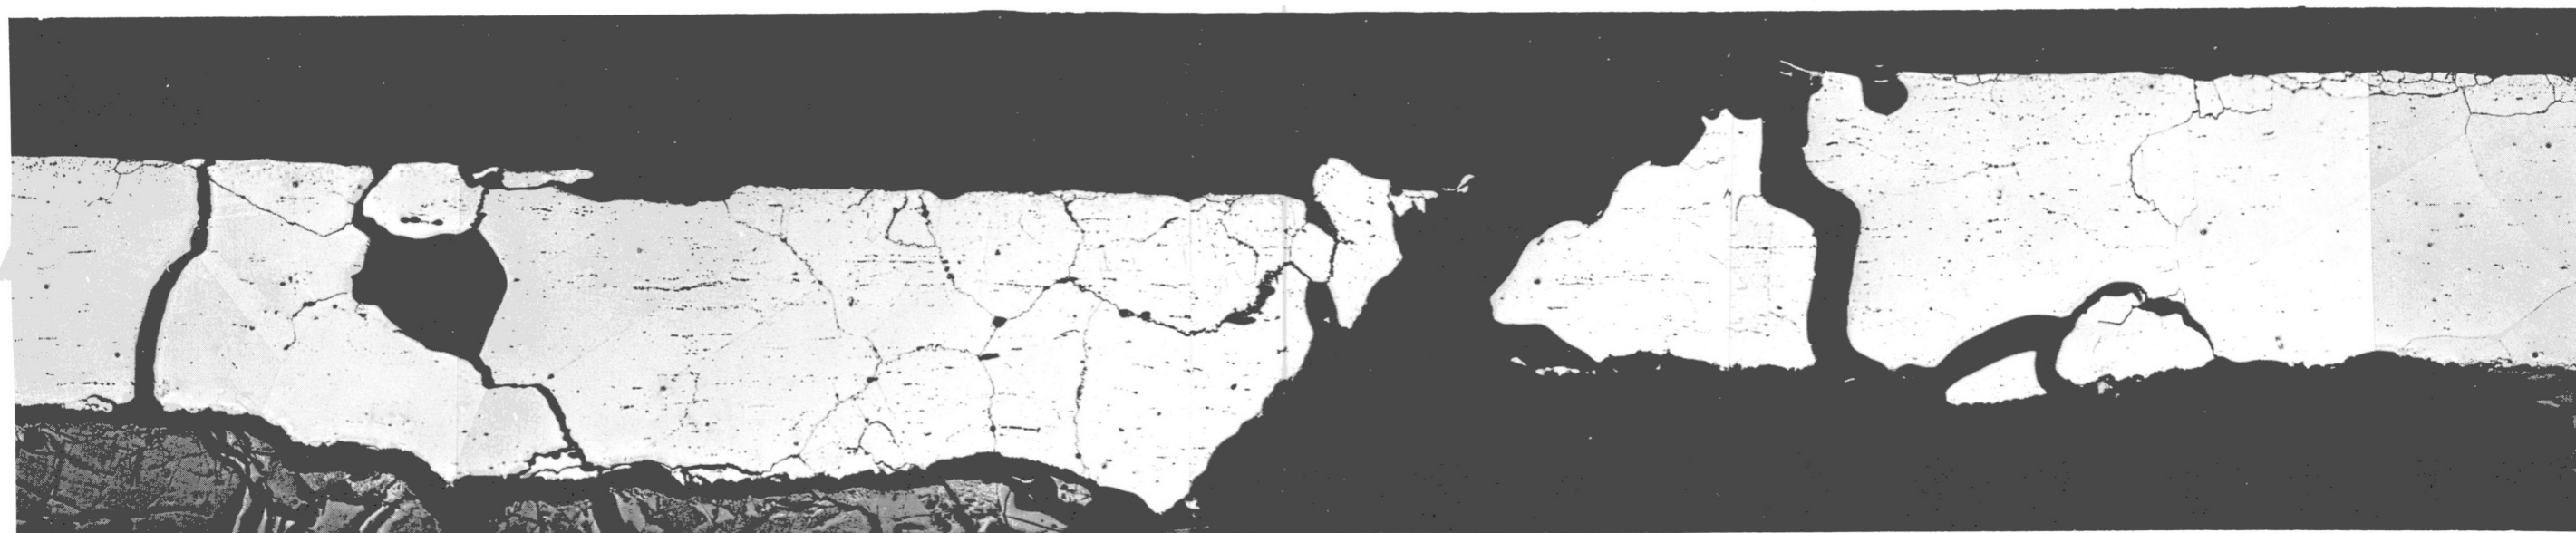
A composite photograph of the unetched clad in the vicinity of a failure is shown in Figure 15a. This photograph indicates that there is wide variation in the metallurgical structure of the clad. For example, there are areas in which there is a large amount of grain boundary precipitate while in other areas, there is considerably less grain boundary precipitate. This figure indicates that there are many hairline cracks in the clad which did not result in fracturing of the fuel rod, but certainly reduced the integrity of the rod. A composite photograph of the same section after etching with Vilellas' reagent is shown in Figure 15b. These photographs also demonstrate the wide variation in the metallurgical structure of the clad, even in a one-inch longitudinal section. Many of the areas which did not show a grain boundary precipitate in the unetched condition do, however, contain some precipitate at the grain boundary and within the grains as shown by comparing Figure 15a with Figure 15b.

FIGURE 15 APPEARANCE OF CLAD IN A LONGITUDINAL SECTION OF THE FUEL ROD IN THE AREA OF FAILURE

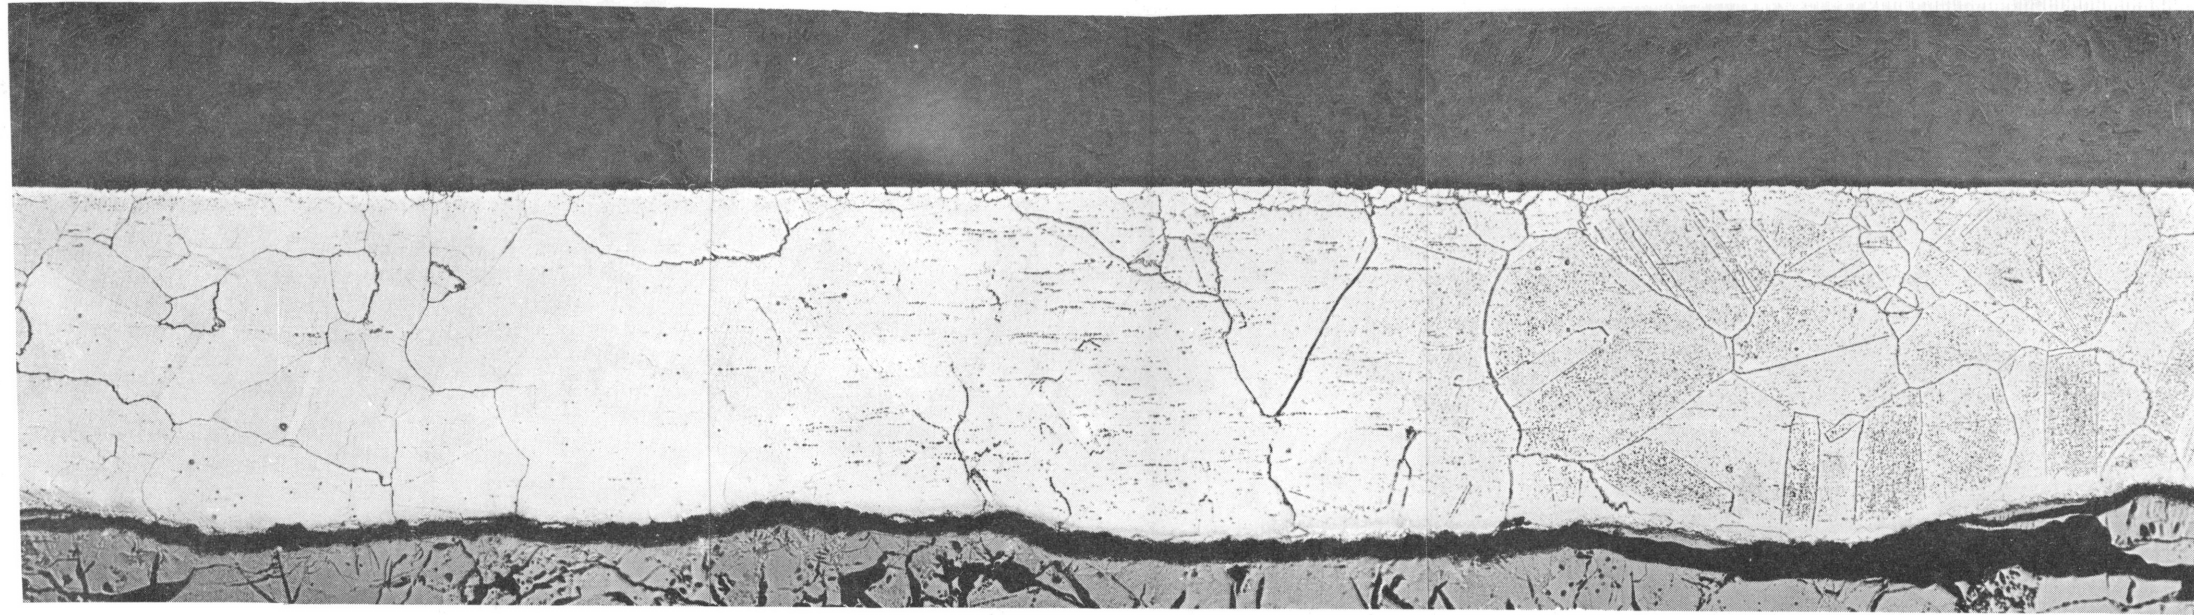
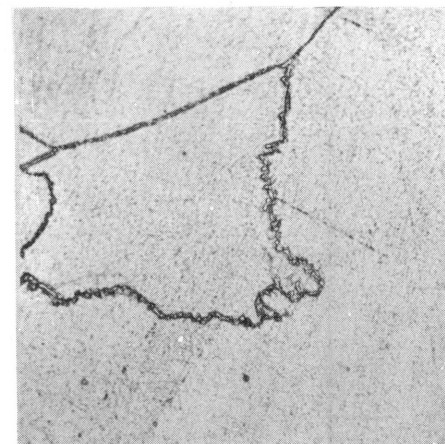
Figure 16. Appearance of Clad in a Non-Failure Area - Hot Gas Isostatic Pressed Rods, Assembly 4-L

A composite photograph of the clad sample taken from a nonfailure area is shown in Figure 16a. Even in a nonfailure area, there are large amounts of precipitate in the grain boundaries, within the grains, and on twin faces. There are no hairline cracks visible in this photograph, however, the large amount of precipitate at the grain boundaries indicates that this area of the clad could be quite susceptible to intergranular corrosion and/or cracking. There is some evidence of intergranular corrosion as indicated by the heavy film surrounding some of the grains in the left side of the photograph. An enlarged photograph more clearly defining one of these grains is shown in Figure 16b.

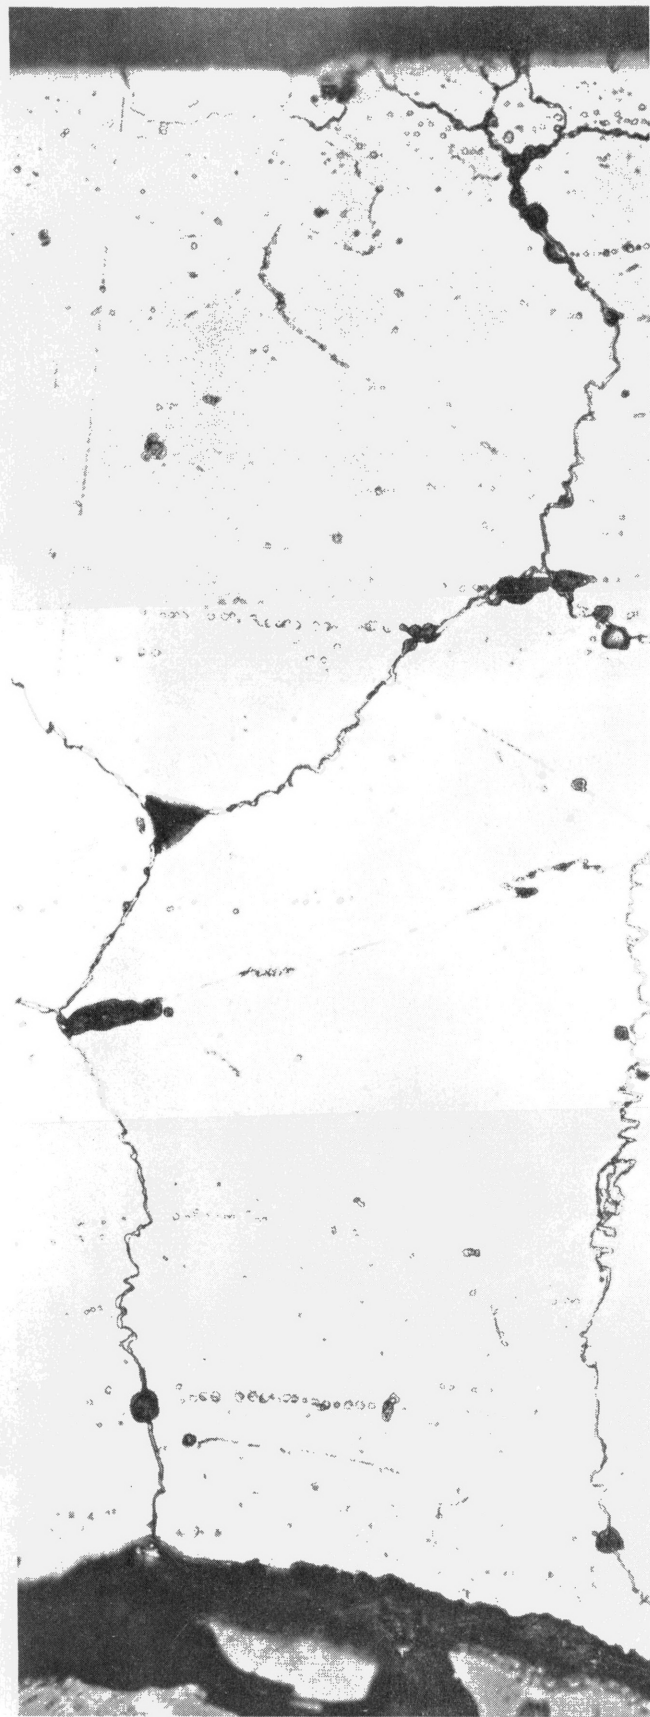
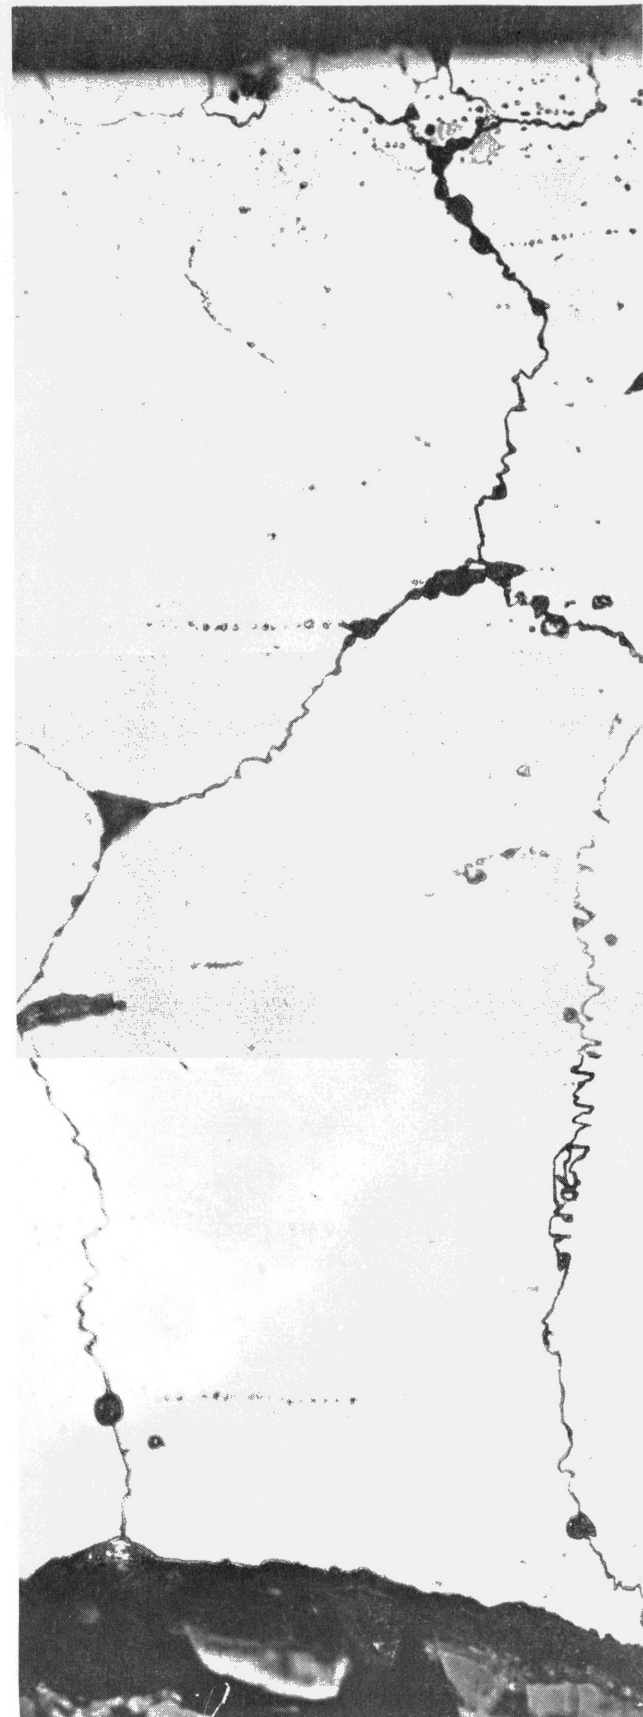
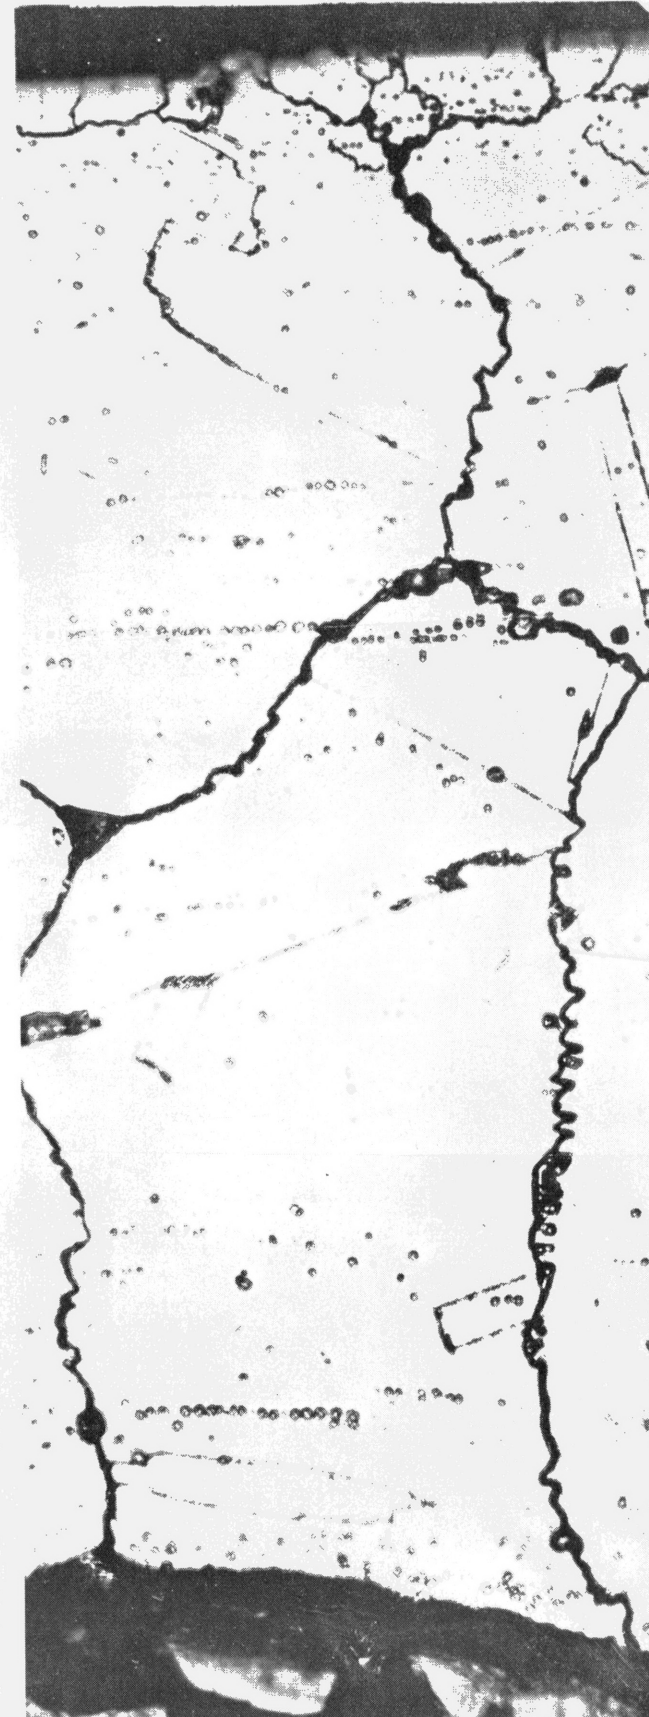
FIGURE 17 IDENTIFICATION OF
PHASES IN FAILURE
AREA OF FUEL ROD.

The identification of the precipitate was determined by etching for carbides, ferrite and sigma phase. Photographs of the clad in failure and nonfailure areas which were obtained during the investigation, are shown in Figures 17 and 18 respectively. The investigation indicated that carbides, sigma phase, and ferrite are present in the grains and at the grain boundaries of both samples of clad. The presence of a carbide precipitate is indicated in photograph b while the presence of sigma phase is proven by comparing photographs c (carbides and sigma phase etched) and b (carbides etched). The presence of ferrite is proven by comparing photograph a (austenite etched; ferrite, sigma phase, and carbides in relief) with photograph c.

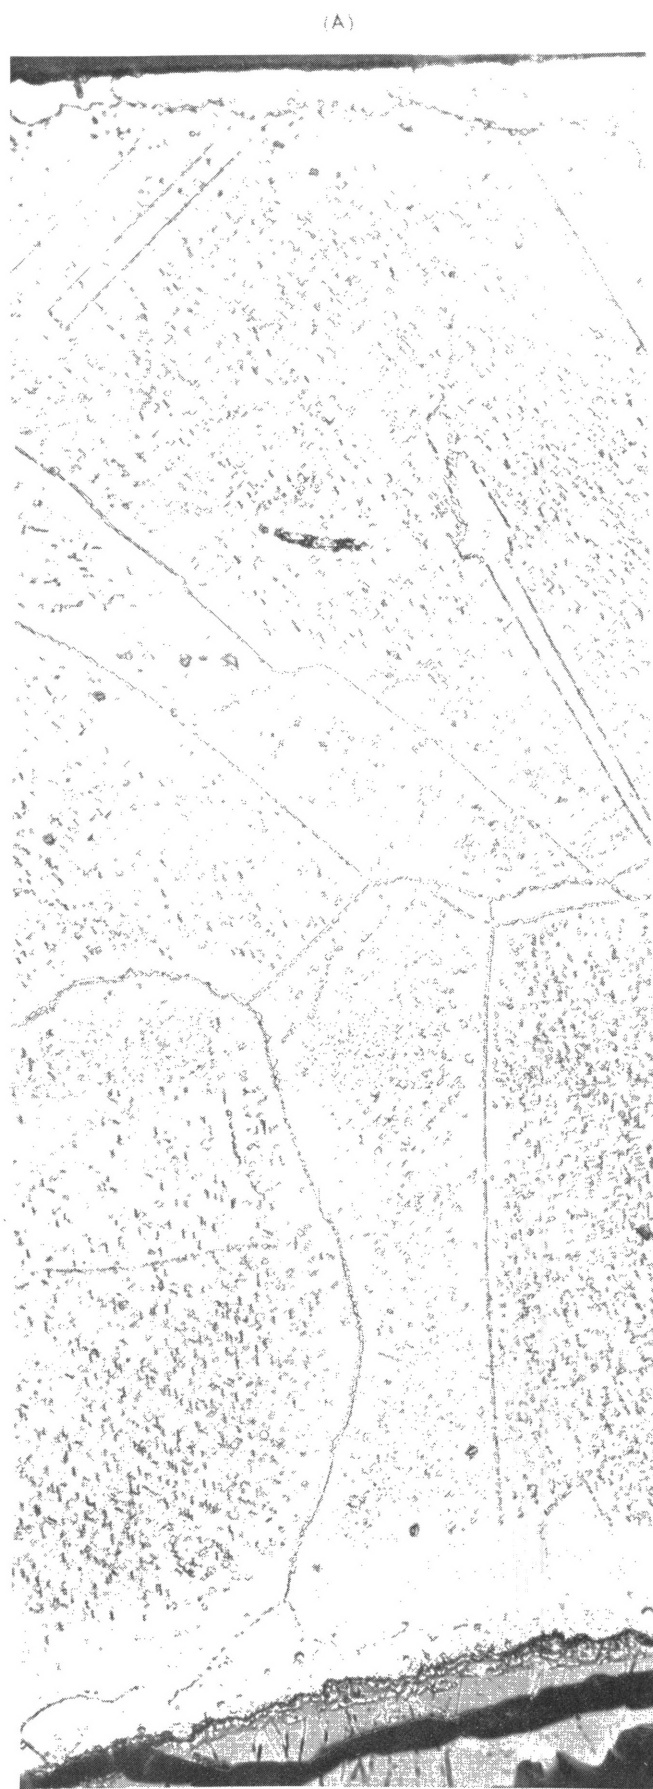
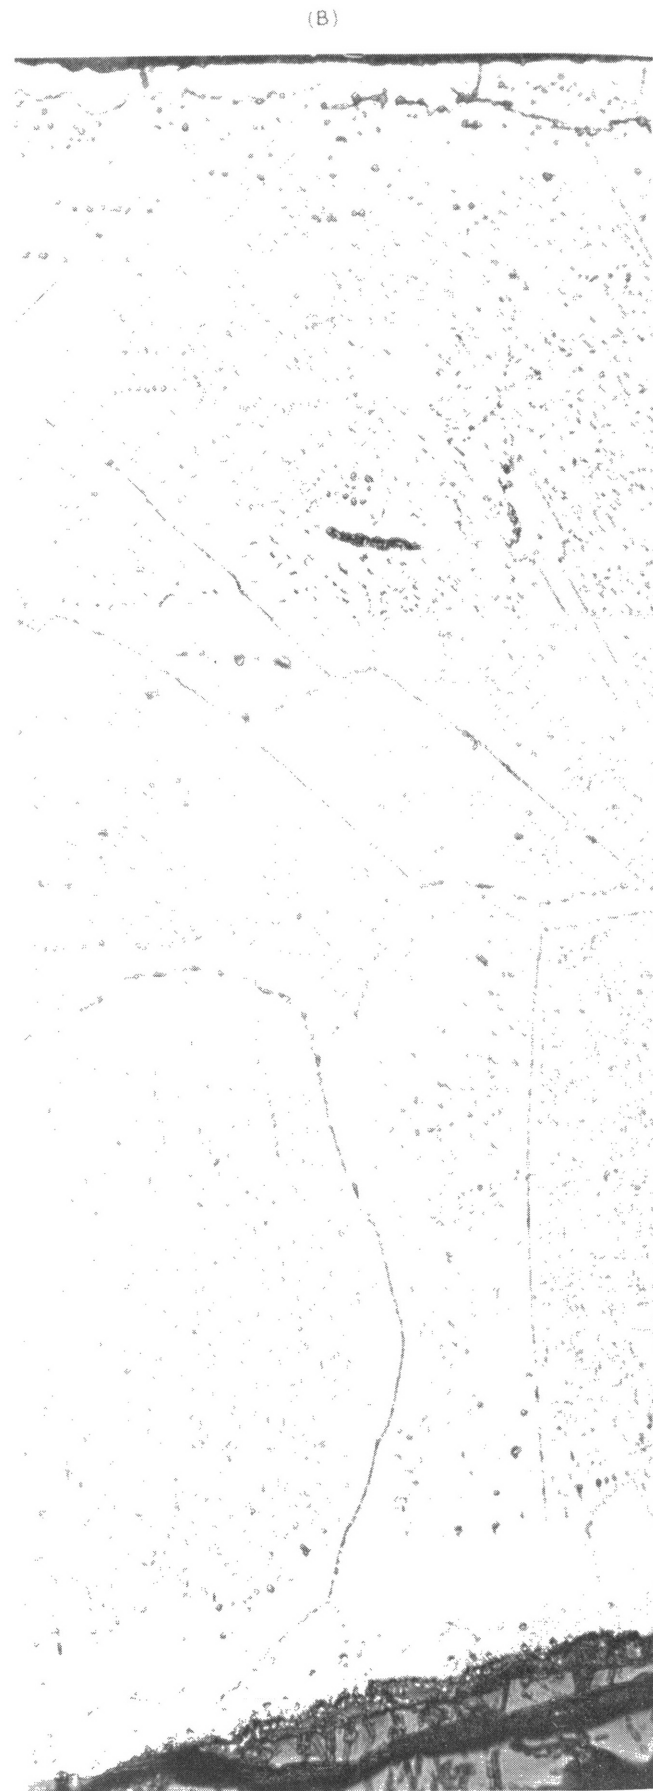
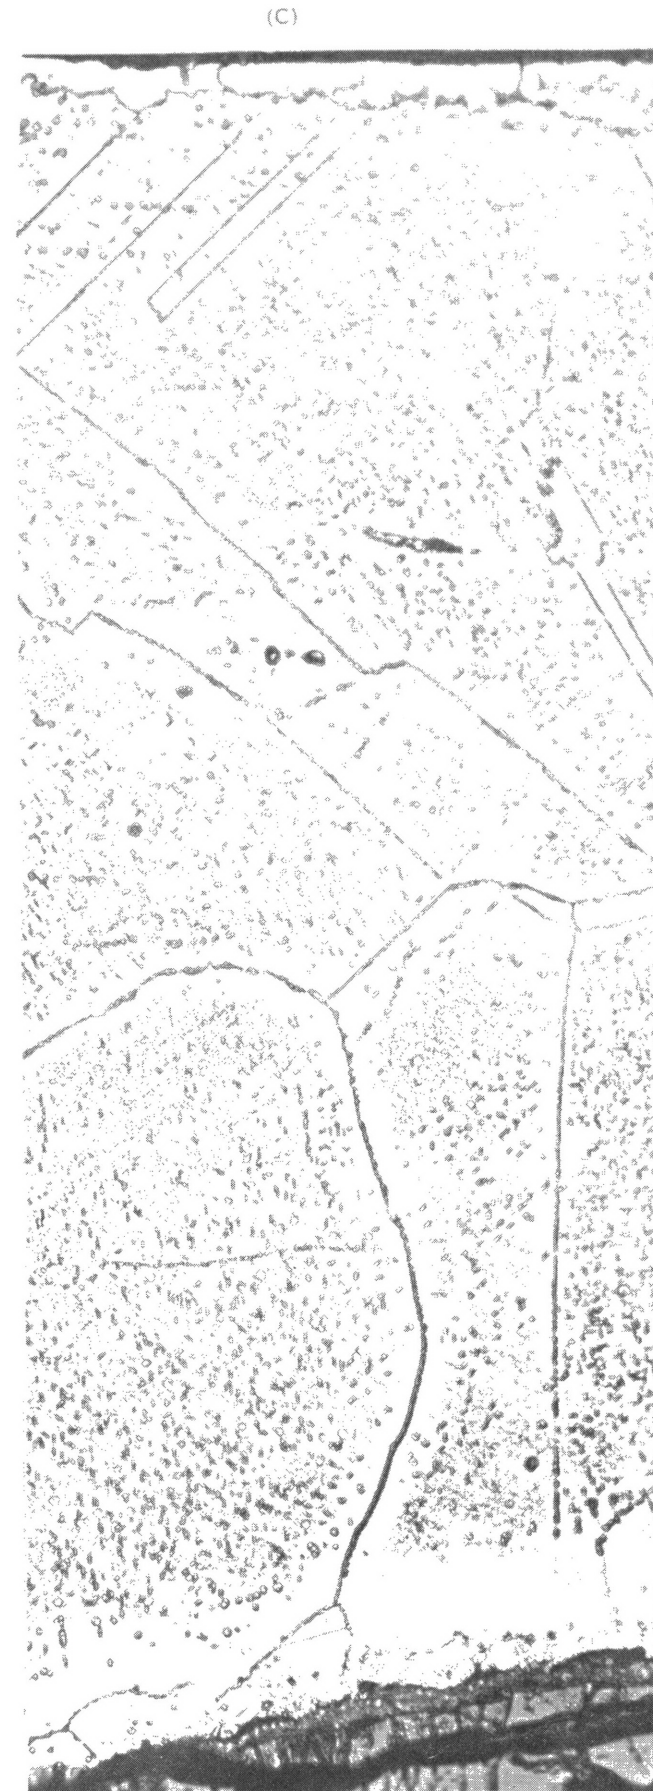
FIGURE 18 IDENTIFICATION OF PHASES IN
NON-FAILURE AREA OF FUEL
ROD

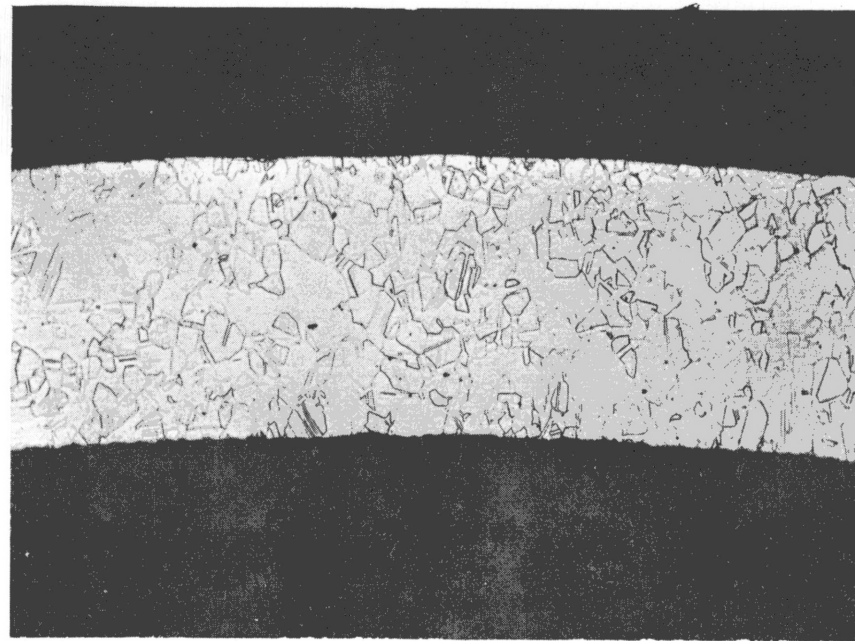
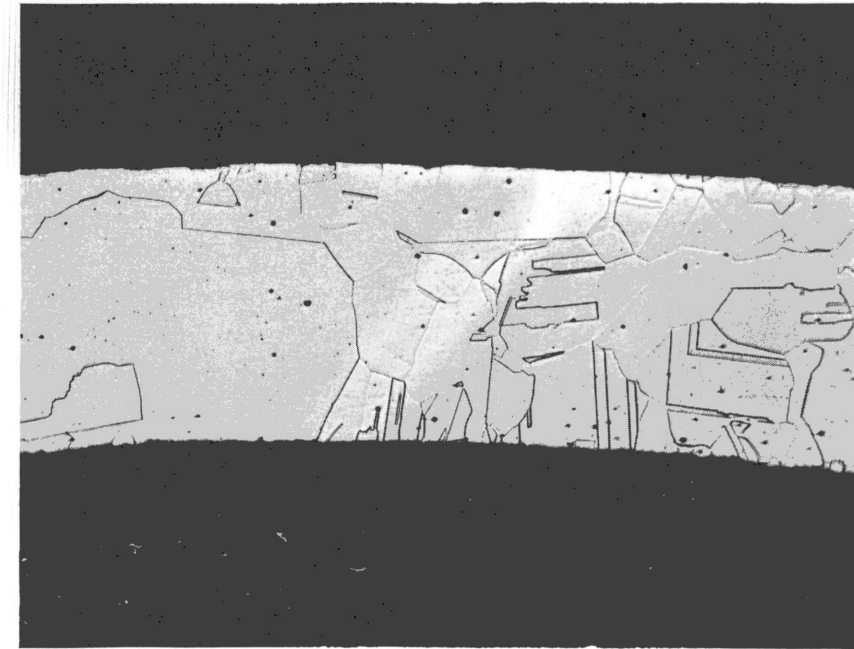
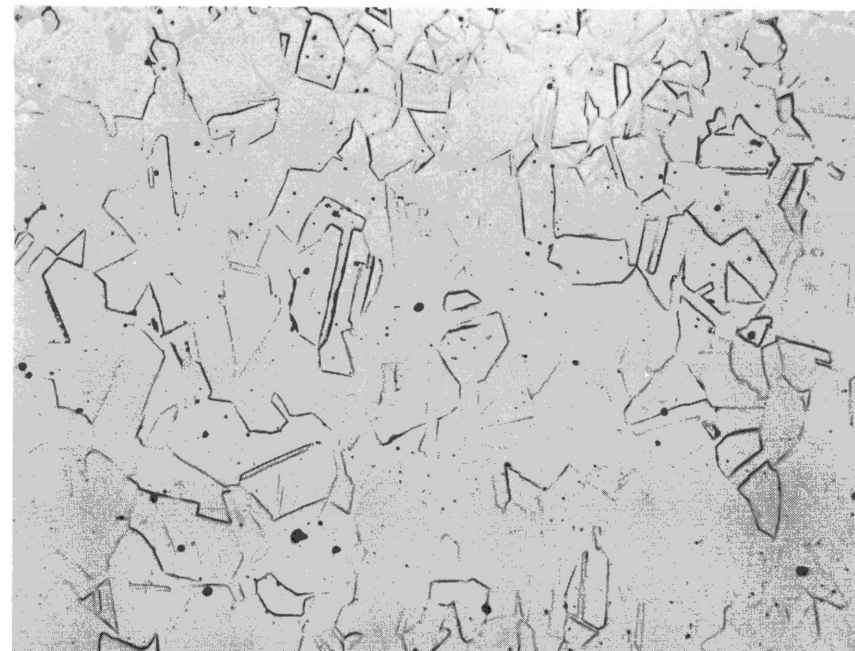
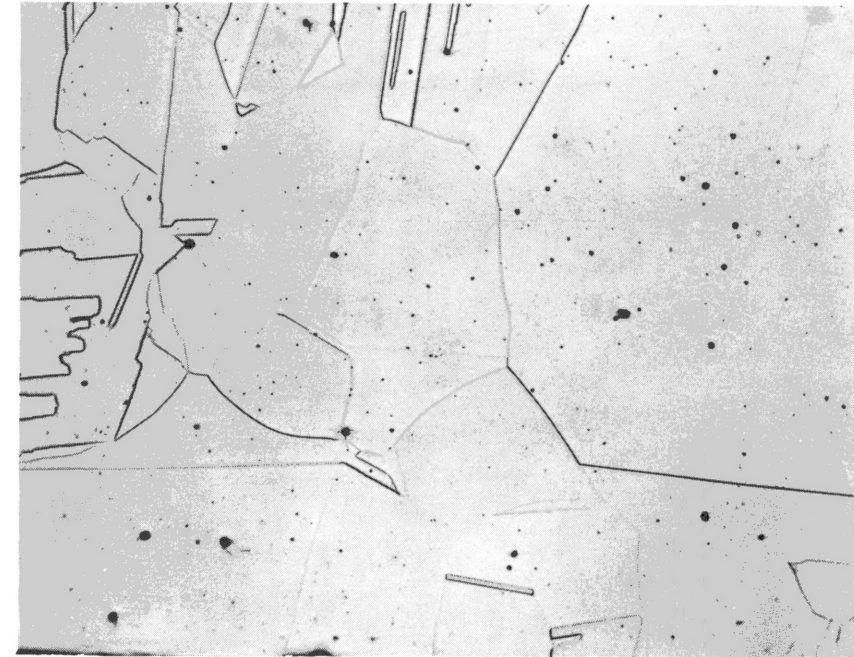
the tubing did not contain UO_2 and any effects noted could, therefore, be attributed to the heat treatment or autoclave atmosphere. Representative structures of the material in both conditions are shown in Figure 19. A marked increase in grain size is evident due to the pressing cycle, an effect noted in previous fabrication of the isostatic pressed fuel rods. Grain boundary precipitates are not apparent suggesting that the pressing treatment would not cause embrittlement of the cladding. The Diamond Pyramid Hardness (DPH) of the as-received material was 301 (29Rc), which is characteristic of a 5 to 10 per cent cold worked steel. The DPH hardness of the fabricated cladding was 196 (90 Rb) which is representative of annealed stainless steel.

FIGURE 19 COMPARISON OF THE CLAD STRUCTURES IN THE AS-RECEIVED AND HOT GAS ISOSTATIC PRESSED CONDITIONS
