EVALUATION OF FAILED HOT GAS ISOSTATIC PRESSED FUEL RODS

C. J. Baroch

March 20, 1963

Vallecitos Atomic Laboratory
General Electric Company
San Jose, California

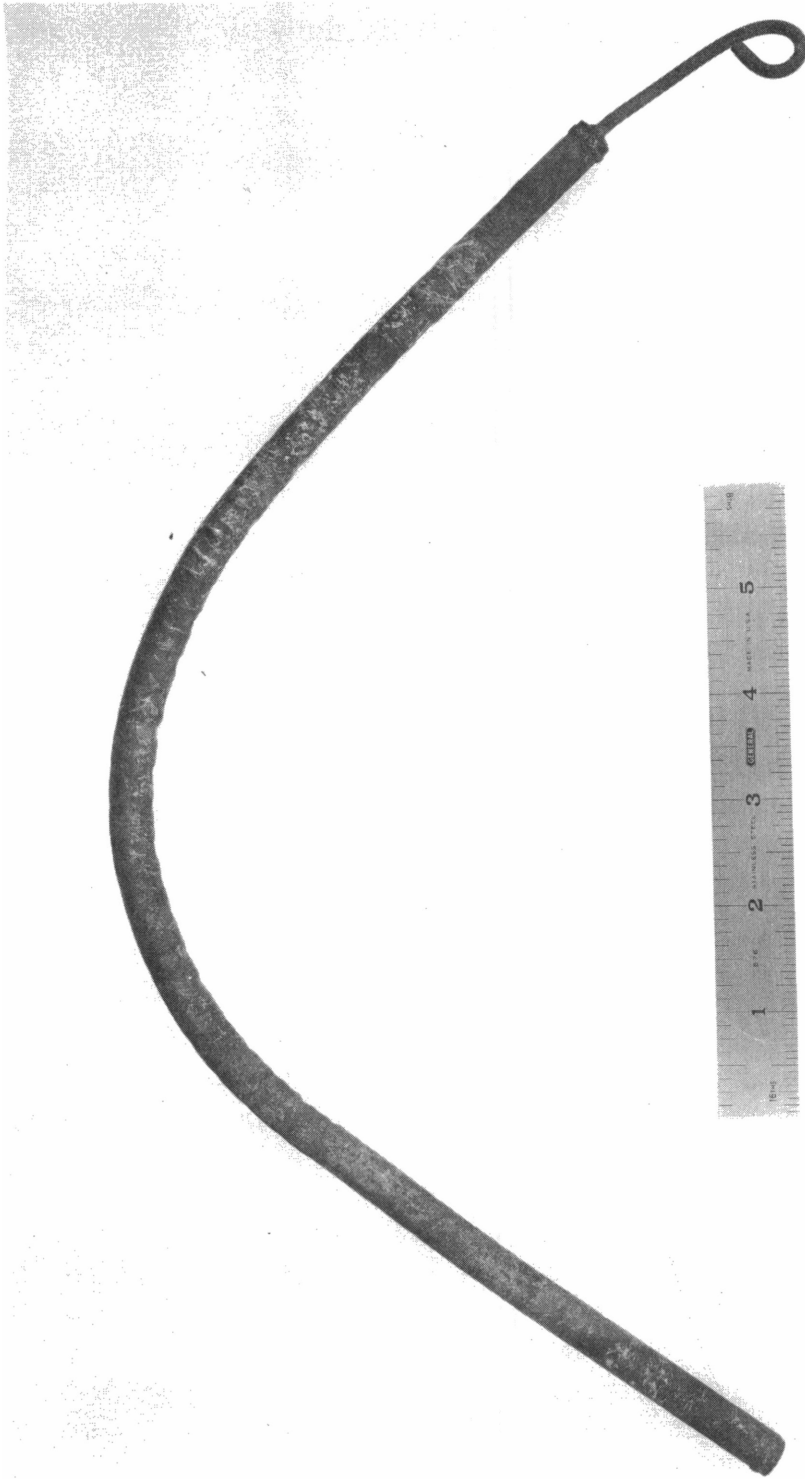
Bending in both cases was accomplished by placing the rods on blocks six inches apart in a Carver Hand Press and loading until a 90 degree bend was achieved. The thermal cycled rod was bent 90 degrees at two points, straightened and then bent by hand as shown in Figure 20. Helium leak testing of this rod revealed a slight leak at one of the 90 degree bends. The corrosion tested rod was also found to be quite ductile in two 90 degree bends, however, cracks did appear in the cladding at the point of bending.

FIGURE 20 HOT GAS ISOSTATIC PRESSED STAINLESS STEEL CLAD UO_2 FUEL ROD AFTER THERMAL CYCLING AND BEND TESTING. ROD WAS BENT 90 DEGREES IN TWO AREAS PRIOR TO BENDING INTO THE ABOVE SHAPE.

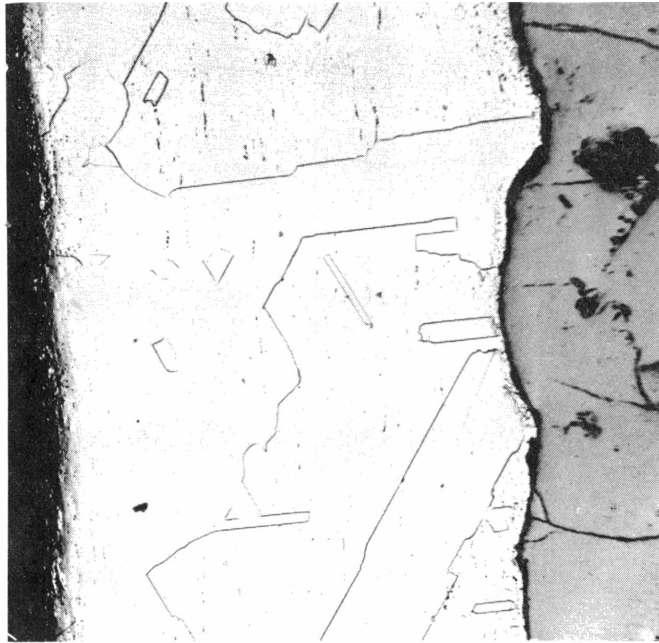
FIGURE 21 CLADDING STRUCTURE OF HOT GAS ISOSTATIC PRESSED FUEL ROD SEGMENT IR-12-6

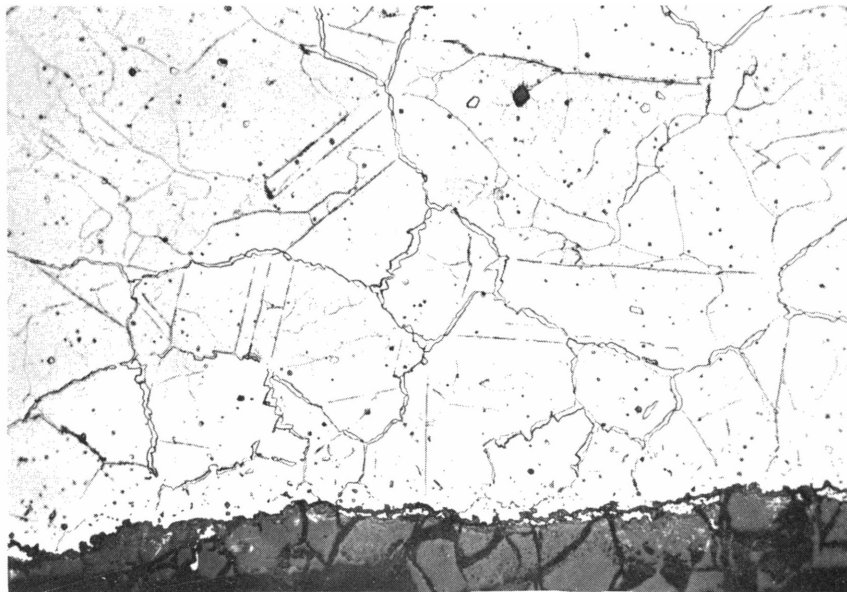
FIGURE 22 MICROSTRUCTURE OF THE BRITTLE CLAD AREA IN THE HOT GAS ISOSTATIC PRESSED ROD IR-12-8
