December 19, 1966

TECHNICAL LETTER: DRIBBLE-46, Supplement 1

FINAL INVESTIGATIONS OF WATER-WELL COMPLAINTS RELATED TO
SALMON EVENT IN TATUM SALT DOME AREA,
LAMAR COUNTY, MISSISSIPPI

R. E. Taylor

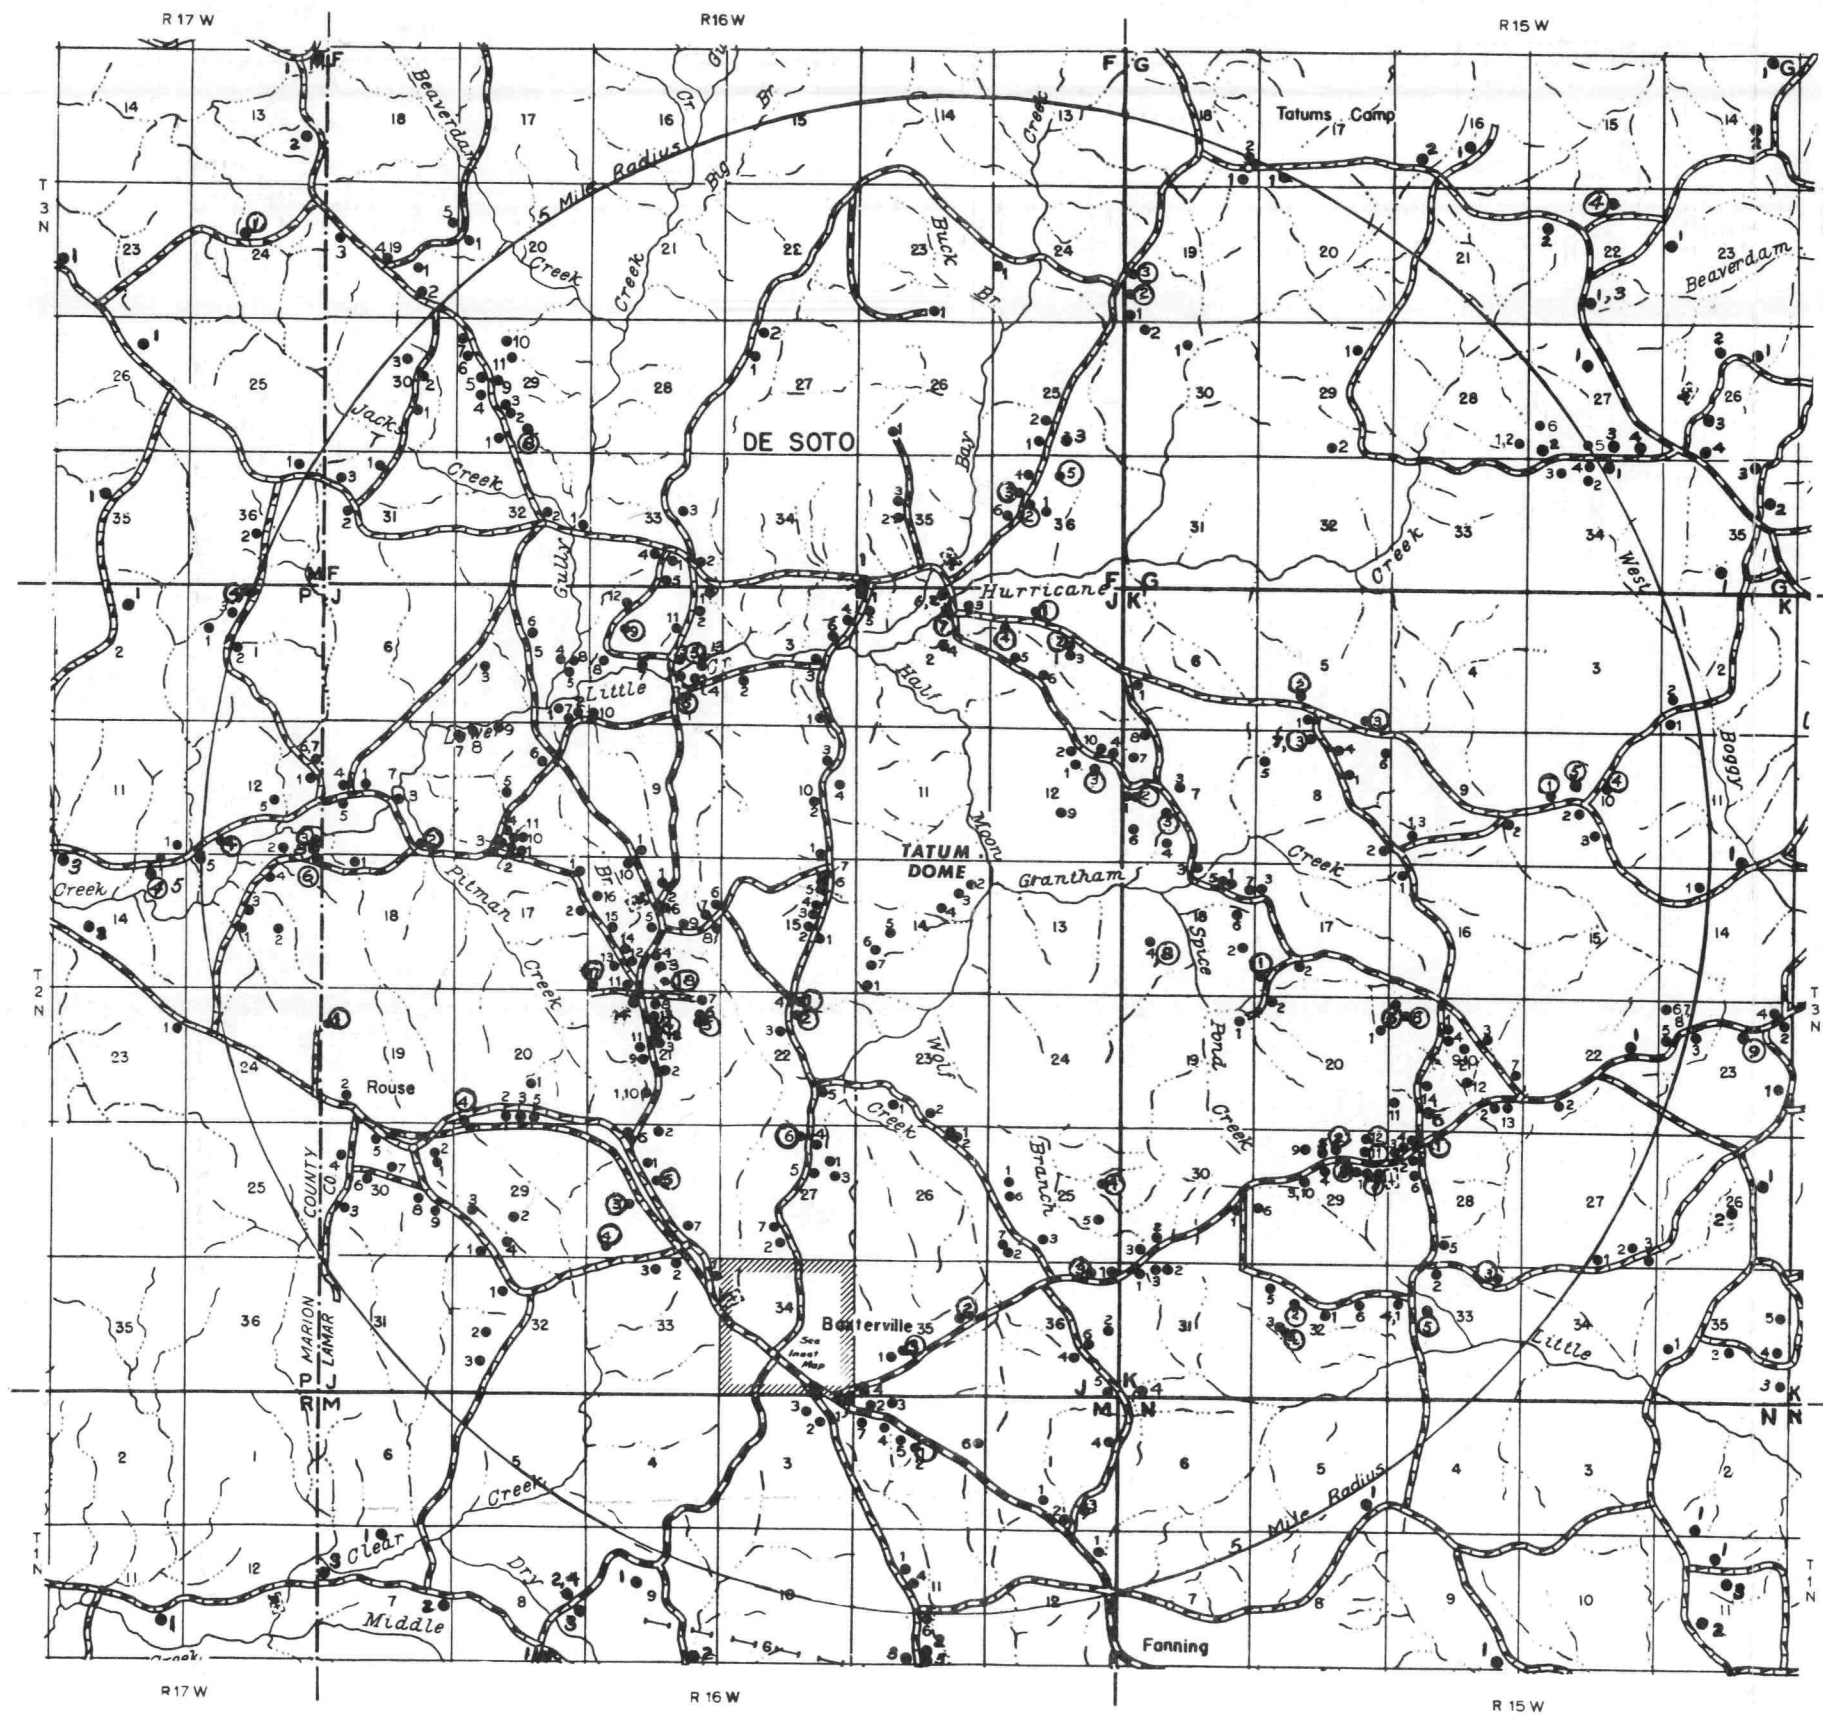
FIGURE 2.— WATER WELL LOCATIONS WITHIN 5-MILE RADIUS OF TATUM DOME, LAMAR AND MARION COUNTIES, MISSISSIPPI.

Figure 2 shows that some complaints on wells are clustered in groups of 2 or 3. This clustering may be partially due to the fact that when one owner or tenant has his well examined or pulled a neighbor may also decide to have his well examined.

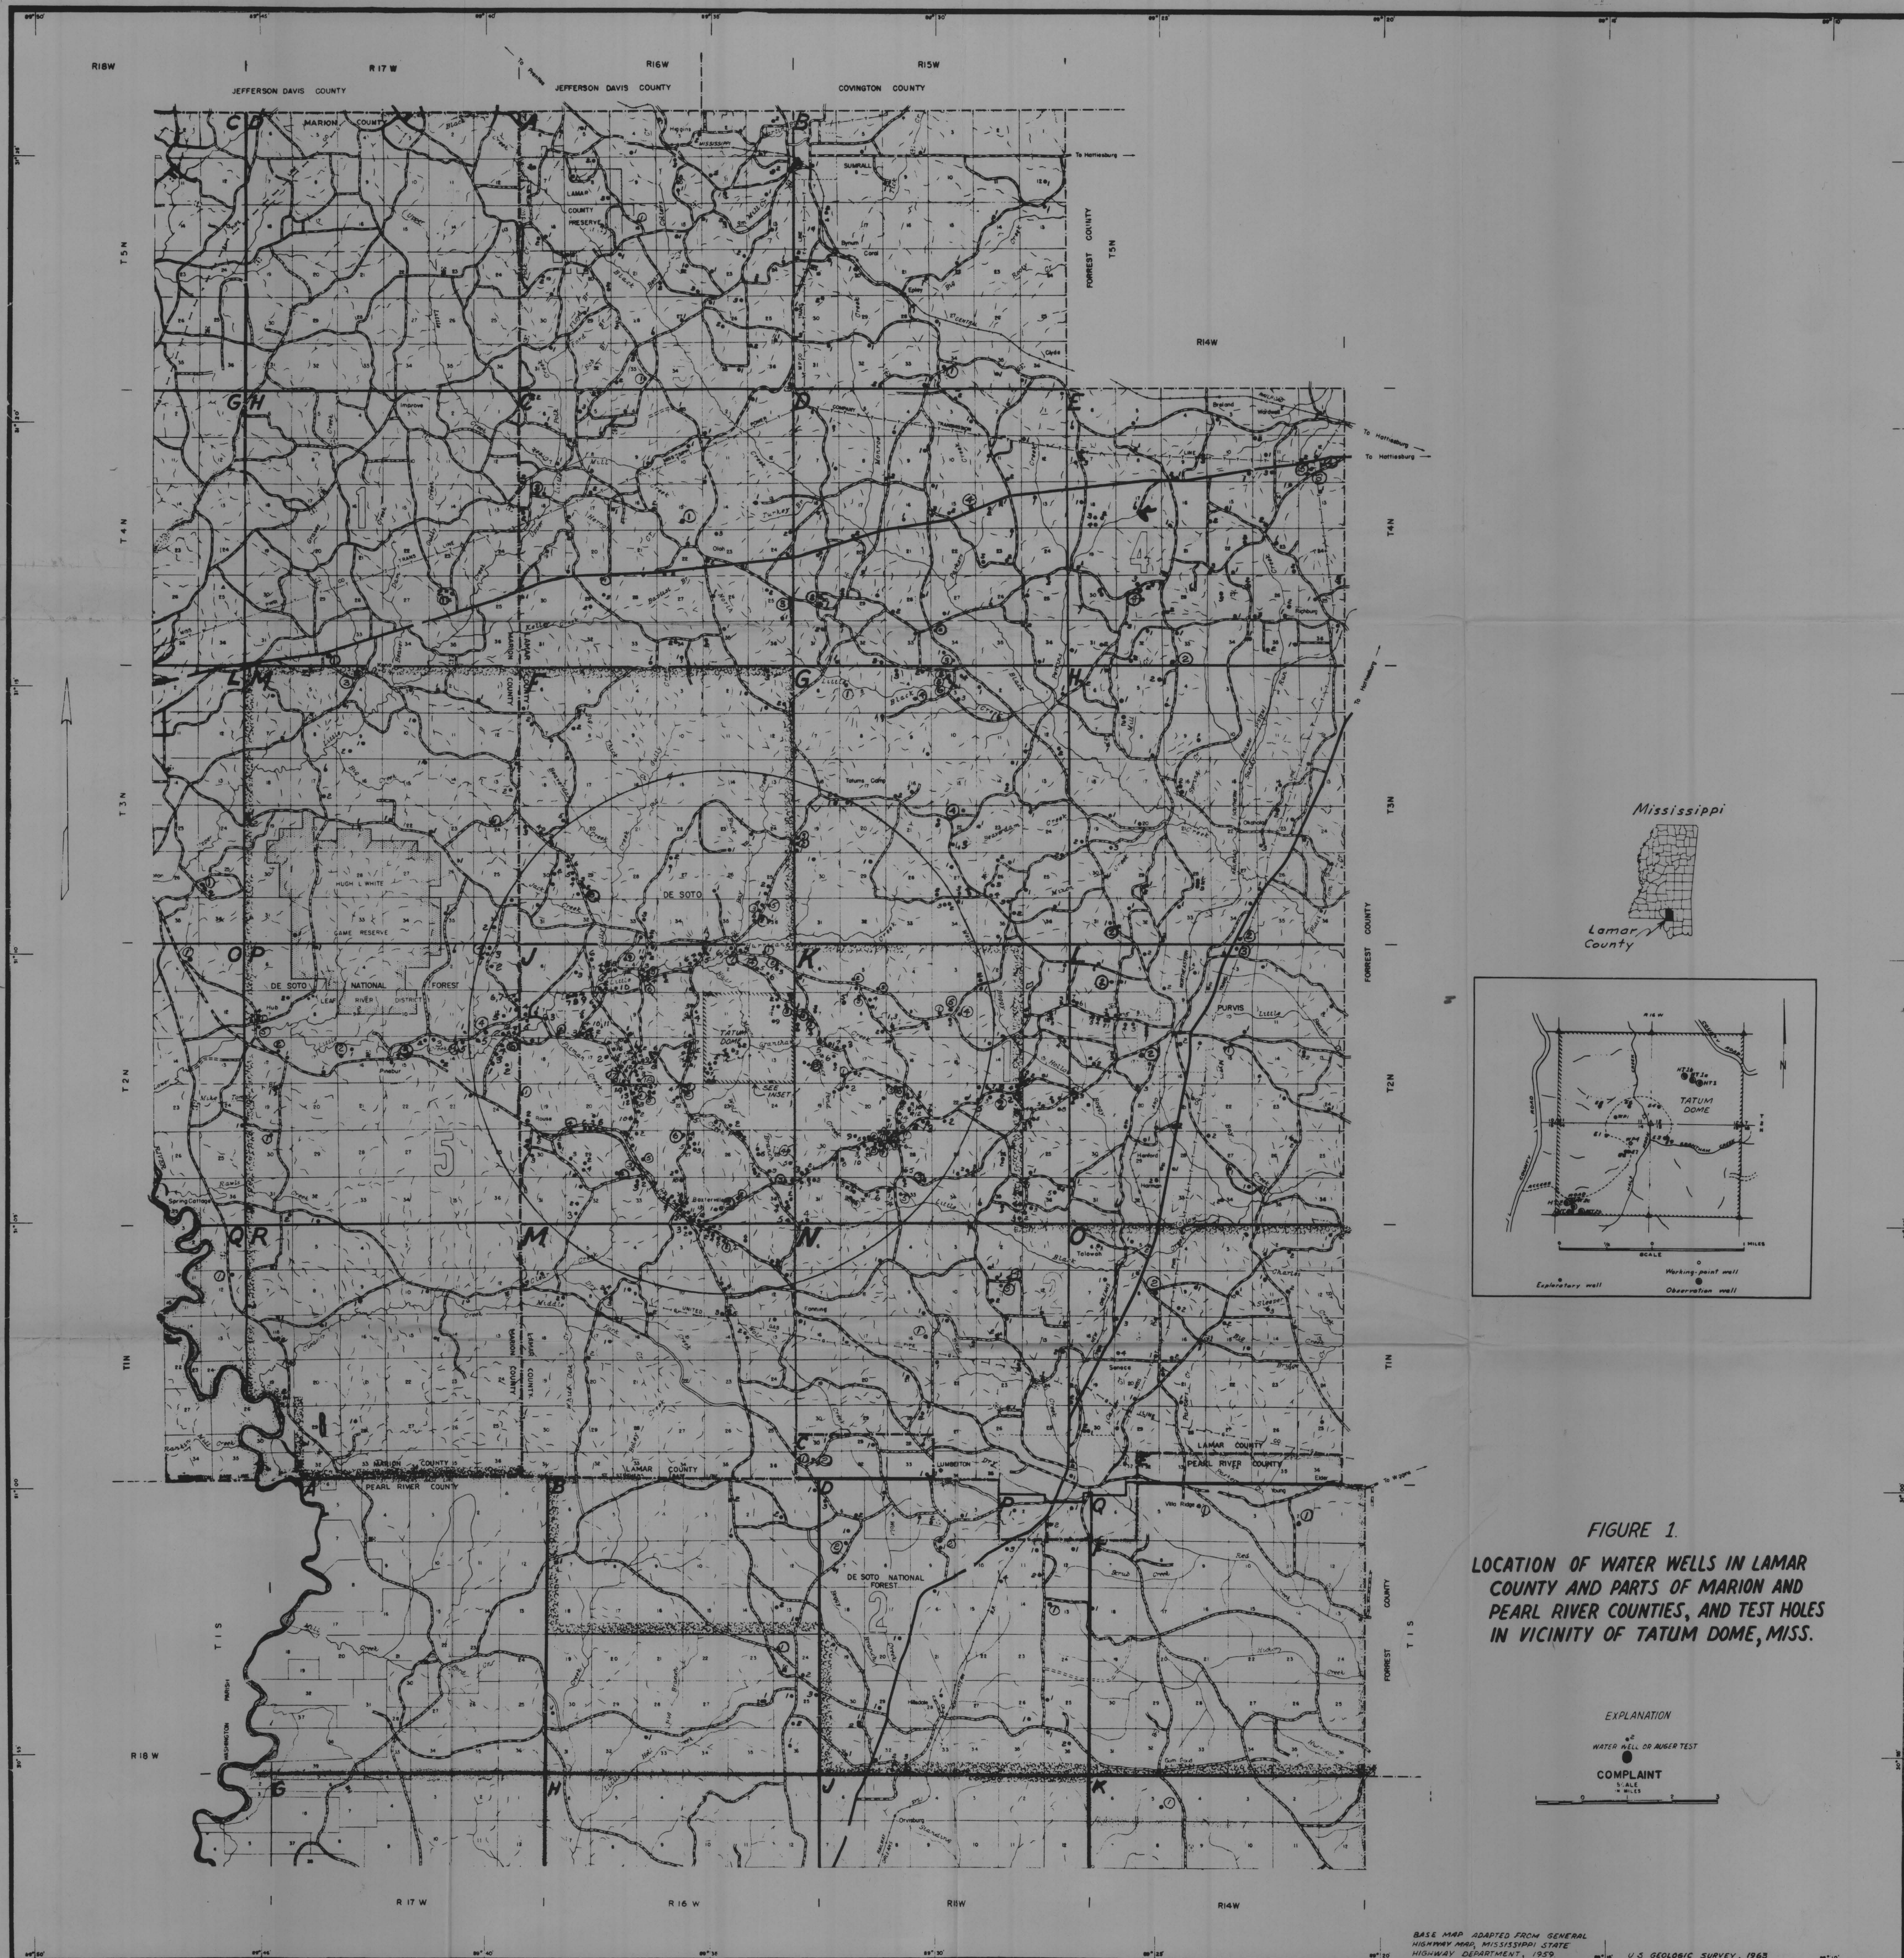
FIGURE 1.
LOCATION OF WATER WELLS IN LAMAR
COUNTY AND PARTS OF MARION AND
PEARL RIVER COUNTIES, AND TEST HOLES
IN VICINITY OF TATUM DOME, MISS.

Figure 1 shows the location of all inventoried wells within the minimum distance of 13 miles from surface-ground zero. Figure 2 is an enlargement of the congested 5-mile-radius area around Tatum dome. Within this radius, the preshot well inventory listed 360 wells. Outside the 5-mile radius the number and distribution of wells listed in the preshot inventory decreased with increased distance from surface-ground zero. All complaints and inquiries do not fall within the scope of these two maps because of the large distances involved in some investigations. The maps and well designations agree with those presented in Technical Letters Dribble 30 (Lang and Harvey, 1963), 38 (Taylor and Grantham, 1963), and 46 (Taylor, 1965), in which a more detailed presentation of well data is available.
