SUBJECT: Summary of Corrosion Data for HRT Mockup Operational Period  
Ending November 5, 1956.

FROM: R. E. Wacker and J. C. Griess

SUMMARY OF CORROSION DATA FOR HRT MOCKUP  
OPERATIONAL PERIOD ENDING NOVEMBER 5, 1956.

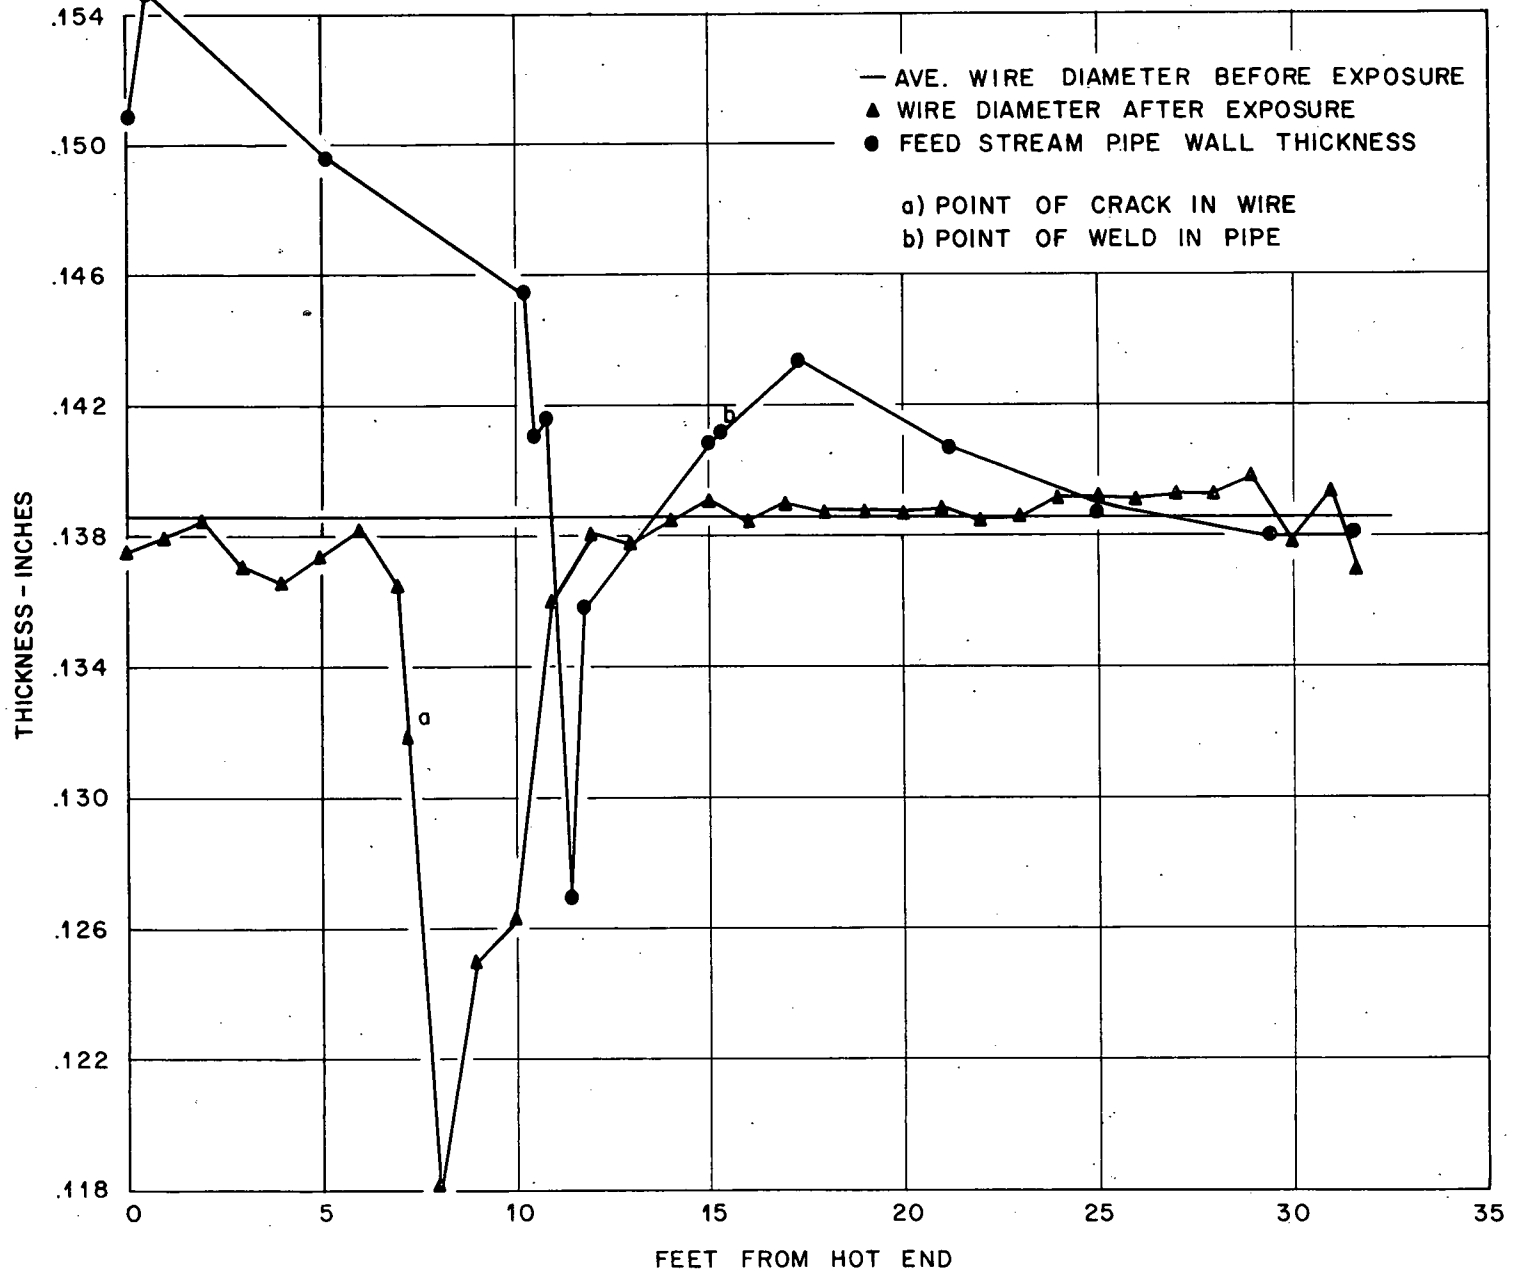
Fig. 1 Feed Pipe and Wire Thickness After Exposure in Mockup Letdown Heat Exchanger

Measurements were taken of the pipe wall thickness at numerous points along the entire length of the feed-stream pipe. These are tabulated in Table V and

and Figure 1 shows a plot of the wall thickness versus the pipe length. Although the exact temperature at any given point along the pipe is not known, the point of heaviest attack is believed to be at a point of approximately  $200^{\circ}\text{C}$ . This agrees with the 100A loop data which show the 200 to  $225^{\circ}\text{C}$  temperature range to be the worst region for low velocity corrosion. A dye-check of the edges of this pipe showed no evidence of cracking.

Before inserting the wire in the feed pipe, micrometer measurements were taken along its length in order to determine the corrosion damage after testing. A reference notch was made in the wire at one end and measurements were taken at 1-ft intervals over the length of the wire. One measurement was taken at each point across the plane of the notch and a second 90 degrees from the plane of the notch. After removal from the exchanger measurements were again taken of the wire in the same manner. The reference notch could not be located on removal so the second set of measurements are probably not in the exact same location or plane as the original set. Therefore the average of the two measurements at each point was used in determining the penetration at that point. The wire measurements are given in Table VI and a plot of the thickness versus length is shown in Figure 1. The point of heaviest attack yielded a corrosion rate of 16 mpy.

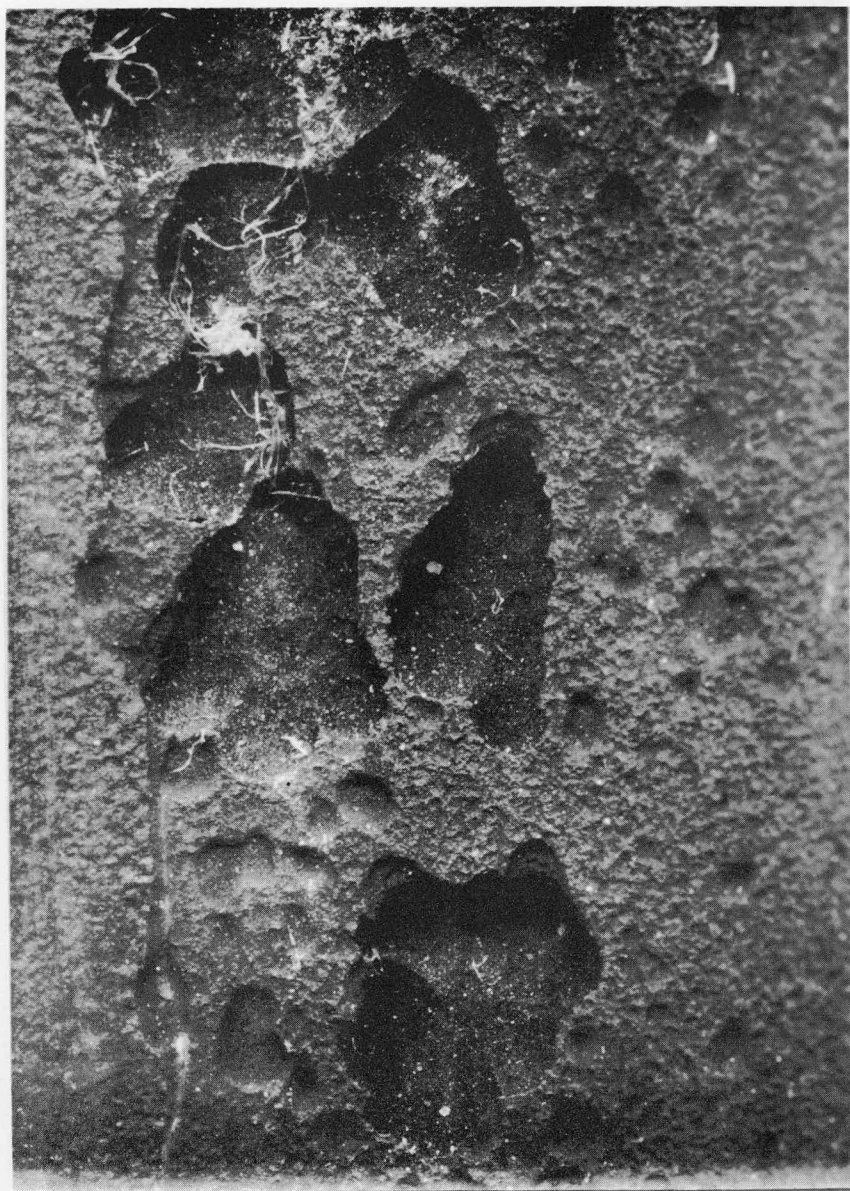
2. The next 6-in. length had heavy pitting attack. Large irregular pits up to 3/64 in. deep along with numerous smaller pits were evident. Adjacent pits were undercut and joined at the bottom. The deepest penetration in this region corresponds to a corrosion rate of 75 mpy. Figures 53 and 54 show this pitted area. The unpitted area had the same red rust colored scale as before, while

the bottom of the pit areas had a brown-black film. There was a shiny line of bare metal along one side of the pitted area. This section of the pipe has been sent to metallography for examination.

Fig. 55 Feed Stream Pipe Pitted Area  
11 ft from Outlet (Hot) End  
(15X)

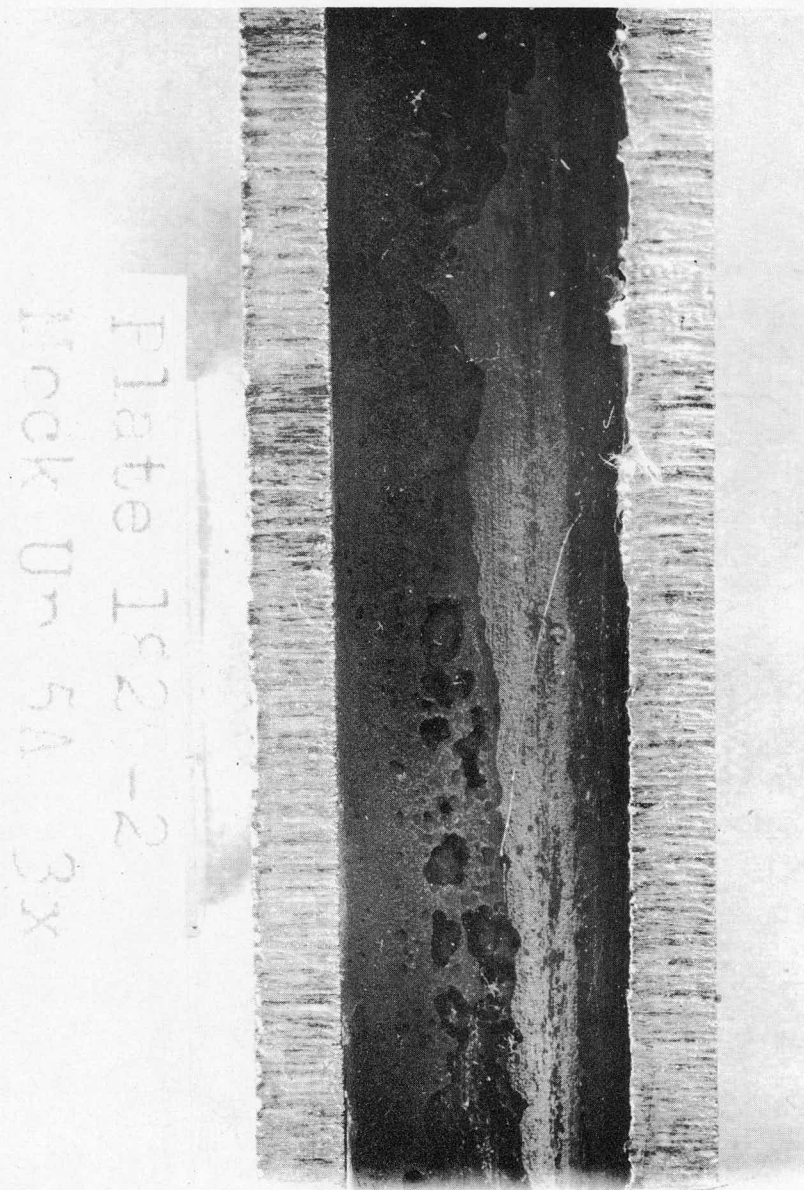
Fig. 54 Feed Stream Pipe Pitted Area  
11 ft from Outlet (Hot) End  
(3X)

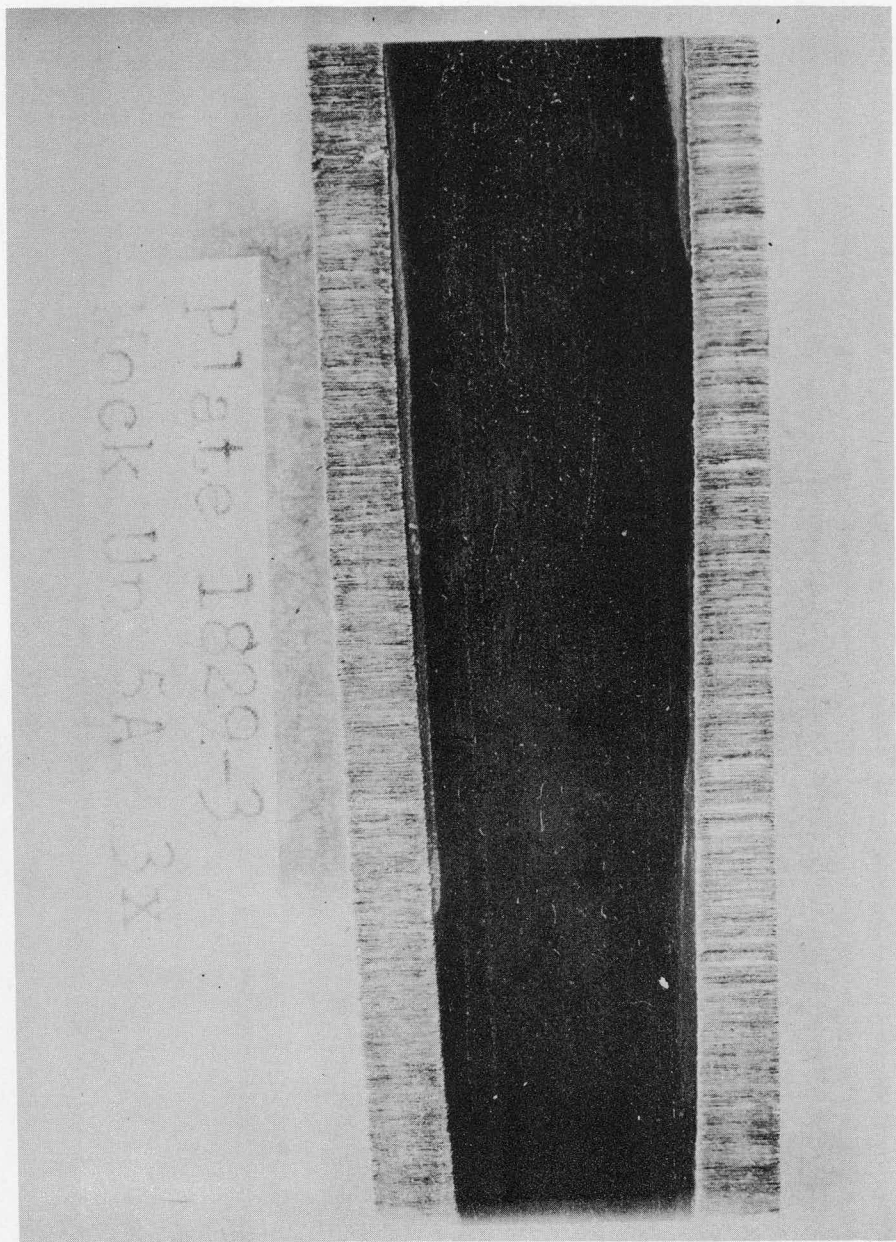
3. The next 4 ft 6 in. of the pipe appeared to have been attacked at a fairly uniform rate, decreasing in attack as the temperature decreased. The first part of this region showed some localized attack, whereas the last part showed a uniform attack. Figures 55 and 56 show the beginning and end of this region, respectively. A section of the pipe from this region was sent for Huey Test and chemical analysis. The sample passed the Huey Test. Results are shown in Table IV, Sample 1.

Fig. 57 Feed Stream Pipe Area 6 in.  
Upstream from Weld. 14-1/2 ft  
from Outlet (Hot) End. (3X)

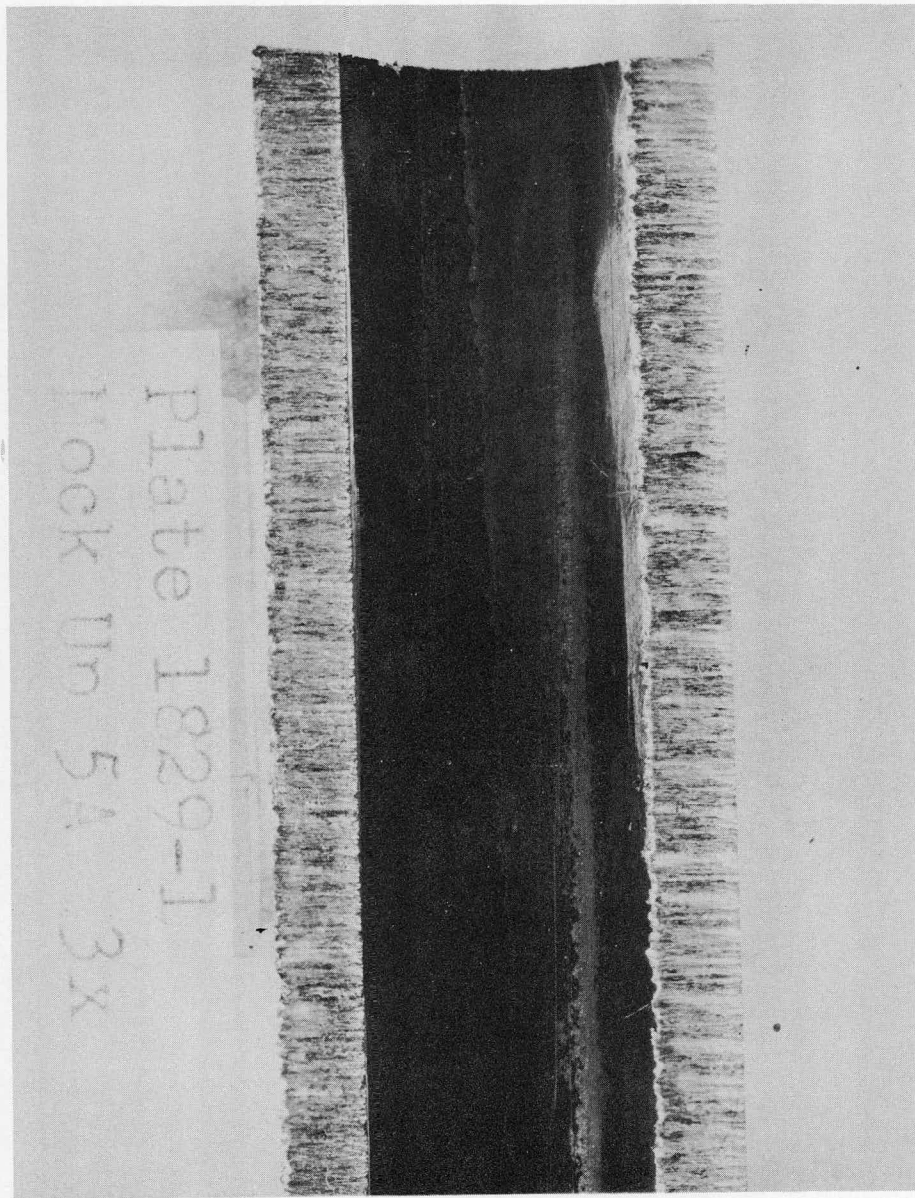
Fig. 56 Feed Stream Pipe 6 in. Downstream  
from Pitted Area. 12 ft from  
Outlet (Hot) End. (3X)

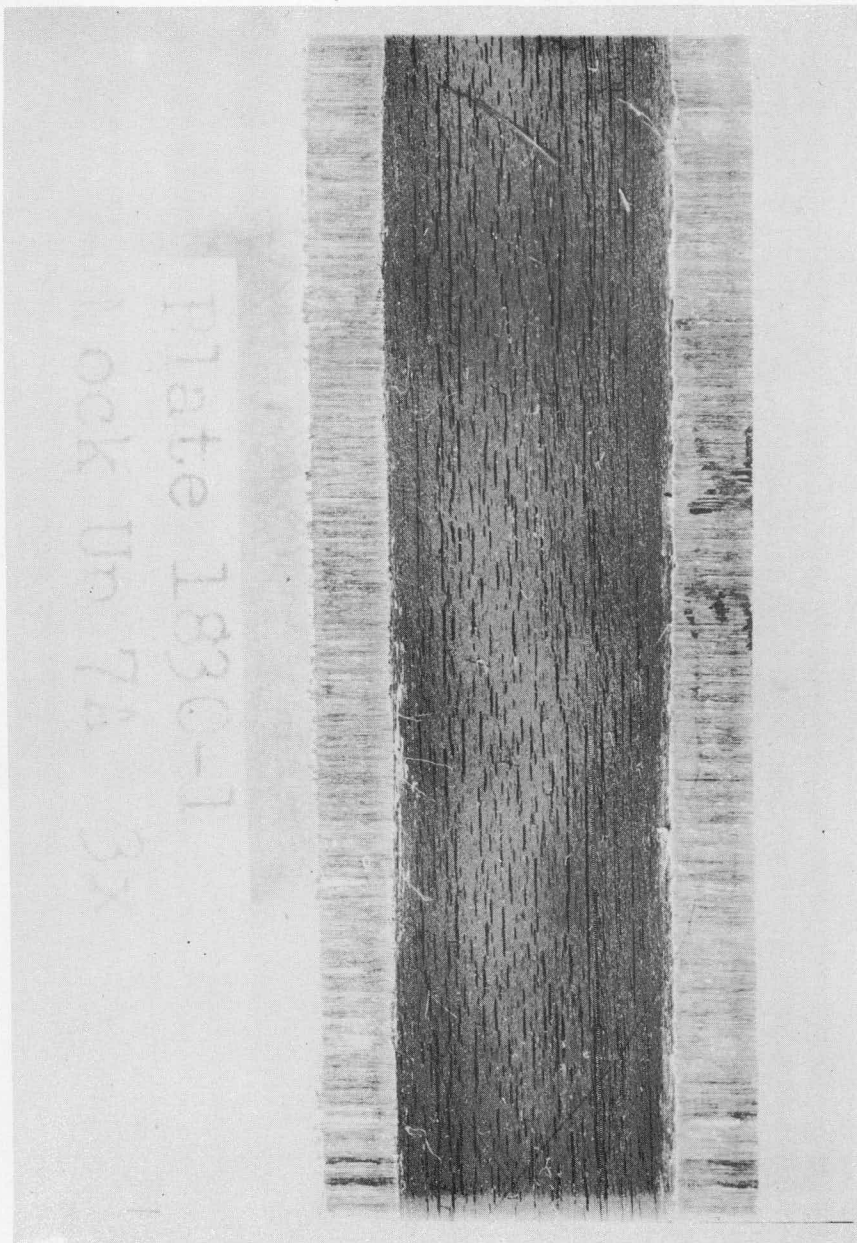
4. At this point (15 ft 6 in. from the hot or outlet end of the feed stream) a second section of 1/2-in. pipe was welded to the first section. This section of pipe extended through the remainder of the feed stream of the exchanger. The entire length of this section of pipe had long narrow parallel grooves running lengthwise of the pipe, with some cracking between grooves. These grooves were from 1/64 in. to 1/16 in. deep. There were pits present which appeared to undercut at the bottom along the length of the pipe to form grooves. Figures 57 and 58 show that portion of the pipe adjacent to the weld and Figures 59 and 60 show the feed stream inlet or cold end of the pipe. The start of grooves through pits can be seen in the latter two photographs. It is believed that this grooving is not a result of uranyl sulfate attack but was caused by something used in the original cleaning or pickling of the metal by the manufacturer. A section of this pipe has been sent to Metallography for examination. Samples were also sent for Huey Test and for chemical analysis. The samples failed the Huey Test and chemical analysis showed it to be low in chromium content. Results are shown in Table IV, Sample 2. This section of pipe had a dark brown film which became light gray as the temperature decreased. Most of the film over the last 10 ft could be rubbed off, leaving bare metal.

Fig. 59 Feed Stream Pipe Downstream from  
Weld. 16 ft from Outlet (Hot)  
End. (3X)

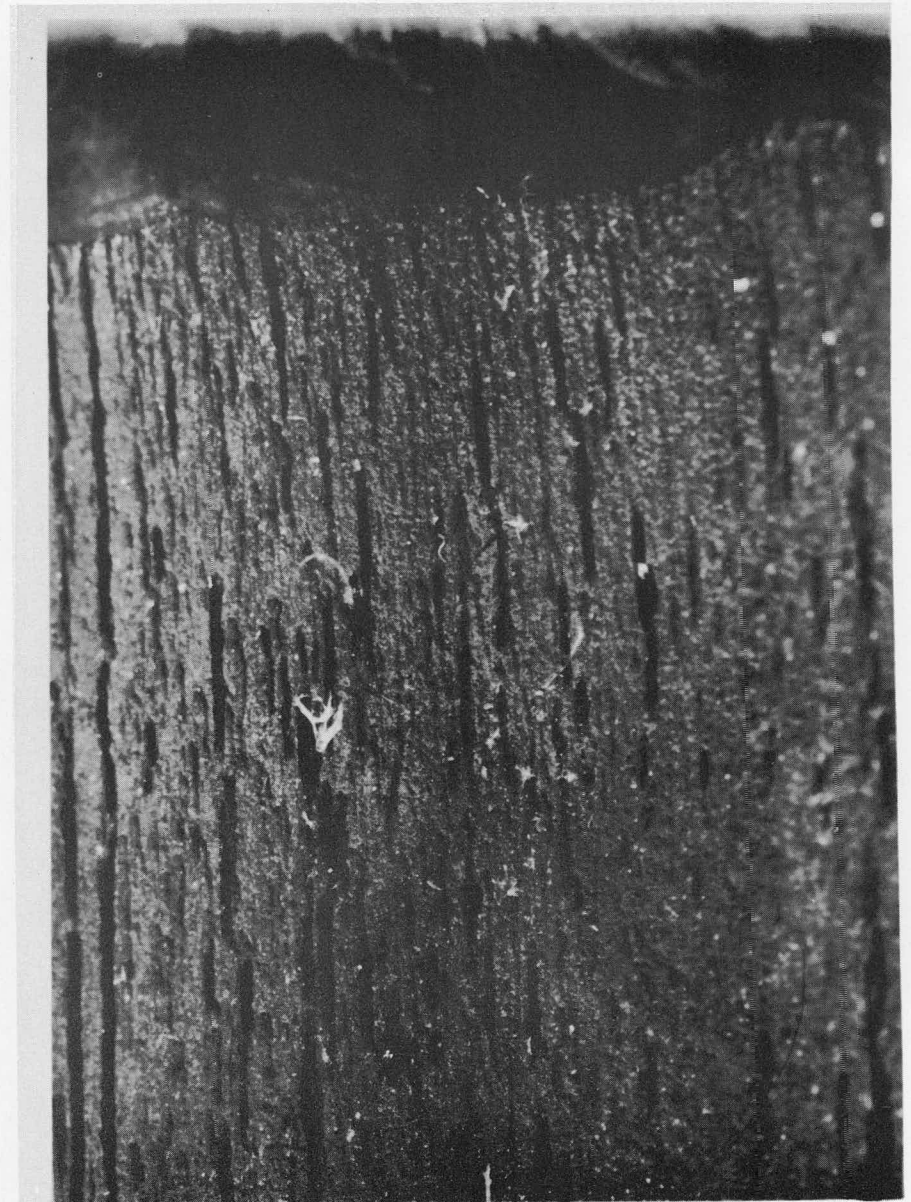
Fig. 58 Feed Stream Pipe Downstream from  
Weld. 15-1/2 ft from Outlet (Hot)  
End. (15X)

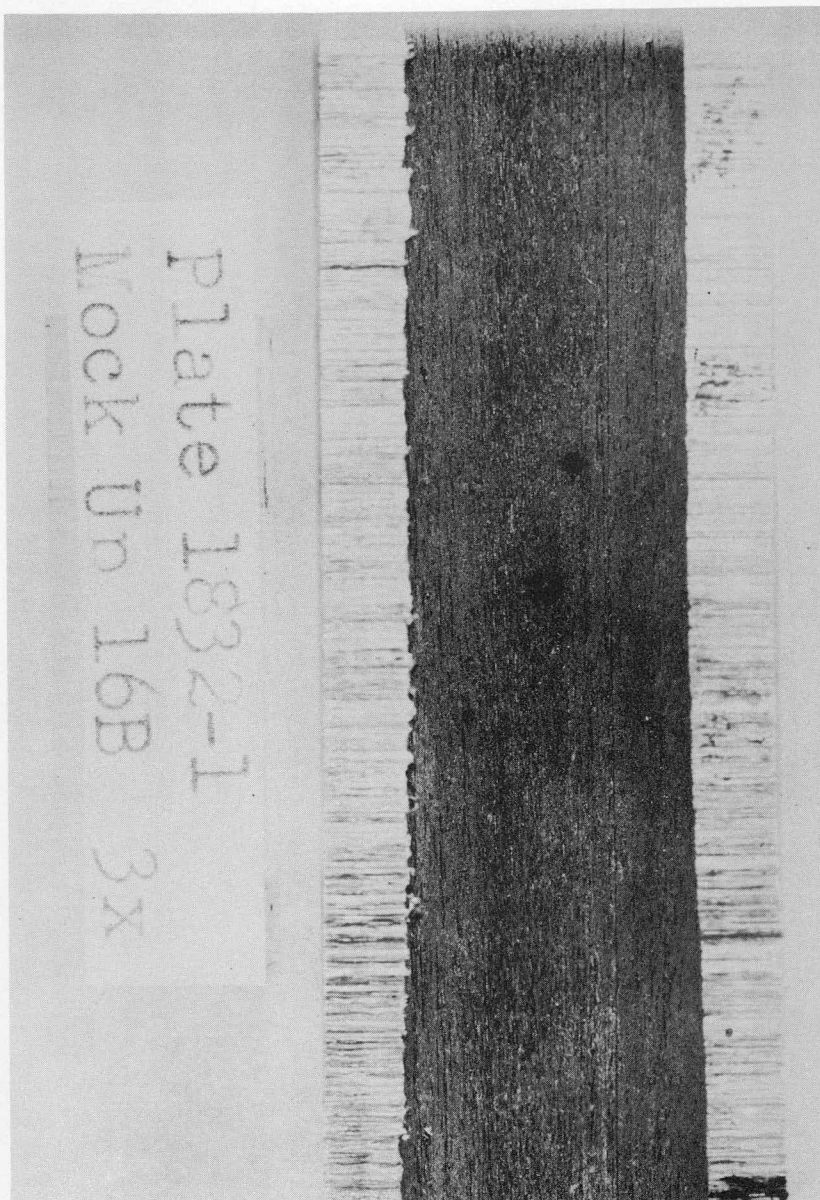
Fig. 60 Feed Stream Pipe Area 31 ft from  
Outlet (Hot) End. (3X)

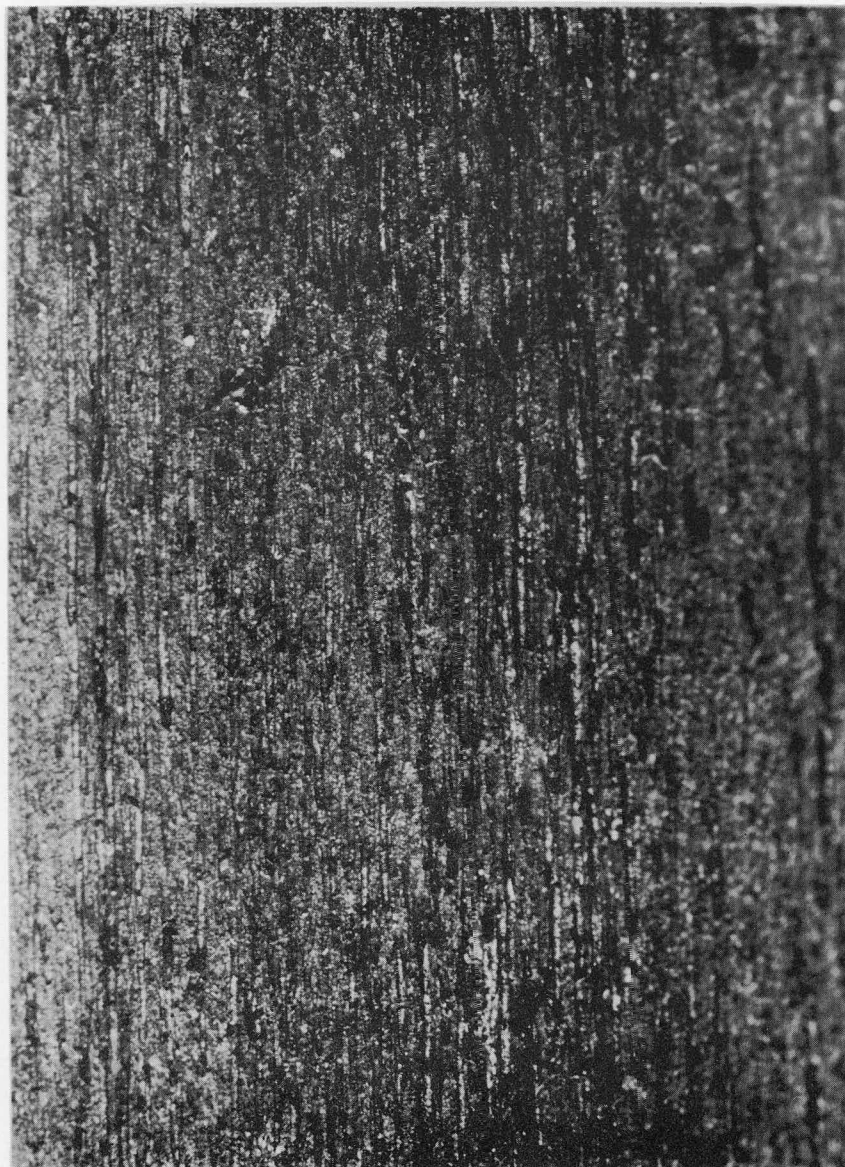
Fig. 61 Feed Stream Pipe Area 31 ft  
from Outlet (Hot) End. (15X)

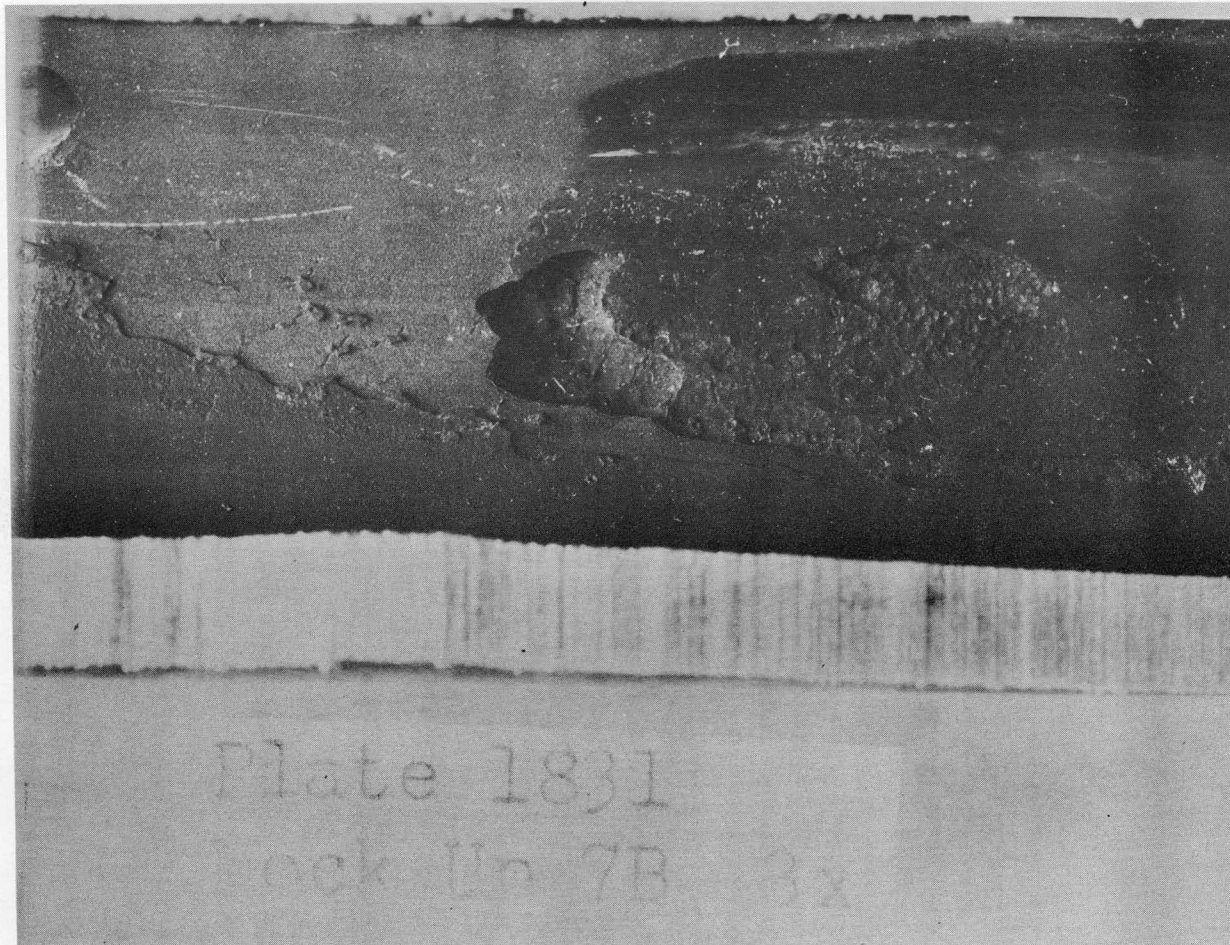
2. A heavier deposit of loose, rust colored scale was found over the next 5 ft of the pipe length, along with regions of localized attack. There was one large pit in the inner wall of the 1-in. pipe in the bend section of the exchanger, 14 ft 6 in. from the inlet end. This pit was just downstream from the weld in the 1/2-in. pipe on the opposite wall of the annulus and undoubtedly resulted from turbulence caused by the weld. The pit was irregular, approximately 1/4 in. wide and 1/8 in. deep. There was a smaller pit 1/2 in. from the large pit, and 2 in. of area immediately downstream from the pit had a shiny thin black film with numerous very small pits. Figure 61 shows the pit along with the localized attack found in this region. This area was in the temperature region of  $200^{\circ}\text{C}$ .

Fig. 62 Letdown Stream Pipe. 14-1/2 ft  
from Letdown Stream Inlet (Hot)  
End. (3X)

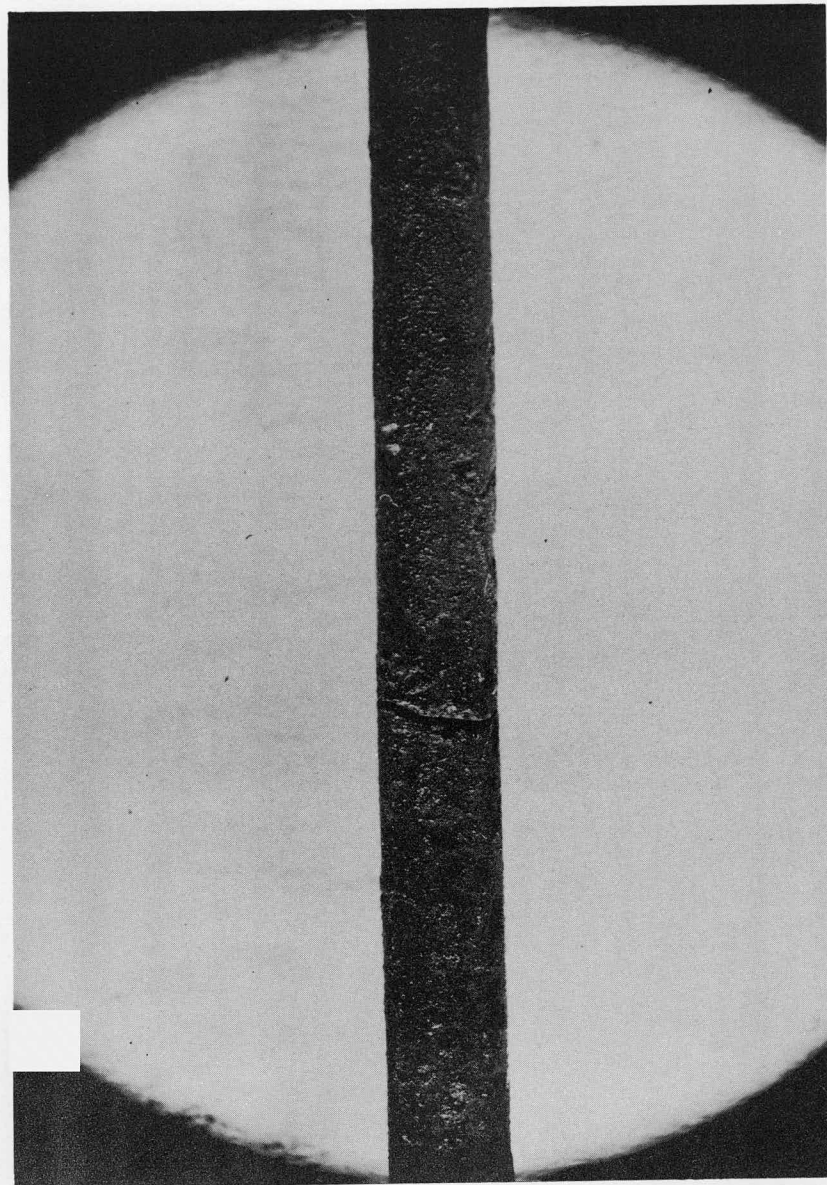
2. The next 10 ft of the wire showed corrosion attack, with the first 4 ft of this section indicating heavy localized attack. At the beginning of this localized attack, the wire was broken and 3 in. downstream from the break a wide deep crack went completely around the wire. Just how deep this crack extended could not be determined. This section of the wire has been sent to Metallography for examination and will be reported by that group along with their findings on the sections of the letdown heat exchanger pipe. Figure 63 shows the crack area and Figure 64 shows the heavy pitting attack just downstream from the crack.

Fig. 63 Corrosion Wire from Feed Stream Pipe. Crack 7 ft 3 in. from Outlet (Hot) End. (5X)

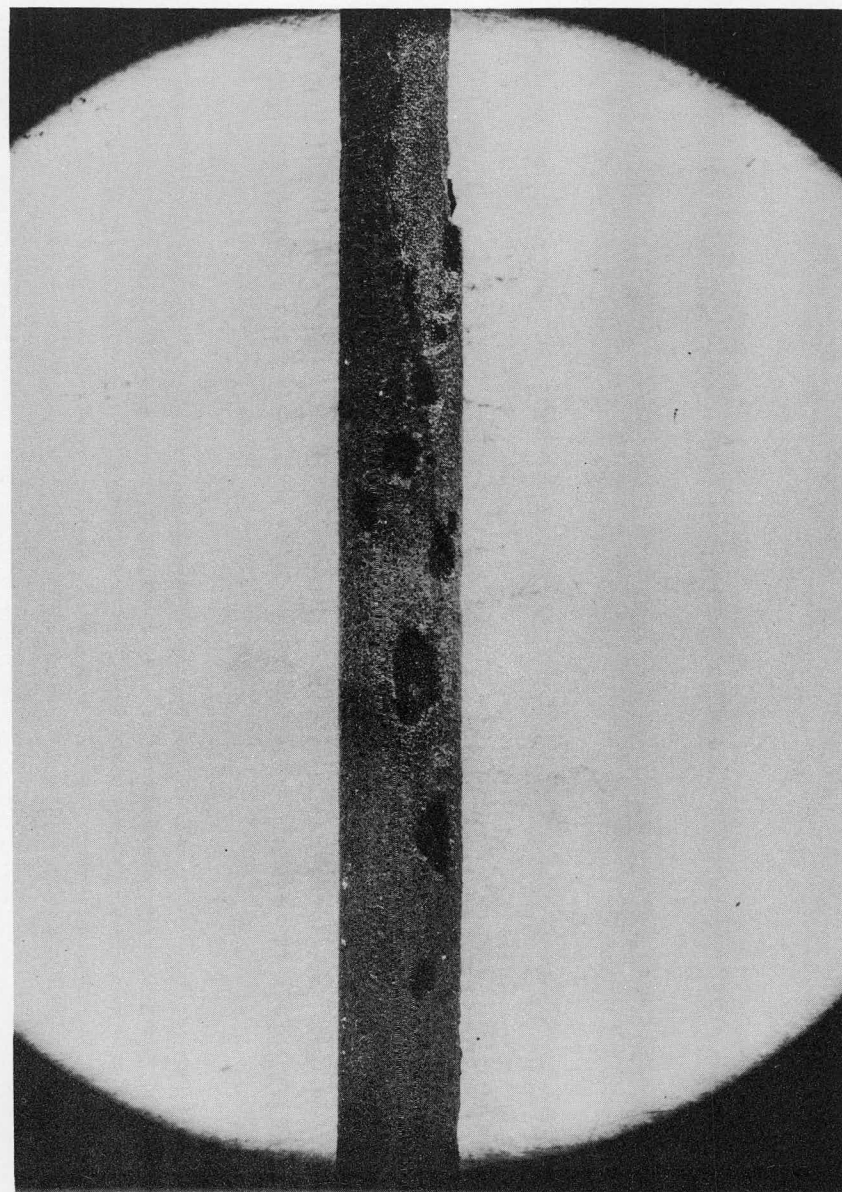
Fig. 64 Corrosion Wire from Feed Stream Pipe. Pitted Area 7-1/2 ft from Outlet (Hot) End. (5X)
