MONTHLY REPORT No. 10 - MAY 1967

COMPILATION OF CURRENT TECHNICAL EXPERIENCE AT  
ENRICO FERMI ATOMIC POWER PLANT

Prepared by  
ATOMIC POWER DEVELOPMENT ASSOCIATES, INC.  
DETROIT, MICHIGAN  
With the cooperation of  
POWER REACTOR DEVELOPMENT COMPANY  
And  
THE DETROIT EDISON COMPANY

Date Issued: July 1967

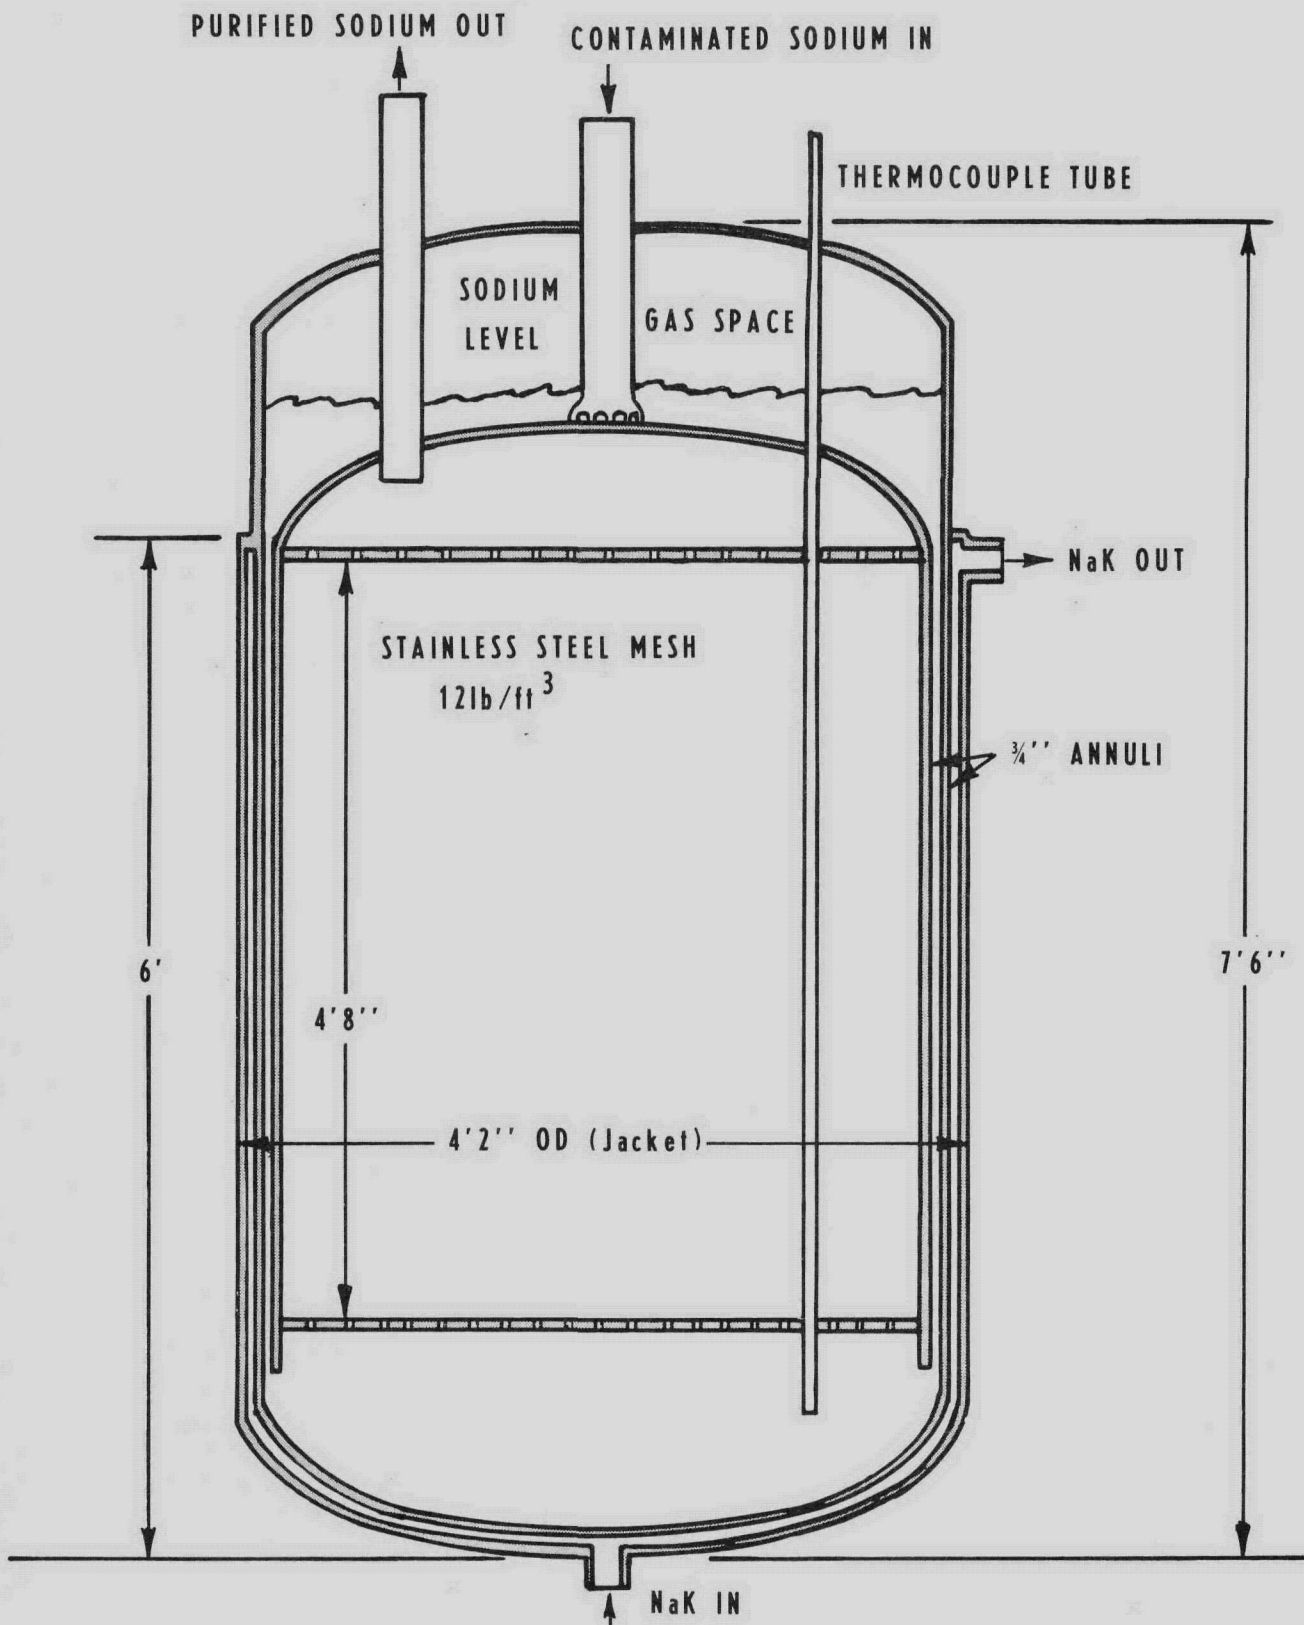
**PRIMARY COLD TRAP**

Both the original and present primary sodium cold traps cool the sodium by means of a NaK jacket on the cold trap to precipitate the oxides. The sodium then enters a low velocity region packed with stainless steel York mesh on which the oxides collect. A sketch of the cold trap is shown on Page 22.

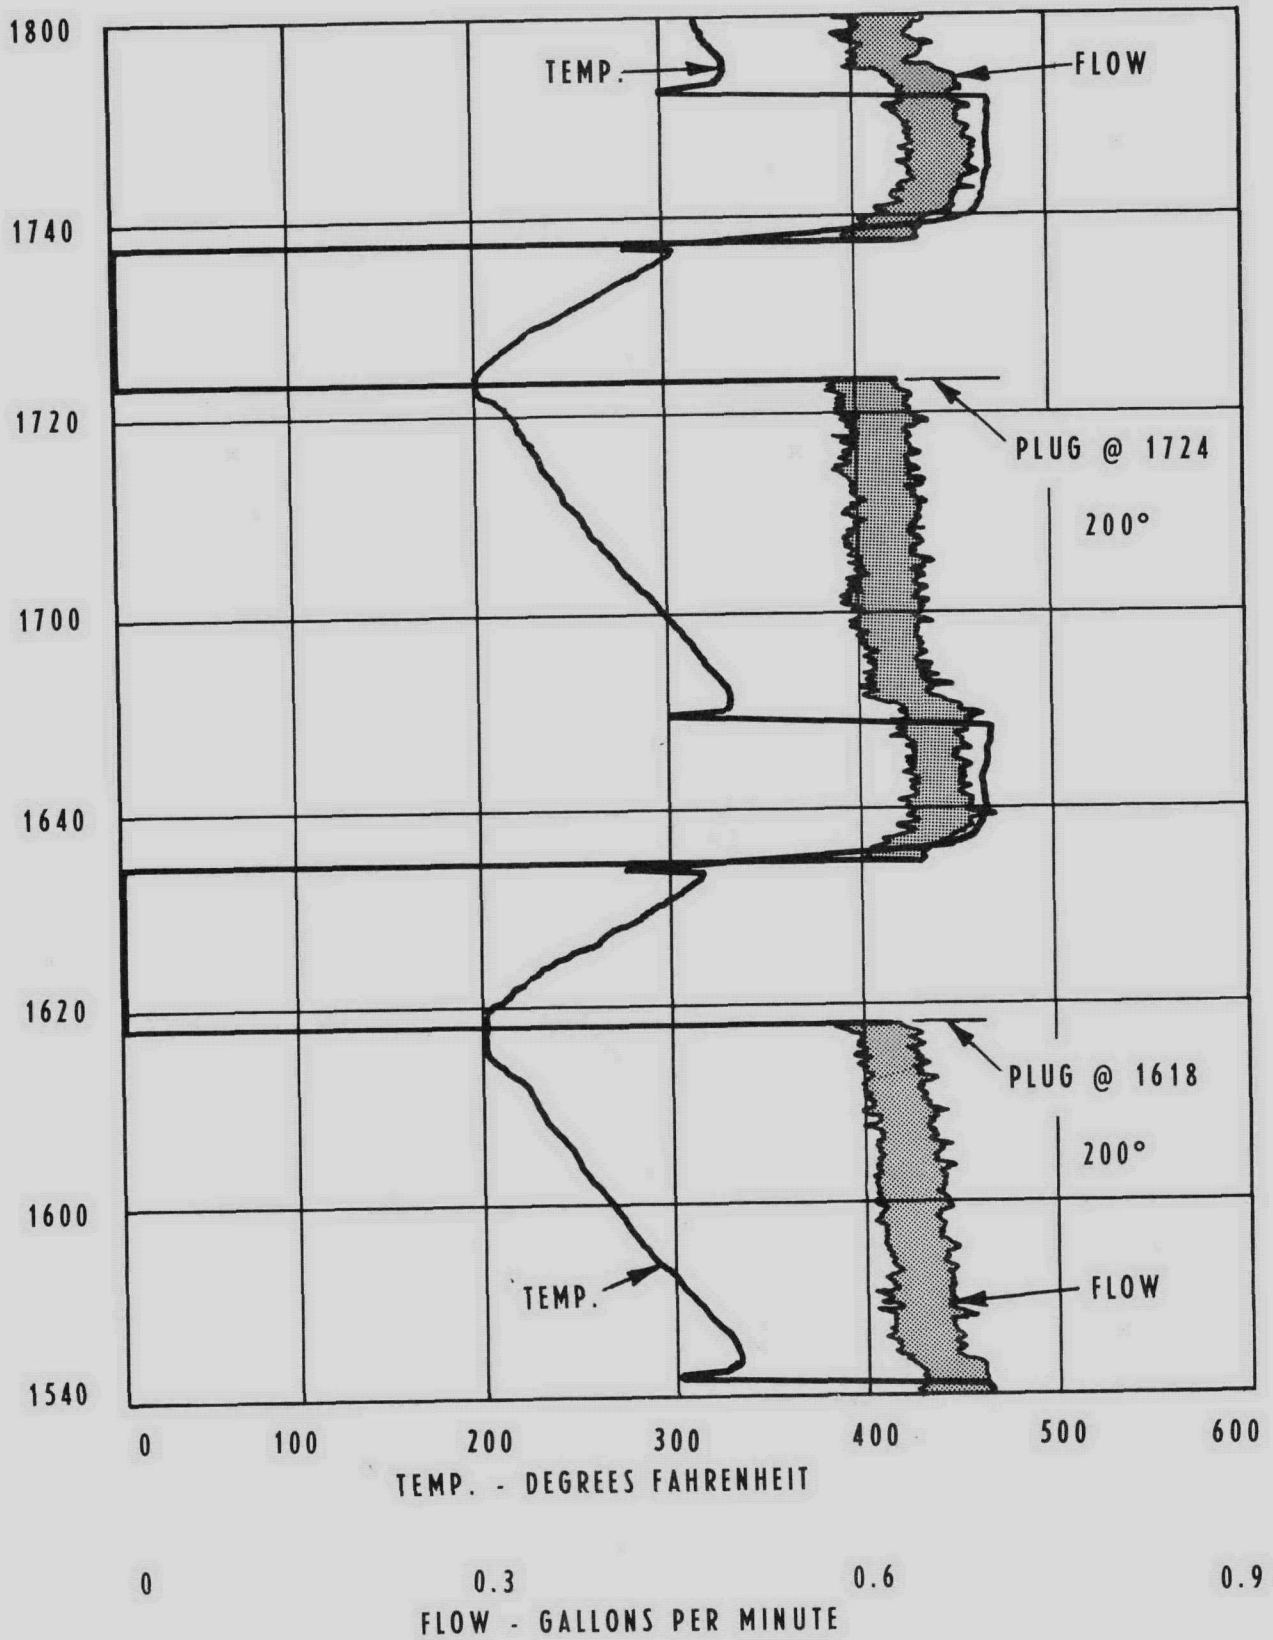
**PLUGGING INDICATOR RECORDER CHART**

The NaK temperature into the plugging indicator was held at about 160-180 F and the NaK flow was increased automatically (the usual mode of operation). The sodium flow suddenly stopped when the temperature reached 208 F, indicating freezing. A portion of the recorder chart, showing two plugging cycles made under these conditions, is shown on Page 25.

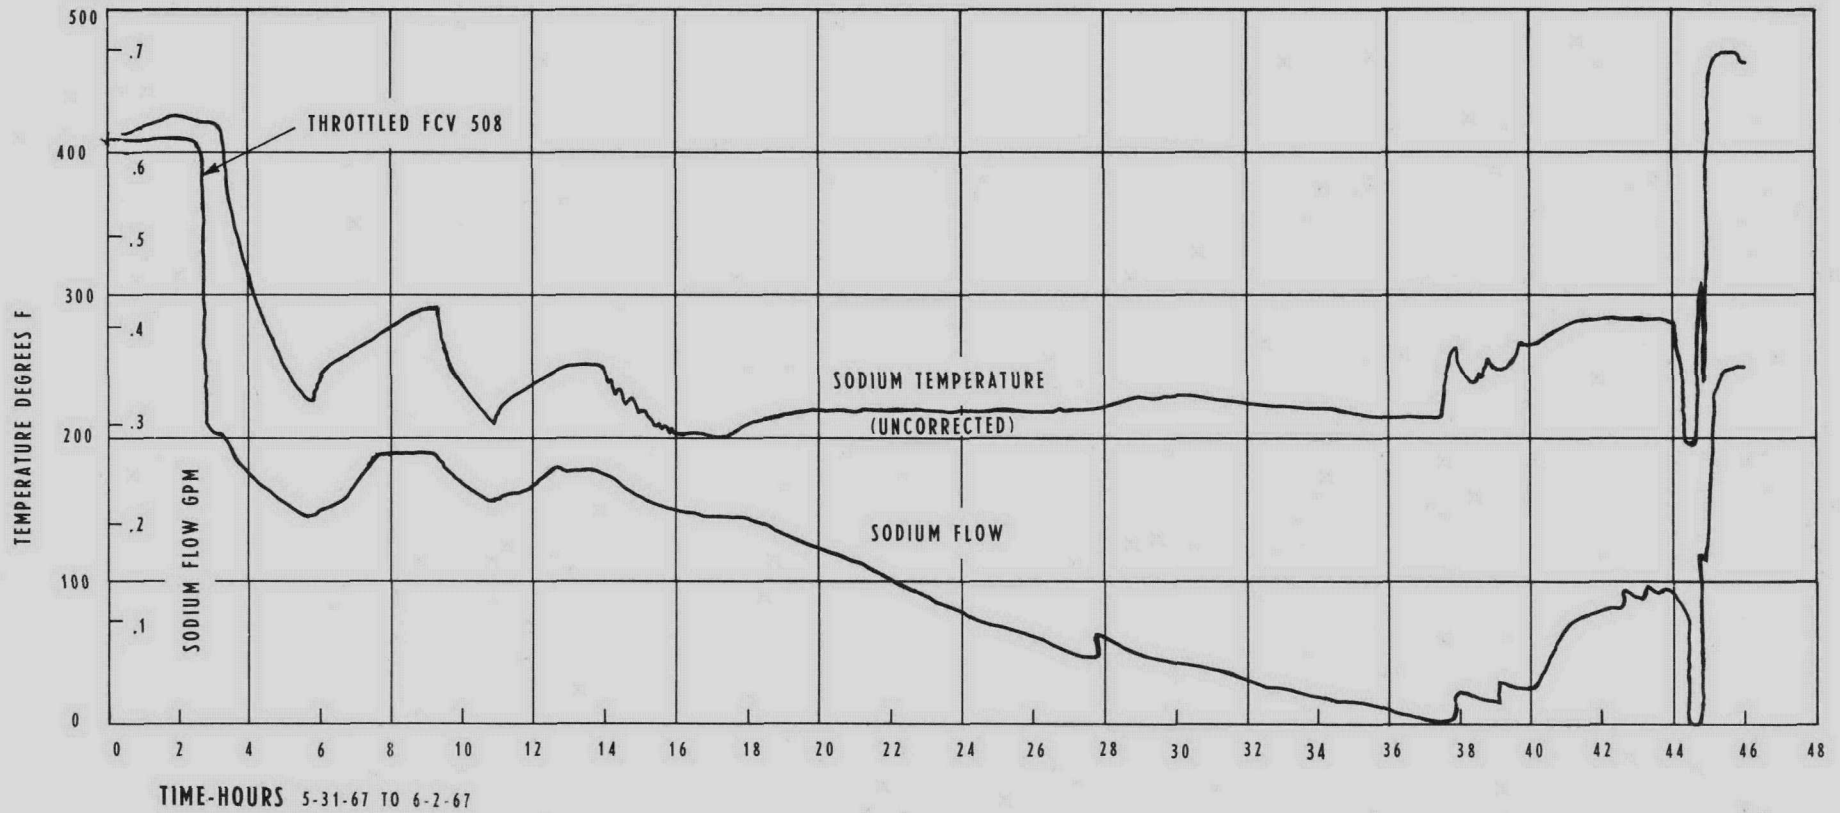
## RESULTS OF PRIMARY SODIUM PLUGGING INDICATOR RUN

The sodium temperature was held relatively constant over the next 24-hour period. Acturally, it rose slowly to 240 F and then returned to 215 F. The sodium flow slowly declined during the period and reached zero after 24 hours. The NaK temperature rose to 225 F and declined to 210 F during the 24-hour period. It was concluded that the sodium oxide saturation or plugging temperature was between 210 F and 250 F. See Page 26 for a graph showing the sodium flow and temperature during the run.

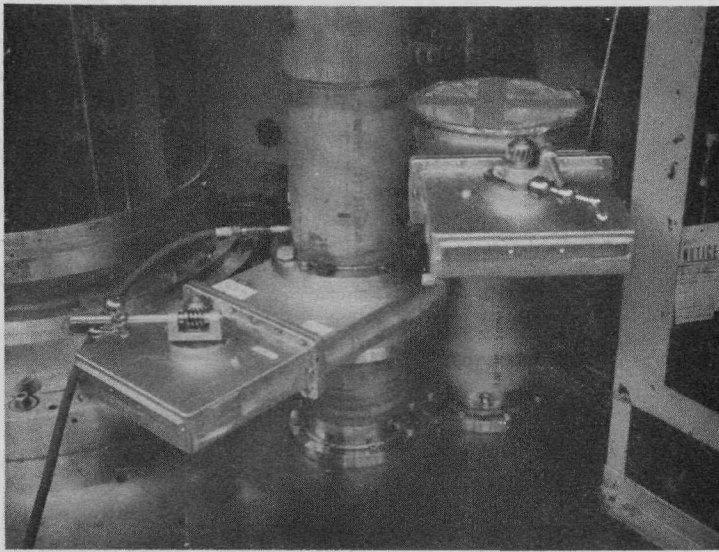
ADAPTORS AND VALVES  
INSTALLED FOR ACCESS TO  
REACTOR CORE THROUGH  
THE PLUG PENETRATIONS.

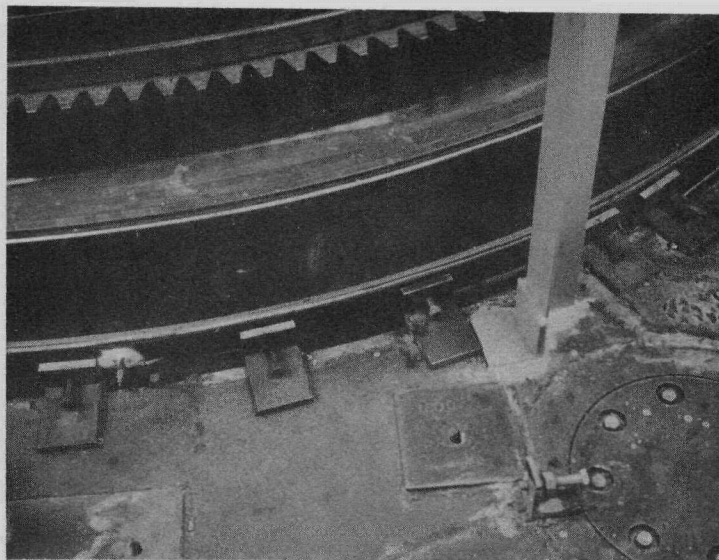
The reactor rotating plug Klozure seal backup gasket has been installed as shown in the lower photograph on Page 30. A leak test revealed leaks around the ball bearing inspection ports and these are being repaired. A connection has been made to the primary inert gas supply system so that the gas pressure in the space between the Klozure seal and the backup gasket will be the same as the pressure inside the Klozure seal.

BACKUP GASKET, MOUNTING  
BAND AND CLIPS INSTALLED  
TO SUPPLEMENT THE PLUG  
KLOZURE SEAL.
