CF-56-8-166

DATE: August 24, 1956
SUBJECT: EXAMINATION OF TITANIUM PULSE FEEDER
DIAPHRAGM FAILURE
TO: G.M. Adamson
FROM: T.M. Kegley, Jr.

EXAMINATION OF TITANIUM PULSE FEEDER DIAPHRAGM FAILURE

Metallography Report (Y-12) No. 30

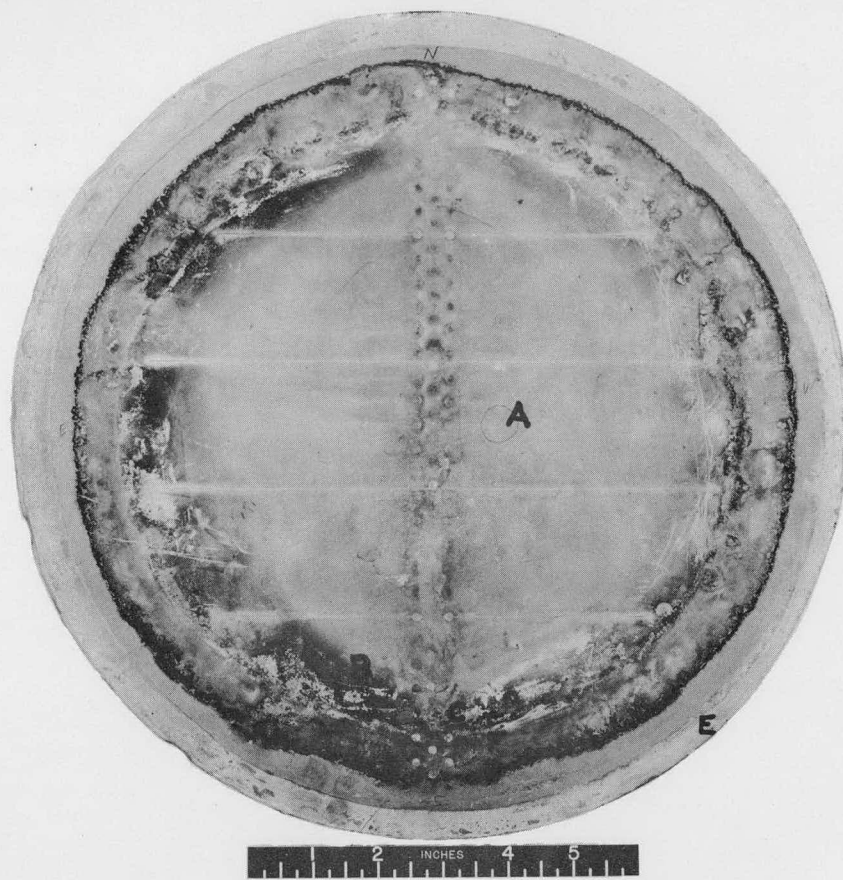
The appearance of the as-received titanium diaphragm, (see Figs. 1 and 2), might lead to the conclusion that the diaphragm was severely corroded. However, upon removal of the surface scale by brushing, the surface appeared to be relatively unattacked. Surface markings due to fabrication were still clearly visible as seen in Fig. 7. Thickness measurements showed the diaphragm to be about the same thickness as a sheet specimen of the material from which the diaphragm was fabricated. Also the diaphragm surface had about the same appearance as the surface of the sheet from which the diaphragm was made.

Liquid penetrants revealed only three crack which are located at A, B, and C in Fig. 1. The cracks at B and C were both located in the lower fourth of the diaphragm.

Figure 1 T10150
Soup Side of Titanium Diaphragm

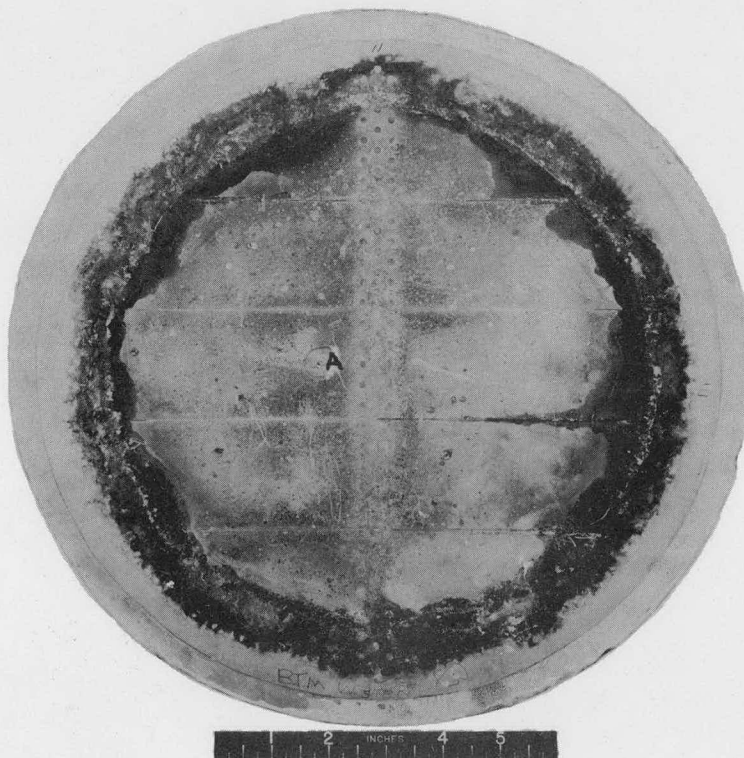
Figure 2 T10149
Water Side of Titanium Diaphragm

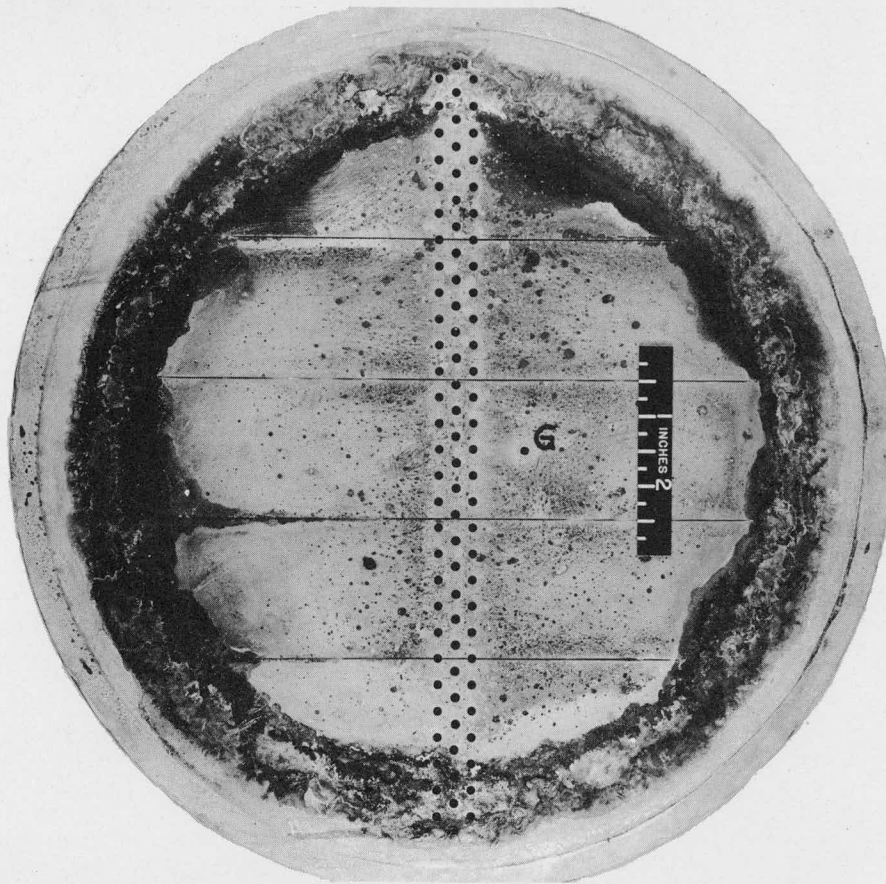
The hole at G in the stainless steel housing reportedly had a rough edge which remained from drilling. This rough edge would account for the circular groove found about crack A on the water side of the diaphragm.

Figure 3 T10168
Face of Stainless Steel Housing Adjacent to Water Side of
Titanium diaphragm.

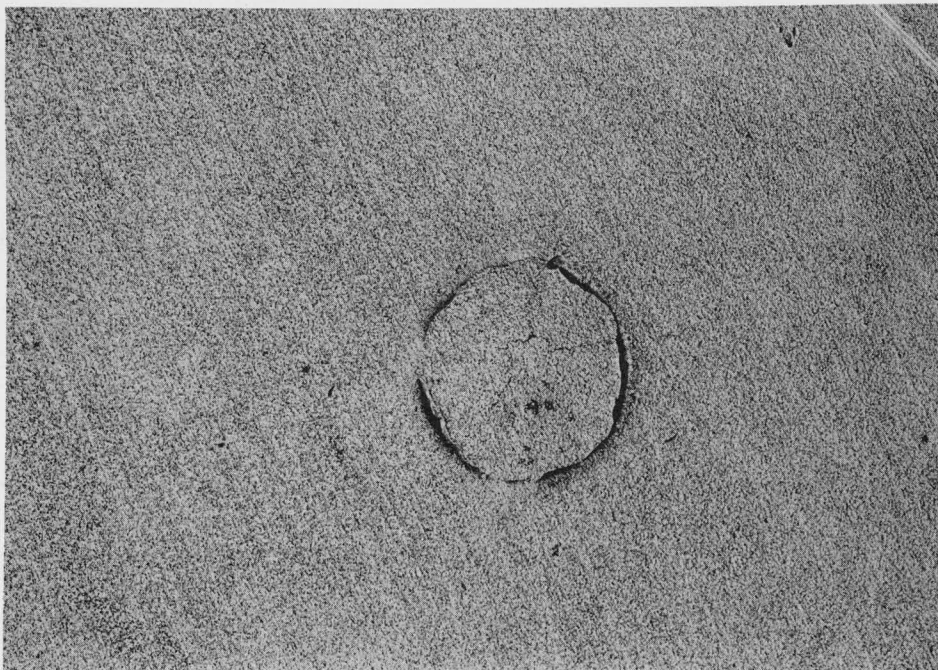
Crack A, located at A, occurred near the center of the diaphragm in a position such as to be opposite a hole in the face of the stainless steel housing. This hole may be located at G in Fig. 3. A circular groove was formed about crack A on the water side of the diaphragm as shown in Fig. 4. This groove was an image of the hole in the face of the stainless steel housing. A photomicrograph of the section taken through crack A, (see Fig. 5) shows the crack to be transgranular. No impression appeared to be connected with crack A other than the circular groove.

Figure 4. T10154 10X
Crack A, see Fig. 2 for location. Water Side of Diaphragm After Scale Removal

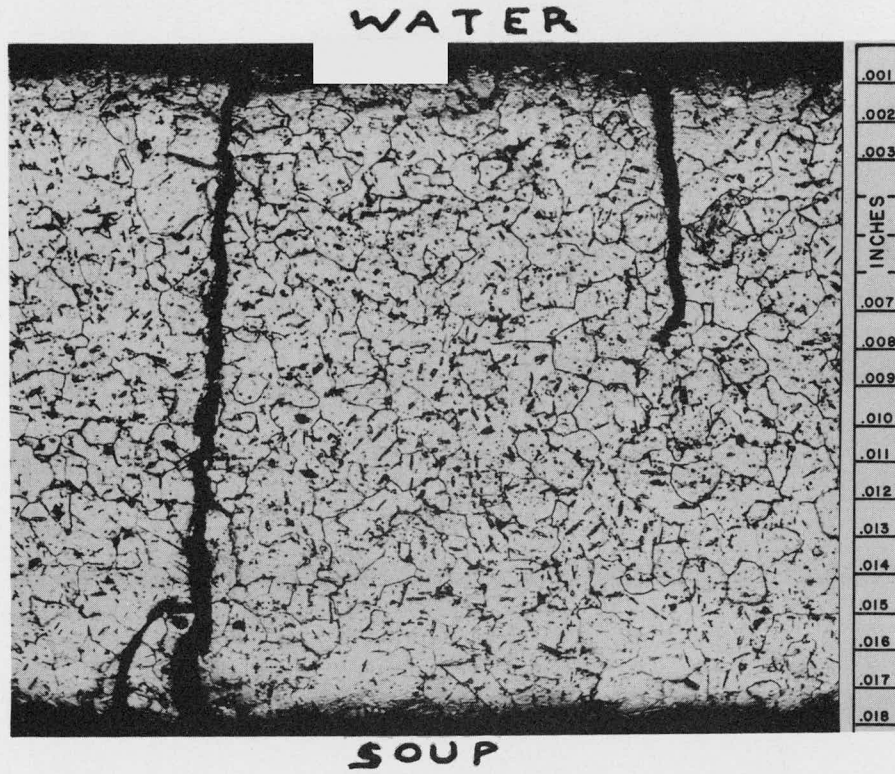
Figure 5 T10358 200X
Section Containing Crack A, See Figure 4

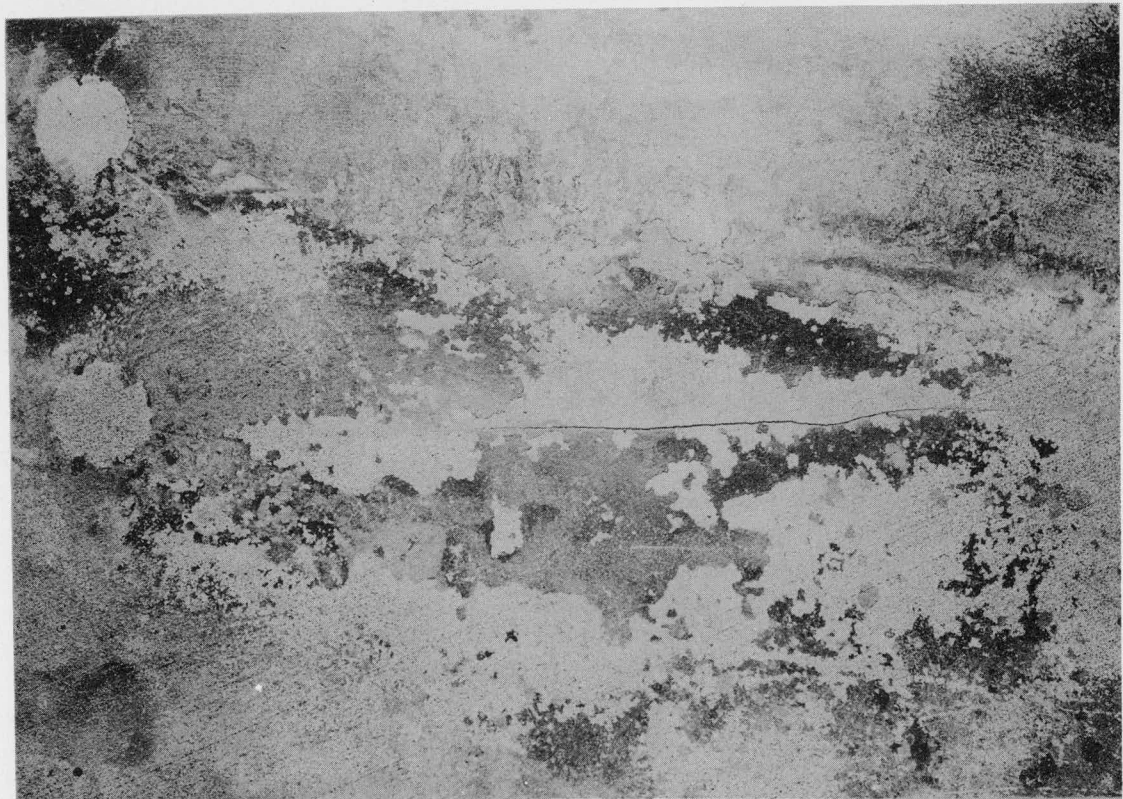
Crack B, is located at B in Fig. 1, is shown in Fig. 6. Shallow impressions occur in crack B on the water side, but none occur on the soup side.

The titanium diaphragm was in operation for more than two million cycles. The two cracks in the lower fourth of the diaphragm were associated with surface impressions which act to lower the fatigue strength of the metal. Spretnak, et al.¹, have shown that at room temperature the endurance

Figure 6 T10160 5X
Crack B, See Figure 1 for Location. Soup Side of Diaphragm before Scale Removed.

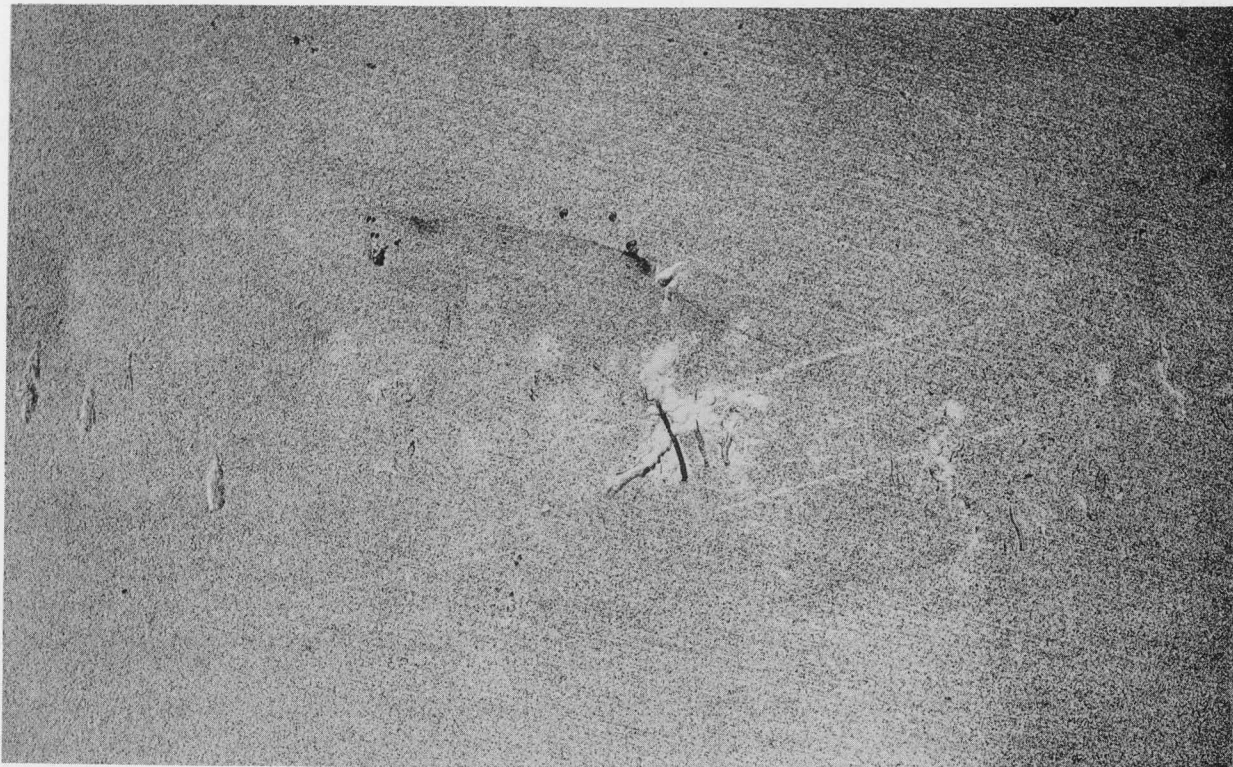
Crack C, located at C in Fig. 1, is shown in Figs. 7 and 8. Shallow impressions appear on the water side as shown in Fig. 8. One small dent appeared in crack C on the soup side. A section containing crack C is shown in Fig. 9. Again cracking appears to be transgranular.

Figure 7 T10162 5X
Crack C, See Fig. 1 for Location. Water Side of Diaphragm After Scale Removed

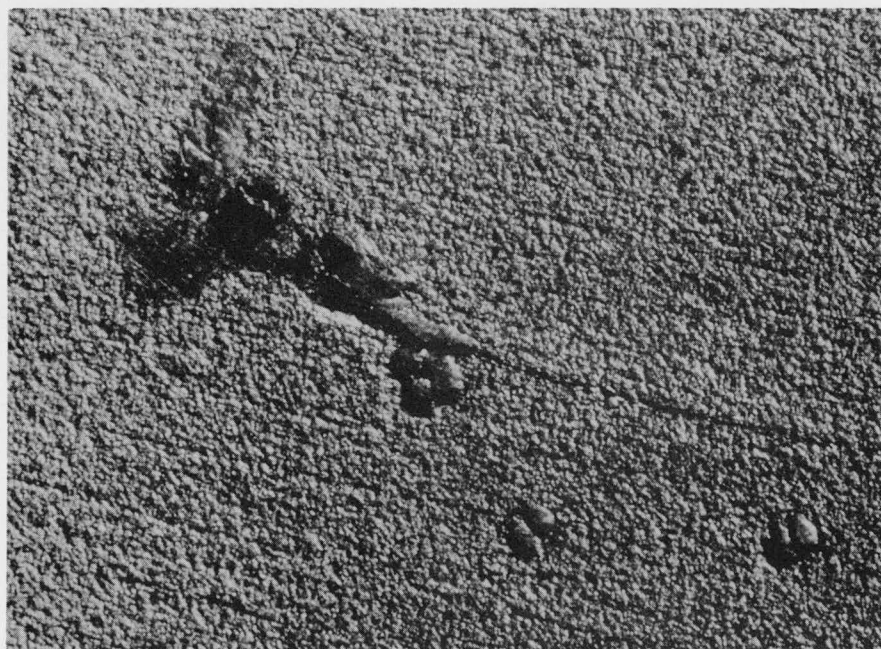
Figure 8 T10163 25X
Indentations in Crack C. Enlargements of Area Shown in Fig. 7.

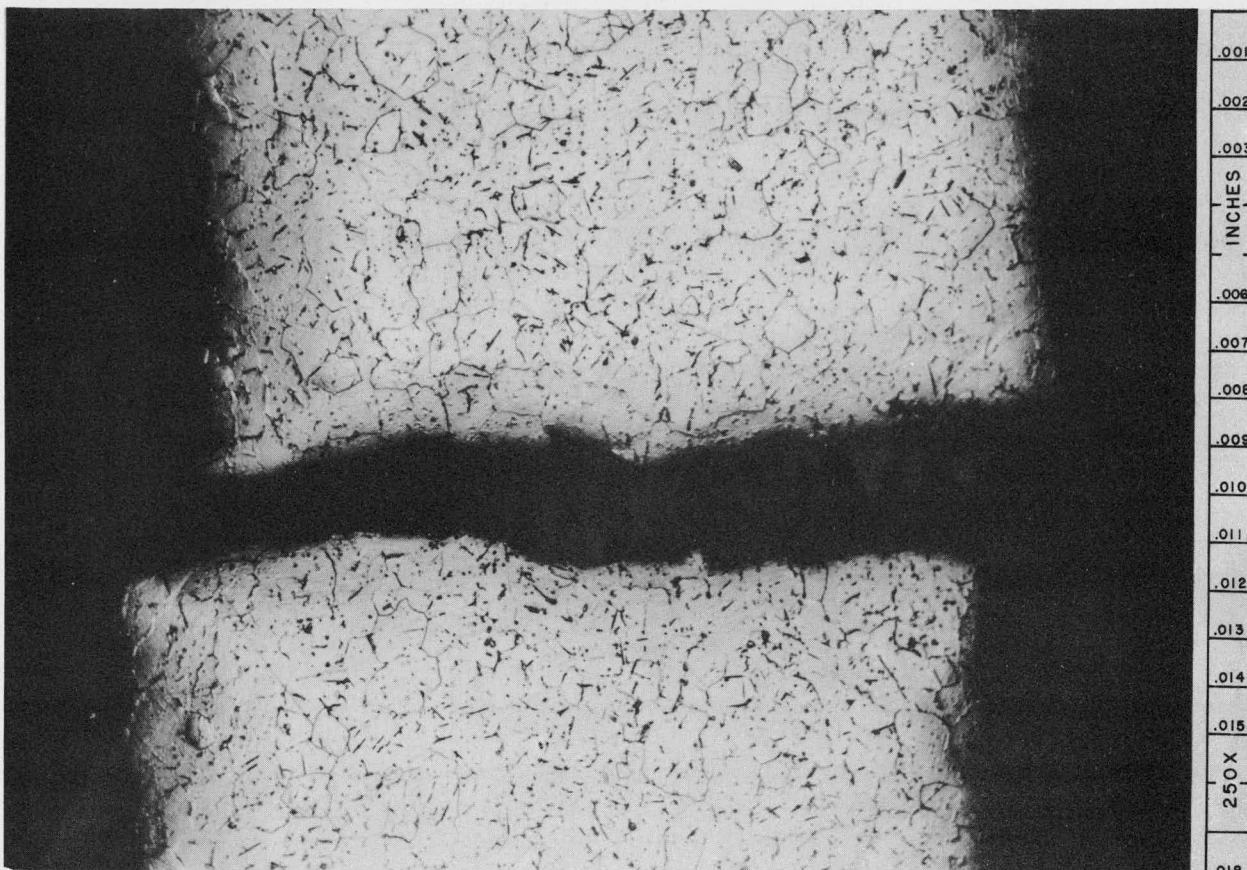
No evidence of a tensile type failure such as necking was seen in any of the cracks examined. While the crack shown in Fig. 9 appears to be offset somewhat, this probably occurred during the mounting of the specimen.

Figure 9. T10362 250X
Section Containing Crack C. Etch: 1HF 1HNO₃: 2 Glycerine

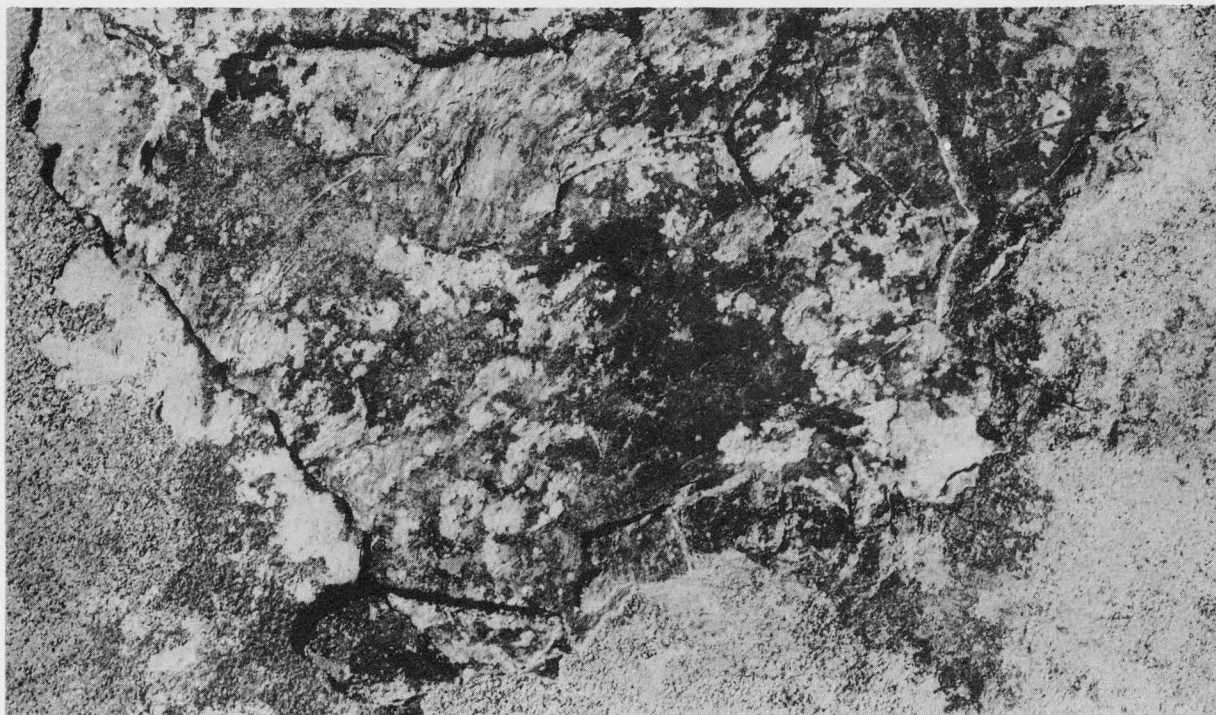
The layer shown in Fig. 10 proved to be tin and is shown in cross section in Fig. 11. There appeared to be a corrosion product of unknown composition between the tin layer and the titanium surface. The tin layer shown in Fig. 12 appeared to be fairly adherent as it did not come off during the brushing. However, during mounting for metallographic examination, the tin layer was pulled away from the titanium surface as shown in Fig. 13. The titanium surface beneath the tin layers did not appear to be corroded.

Figure 10 T10165 20X
Tin on Surface of Diaphragm at D, Location Shown in Figure 3

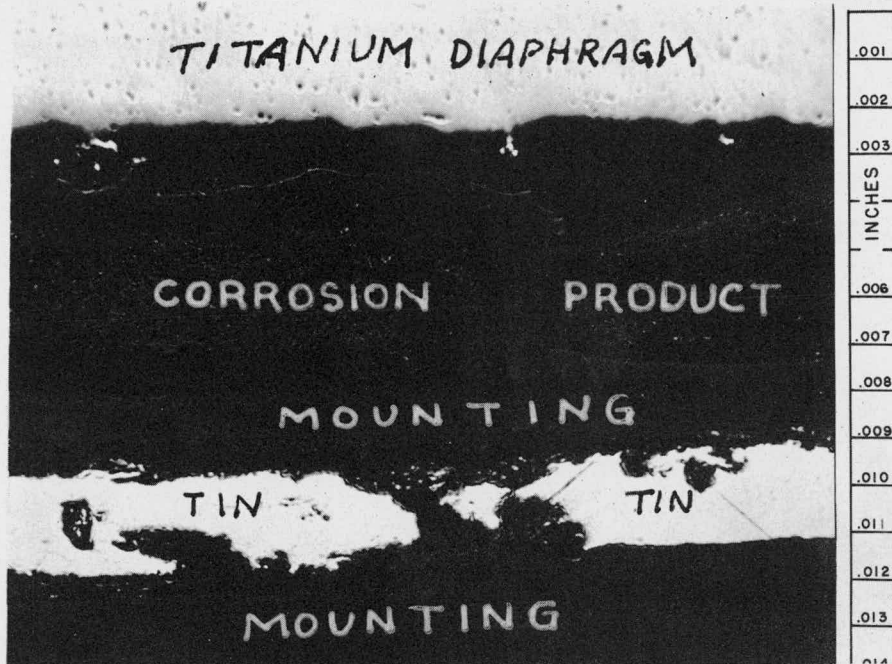
Figure 11 T10367 250X
Section Taken at D Shown in Figures 2 and 10

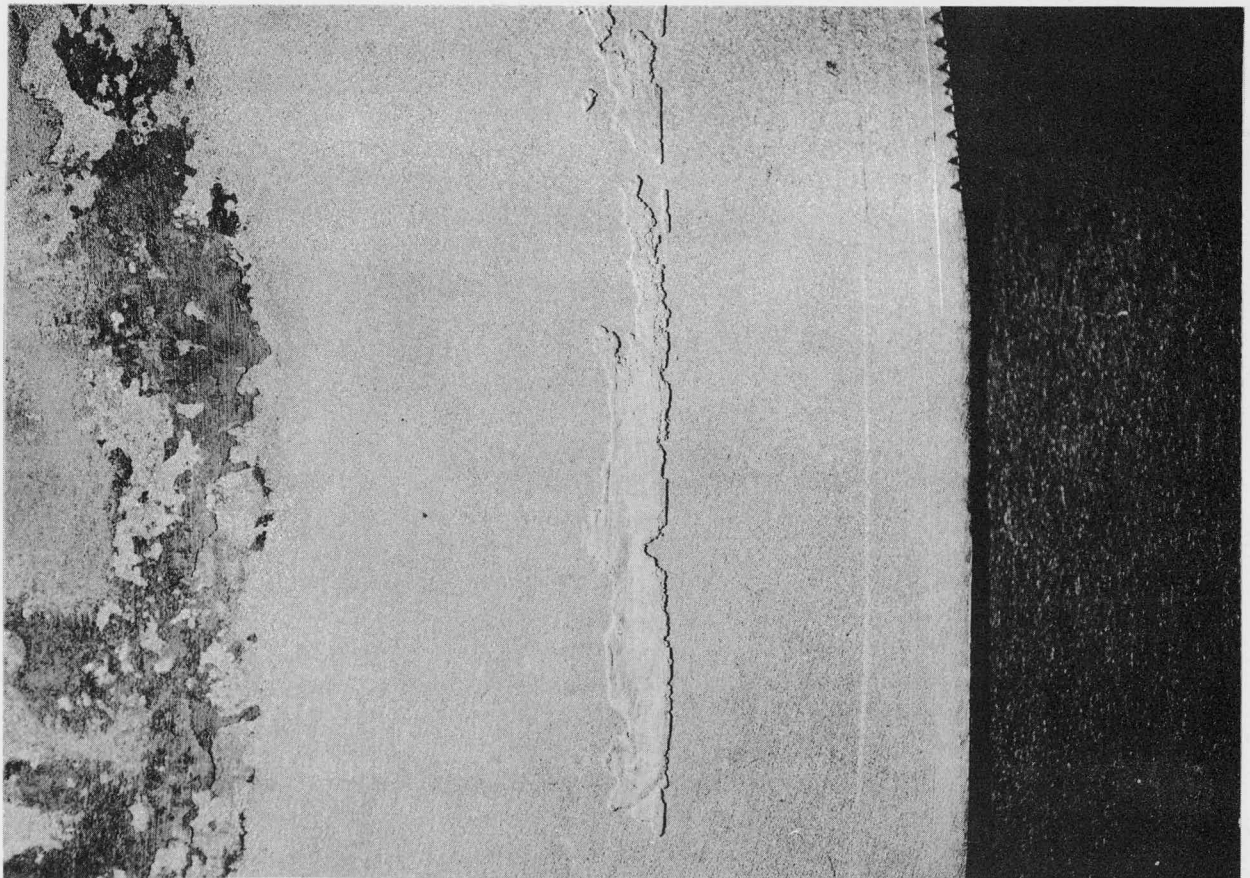
Figure 12 T10151 5X
Tin Layer on Surface at E (see Fig. 1) near Outer Edge of Diaphragm. Soup Side of Diaphragm before Scale Removed.

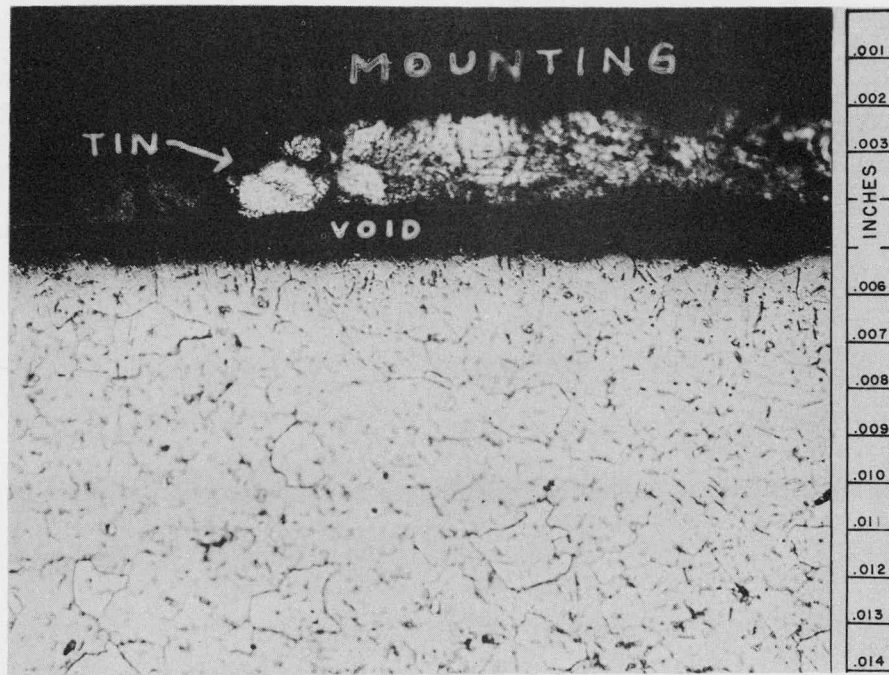
Figure 13 T10414 250X
 Tin Layer on Surface at E, see Fig. 1 for location. Etch: 1 HF: HNO_3 :
 2 Glycerine

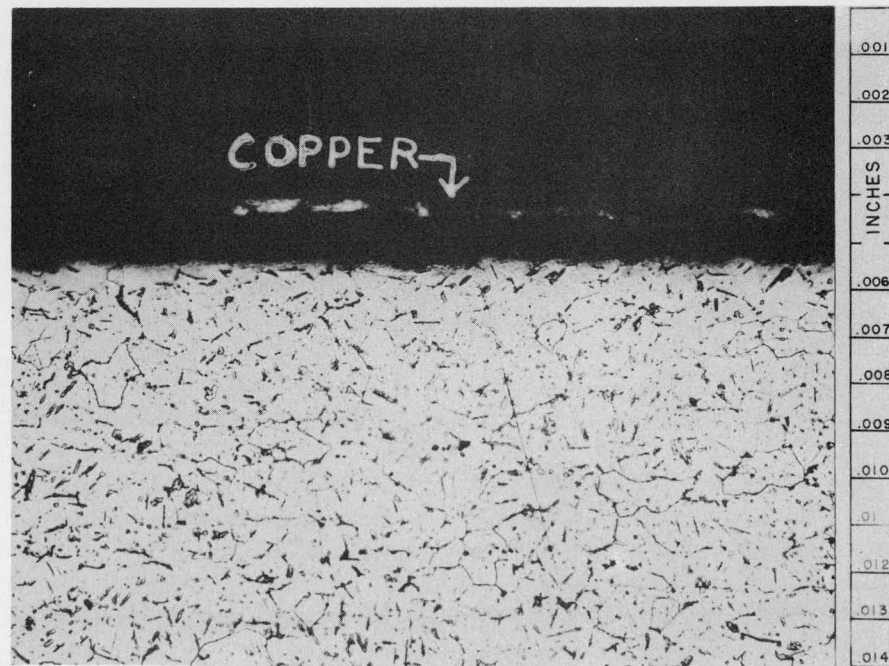
Small areas of the diaphragm surface were colored with a reddish metallic deposit suggestive of copper. X-ray diffraction had previously verified that this was copper. One copper deposit on the diaphragm surface is shown in Fig. 14. Since the uranyl sulfate solution contained copper, the supposition might be that tin displaced the copper from the solution causing the copper to plate on the titanium.

Figure 14 T10412 250X
 Copper Deposit on Surface at E, see Fig. 1, for location. In Mounting
 Process Copper Has Loosened from Surface. Soup Side of Diaphragm.
 Etch: See Fig. 13.
