EXPERIENCE WITH STRESS CORROSION CRACKING AND MATERIALS

COMPATIBILITY AT THE HIGH FLUX BEAM REACTOR

R. W. Powell
J. G. Y. Chow
W. J. Brynda
M. H. Brooks
J. R. Weeks

Brookhaven National Laboratory
Upton, L. I., New York

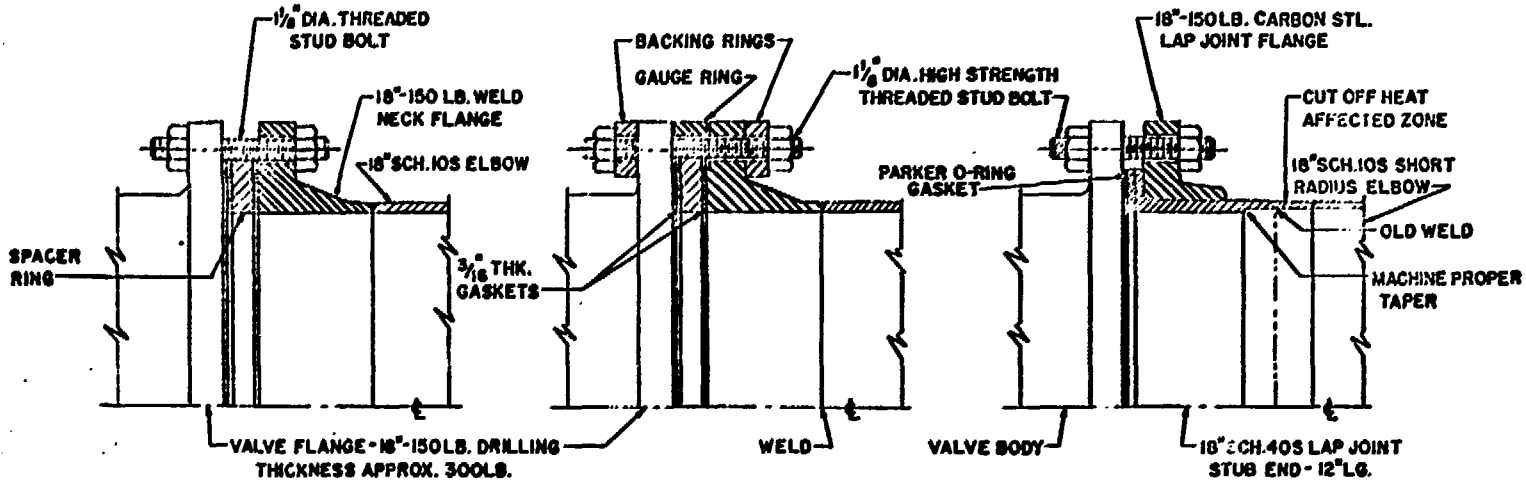
ORIGINAL JOINT CONSTRUCTION
FIG. 7

It should be noted at this point, referring to Fig. 7, that there is a spacer between the weld-neck flange in question and the valve flange to which it is bolted. The thickness and taper of this spacer were determined as necessary to provide the final closure of each loop. In 1965 our analysis indicated that the leakage had occurred because the bolt loading required to develop the gasket face pressure needed to make the 300 lb. type Flexitallic gaskets tight had caused the weld-neck flange to deflect, thus creating an uneven gasket loading. Our solution to this situation, indicated in Fig. 8, was to provide a gage ring between the flanges to prevent deflection and to provide backup rings for the flanges to provide equal loading. Calculations and measurements were made in rebolting to assure no excessive stressing, but no calculations were done at that time to indicate the stress levels previously experienced in the repeated tightening attempts by the contractor.

The primary system is constructed with two types of flanges; one the weld-neck type (Fig. 7) which was subject to the aforementioned difficulties, and the other the Van Stone lap joint (Fig. 9), having a loose flange ring which, upon analysis, showed no hoop stresses due to bolting. In the primary system there are only two 150#, 18" weld-neck flanges. All other pipe flanges are of the 300# Van Stone lap joint type. Two types of gaskets were used in the plant; the Parker-O-Ring type which requires light face loading but exhibits more sensitivity to radiation damage; and the Flexitall type which requires very high bolt loading and exhibits little radiation damage.

In line with recommendations made by the Metallurgy Division, the Van Stone lap joint type flange and the Parker-O-Ring gasket

were chosen for the repair of the A loop. It was further decided to replace the Flexitallic gaskets with Parker O-rings at the similar weld-neck flange in the B loop, since actual radiation exposure had been less than anticipated in the design. The configuration for the A loop Repair is shown in Fig. 9 along with the original design which leaked in Fig. 7 and the BNL solution to the original leak problem in Fig. 8.
