DESTRUCTIVE ANALYSIS OF NEUTRON SOURCES M-71 AND 1053S

April 6, 1972

K. L. Breakall

MOUND LABORATORY

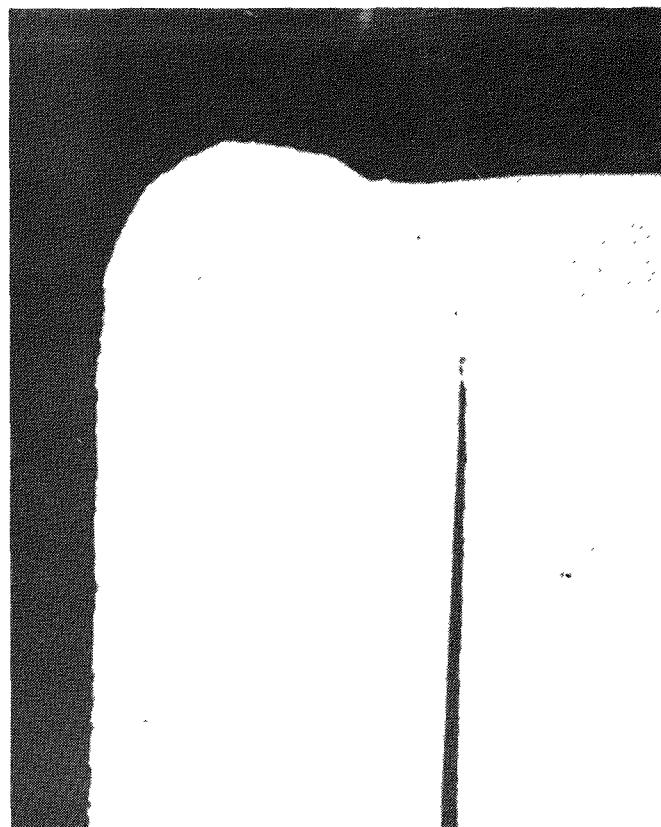
Photomicrographs of the unetched and etched structures of the outer (SS) container welds of M-71 and 1053S were taken and are shown in Figures 5-12. Cracking can be observed in the

weld zones of both sources. Figure 13 shows the cracking through the weld zone of the inner tantalum container of M-71. A reaction product on the outside wall of M-71 weld area is shown in Figure 14.

FIGURE 5. Photomicrographs of Unetched
and Etched Weld Zones of M71
Top Weld - SS Outer Container
Source M71 60.5X

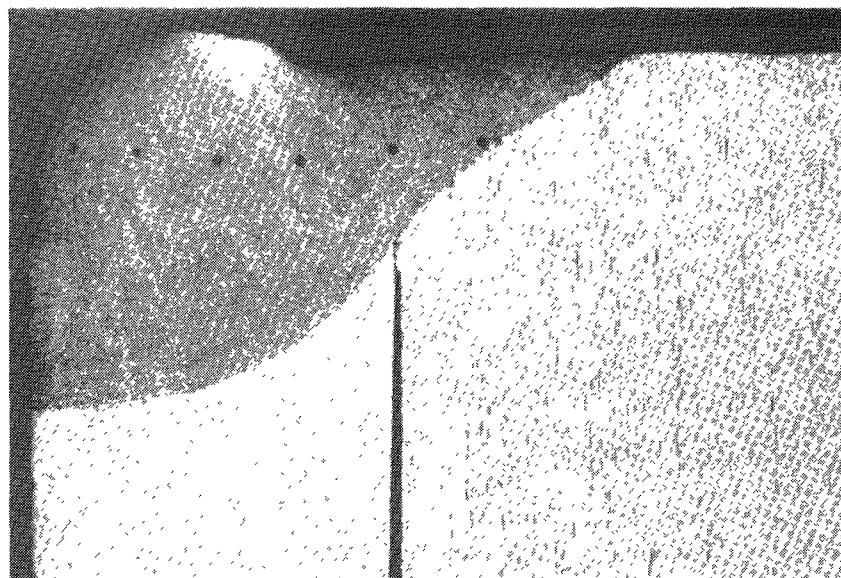
FIGURE 6. Photomicrographs of Unetched and
Etched Weld Zones of M71
Top Weld - SS Outer Container
Source M71 60.5X

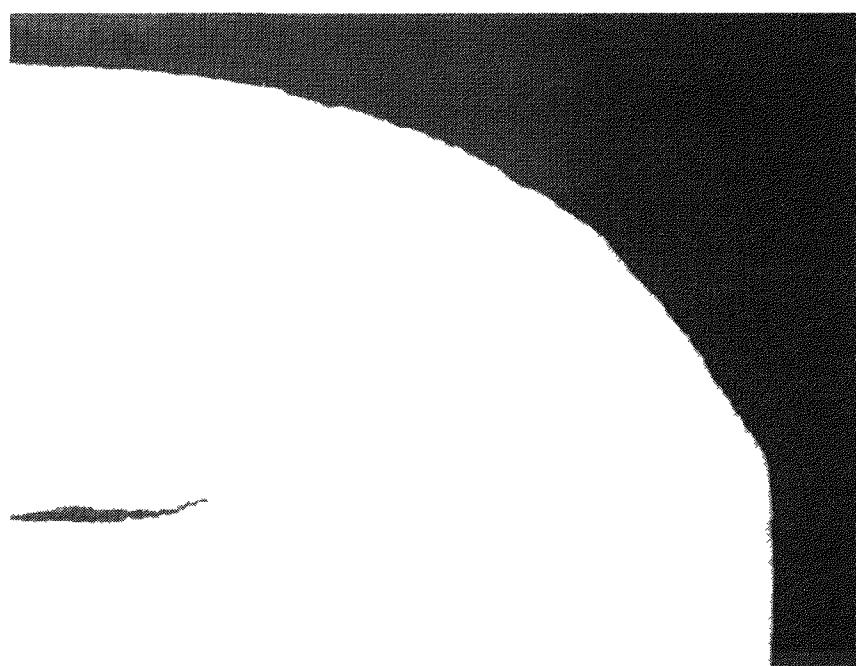
FIGURE 7. Photomicrographs of Unetched
Weld Zones of M71
Bottom Weld - SS Outer Container
60.5X

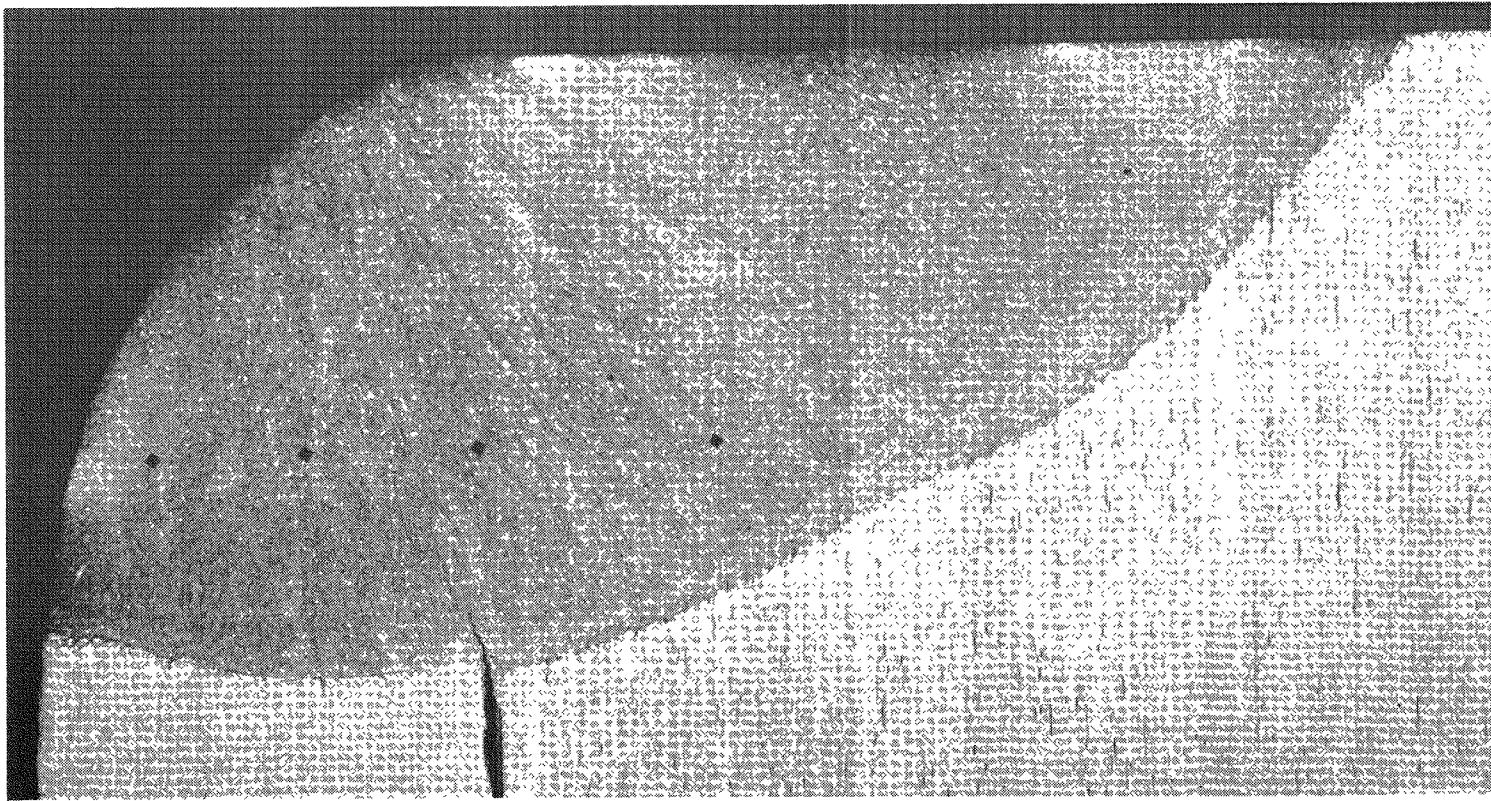
FIGURE 8. Photomicrographs of Etched Weld Zones of M71
Bottom Weld - SS Outer Container
60.5X

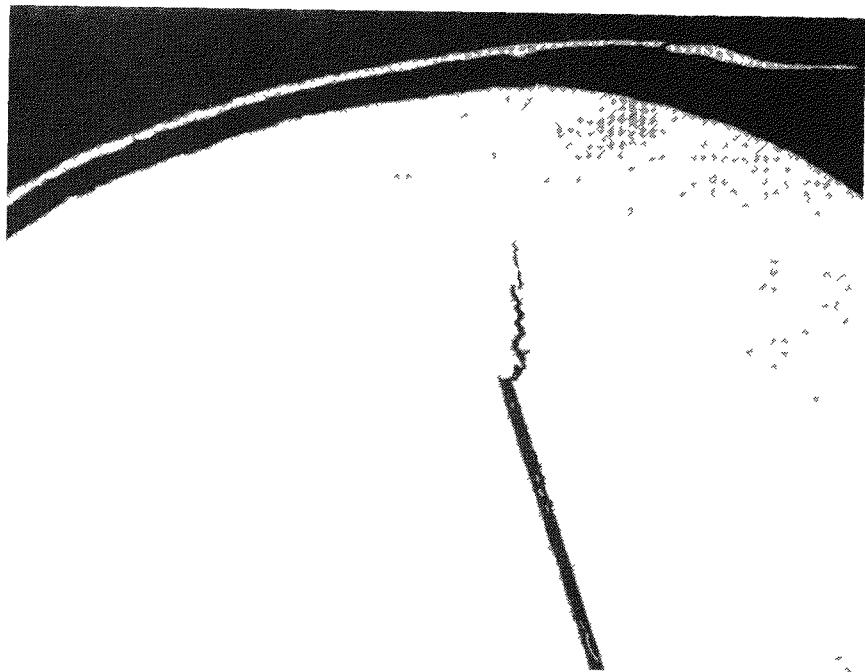
FIGURE 9. Photomicrographs of Unetched Weld
Zones of 1053S
Top Weld - SS Outer Container
60.5X

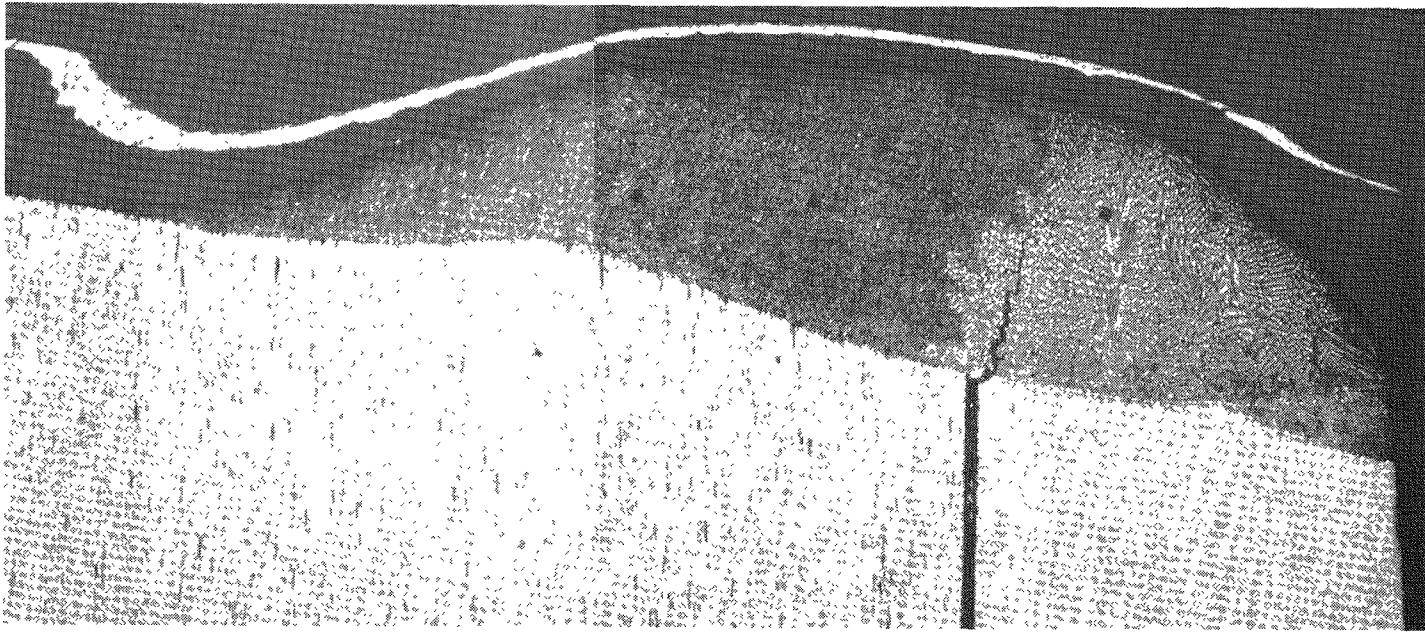
FIGURE 10. Photomicrograph of Etched Weld Zones of 1053S
Top Weld - SS Outer Container
60.5X

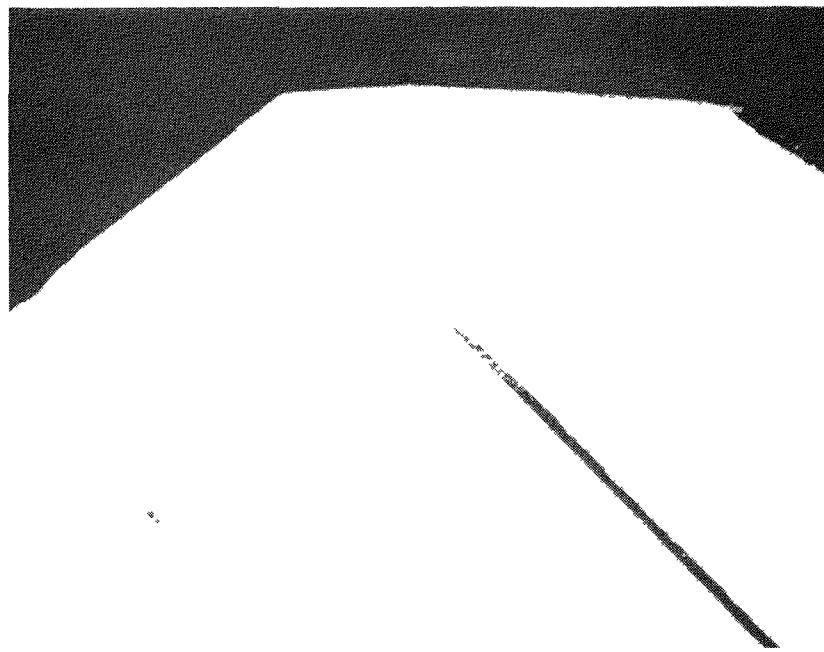
FIGURE 11. Photomicrograph of Unetched Weld
Zones of 1053S
Bottom Weld - SS Outer Container
60.5X

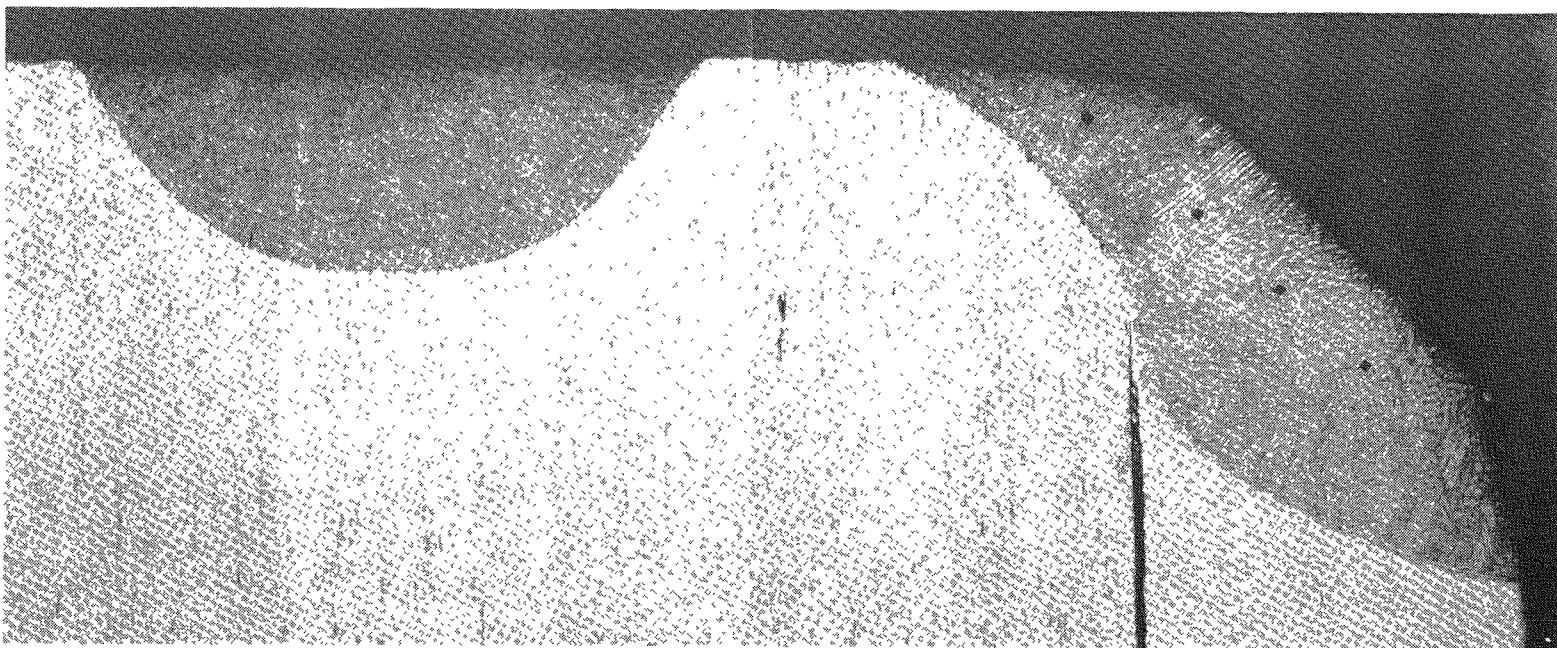
FIGURE 12. Photomicrograph of Etched Weld Zones of 1053S
Bottom Weld - SS Outer Container
60.5X

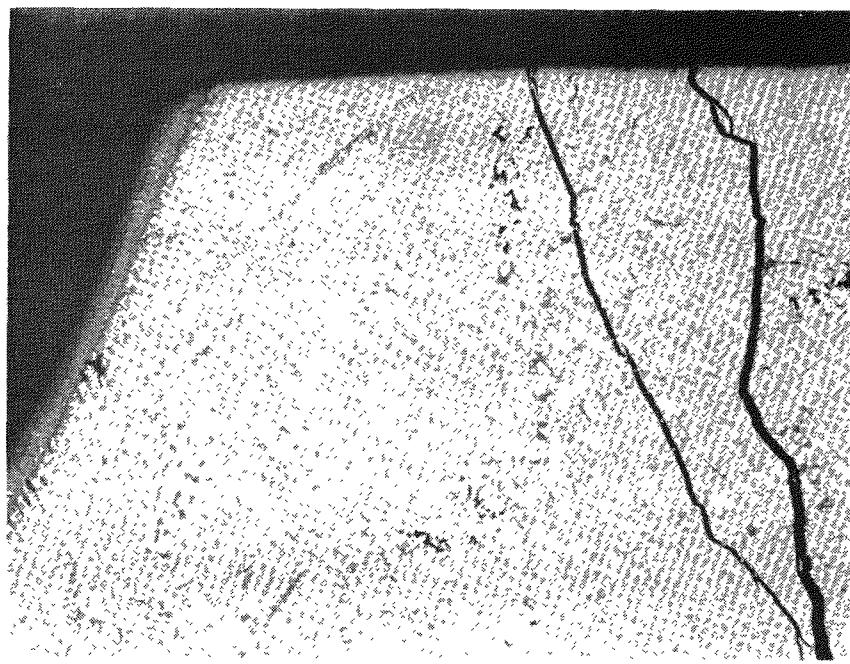
FIGURE 13. Photomicrograph of Weld Zone -
Inner Container of M71
125X

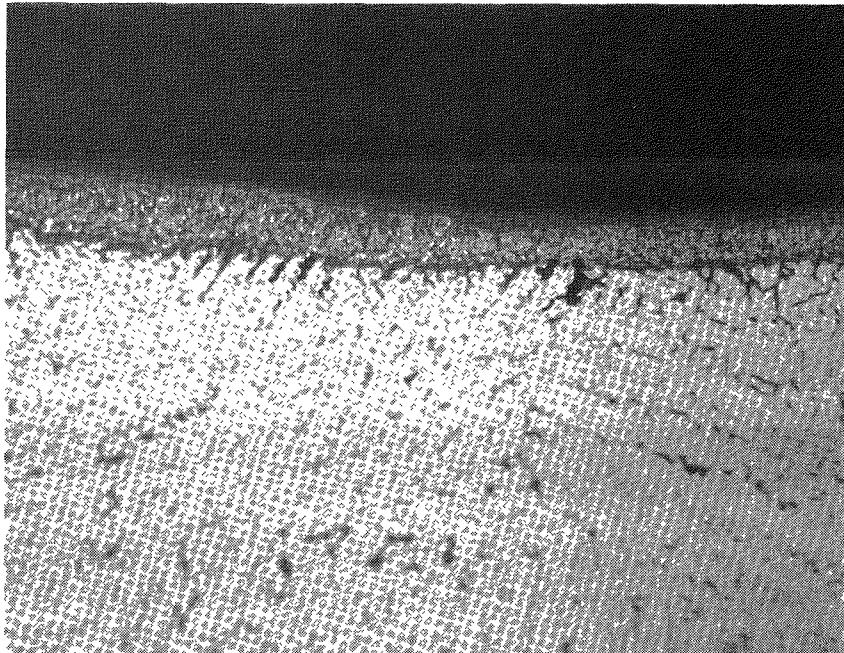
FIGURE 14. Outside Edge of Inner Container of M71
250X

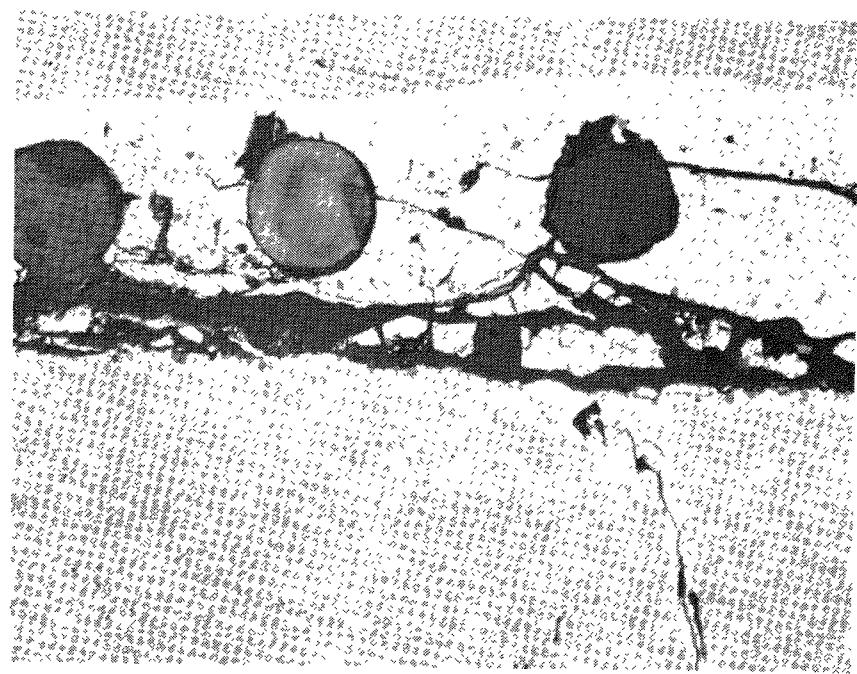
Representative microphotographs of the inner tantalum liners are shown in Figures 15-18. Intergranular attack, cracking, and complete penetration of the side wall is readily apparent. Figure 18 shows penetration of the side wall has occurred, although this was not indicated by radiography. Figure 19 is typical of the fuel showing the porosity that exists. Full investigation of the inner liners is incomplete at this time as x-ray microprobe analysis is required.

FIGURE 15. Top Lid and Sidewall Interface of 1053S
125X

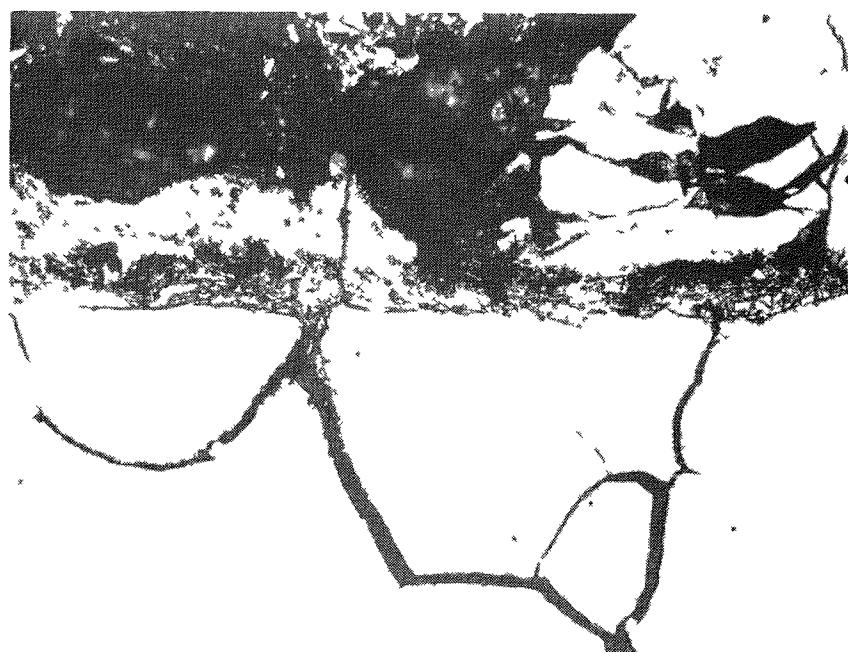
FIGURE 17. Weld Area of Source M71
Inner Container 125X

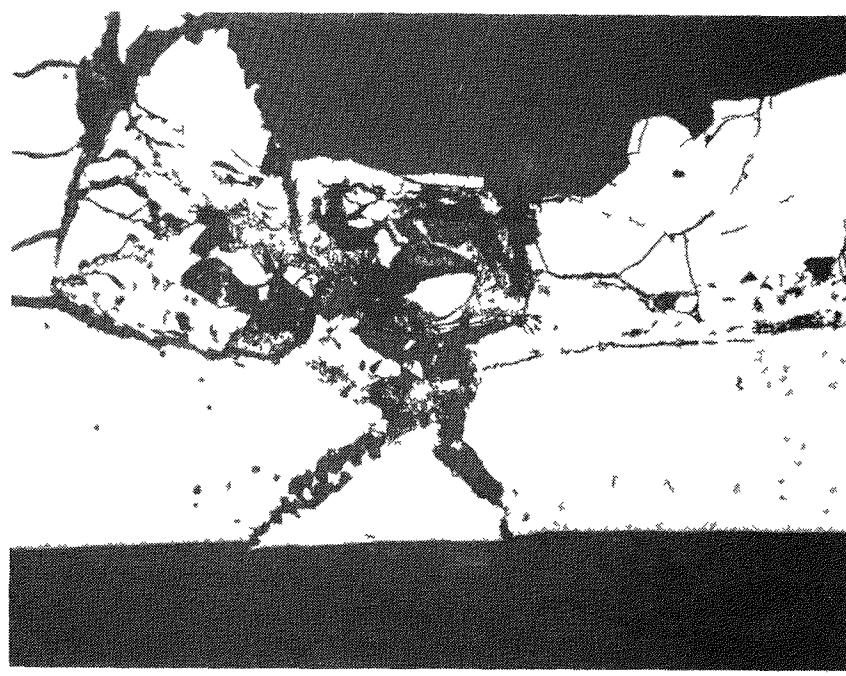
FIGURE 18. Fuel Sidewall Interface M71
125X

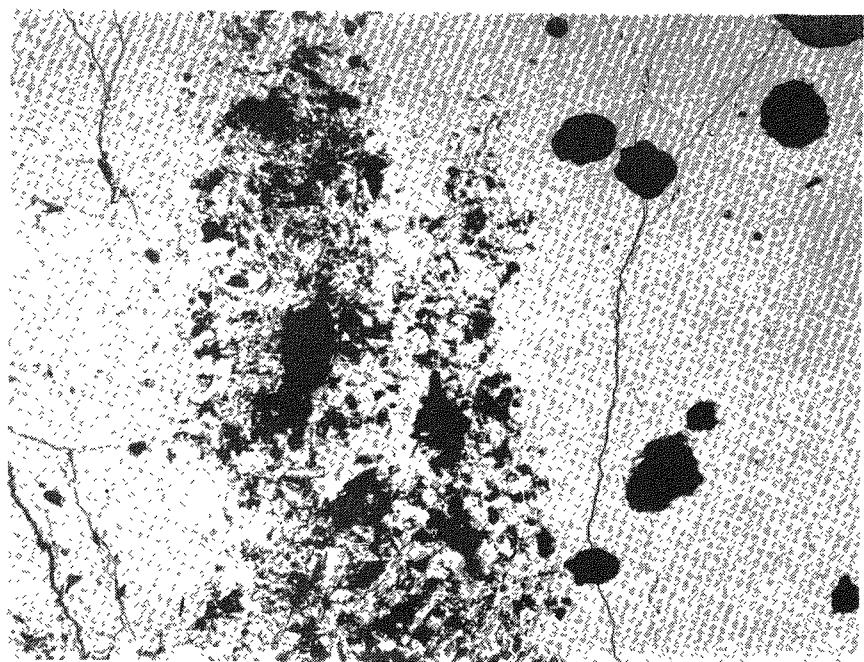
FIGURE 19. Fuel Chunk From 1053S
60.5X

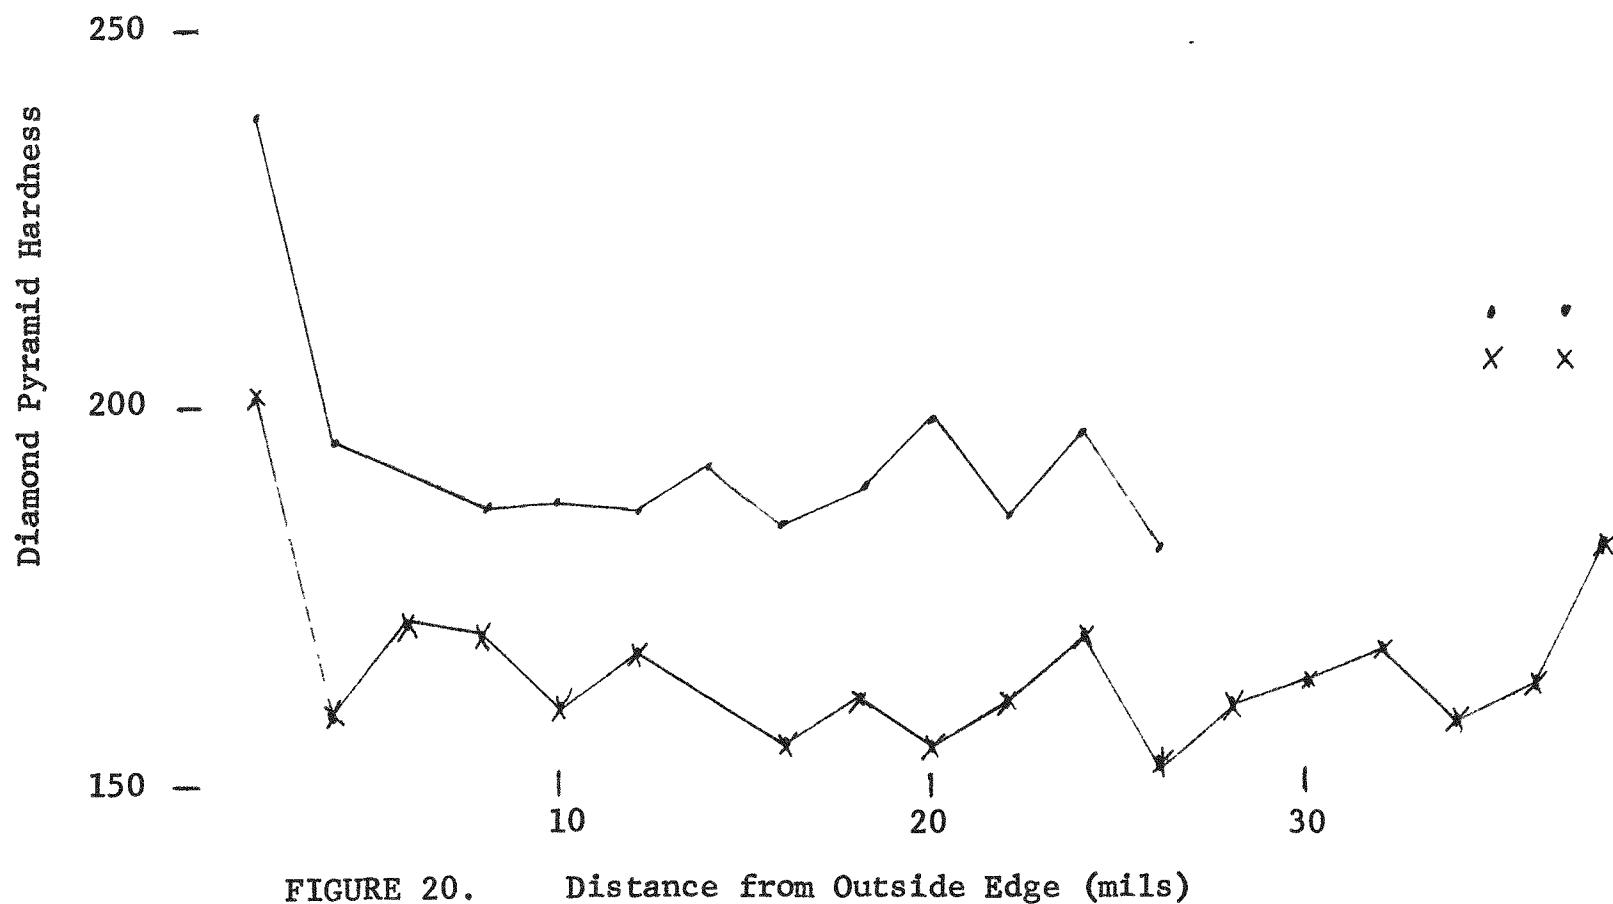
FIGURE 20. Distance from Outside Edge (mils)

Microhardness data, as shown in Figure 20, was typical of the values obtained for the top edge and side walls of the outer stainless steel container. Figures 21 and 22 show photomicrographs of the areas tested. The differences in the hardness that exist may be attributed to the cold working and the small grain size of the outer stainless lid in Figure 21, as compared with the annealed side wall in Figure 22. Figure 23 represents the hardness of the stainless outer top and side wall of M-71. These larger differences are unaccountable at this time, but are probably related to the reasons already stated. This source was subjected to a severe overpressure which may have contributed to the greater hardness differences.

Typical Hardness of SS Outer Container Top Edge and Side Walls
