ORNL-NSIC-64

ABNORMAL REACTOR OPERATING EXPERIENCES 1966—1968

U. S. Atomic Energy Commission
Division of Reactor Licensing

NUCLEAR SAFETY INFORMATION CENTER

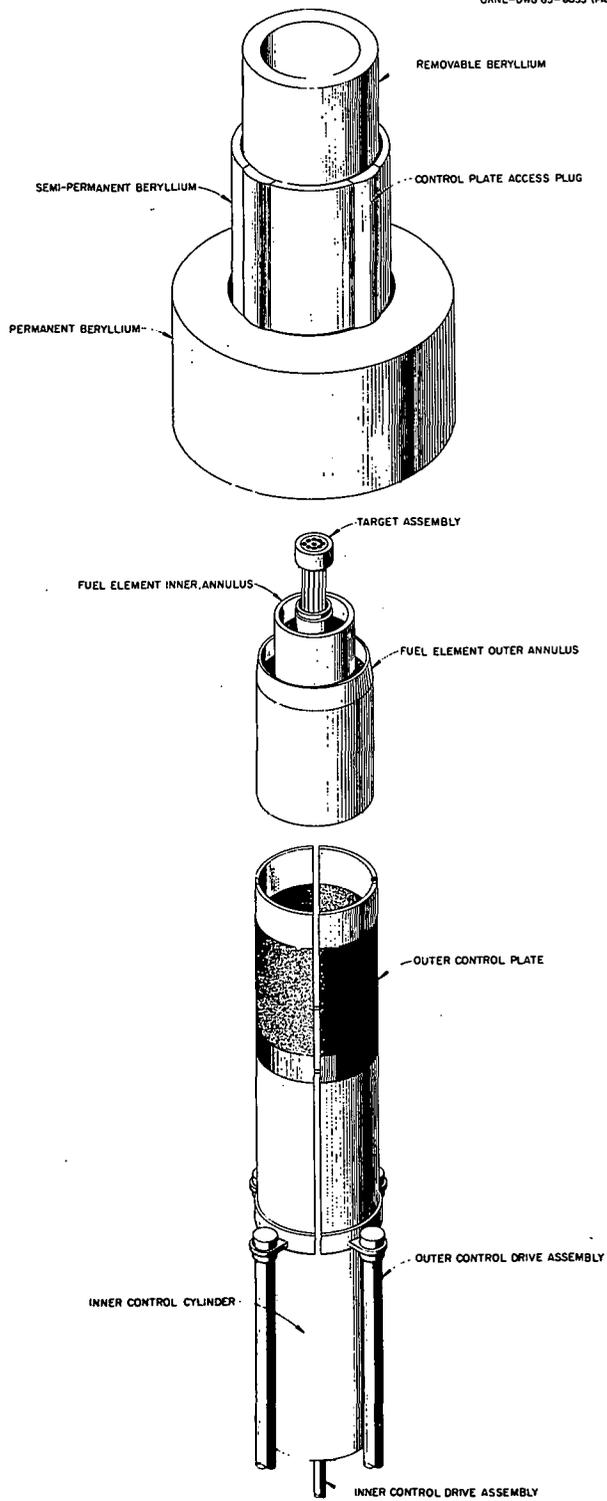
Fig. 66-4-1. HFIR Element, Exploded View.

During the shutdown terminating the first 100-Mw cycle, ten 3/16-in.-diameter balls were found in the primary system strainer. An inspection of the control plates in the pool revealed that the source of these balls was one of the upper bearings of the No. 4 control plate. It was also apparent that some other upper bearings had worn excessively. All four control plates and the inner control cylinder were removed from the reactor. The race on the failed bearing was retrieved as the control plate was removed. By using a periscope, a detailed inspection of all the control-plate bearings was made and indicated that considerable wear had been incurred on all the upper bearings of the control plates; and, in fact, a race and its companion balls were missing from the upper bearing of a No. 3 plate. This race and three balls were found in the pool, indicating that this bearing came apart after being removed from the reactor. There was some evidence of wear on the lower control plate bearings but to a much lesser degree than the upper bearings. The bearings attached to the track assemblies were inspected and found to be in good condition.

After the primary coolant was circulated at full flow for approximately one hour, the strainer was inspected again. Six additional balls were found in the strainer. Of the 26 balls missing from the two bearings, 19 have been accounted for--16 recovered from the strainer and 3 found in the pool. The balls unaccounted for are of no real concern, as it has been demonstrated that they are small enough to pass through the control region; and it is improbable that they can cause any trouble.

The excessive wear of the control bearings was probably caused by fretting corrosion. Plate vibration apparently results from the turbulence of the cooling water which enters the reactor vessel just above the upper end of the control plates. This vibration is probably maximum at the end of the fuel cycle when the plates are in the upper portion of their travel.

The top bearings showed much more wear than the bottom bearings. Vibration of the bottom end of the plates is reduced by spring loaded bearings which maintain contact with the lower end of the plates. Also, there is probably less turbulence in this region.

To prevent a recurrence of a bearing failing while in the reactor, a new set of control plates was installed on which the bearings were modified to provide retainers for both the balls and the race. Routine tests of the time-of-flight of the new plates were normal. While this change does not alleviate the wear problem, it does prevent the bearings from coming apart. More frequent inspections of the bearings will be made to observe the rate of wear and plates will be changed before the wear becomes excessive. Also, the method of attaching the bearings to the control plates was modified to provide an easier means of replacing a bearing remotely when this becomes necessary. For the longer term, work is under way to develop better bearings and to investigate the mechanism of the wearing process.

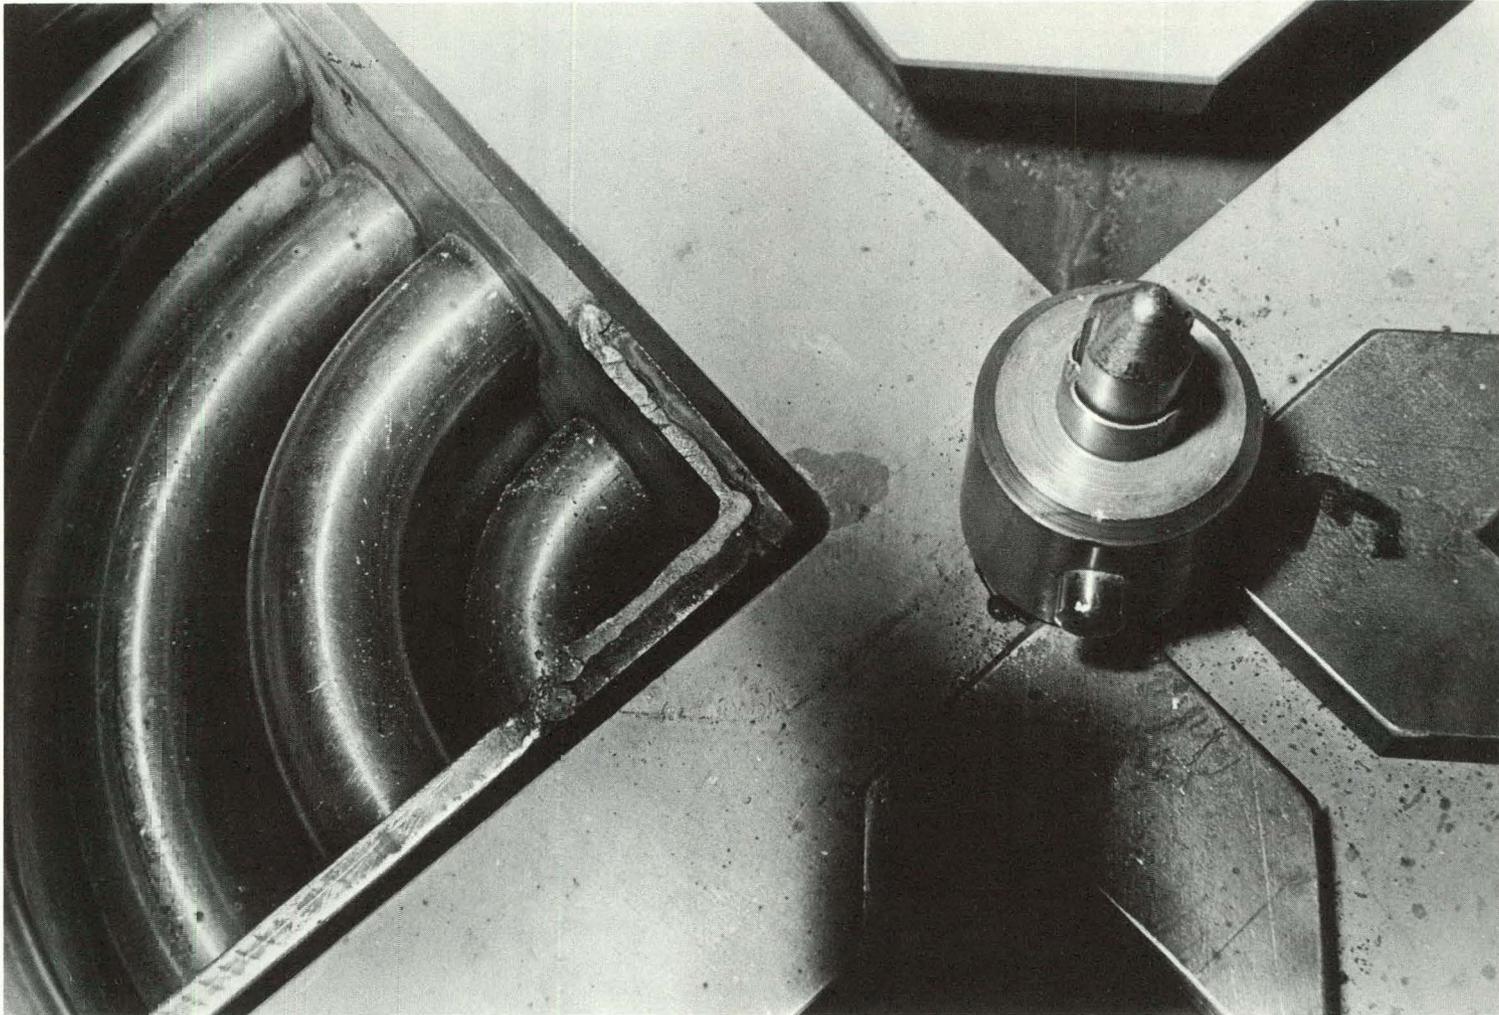
Fig. 67-7-2. Failed Segment of Anticritical Grid.

Luckily no serious damage resulted from the failures of these lugs even though there was potential danger in damaging the pumps, heat exchangers, and possibly core components. Repairs to the grid were made without concern for radiation as fuel had not yet been used.

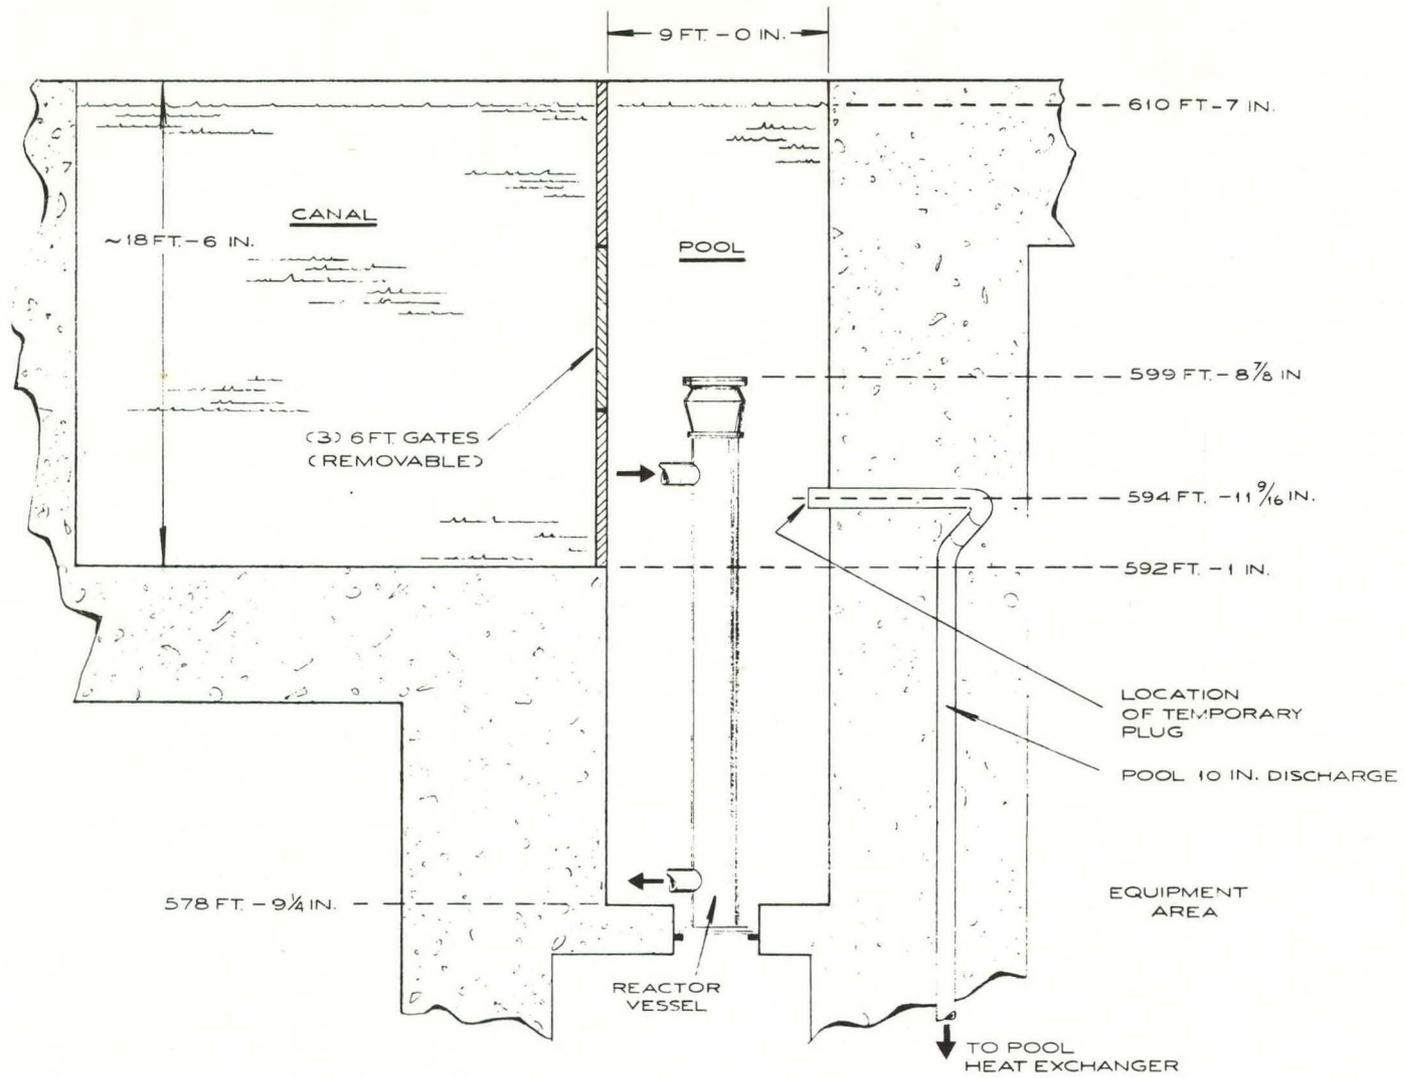
Fig. 68-1-1. Canal and Pool.

During a scheduled shutdown, modifications were to be made to the reactor pool cooling system which required cutting the suction line and relocating a pump. The reactor was shut down, and all fuel except one control rod fuel section was removed from the core and placed in the fuel storage racks in the canal. In preparation for pump relocation, the reactor pool water level was lowered to the pool cooling suction line level. A regulation basketball, wrapped in rubber tape to increase the diameter by 2 inches, was inserted into the intake of the suction line and inflated. The basketball had been fitted with a wire harness and the harness was fastened to a nearby pipe in the pool. The reactor pool water level was then raised five feet, to the level normally maintained during shutdown, to permit capsule and irradiated component handling in the reactor tank. The ten-inch suction line was parted and work on pump relocation began. Only the basketball plug prevented leakage out of the open suction line (Fig. 68-1).

Unanticipated maintenance problems developed during pump relocation which extended the job. Capsule transfer from the reactor pool into the canal had been scheduled, and the shift supervisor decided to proceed with the transfer while the work on the cooling system piping was in progress. The reactor pool water was raised to the normal level, approximately 16 feet above the level of the basketball, the gate seal was deflated, and one section of the vertical gate between the reactor pool and fuel storage canal was removed. A second section, immediately below the top section, was to be removed to facilitate the capsule transfer, when the basketball plug was forced through the pipe and out the open

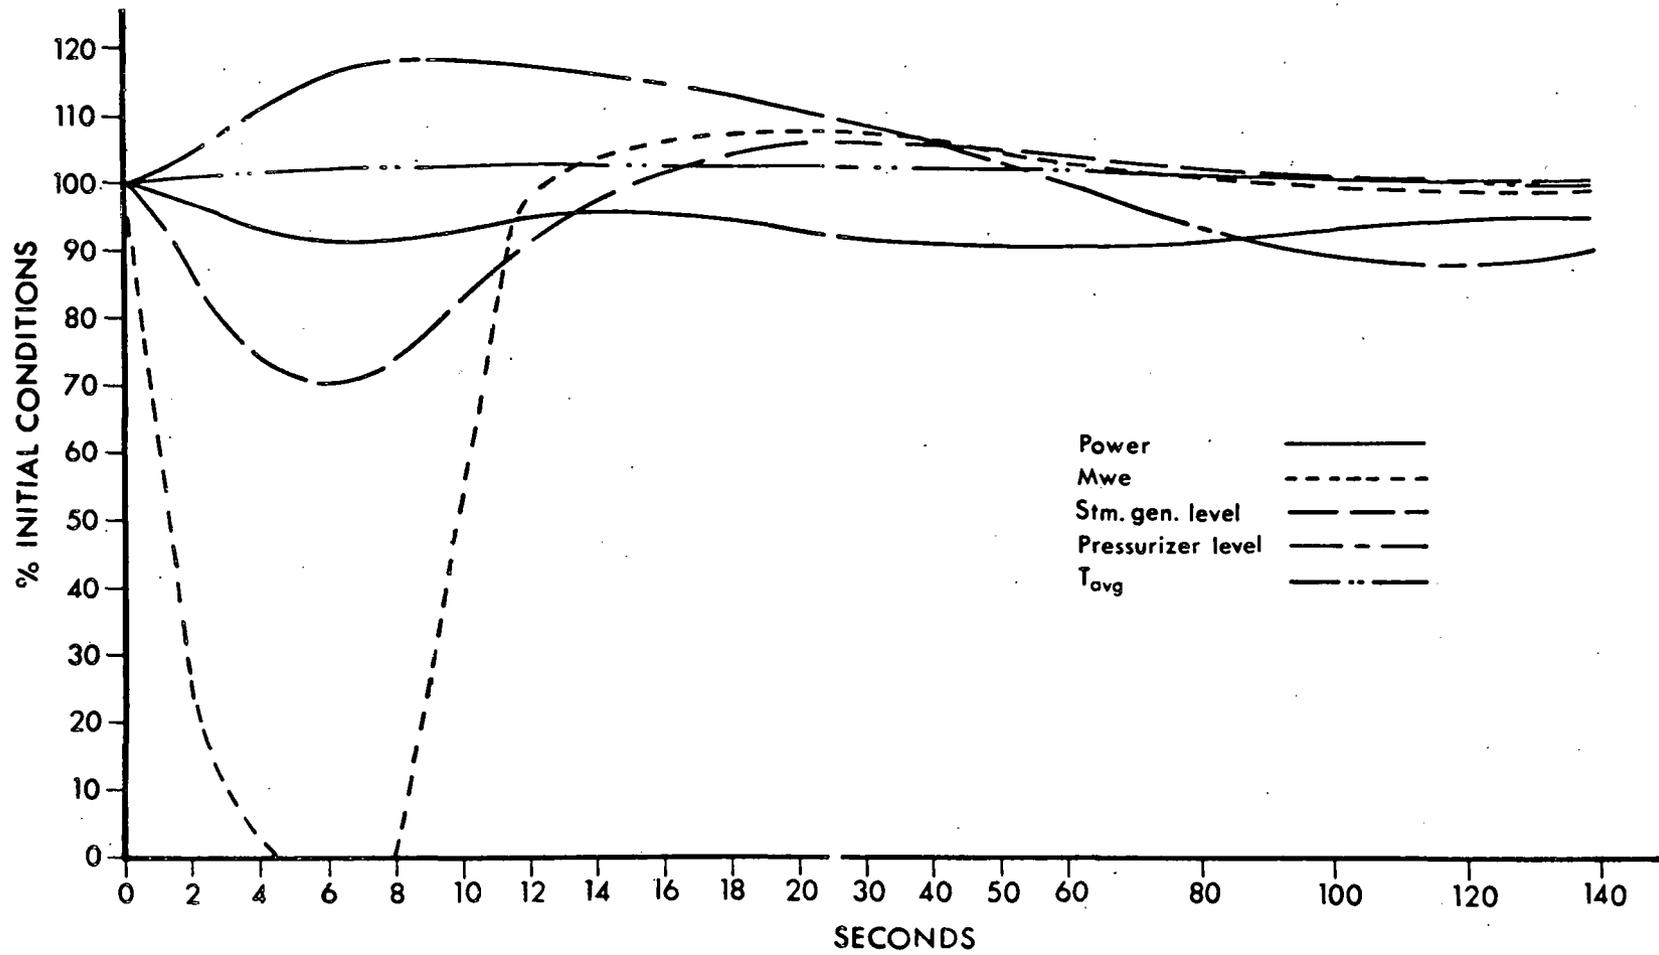
Fig. 68-2-1. PWR System Response to Turbine Control Valve Cycling.

When the valves closed the average coolant temperature began to rise because the heat sink was lost; the operator reacted rapidly to insert a
