Westinghouse Nuclear Energy Systems

SAXTON PLUTONIUM PROJECT
QUARTERLY PROGRESS REPORT FOR THE PERIOD
ENDING MARCH 31, 1973

May 1973

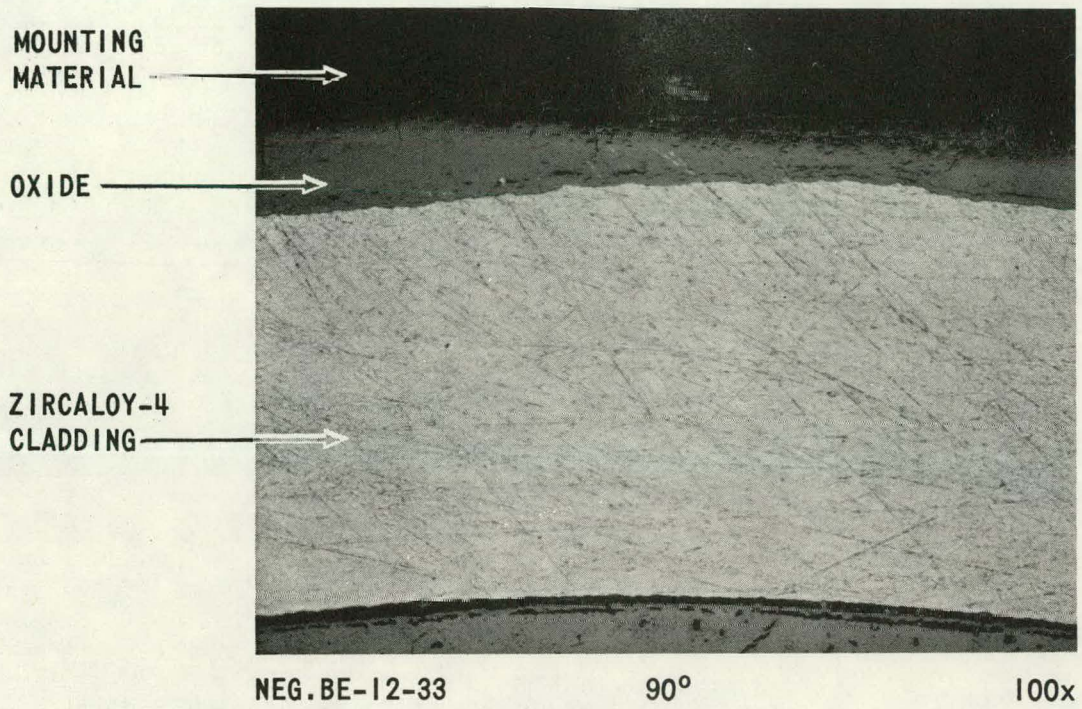
where a white corrosion product had been observed during visual examination^[1]. The abnormally thick oxide film is shown in Figure 2-1. In several areas, there was evidence that the thick oxide film had partially spalled off, resulting in the rough surface appearance previously reported^[1]. On the other hand, the typical and maximum oxide thicknesses observed on the samples from rod BK were 0.8 mil and 1.0 mil, respectively.

The significantly thicker oxide on rod BE and the adherent crud deposits on both rods BE and BK were in contrast to surface conditions observed on the highest power rods, BO and NI, removed at mid-life^[2]. The latter rods exhibited thinner oxide films and negligible adherent crud, despite having operated for 3700 EFPH's at higher power prior to mid-life than did rods BE and BK during 2200 EFPH's after mid-life. This comparison indicates an abnormally high corrosion rate on rod BE after mid-life, the cause of which has not been determined.

Figure 2-1. Abnormally Thick Oxide on Outer Surface of Rod BE, 12 Inches from the Bottom

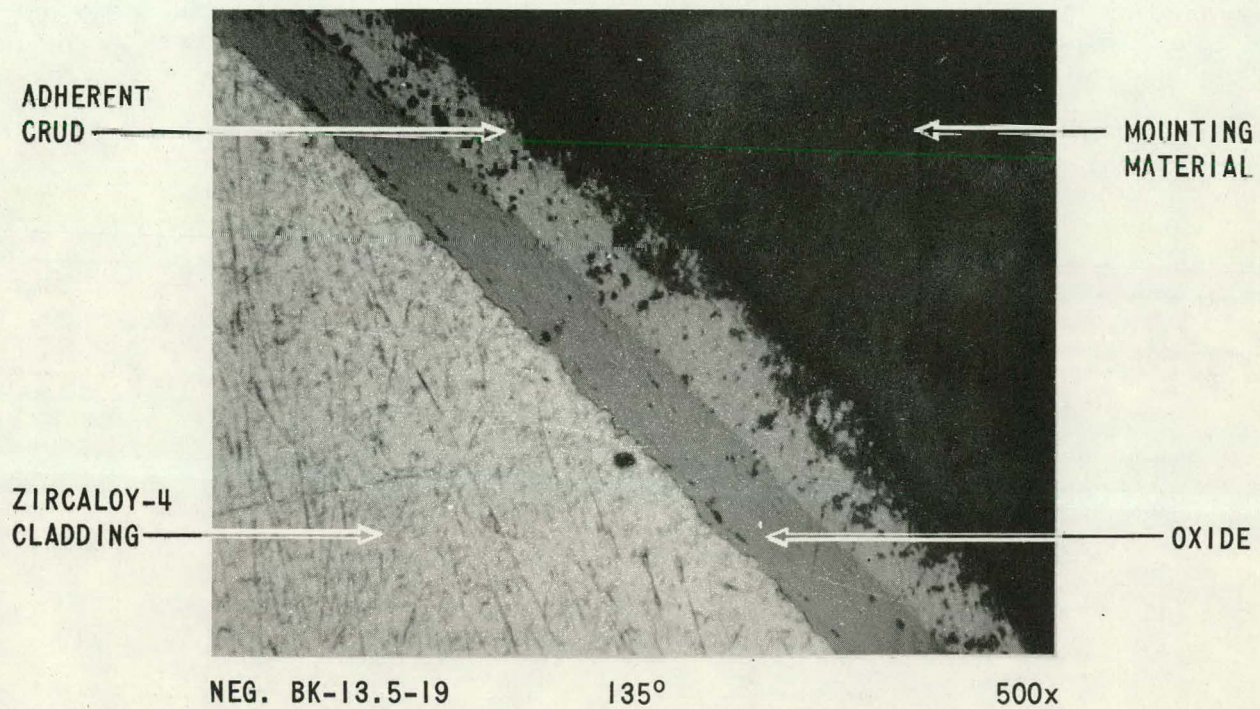
Another feature of the external surfaces of rods BE and BK was the presence of relatively hard, adherent crud ranging in thickness from 0.2 to approximately 1.0 mil (see Figure 2-2). In addition, a soft, highly porous crud up to 3 mils thick was observed on the two samples from rod BE (Figure 2-3), where special precautions were taken to preserve the crud.

Figure 2-2. Typical Oxide Film with Adherent Crud, 13.5 Inches from the Bottom of Rod BK

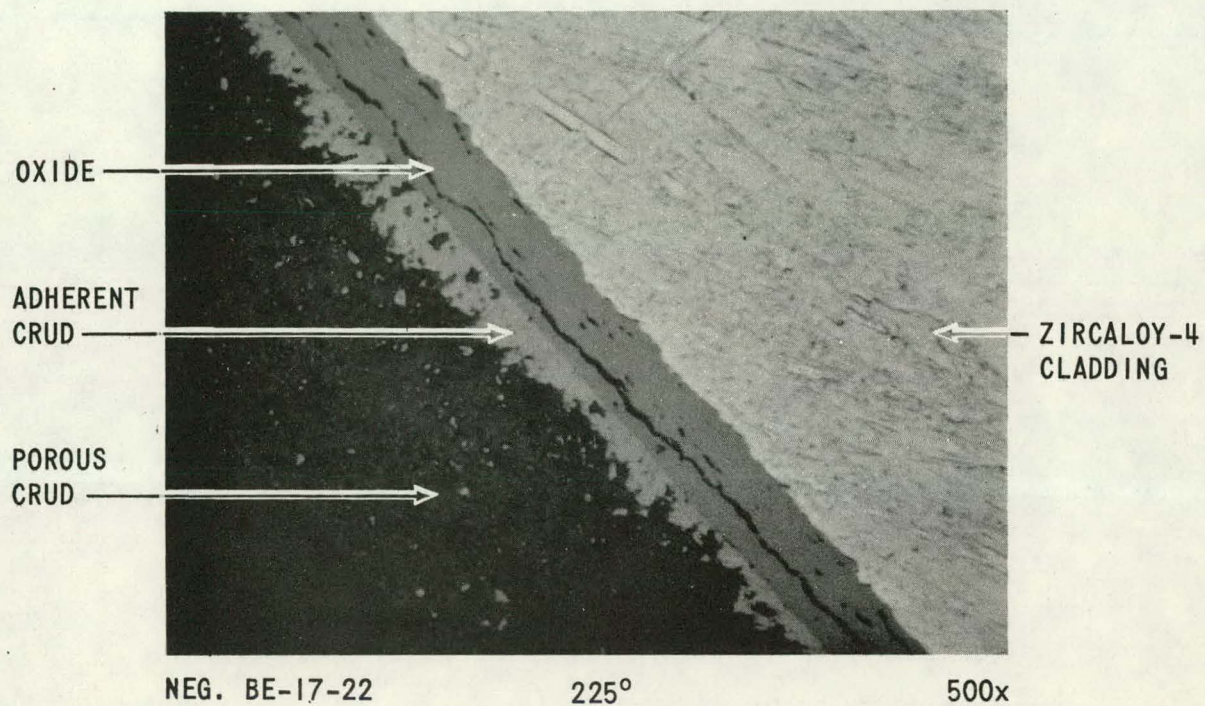
Figure 2-3. Adherent and Porous Crud and Oxide on Outer Surface of Rod BE, 17 Inches from the Bottom

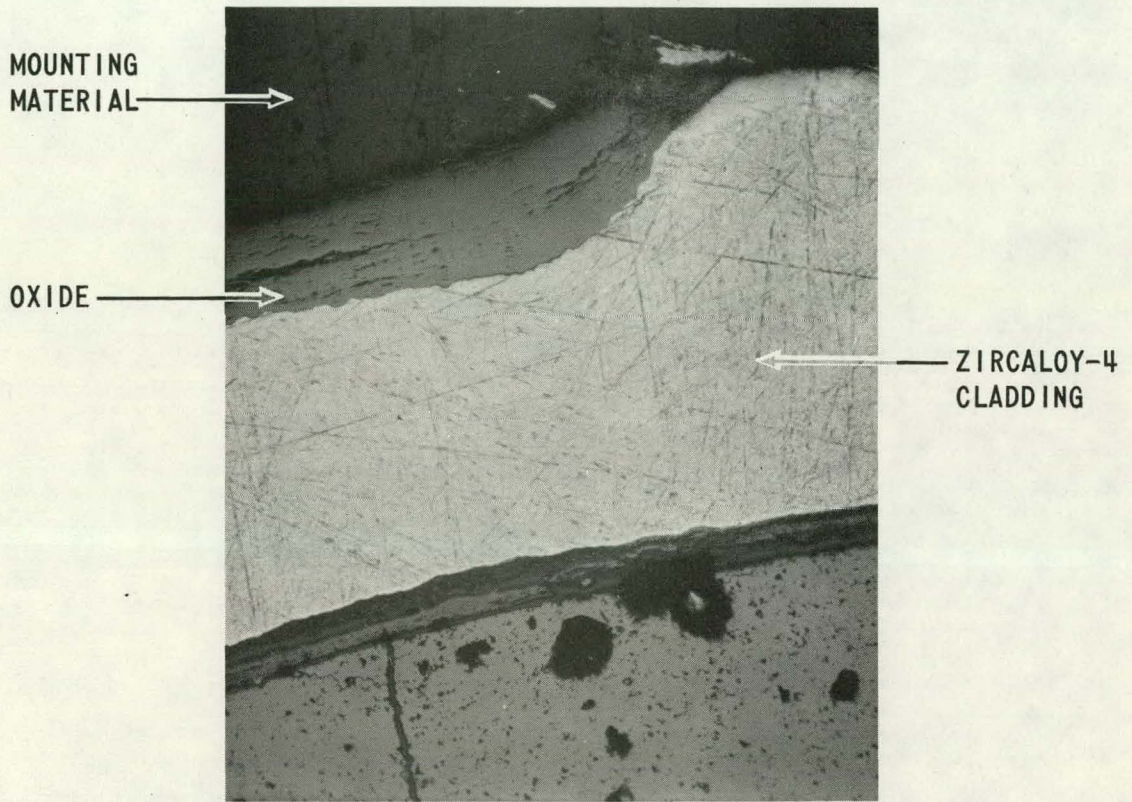
NEG. JX-13-20 350° 100x

Failed rod JX, which had been substituted for rod QL in the sampling plan^[1], was examined at three axial locations: 13, 18, and 26.5 inches from the bottom of the rod. The first two sections were in or close to defected areas, while the third section was representative of a non-failed region of the rod. The 13 inch plane showed surface features similar to those of rod BE at the 12 inch plane, e.g. heavy oxidation of the outer clad surface, penetrating into the base metal about 8 mils (Figure 2-4). There was evidence that some of the thick oxide had spalled, which accounts for some of the surface roughness noted during visual examination and profilometry.

Figure 2-4. Thick Oxide on Outer Surface of Rod JX,
13 Inches from the Bottom

Although defected rod symptoms are clearly evident, neither the 13 inch nor 18 inch sections showed complete penetration of the cladding. Therefore, an additional section has been identified for detailed characterization of the principal defected area just above the 13 inch plane during the next quarter.

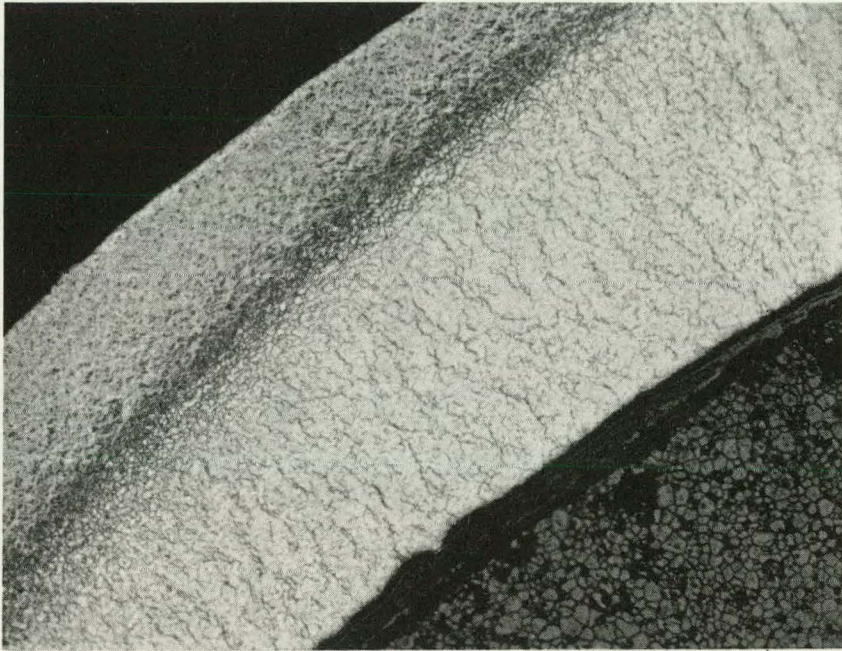
NEG. JX-18-62

The 18 inch section of rod JX exhibited thick oxide on the outer surface, also, but not to the same extent as the 13 inch plane. There was some evidence of local reductions in clad wall thickness, suggesting that oxide had spalled off at this location also. The main feature of the microstructure at this location was the presence of extensive hydriding around most of the periphery,

as indicated by numerous hydride precipitates and several areas of solid zirconium hydride, one of which contained two small cracks originating at the external surface. There was also considerable oxidation (several mils) of the inner surface of the cladding, which is characteristic of a failed rod which has operated for an extended period following failure. Examples of these latter conditions are shown in Figures 2-5, 2-6, and 2-7.

Figure 2-5. Extensive Hydriding, 18 Inches from the Bottom of Rod JX

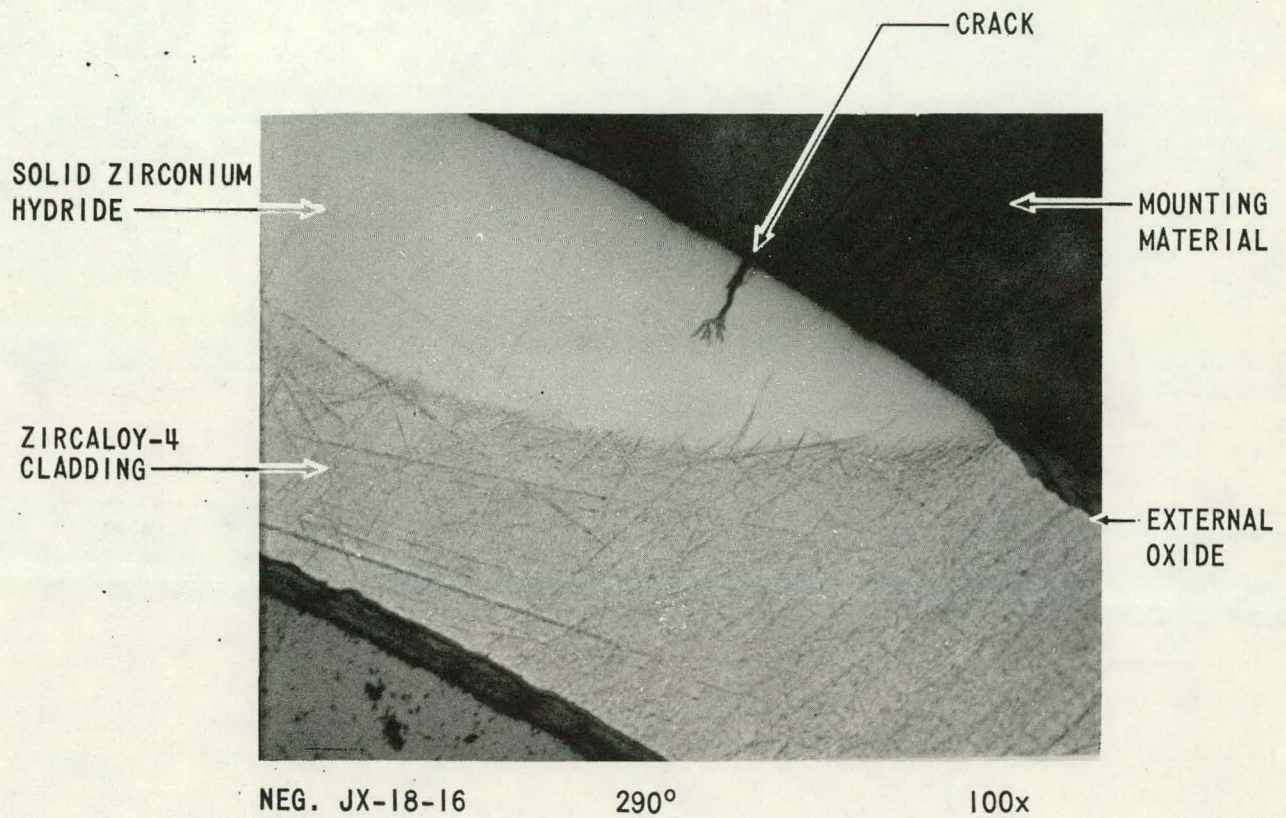
Figure 2-6. Part of Solid Hydride Area Containing External Crack, 18 Inches from the Bottom of Rod JX

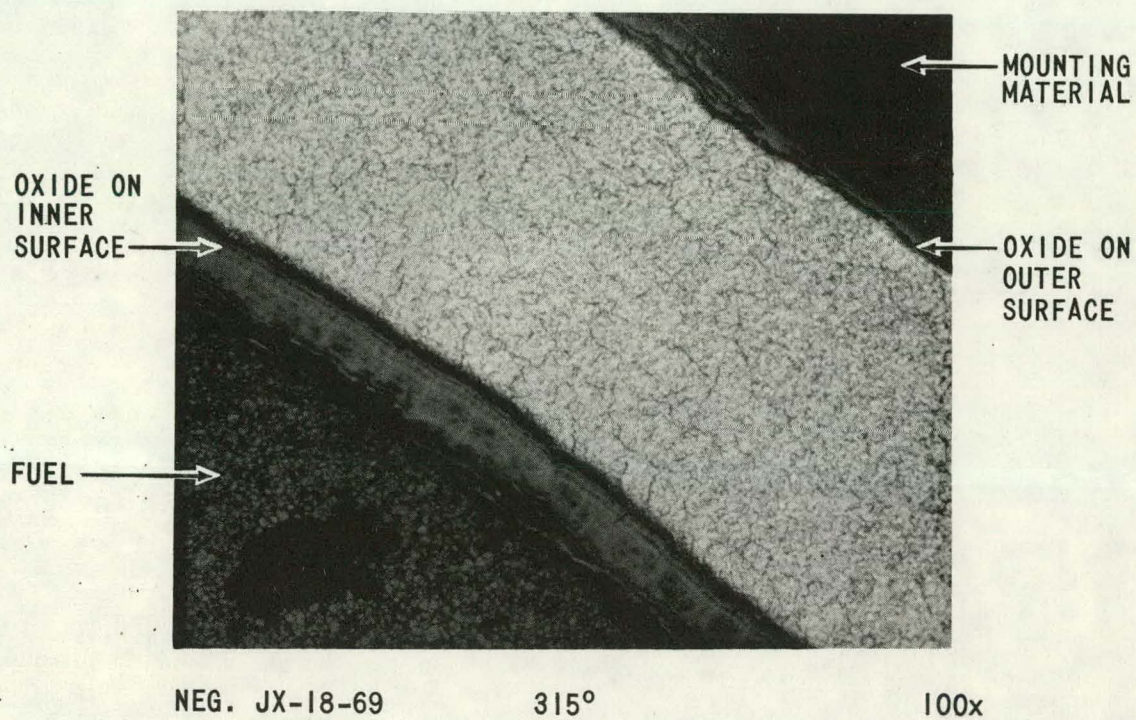
Figure 2-7. Oxide on Both Outer and Inner Surfaces of Rod JX, 18 Inches from the Bottom

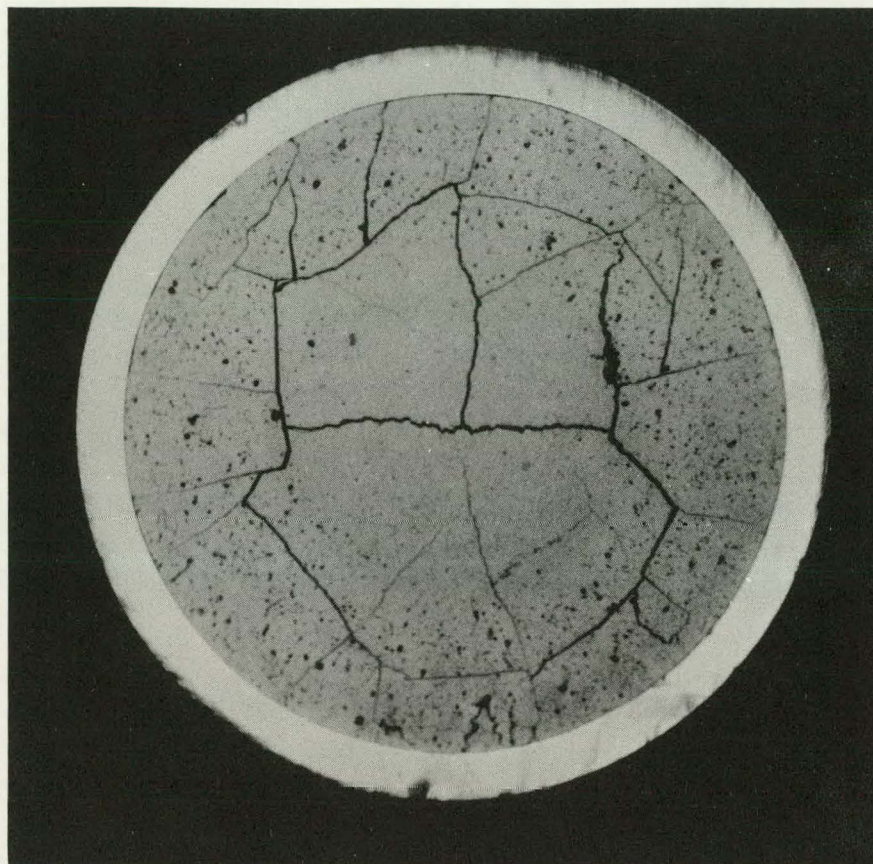
NEG. HC 30906

Macroscopic examination of all sections indicated that the gap between clad and fuel was either non-existent or very small. A characteristic pattern of radial and circumferential cracks was present in all cases. A typical macrograph of a transverse cross section is shown in Figure 2-8.

Figure 2-8. Macrograph of Transverse Section of Rod IM,
12.25 Inches from the Bottom
