**Shippingport Atomic Power Station  
Steam Generator Tube Damage  
and Water Chemistry Control  
(1965 - 1975)**

W. J. Singley

January 1978

BETTIS ATOMIC POWER LABORATORY

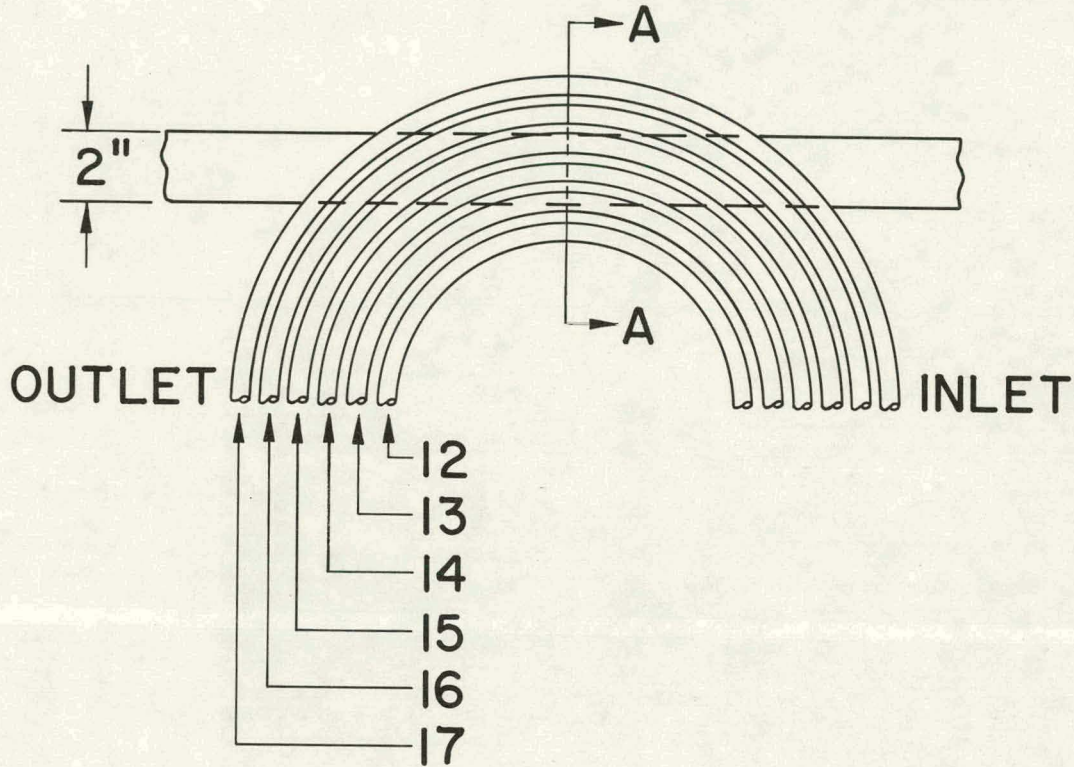
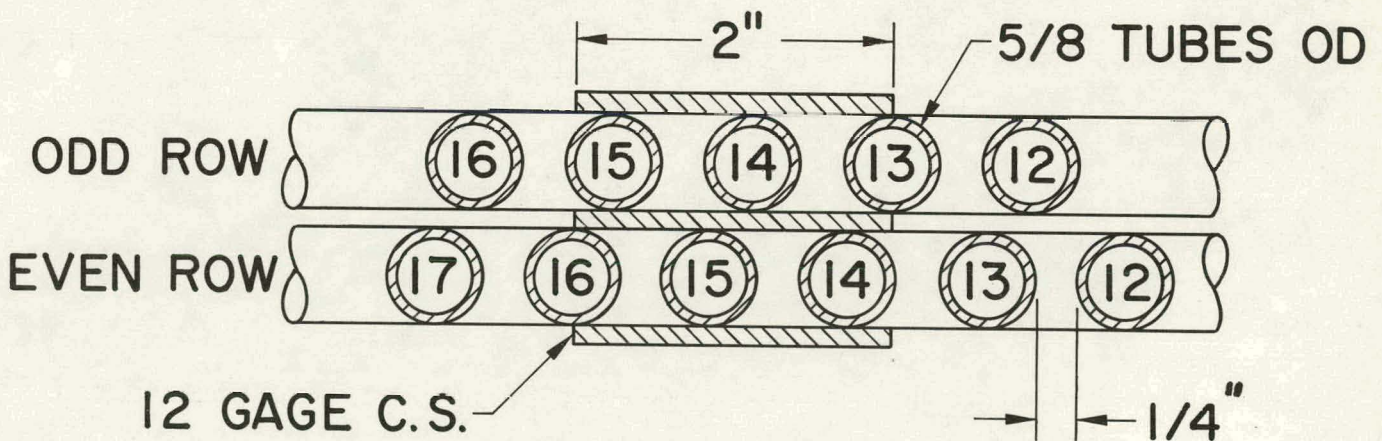
to be responsible for the damage (initially believed to be caused by flow-induced vibration) that occurred in the loop-end support region of the 1B and 1C steam generator. As shown in Figure 3, the presence of the wide loop-end straps creates a flow blocked region which permits phosphate to concentrate and attack the tubing. The hourglass support plate design (Figure 2) used on the straight tube lengths of the 1B and 1C steam generator provides better crevice flushing than the cylindrical hole design of the 1A and 1D units. The concentration of phosphate is minimized with the 1B and 1C hourglass design; and, hence, only minimal tube damage might be expected, as was shown by the 1970 eddy current inspection of the 1C unit.

Fig. 3 1B and 1C Steam Generators View of Tubes in Loop End Support Area  
(For upper illustration the vertical axis of the Steam Generator is perpendicular to the plane of the tubes shown. For the lower Figure, the top of the Steam Generator is toward the top of the illustration.)

Repairs of the 1B and 1C steam generators were achieved initially by tube plugging (1966 and 1967) and ultimately by installation of flow blocking plates (1968) in the outlet plenum to eliminate primary water flow through those tubes having long lineal contact between the apex of their U-bends and the loop-end support straps. The presence of the flow blocking plate prevents heat transfer from these tubes and concentration of any chemicals on the secondary side in this region. No tube leakage occurred in the 1B and 1C units after installation of the flow blocking plates.

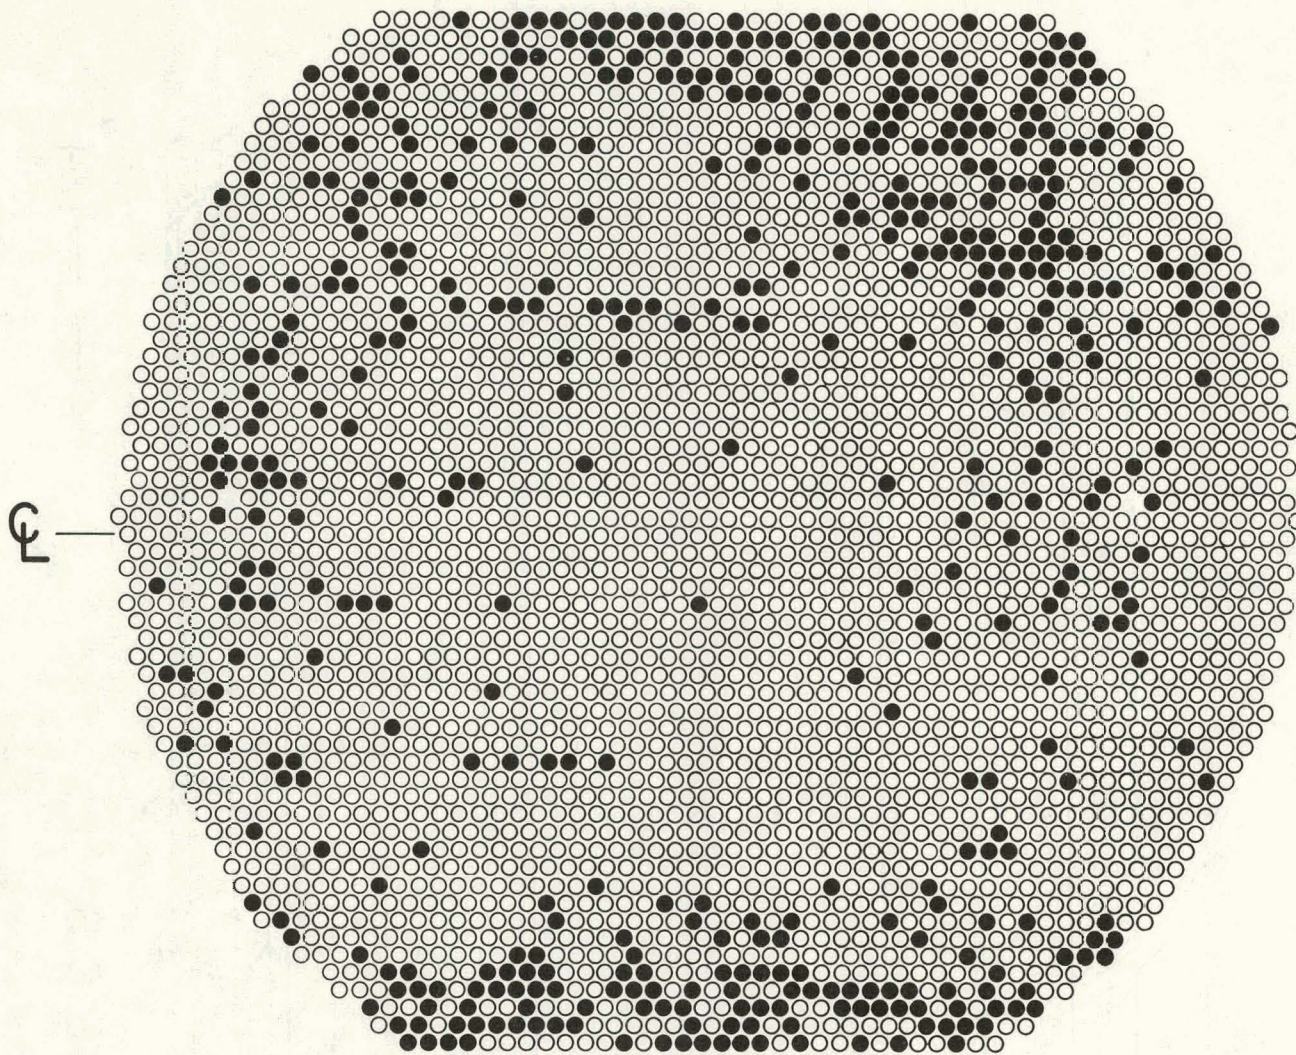
Fig. 4 Shippingport 1D Steam Generator Location of all defects at 3rd Support Plate (1969-1970 Inspection)  
 NOTE: The top of the steam generator is toward the top of the figure.

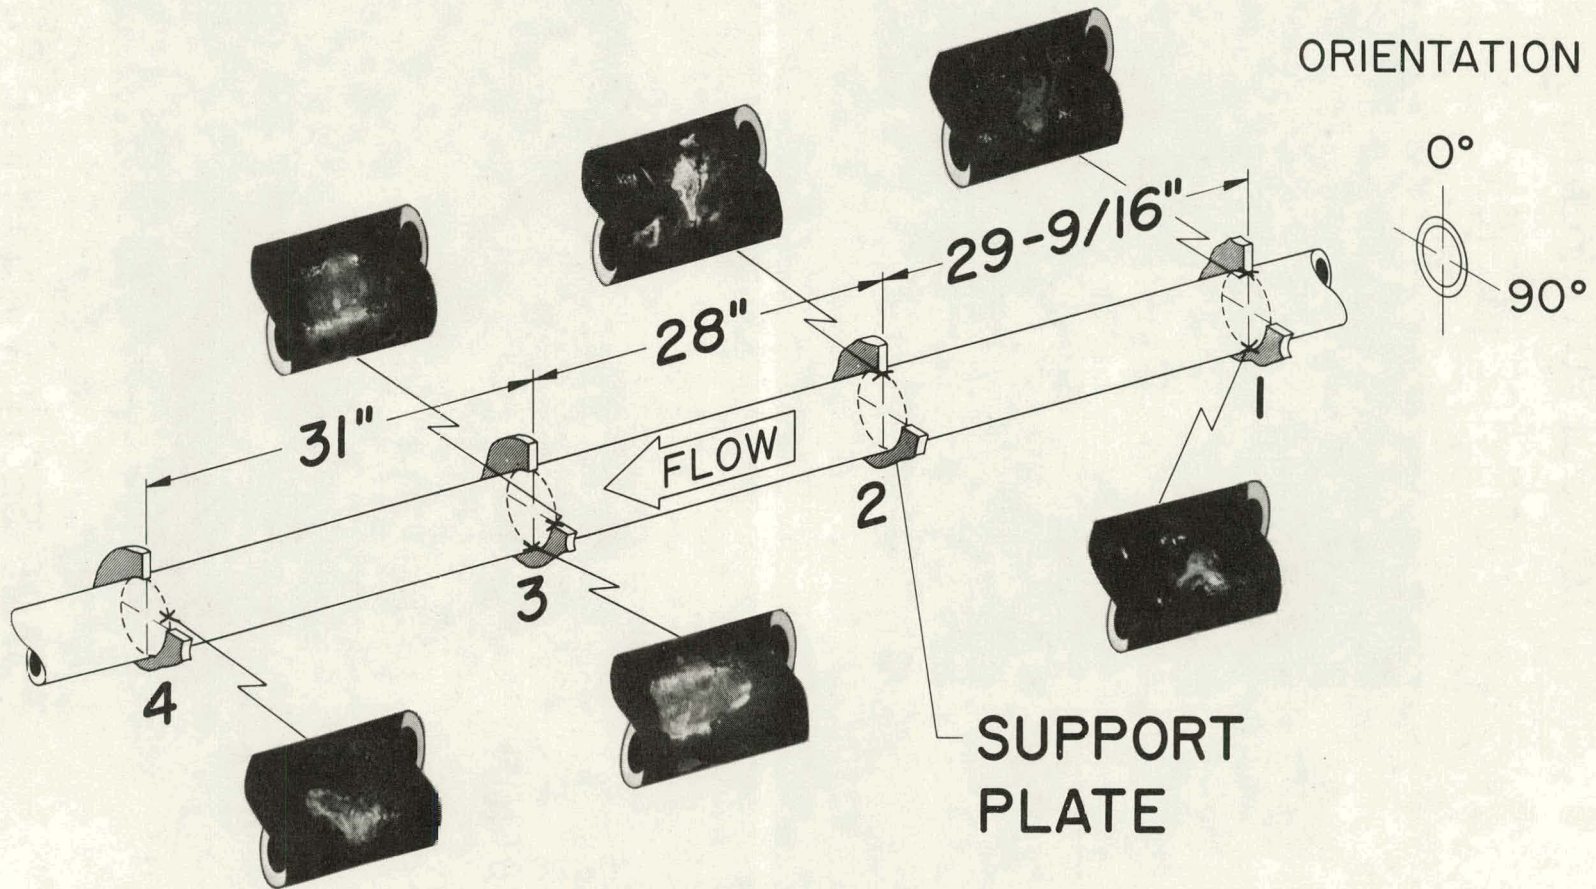
# .50" TUBE NO. 26A7S

within the support plate crevice region. The visual appearance and orientation of defects found at the first through fourth support plates for the 1D steam generator is shown in Figure 5. A typical defect, with about 20 mil depth is shown in Figure 6. The defects on removed tubes were examined in detail by metallography and by scanning electron microscopy. In general, the defects appeared to be large diameter (up to 1/4 inch), irregularly shaped, steep-walled pits, centrally located within the support plate region. The defect surface was usually covered by a thin layer of a whitish deposit having a high elemental phosphorus content, presumably as phosphate. Where the deposits were thin and corroded metal surfaces were exposed, it was found that grain boundary attack and intragrain pitting were visible as shown in Figures 7 and 8. The grain boundary attack was shallow based on metallographic examinations, and the penetrations were less than a few tenths of a grain in depth.

Fig. 5 Shippingport 1D Steam Generator - Major Defect (leak) at Support Plate #1, Minor Defects at Support Plates #2 and #4. Burnishing mark at support plate #2 and #4.  
NOTE: 0° is toward top of steam generator.

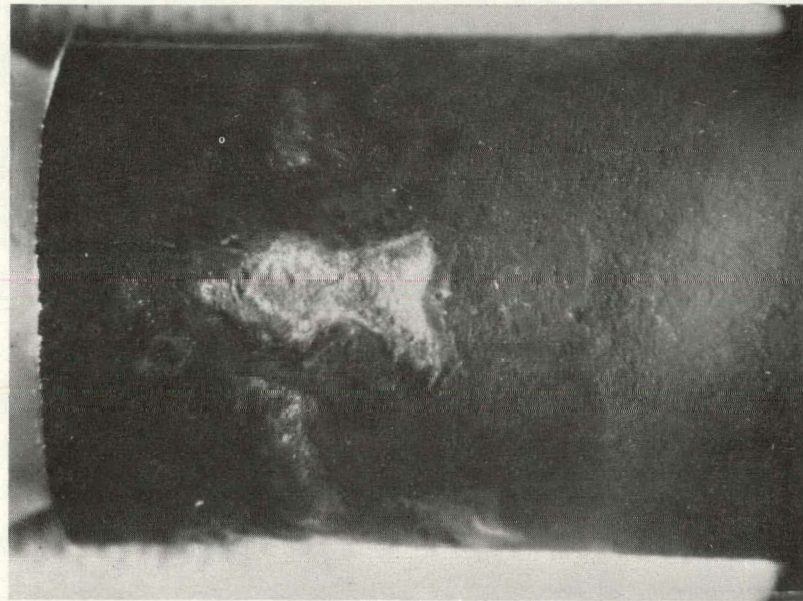
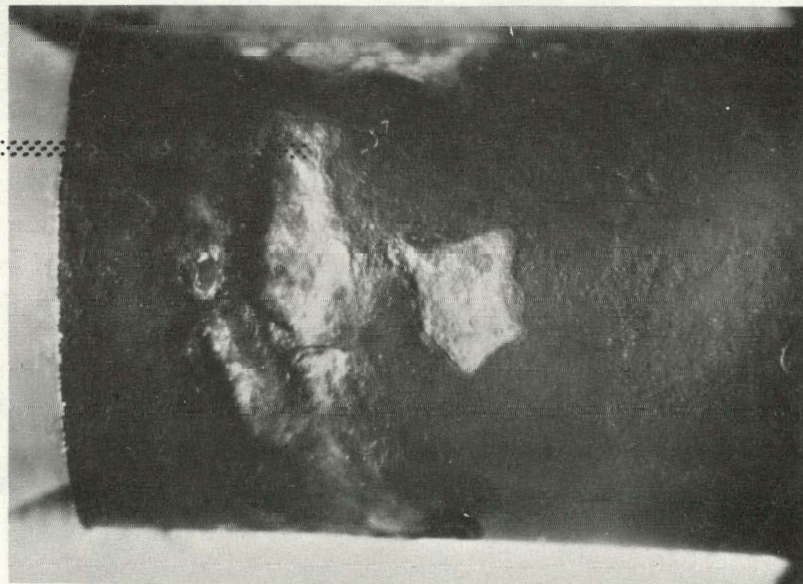
Fig. 6 Defected Section of Alloy 600 Tubing From Shippingport 1D Steam Generator

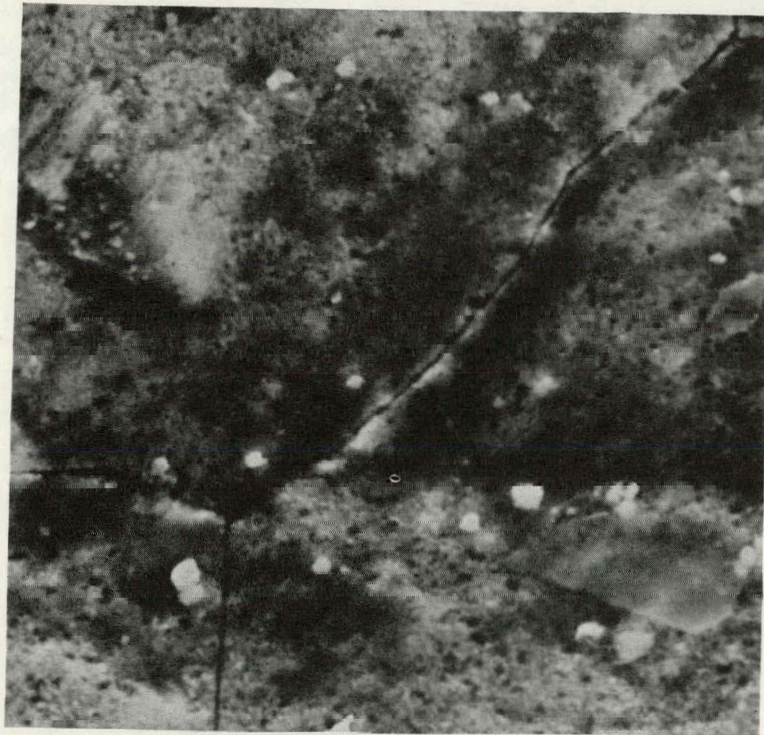
Fig. 7 Photograph of Defect Zone from Examination Position of Figure 1.

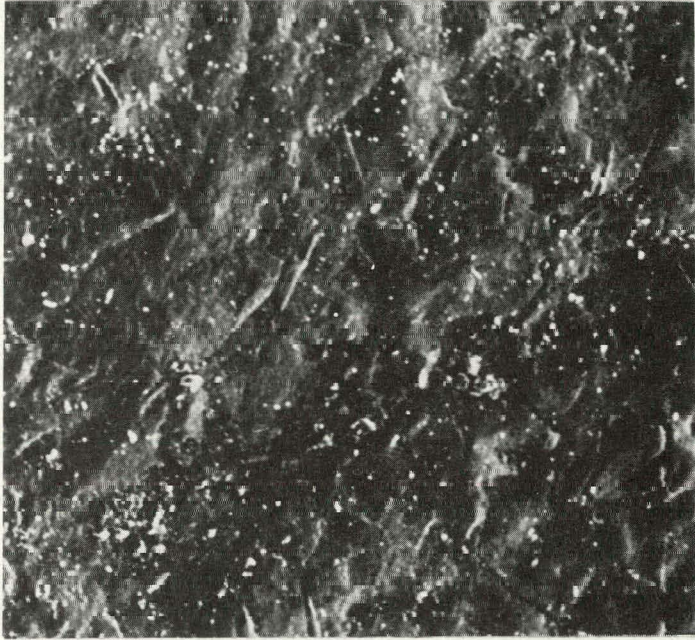
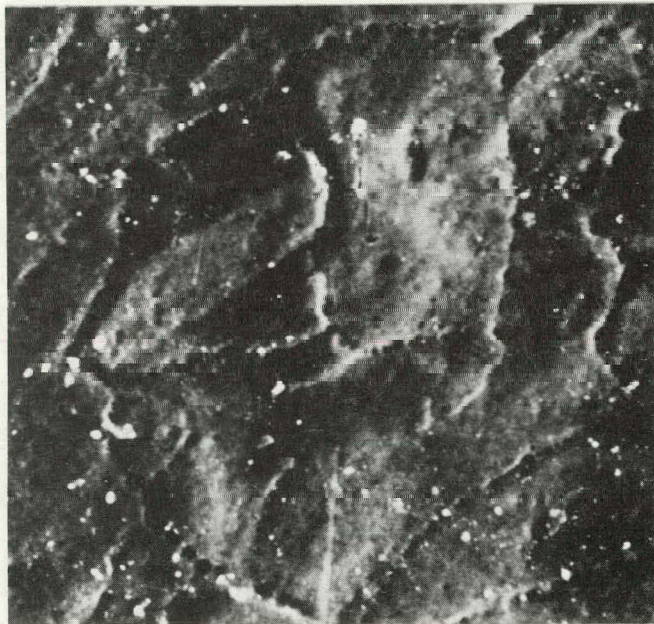
Fig. 8 Defect Surface from 1D Steam Generator at Third support plate.

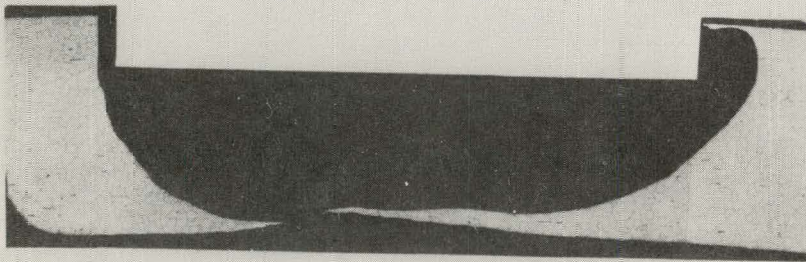
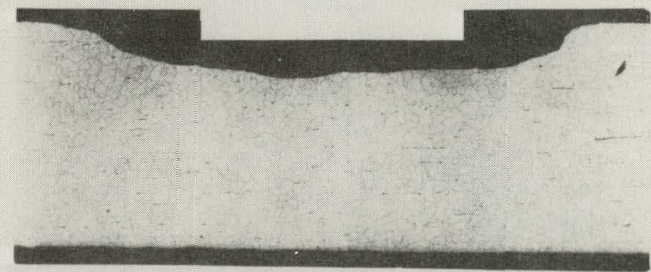
Metallographic examinations performed on defected tube sections showed no unusual microstructure. Metallographic sections through a leaking and non-leaking defect are shown in Figure 9. The metallurgical attributes and the chemical and physical properties of the Alloy 600 tubing were all within normal ranges. Hence, it was concluded that defective material was not an assignable cause of the tube damage. The presence of shallow grain boundary attack within the defect suggested that corrosion was responsible for the damage. Reviews of secondary water treatment records did not show the presence of any excessive contaminants, such as chlorides, that could have contributed to the damage. Further, the high concentrations of phosphorous found within the defect suggested that phosphate was the chemical species causing the corrosion. The concentration of defects at support plates near

LONGITUDINAL SECTION AT SUPPORT  
PLATE NO. 1 LOCATION

LONGITUDINAL SECTION AT SUPPORT  
PLATE NO. 2 LOCATION

Fig. 9 Metallographic Sections of a Leaking Defect and a Typical Non-Leaking Defect - 1D Steam Generator

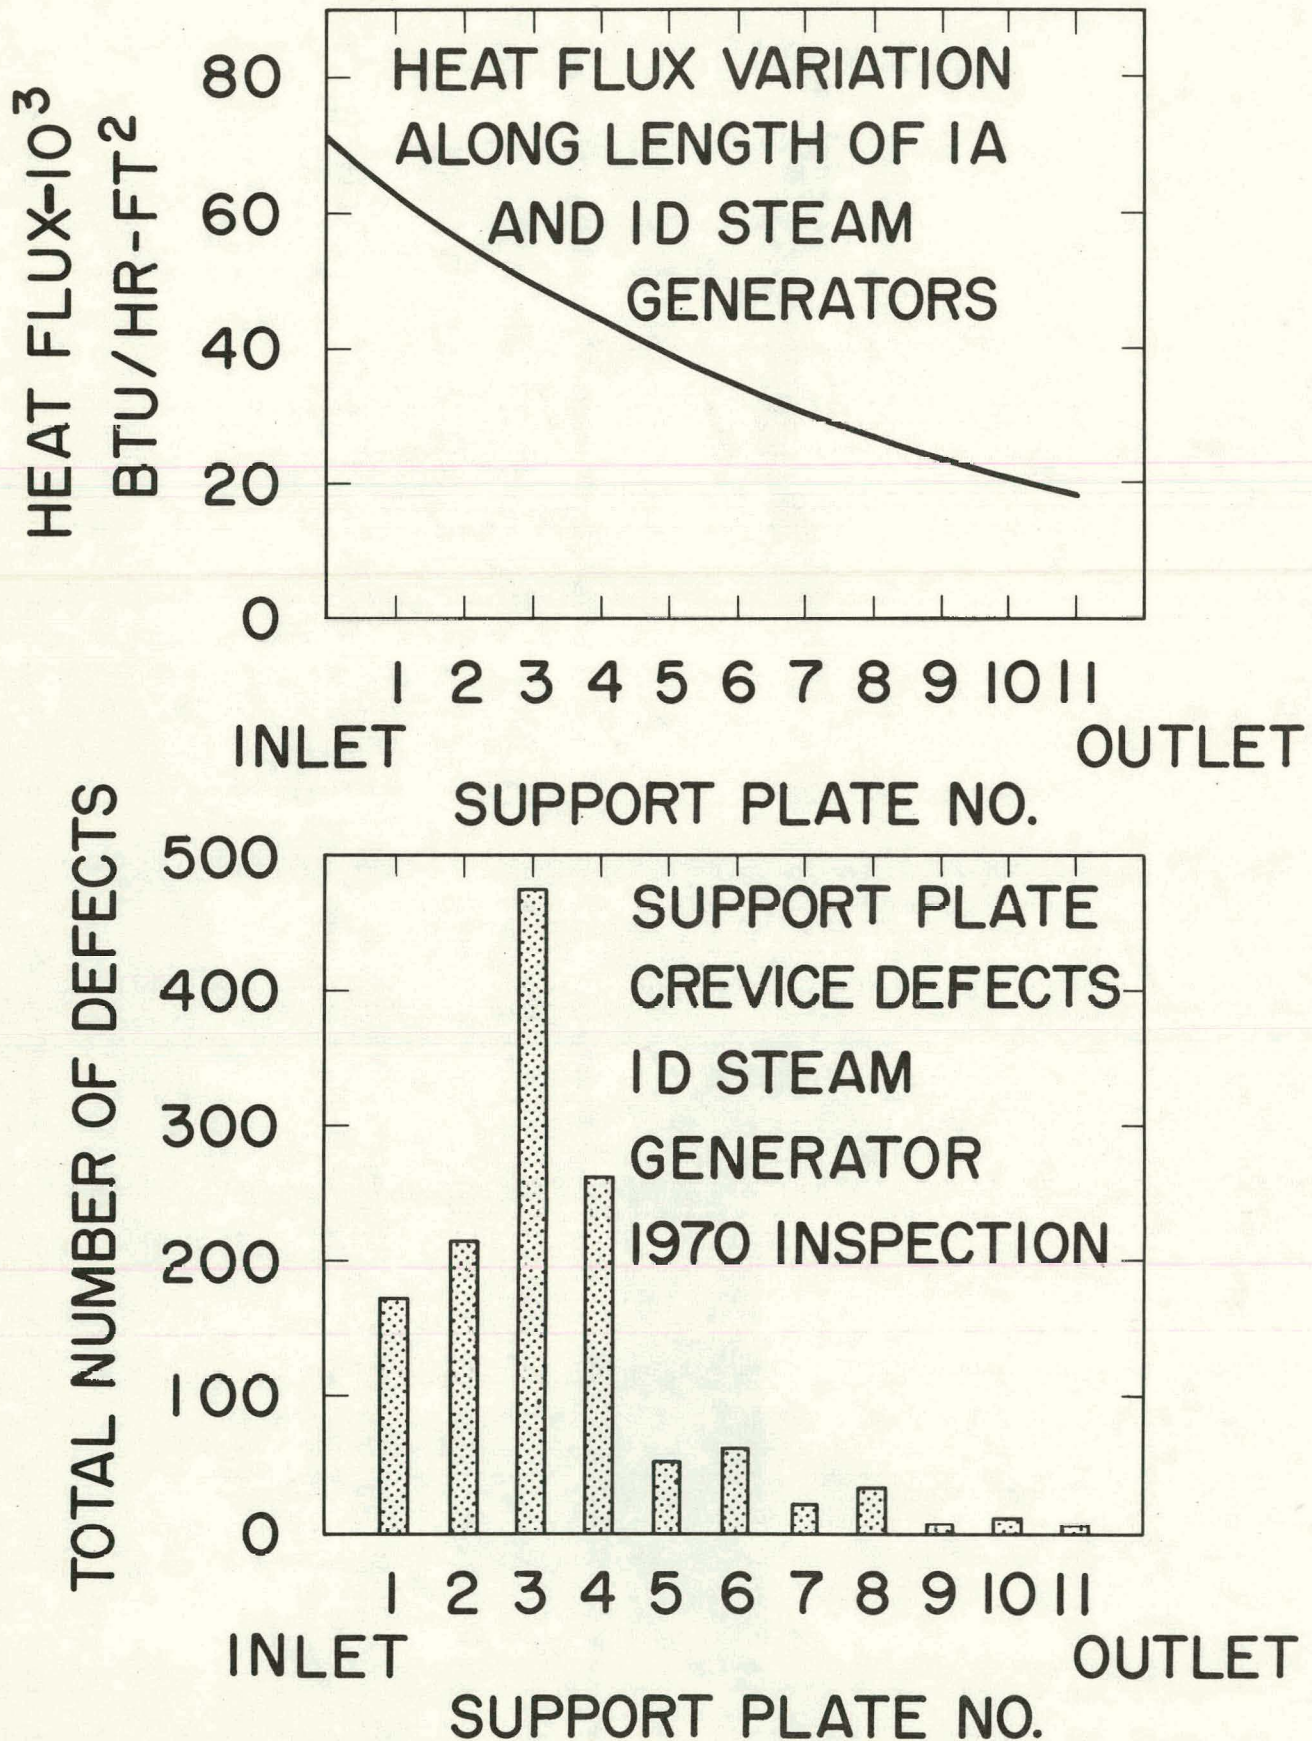
Calculated heat flux variations along the length of the straight tube steam generators are shown in Figure 10. Also, superimposed on Figure 10 are the numbers of defects found at each support plate location of the 1D steam generator during the 1970 inspection. The highest heat flux ( $63,000 \text{ BTU/hr-ft}^2$ ) occurs at the support plate nearest the primary inlet (No. 1). A large number of defects (172) occurred at the No. 1 support plate, but the maximum number of defects (475) were found at the third support plate. There is not, at present, an explanation for the maximum number of defects occurring at the third support plate. It is possible that occurrence of the maximum number of defects at the third support plate may be related to the local thermal and hydraulic conditions, which could have caused the highest phosphate concentrations in this region of the steam generator.

Fig. 10 Variation of Heat Flux and Number of Defects at Support Plate Crevices, 1D Steam Generator

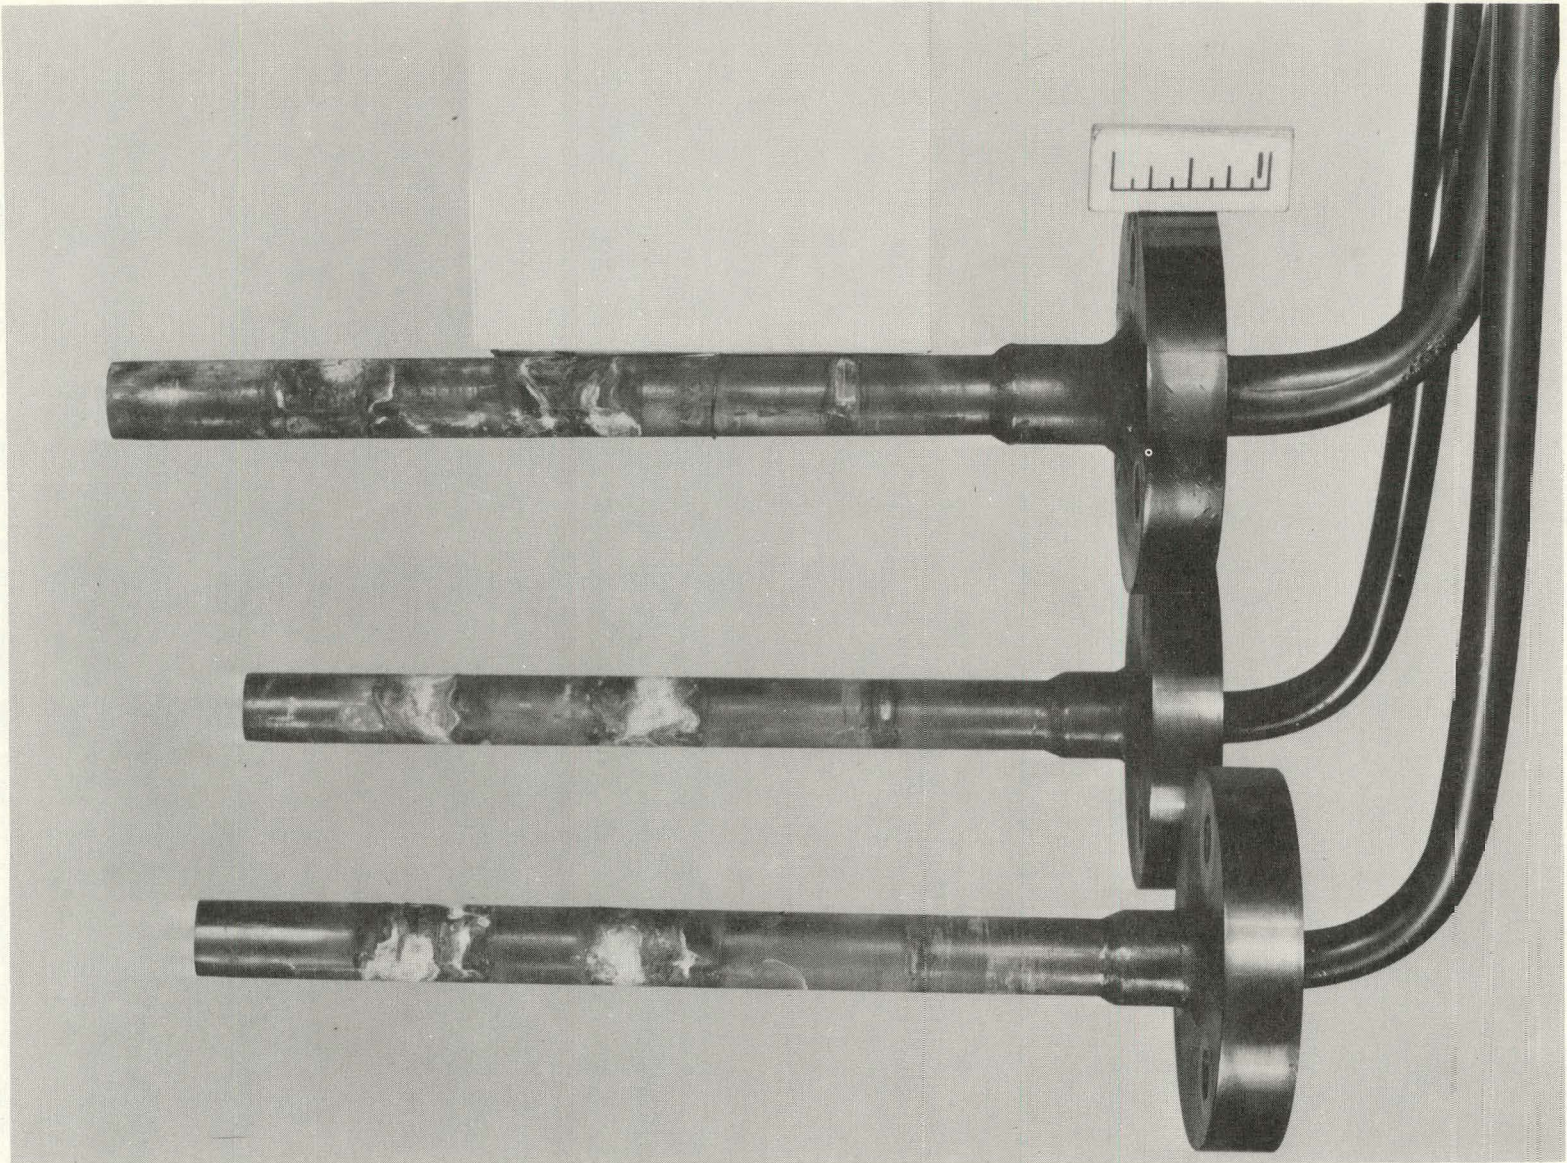
Fig. 12 Appearance of defects on tubes from Heated Tube Test After 4000 hours.  
Note similarity with defects on tube removed from 1D Steam Generator (Fig. 5)

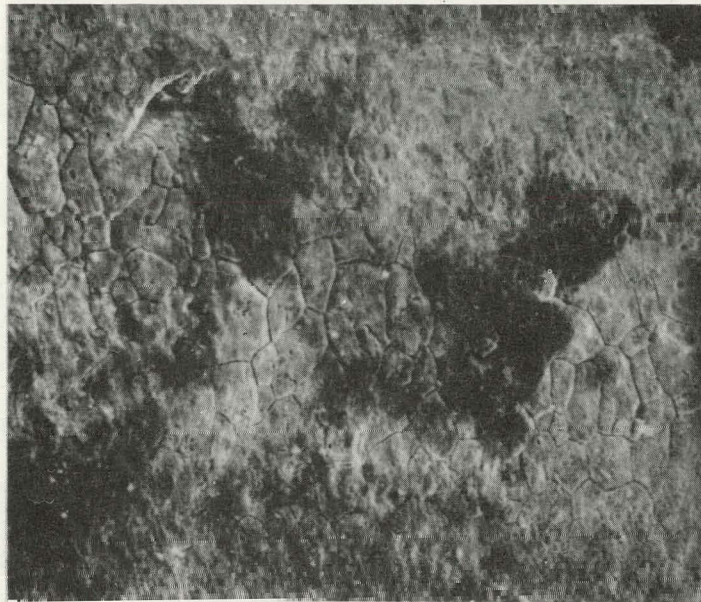
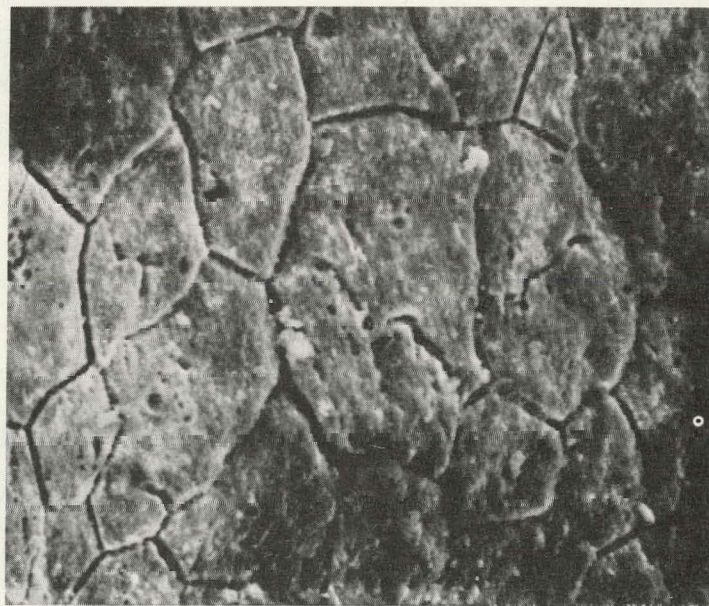
Fig. 13

Heated Tube Test Defect Surface in Support Plate Crevice After 4000 hours of Test. Note similarity with 1D steam generator removed tube (Fig. 8)

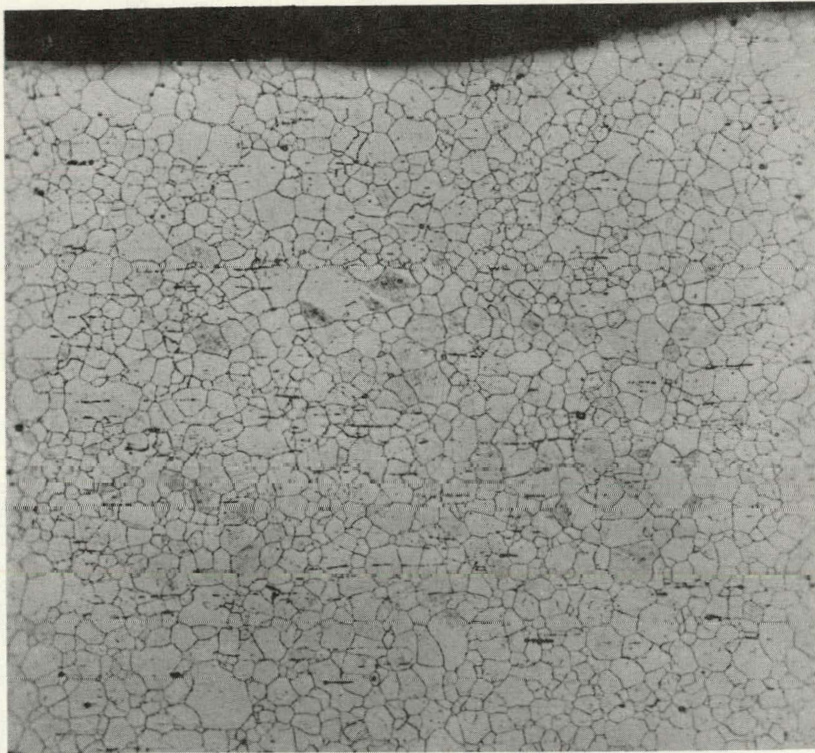
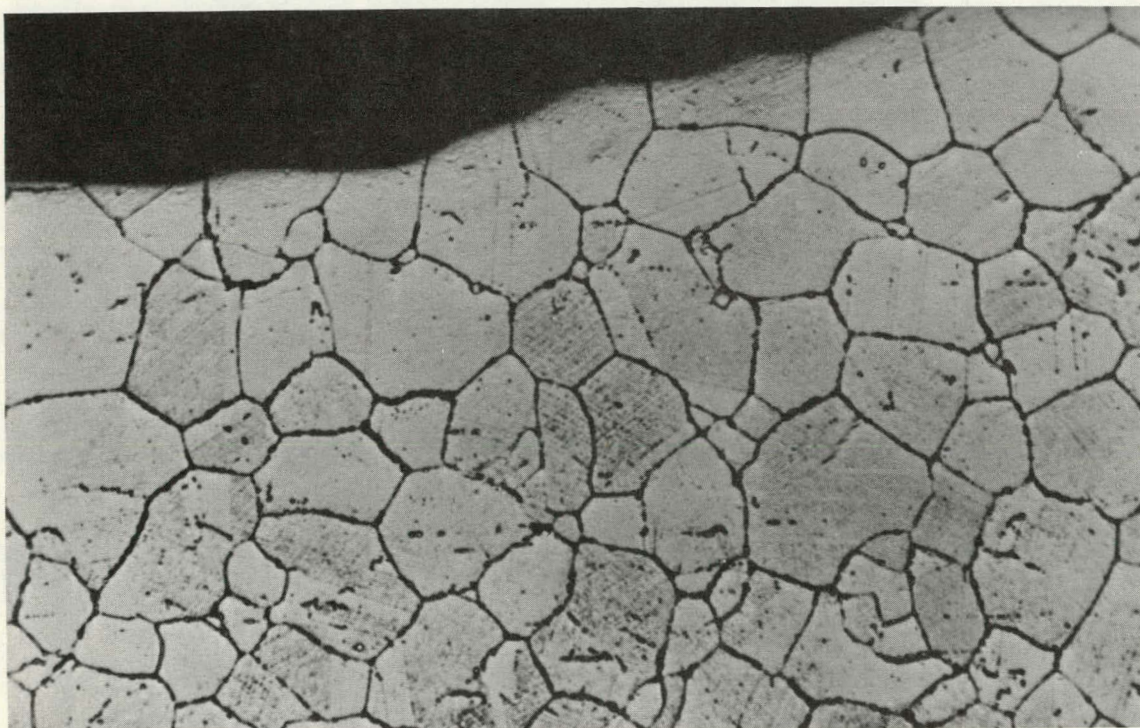
Fig. 14 Metallographic Sections through defect in Support Plate Crevice of Heated Tube Test, after 4000 hours test.

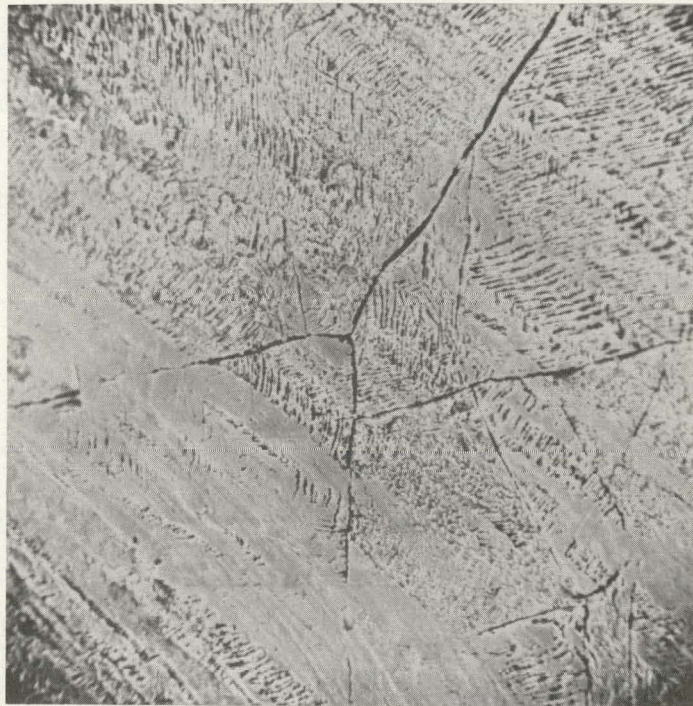
Fig. 15 Defect Surface of NiCrFe Alloy 600 Specimen after 7 days at 550°F in 50,000 ppm phosphate ( $\text{Na}/\text{PO}_4 = 2.15$ ) Vapor Phase of Specimen adjacent to Vapor-Liquid Interface.
