DUQUESNE LIGHT COMPANY  
SHIPPINGPORT ATOMIC POWER STATION

TEST EVALUATION

DLCS 3330201

1A HEAT EXCHANGER LEAK TEST

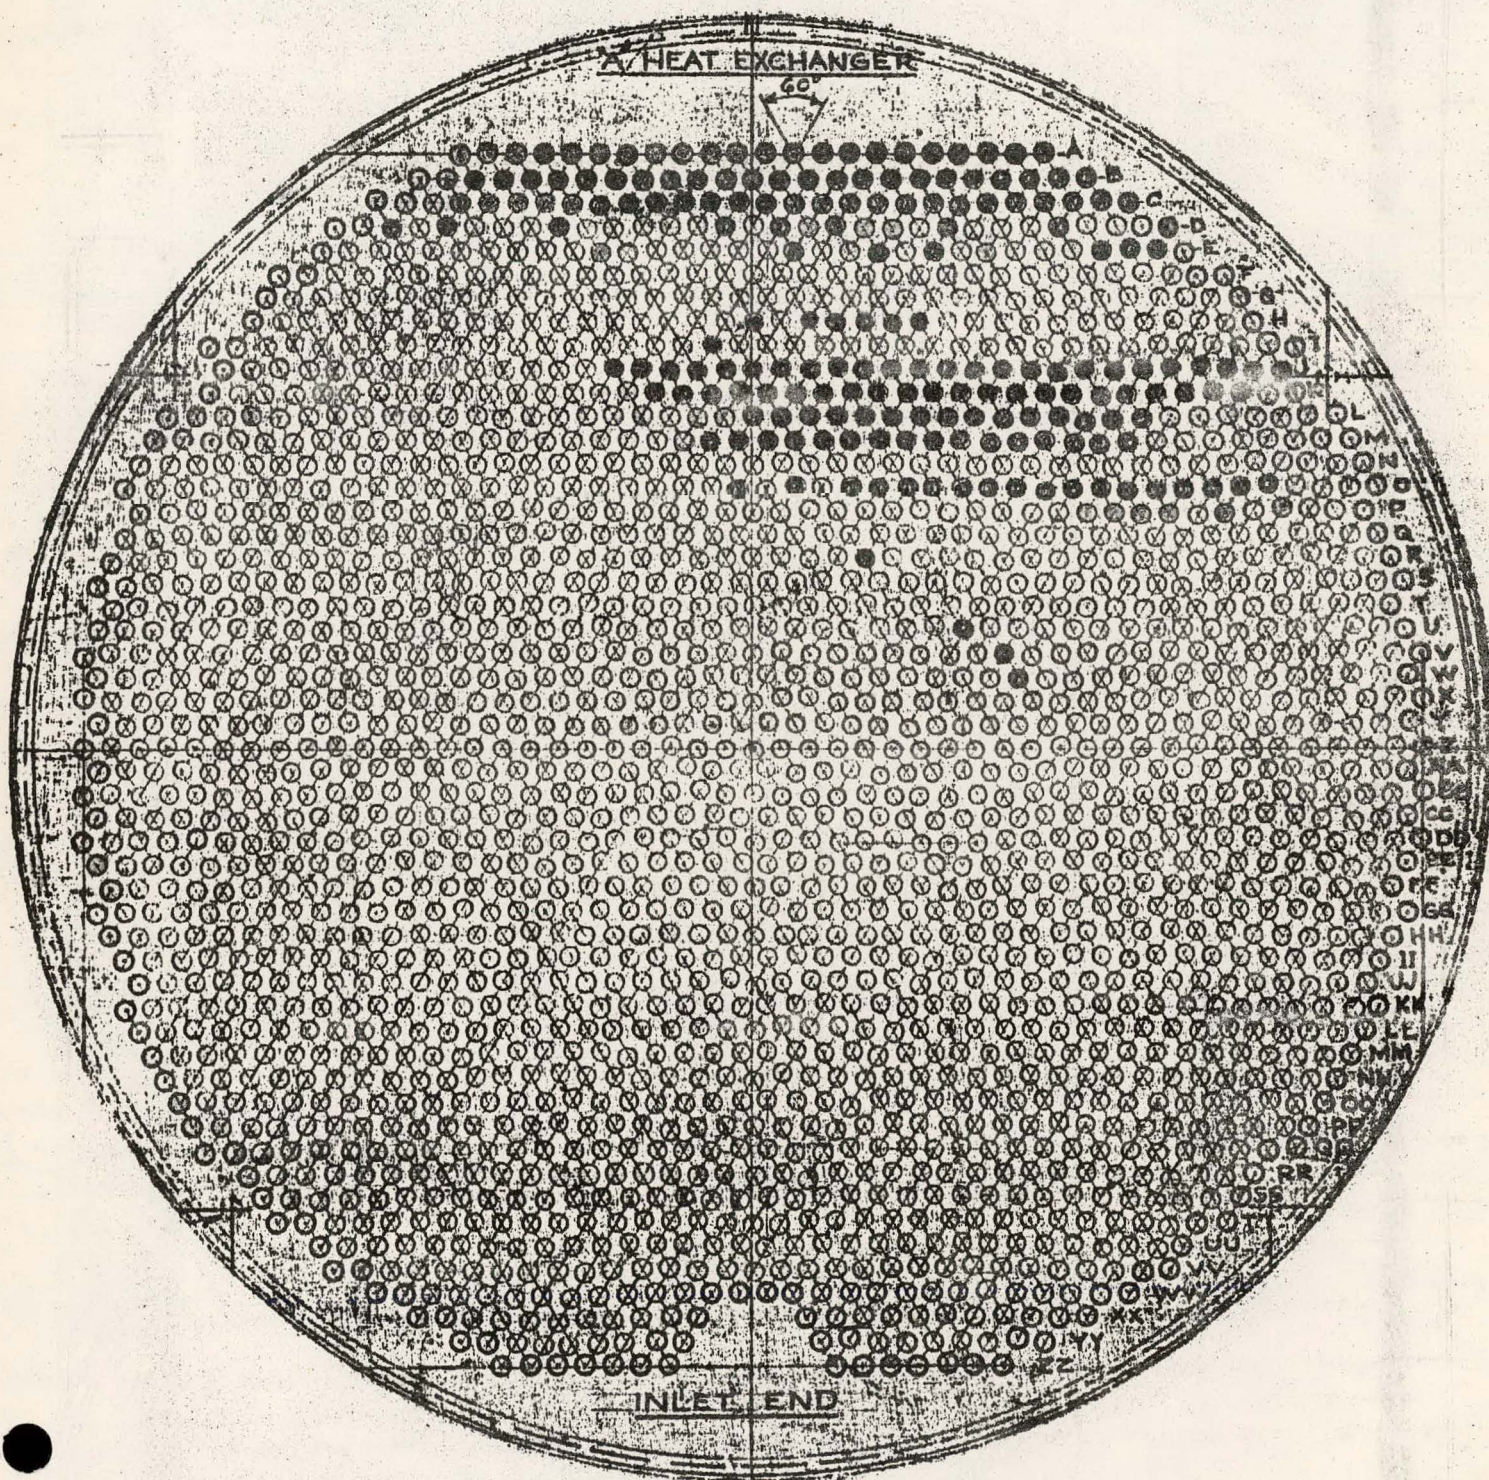
FIGURE 1

Probolog testing of 203 heat exchanger tubes (Figure 1) from the inlet end was performed, and 67 tubes gave indications of irregularities. Interpretations of the severity of the indications has been hampered by the unusual character of the pen deflections and the presence of magnetic crud on the outer surface of the tubes. The evaluation of Probolog results is continuing at Bettis. Preliminary examination of the data suggested more gross irregularities in the following tubes:

Tubes probologed, counted right to left.

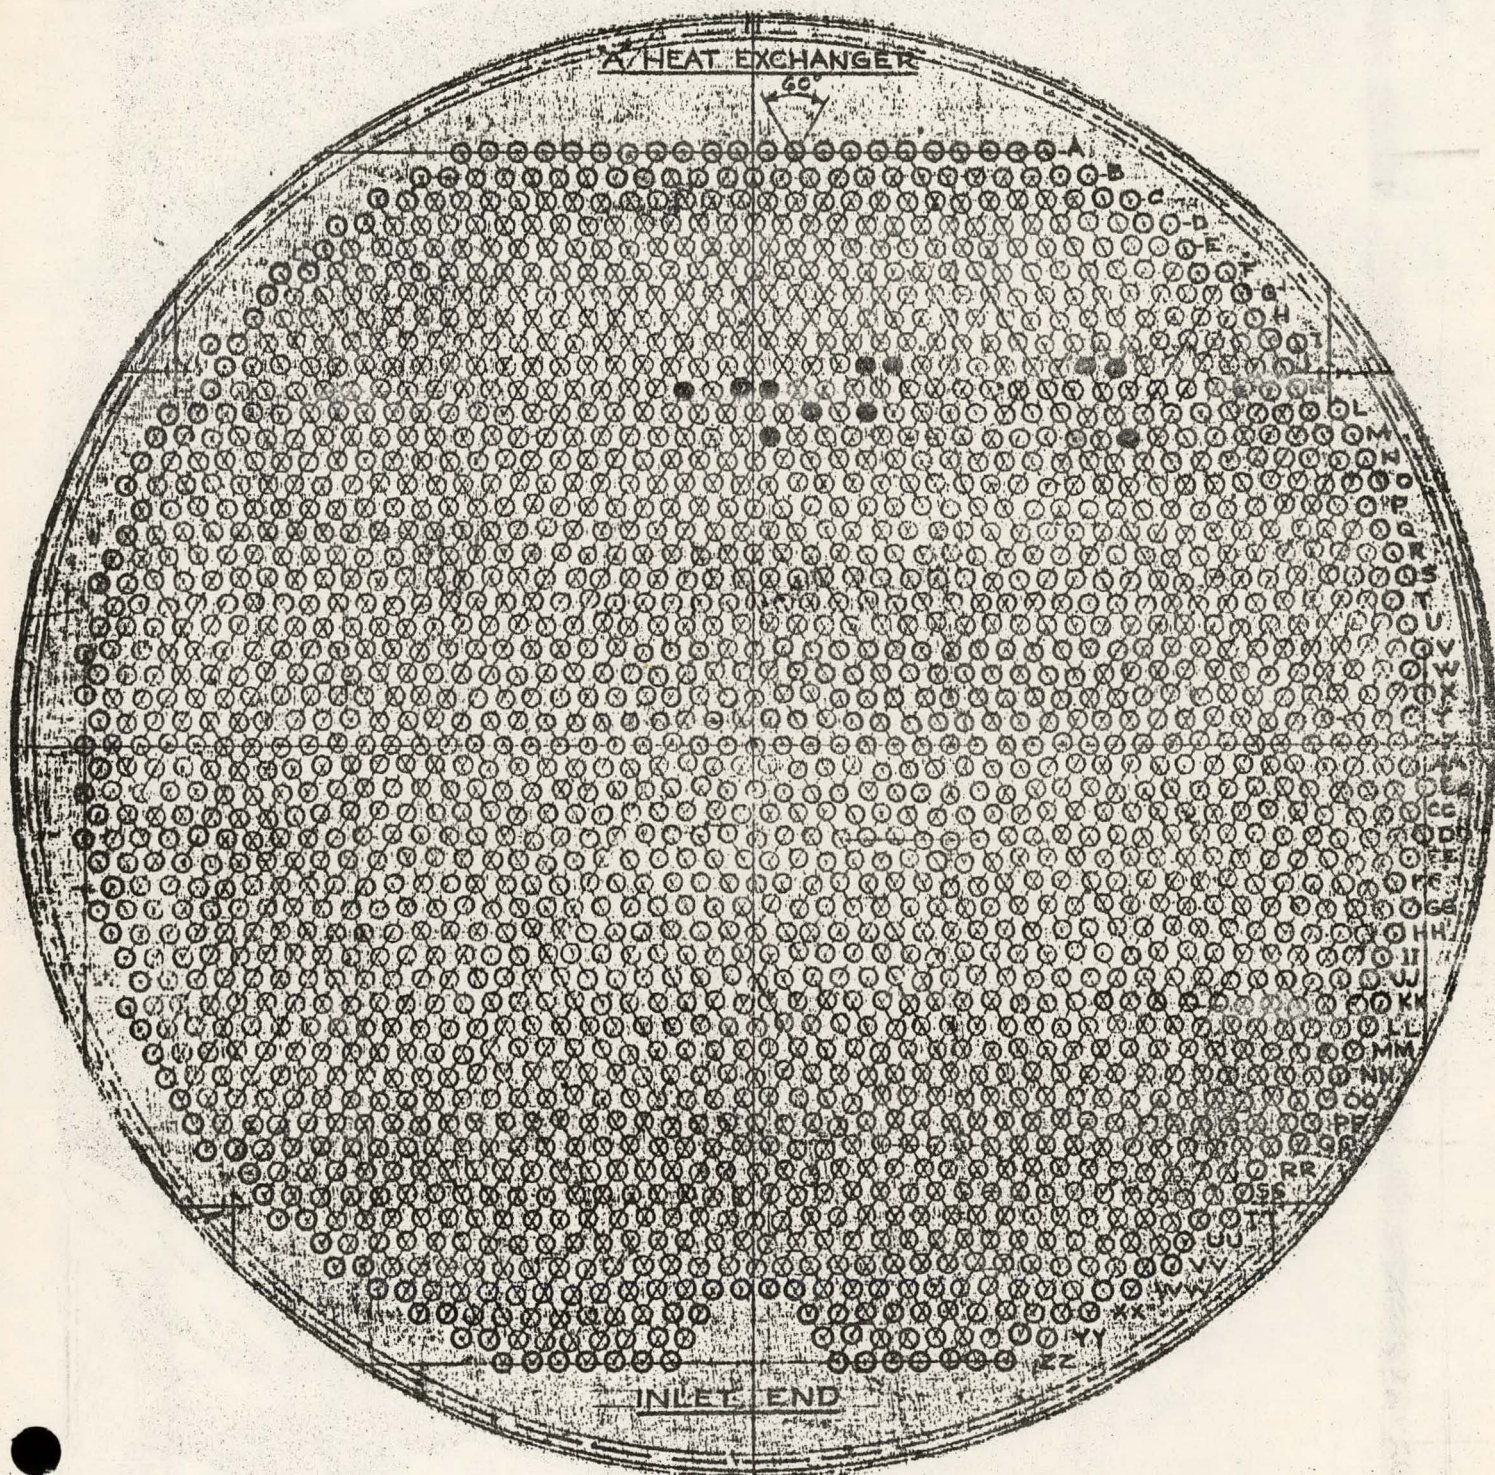
FIGURE 2

51-100% deflection of probolog needle.

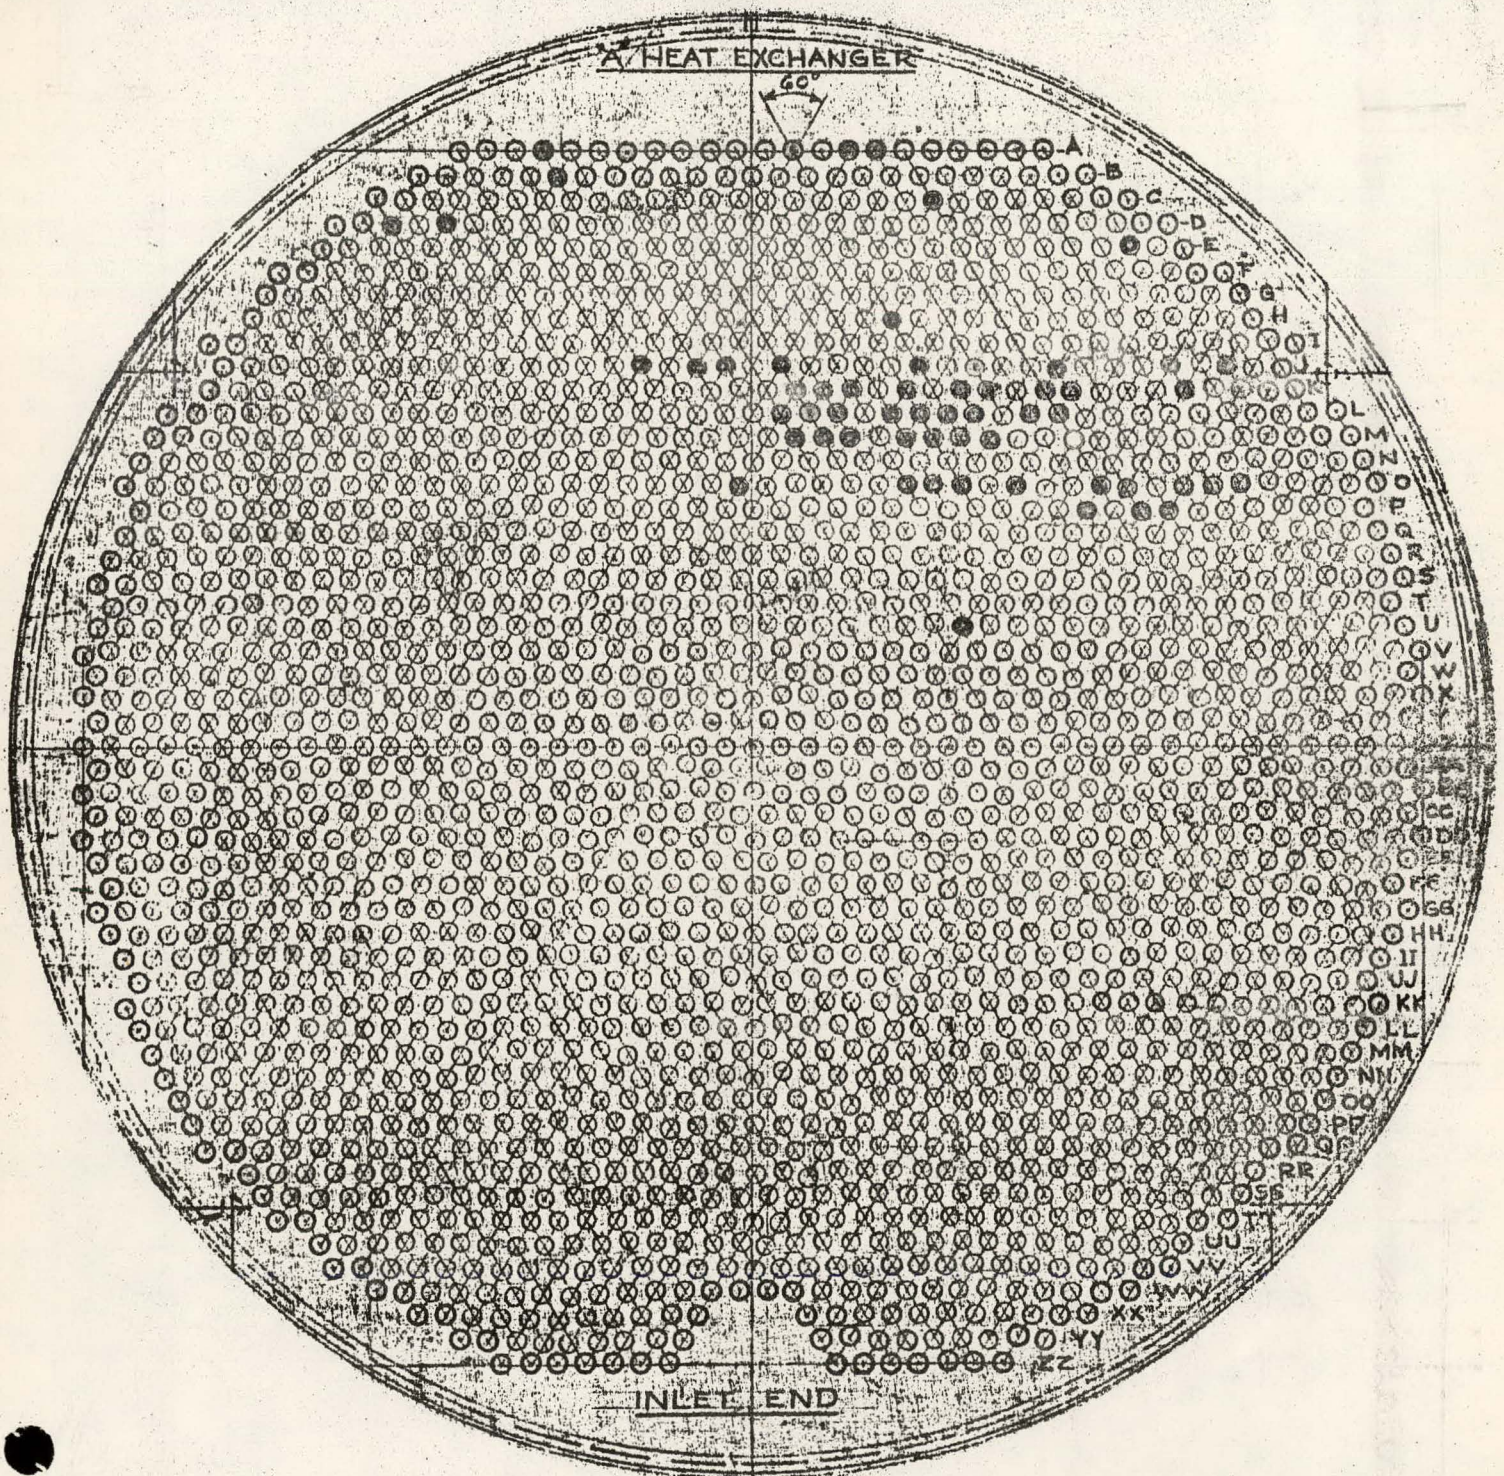
FIGURE 3

25-50% deflection of probolog needle.
