SURPRISING PATTERNS OF CMOS SUSCEPTIBILITY TO ESD
AND IMPLICATIONS ON LONG-TERM RELIABILITY*

J. R. Schwank, R. P. Baker, and M. G. Armendariz
Sandia National Laboratories
Albuquerque, NM 87185
(505) 844-6809

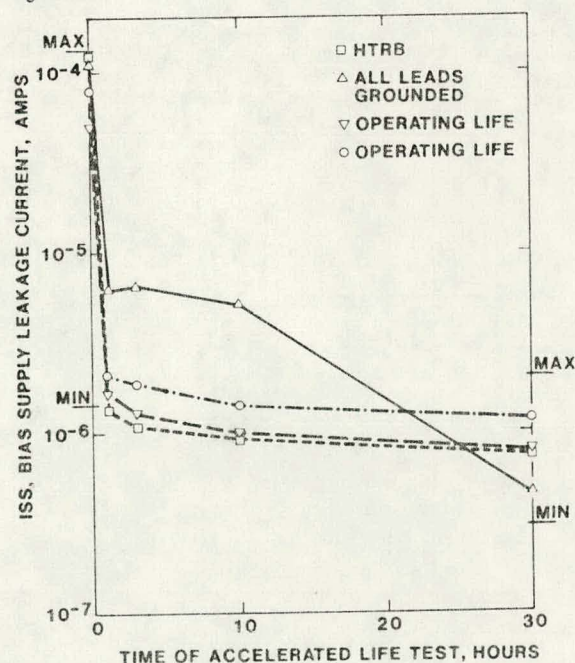
Figure 4. Improvement in I_{SS} During Operating Life.

The rest of the test units showed no change in input leakage during the life test. However, the units that had high I_{SS} improved during the life test. This improvement is shown in Figure 4.

Most of the improvement occurred during the first hour. At the termination of the test, no unit had an I_{SS} greater than $2 \mu A$. No satisfactory explanation for this improvement in I_{SS} with time and temperature has been found.

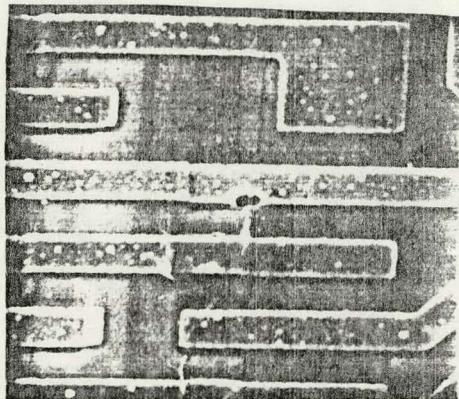
One of the life test units that had an I_{SS} of over $16 \mu A$ as a result of the step stress was given a detailed failure analysis after the accelerated life test. Electrical data indicated that the leakage was associated with the PSC line to one of the parallel input transmission gates. The failure analysis disclosed that the cause of the high I_{SS} current was a rupture in the gate oxide of the p-channel transistor of the PIg transmission gate. As stated previously, the unit was still functional before failure analysis. An SEM photomicrograph of the rupture is shown in Figure 5(a).

(5a) Gate Oxide Rupture on the N-Channel Transistor in the PSC Input. Unit Failed Functional Test.

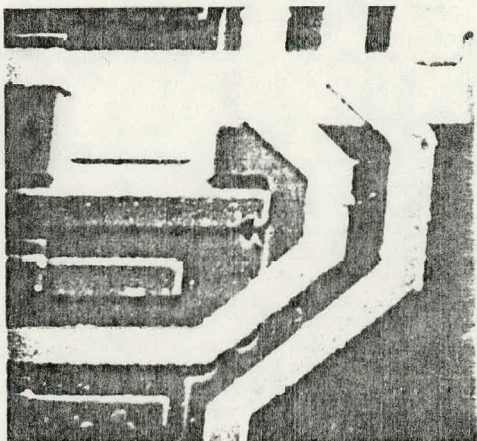
(5b) Gate Oxide Rupture on the P-Channel Transistor in the PIg Transmission Gate. Functional after Life Test.

For comparison, Figure 5(b) is an SEM photomicrograph of a gate oxide rupture in a unit that was found as a functional failure in incoming inspection. The failure analysis verified that the failure was at the site of the rupture. It appears that a gate oxide rupture does not necessarily cause functional failure and that a unit with a gate oxide rupture does not necessarily become a failure in an accelerated life test. Instead, because of the improvement in I_{SS} with time and temperature, an accelerated life test may hide units whose I_{SS} leakage has increased because of ESD. As a further investigation of the possibility of failure of a degraded unit, particularly one with an oxide rupture, 18 additional units were subjected to one ESD pulse of -1000 volts on the V_{SS} terminal and put on the life test.

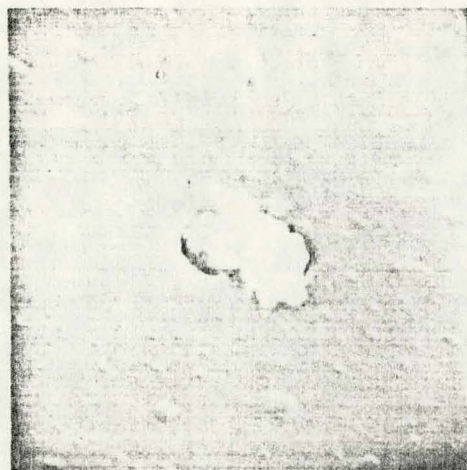
(7b) ESD TEST UNIT. Gate Oxide Rupture on the N-Channel Transistor in the PSC Input.

Figure 7. Comparison of Production Line Failure and ESD-Created Failure.

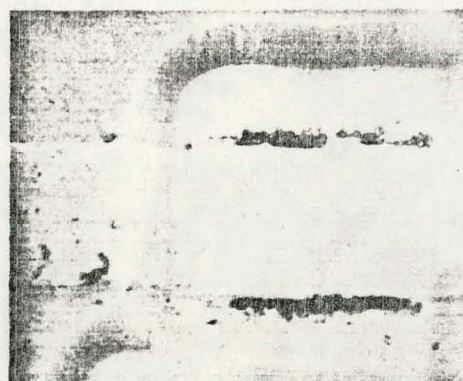
Figure 8. Control Units Analysis. Both Pictures Show the Gate Region on the N-Channel Transistor in the PSC Input.

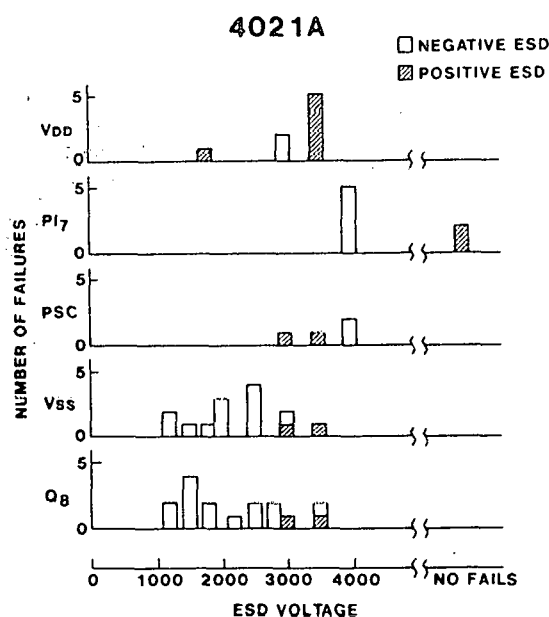
Figure 9. Step Stress to Functional Failure.

Following the life test, 49 devices including 40 of the life test units were step stressed at 500 volt increments up to 5500 volts. Once a device became a functional failure it was removed from the test. Figure 9 shows that the Vss and Qg terminals are the most susceptible to ESD. The greatest susceptibility is to negative pulses. The figure shows that, even though the ESD stress was applied directly to the inputs, there were no failures due to input stress below 3000 volts. Note that there were no failures on the transmission gate input below 4000 volts. Two of the 49 units did not fail. These two were stressed on transmission gate inputs.

Although other 4000 series types tested did not show the high susceptibility to ESD on the supply and output terminals as did the 4021A, they show supply and output terminal susceptibility about equal to input terminal susceptibility. The supply and output terminals of completed assemblies must be protected from ESD.

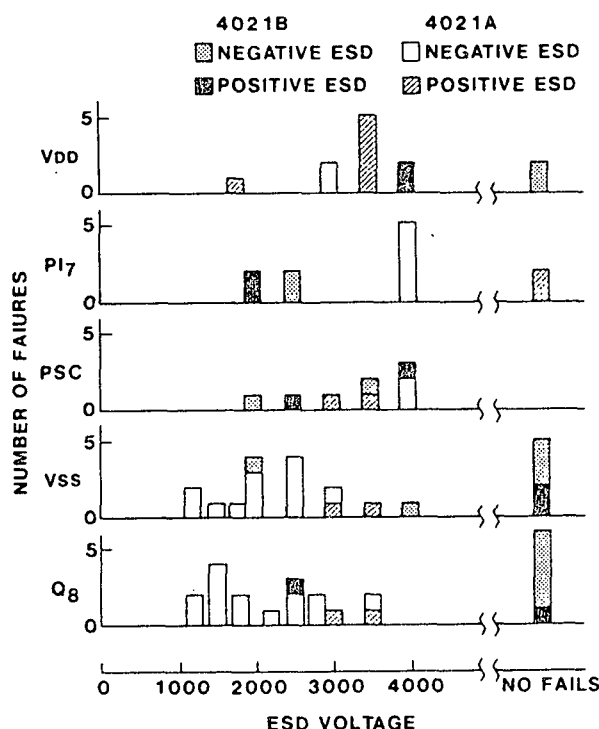
Figure 10. Comparison of 4021A and 4021B Devices.

We applied an identical (except that the maximum stress was 4000 volts) step stress to 29 silicon gate technology 4021B units for comparison of the metal gate technology with silicon gate technology. Figure 10 shows that the silicon gate units did not have the high ESD susceptibility on supply and output terminals. However, the input susceptibility was greater.

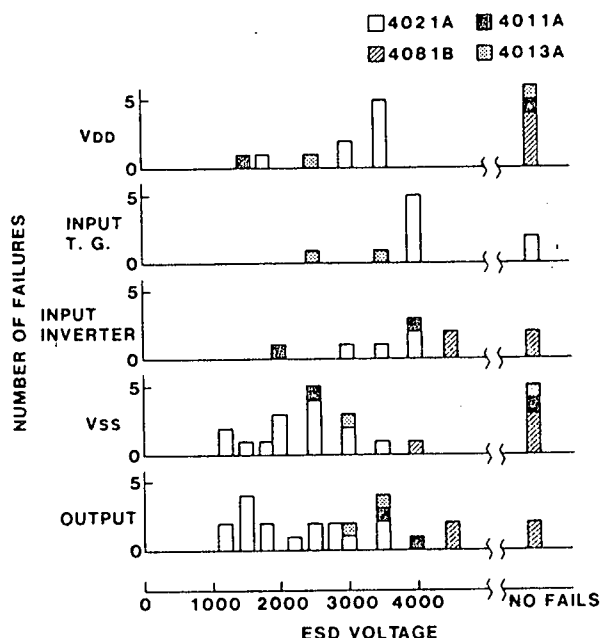
Figure 11. Comparison of 4000A and 4000B Device Types.

The results of an identical step stress on a mix of eight each 4011A, eight each 4013A, and 20 each 4081B metal gate circuits are compared with the results of the 4021A in Figure 11. Except for the 4021A, supply terminals, output terminals and input terminals show comparable susceptibility. Note that, as expected, the B series is much more resistant to ESD than the A series as evidenced by the 4081B.
