**A SUMMARY OF  
INDUSTRIAL ACCIDENTS  
IN USAEC FACILITIES**

UNITED STATES ATOMIC ENERGY COMMISSION  
Safety and Fire Protection Branch  
Office of Industrial Relations

## PREFACE

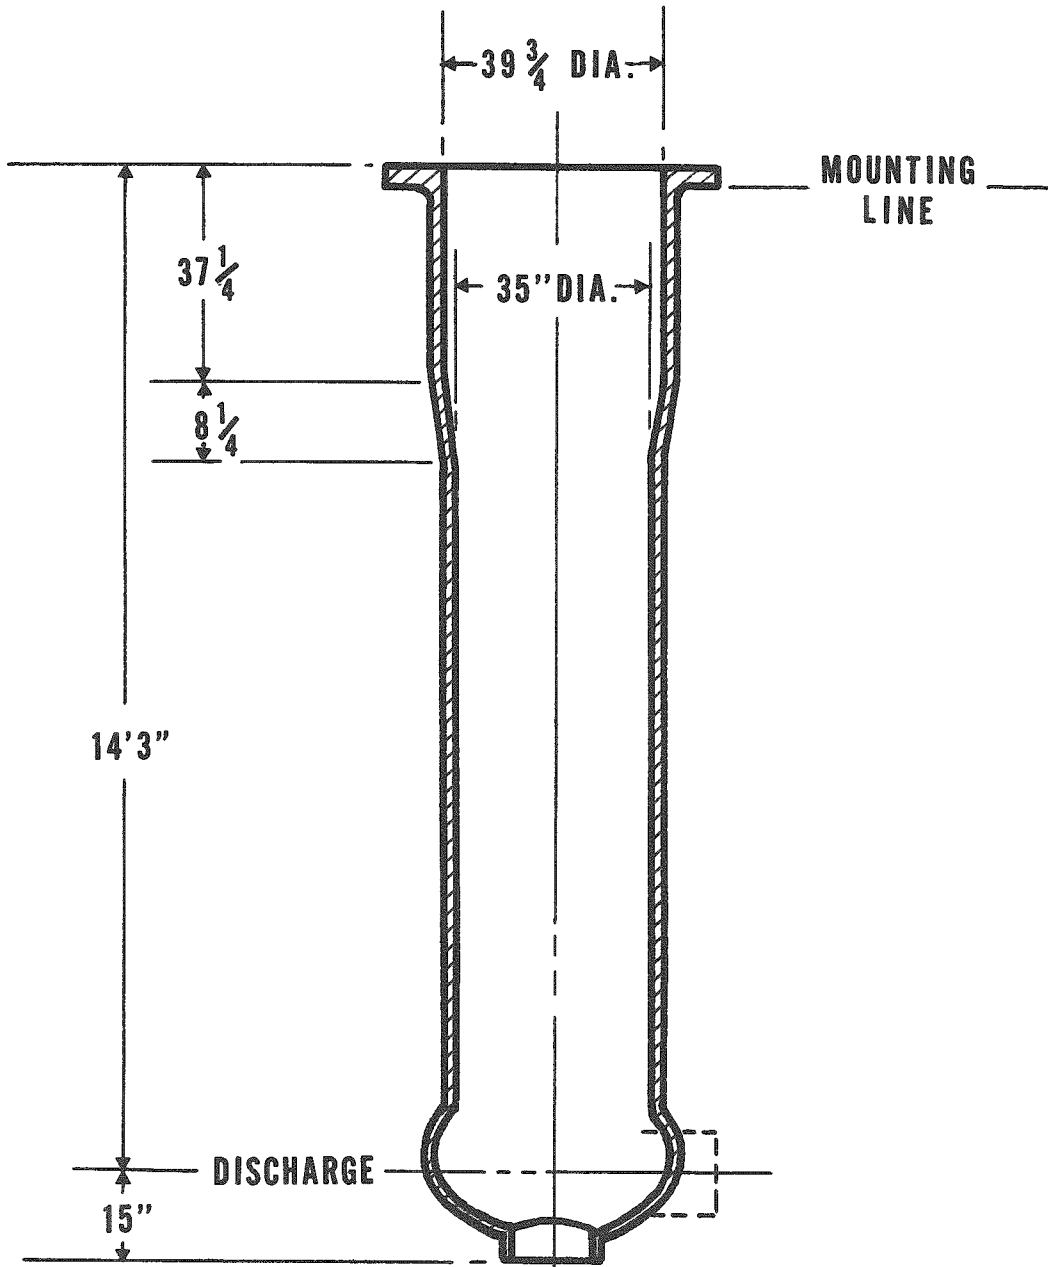
**PUMP CASE**  
 12 FREE-SURF SODIUM PUMP

Information was being sought in connection with the recent failure of the sodium pump (see drawing) while being tested. To minimize oxidation of sodium residue on interior walls of the casing, argon gas was fed into it by tubing through a wooden cover plate.

It is reported that the inspector was wearing only a filter respirator face mask and that he rode the hoist hook down by standing on it. He collapsed after a short time at the bottom of the casing.

The primary cause of these two accidents appears to have been the failure on the part of both men to wear proper breathing equipment appropriate to an inert gas. The reactor-assemblyman wore a filter-type respirator which is designed to filter out toxic and noxious particulate matter in a breathing atmosphere. The filter respirator does not filter out gases, nor does it provide a source of oxygen if no oxygen is present in the breathing atmosphere. Hence, this respirator could give no protection to the inspector. The senior reactor welder's action in descending without any protection at all was the result of an emotional reaction and not based on a calm and logical deliberation. A contributing cause was failure to wear a safety harness or belt which was available and convenient or to wear a lifeline, for which rope was on the site.

The preventive measures which will be implemented and enforced are:

1. It will be the responsibility of the immediate supervisor to orient and inform all persons performing hazardous work as to the entire scope of hazards and/or materials to be encountered in an operation and to insure, by proper supervision, that prescribed safety measures are carried out.

2. All future operations requiring personnel to enter tanks or areas devoid of oxygen or provided with any inert gases will require the presence of a completely equipped fireman to stand by in readiness to effect a rescue.
