DOE/ET/15457-1523  
(DE84008900)

LONG TERM MATERIALS TEST PROGRAM

Quarterly Report, April—June 1983

By  
General Electric Company  
Advanced Energy Programs Department  
Schenectady, New York

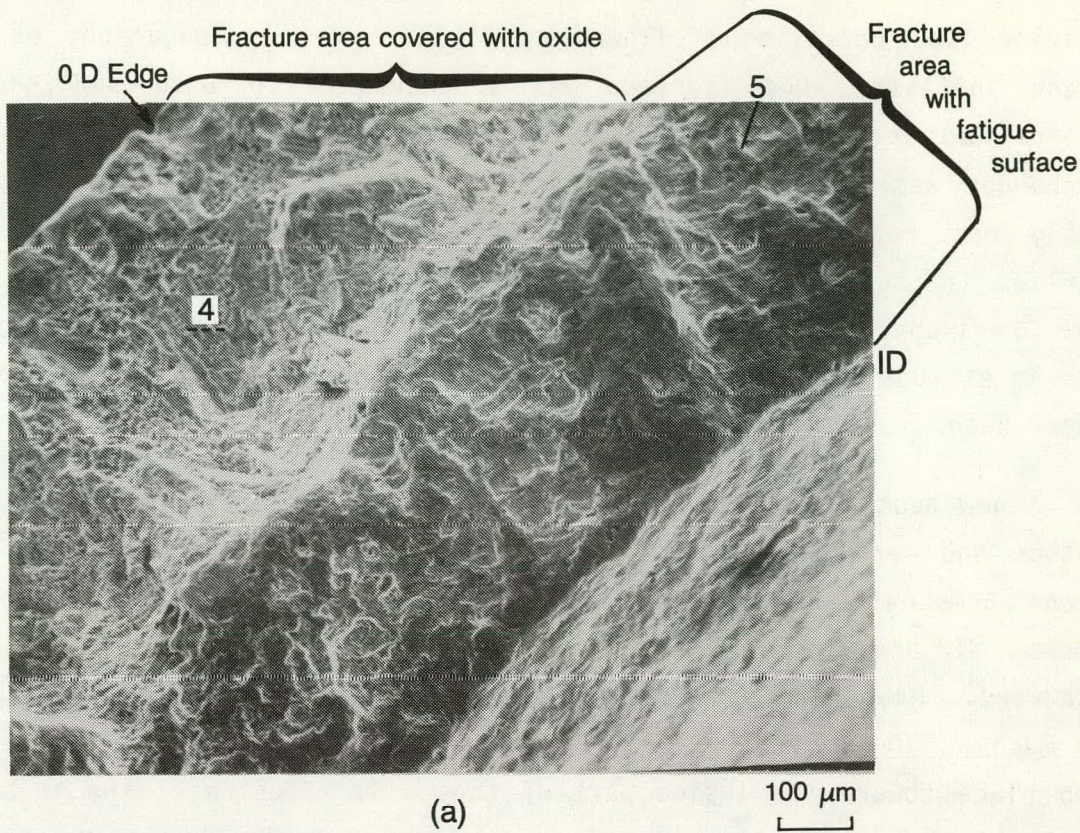
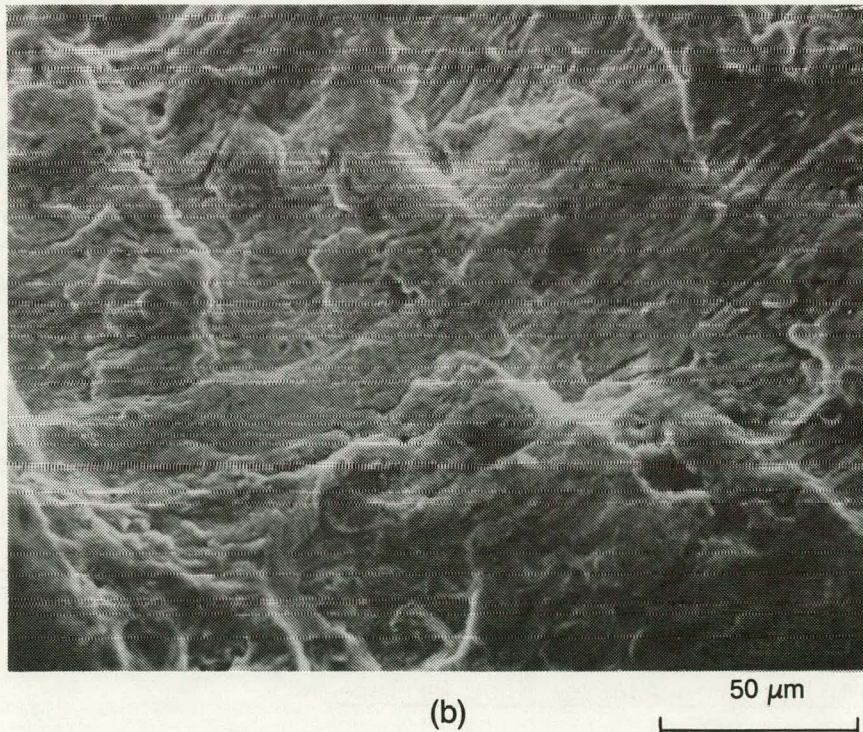
After approximately 620 hours of service, failure of this coil occurred by complete fracture of the inlet tube just below the Swagelok fitting that connects the 310 SS coil to the Inconel 625 riser tube, Figure 2-1. Figures 2-2 (a & b) are scanning electron micrographs of the fractured tube wall. Approximately one-half of the wall thickness toward the OD, Figure 2-2a, is covered with a thick corrosion or oxide layer with the remaining area extending to the ID covered with fatigue striations, Figure 2-2b. The fatigue striations indicate propagation from the OD to the ID of the tube wall. It is unclear, however, whether the failure initiated on the outer surface by pitting or

Figure 2-2. Fracture Surface of 310SS Tubing  
a) Corrosion Towards OD and Fatigue ID b) High Magnification of Fatigue Striations

crevice type corrosion, followed by fatigue crack propagation, or a fatigue crack initiated whose surface was subsequently corroded/oxidized. Pitting attack has previously been observed at various locations on the in-bed heat exchanger assembly. (Fractures similar to that described above have previously occurred on the heat exchanger heat exchanger assembly, but these earlier fractures occurred in the downcomer assembly at the weld connecting the 3/4-inch diameter riser tube to the 3-inch downcomer, see Figure 2-1.) The inlet tube was replaced and the coil successfully returned to service at a later date.

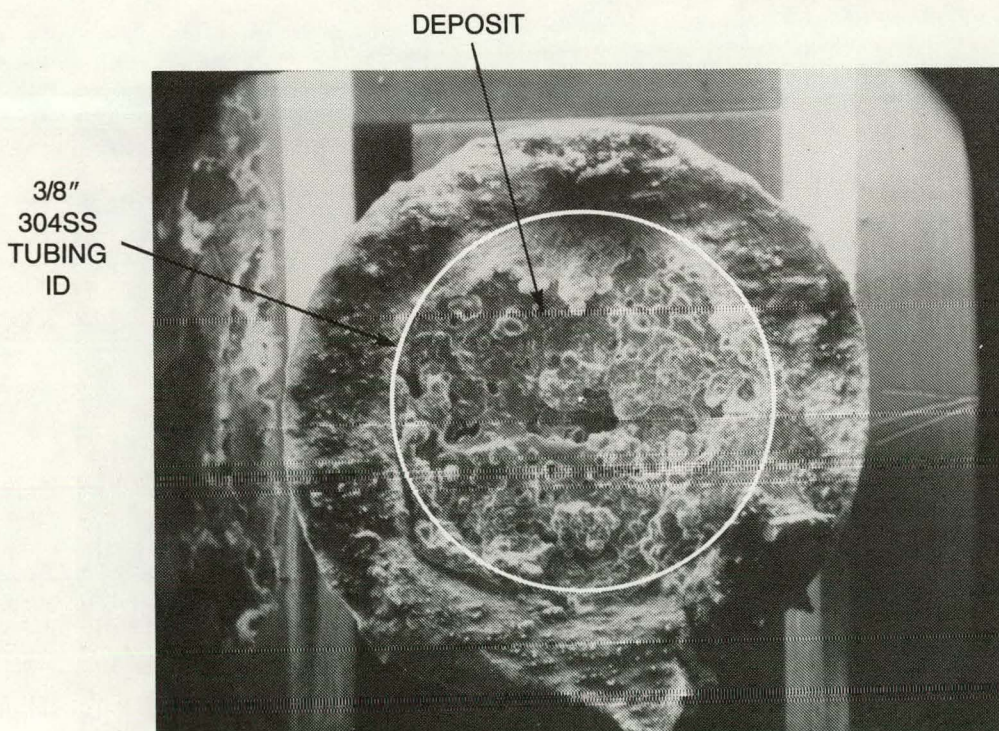
Figure 2-4. Cross-Section of Failed 304SS Adapter Tube. Tubing Is Plugged with Hard Deposit.

is plugged with a hard deposit which was determined to be water soluble. X-ray analysis of this deposit revealed it was composed of PFB combustion products, Ca, K, S, Mg, Al, Si along with Fe, Ni and Cr, Figure 2-5. Chemical analysis of deposits taken from the OD of the tube in the fracture area revealed high levels of chlorides and sulfates as noted in 4 above. A photomicrograph of a longitudinal section from the adapter tube is shown in Figure 2-6, illustrating the multiple transgranular branching nature of the cracks, characteristic of stress corrosion or corrosion fatigue cracks in stainless steel exposed to chloride environments. The thermal stresses imposed on the pins during service, combined with the presence of high levels of chlorides and sulfates caused stress corrosion or corrosion fatigue cracking of the stainless steel adapter tubes.

The corrective action taken to alleviate this problem was to replace all the 304 SS inlet adapter tubes on the 1100°F pins with Inconel 625 tubing. This change has been performed on all the long-term pins which have been exposed 1800-2100 hours and also on all new pins to be tested at 1100°F. Inconel 625 is a high strength nickel-base alloy with better fatigue resistance than 304 SS and better resistance to corrosion by chlorides. Further, the 1/4-in. diameter stainless tubes, connecting the 1100°F pins to the cooling air inlet and exhaust manifolds have been replaced with new stainless tubing to minimize potential pitting failures caused by exposure to the low pH condensate resulting from an adapter tube failure.

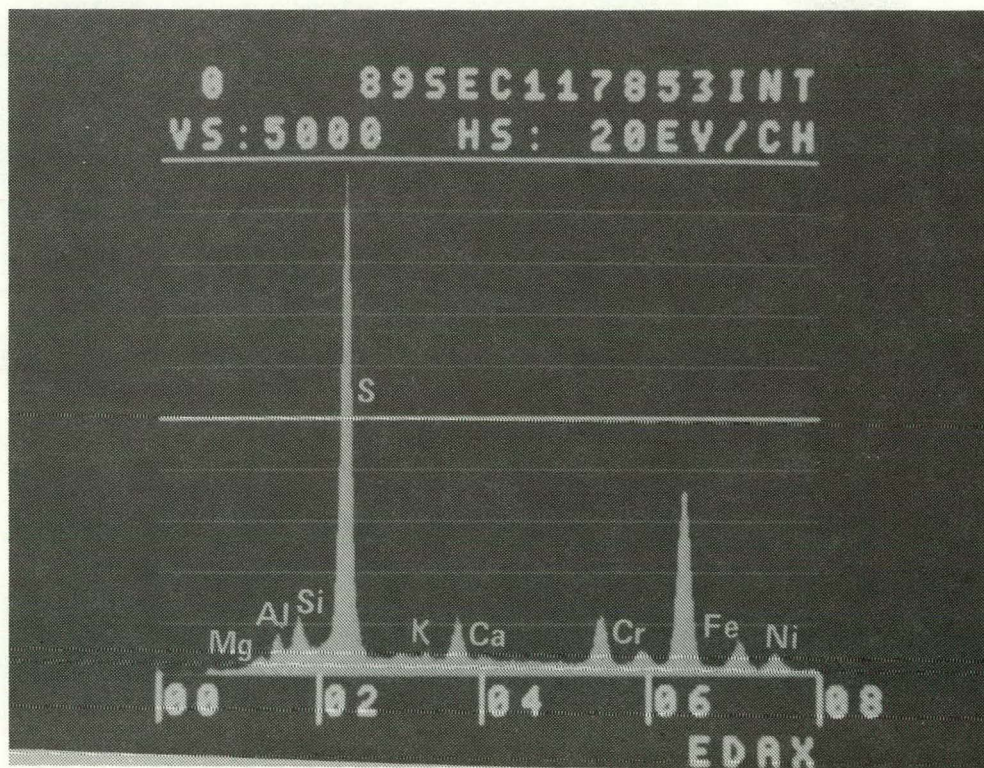
Figure 2-5. X-Ray Spectrum of Deposit Inside Adapter Tube

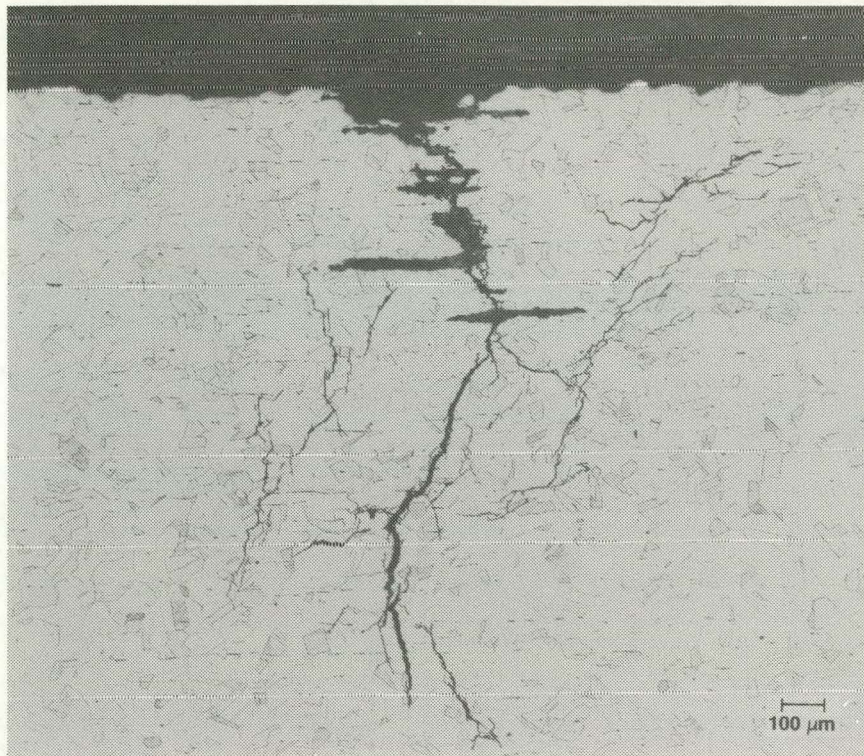
The 1100°F cooled pins operate 350°-450°F below the gas temperature, 1440°-1520°F. This temperature difference imposes stress/strain on the cooled pins during high-temperature service. Figure 2-4 shows a scanning electron photomicrograph of a failed 3/8-inch diameter 304 SS adapter tube. The tube

Figure 2-6. Cracking of 304SS Adapter Tube

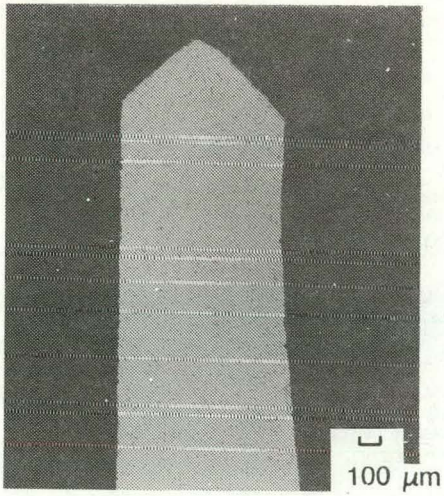
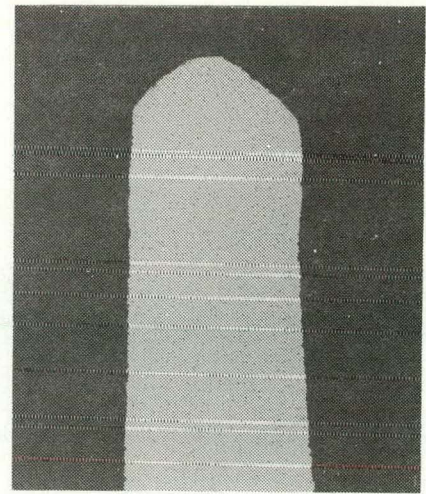
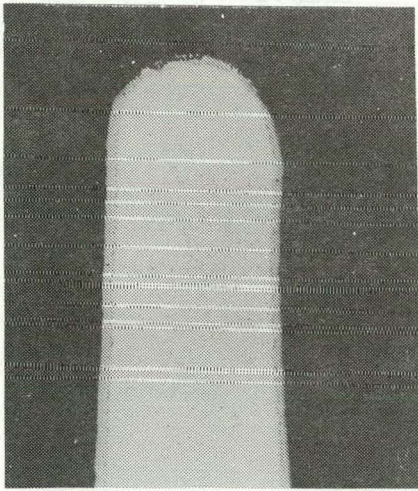
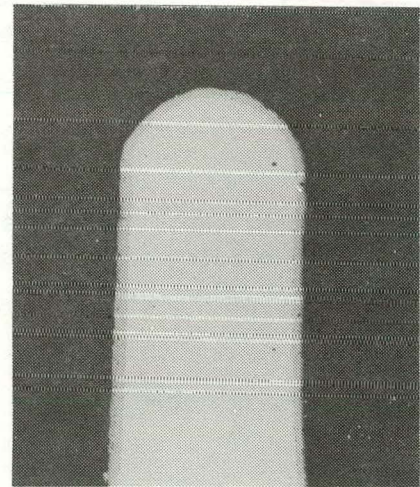
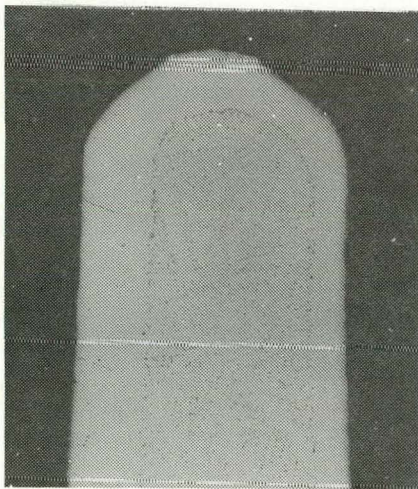
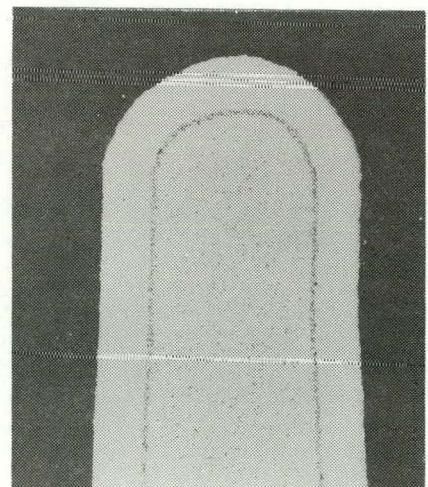
The RT-19 aluminide coating exhibited metal loss to 1.2 mils on either side of the leading edge (Figure 3-2c) and some thinning of the coating along the pressure wall (<0.05 mils). RT-44 rhodium-aluminide coating showed good erosion resistance with less than 1 mil of metal recession at any location on the airfoils, (Figure 3-2d).

The MCrAlY overlay coatings also showed good erosion resistance on the airfoils with the Co-23Cr-10Al-0.4Y experiencing 0.8 mil or less of leading edge metal loss (Figure 3-2e), and the FeCrAlY coating less than 1.0 mil of metal loss (Figure 3-2f). The pressure surface of the MCrAlY coated airfoils typically were roughened with a maximum of 1.2 mils of metal removal.

Figure 3-2. HVTs Airfoil Leading Edge Profiles After 1150 Hours at 1350°F

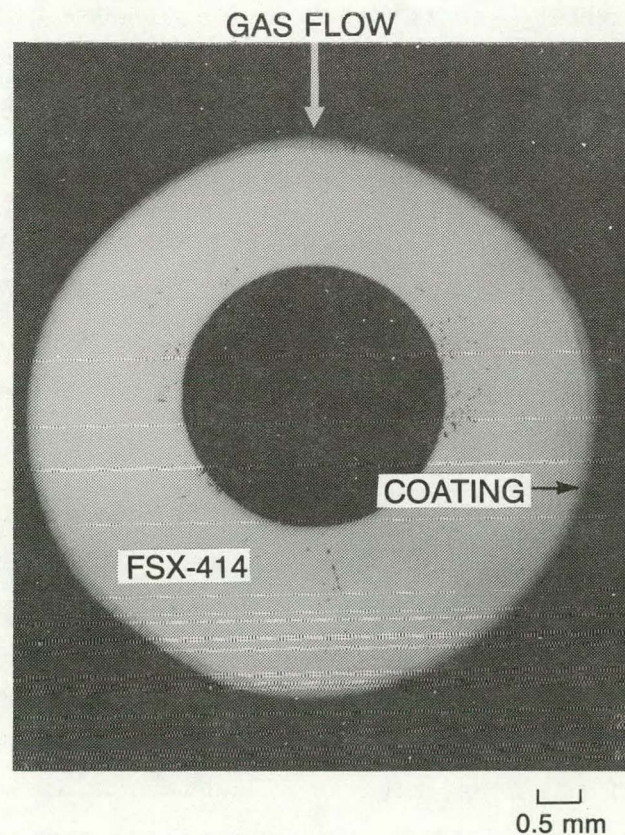
- o Metal recession rates of 8 mils/1000 hours on a platinum-aluminide coated IN-738 pin and 2 mils/1000 hours on a Co-23Cr-10Al-0.4Y coated pin have been observed at 1200-1400 ft/s.

Figure 3-3. CoCrAlY Coated Erosion Pin After 1150 Hours at 1350<sup>o</sup>F, 1200-1400 ft/s in HVTS

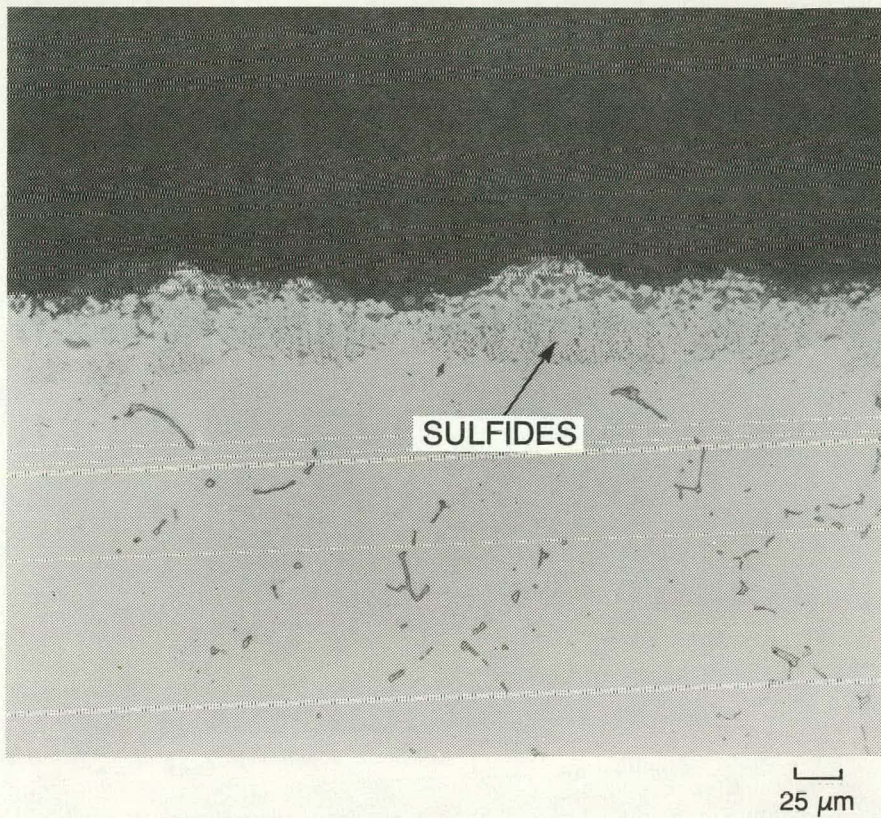
Figure 3-4. Sulfidation Corrosion on Pressure Surface of IN-378 After 1150 Hours at 1350<sup>o</sup>F

The nickel-base alloys, IN-738 and IN-939, showed the most overall materials degradation with 4.2 and 3.0 mils of maximum total affected metal, respectively. Corrosion of the nickel alloys was particularly severe as evidenced by the extensive sulfidation attack shown in Figure 3-4. This internal sulfidation morphology is similar to the type of attack observed on these same materials at 1300°F in the LVIS, but is somewhat accelerated due to the combined effects of erosion and corrosion introduced by the high-velocity particle impaction.

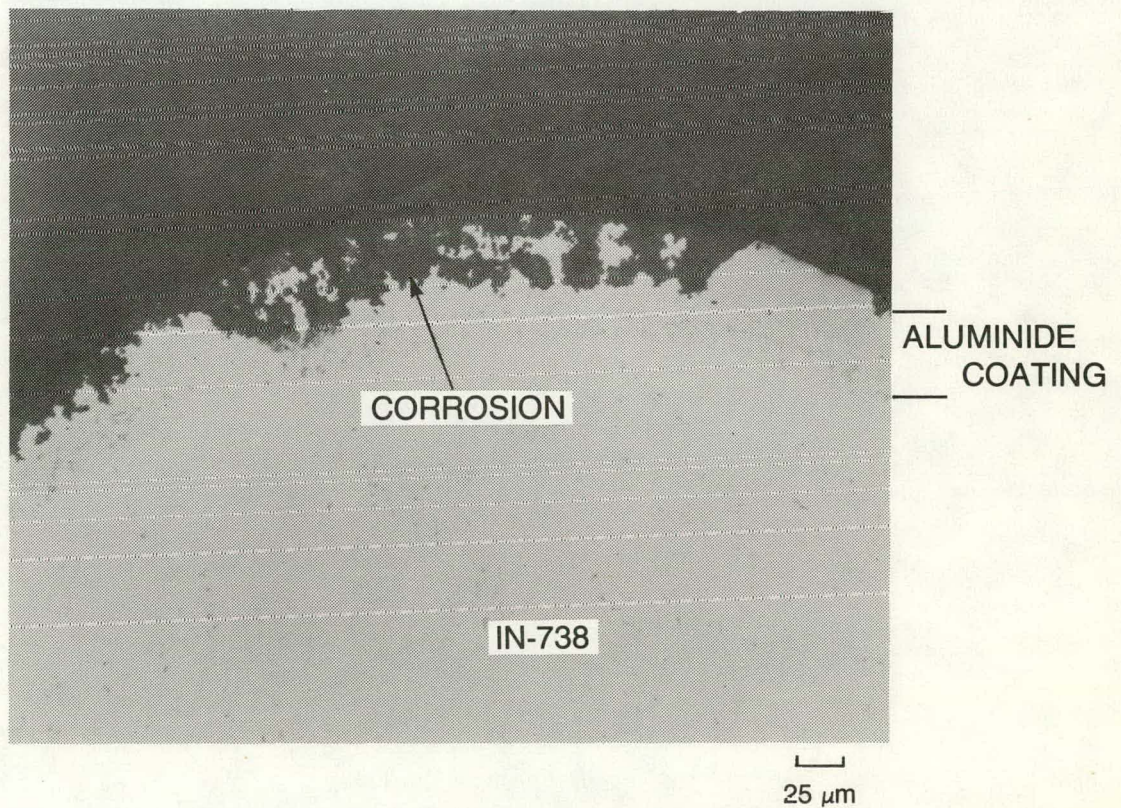
The aluminide coating, RT-19 showed hot corrosion attack as shown in Figure 3-5 with penetration of the coating to the interdiffusion zone. No attack of the IN-738 was observed. In addition to corrosion at the leading edge and pressure surface, the aluminide coating also showed corrosion attack around the crown region of the airfoil on the suction surface.

Figure 3-5. Corrosion at Leading Edge of RT-19 Aluminide Coating After 1150 Hours at 1350<sup>o</sup>F

The RT-19 aluminide coating was penetrated by corrosion to the inter-diffusion zone in the 1150-hour exposure, although metal loss due to erosion was not particularly severe. This aluminide coating has shown a high susceptibility to hot corrosion attack at all three temperatures, 1100°, 1300° and 1500°F in the LVTS.

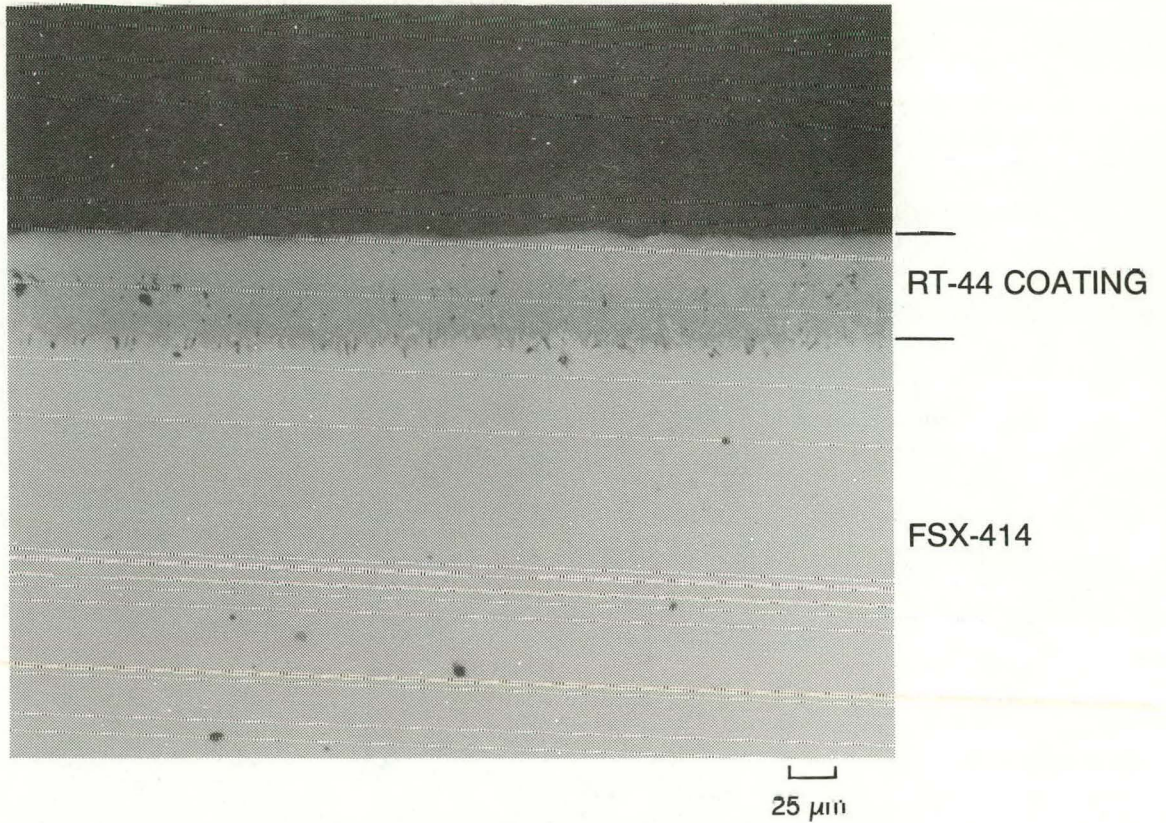
The rhodium-aluminide RT-44, coating exhibited excellent corrosion resistance with no evidence of attack on any specimen. Figure 3-6 shows the typical appearance of the RT-44 coating after 1150 hours exposure.

Figure 3-6. RT-44 Rhodium-Aluminide Coating on FSX-414 After 1150 Hours at 1350° F

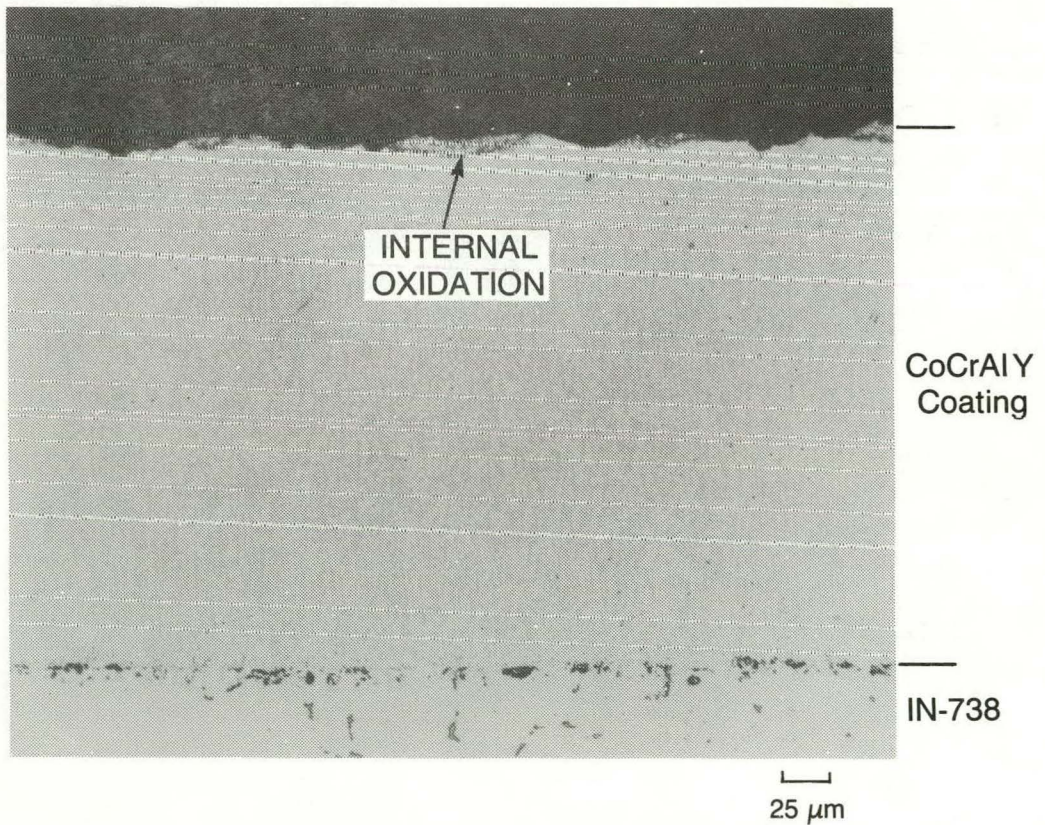
The MCrAlY coatings also showed generally good corrosion resistance with both the Co-23Cr-10Al-0.4Y and Fe-Cr-AlY coatings exhibiting areas of internal oxidation less than 1.0 mil deep, Figures 3-7 and 3-8. These areas were again confined to areas of particle impaction with no evidence of corrosion around the suction (convex) surface. Along with internal oxidation of the coating, the CoCrAlY material exhibited a narrow depletion zone ahead of the oxidation attack, Figure 3-7.

Figure 3-7. CoCrAlY Coating Showing Internal Oxidation on Pressure Surface After 1150 Hours at 1350° F

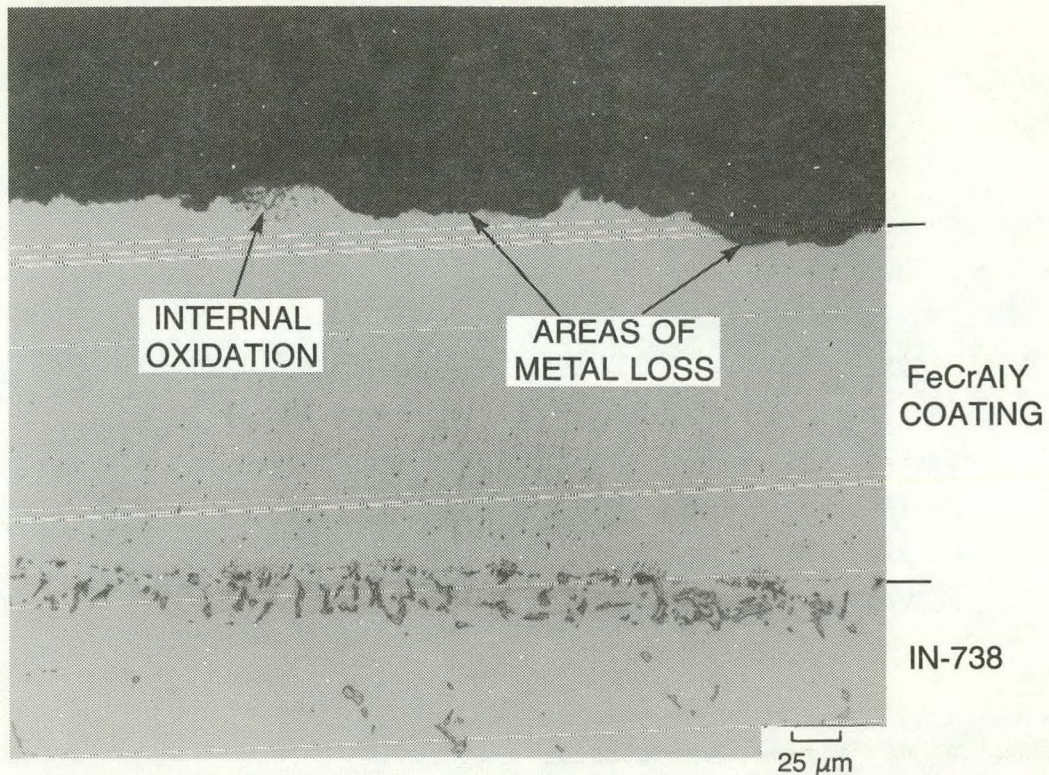
Figure 3-8. FeCrAlY Coating Showing Internal Oxidation on Pressure Surface After 1150 Hours at 1350°F
