Outages of Electric Power Supply Resulting from Cable Failures Boston Edison Company System

July 1980

Prepared by:
Commonwealth Associates Inc.
Jackson, Michigan 49201
Under Contract No. AC01-78RG06674

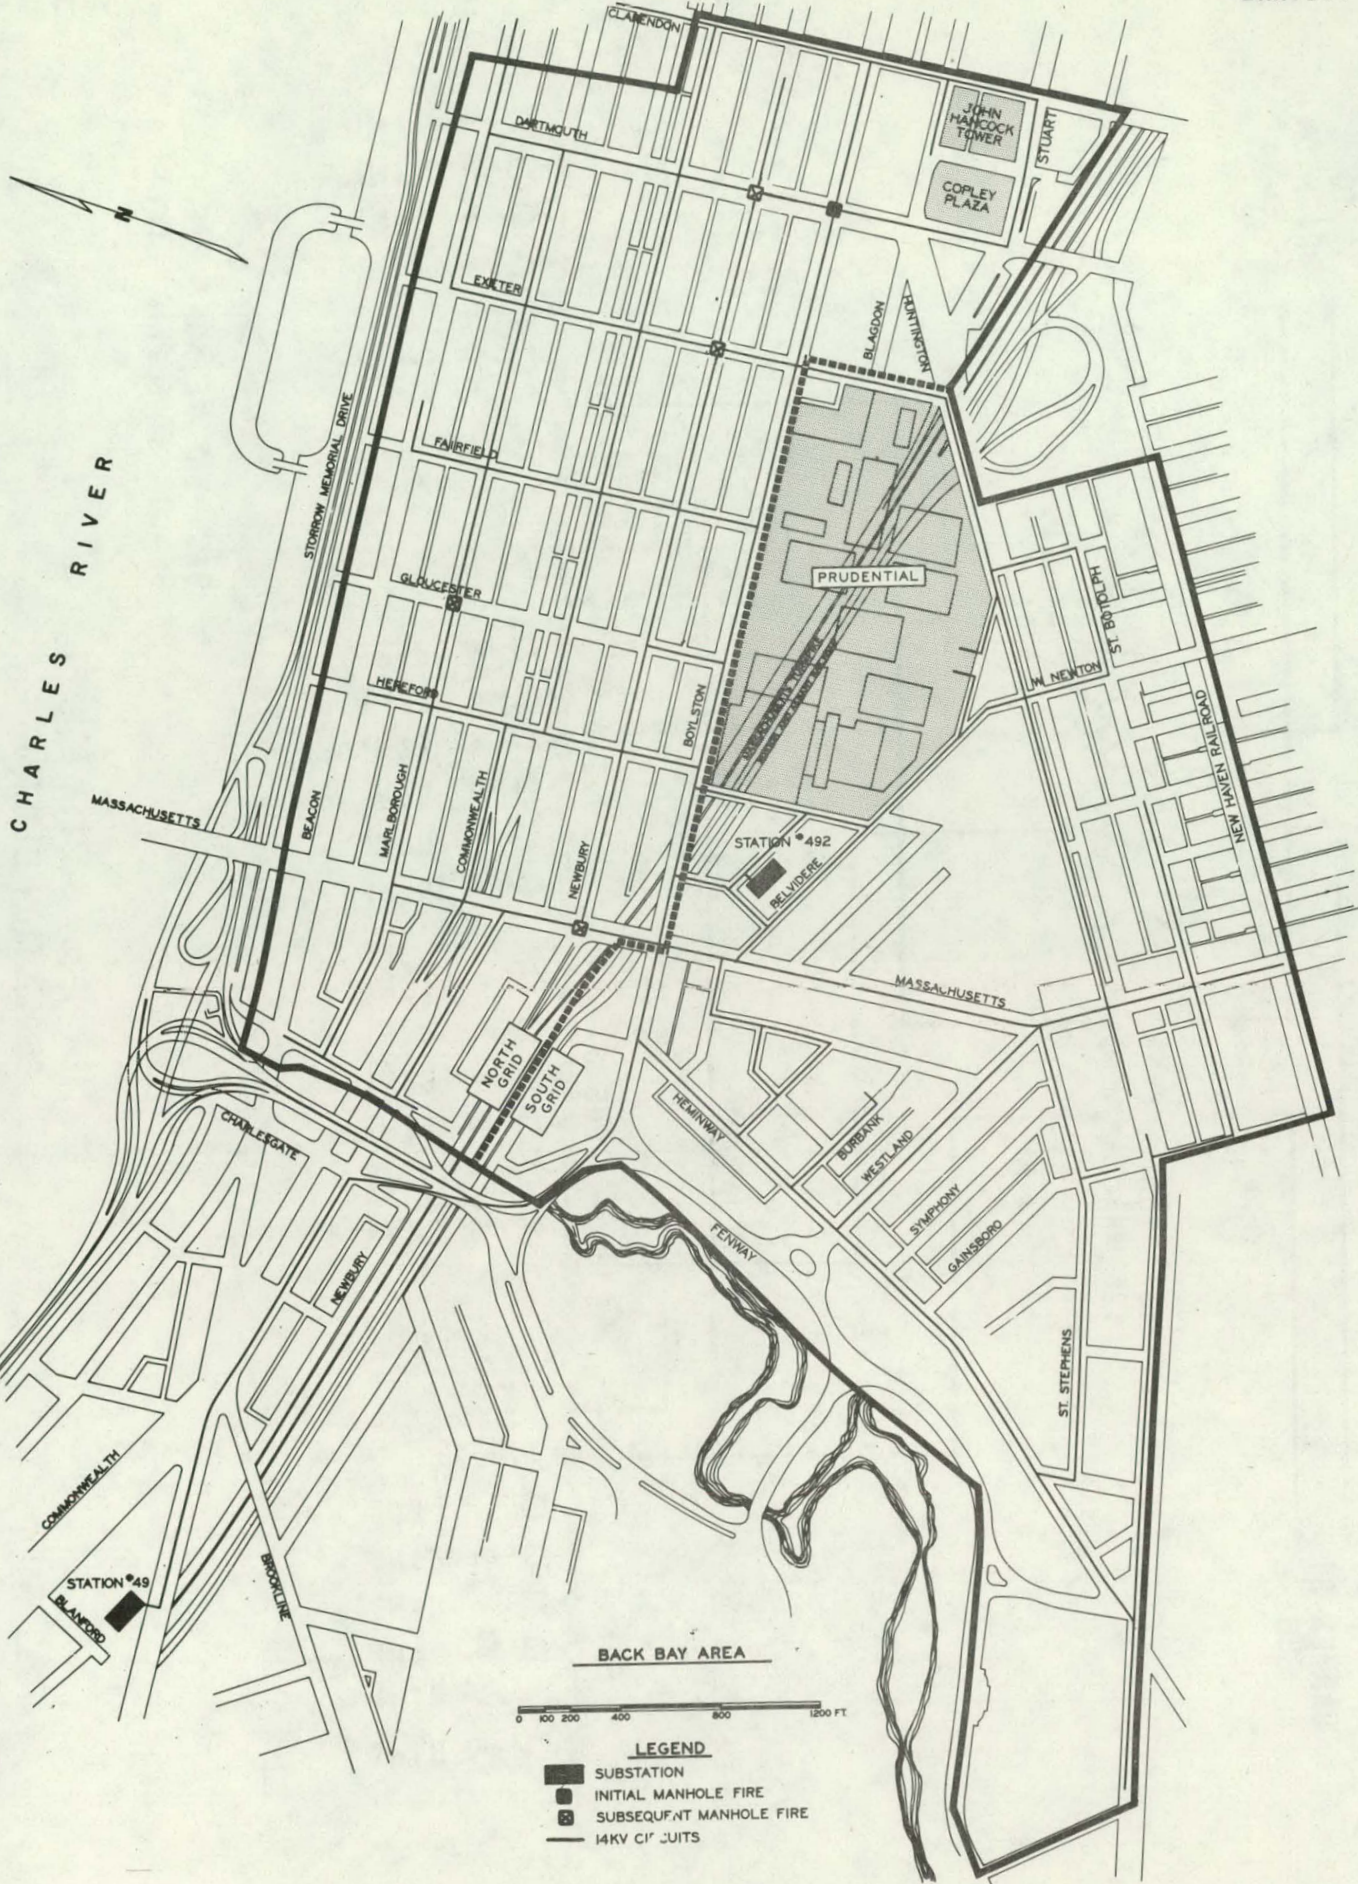
BACK BAY AREA

The Back Bay Network problems were initiated by a fire in Manhole 1456 at Boylston and Dartmouth Streets on

Sunday, April 1, 1979. An investigation by Boston Edison personnel indicated that the probable cause of the fire was the failure of a 240/120 V dc cable in Duct 11 (see Exhibit 6). The dc cable failed at or near the duct mouth, and the ensuing fire eventually destroyed all the cables within one to two feet of this location. Four 14 kV network feeders (IN45, IN11, IN12, IN22) were damaged and sequentially relayed out of service within a 15-minute period just prior to 1 PM, Sunday, April 1, 1979. Also at this time, a fifth 14 kV feeder (IN25) was out of service because of scheduled maintenance at the John Hancock Tower. The estimated Back Bay Network load was 29,000 kVA; no secondary network customers were out of service at this time.

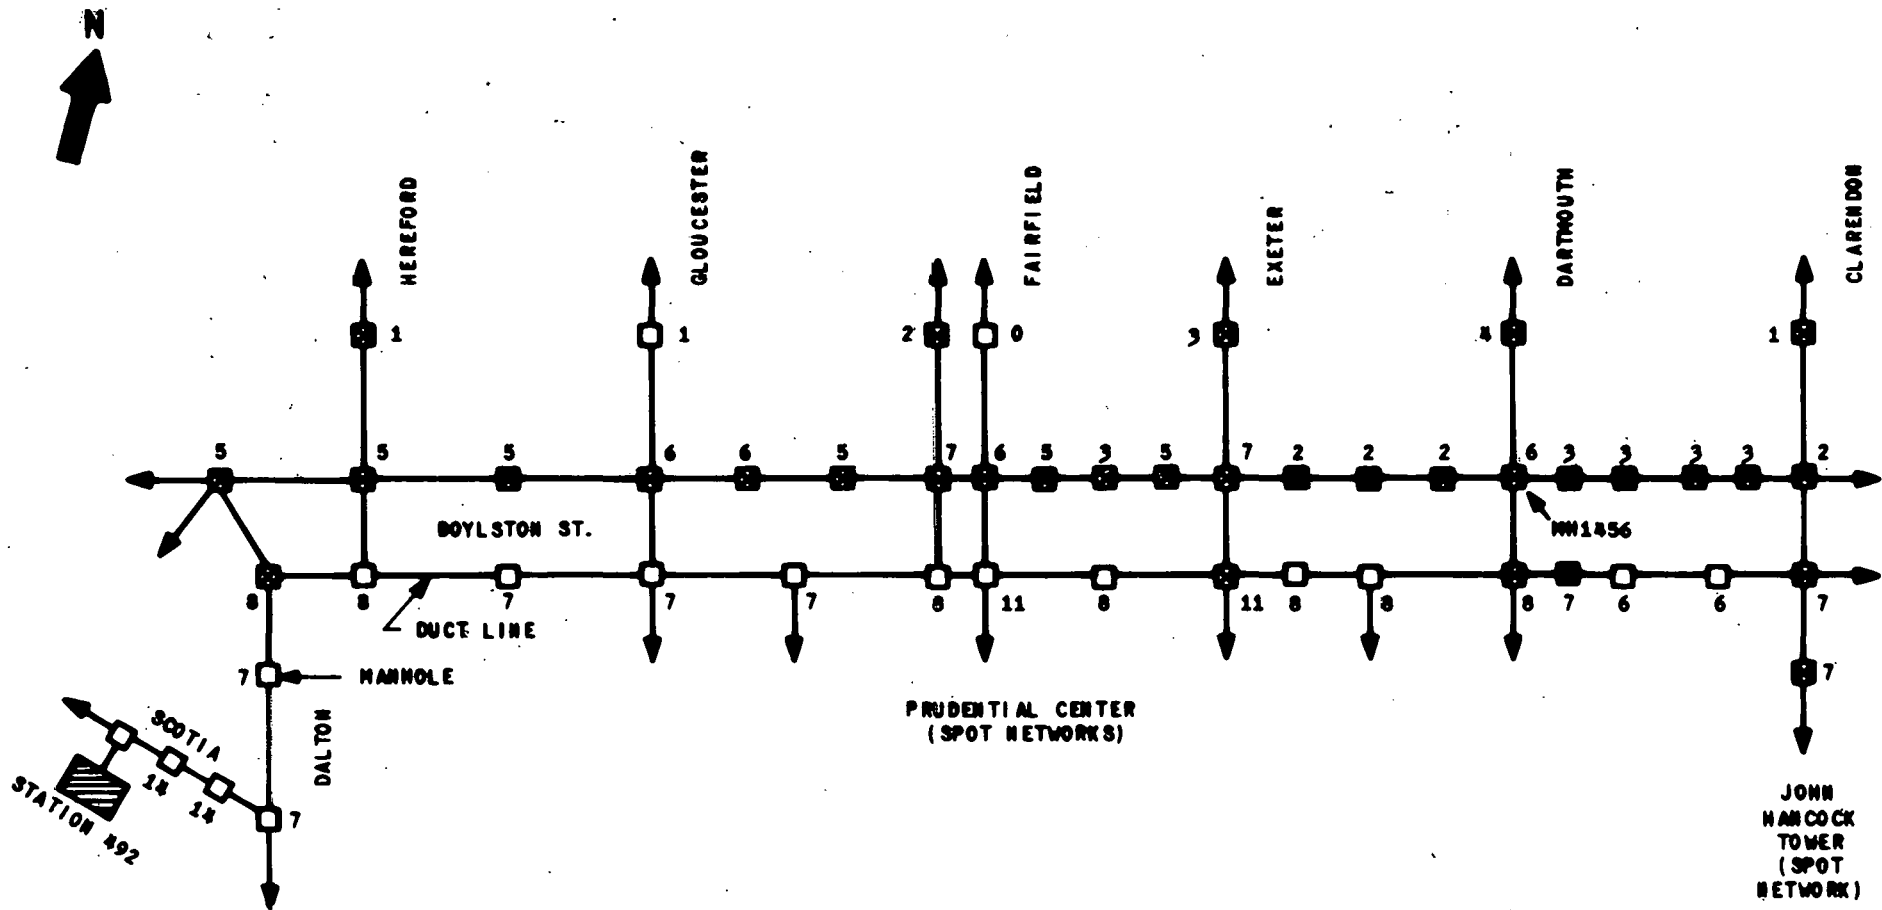
**BACK BAY NETWORK UNDERGROUND SYSTEM
MANHOLES AND 14 KV CABLES ON BOYLSTON ST.**

The Boston Edison system is more vulnerable to outages caused by a single manhole fire than some other utilities since many of the feeders supplying the networks are run in a common manhole/duct system. (See Exhibit 5.) A sustained fire in a single manhole could conceivably take out as many as eleven

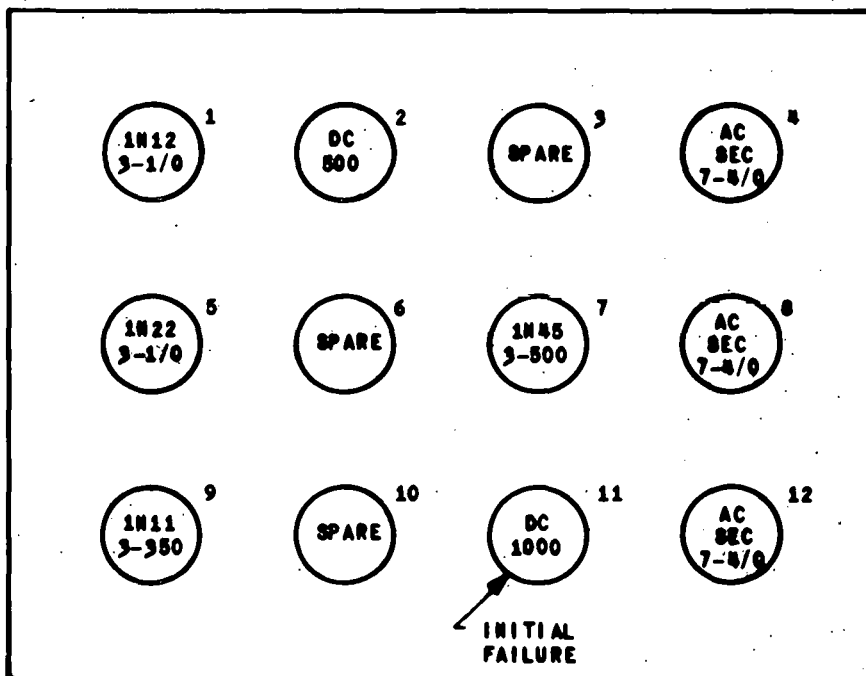
DUCT FACE - MANHOLE 1456
 BOYLSTON AND DARTMOUTH STREETS
 (FACING NORTH)

The cause of the dc fault that initiated the Back Bay incident is not known. The cable that failed was placed in service on November 22, 1922; it was 57 years old. Several weeks prior to the failure, this manhole was used to film a TV documentary on cable splicing. Possibly, this cable was kicked or moved. If this happened, it could have been the cause of the fault. Cable insulation deteriorates with age, becomes brittle, and perhaps dry because of oil migration in impregnated-paper insulated cables of the type used for the dc system. However, particularly in the case of cables operating at low voltage as in this instance, satisfactory service can be rendered indefinitely, provided that the cable is not moved. However, movement can disturb this rather delicate balance with subsequent failure. The dc cable that failed occupied Position 11, a bottom position, in Manhole 1456 (Exhibit 6) and might have been more vulnerable to accidental movement than some other cables in the manhole. The fault current completely destroyed the cable, leaving little evidence to determine how the cable initially failed. However, none of the fuses in the dc system blew, indicating that the initial problem was a high-resistance dc fault that failed to clear.

Shortly after the extent of damage was assessed, a decision was made to cut and cap four of the five feeders which had been removed from service. This was faster than full repairs and would permit the return to service of a part of each of the circuits. In this way, as many transformers as possible could be made available prior to the Monday morning load. Electrical Operations Department personnel were dispatched to 46 network

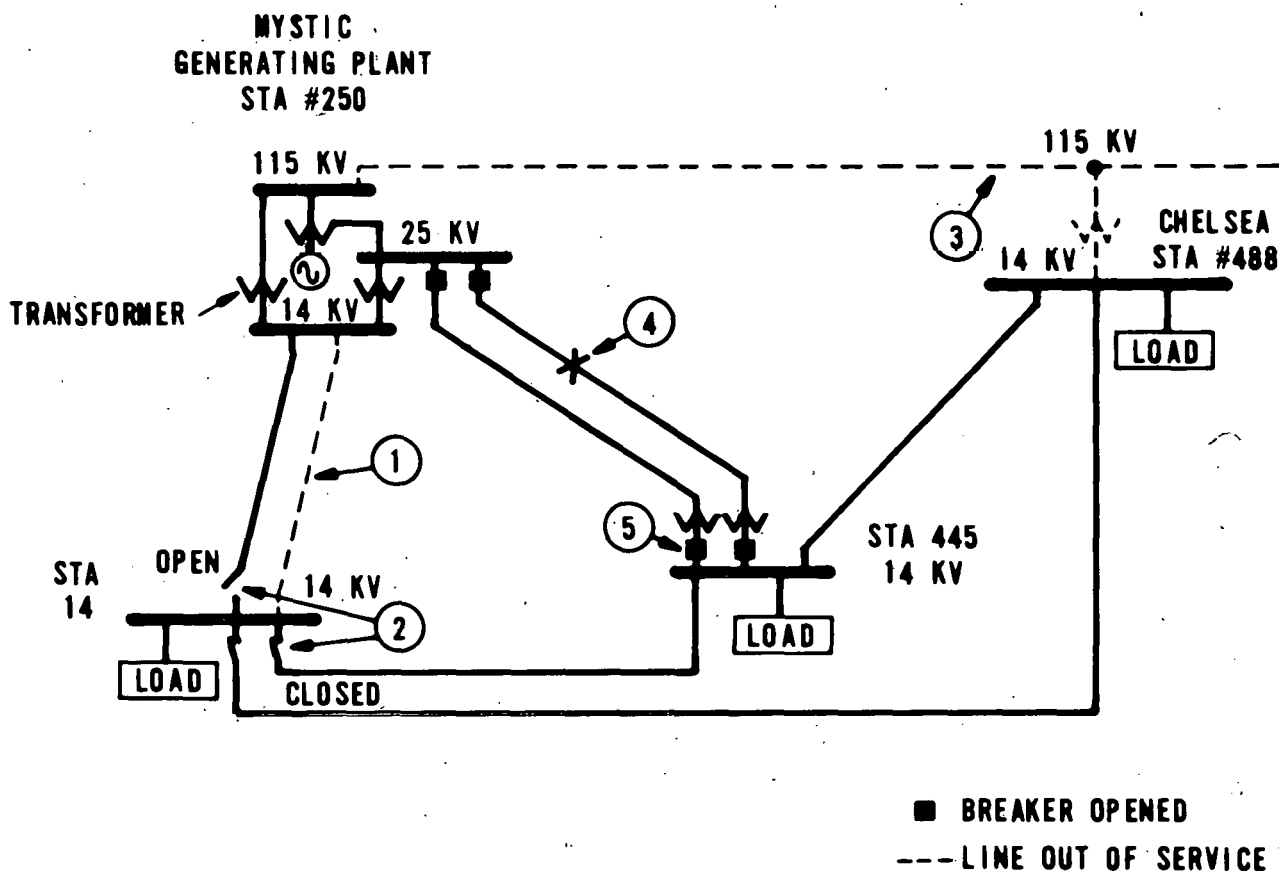
**SIMPLIFIED DIAGRAM CHELSEA/EAST BOSTON INCIDENT
(NOT ALL FACILITIES ARE SHOWN)**

1. OUT OF SERVICE DUE TO CABLE FAULT ON JUNE 1.
2. STA #14 LOAD TRANSFERRED TO STA'S 445 & 488 ON JUNE 1.
3. LINE AND TRANSFORMER SCHEDULED OUT FOR MAINTENANCE SATURDAY, JUNE 2.
4. AT 9:07 AM, SATURDAY, JUNE 2, 25 KV CABLE FAULTS AND CIRCUIT BREAKERS OPEN TO CLEAR LINE.
5. AT 9:10 AM TRANSFORMER OVERCURRENT RELAYS AT STA. 445 TRIP CIRCUIT BREAKER OPENING LAST SOURCE TO CHELSEA/EAST BOSTON AREA.

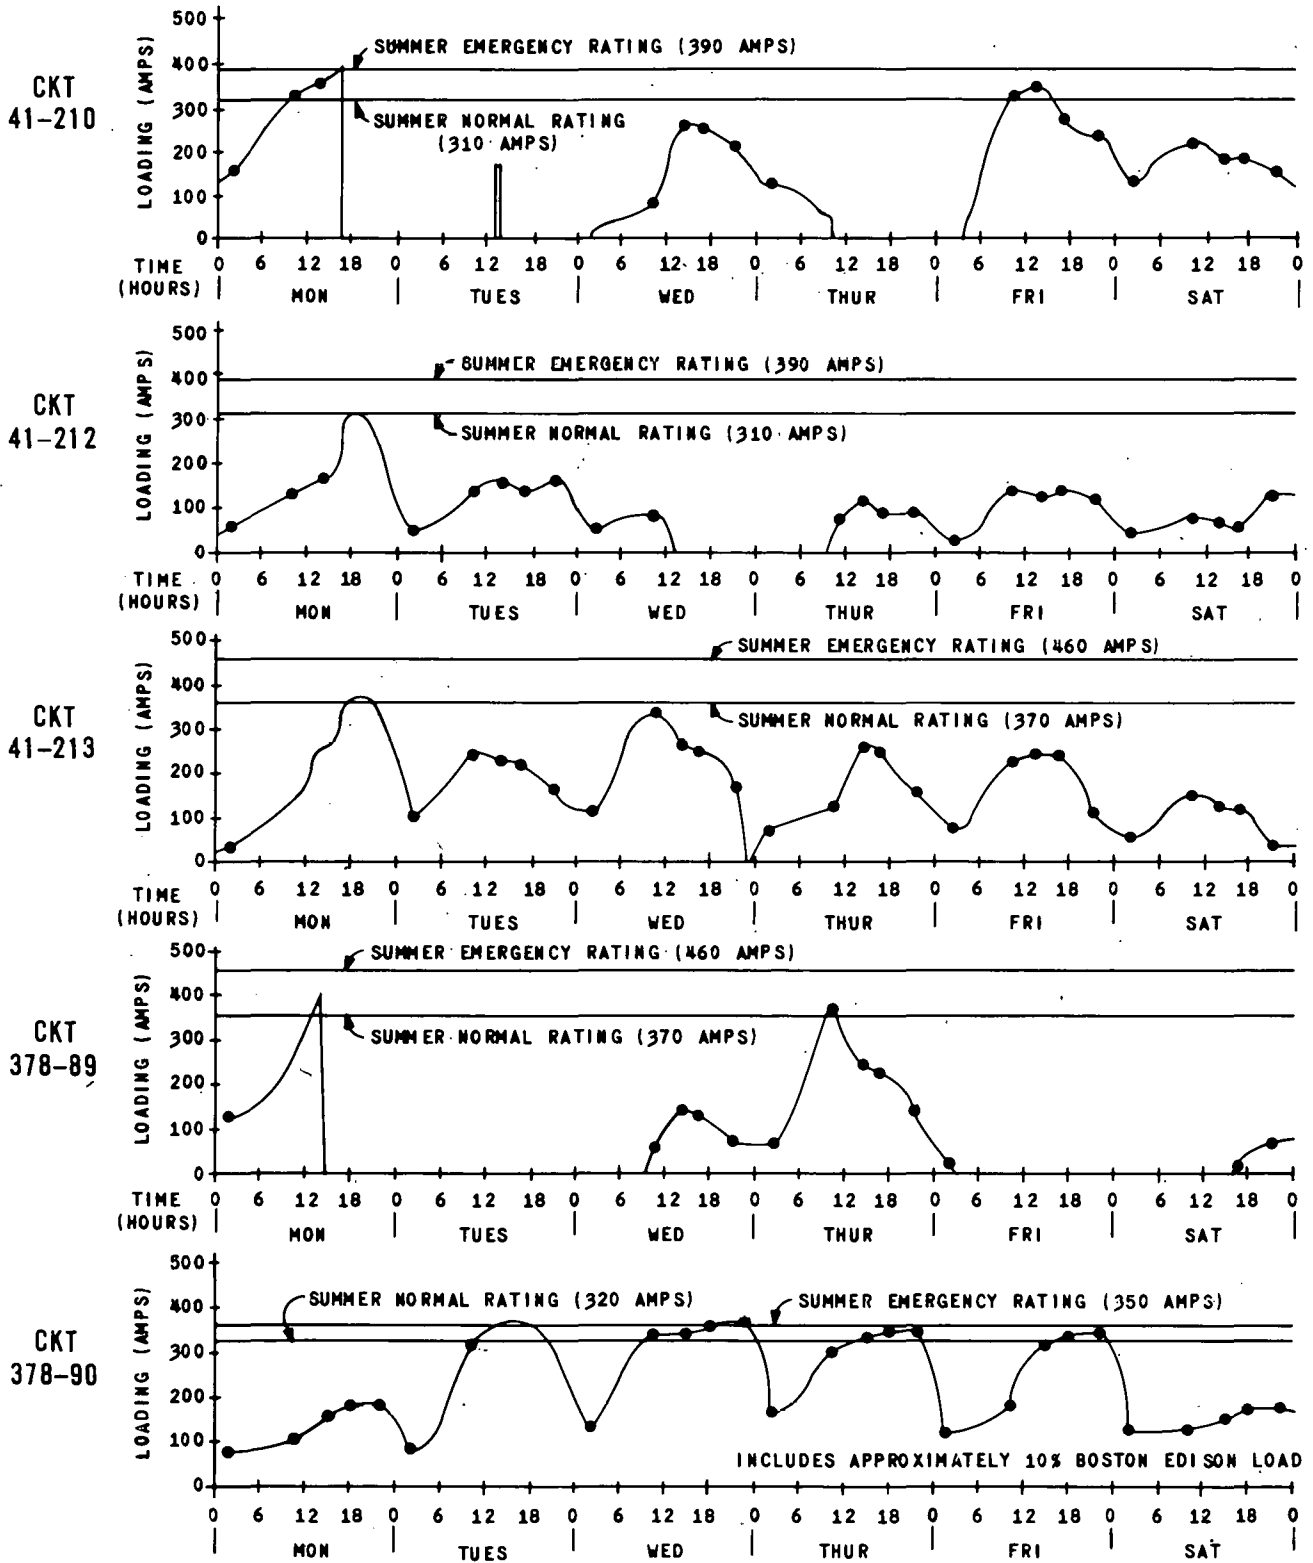
ESTIMATED LOADS WELLESLEY SUPPLY CABLES

Upon closer examination of the four supply cables, both outside and inside the town of Wellesley, additional cracks were found. This is a hilly area and most cracks were found in

this area. Boston Edison has hypothesized that the cracking of the cable sheath may be caused by the combination of the steep grades and thermal cycling. The cables, on expansion, may be moving in the downhill direction, but upon contraction, there may be less movement back uphill. Through many cycles of thermal expansion and contraction, the cable movement may have caused stress and cracking of the cable sheath.

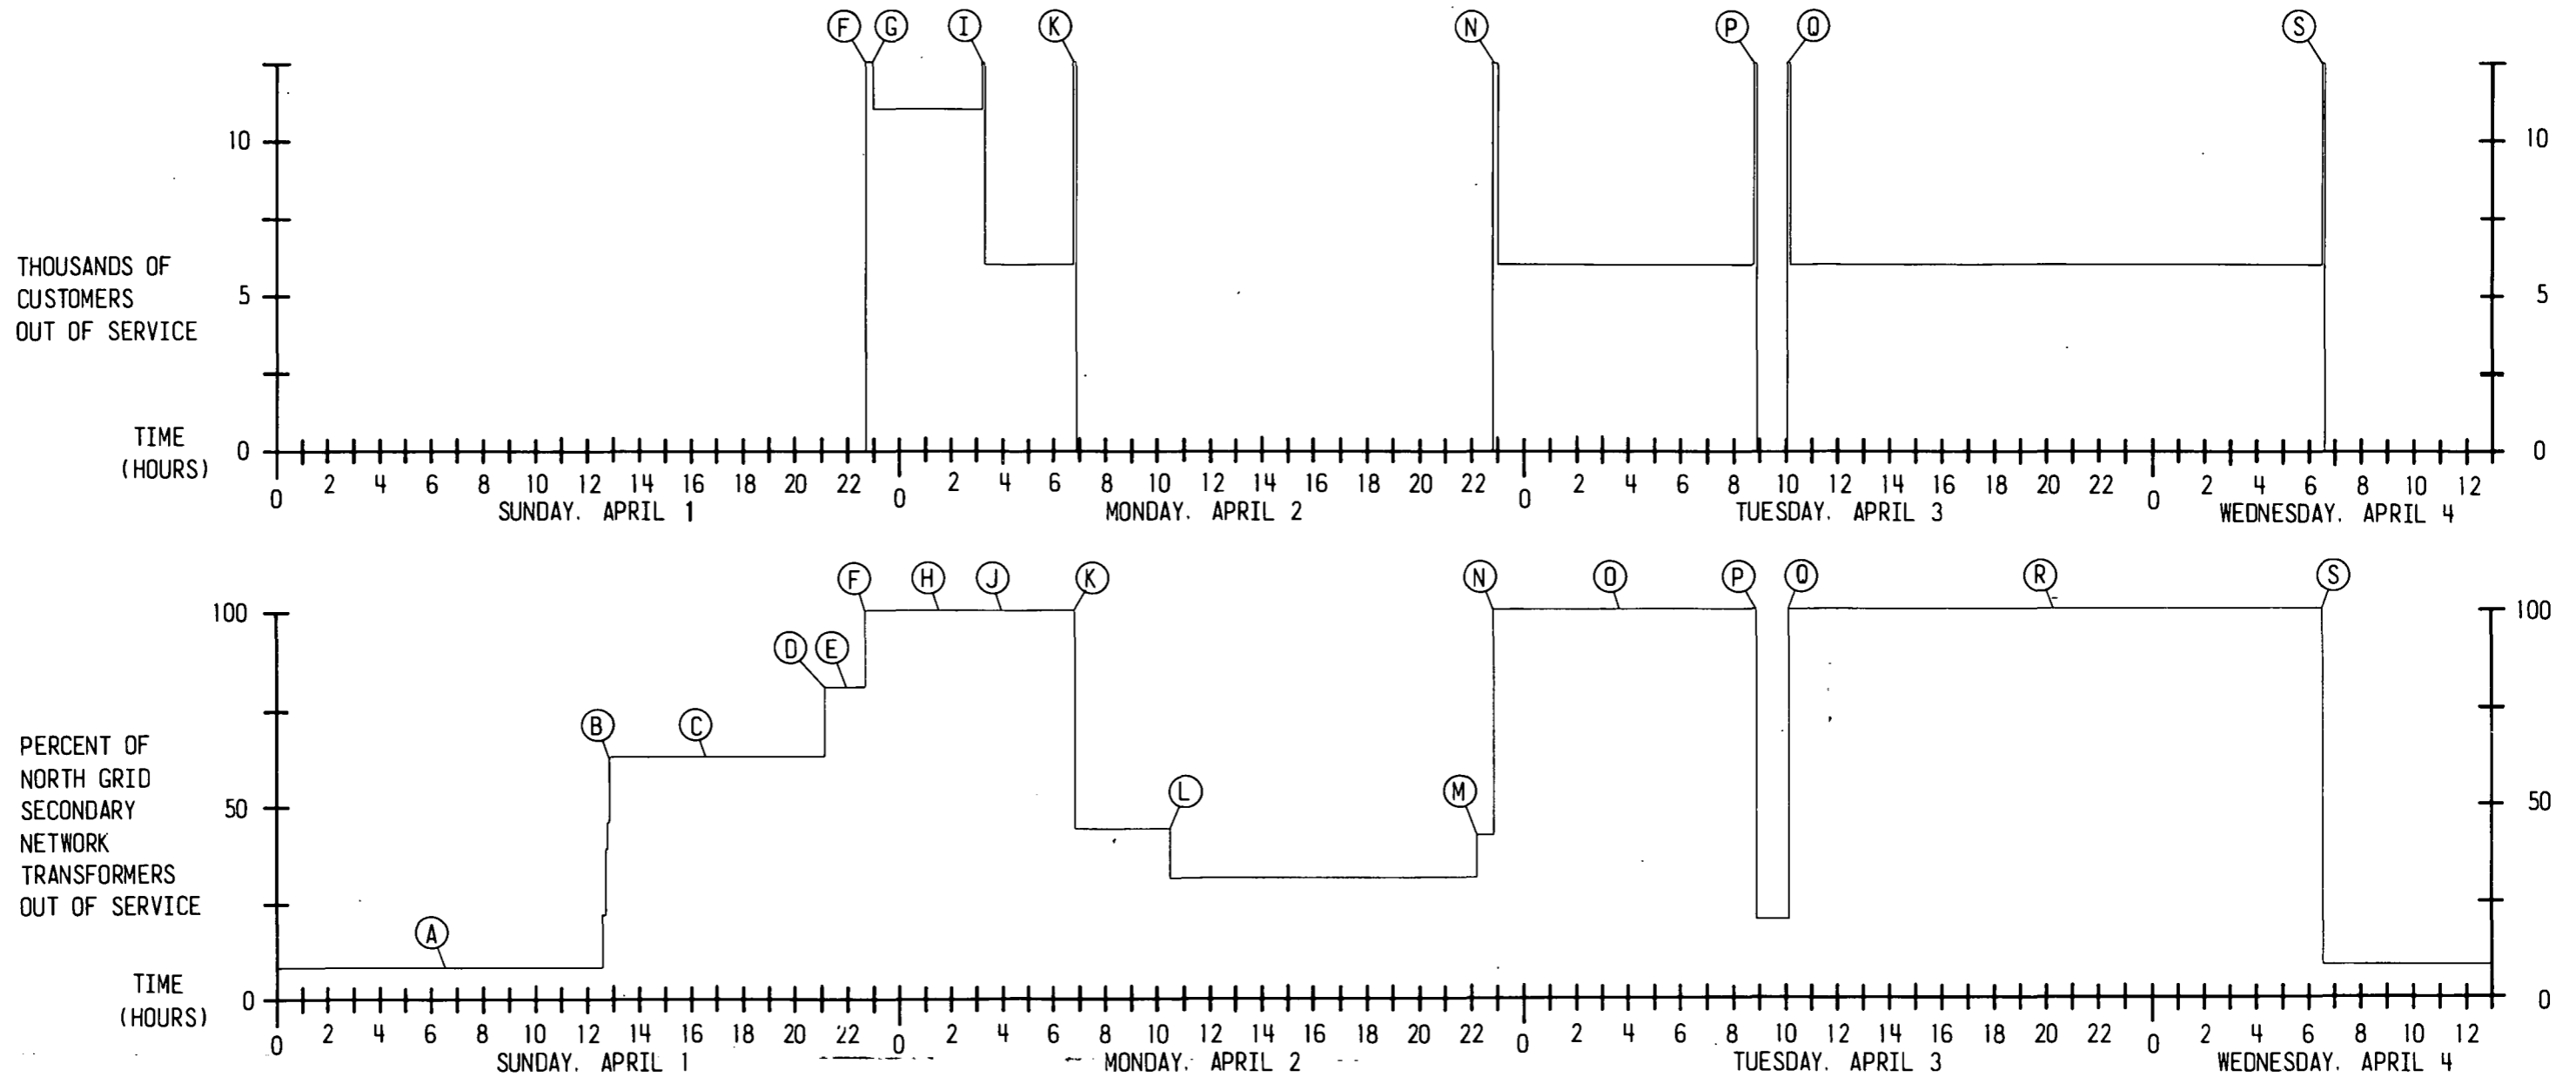
- A. FEEDER 25 OUT ON SCHEDULED MAINTENANCE
- B. REPORTED MANHOLE FIRE. FEEDERS 45, 12, 11, 22 RELAY OUT RESPECTIVELY
- C. TROUBLE SHOOTERS AND MAINTENANCE PERSONNEL DISPATCHED TO ISOLATE FAULTED CABLES

- D. REPORTED MANHOLE FIRE . FEEDER 31 RELAYS OUT
- E. SECONDARY CABLES FAULT AT 5 LOCATIONS
- F. STATION #492 CIRCUIT BREAKERS MANUALLY TRIPPED DE-ENERGIZING BACK BAY NETWORK AND BACON ST. STATION #49

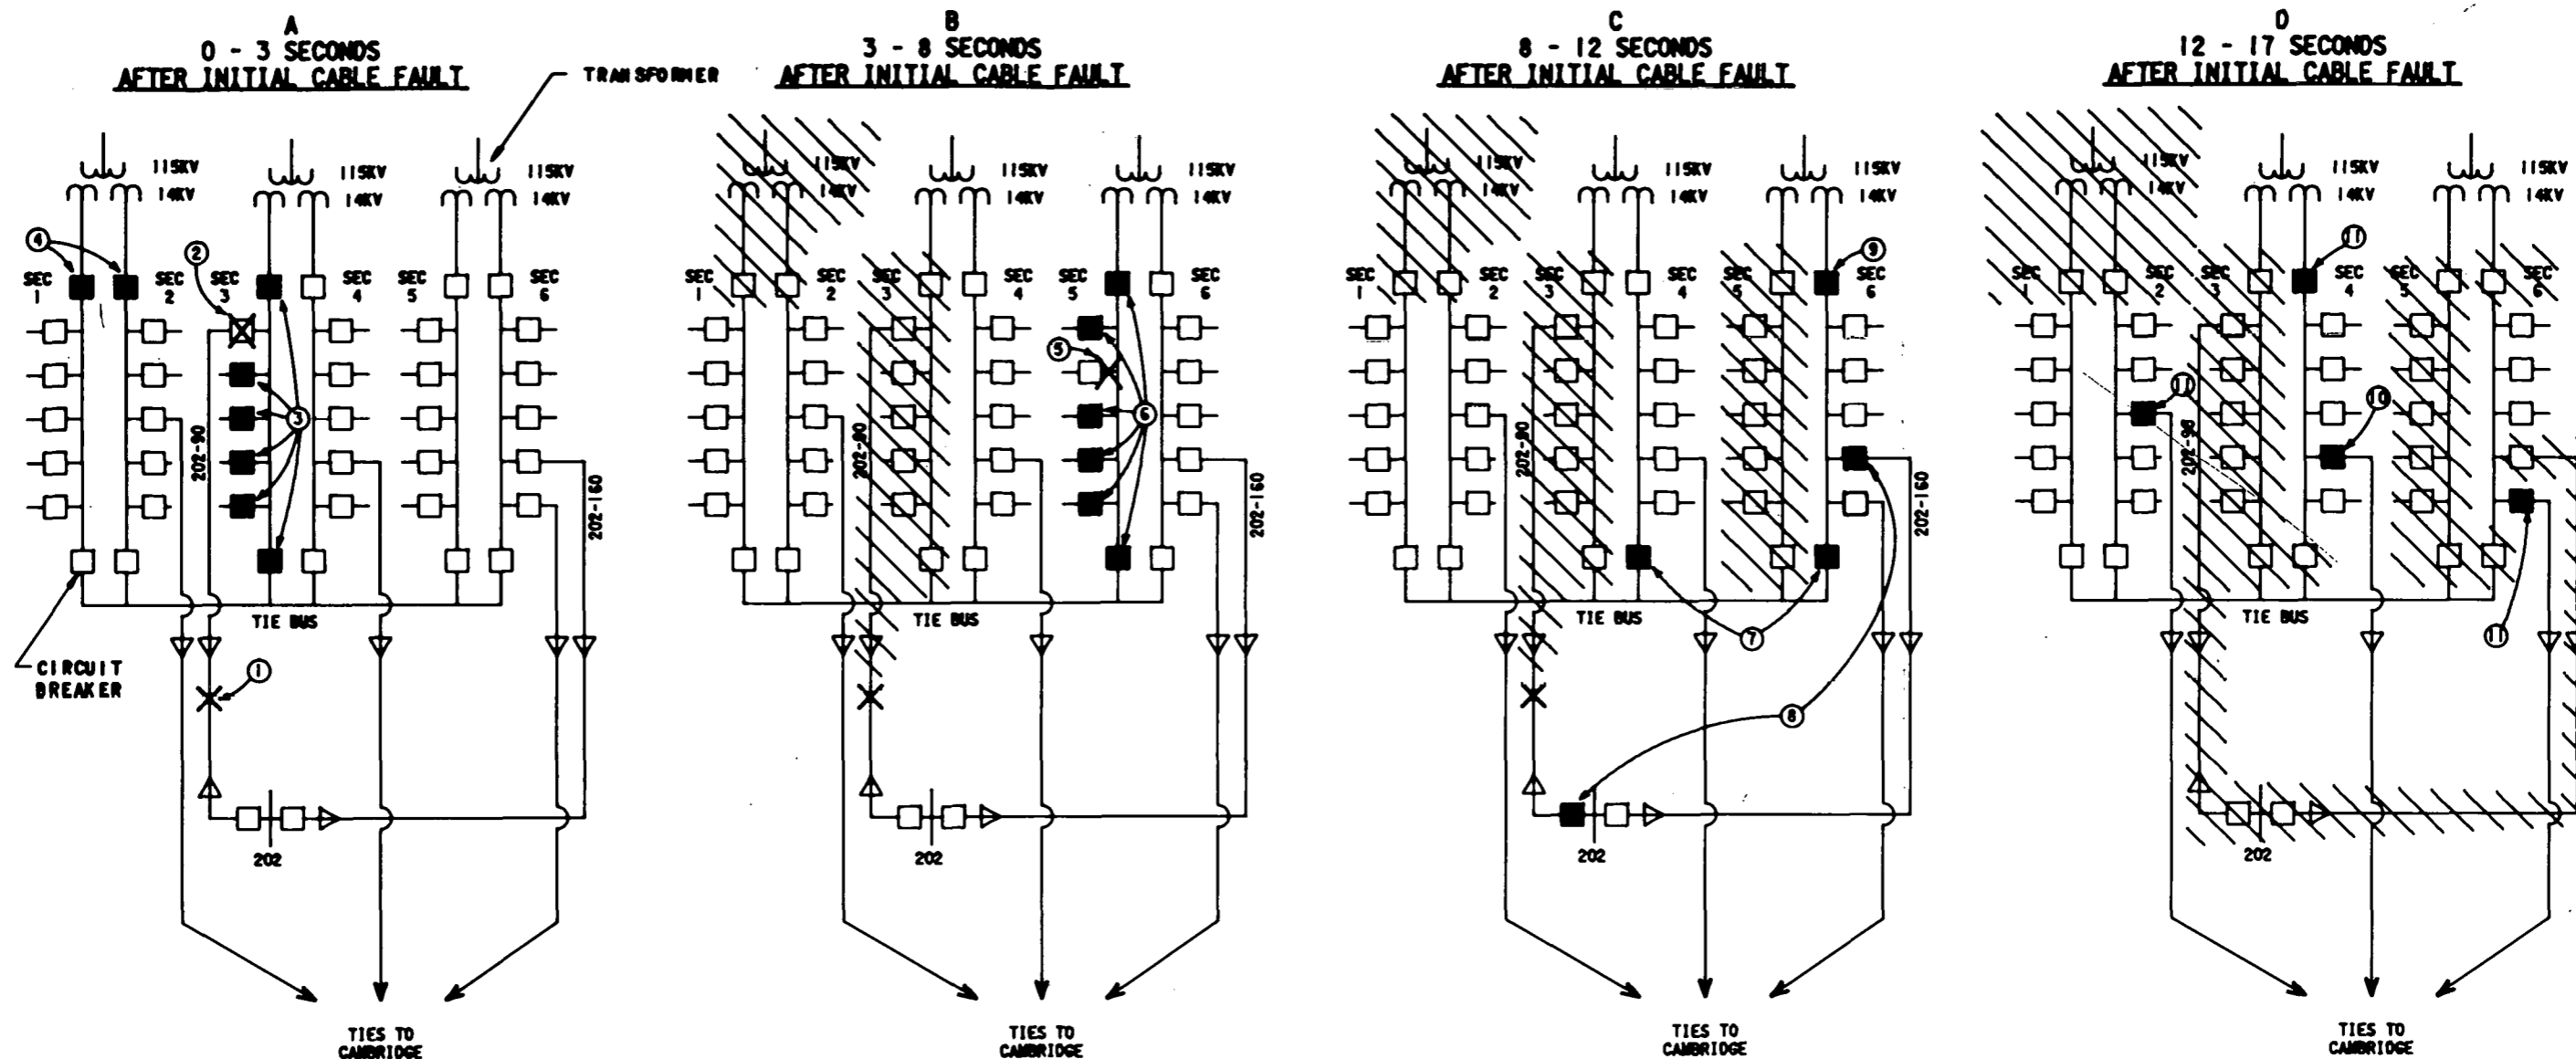
SEQUENCE OF 14KV CIRCUIT BREAKER OPERATIONS
BRIGHTON SUBSTATION

- ① 14KV CABLE FAULTS (TIME 0 S)
- ② CIRCUIT BREAKER FAILS RESULTING IN BUS FAULT (TIME 2.03 S)
- ③ BUS DIFFERENTIAL RELAYS TRIP ALL BUS SECTION #3 CIRCUIT BREAKERS CLEARING BUS FAULT (TIME 2.19 S)
- ④ UNDESIRED OPERATIONS OF OVERCURRENT PHASE RELAYS OPEN 115KV AND 14KV TRANSFORMER CIRCUIT BREAKERS (TIME 2.19 S)

- ⑤ BUS TAP INSULATOR FAILS RESULTING IN BUS FAULT (TIME 7.35 S)
- ⑥ BUS DIFFERENTIAL RELAYS TRIP ALL BUS SECTION #5 CIRCUIT BREAKERS CLEARING BUS FAULT (TIME 7.35 S)

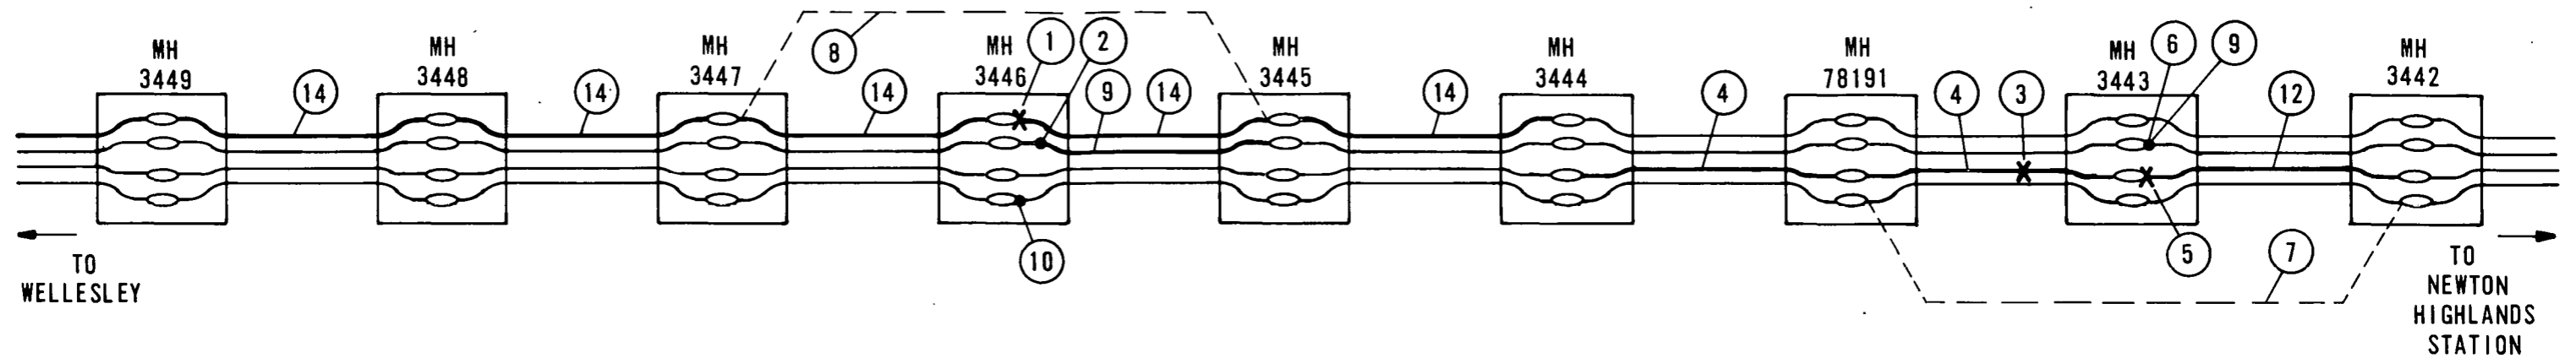
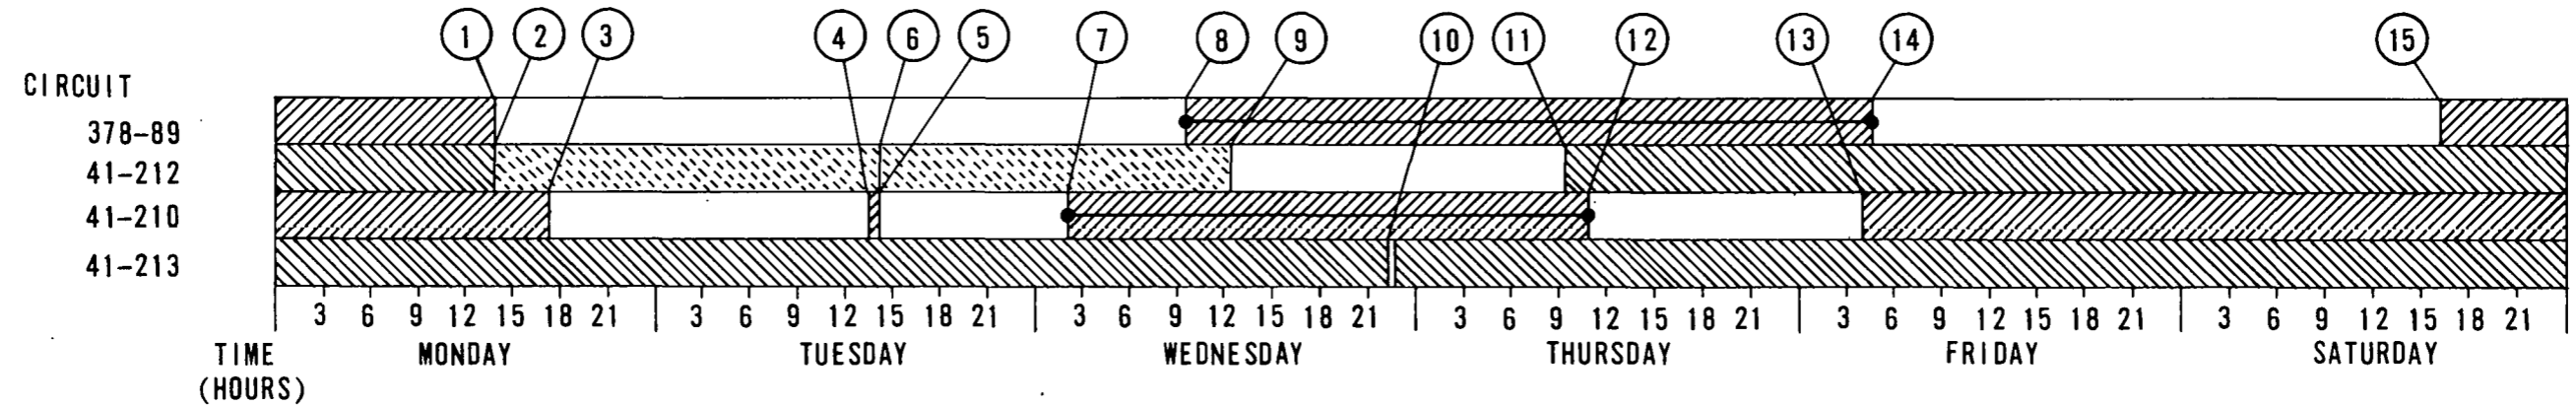
SEQUENCE OF EVENTS ON WELLESLEY SUPPLY LINES, JUNE 18-23, 1979

1. JOINT FAILS DUE TO PRESENCE OF MOISTURE (MH 3446)
2. ADJACENT CABLE DAMAGED BUT REMAINS IN SERVICE (MH 3446)
3. CABLE FAULT IN DUCT (MH 3443-18191)
4. TWO SECTIONS OF CABLE REPLACED AND CIRCUIT RE-ENERGIZED (MH 3443-18191-3444)

5. CABLE FAILS AT OLD CABLE END OF NEW JOINT (MH 3443)
6. ADJACENT JOINT SLEEVE DAMAGED BUT REMAINS IN SERVICE (MH 3443)
7. OVERGROUND JUMPER INSTALLED BY-PASSING MH 3443 (MH 3442-3443-18191)
