NUREG/CR-3562  
PNL-4629

# Steam Generator Tube Integrity Program Leak Rate Tests

## Progress Report

**Pacific Northwest Laboratory**  
Operated by  
Battelle Memorial Institute

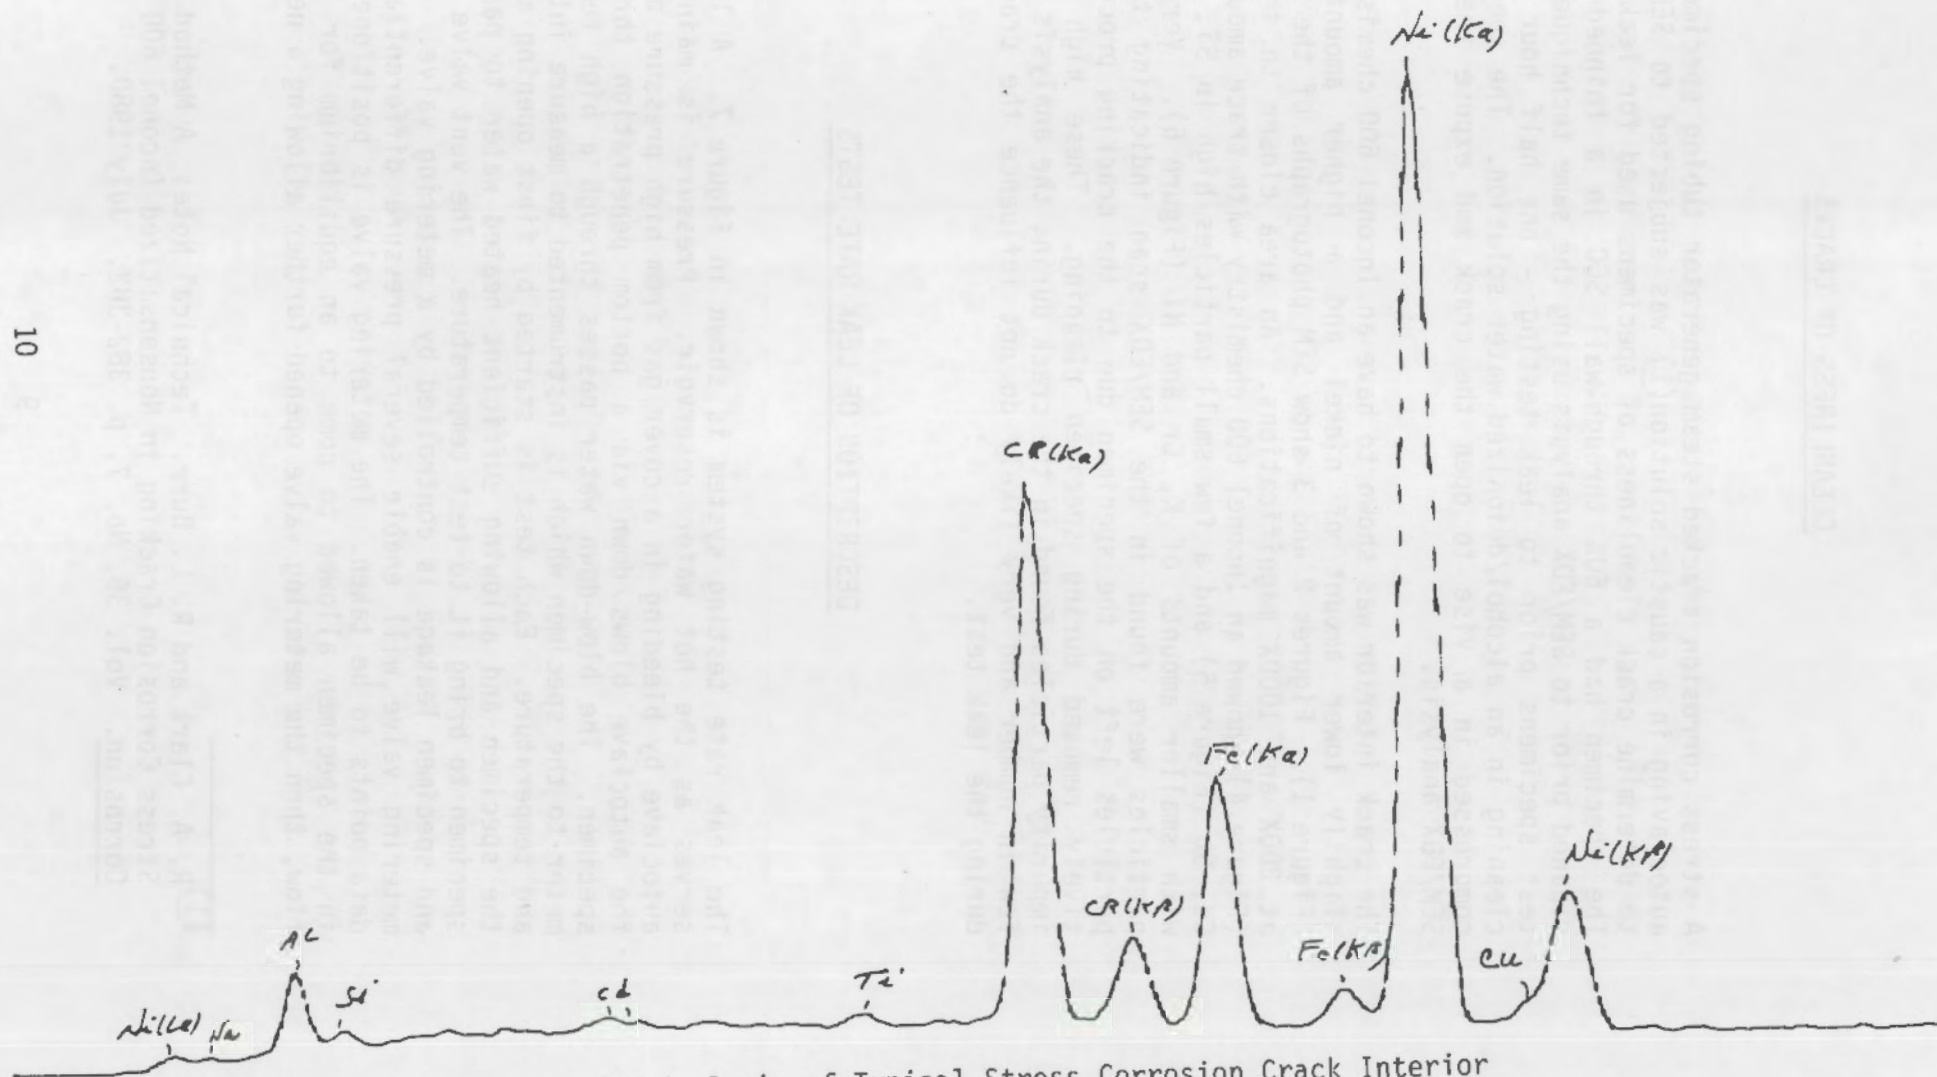
The crack interior was shown to have an Inconel 600 chemistry but with a slightly lower amount of nickel and a higher amount of aluminum (Figure 1). Figures 2 and 3 show SEM photographs of the crack interior at 200X and 1000X magnifications. An area closer to the crack mouth (Figure 4) showed an Inconel 600 chemistry with trace amounts of Al, Si, Cd, Sb (Figure 5) and a few small particles high in Si, Al, Ca and Fe with smaller amounts of K, Cr and Ni (Figure 6). Very few high Cu particles were found in the SEM/EDX scan indicating that excess Cu particles left on the specimen due to the cracking process are effectively removed during specimen cleaning. These high Cu and other impurity particles found in the crack during the analysis were small and few in number and very likely do not influence the crack propagation during the leak test.

FIGURE 1. EDX Analysis of Typical Stress Corrosion Crack Interior

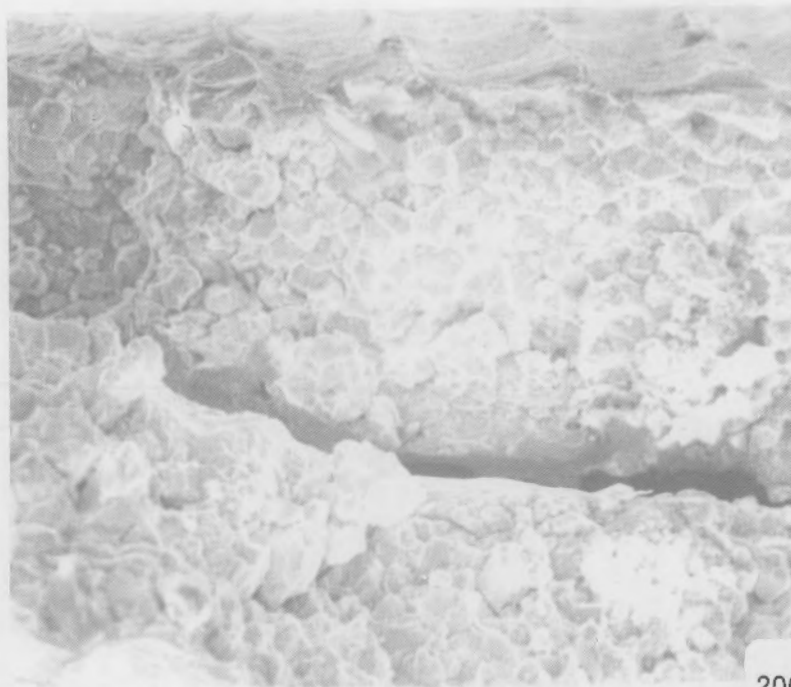
FIGURE 2. SEM Photograph Looking Down into Crack Mouth Showing Crack Interior

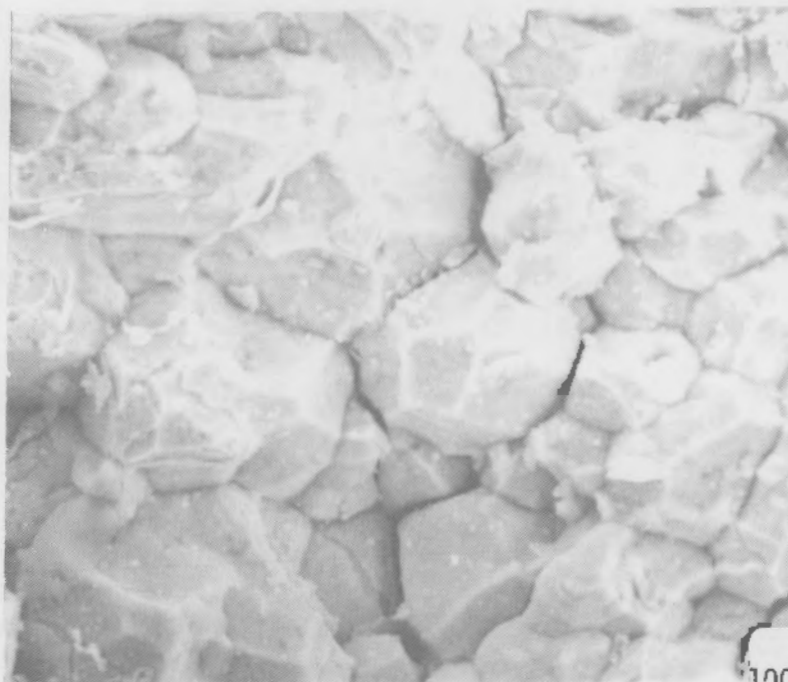
FIGURE 3. SEM Photograph - Close-up View of Interior Section Seen in Figure 2

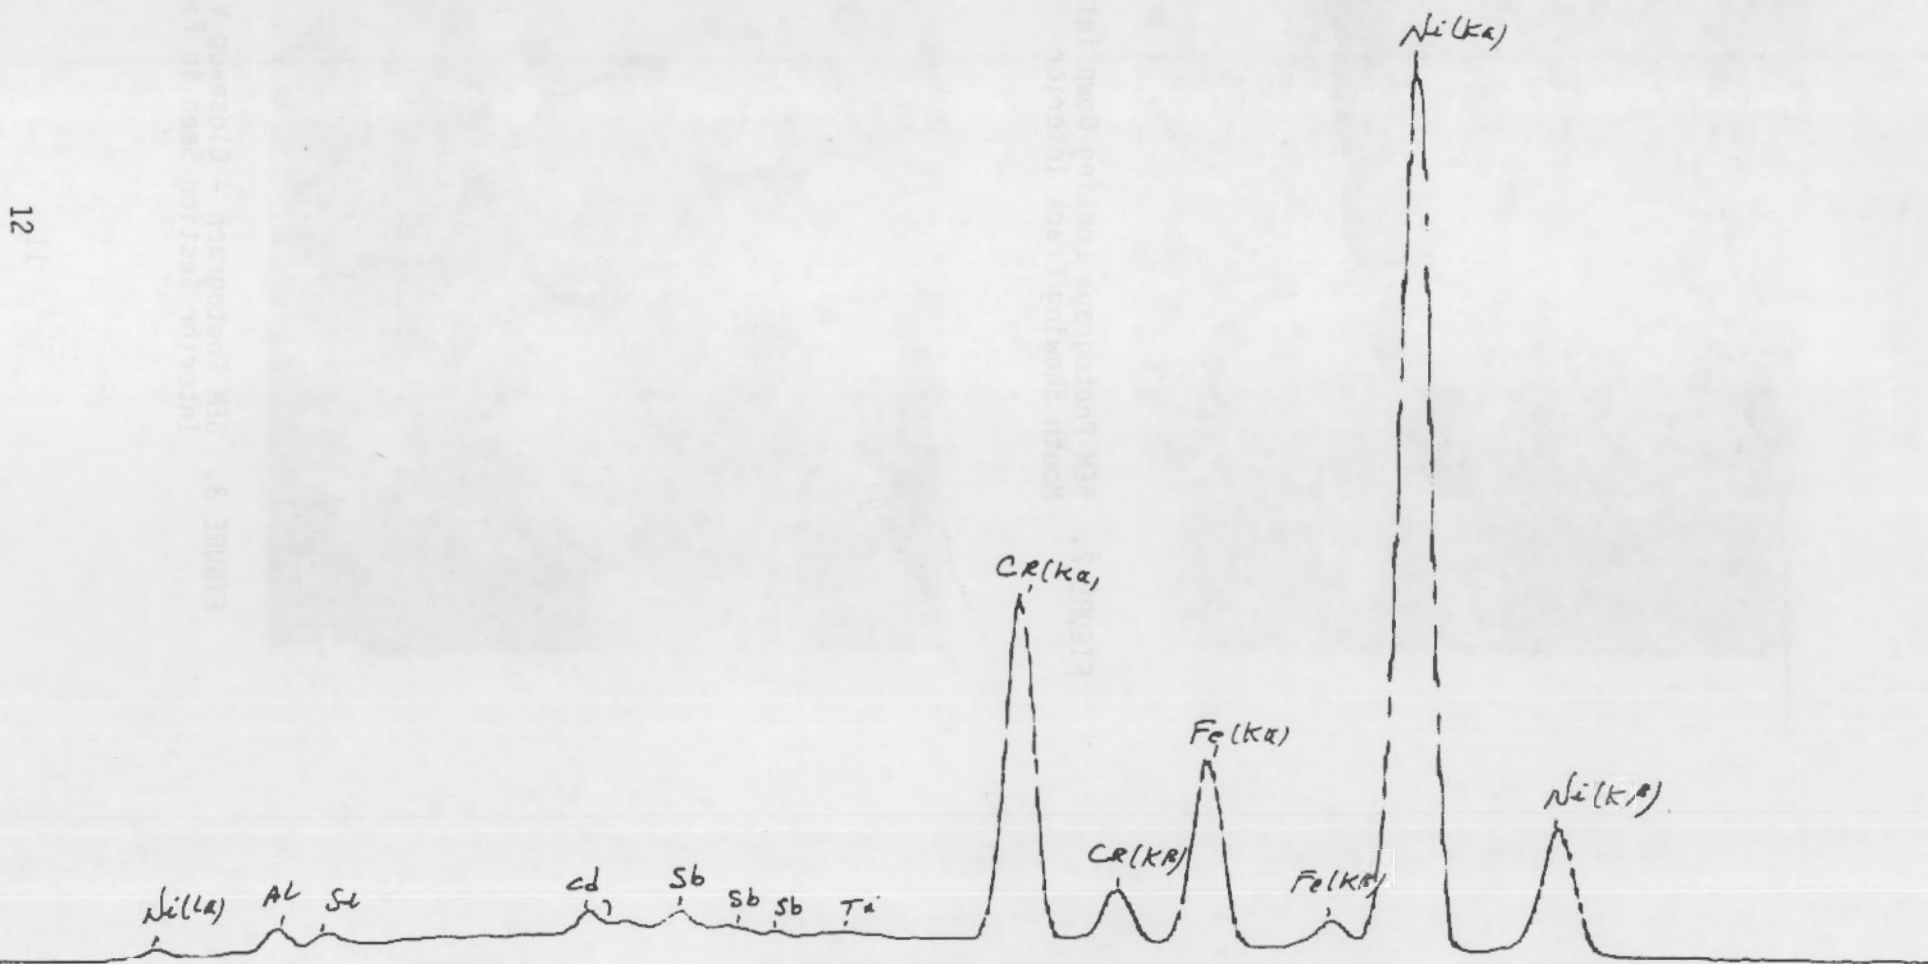
FIGURE 4. EDX Analysis of Area Near Crack Mouth Showing Trace Amounts of Al, Si, Cd, & Sb

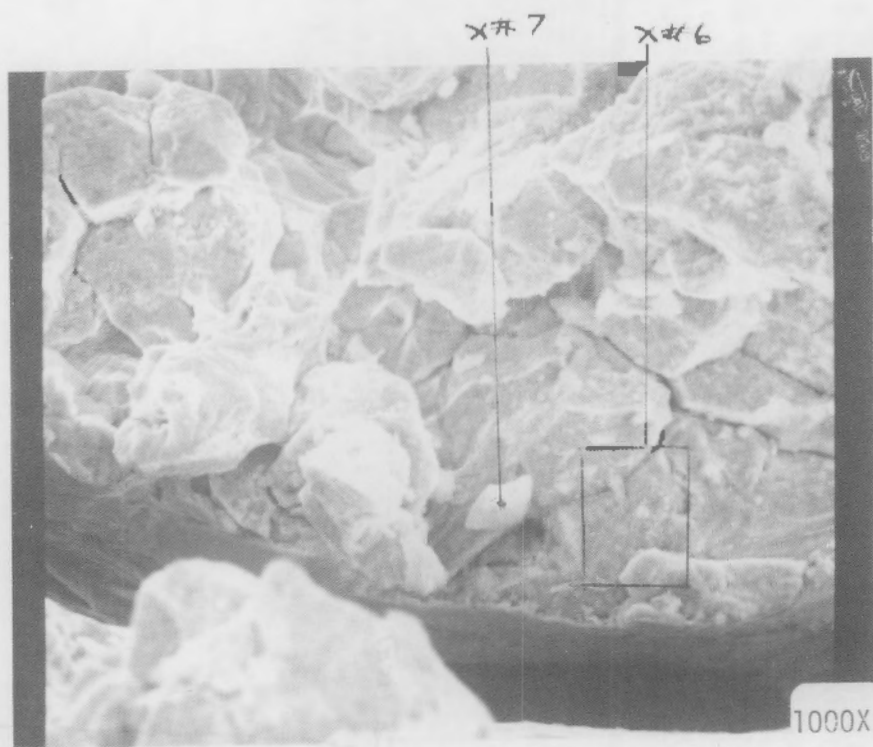
FIGURE 5. SEM Photograph of Area Near Crack Mouth. Impurity Particles Can be Seen.

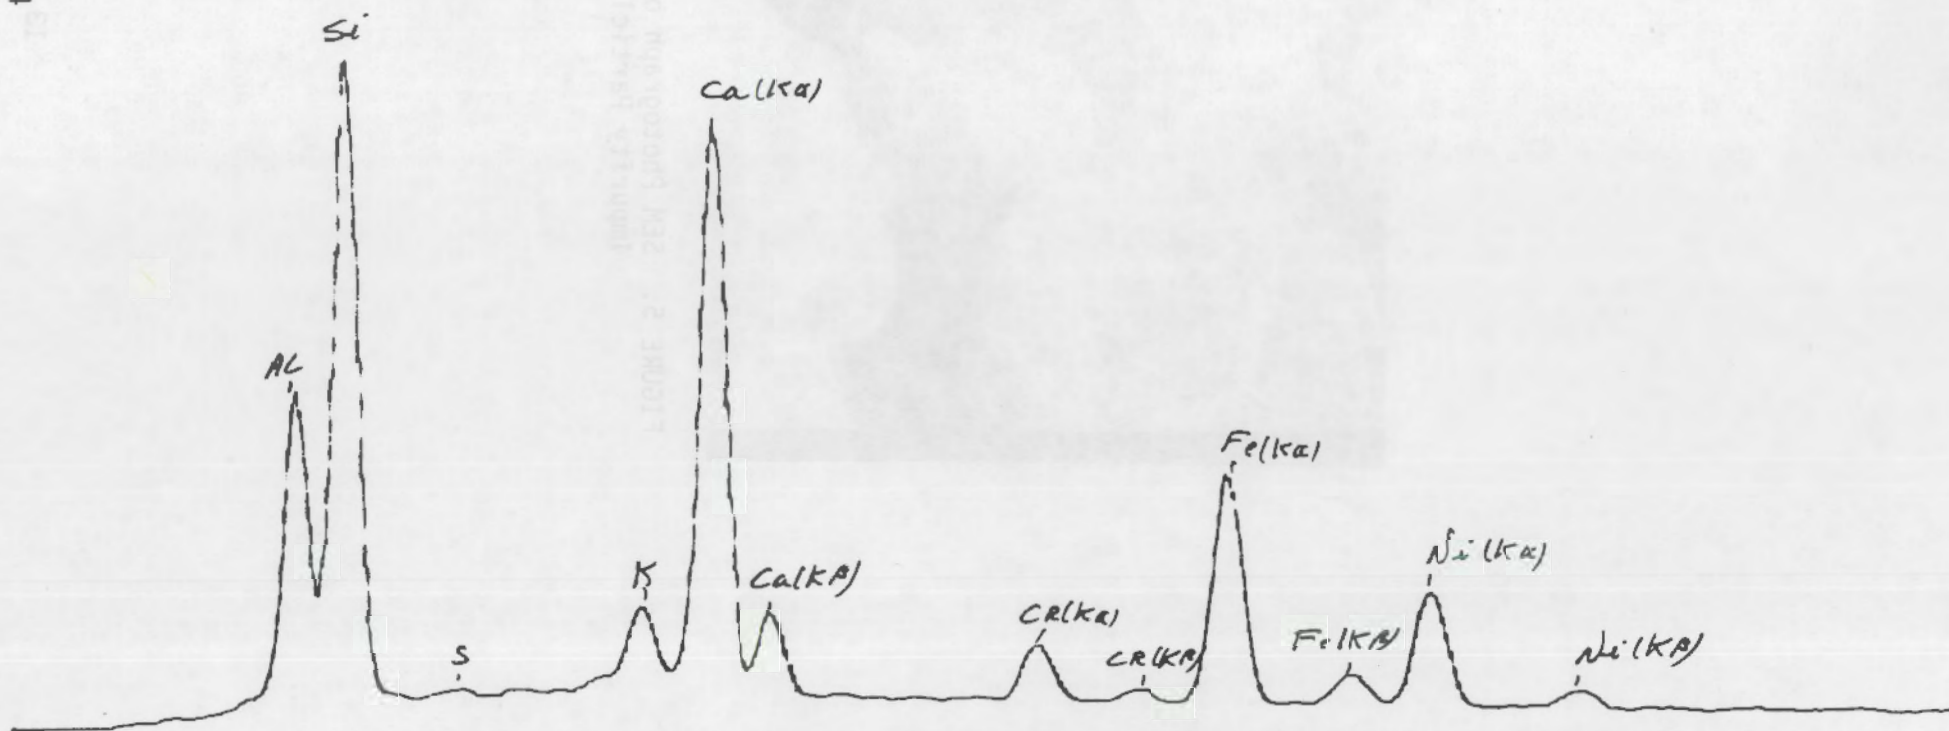
FIGURE 6. EDX Analysis of Impurity Particle Seen in Figure 5

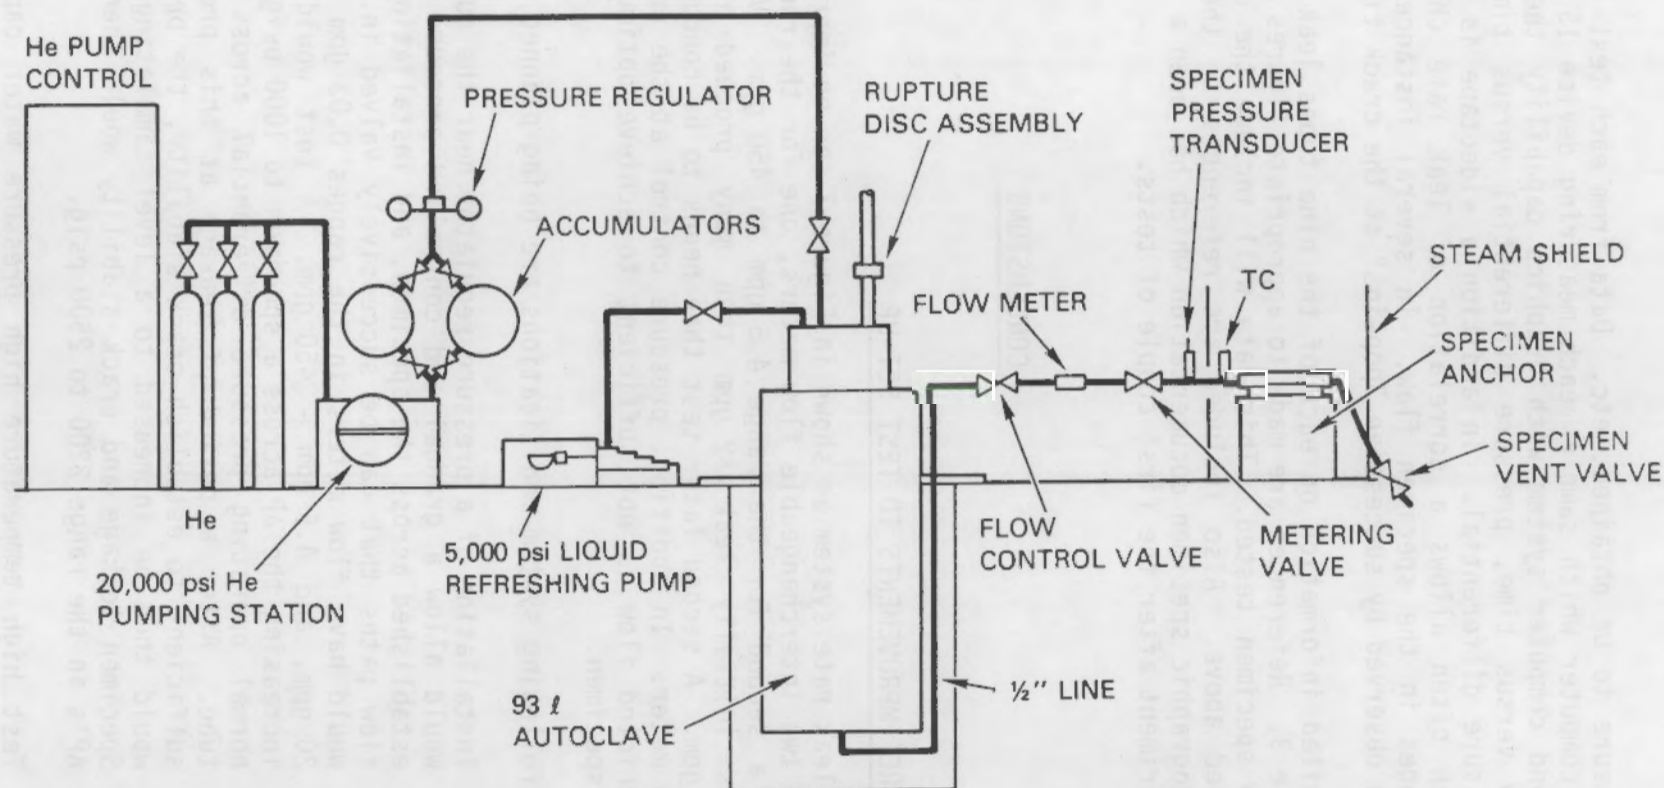
FIGURE 7. Schematic of Leak Rate Test Set-up

The leak rate testing system is shown in Figure 7. A large autoclave serves as the hot water reservoir. Pressure is maintained in the autoclave by bleeding in a cover gas from high pressure accumulators as the autoclave blows down via a bottom penetration through the test specimen. The blow-down water passes through a high temperature flow meter to the specimen which is instrumented to measure internal pressure and temperature. Each test is started by first opening a vent valve on the specimen and allowing sufficient heated water to pass through the specimen to bring it to test temperature. The vent valve is then closed and specimen leakage is controlled by a metering valve. In concept the metering valve will enable several pressure differential versus flow data points to be taken. The metering valve is positioned and pressure in the specimen allowed to come to an equilibrium for the particular flow, then the metering valve opened further allowing a new equilibrium

The leak rate system as shown in Figure 7 can be improved. Currently we have two interchangeable flow meters, one for the range 2 gpm to 20 gpm and a second for the range 4.5 gpm to 450 gpm. Virtually all tight SCC's initially leak <2 gpm then many proceed rapidly to leakage >20 gpm. A second later test then needs to be conducted using the high flow meter. In addition, pressure control at the specimen by means of restricted flow is not sufficient to achieve optimum information from the specimen.

- Installation of a pressure regulator near the autoclave source that would allow a gradual and controlled pressure differential to be established across the specimen, and installation of three parallel flow paths that can be successively valved in. These flow paths would have flow meters in the ranges 0.03 gpm - 3.0 gpm, 2 gpm - 20 gpm, and 4.5 gpm - 450 gpm. A test would be run by slowly increasing the  $\Delta P$  across a specimen to 1000 psig, approximating the normal operating pressure differential across a steam generator tube. After a period of leakage at this pressure differential sufficient to establish crack stability, the pressure differential would then be increased to a level simulating a MSLB condition. Specimen leakage and crack stability would then be determined for  $\Delta P$ 's in the range 2200 to 2500 psig.

- Test high temperature high pressure water capacity needs to be expanded to run longer tests for evaluation of crack stability.
- A larger capacity blower will be installed to keep the camera lens path clear of steam.

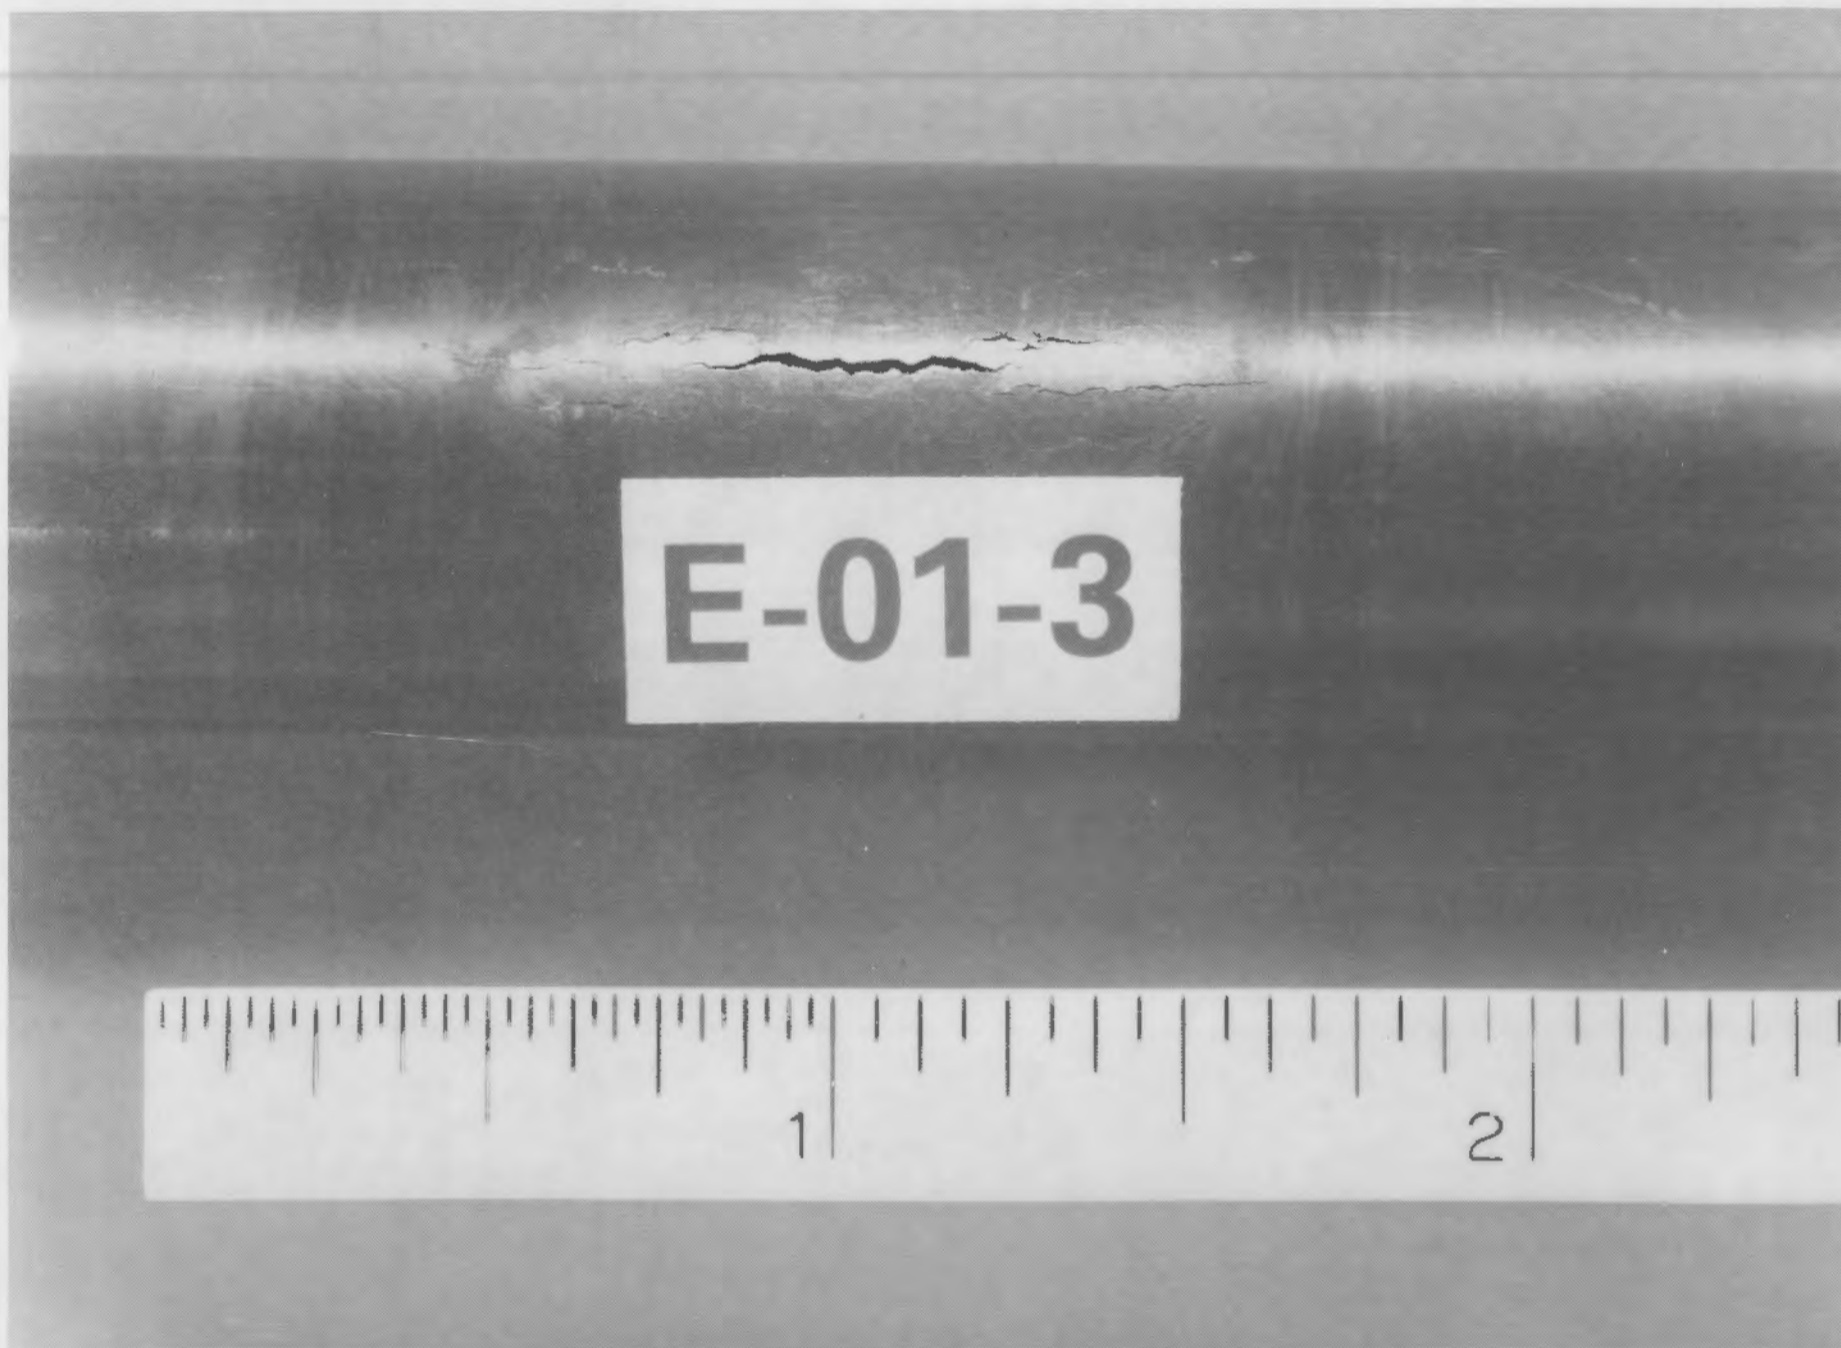
FIGURE 35. After Test Photograph of Specimen E01-3

- Computer data: Figures 8, 9 and 10.
- After test photograph: Figure 35.
- Eddy current before test: 100% through-wall crack.
- Visual inspection: No thinning, 3/8" long crack in center of exposed area.
- Testing: Flow remained <2 gpm although pressure ranged between 2700 and 2500 psig. Test ran for slightly over 2 minutes.
- Test results: Major crack opened slightly and length increased to 1/2". No substantial crack growth noted on videotape.

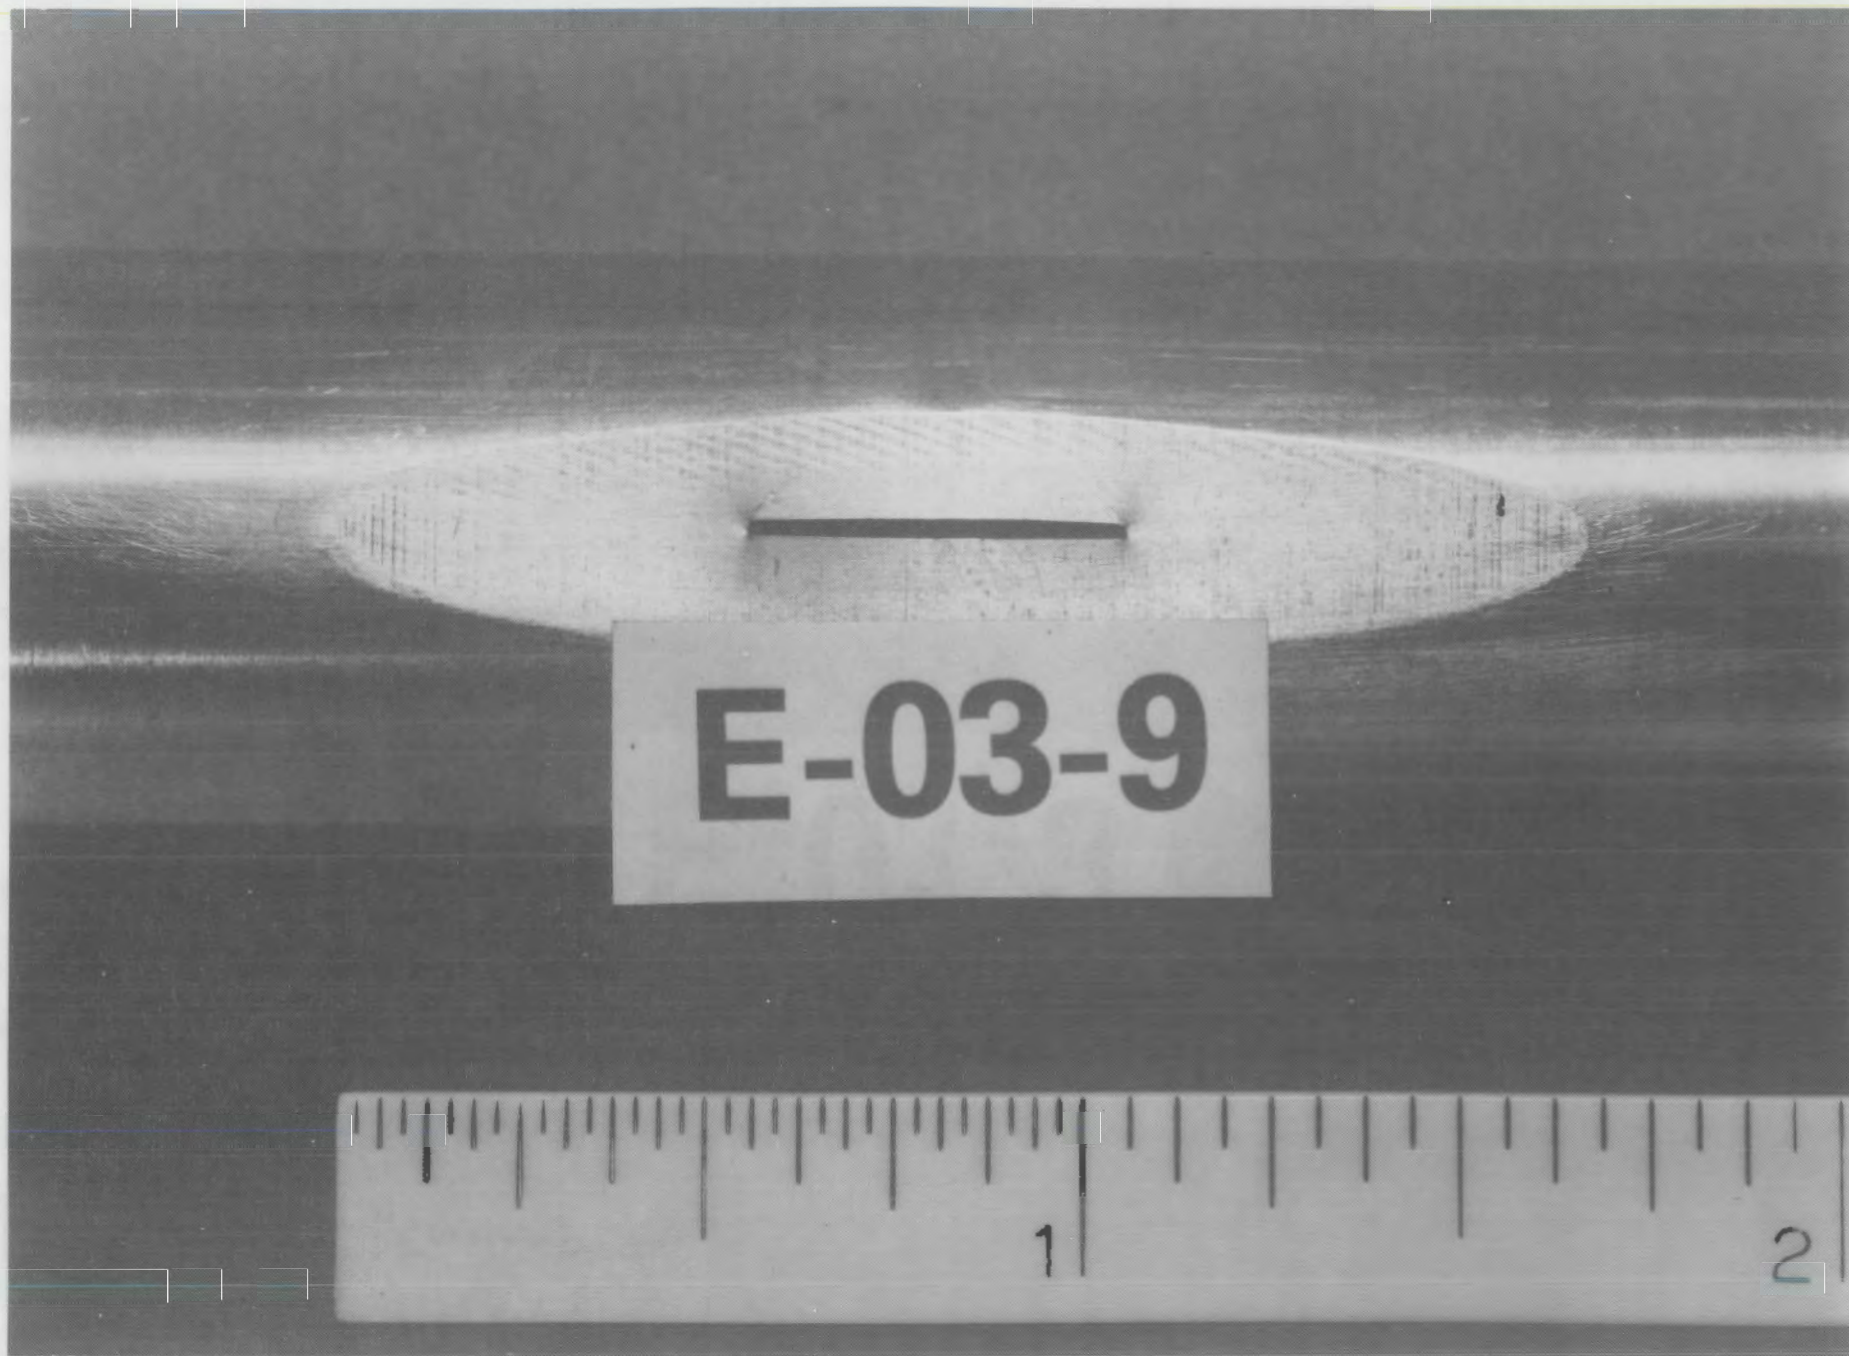
FIGURE 36. After Test Photograph of Specimen E03-9

- Computer data: Figures 11, 12 and 13.
- After test photograph: Figure 36.
- Visual inspection: 1/2" long EDM notch.
- Testing: Pressure built up to 500 psi and flow remained at <2 gpm for first 50 seconds of test. Then pressure increased in steps to a maximum of ~1700 psi while flow increased in steps to 10 gpm.
- Test results: Notch bulged slightly at both edges.

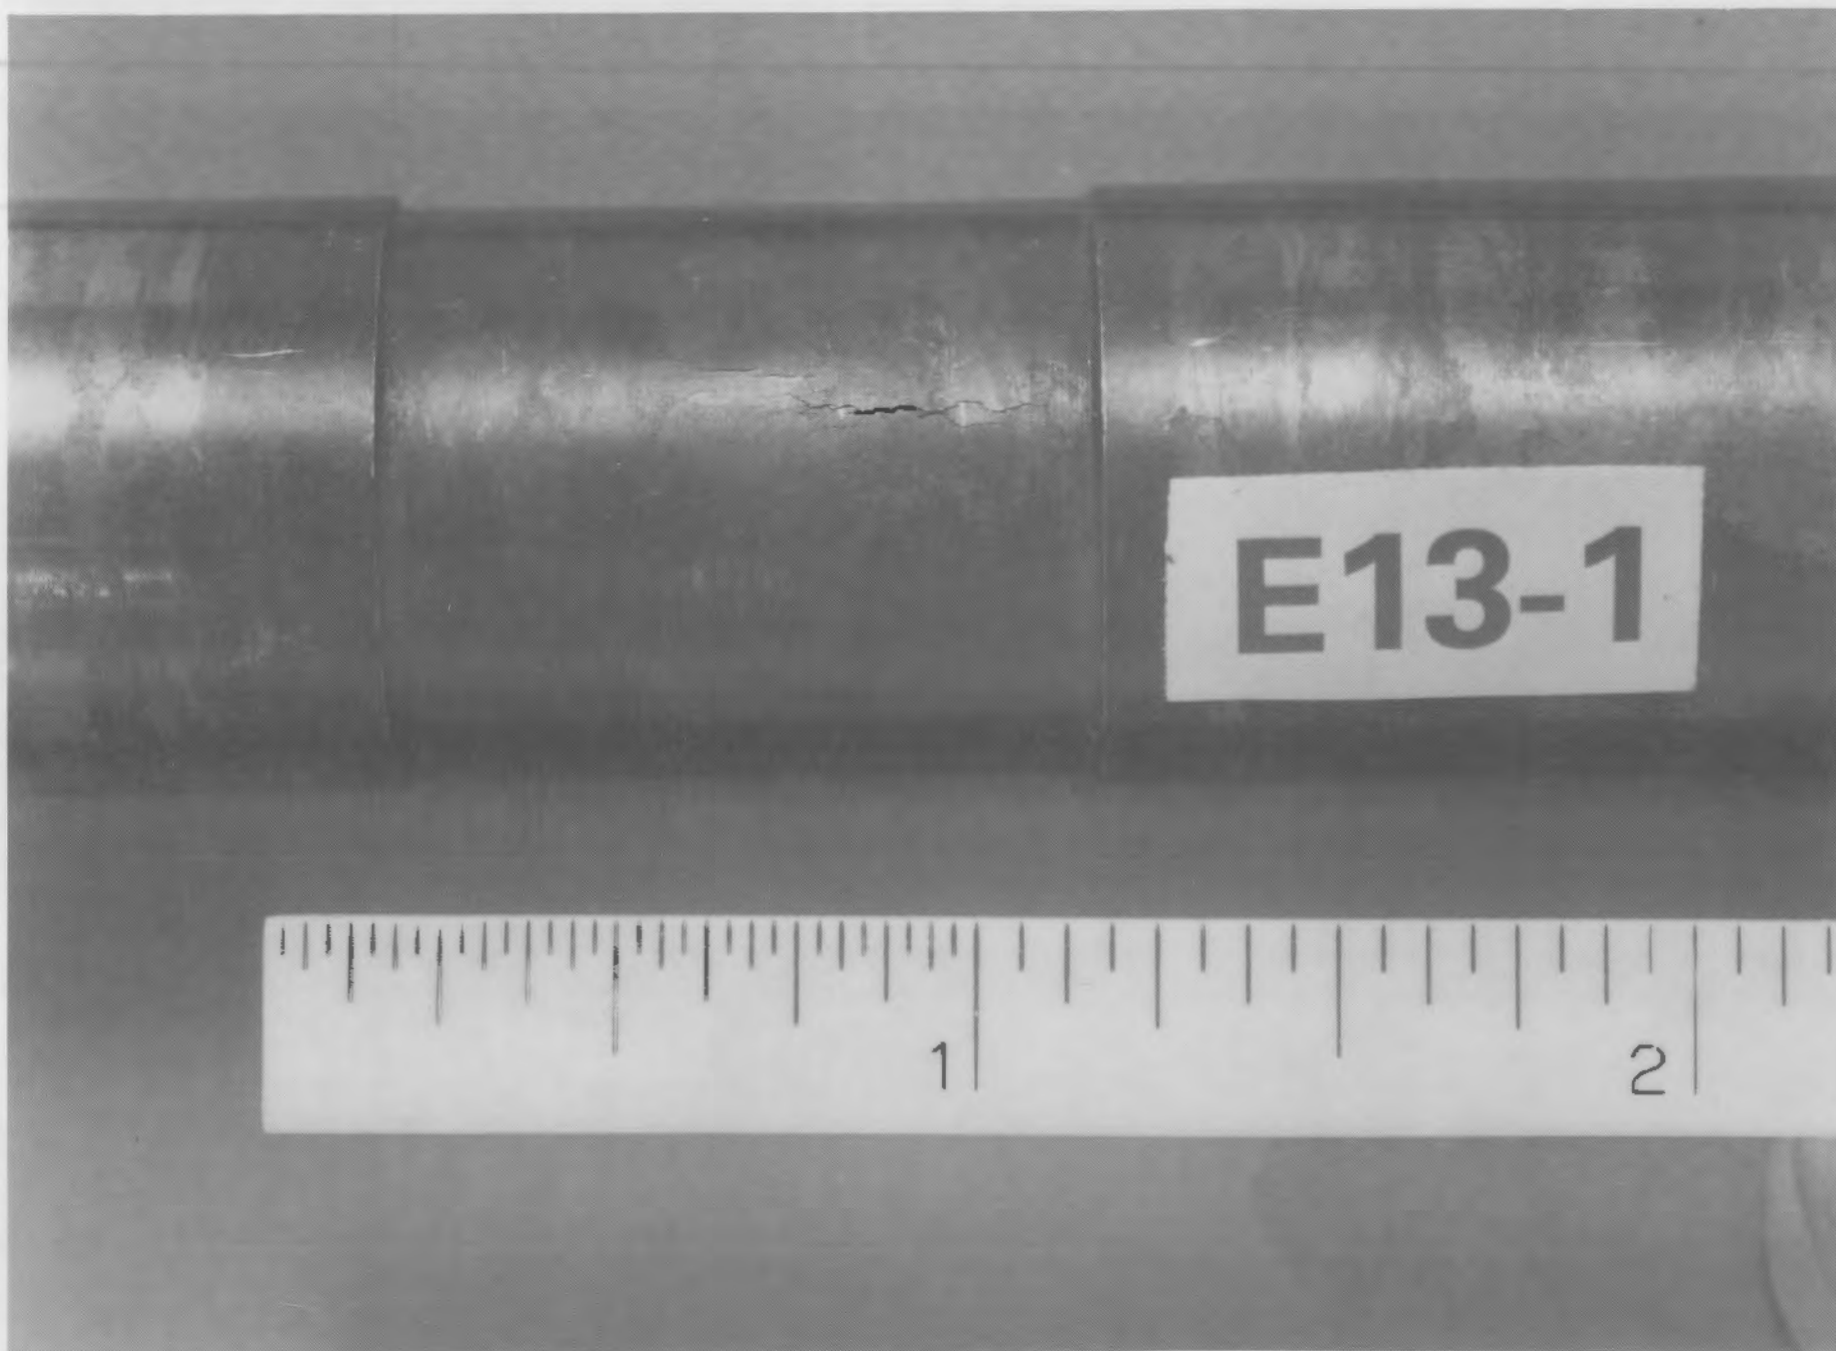
FIGURE 37. After Test Photograph of Specimen E13-1

- Visual inspection: 1" long thinned area, 40% thinning (60% of wall remaining), major crack ~1/4" long and towards one side of thinned area, several small shallow cracks in same area.

- Testing: On the first run, the control panel indicated that hot water never got to the specimen (this problem and action taken are discussed previously in this paper). Flow remained at <2 gpm and pressure was ~2700 psi. Test terminated after 2 minutes due to water temperature problem. The retest was run after the specimen drain valve was installed in the line. The pressure on the specimen remained at 2500 psi and flow was <2 gpm for ~70 seconds. Specimen then burst and flow increased to 20 gpm and pressure decreased to ~600 psi. Test remained running for 80 seconds. Flow vs. pressure plot for this run shows a nice curve.

- Testing results: Tube burst; length of crack increased to 6/10".

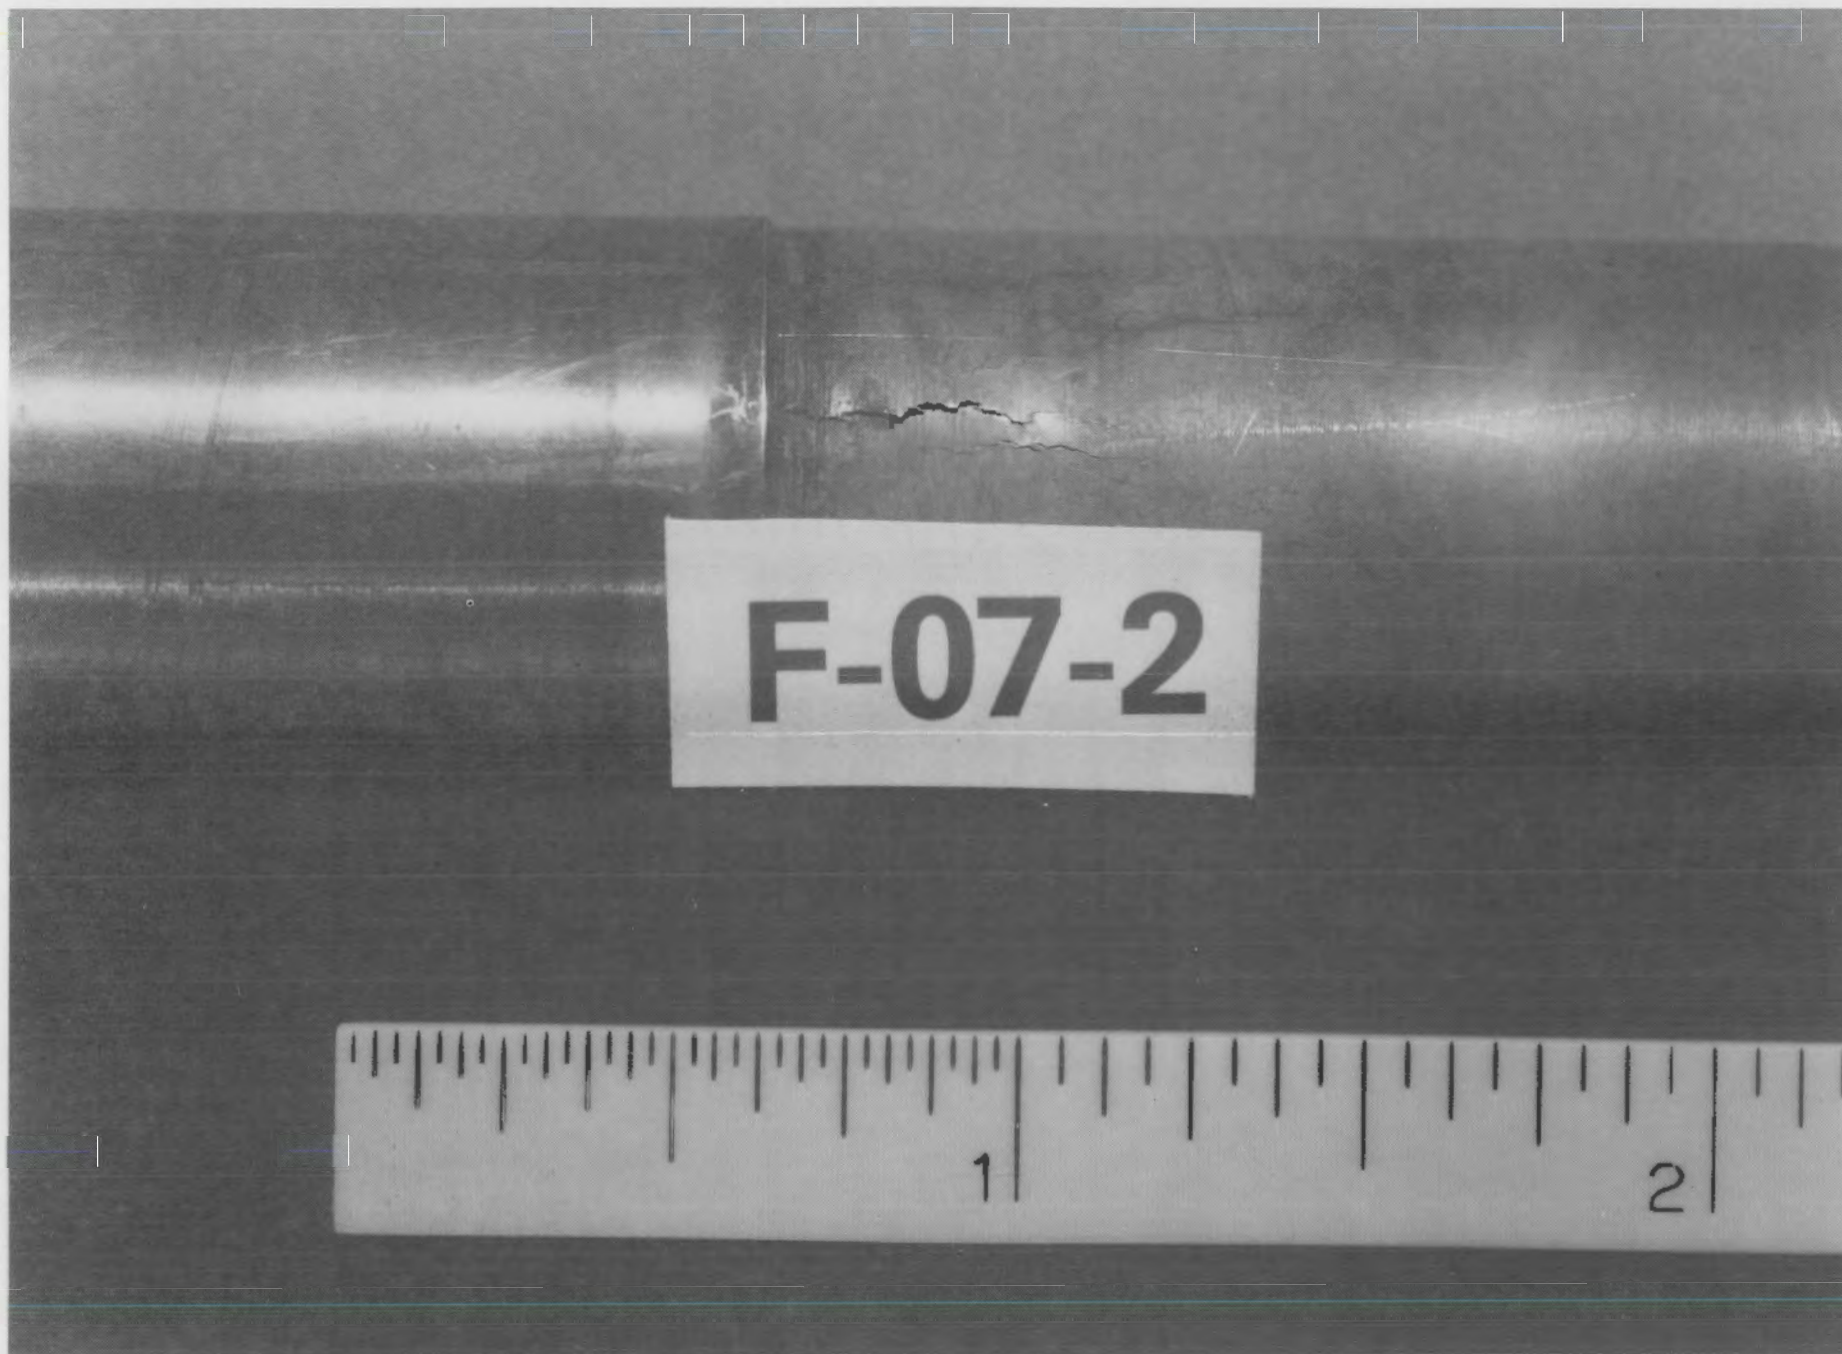
FIGURE 38. After Test Photograph of Specimen F-07-2

- Computer data: Figures 20, 21 and 22.
- After test photograph: Figure 38.
- Eddy current before test: Major crack ~90% through-wall.
- Visual inspection: 2" long thinned area, 40% thinning (60% of wall remaining), crack ~3/8" long - started at very edge of thinned area.
- Testing: Flow remained at <2 gpm for 10 seconds then increased to 4 gpm until test was terminated. Pressure started out at ~2300 and decreased to ~1750 psi when 4 gpm flow started. Test lasted for 150 seconds.
- Test results: Length of crack grew to 6/10" and opened up slightly.

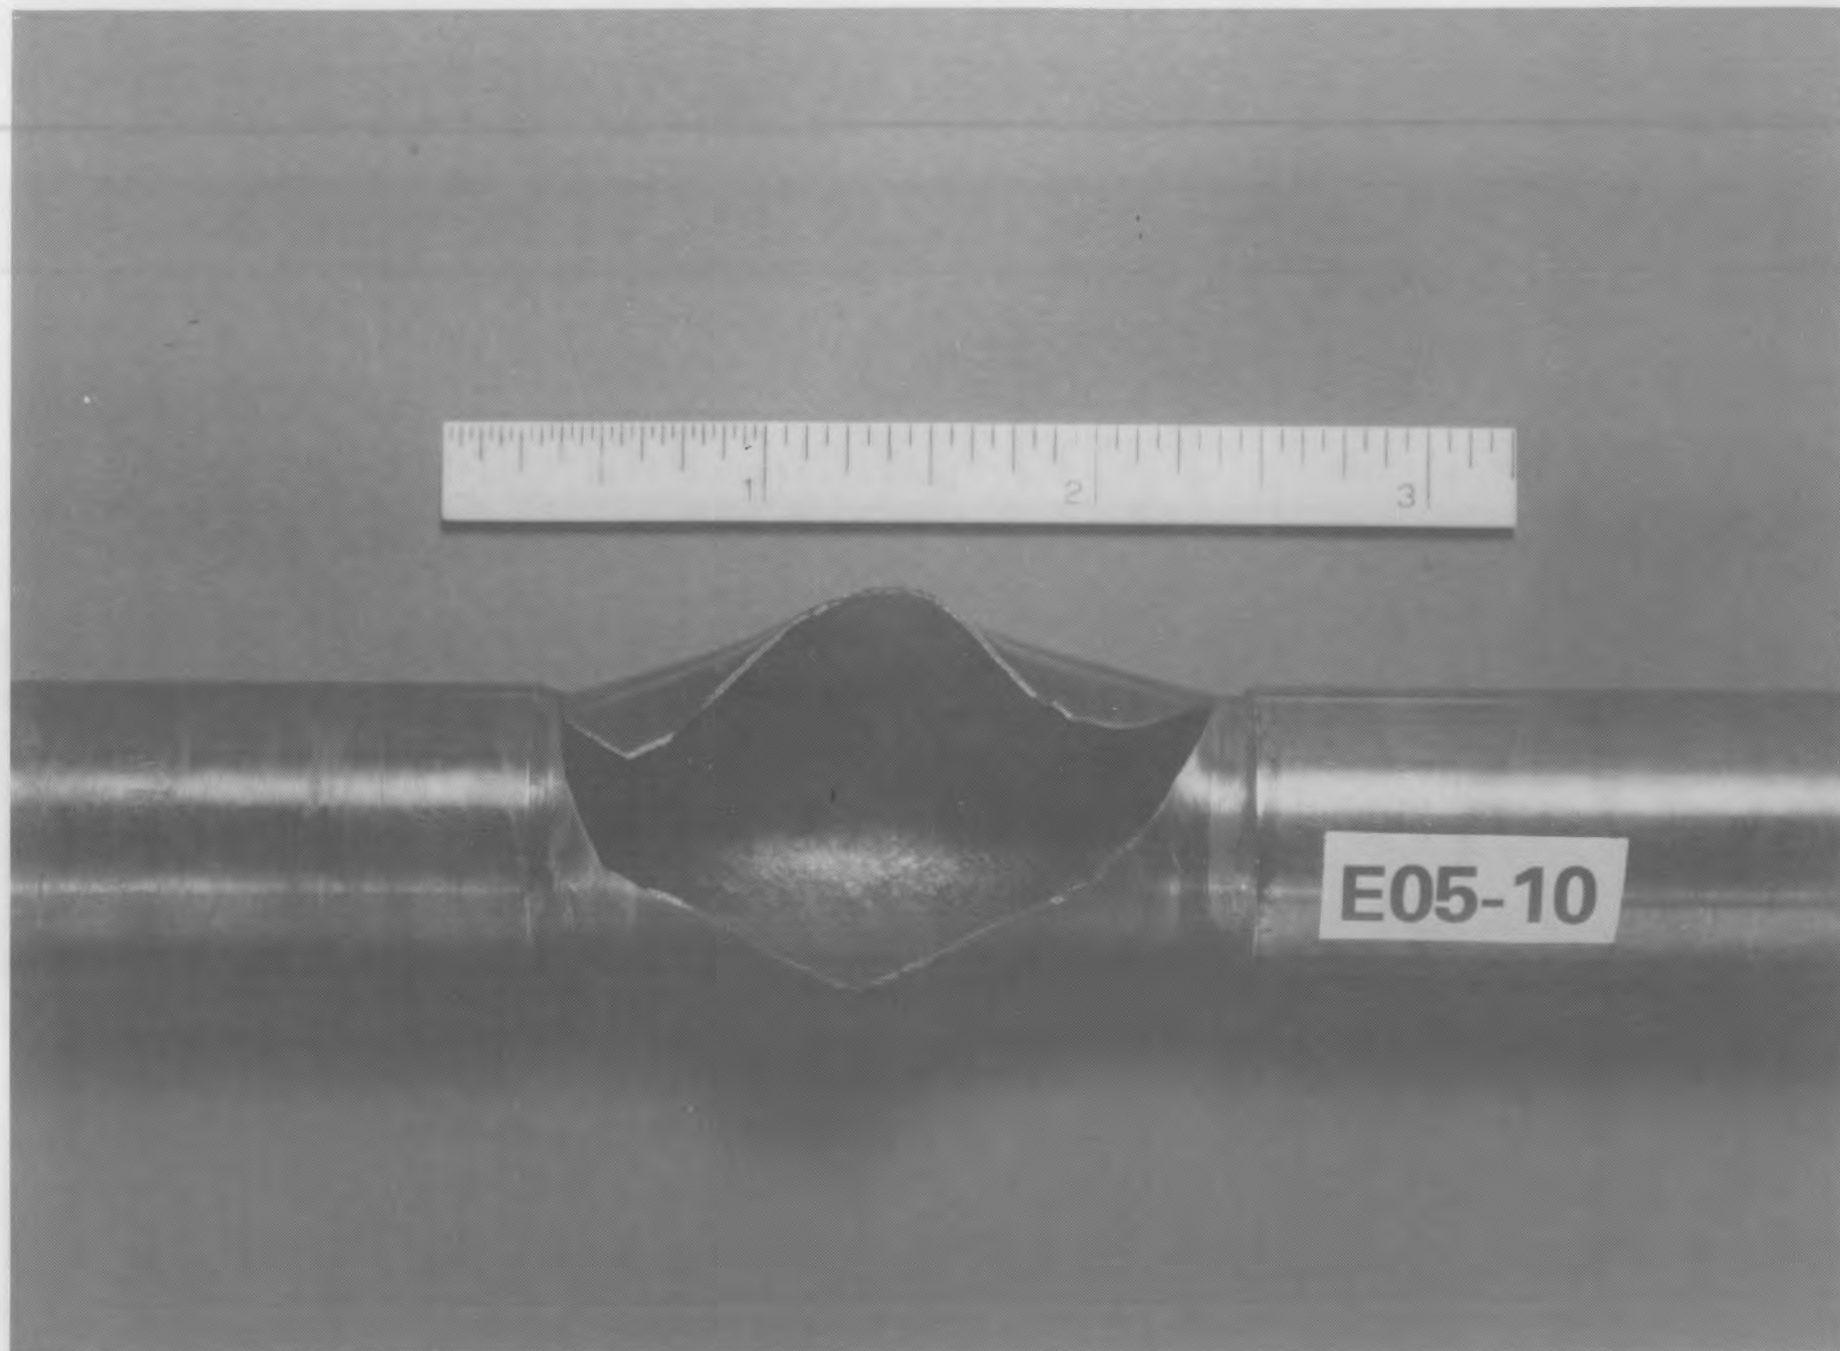
FIGURE 39. After Test Photograph of Specimen E05-10

- Computer data: No computer data due to computer problem developed after test initiation.
- After test photograph: Figure 39.
- Eddy current before test: One crack 100% through-wall.
- Visual inspection: 2" long thinned area, 60% thinning (40% of wall remaining), 7/16" long crack in center of thinned area.
- Testing: No computer results however instrument panel indicated pressure began at ~2500 psi and specimen burst immediately. Flow meter was pegged at 100% (20 gpm).
- Testing results: Specimen burst wide open over almost entire length of thinned area. Small amounts of crack growth could be seen on videotape before bursting occurred.
