NUREG/CR-3562  
PNL-4629

# Steam Generator Tube Integrity Program Leak Rate Tests

## Progress Report

**Pacific Northwest Laboratory**  
Operated by  
Battelle Memorial Institute

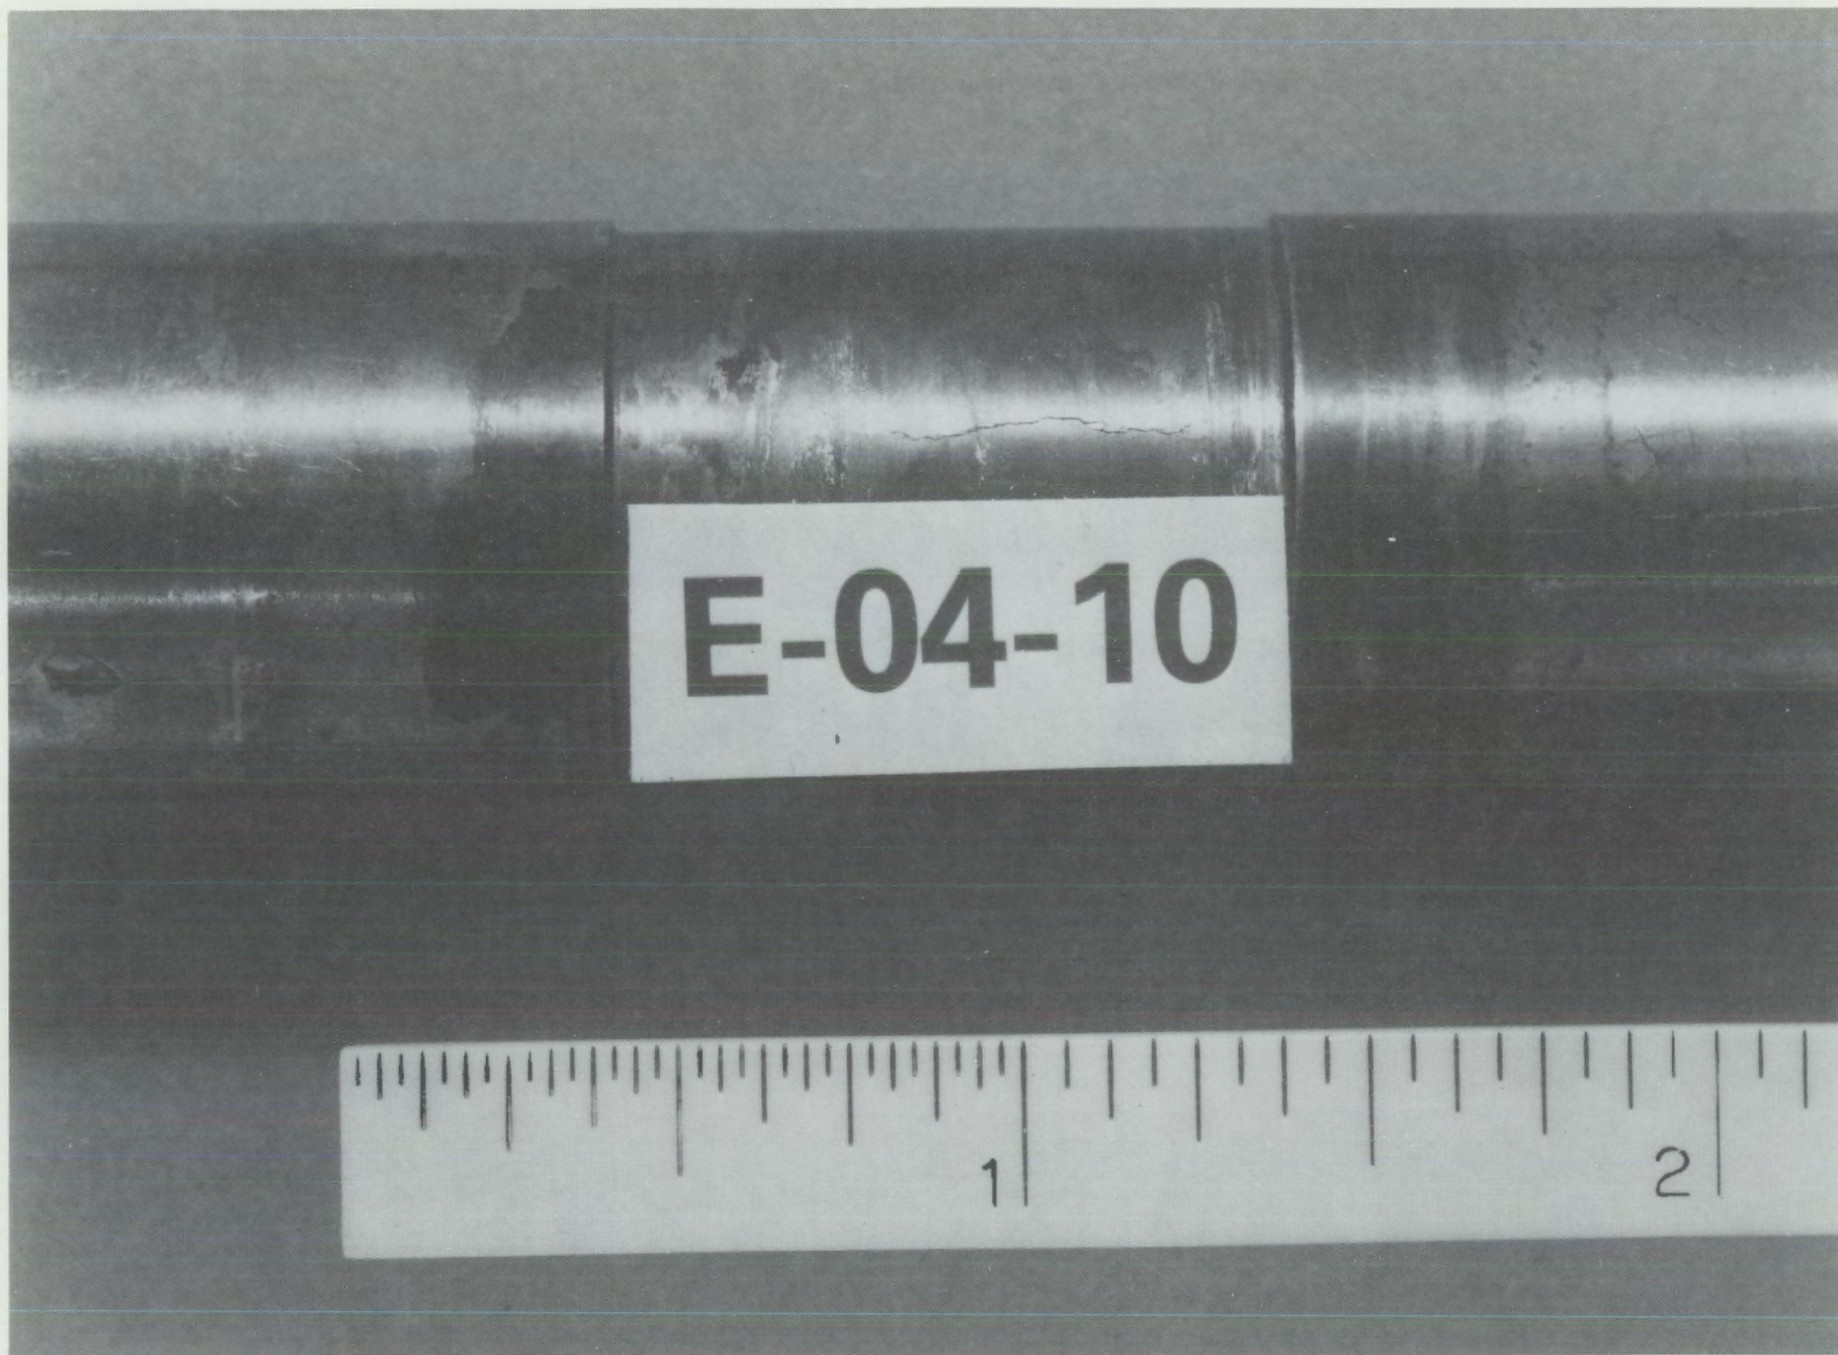
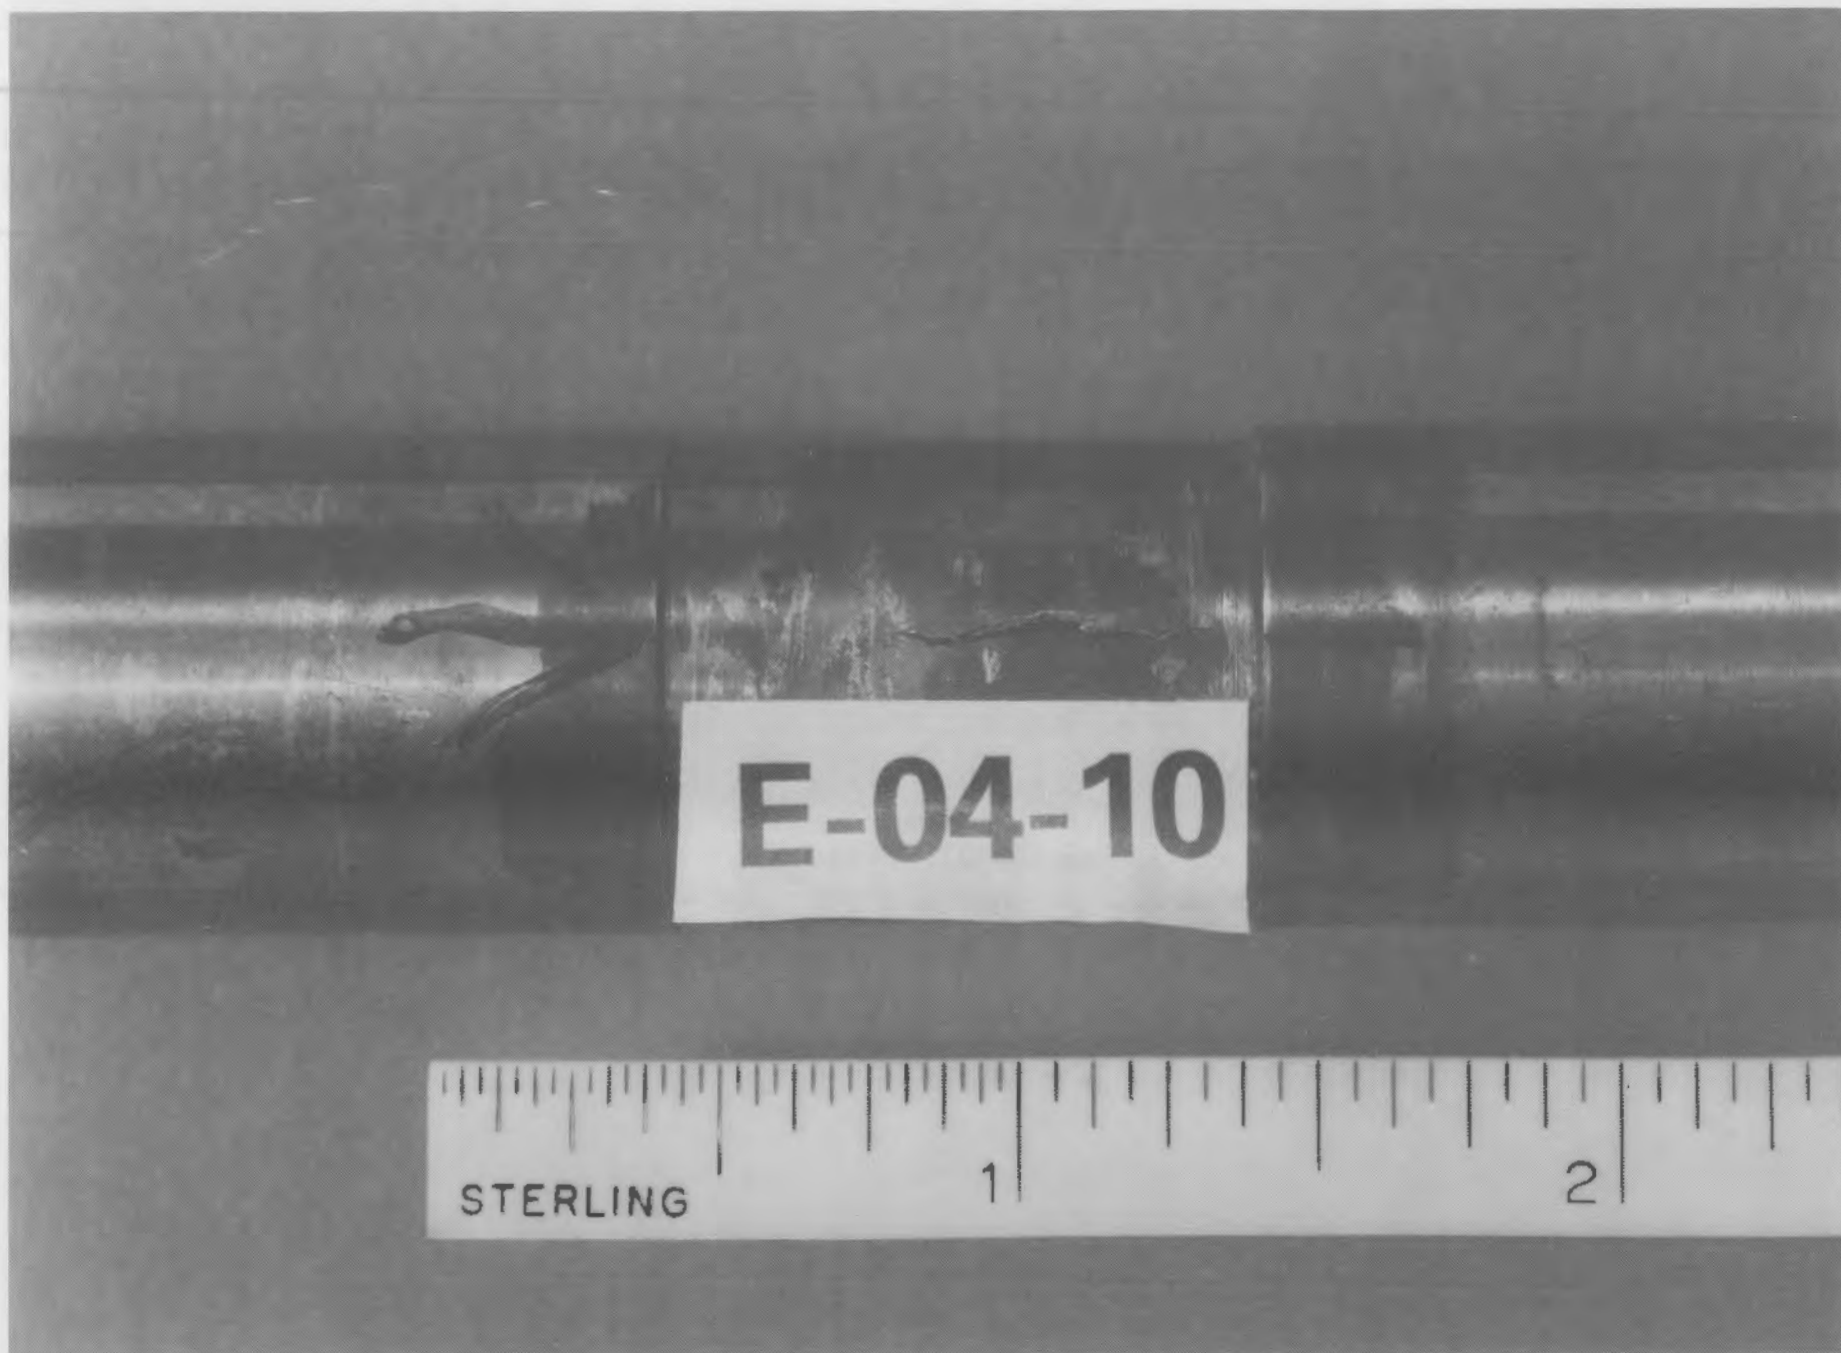
- Computer data: Figures 23, 24 and 25.
- Before and after photographs: Figures 40 and 41.
- Eddy current before test: 90% through-wall - 2 indications.
- Visual inspection: 1" long thinned area, 40% thinned (60% of wall remaining) 1/2" long crack running towards one side of thinned area.
- Testing: Pressure was not applied to specimen until ~25 seconds into the test. Pressure started out then to be 1000 psi and flow increased from <2 gpm to 7 gpm. Test ran for 60 seconds after maximum flow.
- Test results: Crack opened up over its entire length but did not burst.

FIGURE 40. Before Test Photograph of Specimen E-04-10

FIGURE 41. After Test Photograph of Specimen E04-10

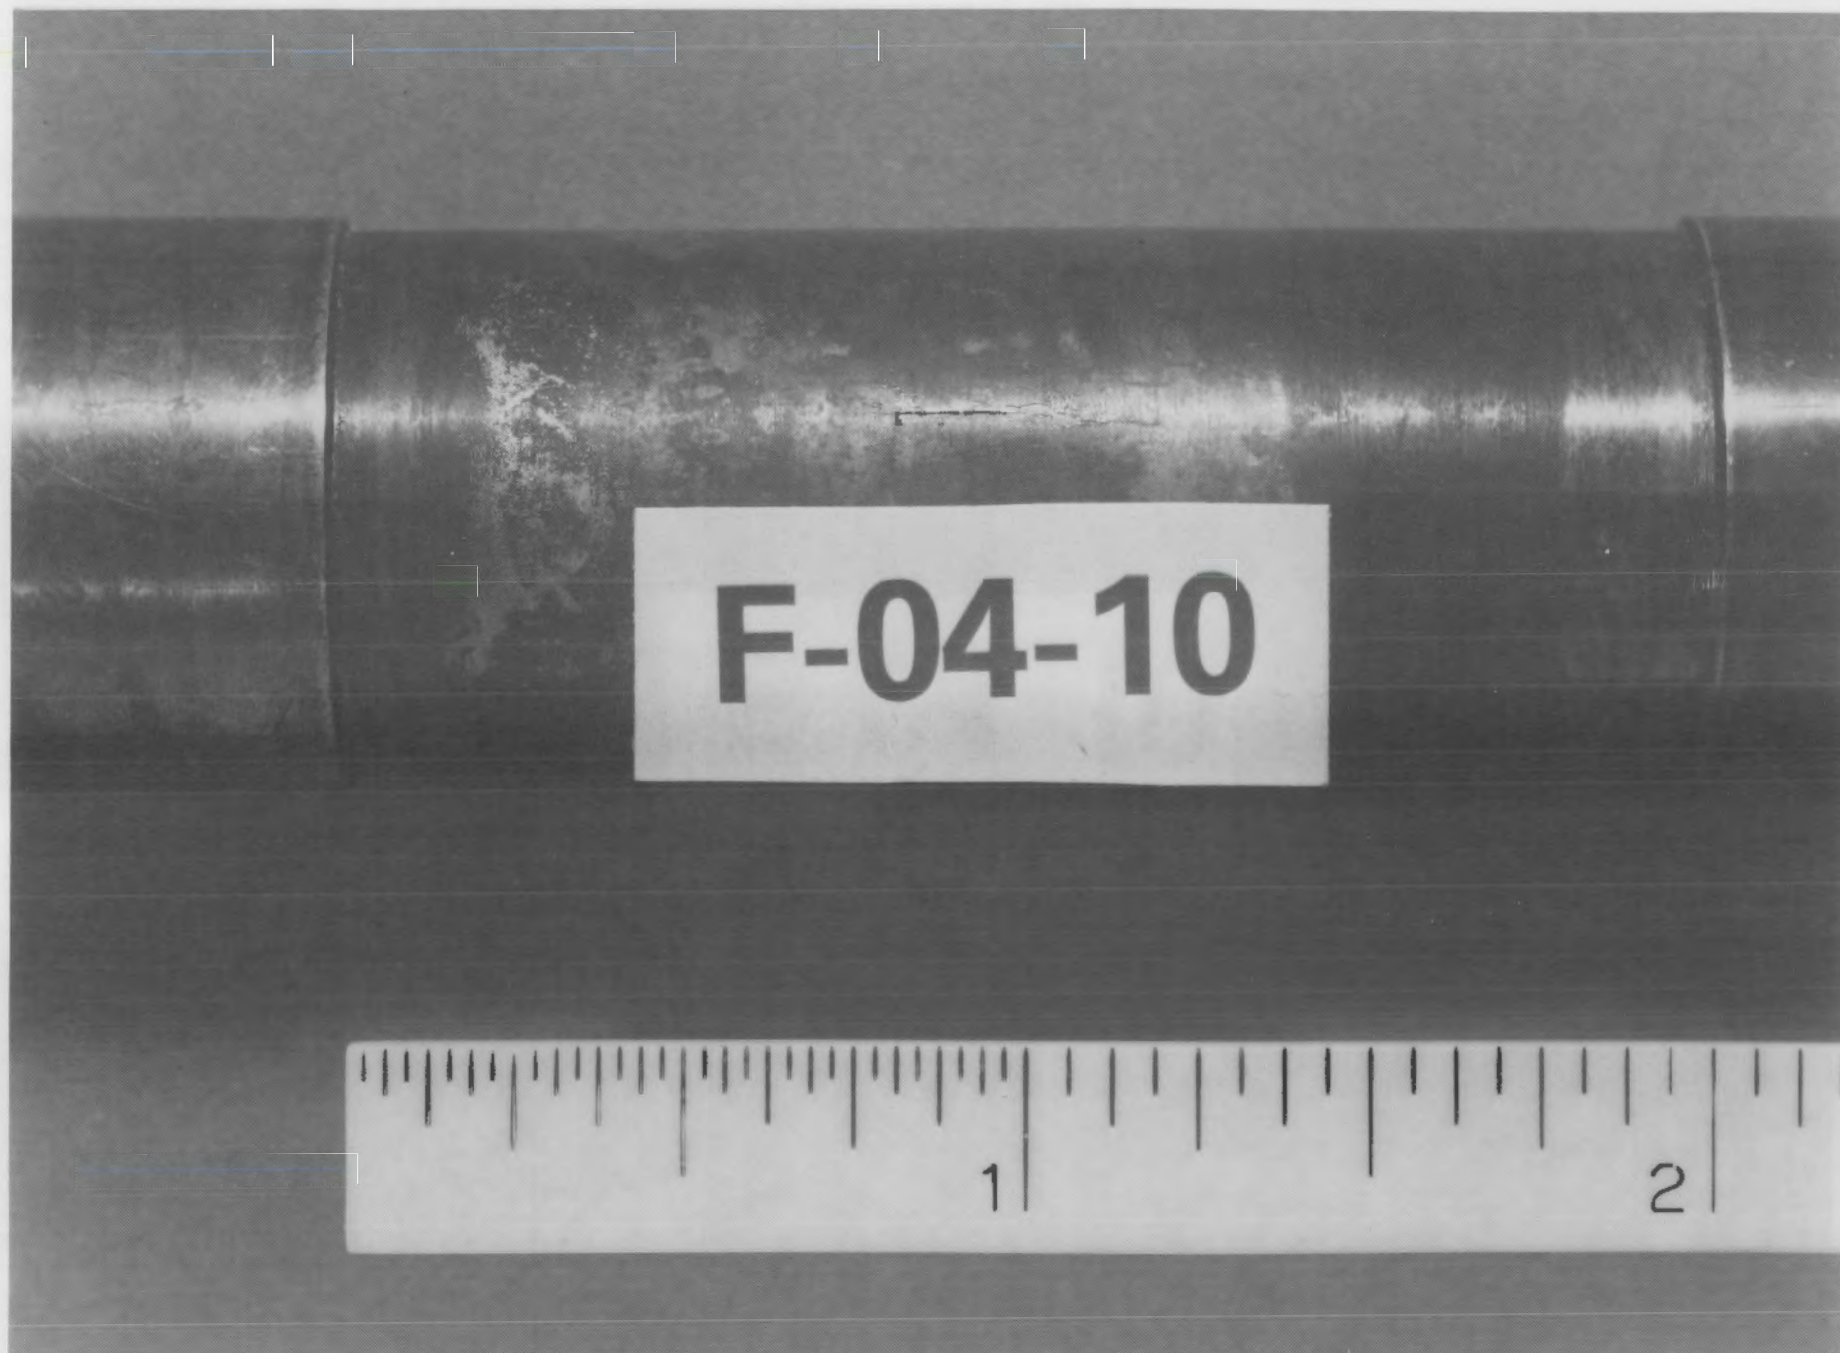
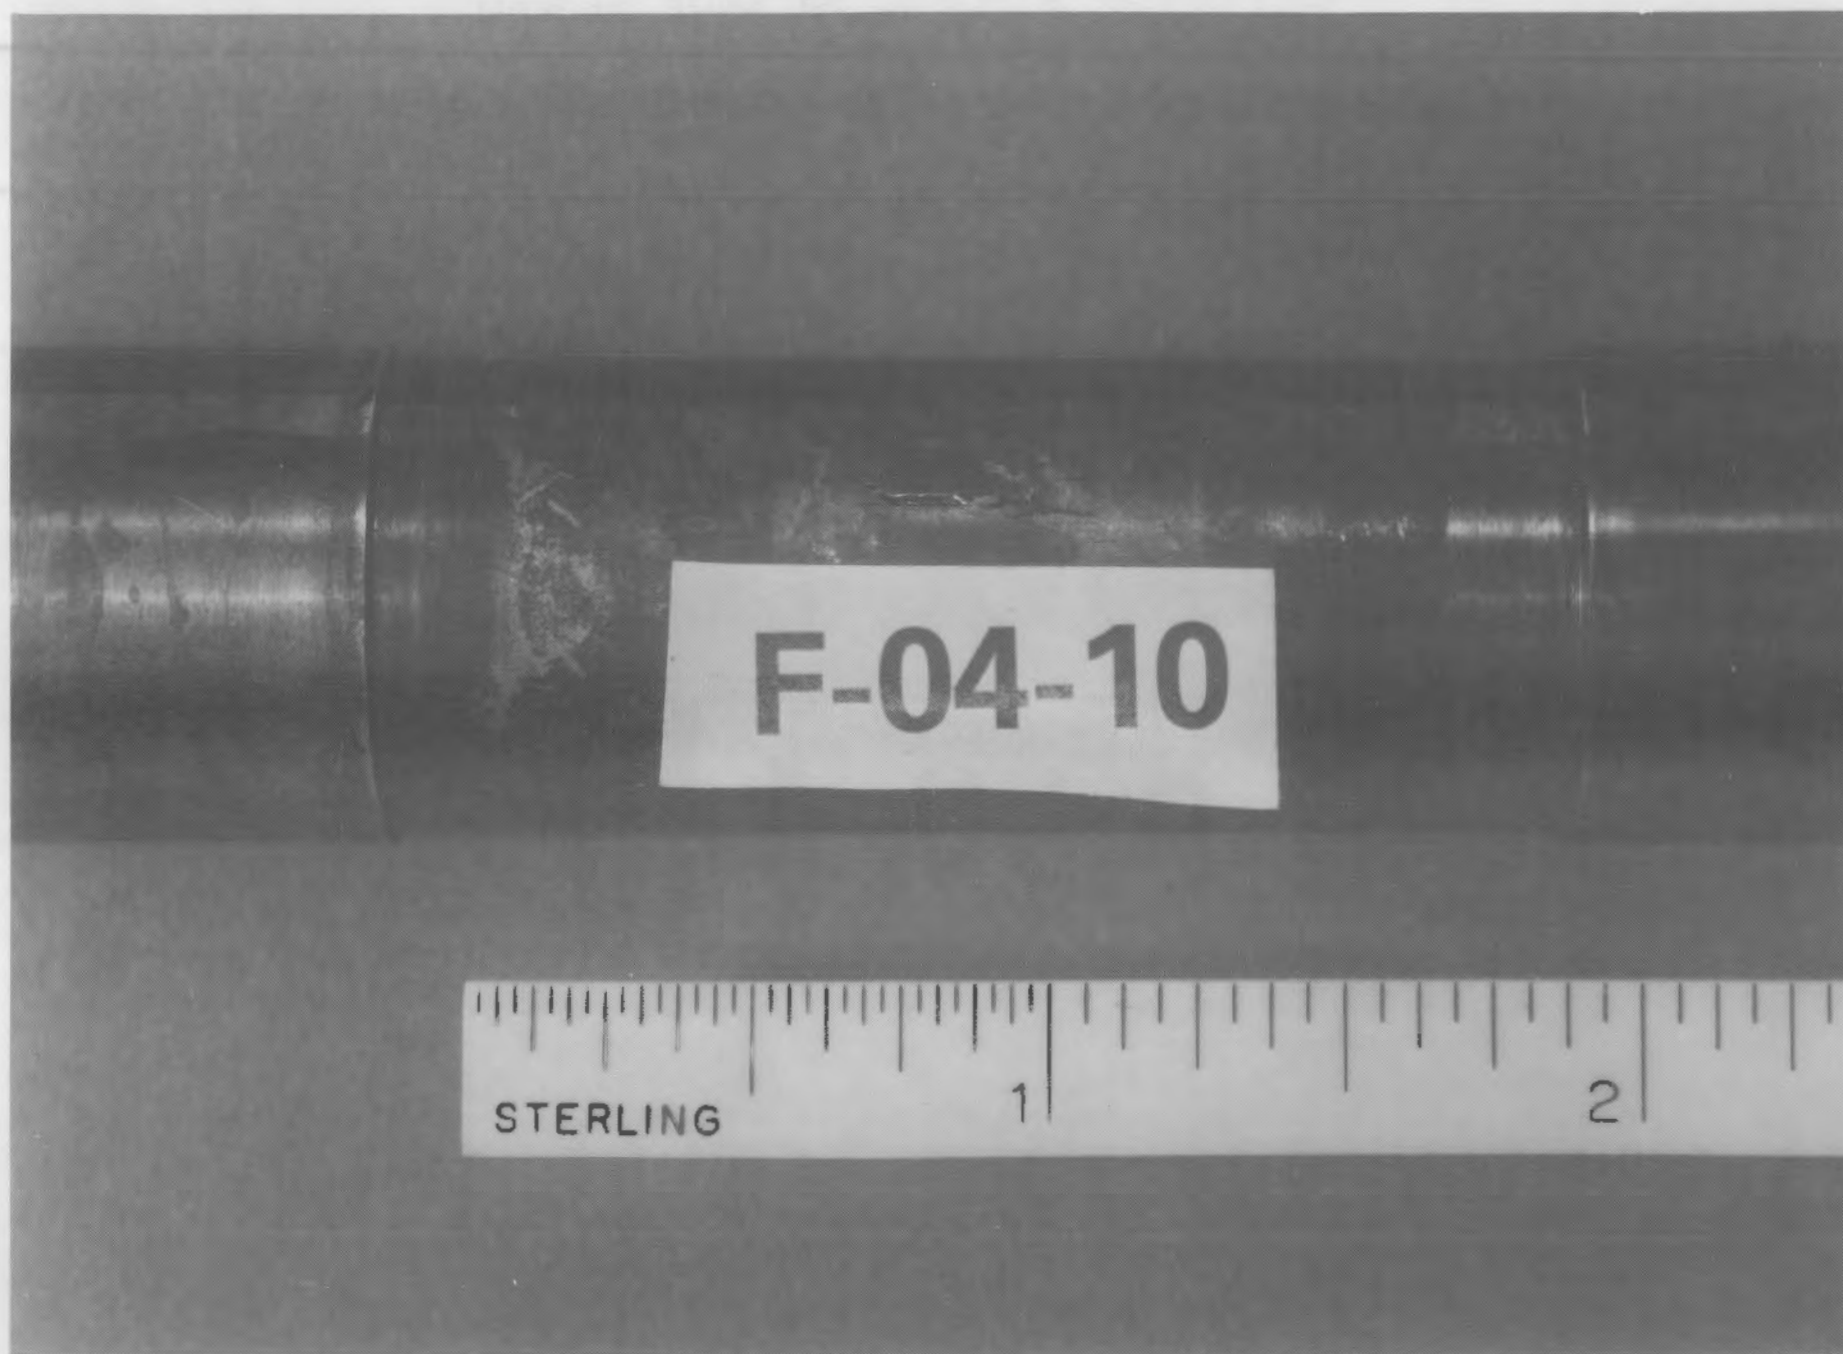
- Computer data: No computer data due to computer problem developed after test initiation.
- Before and after photographs: Figures 42 and 43.
- Eddy current before test: One crack 90% through-wall.
- Visual inspection: 2" long thinned area, 40% thinning, 1/2" crack in center of thinned area.
- Testing: All data was obtained from control panels. Pressure remained at 2400 psi and flow was <2 gpm for entire test. Test lasted 80 seconds.
- Test results: Crack opened up slightly but flow never increased over <2 gpm.

FIGURE 42. Before Test Photograph of Specimen F04-10

FIGURE 43. After Test Photograph of Specimen F04-10

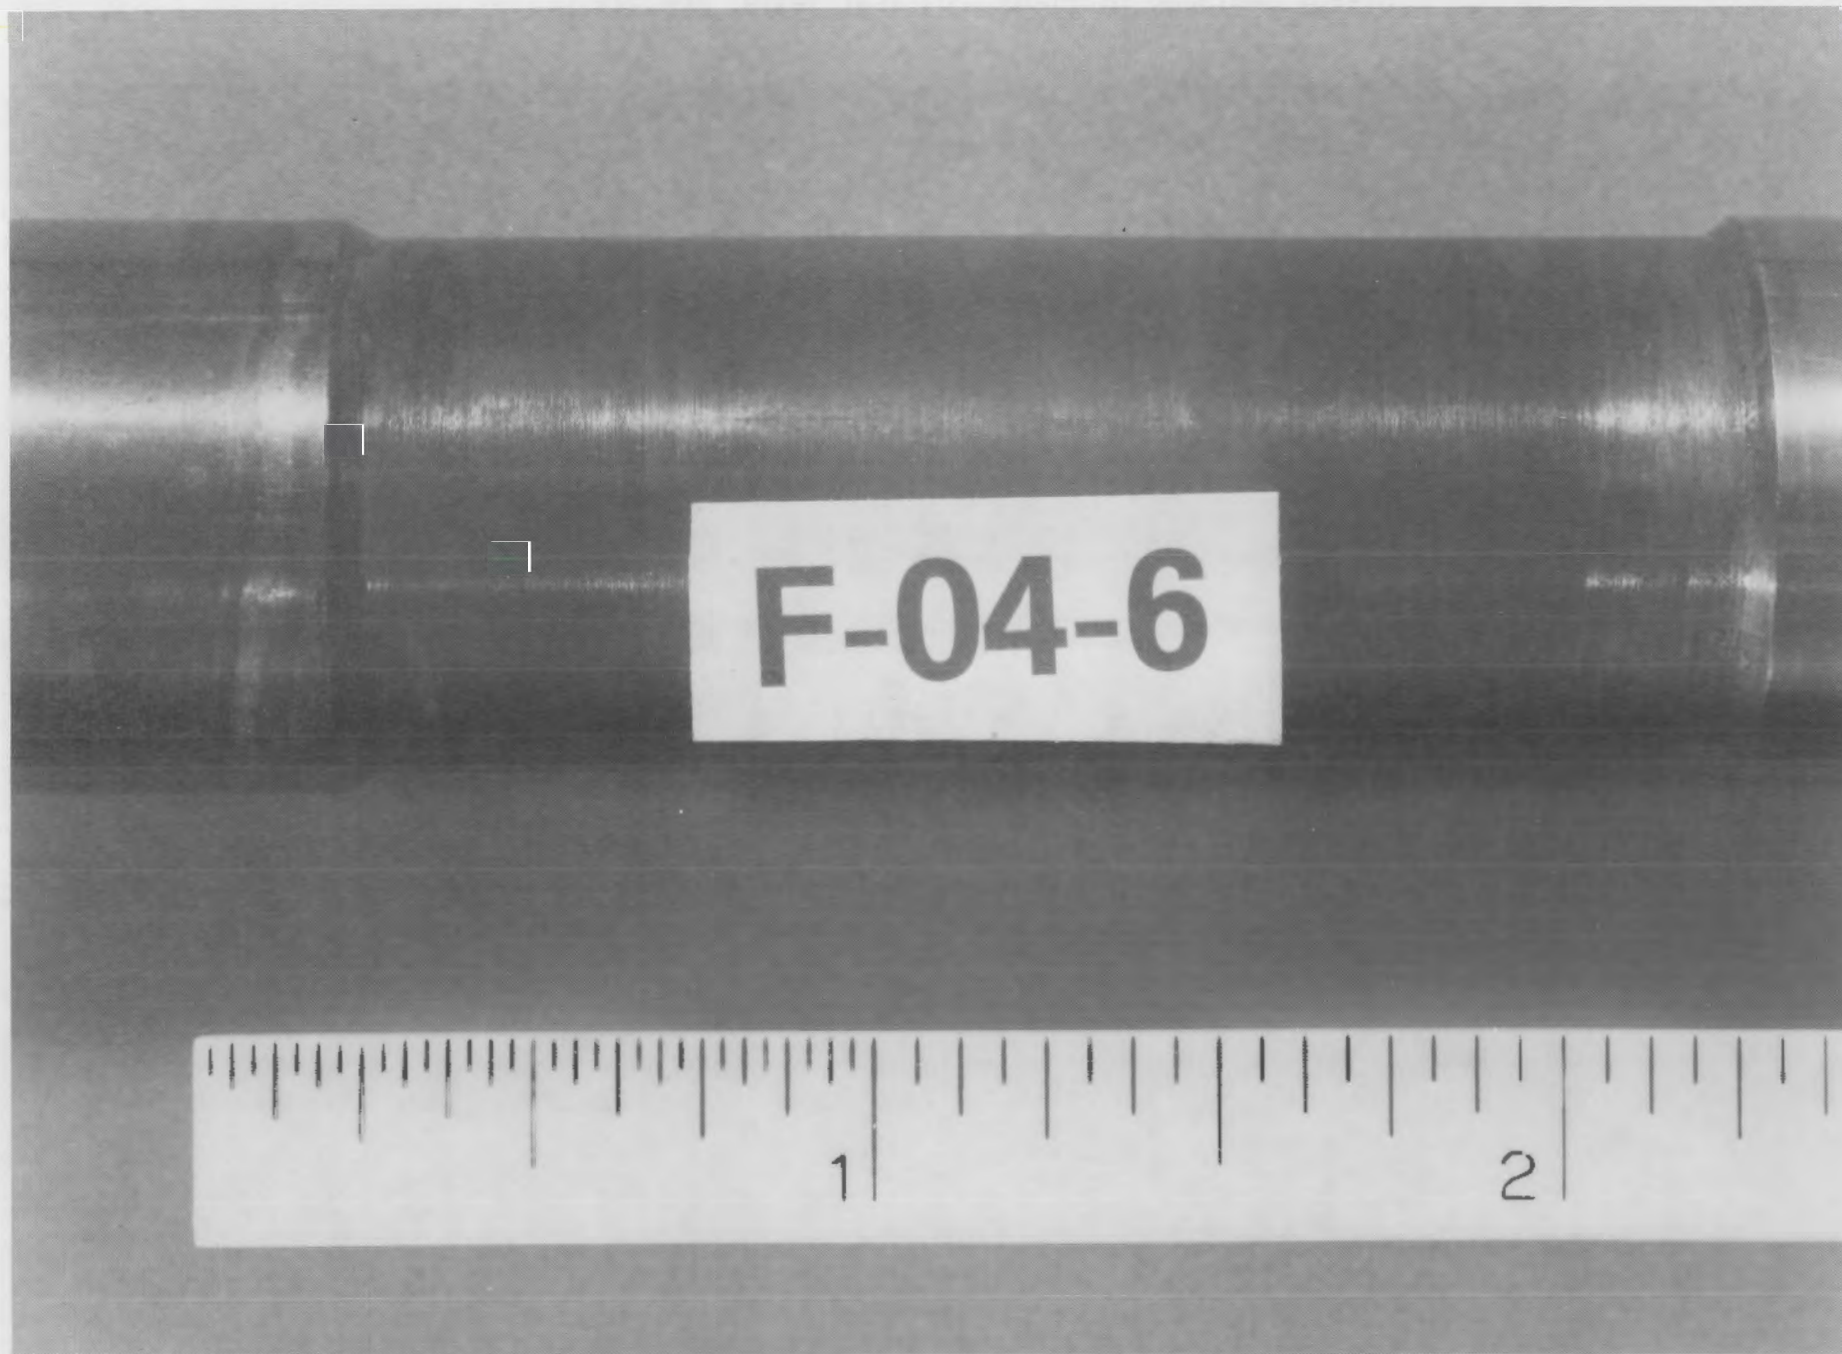
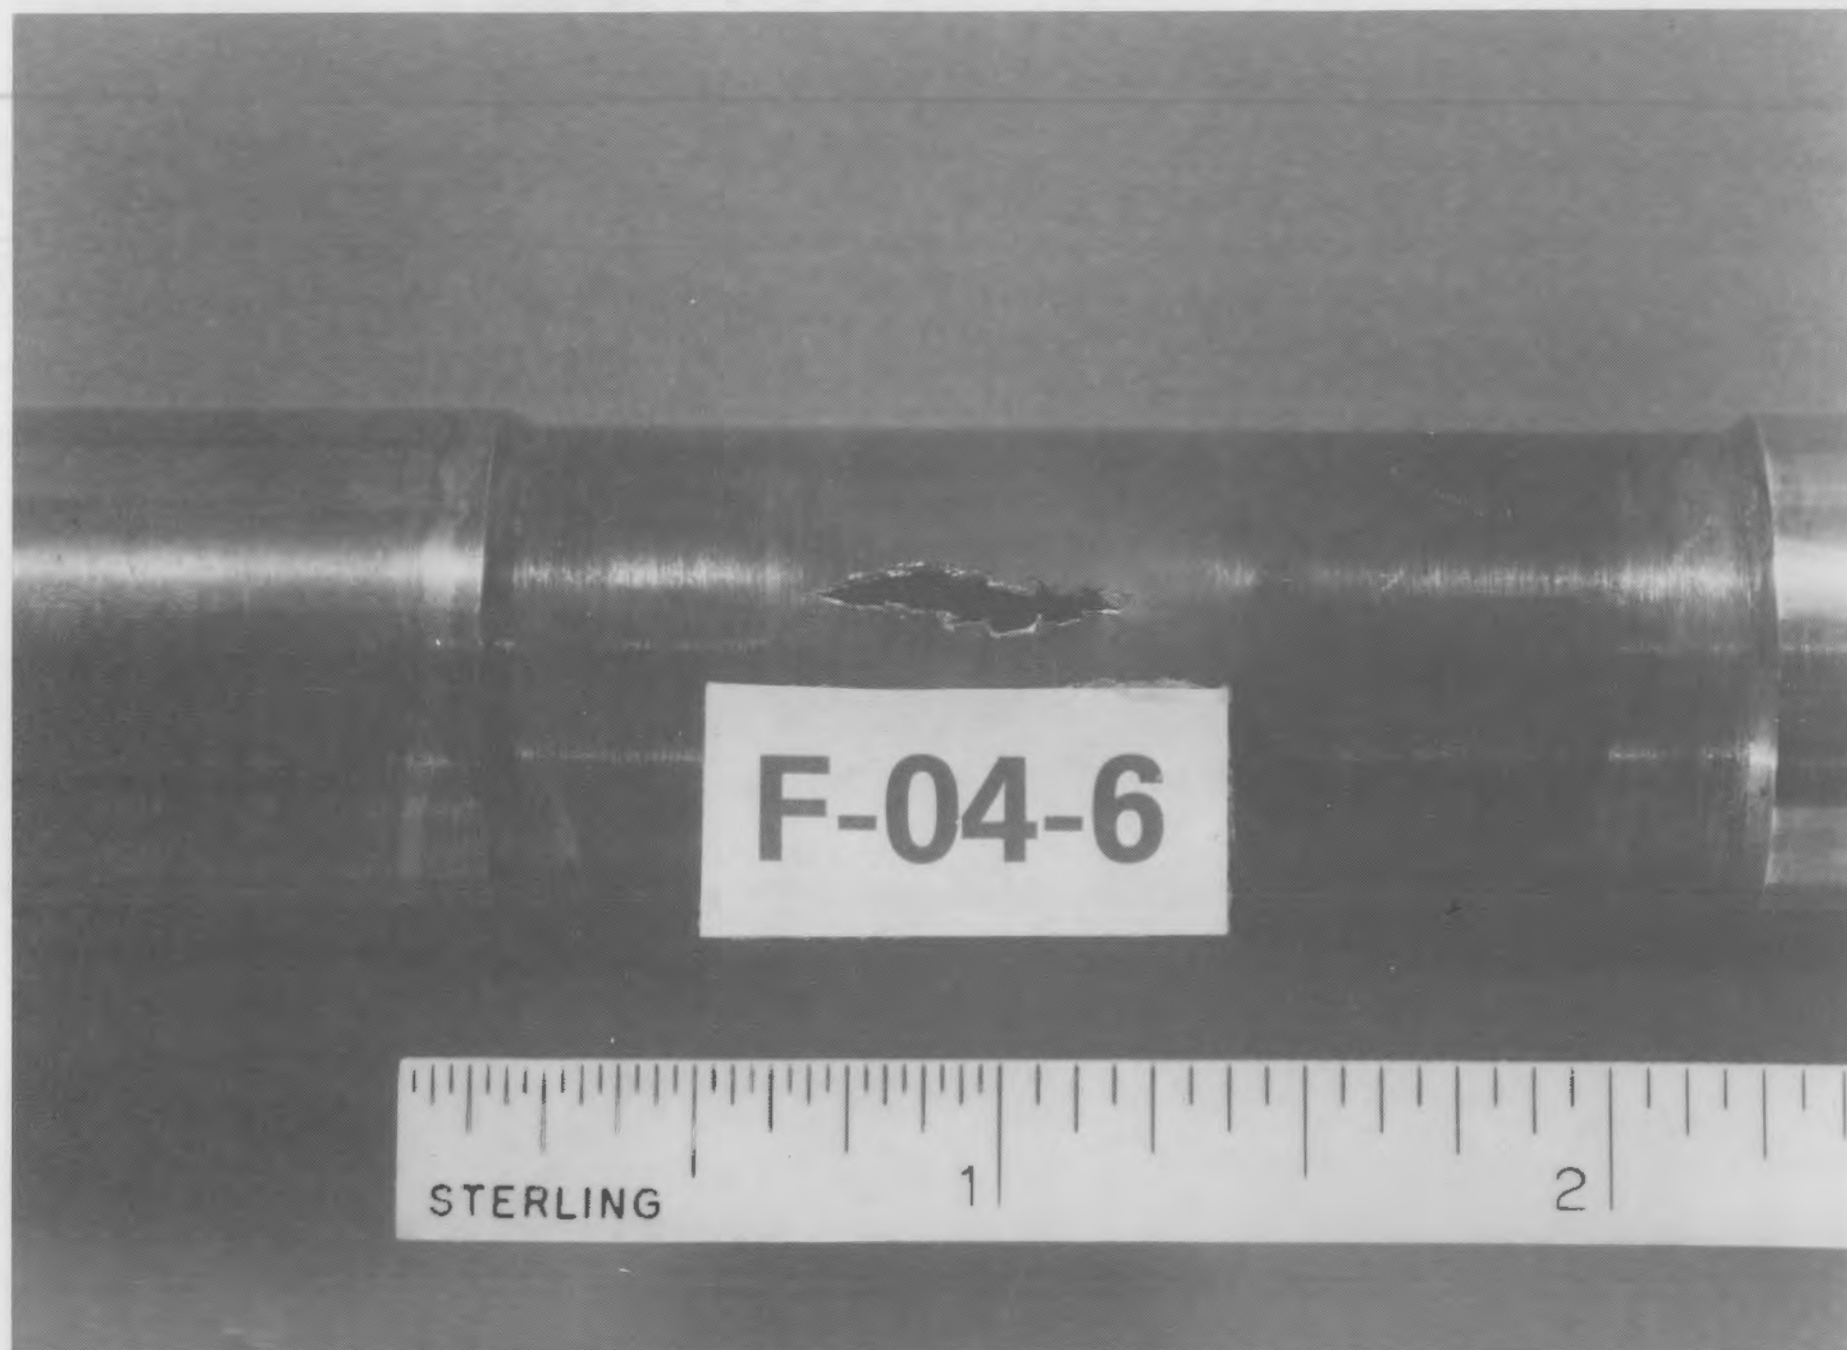
- Computer data: Figures 26, 27 and 28.
- Before and after photographs: Figures 44 and 45.
- Eddy current before test: One crack 90-100% through-wall.
- Visual inspection: 2" long thinned area, 60% thinning, 1/2" crack in center of thinned area.
- Testing: Flow was increased in steps to a maximum of ~14 gpm. This flow was held for 30 seconds. Pressure was increased slowly to a maximum of 600 psi during maximum flow.
- Test results: Crack burst open but its length did not increase significantly.

FIGURE 44. Before Test Photograph of Specimen F04-6

FIGURE 45. After Test Photograph of Specimen F04-6

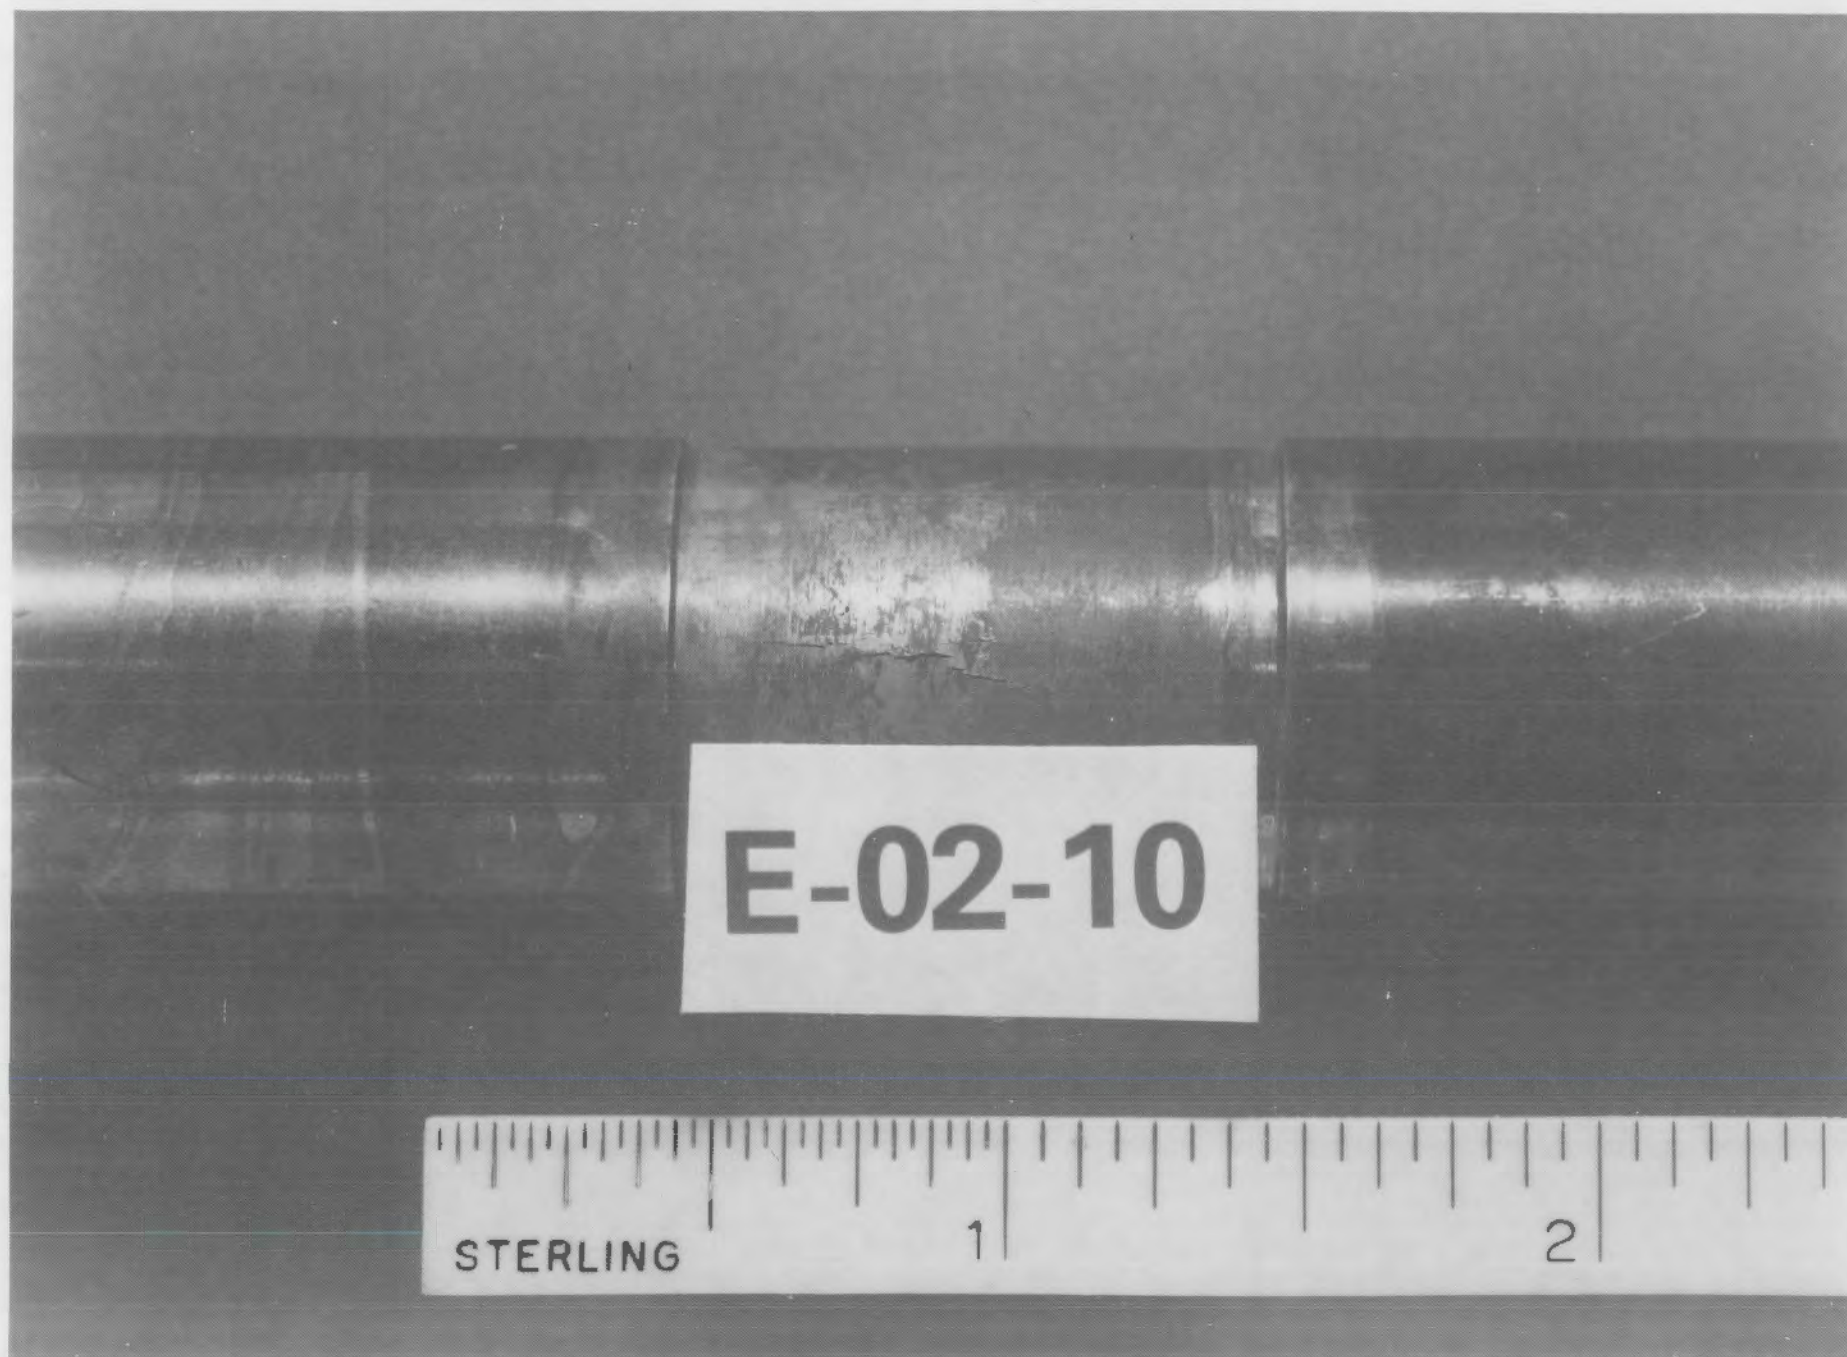
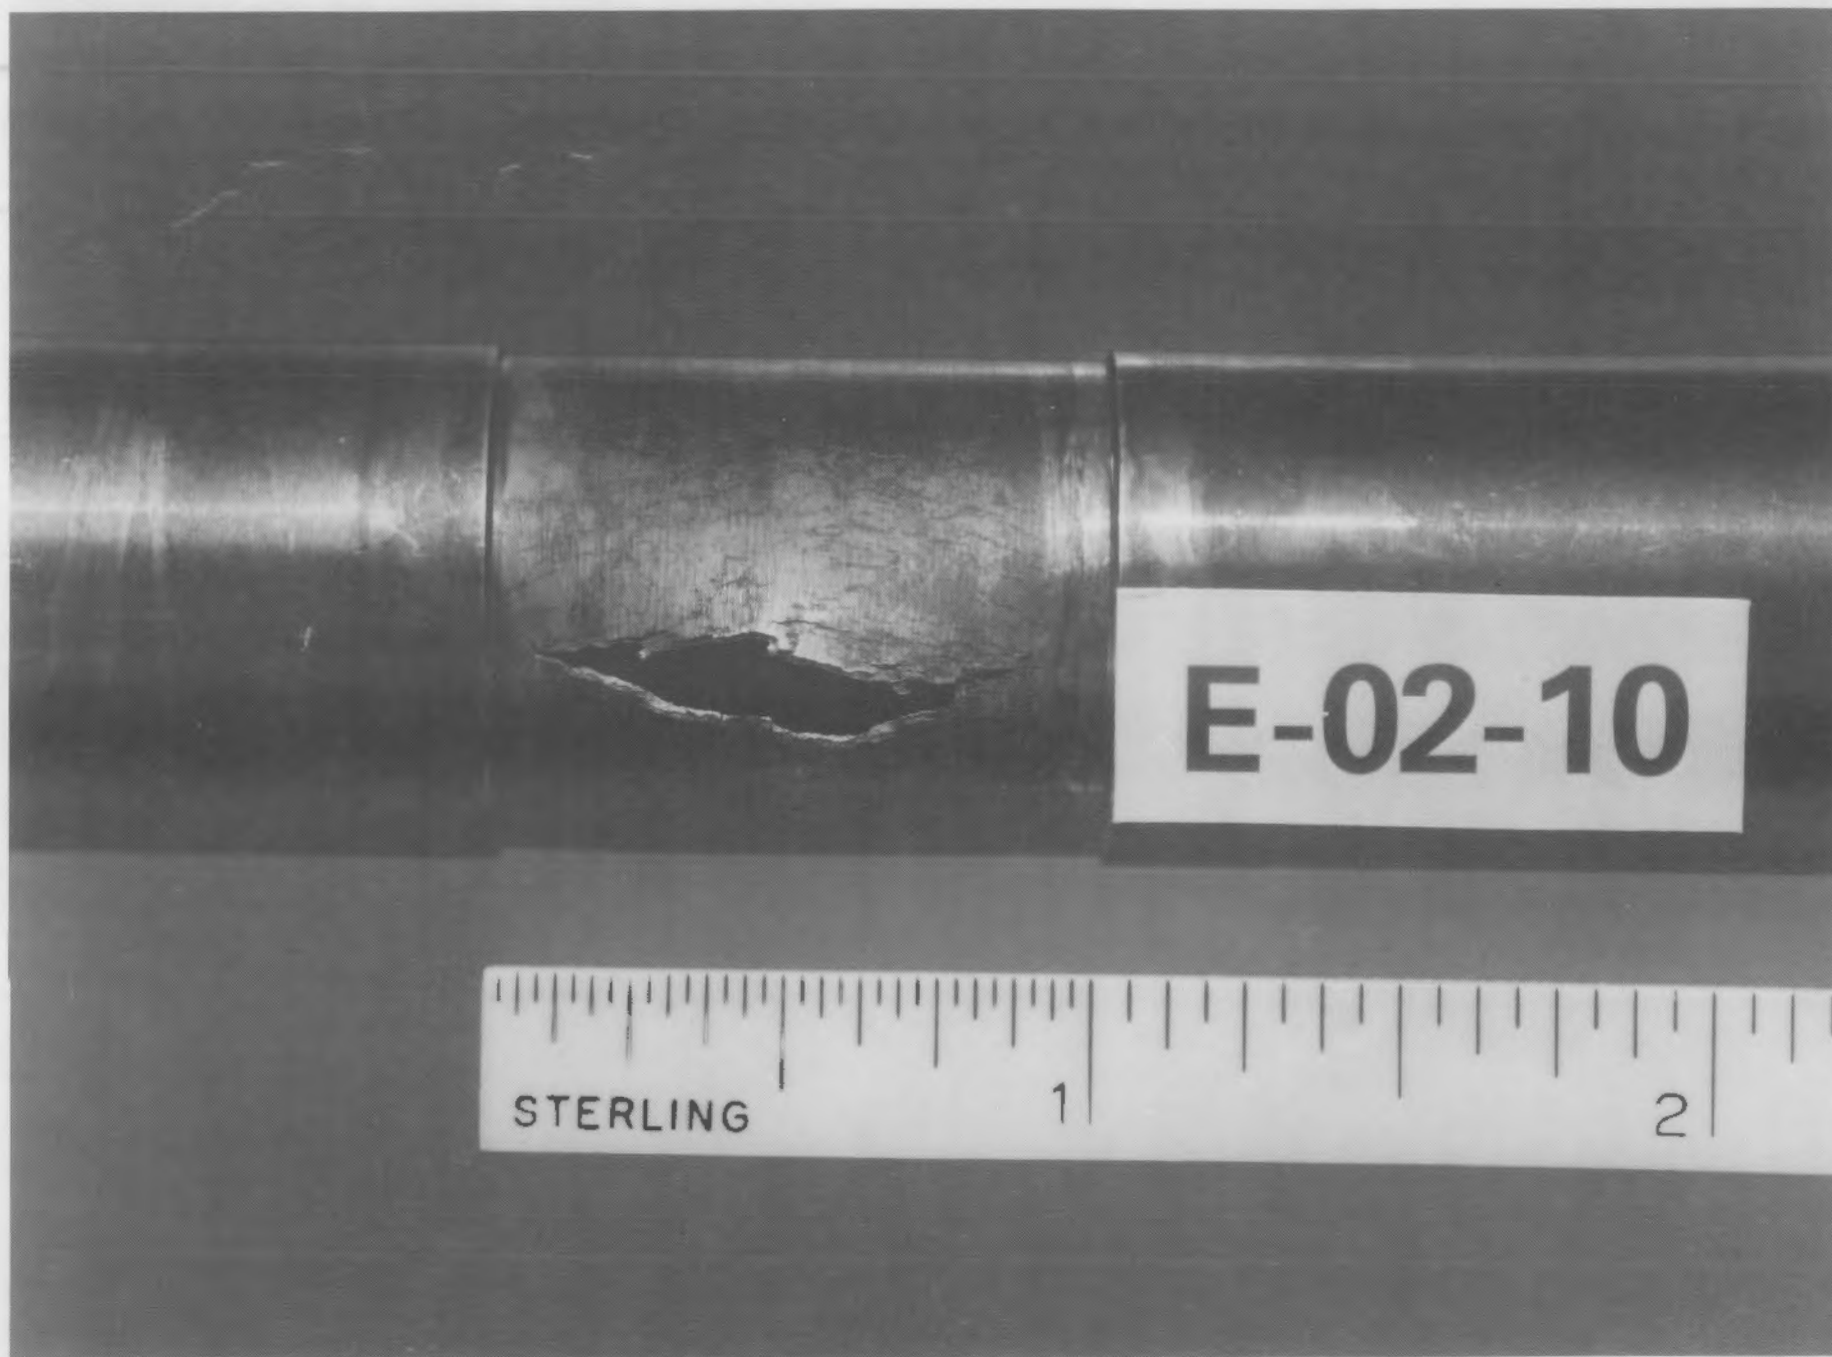
- Computer data: Figures 29, 30 and 31 - original test.  
Figures 32, 33 and 34 - retest.
- Before and after photographs: Figures 46 and 47.
- Eddy current before test: One crack 100% through-wall.
- Visual inspection: One major crack and several branching cracks, 1" long thinned area, 40% thinning.
- Testing: Original test produced no results due to water temperature problem in specimen. Test was run for 5 minutes but temperature never increased substantially. This problem was remedied by installation of a specimen vent valve. The retest was run for 100 seconds. The flow was increased in steps to a maximum of 20 gpm. Pressure remained at ~200 psi for most of test.
- Testing results: Crack burst open. Length 3/4".

FIGURE 46. Before Test Photograph of Specimen E02-10

FIGURE 47. After Test Photograph of Specimen E02-10
