POST-TEST EXAMINATION OBSERVATIONS
FOR THE W-2 SLSF EXPERIMENT

A. L. Pitner
D. E. Smith
G. E. Culley

September, 1983

A. L. Pitner, D. E. Smith, G. E. Culley
Westinghouse Hanford Company
Hanford Engineering Development Laboratory, Richland, Washington

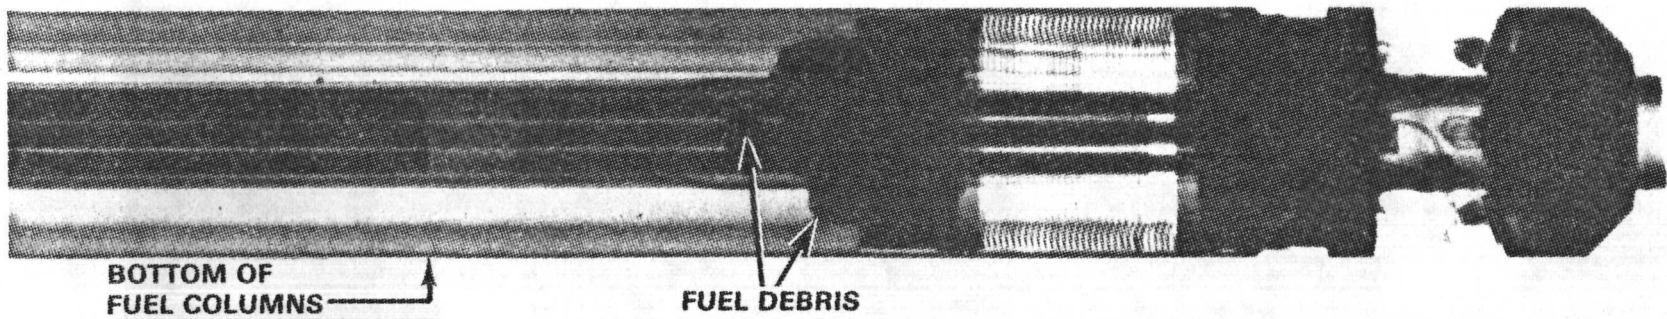
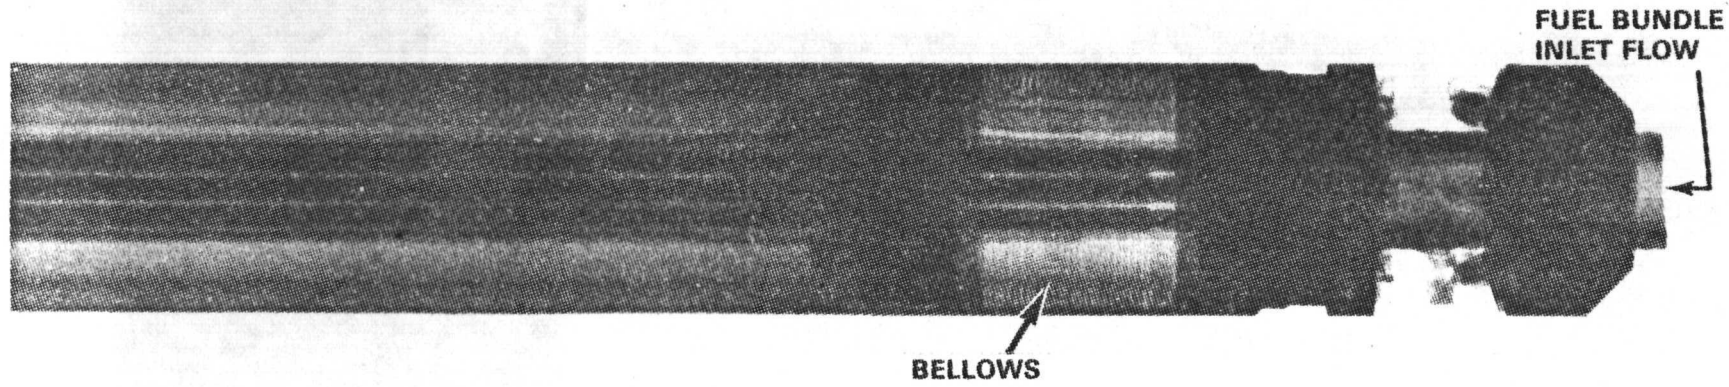
FIGURE 2. Neutron Radiographs of Bottom of Test Section.

Following completion of the transient test, the experiment was partially disassembled and neutron radiographed⁽¹⁾ at the Hot Fuels Examination Facility-North (HFEF-N). The radiographs (both thermal and epi-thermal) of the test assembly are shown in Figures 2 through 5. It was evident that severe disruption of the fuel bundle occurred over a ~10 cm long section near the axial midplane, substantiating the axial midplane failure indication by the test section thermocouples. Failure of the fluted tube was also indicated in the radiographs, as evidenced by molten fuel debris at the bottom of the fuel bundle and sodium filling of the thermal barrier region to a level near the axial midplane. Below the midplane failure site, the fuel bundle appeared to be undisturbed. The upper portion of the fuel bundle, however, was noticeably distorted, or warped. Fuel particulate could be seen dispersed throughout the upper test section.

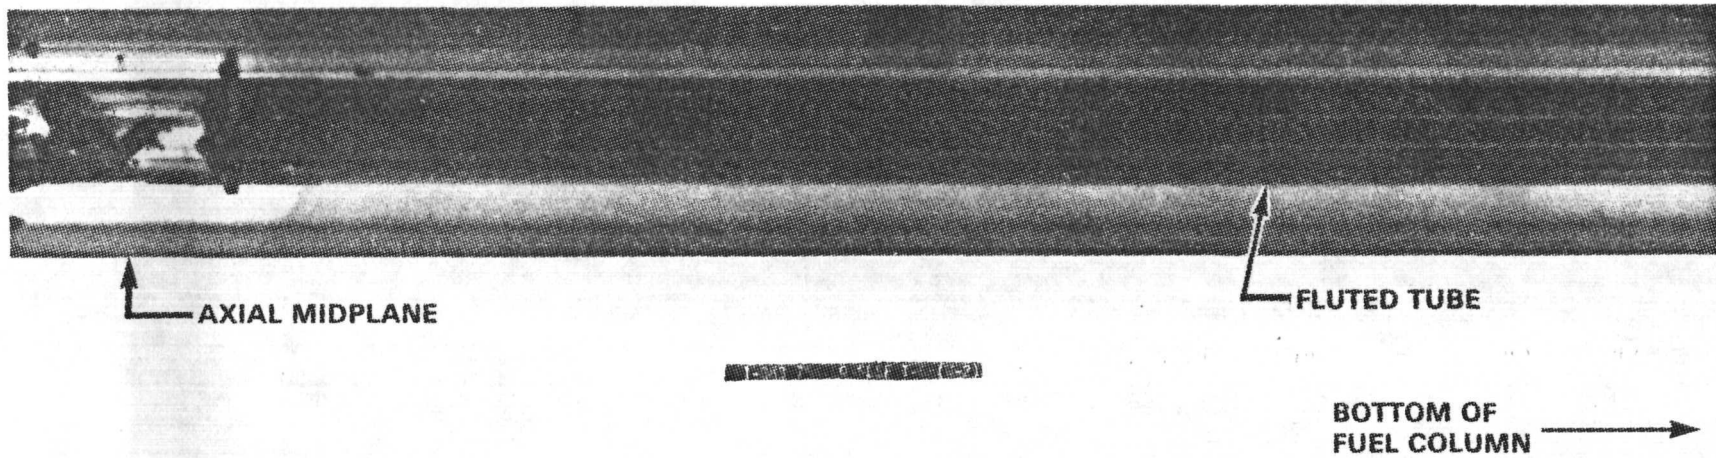
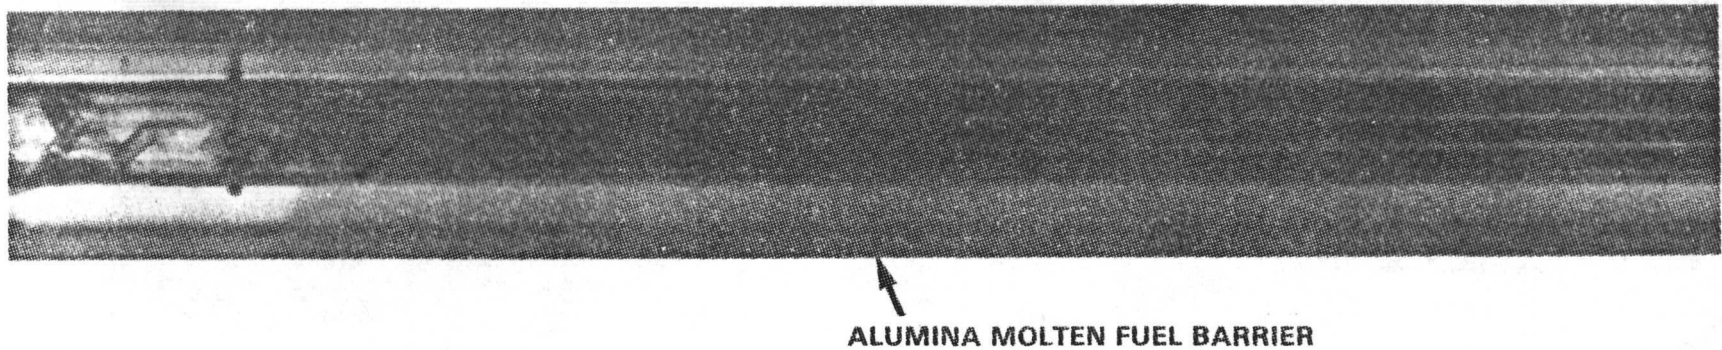
FIGURE 3. Neutron Radiographs of Below-Midplane Test Section.

An interesting feature observable in the neutron radiographs was that a number of intact fuel pellet shell fragments were visible near the midplane gross failure site. These shells, or rinds, were presumably remnants of fuel pellets after the central molten core had been expelled. The fact that these delicate shells remained intact during the major failure event gave testimony to the comparatively nonviolent nature of the failure event itself. These shells were observed to possess very little strength when recovered during the disassembly operation.

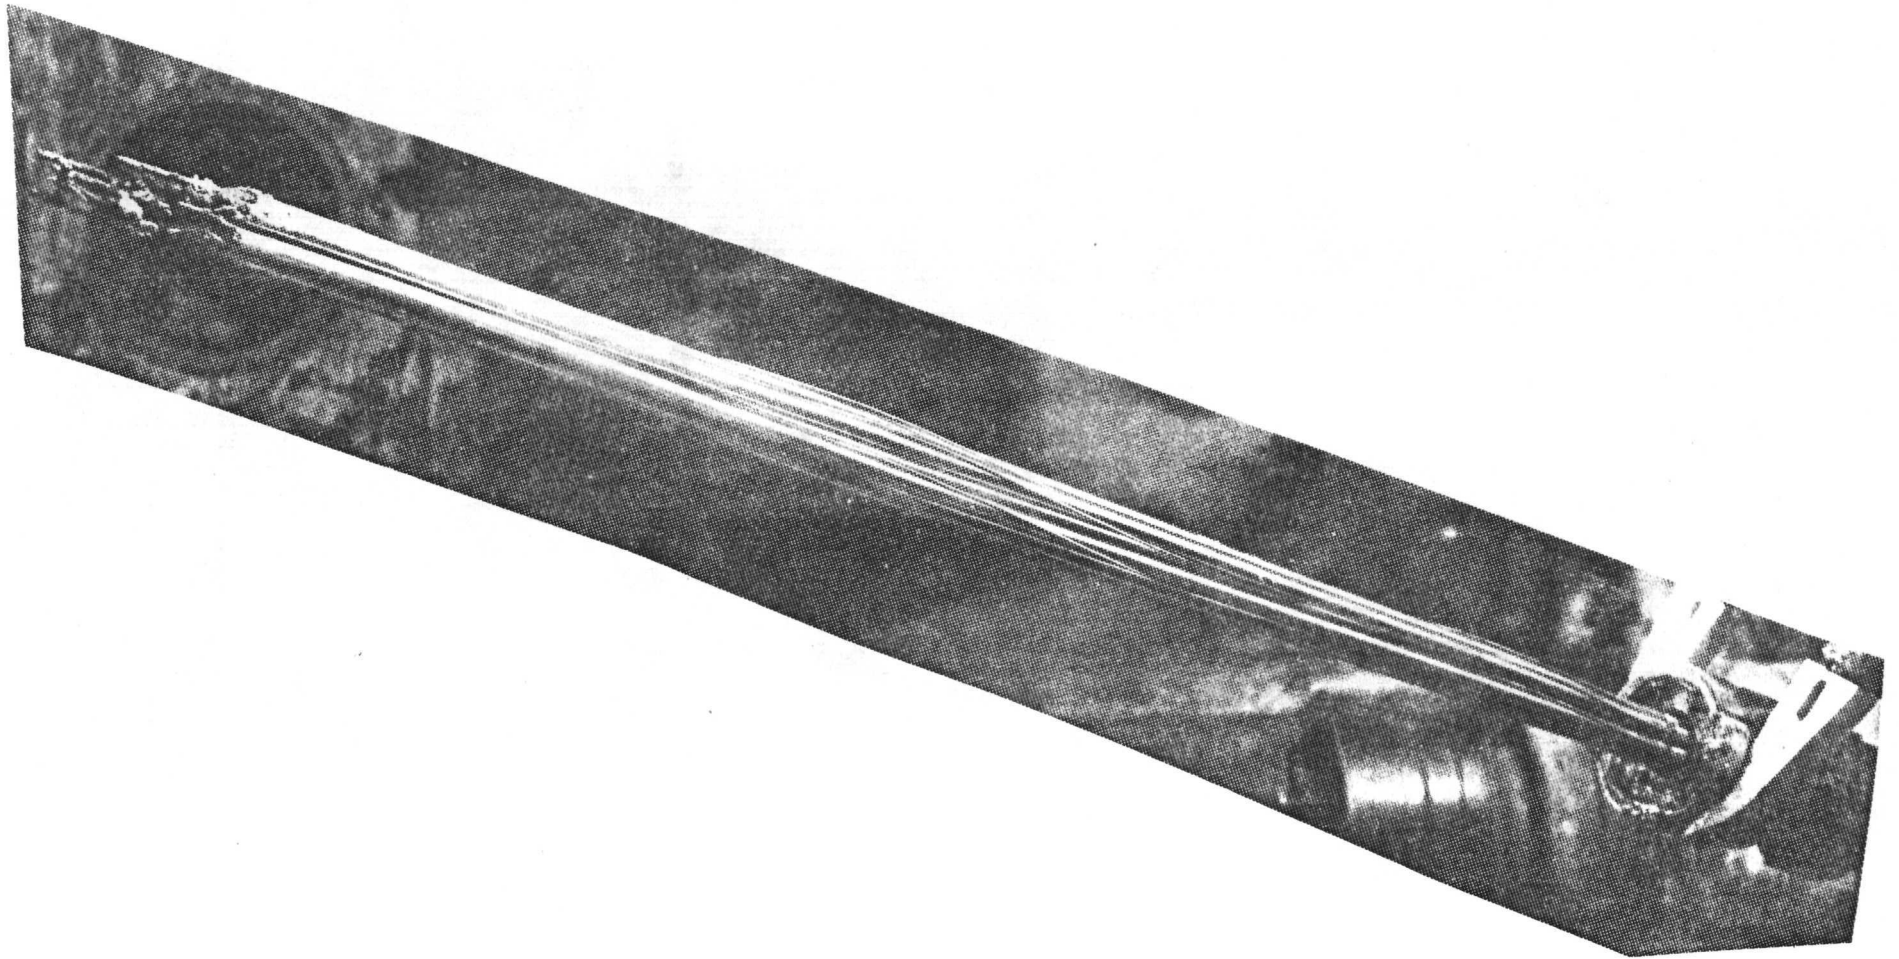
FIGURE 6. Fuel Pin Bundle in Lower Test Section.

The general approach taken in disassembling the test train was to cut the assembly in half at the axial midplane location and separately recover test components from the upper and lower sections. The fuel pin bundle from the lower section after removal from the fluted containment tube is shown in Figure 6. The lower extent of the failure region is ~40 cm above the bottom of the 91.4 cm long fuel column. Below this area, the fuel pins appeared to be in good condition with no detectable cladding breaches in any of the pins.

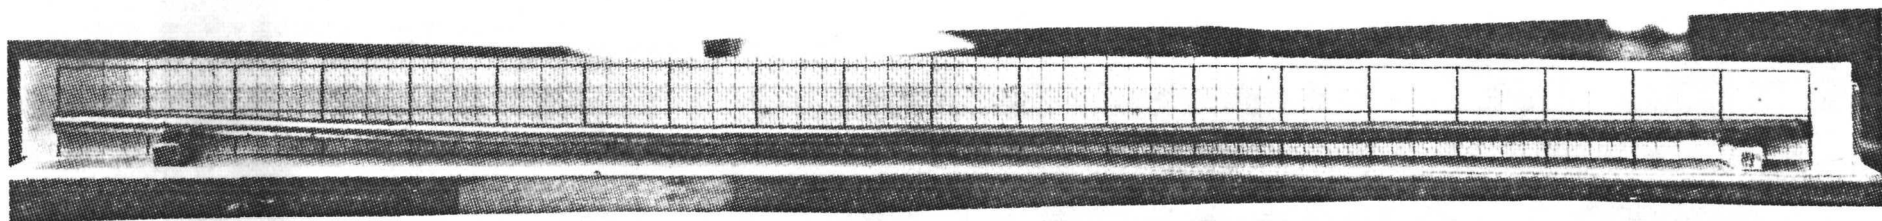
FIGURE 7. Bowing Measurement in a Lower Pin Section.

The fuel bundle in the lower section did exhibit a slight barrel-shaped bow. After further disassembly, the individual pins were photographed against a gridded background to obtain a measure of the bow magnitude. One such photo is shown in Figure 7. The maximum bow measured by this technique was 0.41 cm. It was determined during analysis⁽²⁾ of thermocouple data (oscillating temperatures) that dynamic bowing of the fuel pins occurred during the transient portion of the experiment. Post-test analyses⁽²⁾ performed to evaluate the consequences of these temperature oscillations indicated that the associated pin bowing was of great enough magnitude to enter into the plastic deformation domain. The observed permanent bow in these fuel pins appears to verify that this was indeed the case.

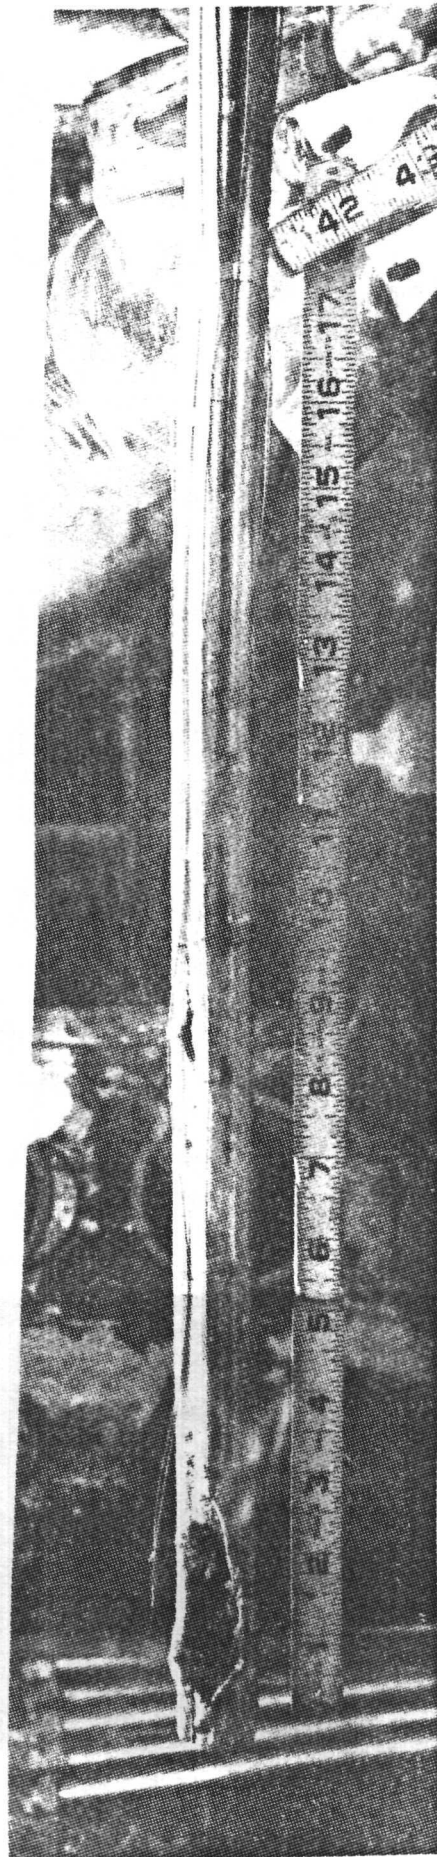
FIGURE 8. Upper Test Section.

As was known from the neutron radiography, the upper test section was substantially more damaged than the lower section. Figure 8 shows that there were multiple failure sites in the fluted containment tube, and that the upper fuel bundle was noticeably warped. The lower ~5 cm of this section was basically void, with the next ~5 cm of the test train containing a fused mass of fuel and cladding debris.

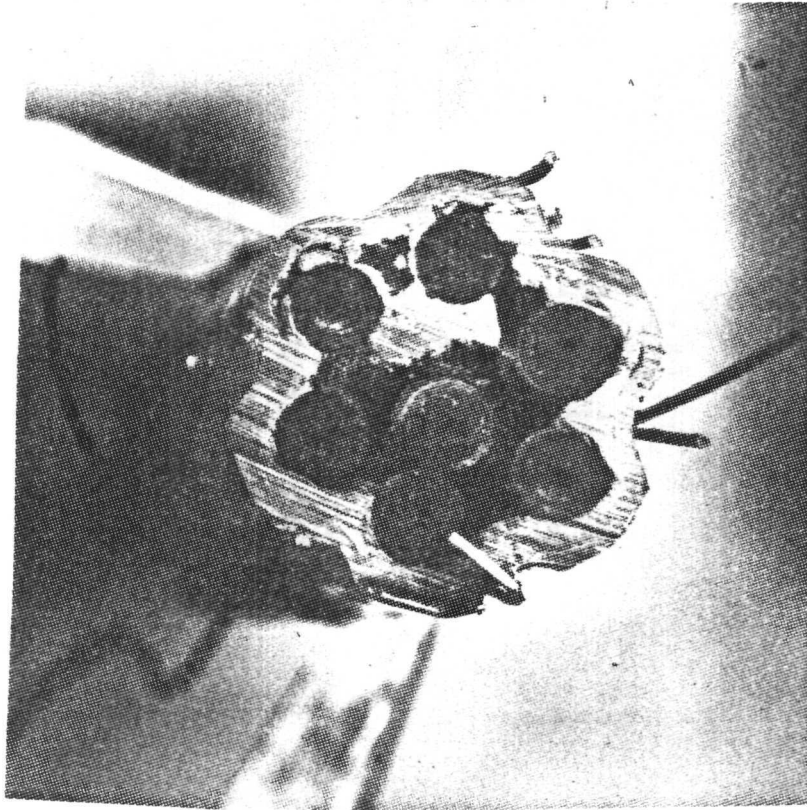
FIGURE 9. Transverse Section of Fuel Pin Bundle at 88 cm Level (Looking Up).

The disassembly plan for the upper test section was to cut it into ~14 cm long segments and attempt to recover fuel pin remnants from each segment individually. A transverse view of the uppermost section (88 cm level) is shown in Figure 9. While all seven fuel pellets were found to be intact and in their proper position at this level, very little evidence of cladding remaining around the pellets could be found. There was considerable redeposition of once-melted cladding on the inner surface of the fluted containment tube. The flow area reduction due to this redeposition was ~40%, which is approximately sufficient to account for the coolant flow reduction observed following the final TOP test. All the fuel pellets at this level appeared to have a central void, although the voids were filled with cutting debris in some instances.

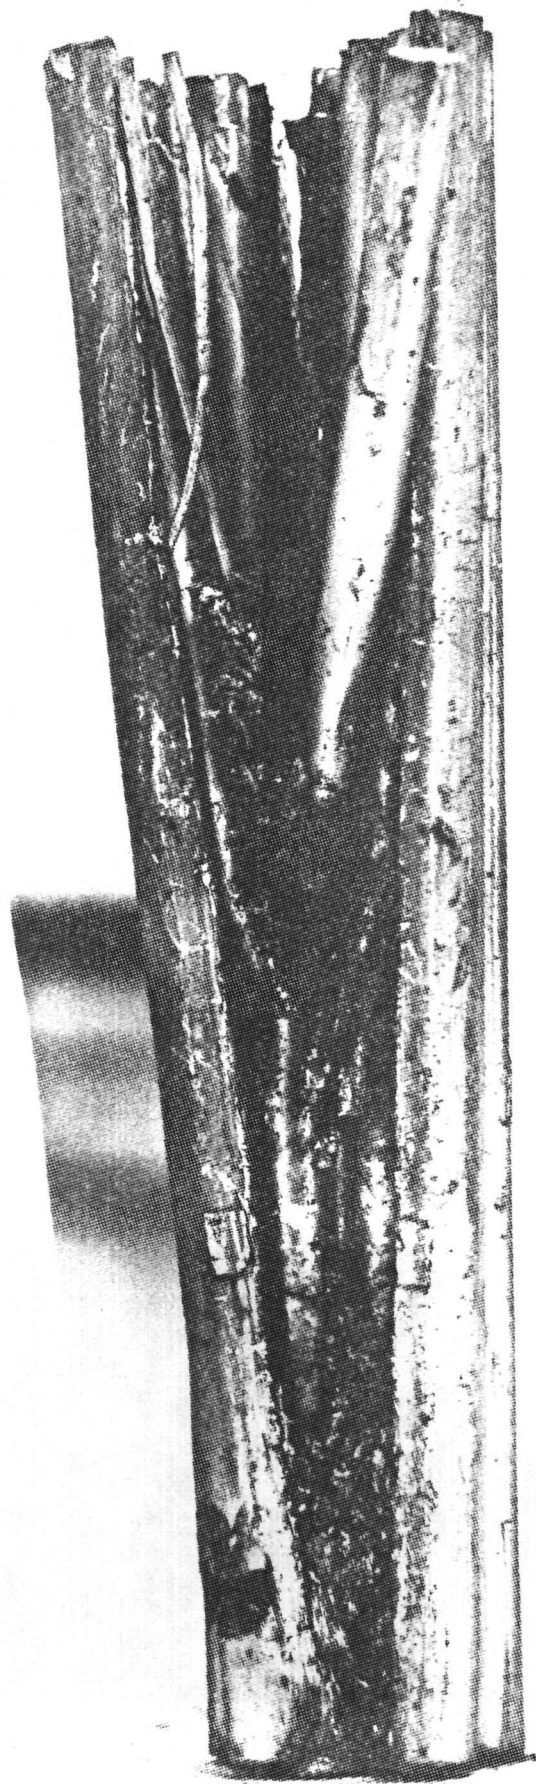
FIGURE 10. Topmost Section of the Fuel Pin Bundle.

however, were unsuccessful due to the excessive fusion of components that occurred at this level. Figure 10 shows a side view of this section after repeated attempts to pry it apart. The cladding in the lower ~2 cm portion of the fuel pin visible here appeared to be melted away. The upper portion of this section where the inconel reflectors were located appeared to be in good condition, with no apparent fusion of components. The lower portion where the fuel was located, however, displayed extensive fusion of fuel pin cladding with molten fuel debris interspersed throughout the area.

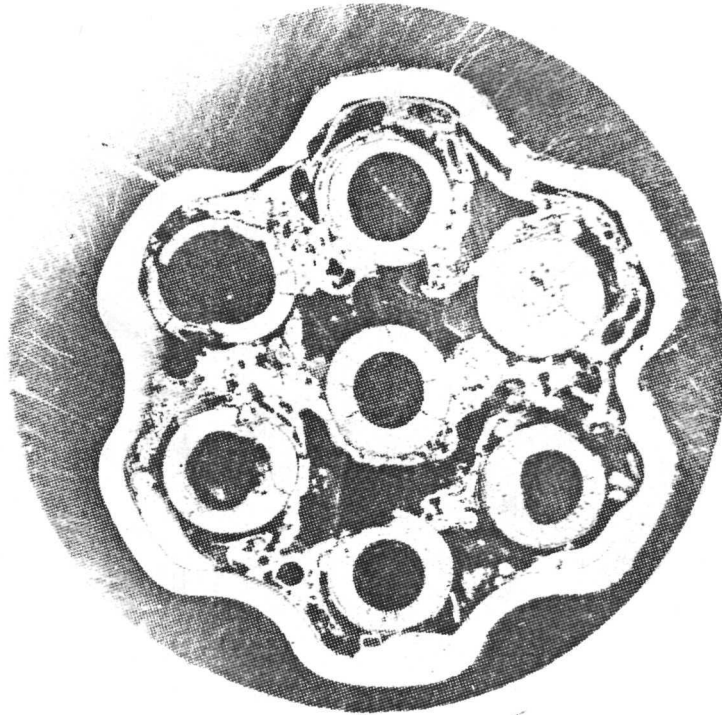
FIGURE 11. Transverse Section of Pin Bundle at the 70 cm Level.

Based on the observations of the uppermost section condition, no further attempts were made at recovering individual pin segments in the remaining portion of the upper test section. Instead, it was decided to obtain metallography specimens of the pin bundle at selected locations. These sections were vacuum impregnated with a resin to fix internal components in place during cutting operations. A transverse view of the pin bundle at the 70 cm level is shown in Figure 11. As observed in the previous section, the cladding was again totally melted away, but the fuel pellets were basically intact and located in their proper positions within the fluted tube. Some deposition of melted cladding on the interior fluted tube wall was evident. The pellets generally showed large central voids where molten fuel had escaped. Molten fuel and cladding residues were interspersed in the flow channels around the fuel pellets. In general, this physical situation was found to prevail from the ~55 cm level up to the top of the fuel column. The intact, free standing fuel pellet columns in the upper levels of the test section are considered additional testimony to the relatively non-violent nature of the overall failure event.

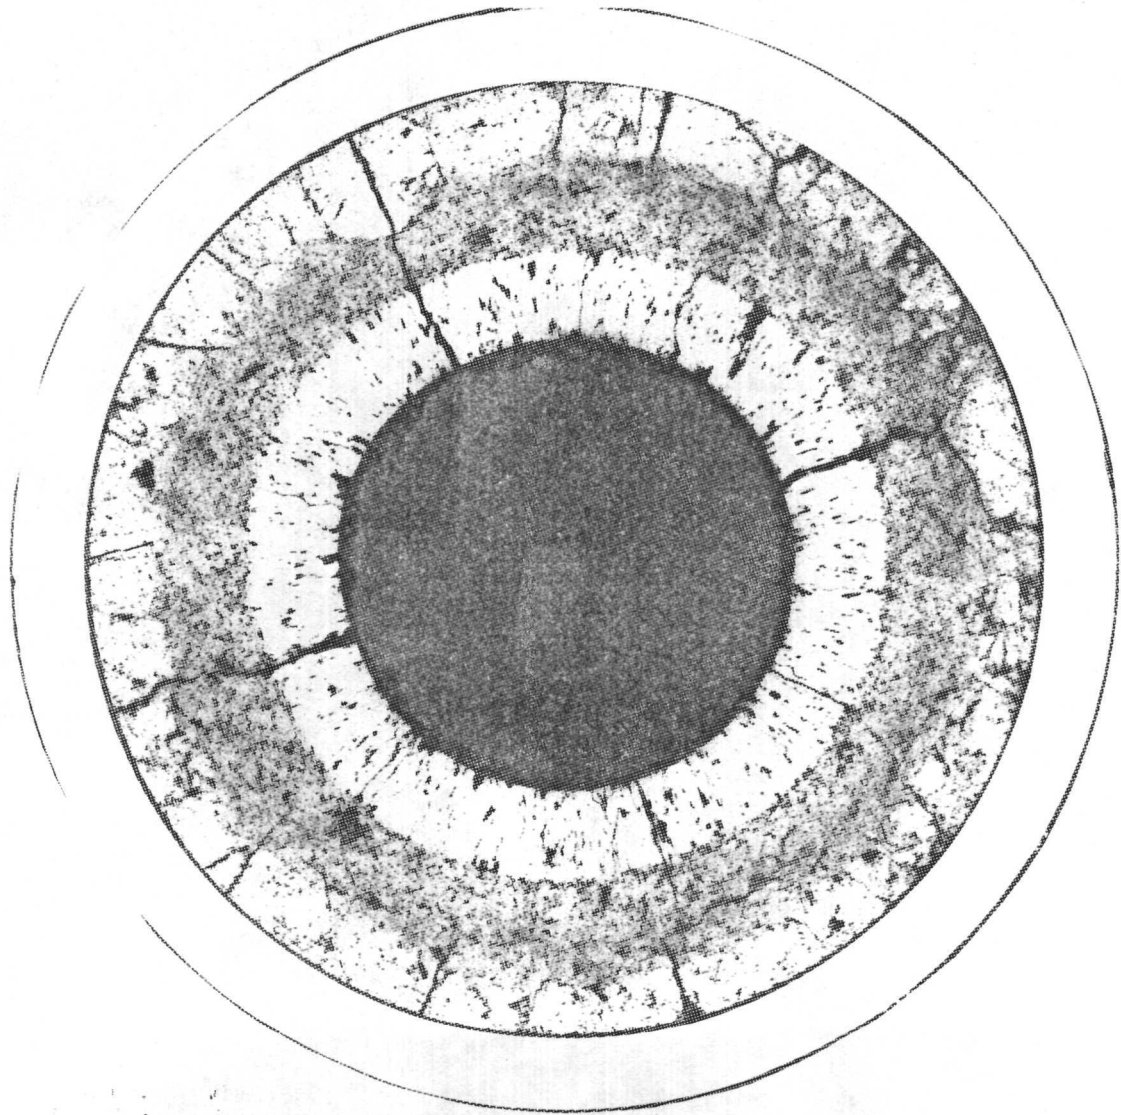
FIGURE 14. Center Pin Specimen at the 31 cm Level.

A number of metallography specimens were taken from the intact lower pin segments. Figure 14 shows a specimen taken from the center pin at the 31 cm level. The various zones progressing from the center out are central void where molten fuel has escaped, resolidified once-molten fuel, restructured (equiaxed grains) fuel, unstructured fuel, and the stainless steel cladding. The zones are located concentrically around the center of the pin, as would be expected for this central fuel pin. Several radial cracks are present in the specimen, but there was no penetration of molten fuel through the solid outer pellet shell. The beta-gamma autoradiograph of this specimen is shown in Figure 15. This image reflects the fission product distribution in the specimen, which presumably corresponds to the burnup or power distribution within the pellet. The darkness intensity perceptibly decreases as one progresses inward from the outer surface, reflecting the radial power gradient that was prevalent in this thermal reactor test. Another observable feature is that the once-molten fuel annulus is uniform in intensity, and less intense than the surrounding solid fuel pellet. This suggests that the once-molten fuel at this location was relocated from lower elevations (lower burnup) after mixing.

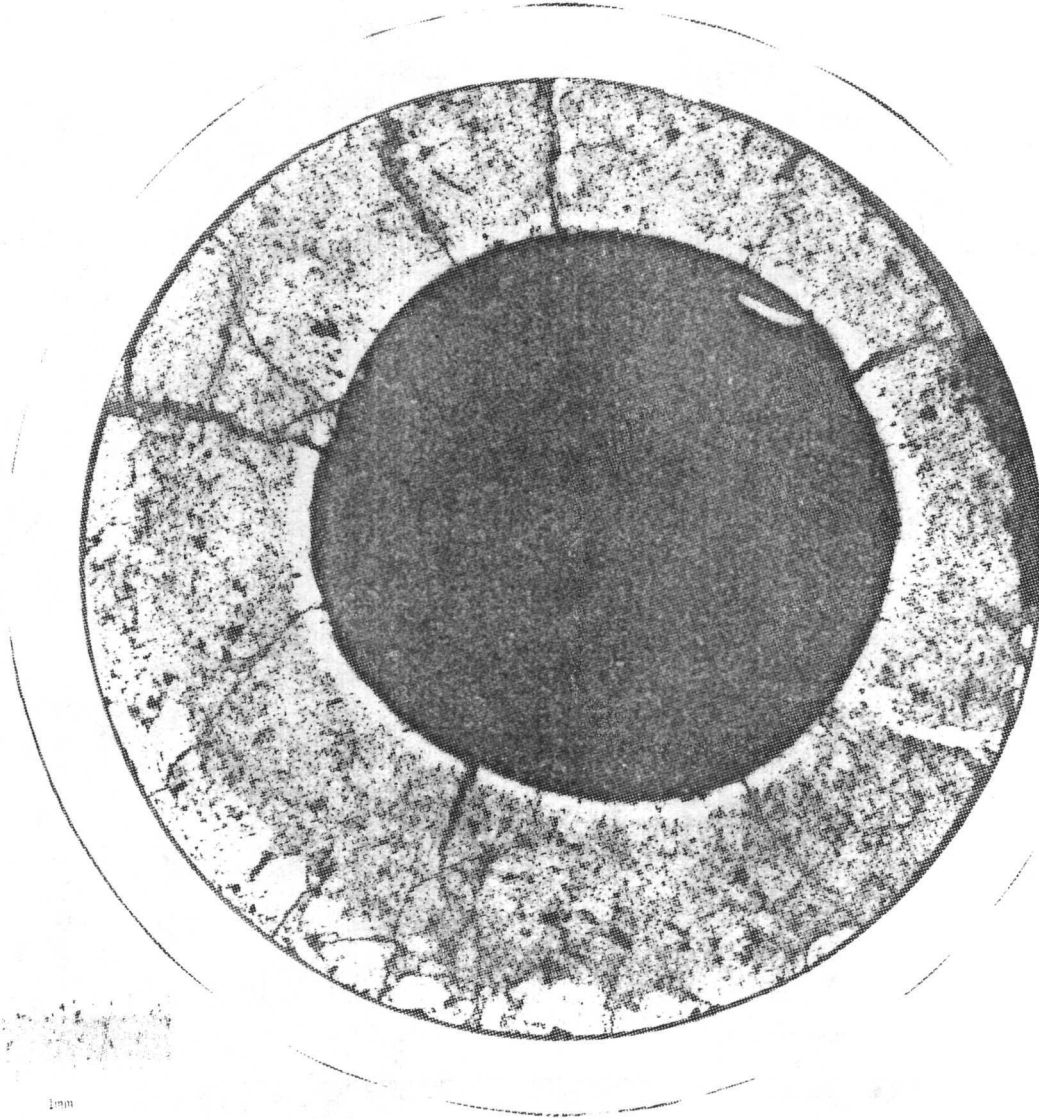
FIGURE 16. Outer Pin Specimen at the 16 cm Level.

Figure 16 presents an outer pin metallography specimen at the 16 cm level. The fluted tube side of this specimen was toward the two o'clock position. The central void and melt annulus are noticeably skewed in that direction, as a result of the steep radial power gradient through this pin. Two occasions of molten fuel penetration through the solid outer fuel shell are noted in this specimen, although there was no perceptible cladding

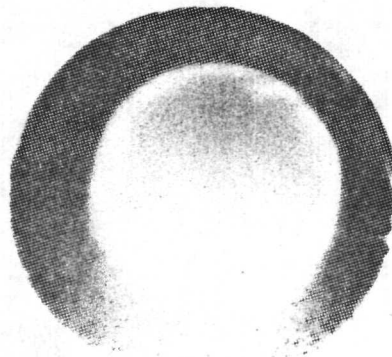
FIGURE 17. Beta-Gamma Autoradiograph of Outer Pin Specimen at the 16 cm Level.

melting at the contact points. The beta-gamma autoradiograph shown in Figure 17 again reflects the large radial power gradient through this outer fuel pin.

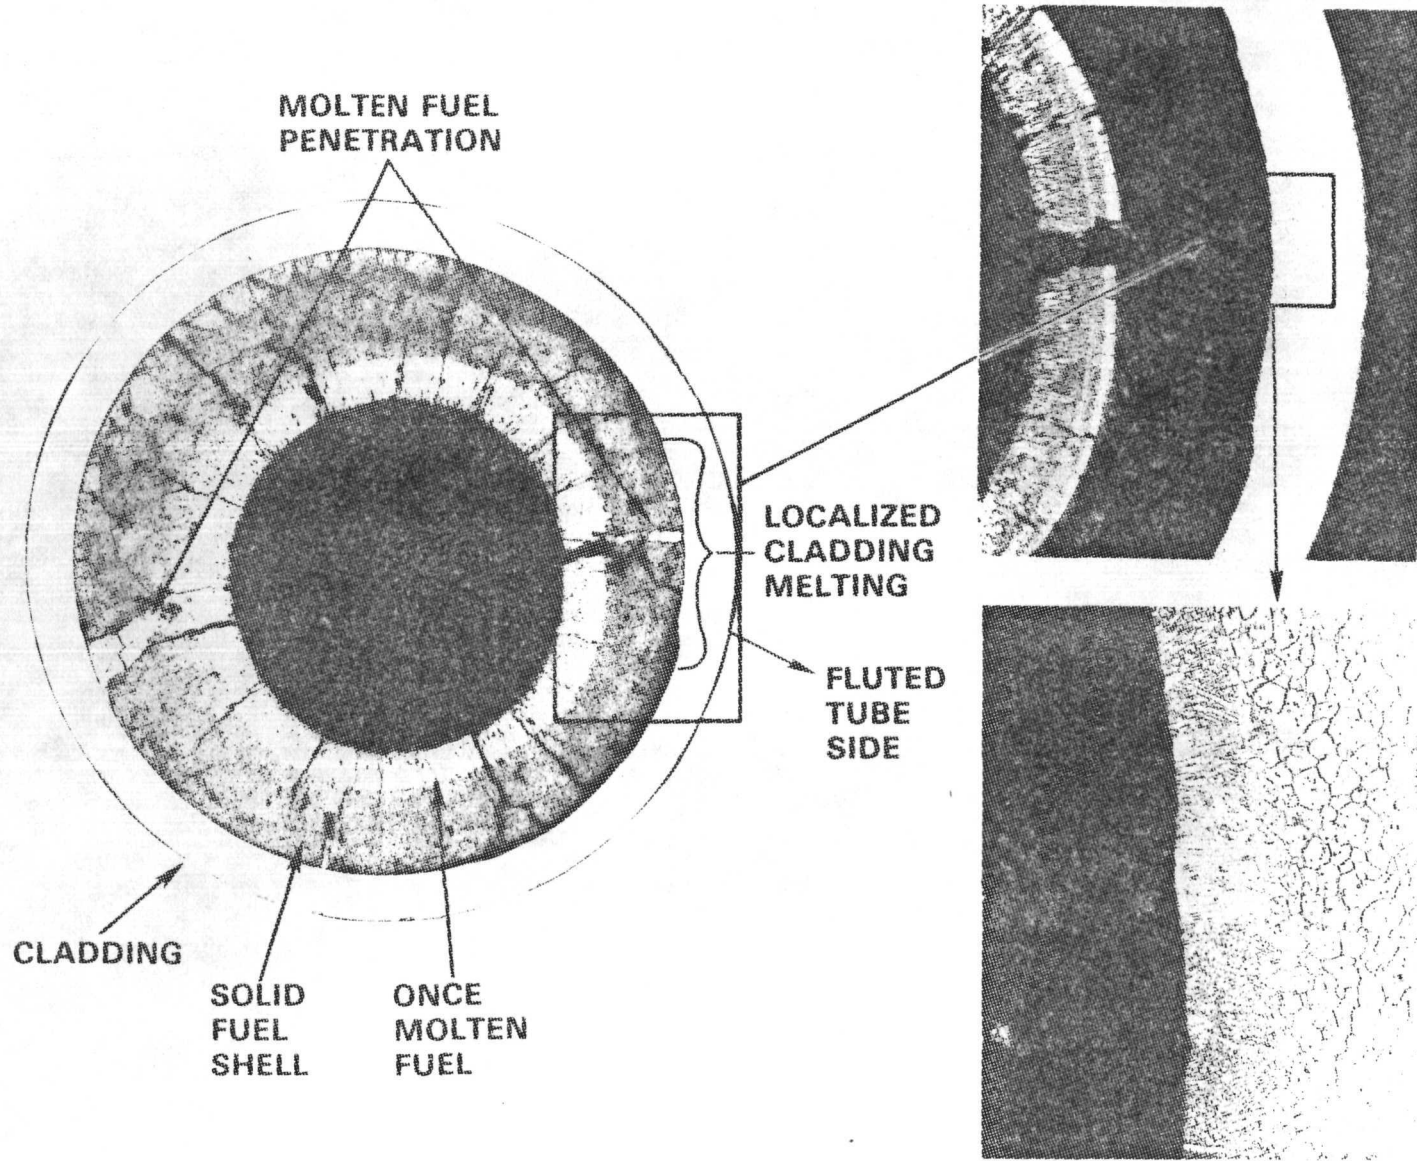
FIGURE 18. Molten Fuel Penetration and Cladding Melting in an Outer Pin Specimen at the 39 cm Level.

In general, it was noted in the 13 metallography specimens examined that molten fuel penetration to the cladding occurred once the melt radius exceeded $\sim 75\%$ of the pellet radius. The penetration usually was in the outward (towards fluted tube) direction. While generally no cladding melting was observable at the point of molten fuel contact, one exception was noted. Figure 18 shows an outer pin specimen taken at the 39 cm level, which is somewhat higher (hotter coolant) than the previous specimen elevations. Once again the central void and melt annulus in this outer pin specimen are offset toward the fluted tube side. A finger of molten fuel penetration on the fluted tube side in this case, however, actually caused some localized melting of the cladding at the inner surface, as depicted in the enlarged views of the etched cladding in Figure 18. The extent of melting was $\sim 25\%$ of the cladding thickness. On the opposite side of the specimen, an even larger finger of molten fuel penetrated to the cladding, but caused no melting of the cladding. This is because the cladding was cooler at this azimuthal location. It is known from test thermocouple data that coolant temperatures in the outside flow channels reached higher levels than the inboard channels. This has been interpreted⁽²⁾ to be a result of flow restrictions that occurred in the containment tube flutes as the outer fuel pins bowed into them. Thus it is evident that molten fuel penetration can cause localized cladding melting if cladding temperatures are high enough.

transient. Additionally, it is inferred from lower-level metallography specimen examinations that the extent of fuel melting in some of the outer pins exceeded 90% of the pellet radius near the axial midplane at the end of the transient. These combined conditions (>90% melt radius and >1100 K coolant temperature) are considered sufficient to produce fuel penetration to (and melting of) the cladding, pin failure, and fuel expulsion. This is considered to have been the dominant failure mechanism operative in the initial W-2 midplane failure event. Subsequent rupturing of the fluted duct tube and blanketing of the fuel bundle with the surrounding fill gas (argon) is believed responsible for the melting of cladding observed in the upper half of the fuel bundle.⁽²⁾

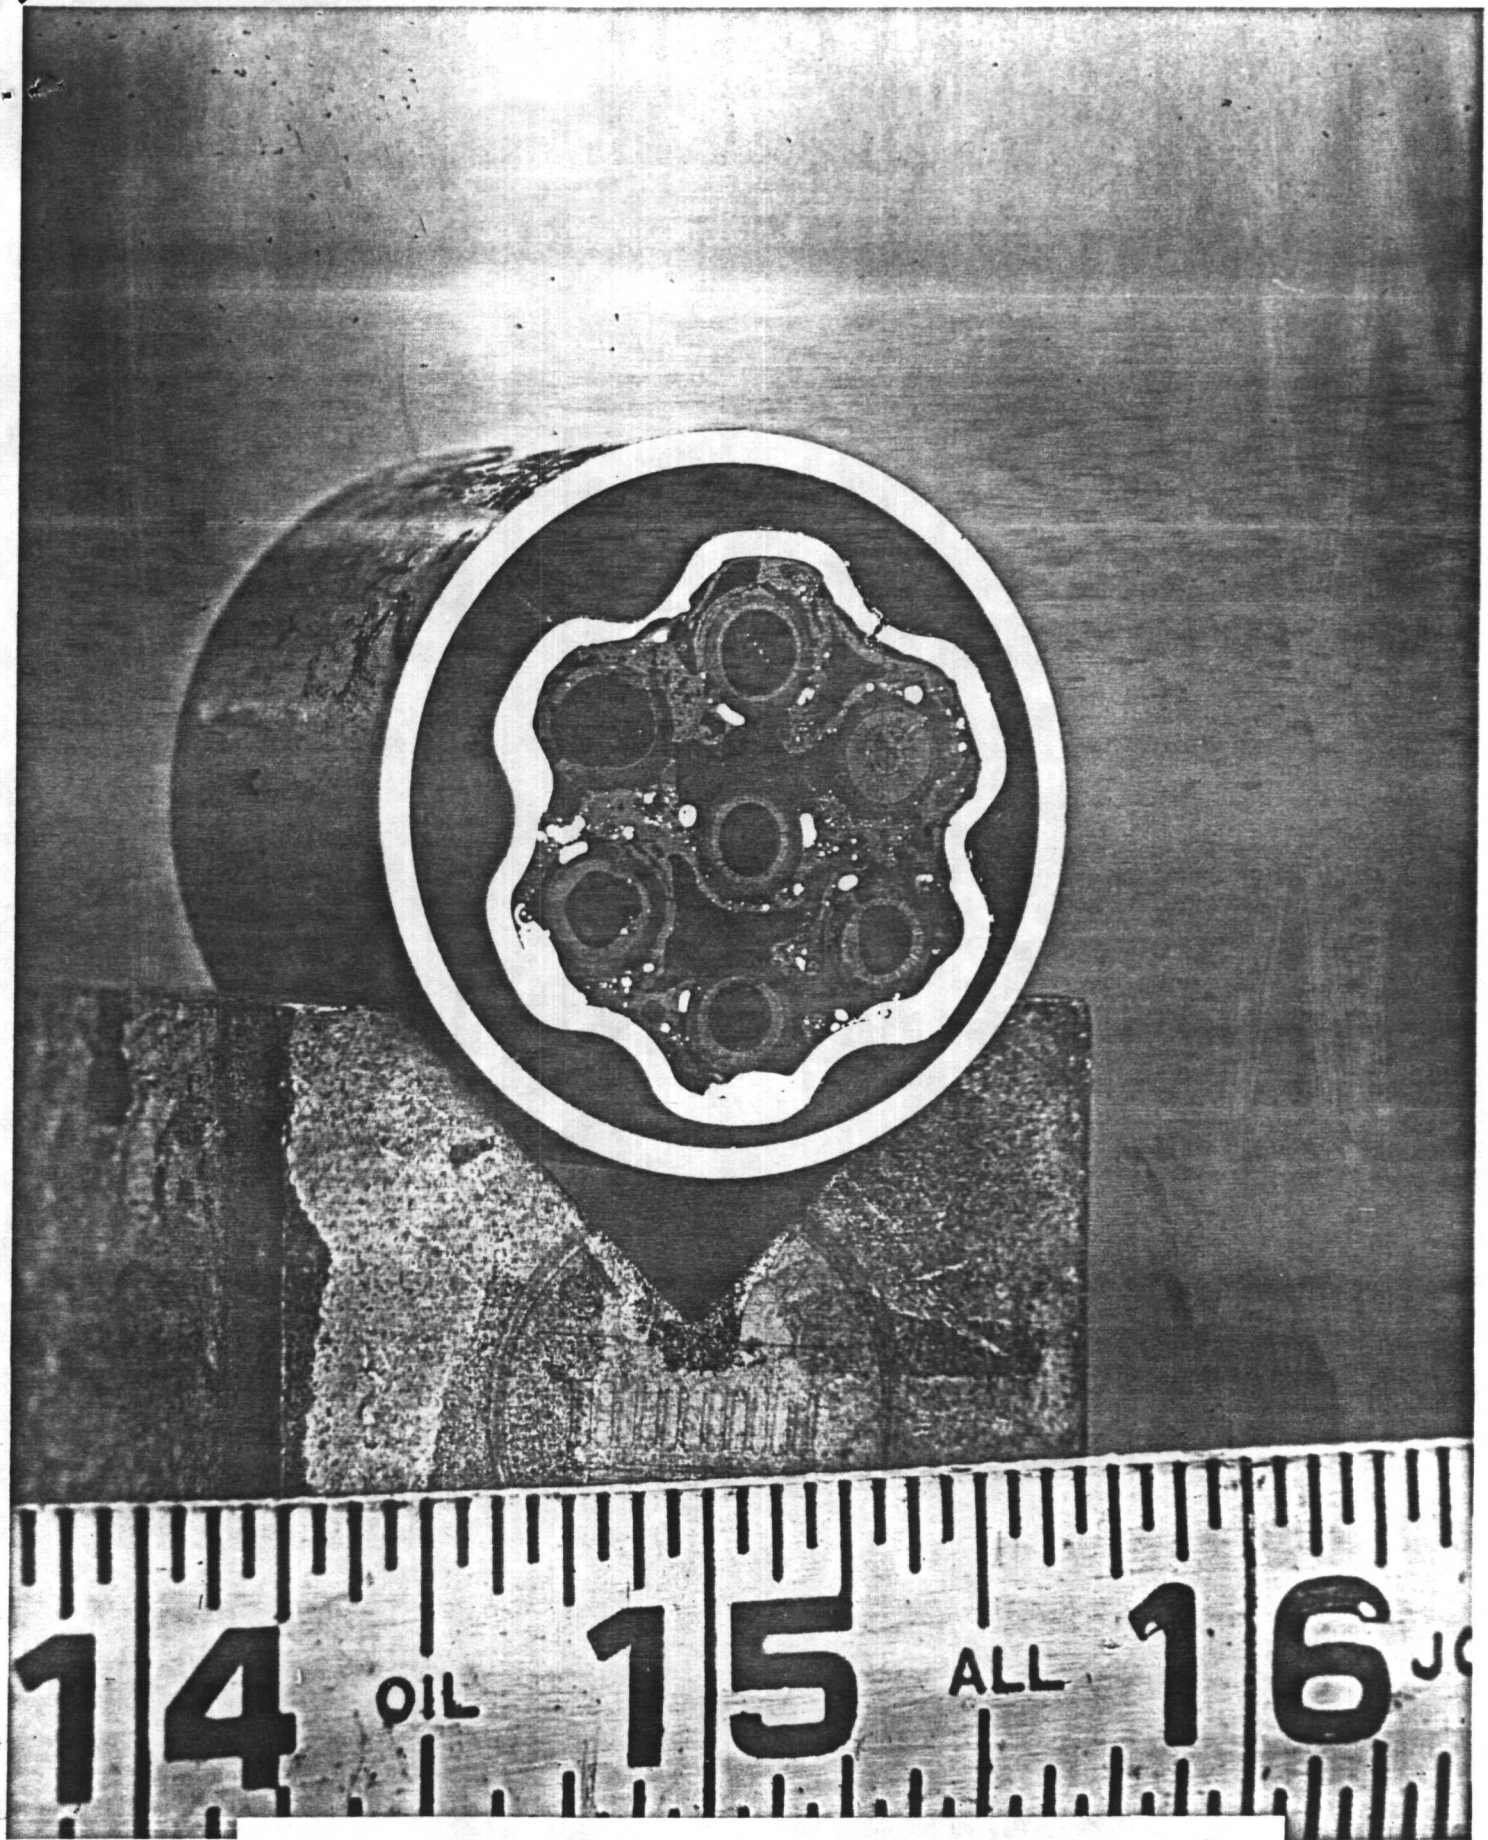
FIGURE 1. Transverse Section of the W-2 Upper Fuel Bundle.

A typical post-test configuration of the upper test bundle is shown in Figure 1, which is a transverse view at the 70 cm above bottom of fuel column level. The fuel pellets generally had large central voids where molten fuel had escaped,

and fuel and cladding residue were interspersed in the flow channels. It is estimated that about one-third of the fuel inventory was expelled during the TOP event.

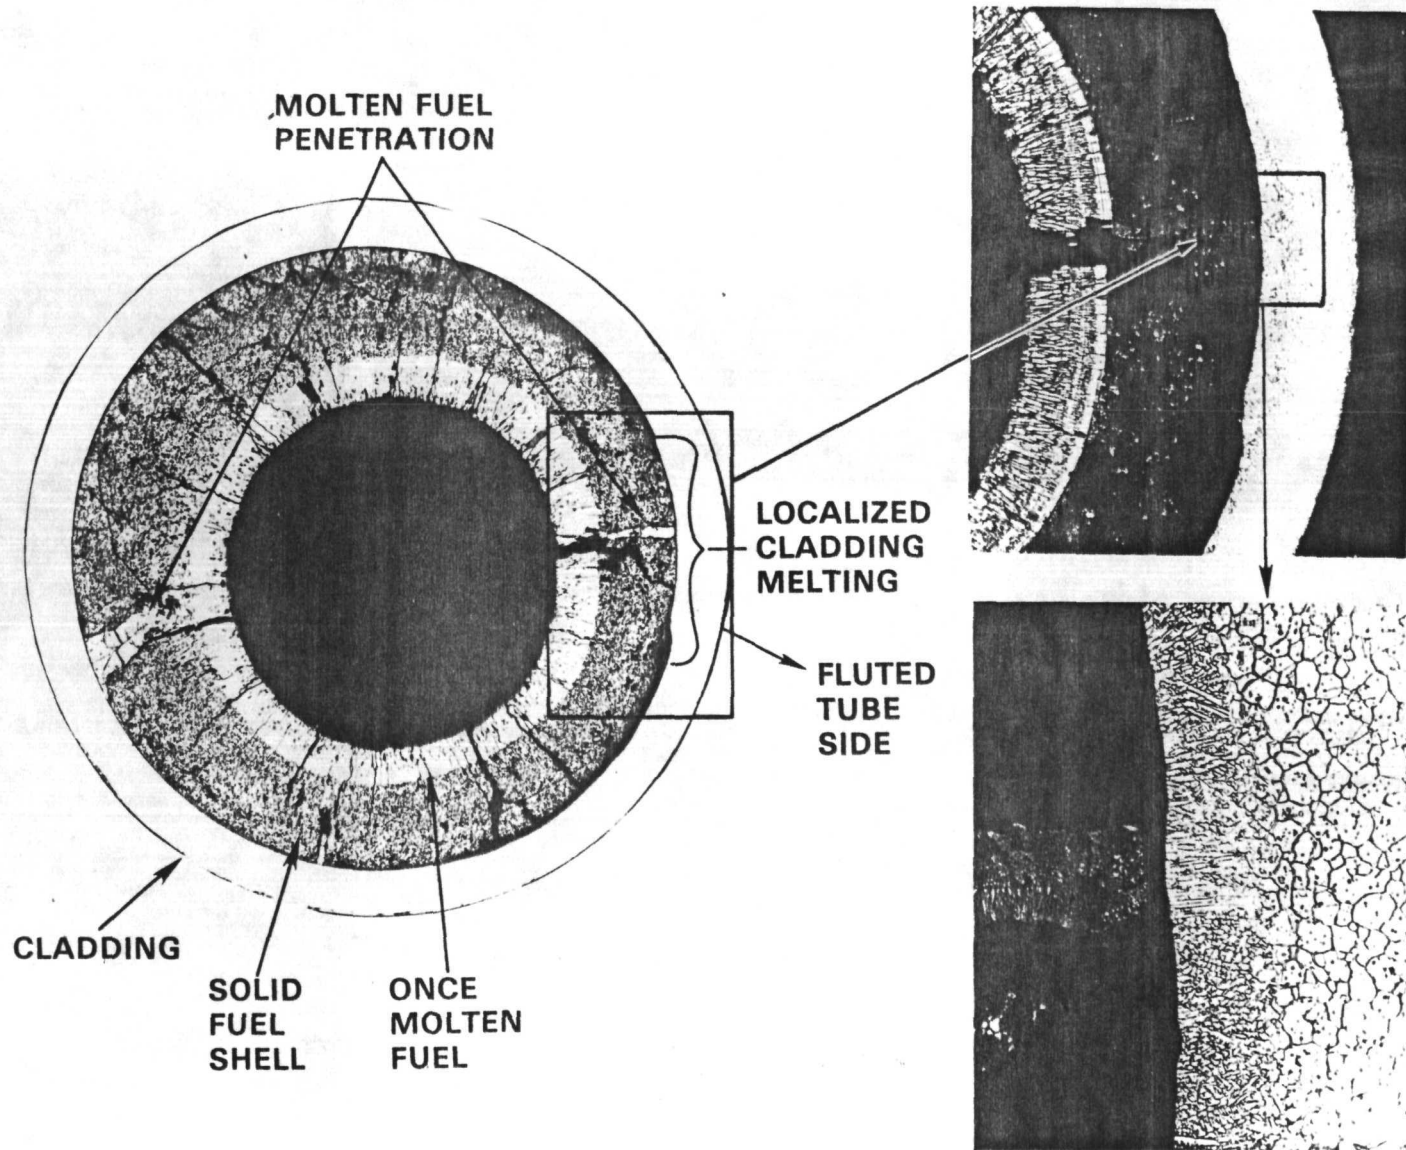
FIGURE 2. Molten Fuel Penetration and Local Cladding Melting in a W-2 Outer Fuel Pin.

Figure 2 shows a transverse metallography specimen taken at the 39 cm level. Several instances of molten fuel penetration of the solid outer fuel shell and contact with the cladding are apparent. On the fluted tube side of the pin, where pin bowing-induced flow restrictions are believed to have caused high cladding temperatures, molten fuel penetration caused localized melting of the cladding inner surface in the vicinity of the contact point. This phenomenon is believed responsible for the initial disruptive pin failure at the axial midplane.
