NUREG/CR-1603
UCRL-53000

Evaluation of Cracking in Feedwater Piping Adjacent to the Steam Generators in Nine Pressurized Water Reactor Plants

Alfred Goldberg, Ronald D. Streit, and Robert G. Scott

Lawrence Livermore Laboratory
7000 East Avenue
Livermore, CA 94550

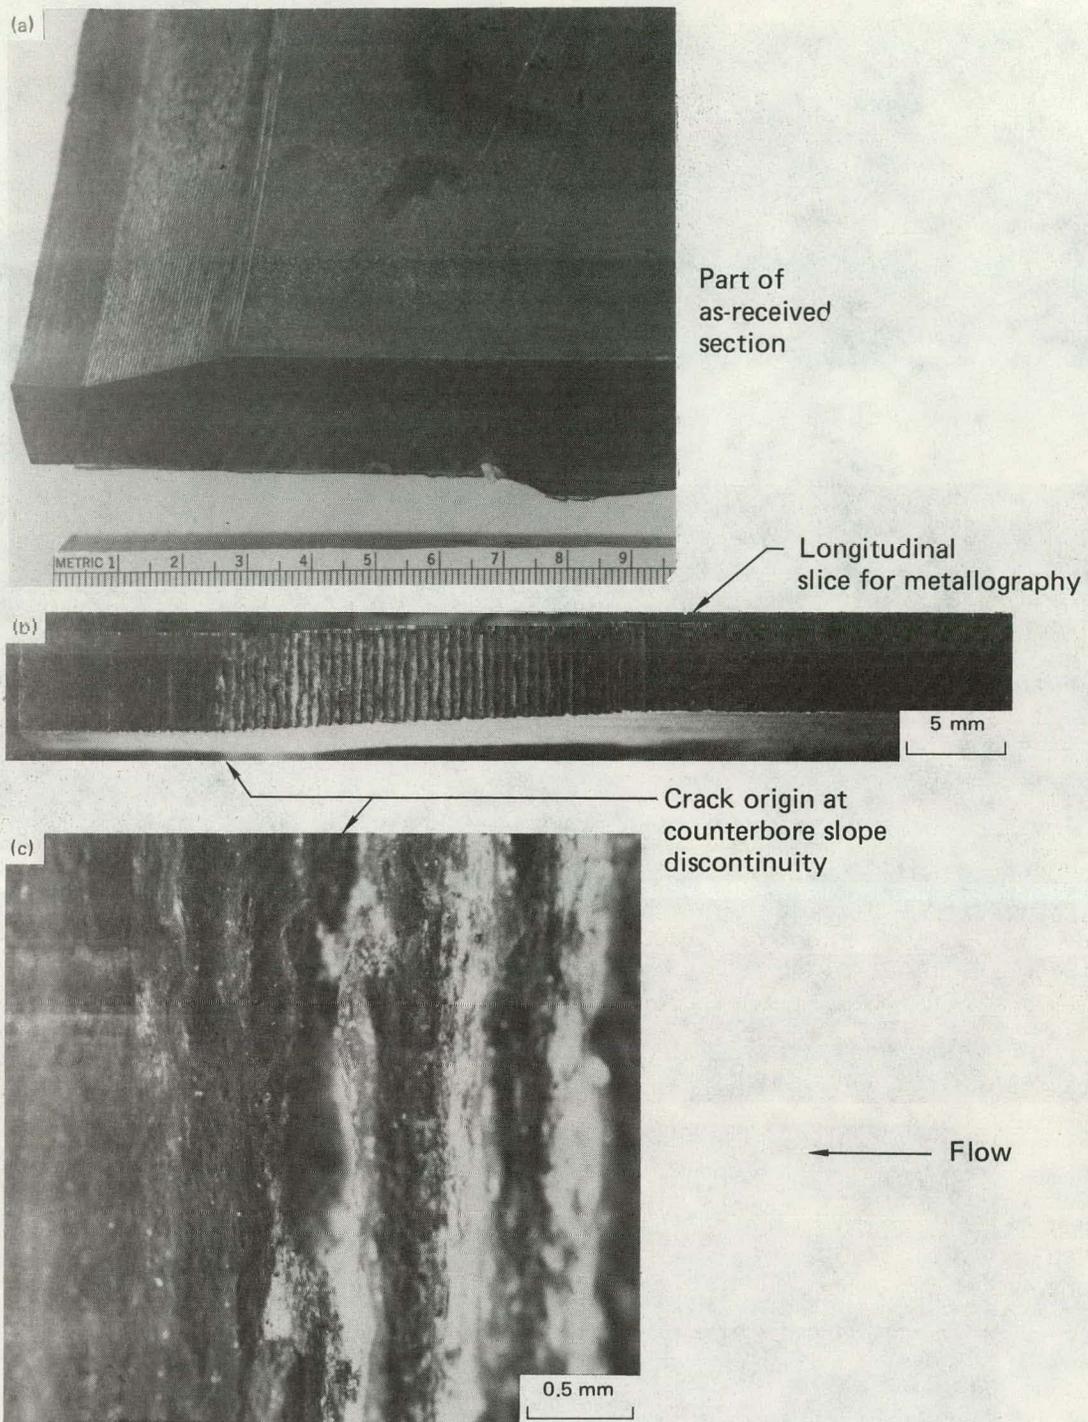
FIG. 3.1. Photographs of Ginna material showing abrupt change in cross section and deep machining grooves along the counterbore. View (a) shows the abrupt change in cross section at the bottom of the counterbore slope. Views (b) and (c) show at higher magnifications machining grooves, corrosion pits, and crack origin along counterbore seen in view (a).

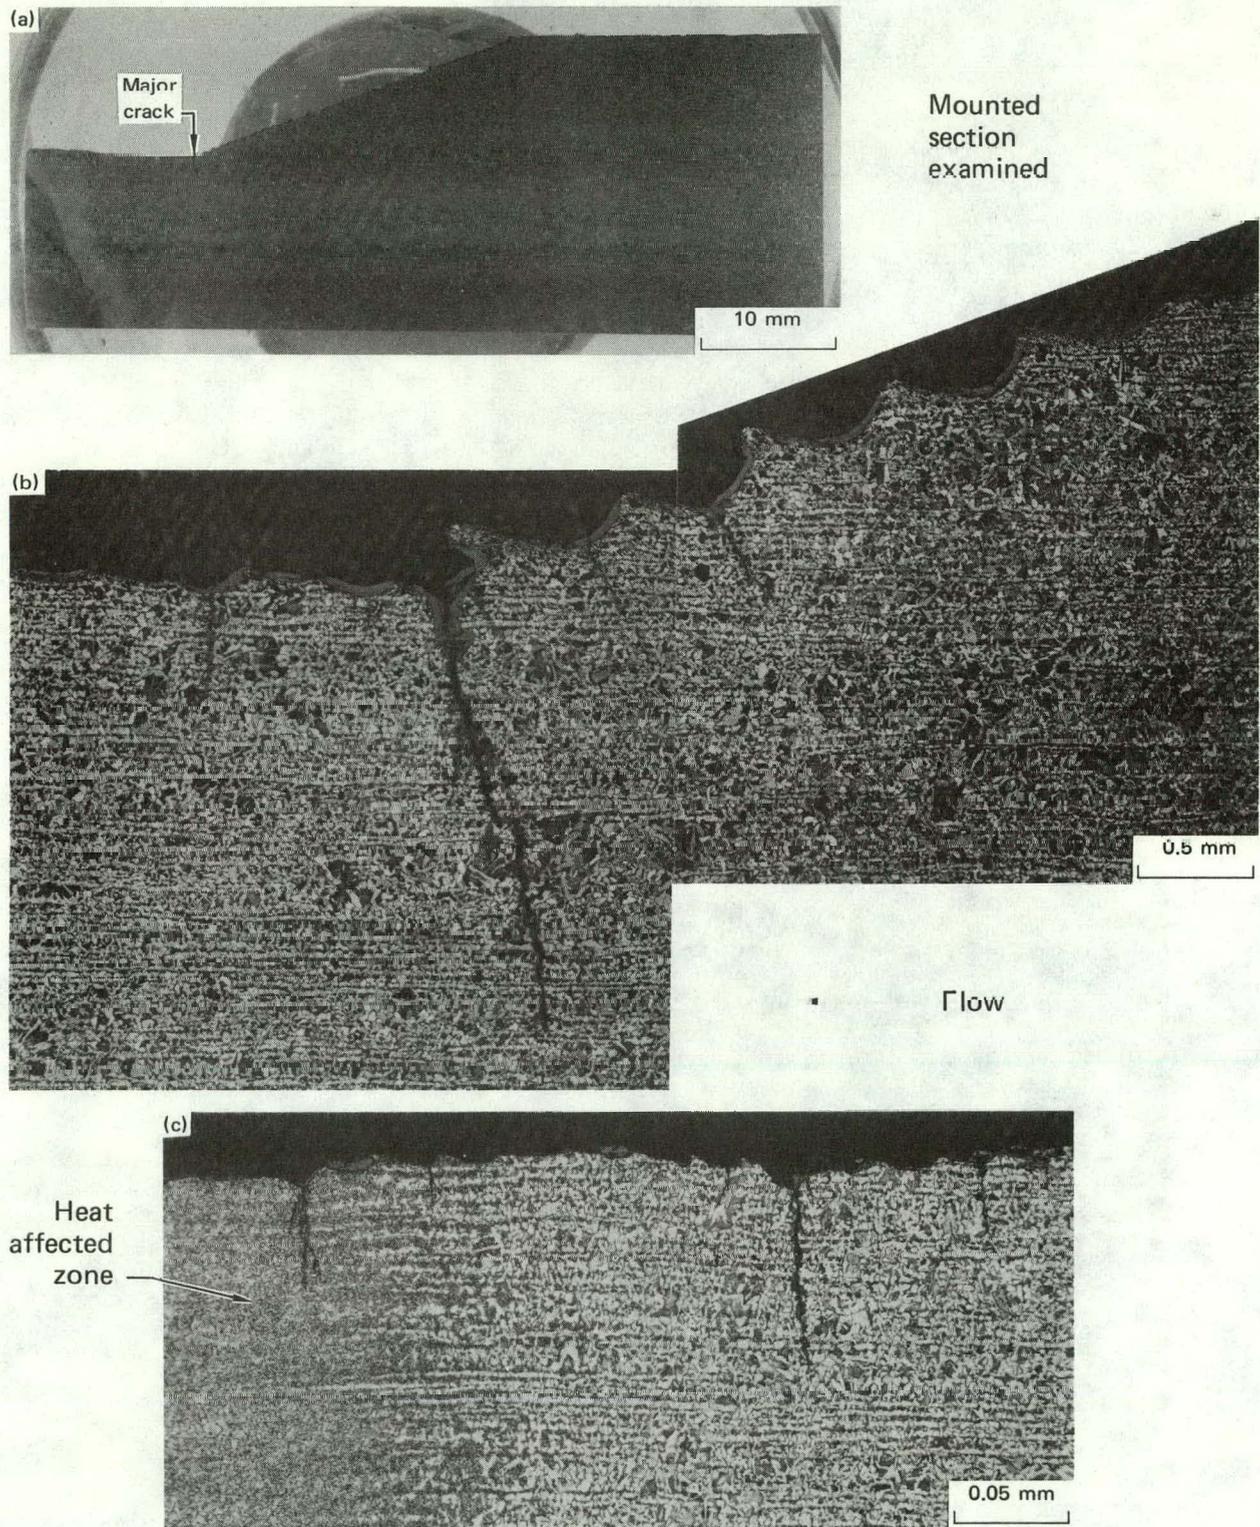
FIG. 3.2. Photomicrographs of Ginna material showing cracks initiating from machining grooves. Note that the major crack at the counterbore section change propagates in a direction that roughly bisects the angle between the normals to the two contiguous surfaces on either side of the crack. Also note corrosion pitting, especially at the crack origin.

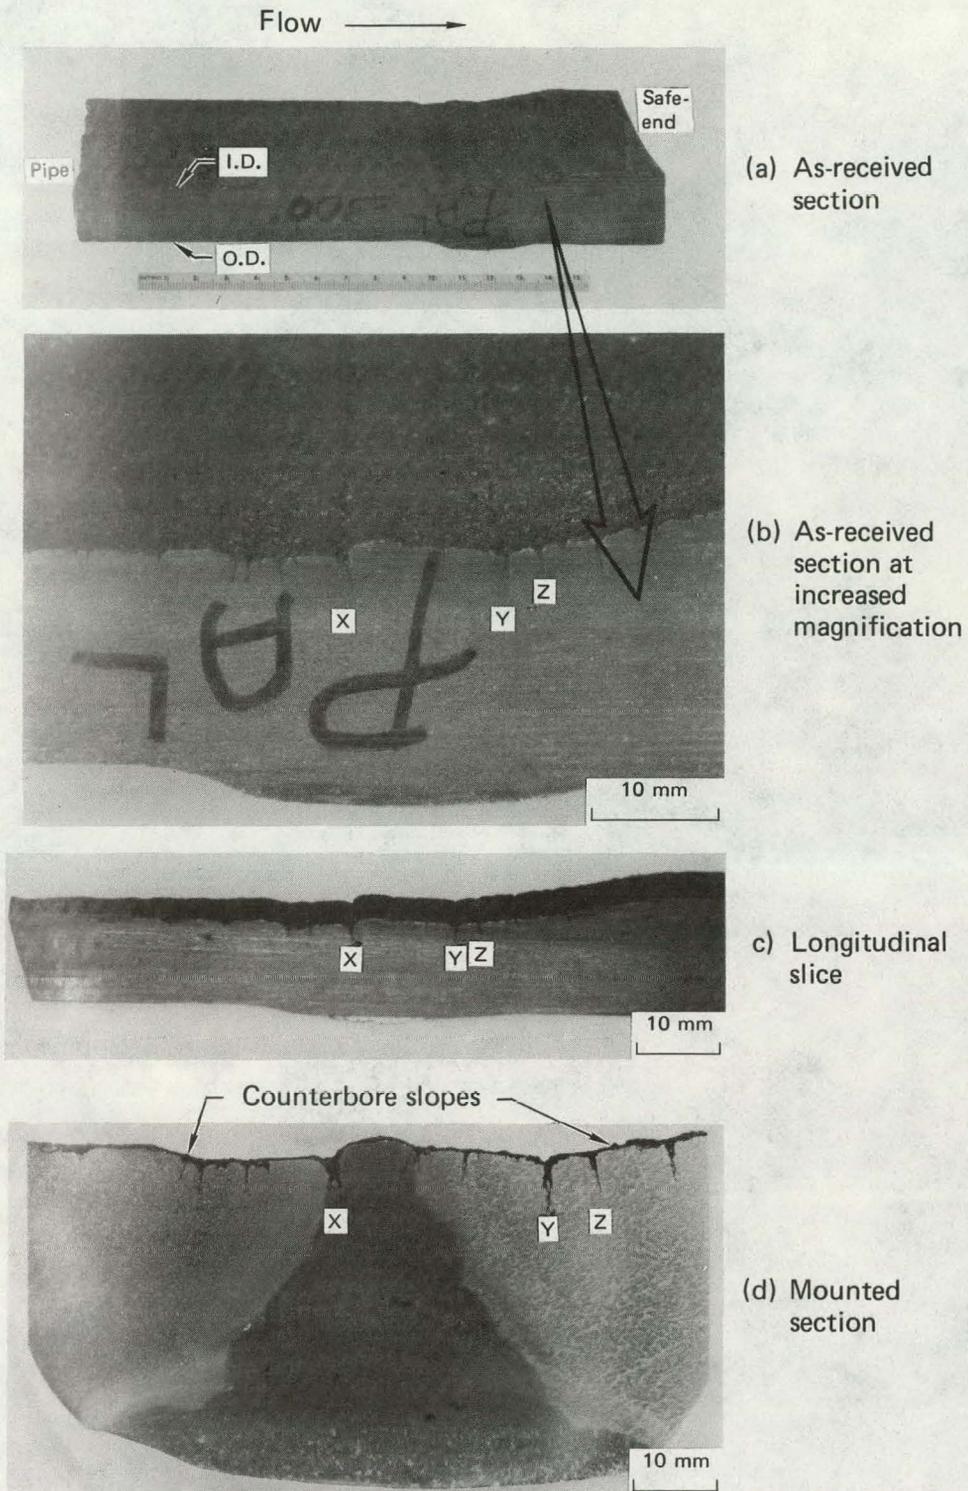
FIG. 3.3. Photographs of Palisades material illustrating the presence of numerous sites for crack initiation: change in section along both counterbores, weld to pipe and weld to safe-end interfaces, and corrosion pits. The three deepest cracks are indicated as X, Y, and Z.

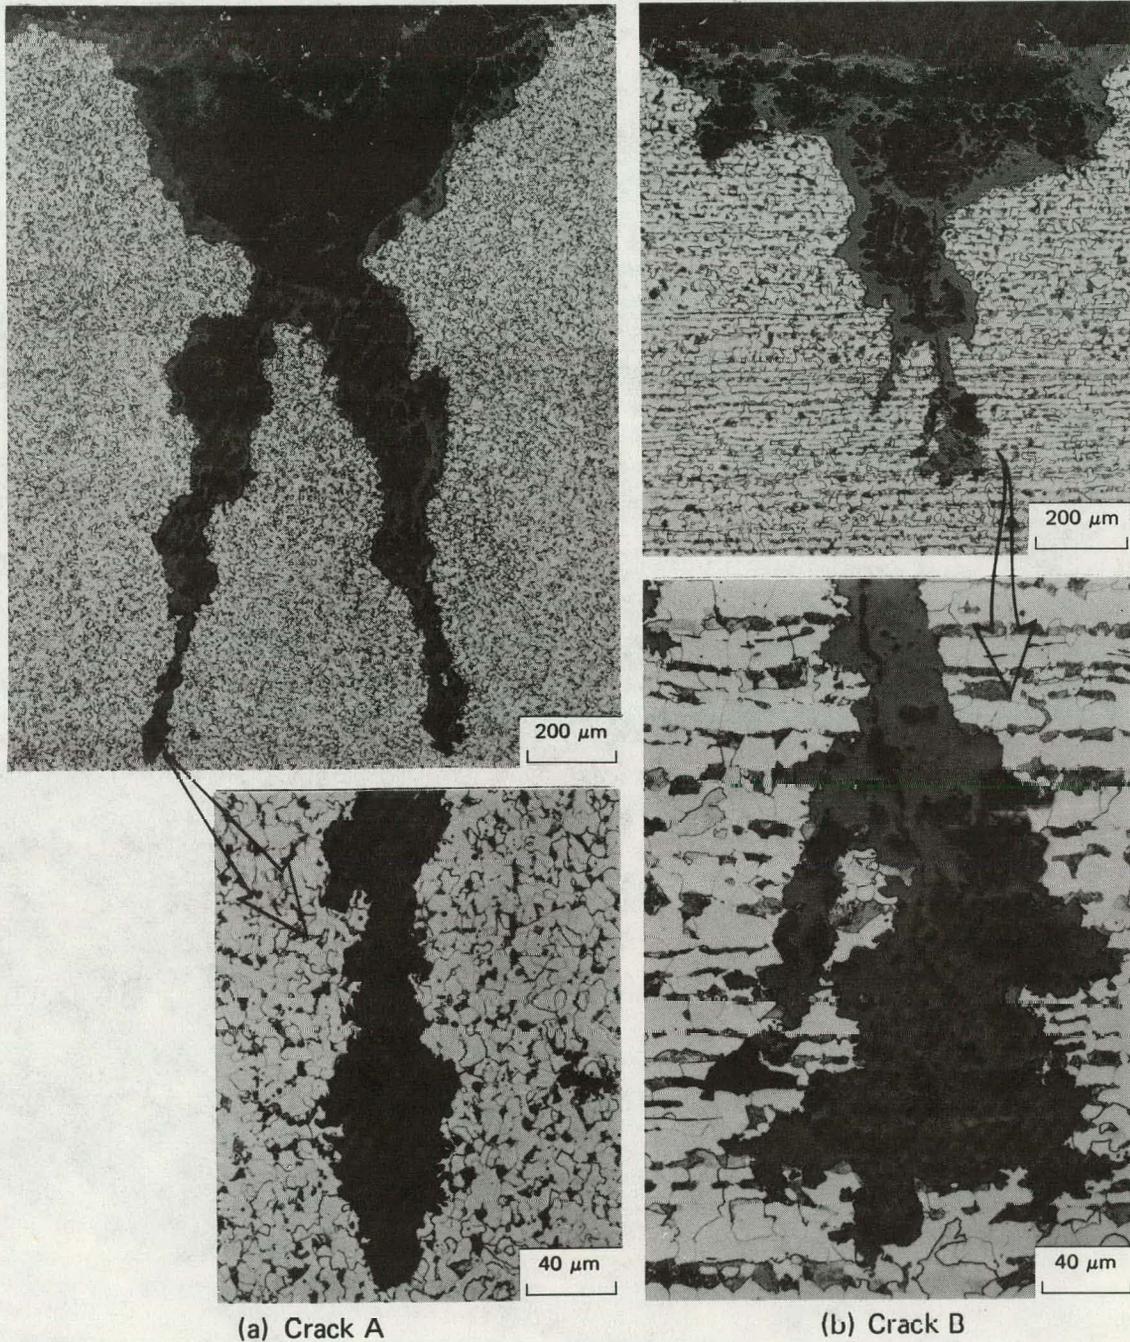
FIG. 3.7. Major cracks in San Onofre section. Refer to Fig. 3.4(a). Crack A initiates at large discontinuity at inside diameter surface of weld. Crack B is largest crack in reducer section; the overriding influence of corrosion is apparent in this crack. Both cracks contain large corrosion craters.

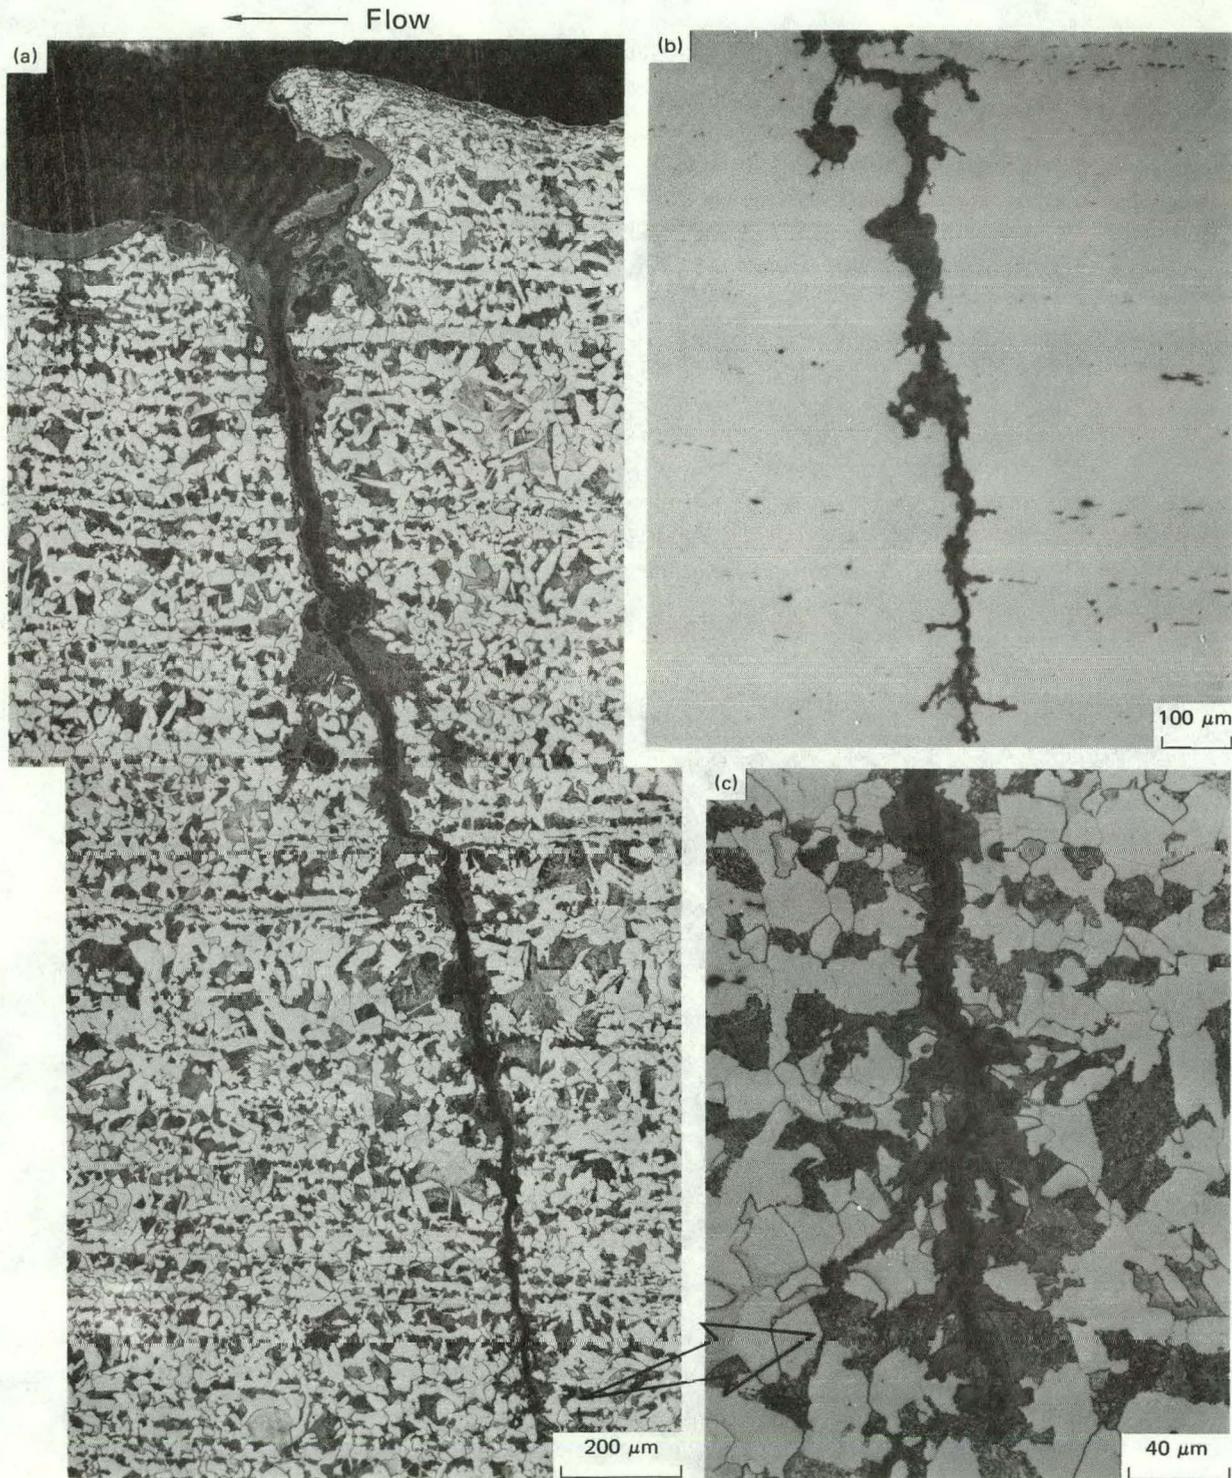
FIG. 3.8. Major crack in Ginna section. Refer to Fig. 3.4(b). In view (a), a major crack initiates at the root of the machining groove at the bottom of the counterbore slope; in view (b), an as-polished section shows lateral corrosion spikes at inclusions. Some branching is evident, especially near crack tip. Minor corrosion craters are present along most of crack.

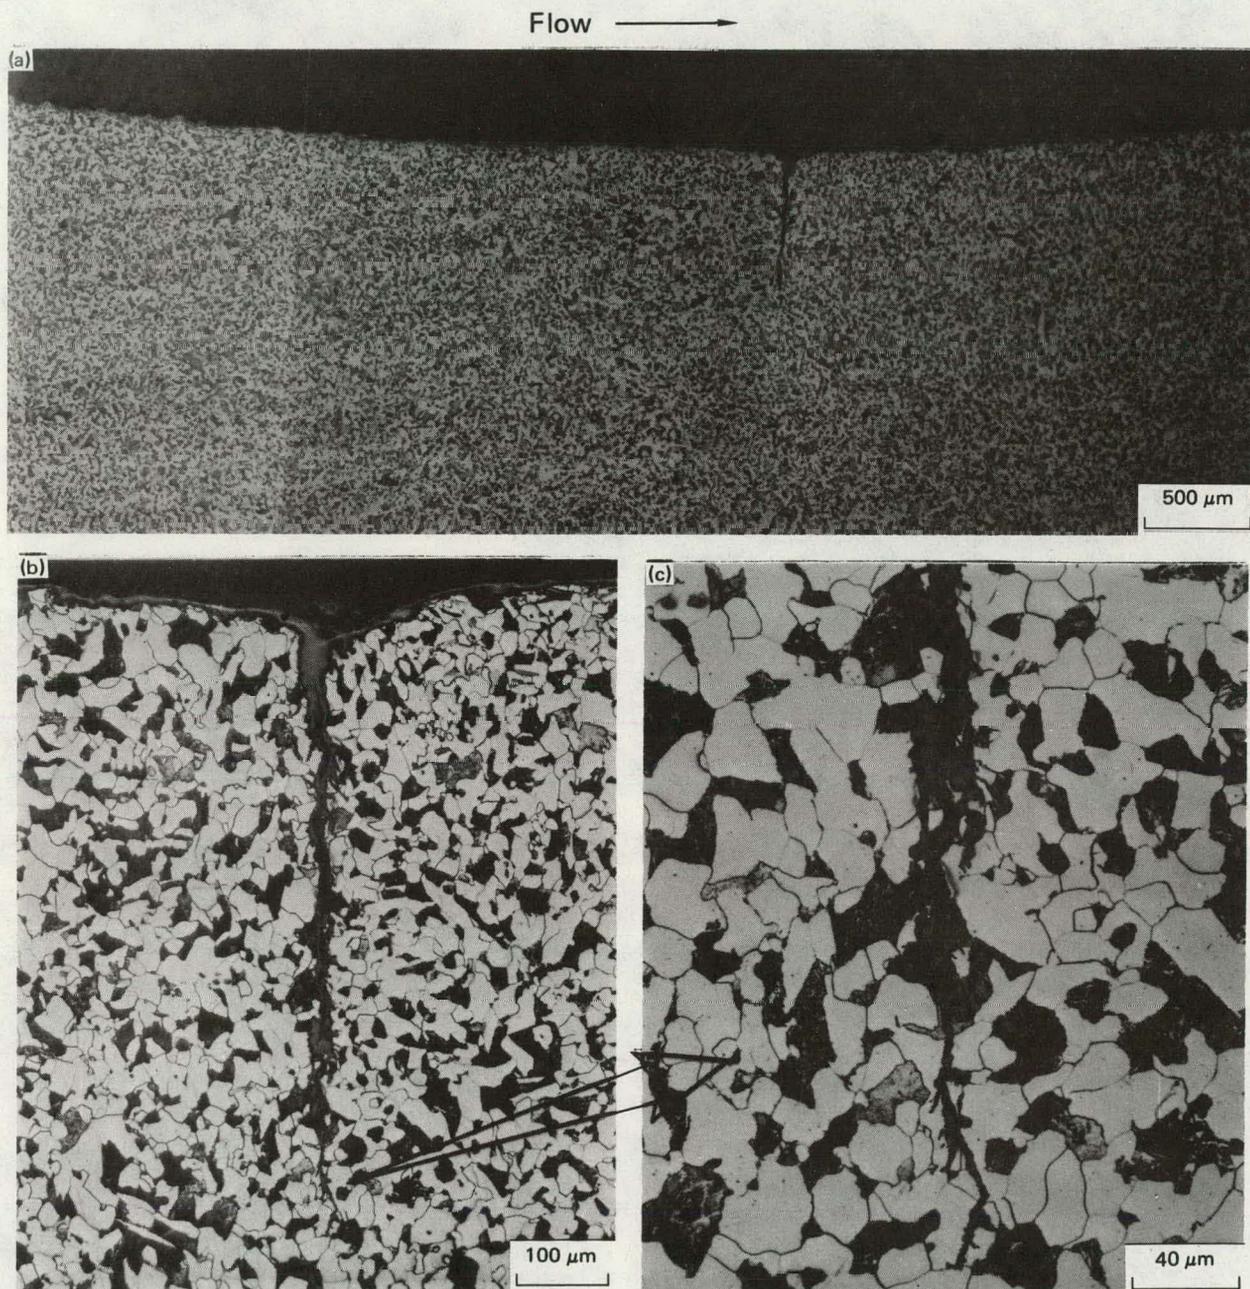
FIG. 3.9. Major crack in H. B. Robinson section. Refer to Fig. 3.4(c). In view (a), a major crack initiates at a small discontinuity along the counterbore bottom; in views (b) and (c), minor corrosion craters and minor branching are evident.

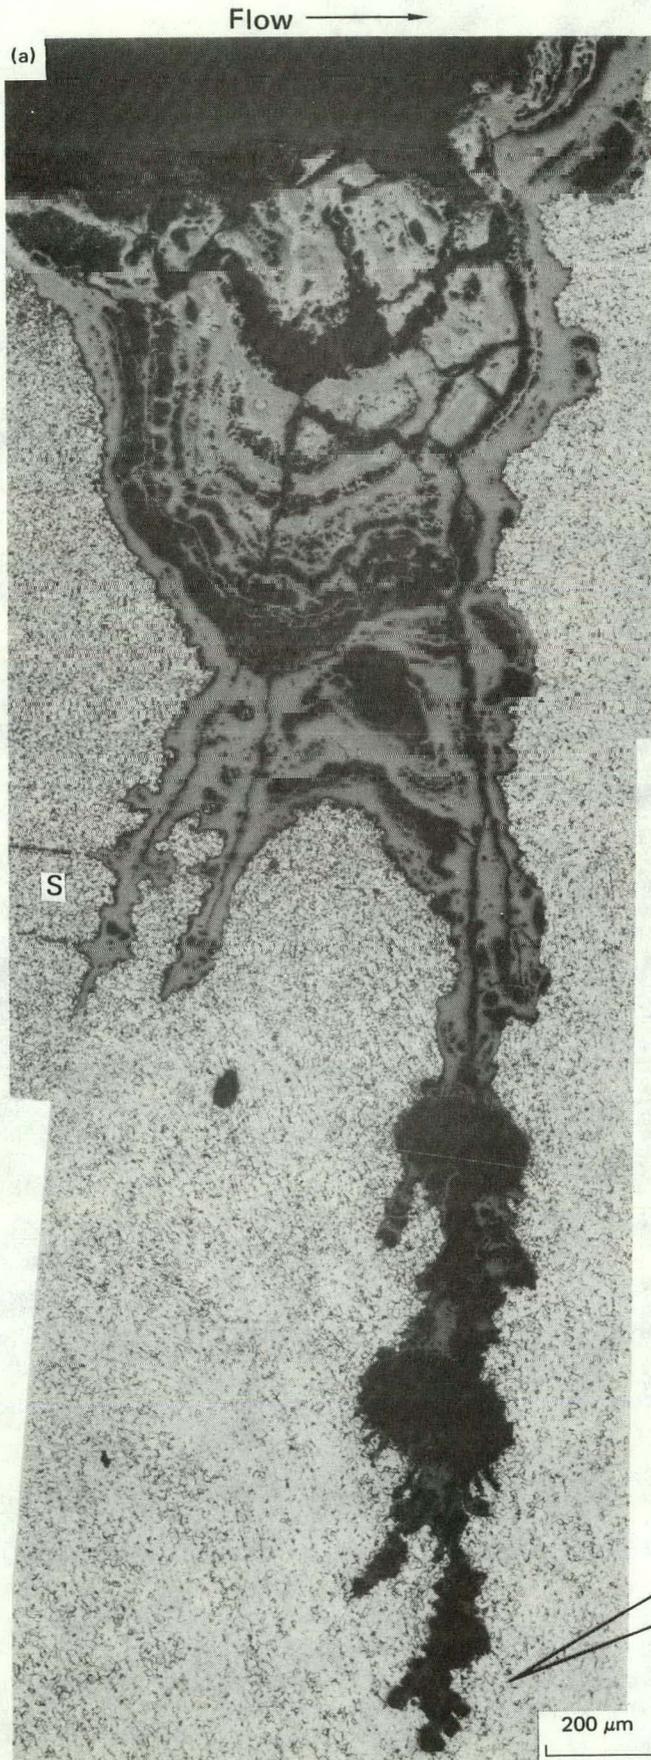
FIG. 3.10. Major crack in Palisades section, Crack A, initiates at pipe-to-weld interface. Refer to Fig. 3.5(a). Note large corrosion craters with corrosion spikes. Some lateral corrosion spikes at inclusions at S in view (a).

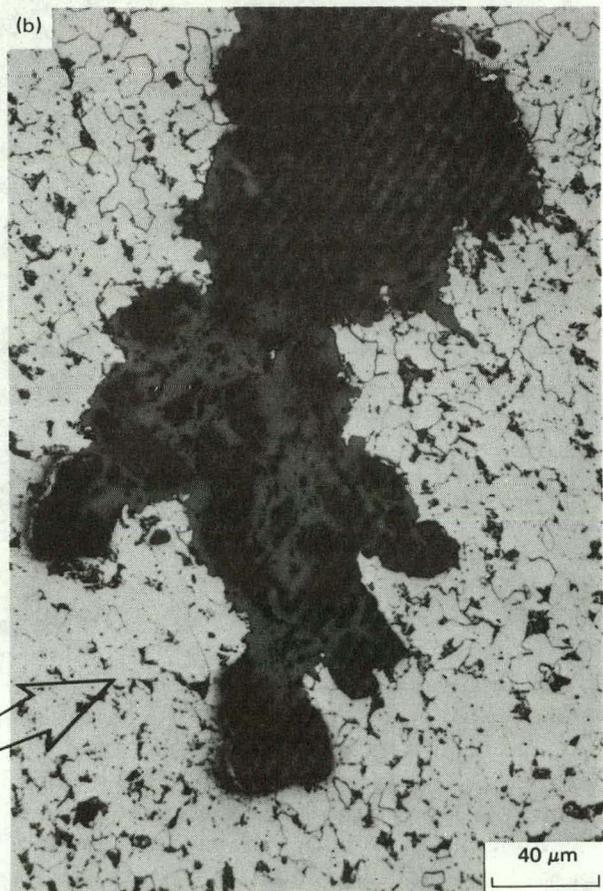
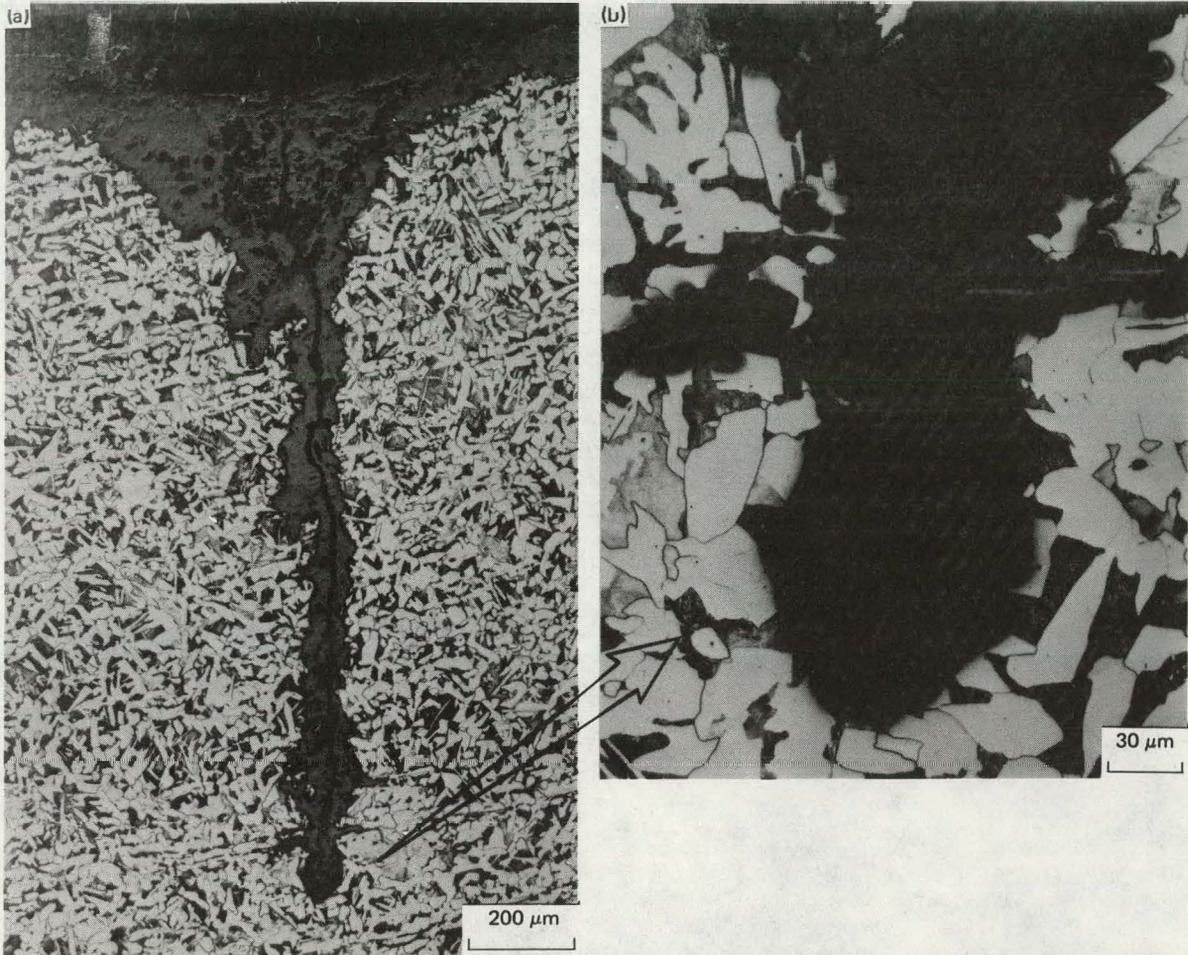
FIG. 3.11. Major crack, Crack B, in pipe of Palisades section initiates at discontinuity at bottom of counterbore slope. Refer to Fig. 3.5(a). See significant amount of corrosion along length of crack with periodic corrosion craters. Some corrosion spikes associated with both inclusions and craters.

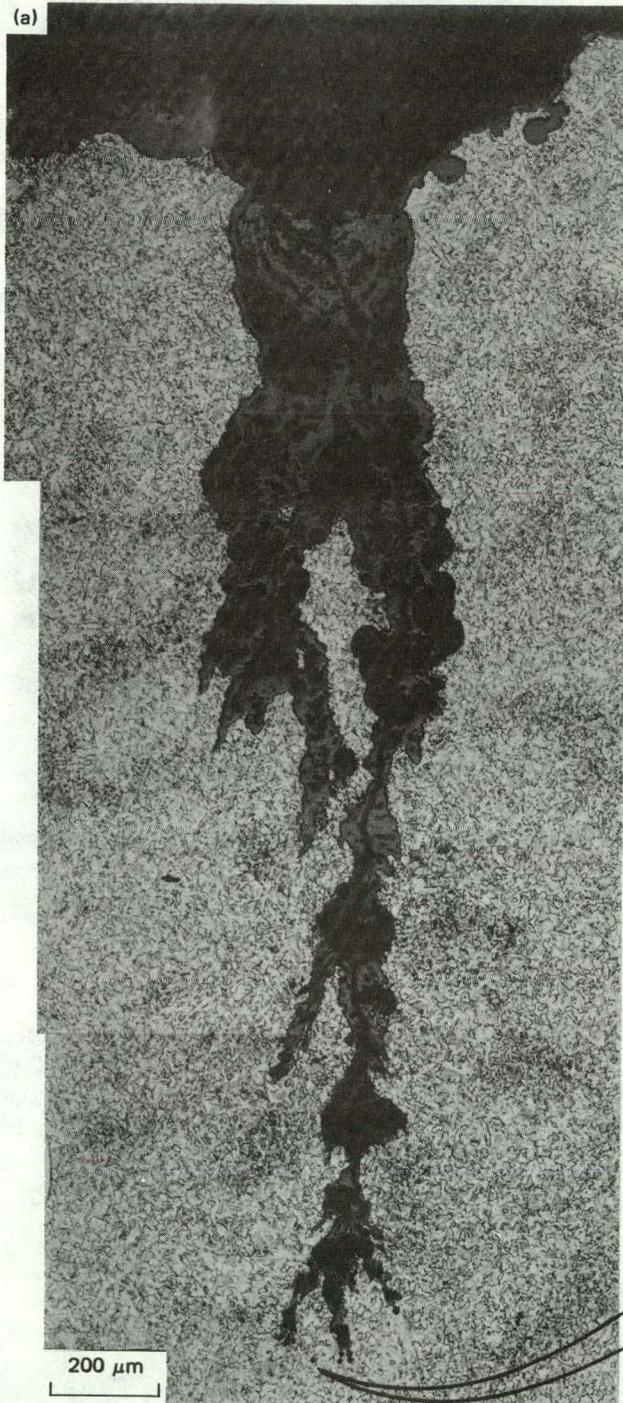
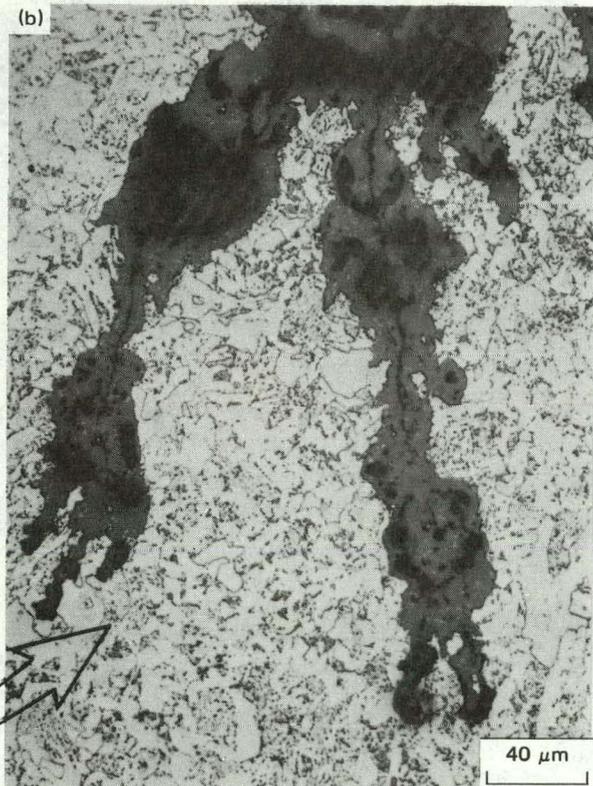
FIG. 3.12. Major crack, Crack C, in safe end of Palisades section initiates at discontinuity at bottom of counterbore slope. Refer to Fig. 3.5(a). Note large corrosion craters with corrosion spikes. Spikes at crack tip are suggestive of initial stage of branching.

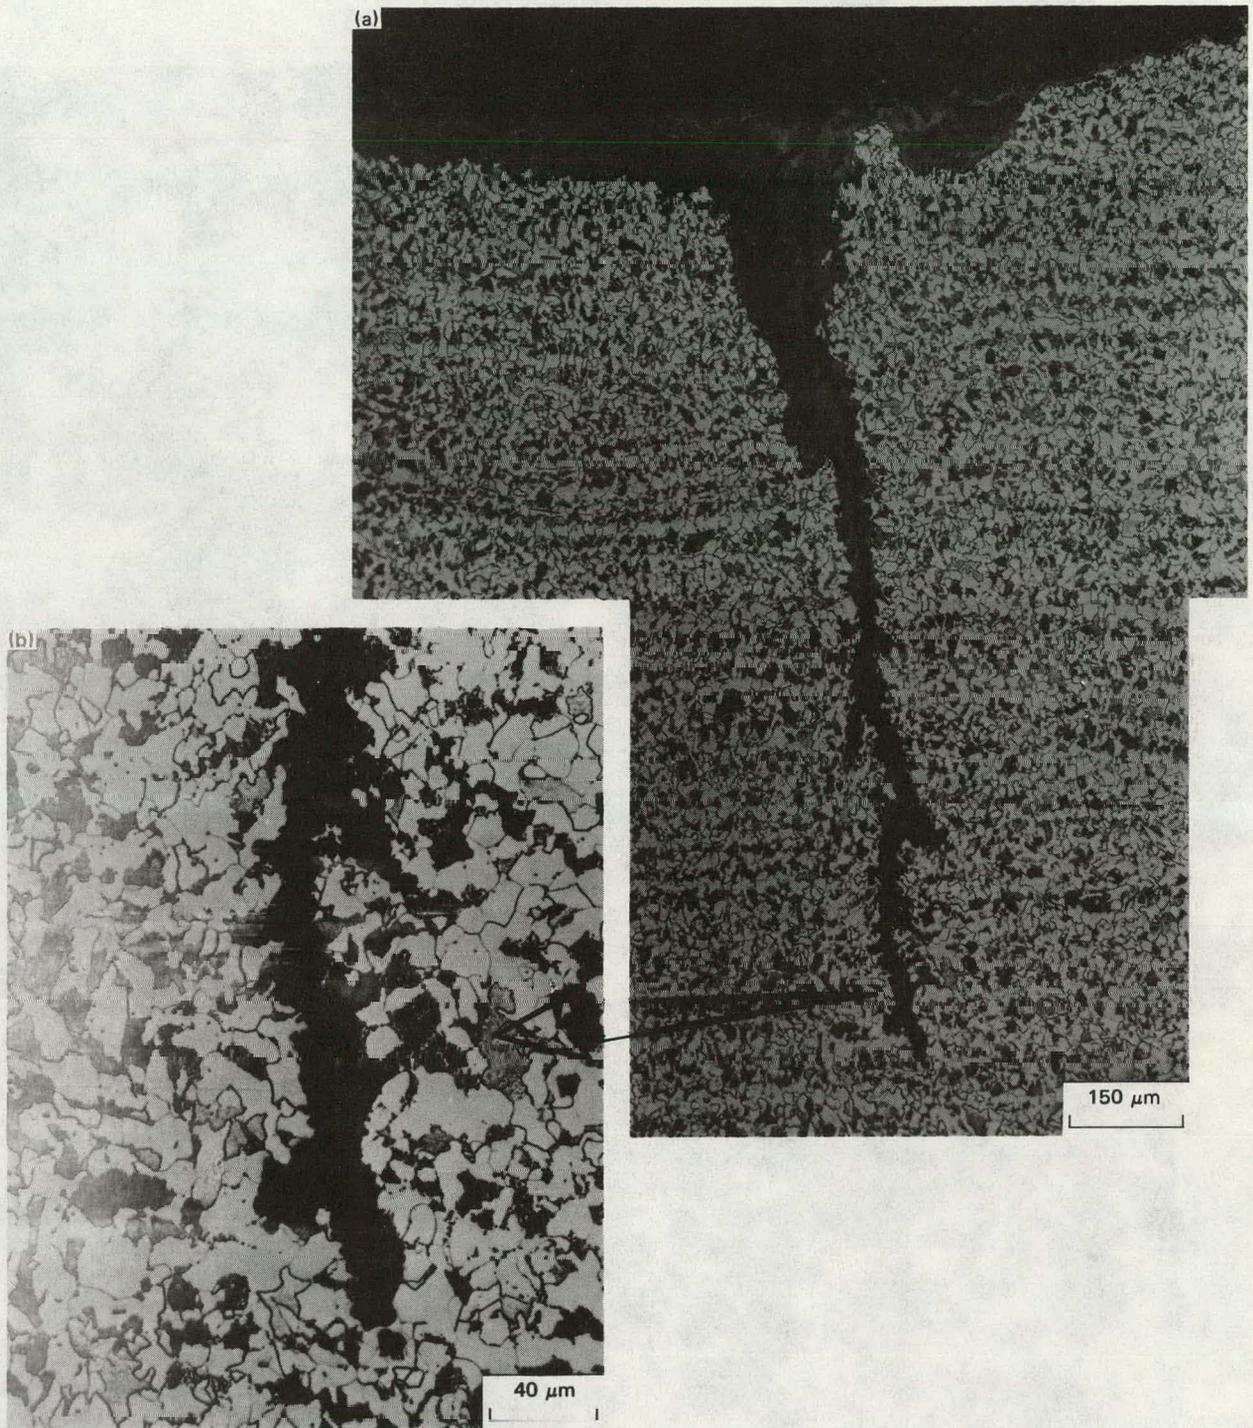
FIG. 3.13. Major crack in Point Beach section initiates at discontinuity at bottom of counterbore slope of reducer. Refer to Fig. 3.5(b). Note minor corrosion craters with corrosion spikes.

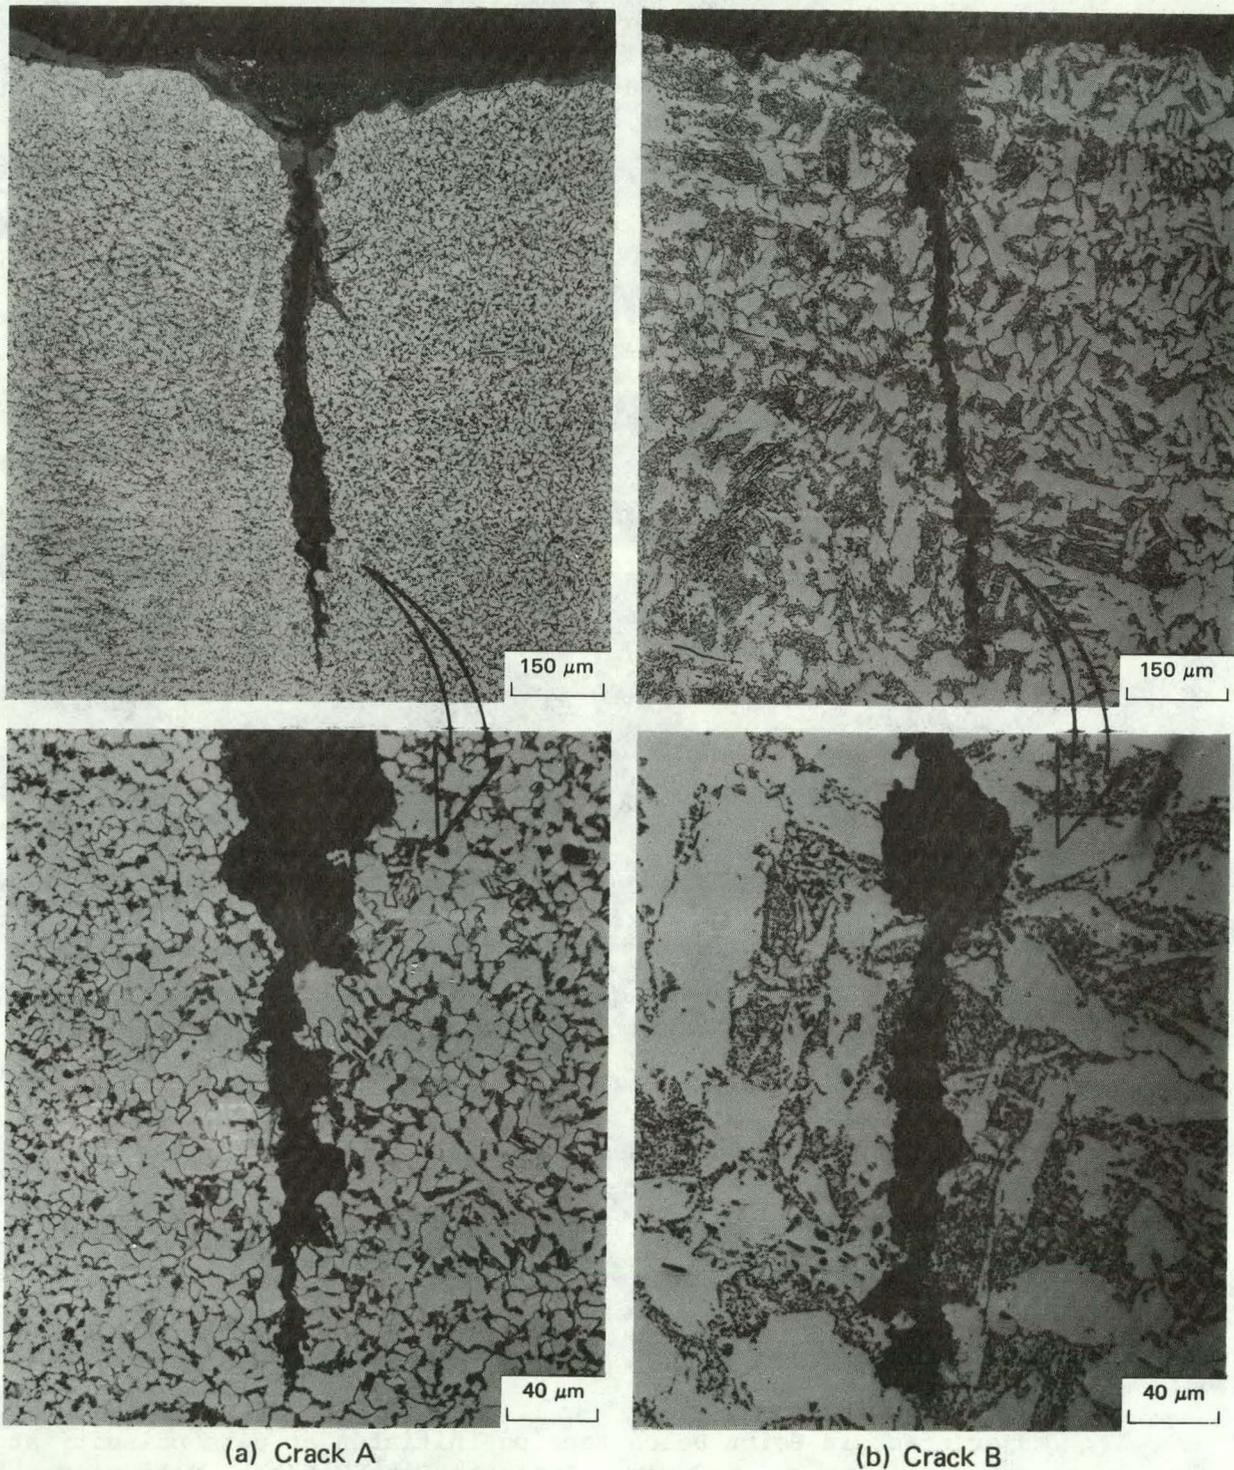
FIG. 3.14. Major crack, Crack A, initiates at pipe-to-weld interface (85X) and Crack B initiates at discontinuity at bottom of counterbore slope (100X) in Kewaunee section. Refer to Fig. 3.5(c). Corrosion craters and spikes are seen at craters. Note that a small sharp crack tip extends from deepest crater in both cracks, lower photographs.

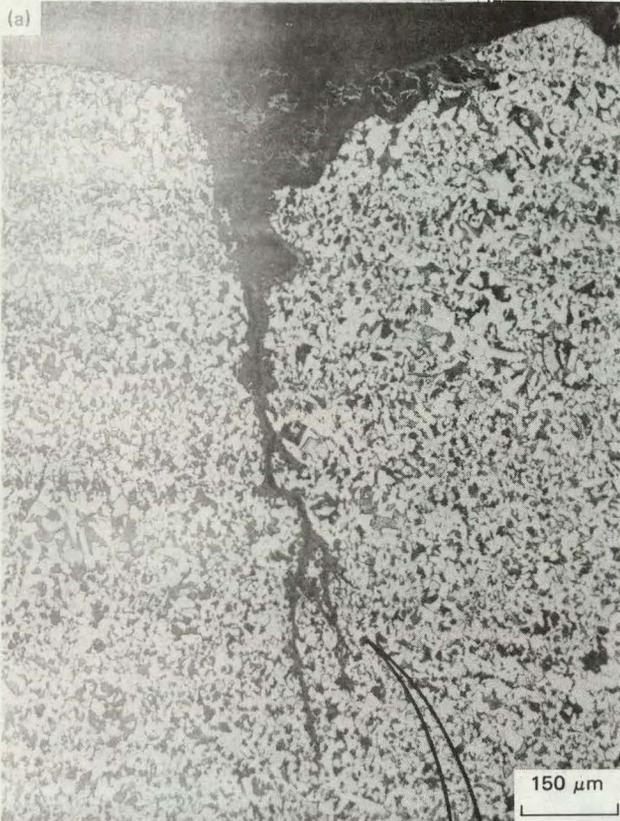
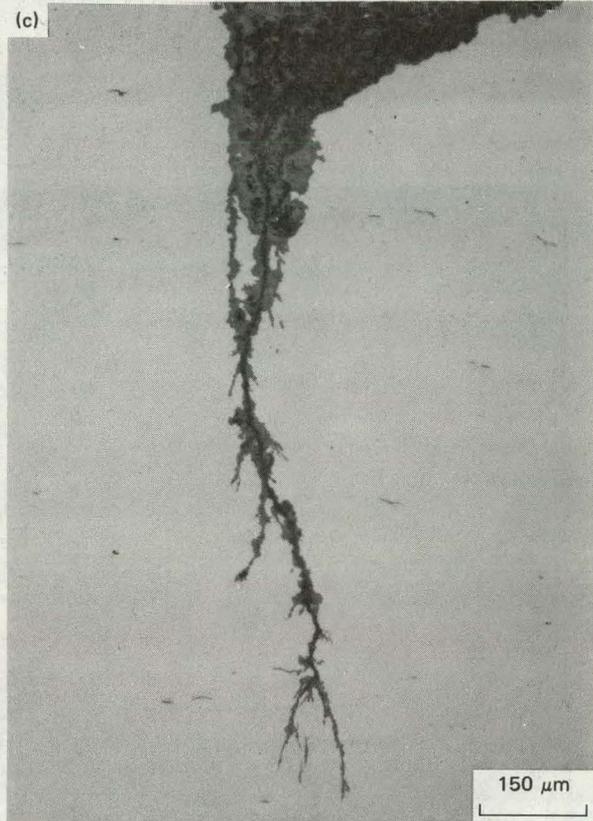
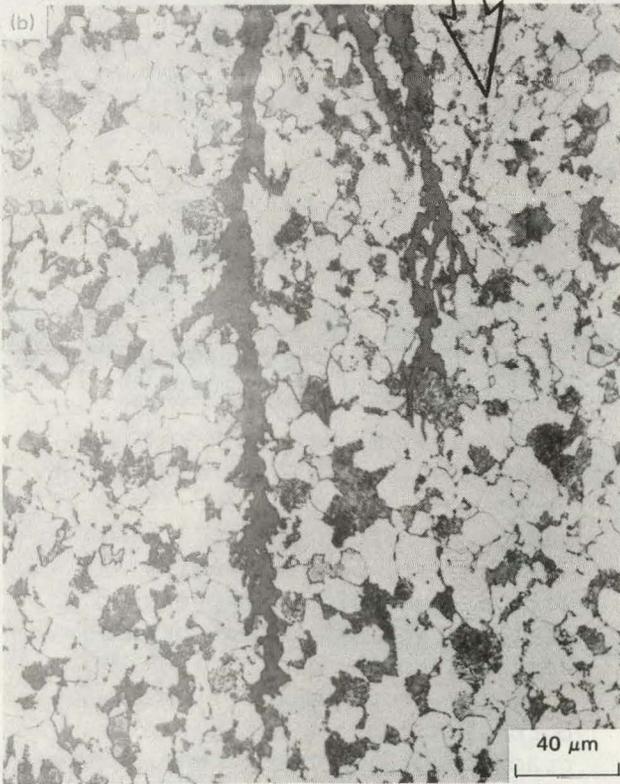
FIG. 3.15. Major crack in Beaver Valley section initiates at discontinuity at bottom of counterbore slope of elbow. Refer to Fig. 3.6(a). Note some corrosion craters. Sample shows most extensive branching of all plants. Note as-polished section.

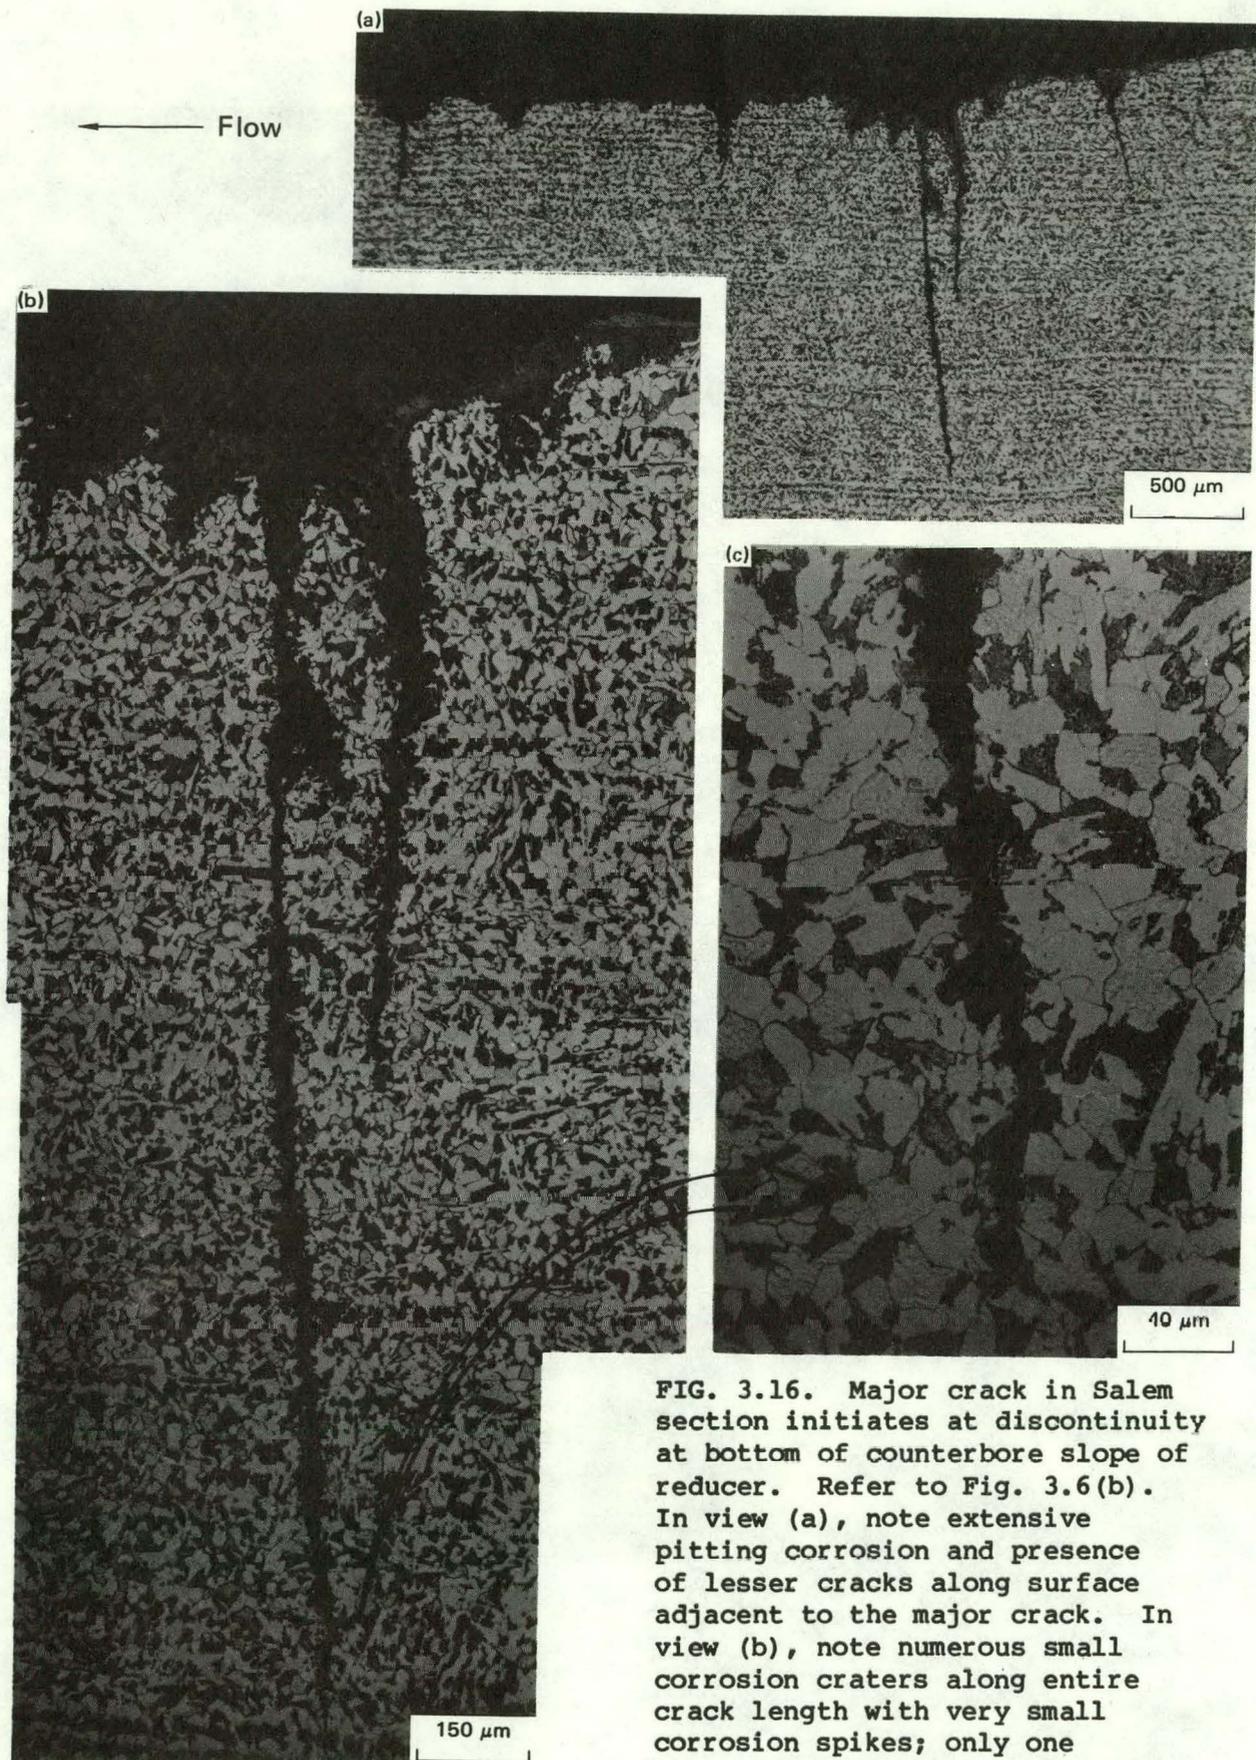
FIG. 3.16. Major crack in Salem section initiates at discontinuity at bottom of counterbore slope of reducer. Refer to Fig. 3.6(b). In view (a), note extensive pitting corrosion and presence of lesser cracks along surface adjacent to the major crack. In view (b), note numerous small corrosion craters along entire crack length with very small corrosion spikes; only one large corrosion spike is visible.
