NUREG/CR-1603
UCRL-53000

Evaluation of Cracking in Feedwater Piping Adjacent to the Steam Generators in Nine Pressurized Water Reactor Plants

Alfred Goldberg, Ronald D. Streit, and Robert G. Scott

Lawrence Livermore Laboratory
7000 East Avenue
Livermore, CA 94550

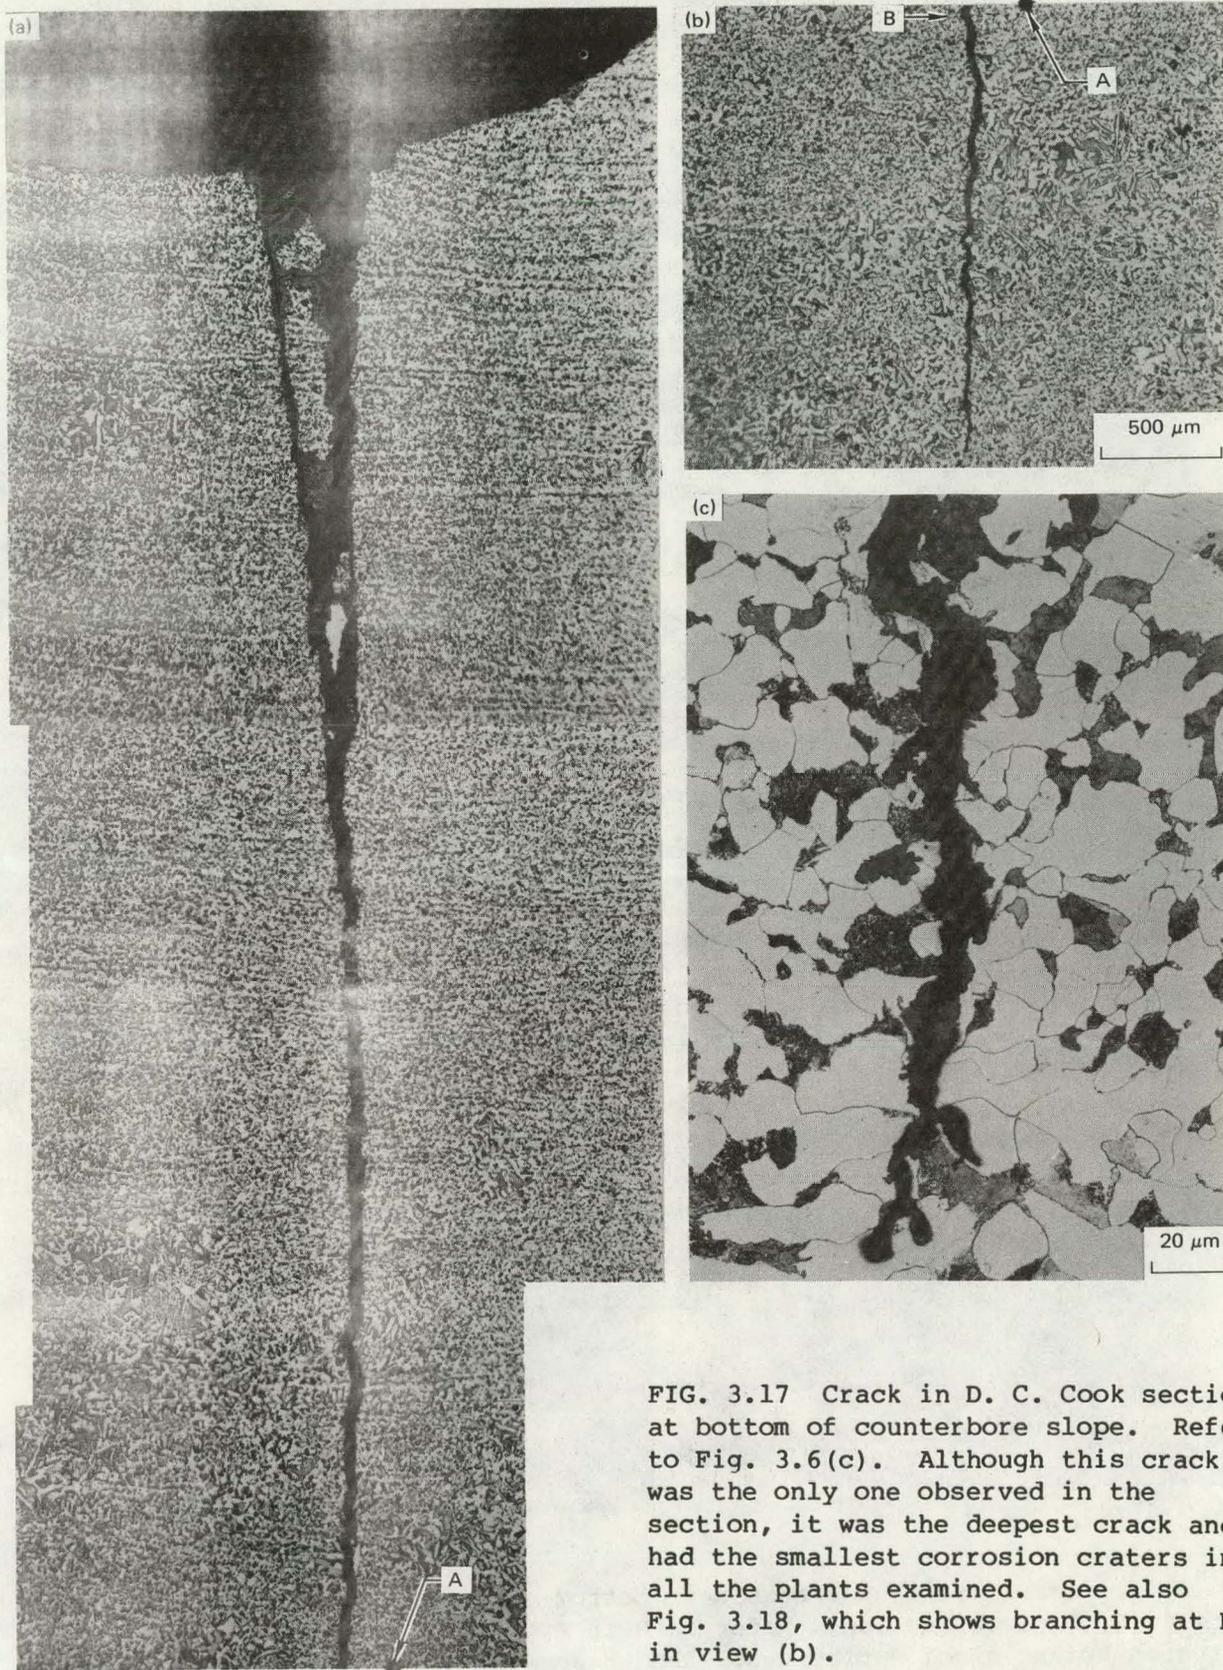
FIG. 3.17 Crack in D. C. Cook section at bottom of counterbore slope. Refer to Fig. 3.6(c). Although this crack was the only one observed in the section, it was the deepest crack and had the smallest corrosion craters in all the plants examined. See also Fig. 3.18, which shows branching at B in view (b).

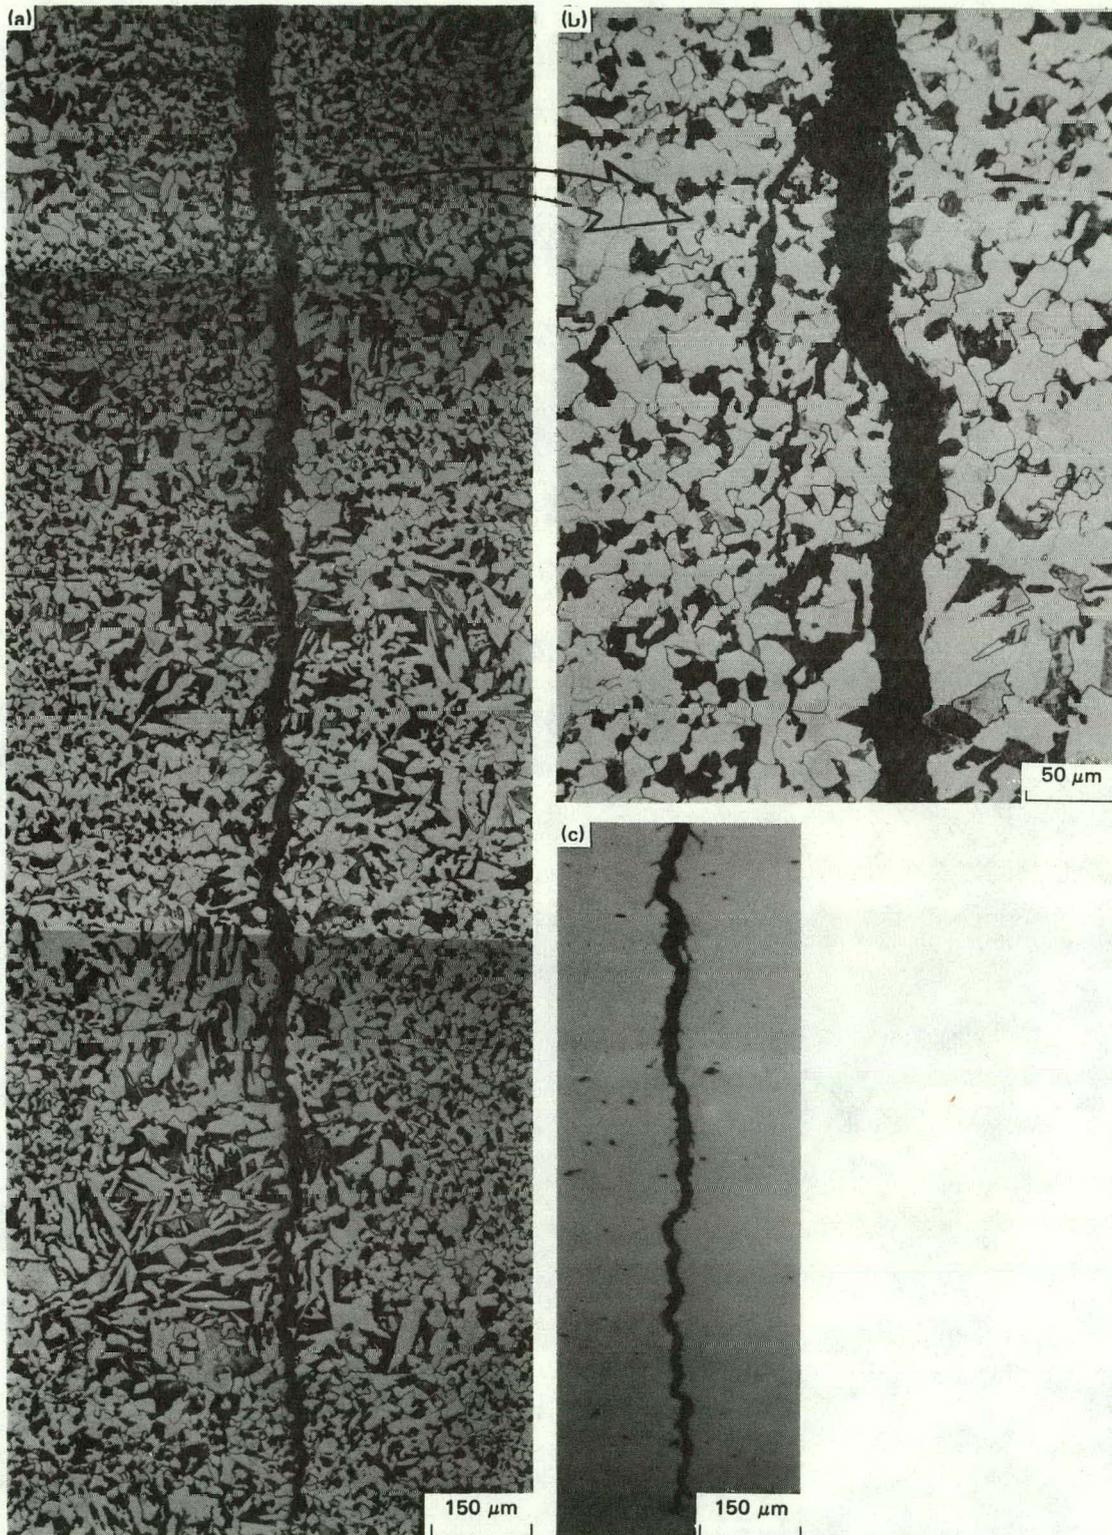
FIG. 3.18. Small branched cracks near bottom of crack at bottom of counterbore slope in D. C. Cook section. Refer to B in Fig. 3.17(b). Note very small corrosion spikes along entire crack length shown, especially in the as-polished section view (c).

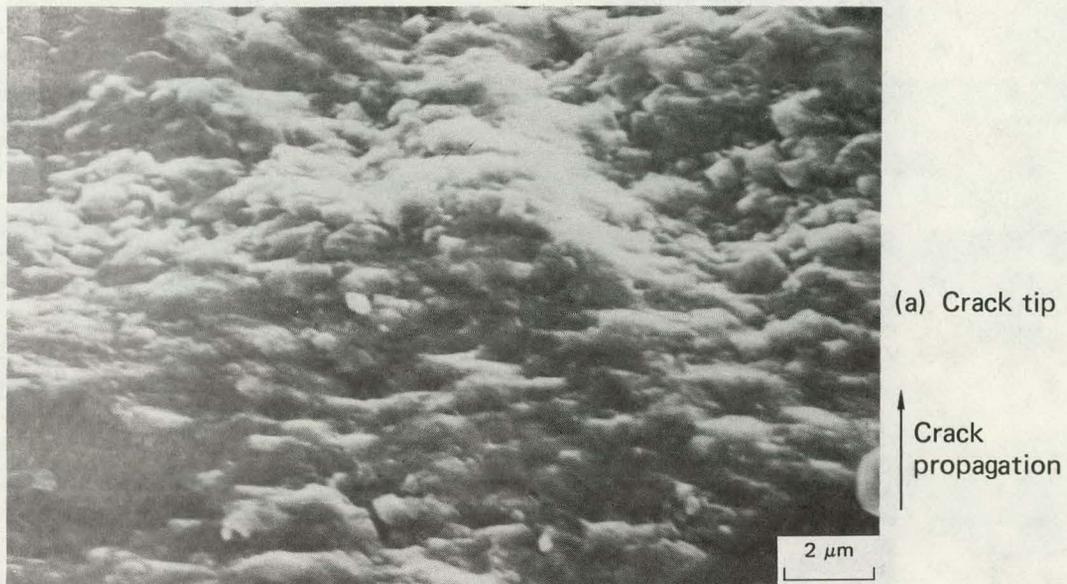
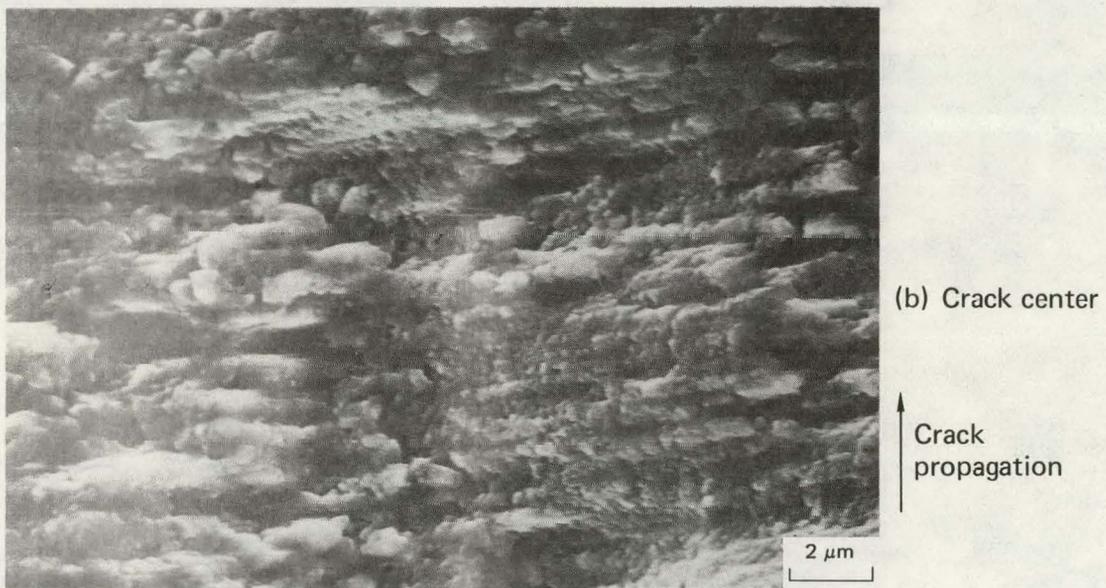
FIG. 3.25. SEM fractographs of as-corroded crack surface from Beaver Valley showing crater-like, parallel ridges suggesting cyclic events.

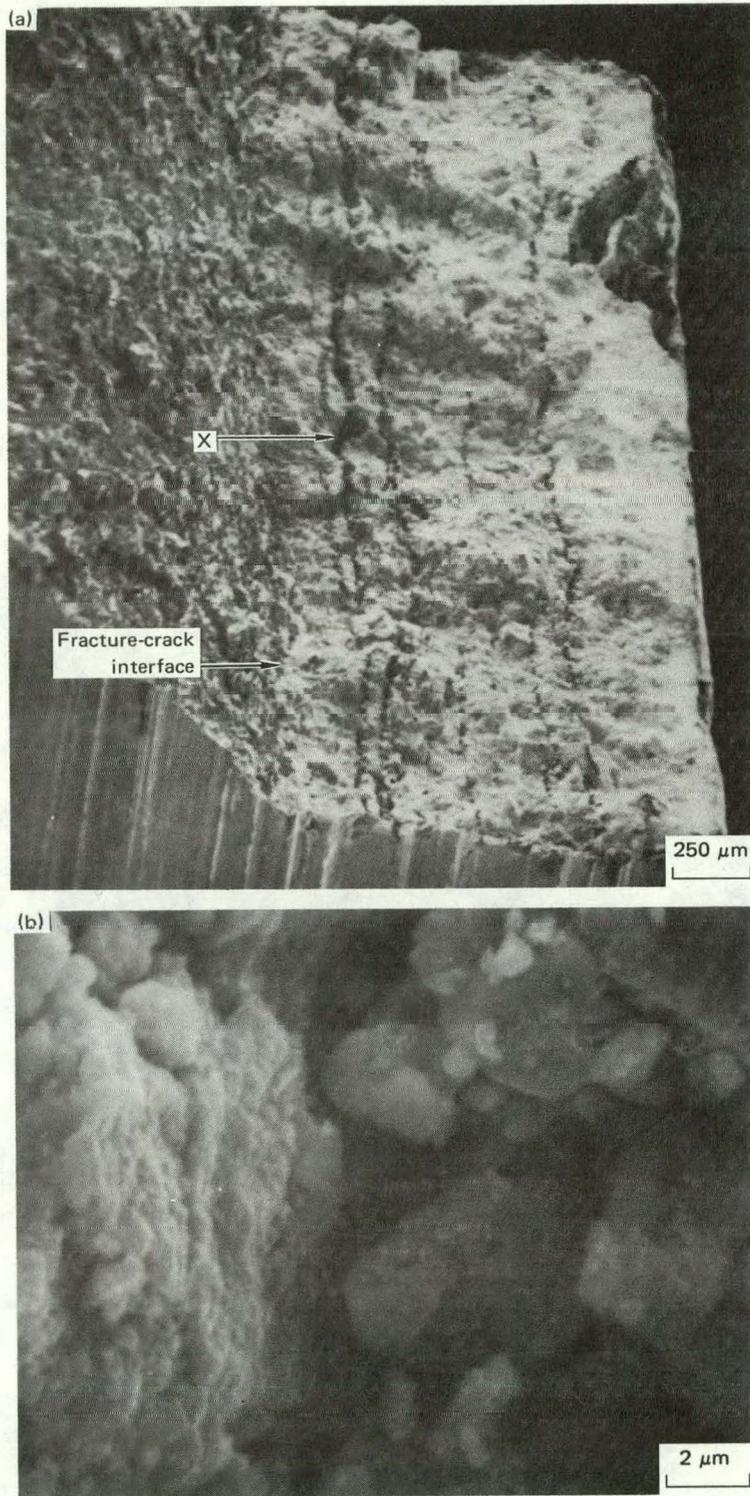
FIG. 3.26. SEM fractographs of as-corroded crack surface from Ginna. View (a) shows arrest bands along the surface. View (b) shows the relatively porous morphology of corrosion product in the arrest band indicated by X in view (a).

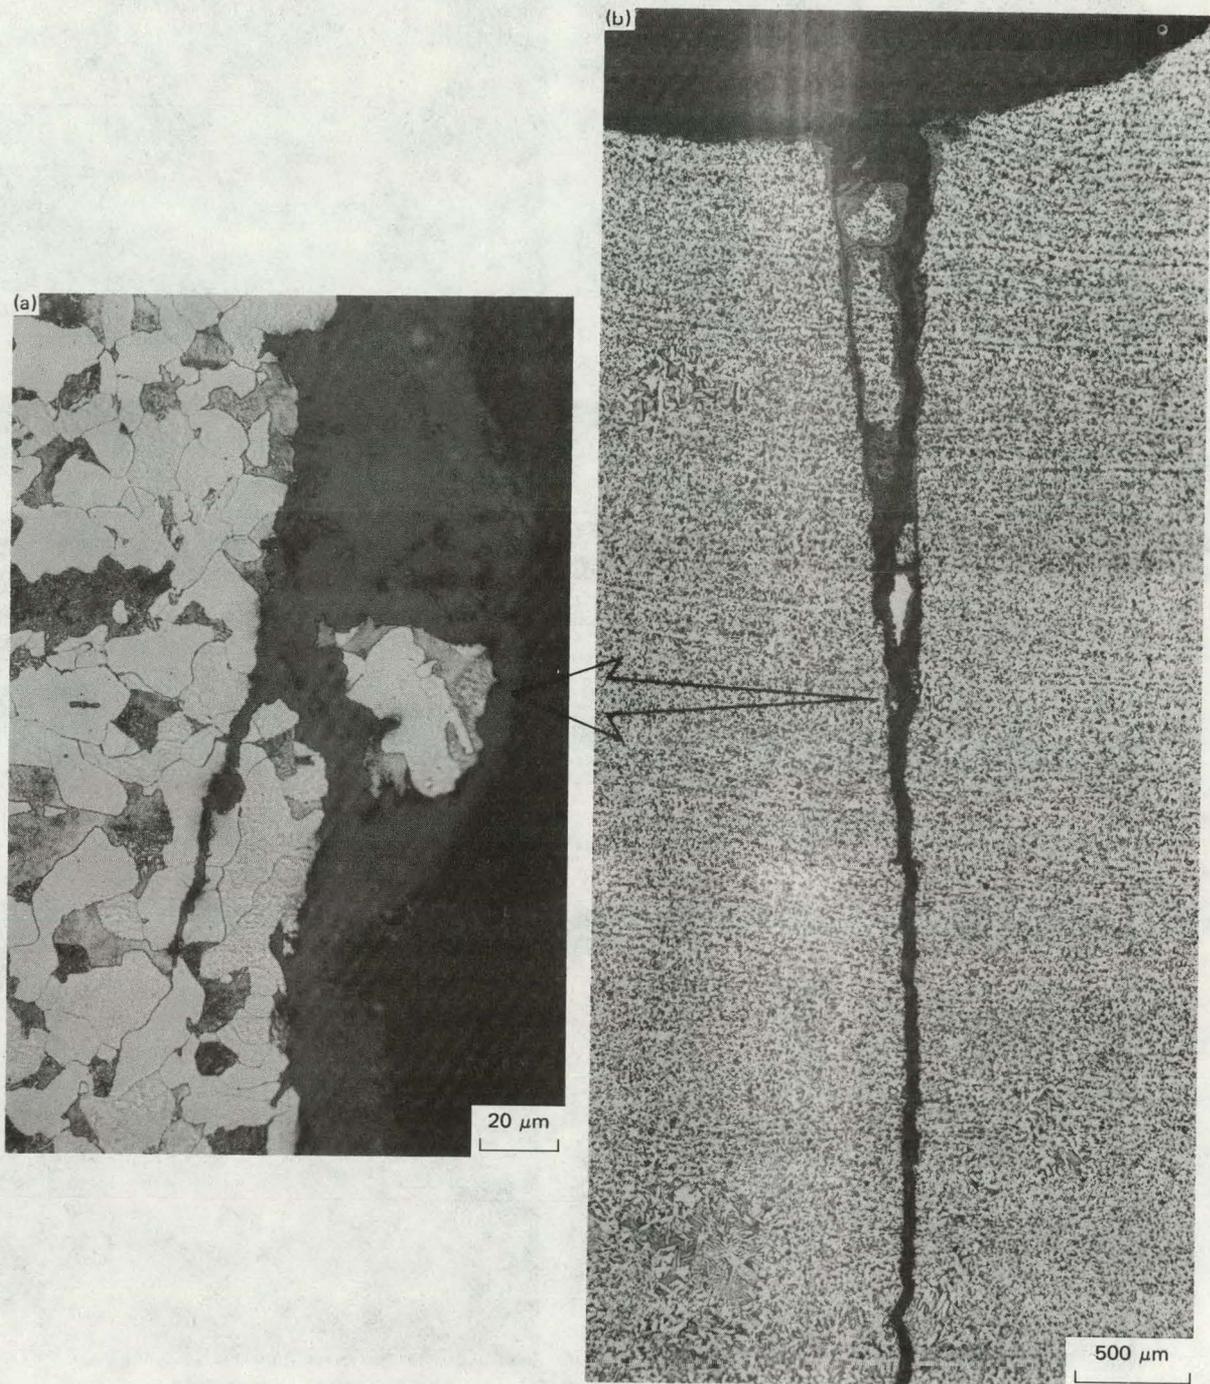
FIG. 3.33. Branched crack tip propagating at grain boundary after mostly transgranular cracking in a D. C. Cook section. The location corresponds roughly to the crack depth in Fig. 3.32.

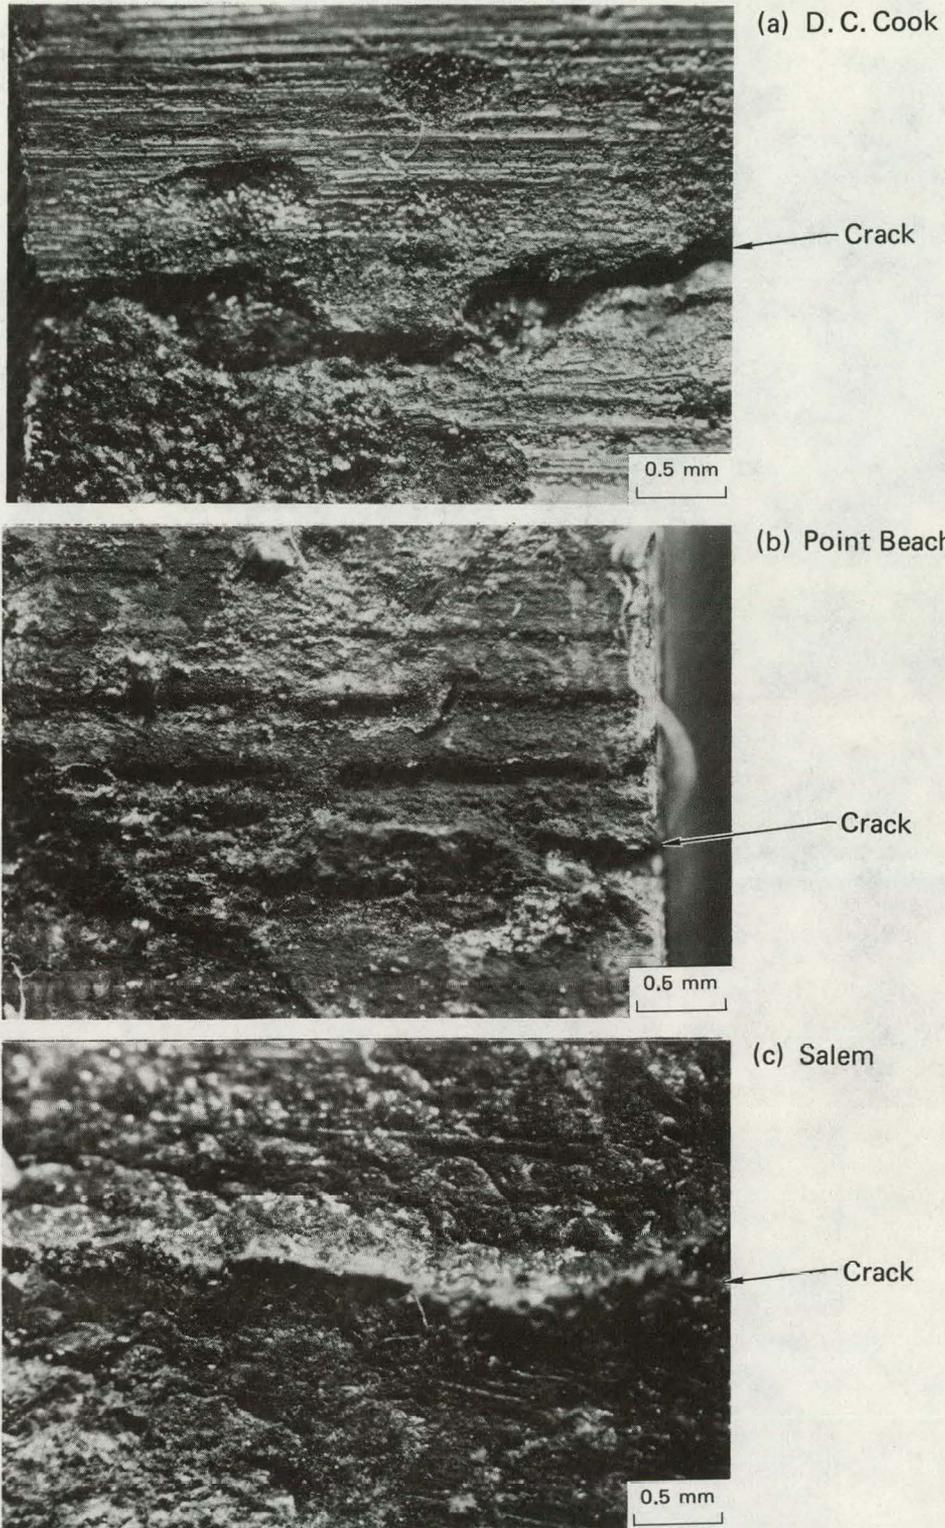
FIG. B.2. Photomicrographs (25X) showing the condition of the counterbore surface in the vicinity of a major crack in as-received sections from D. C. Cook, Point Beach, and Salem.

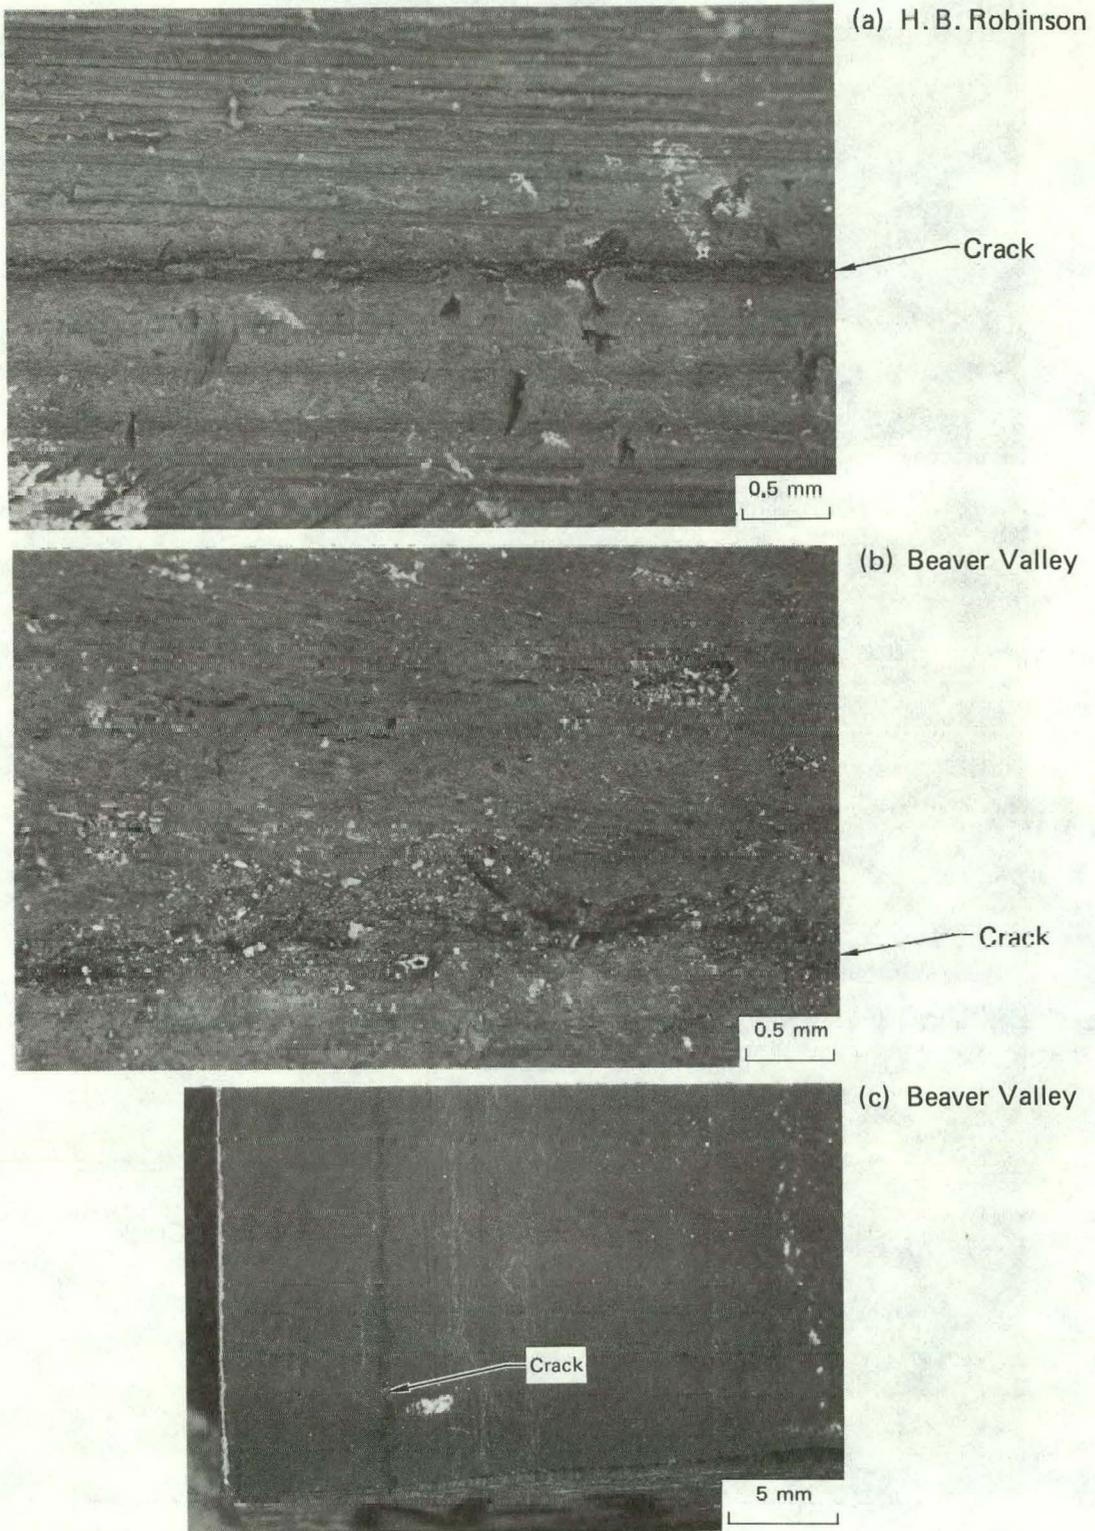
FIG. B.3. Photomicrographs showing the condition of the counterbore surface in the vicinity of a major crack in as-received sections from H. B. Robinson and Beaver Valley.

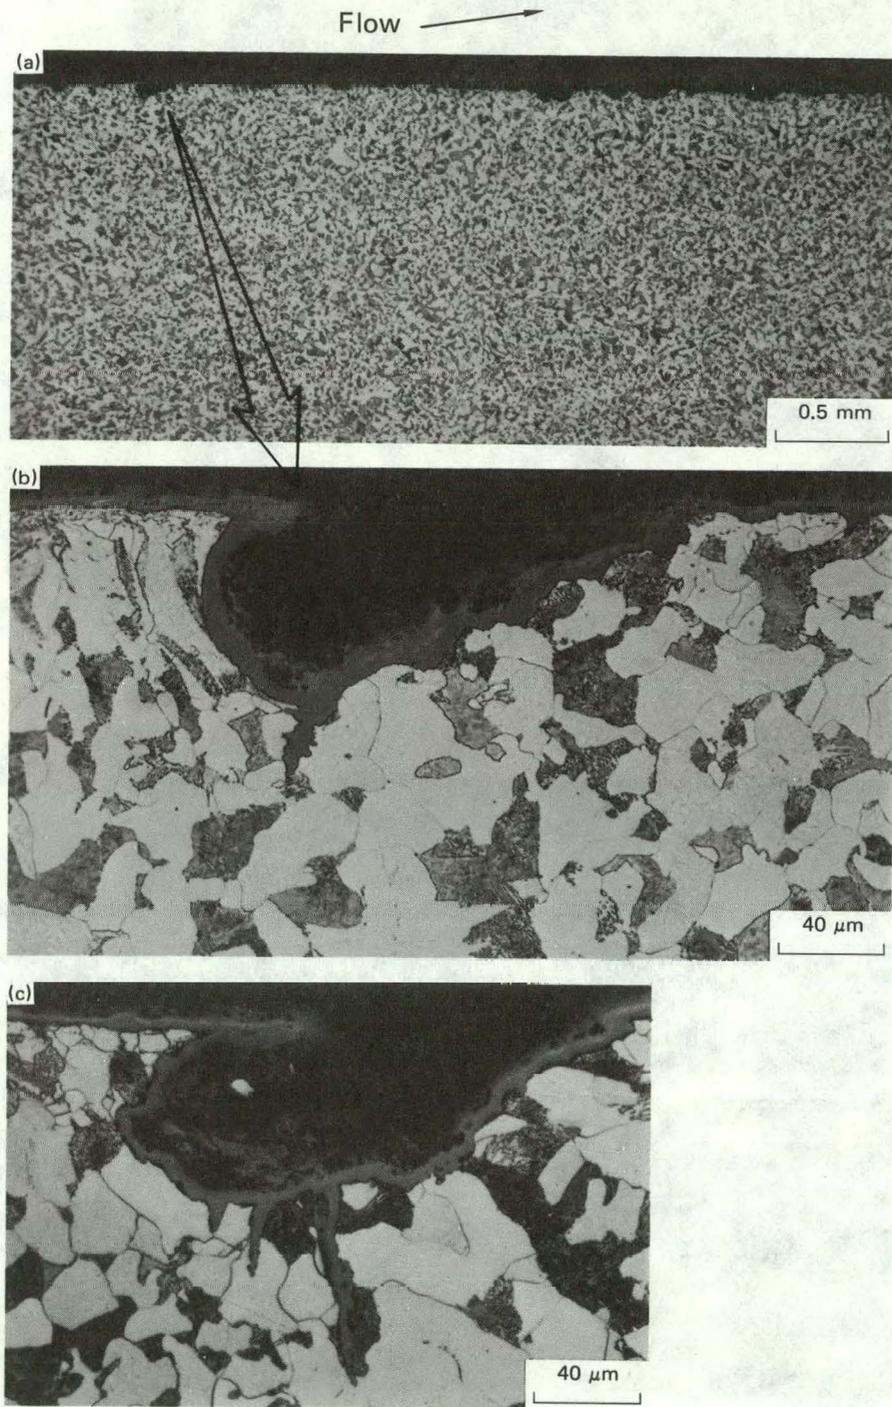
FIG. C.2. Corrosion pits identified as cross sections of machining grooves from an H. B. Robinson section. View (a) shows the pits at low magnification and views (b) and (c) show them at high magnification. Note the deformed region adjacent to both undercuts. Also note the spikes at the root of the grooves.

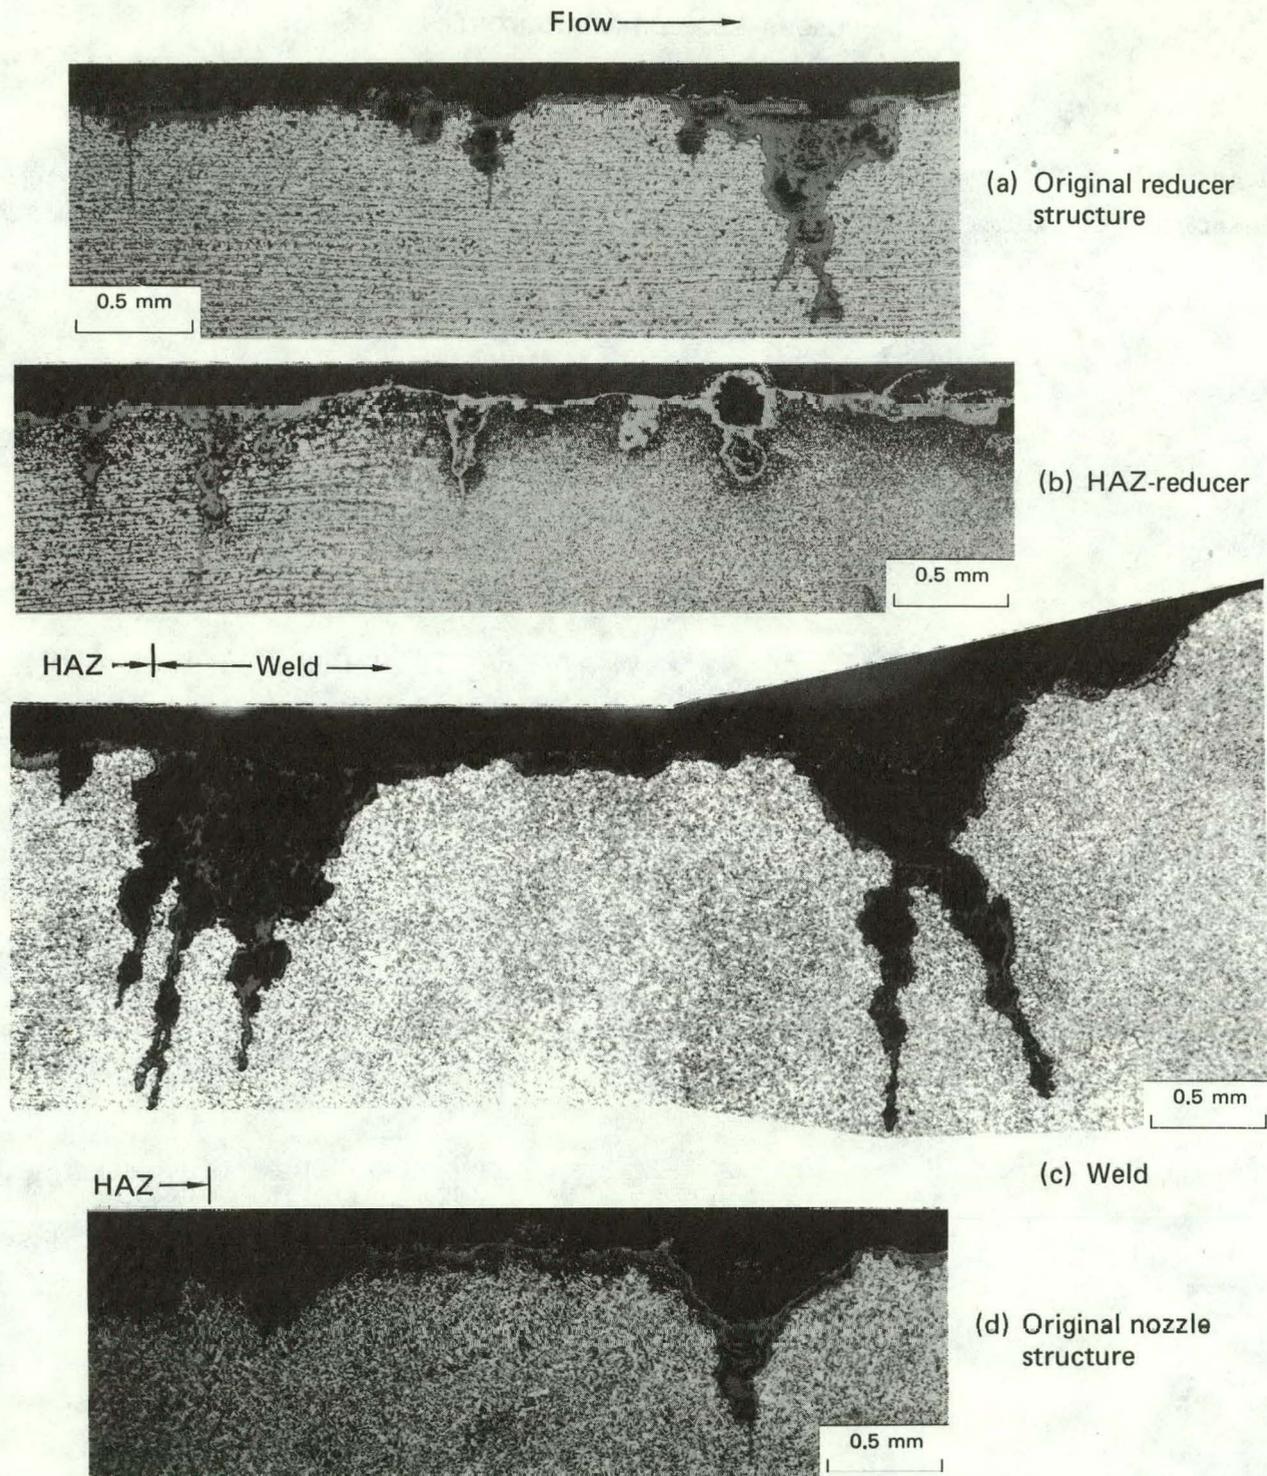
FIG. D.1. Photomicrographs showing corrosion, pits, and cracks along the inside diameter surface of a San Onofre section.

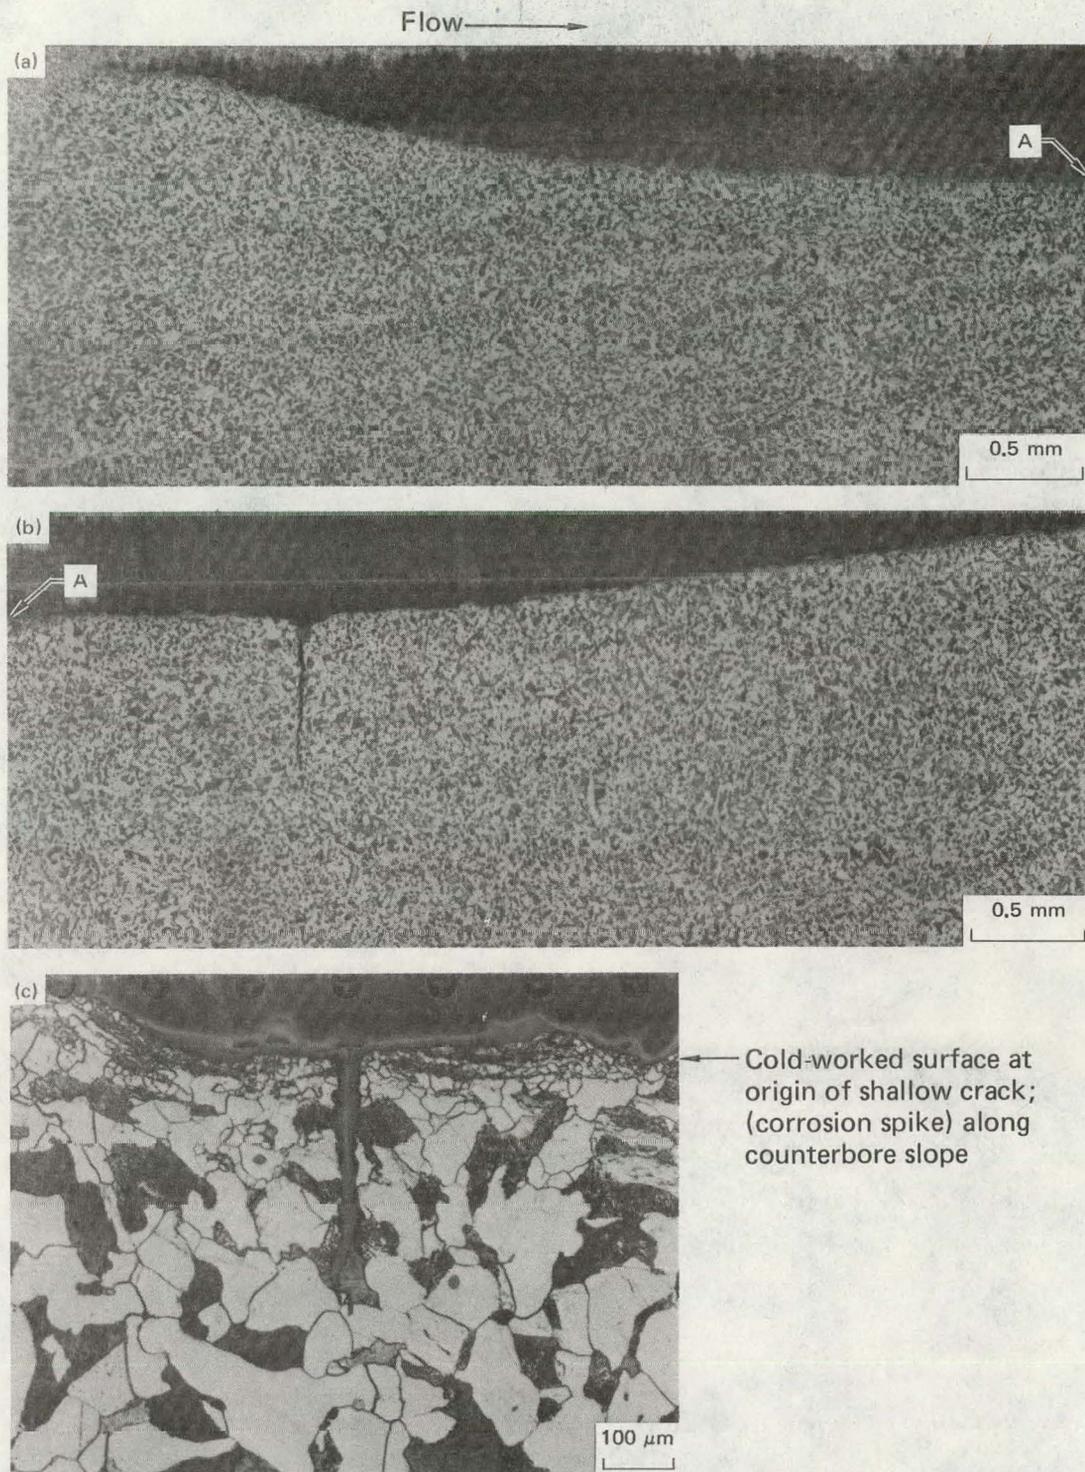
FIG. D.2. Photomicrographs of an H. B. Robinson section showing surface and major crack along counterbore. Views (a) and (b) match up at A and show a crack initiating at the bottom of the counterbore slope. The approximate flow directions for views (a) and (b) are indicated by an arrow.

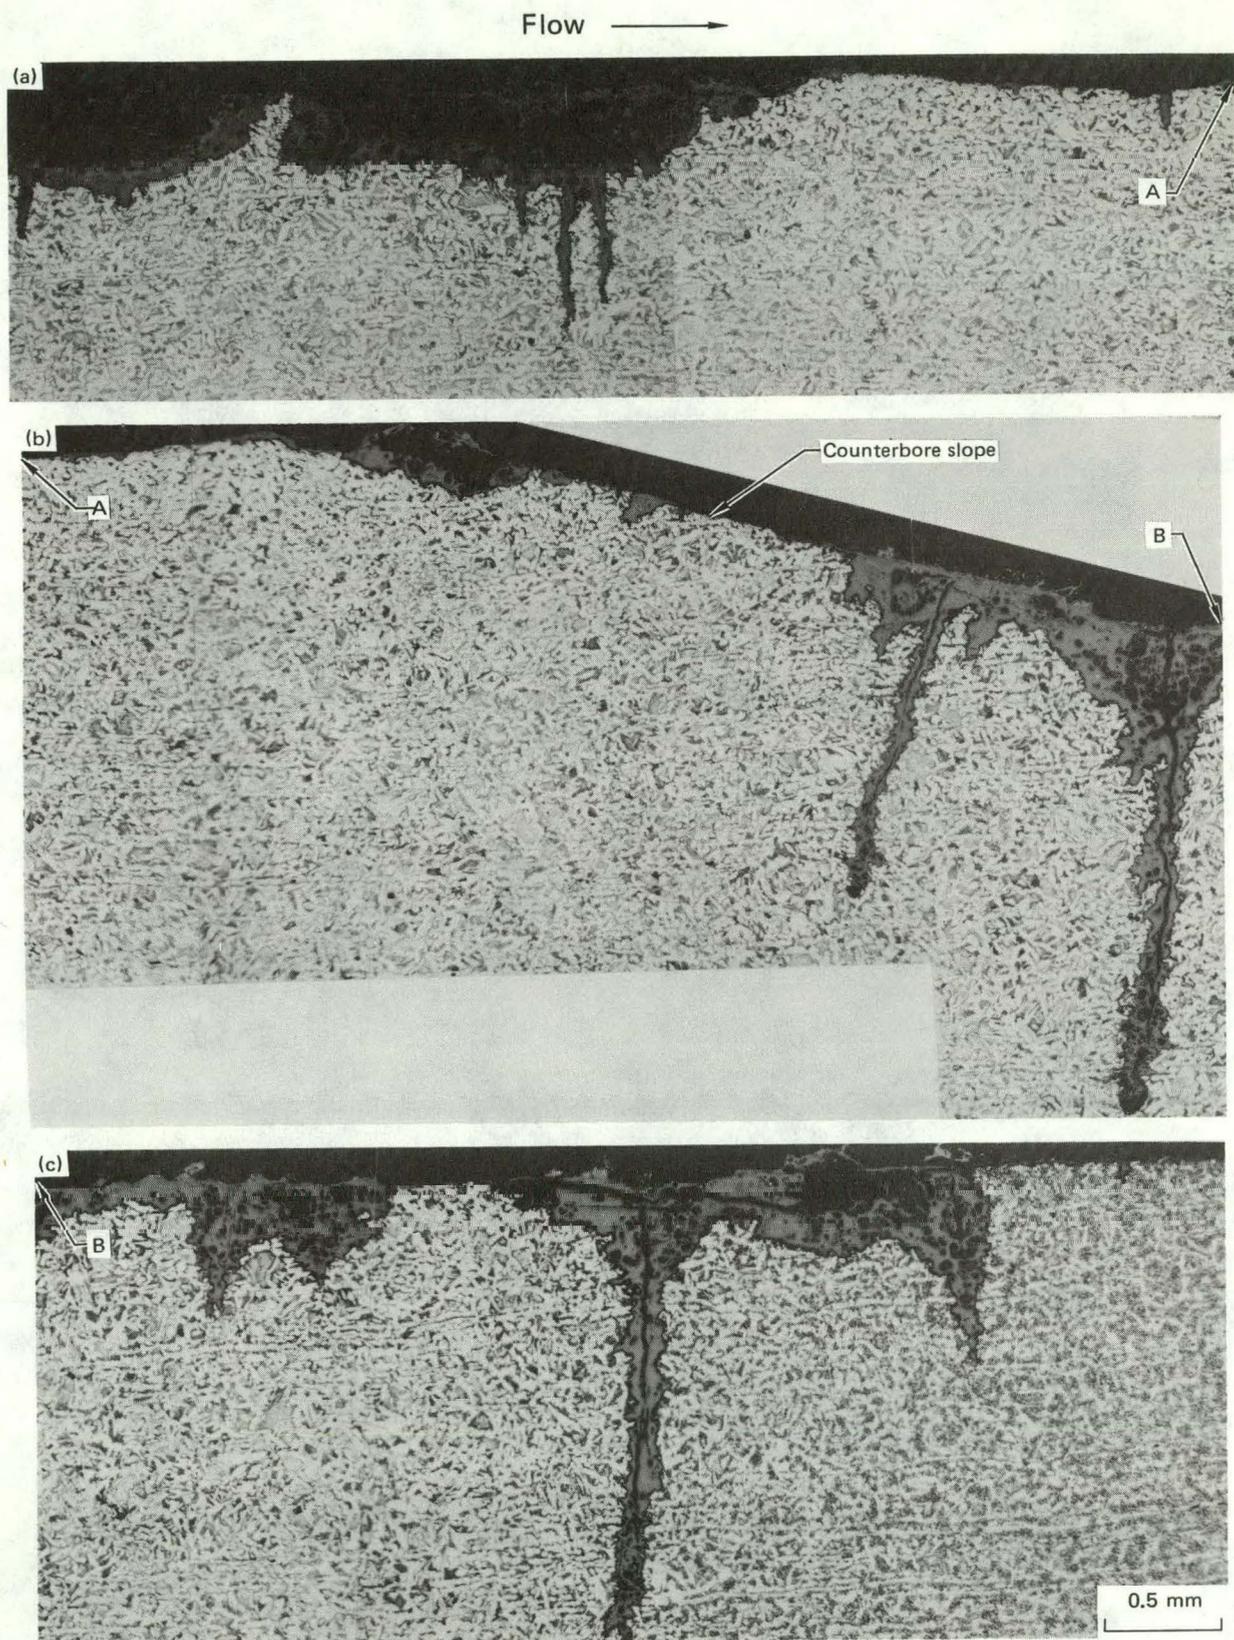
FIG. D.3. Photomicrographs of a Palisades section showing the appearance of corrosion, pits, and cracks. View (a) shows the area along the inside diameter surface above the counterbore slope; view (b), along the counterbore slope; and view (c), at the bottom of the counterbore for the pipe section. Note that views (a) and (b) match up at A, and (b) and (c) at B.

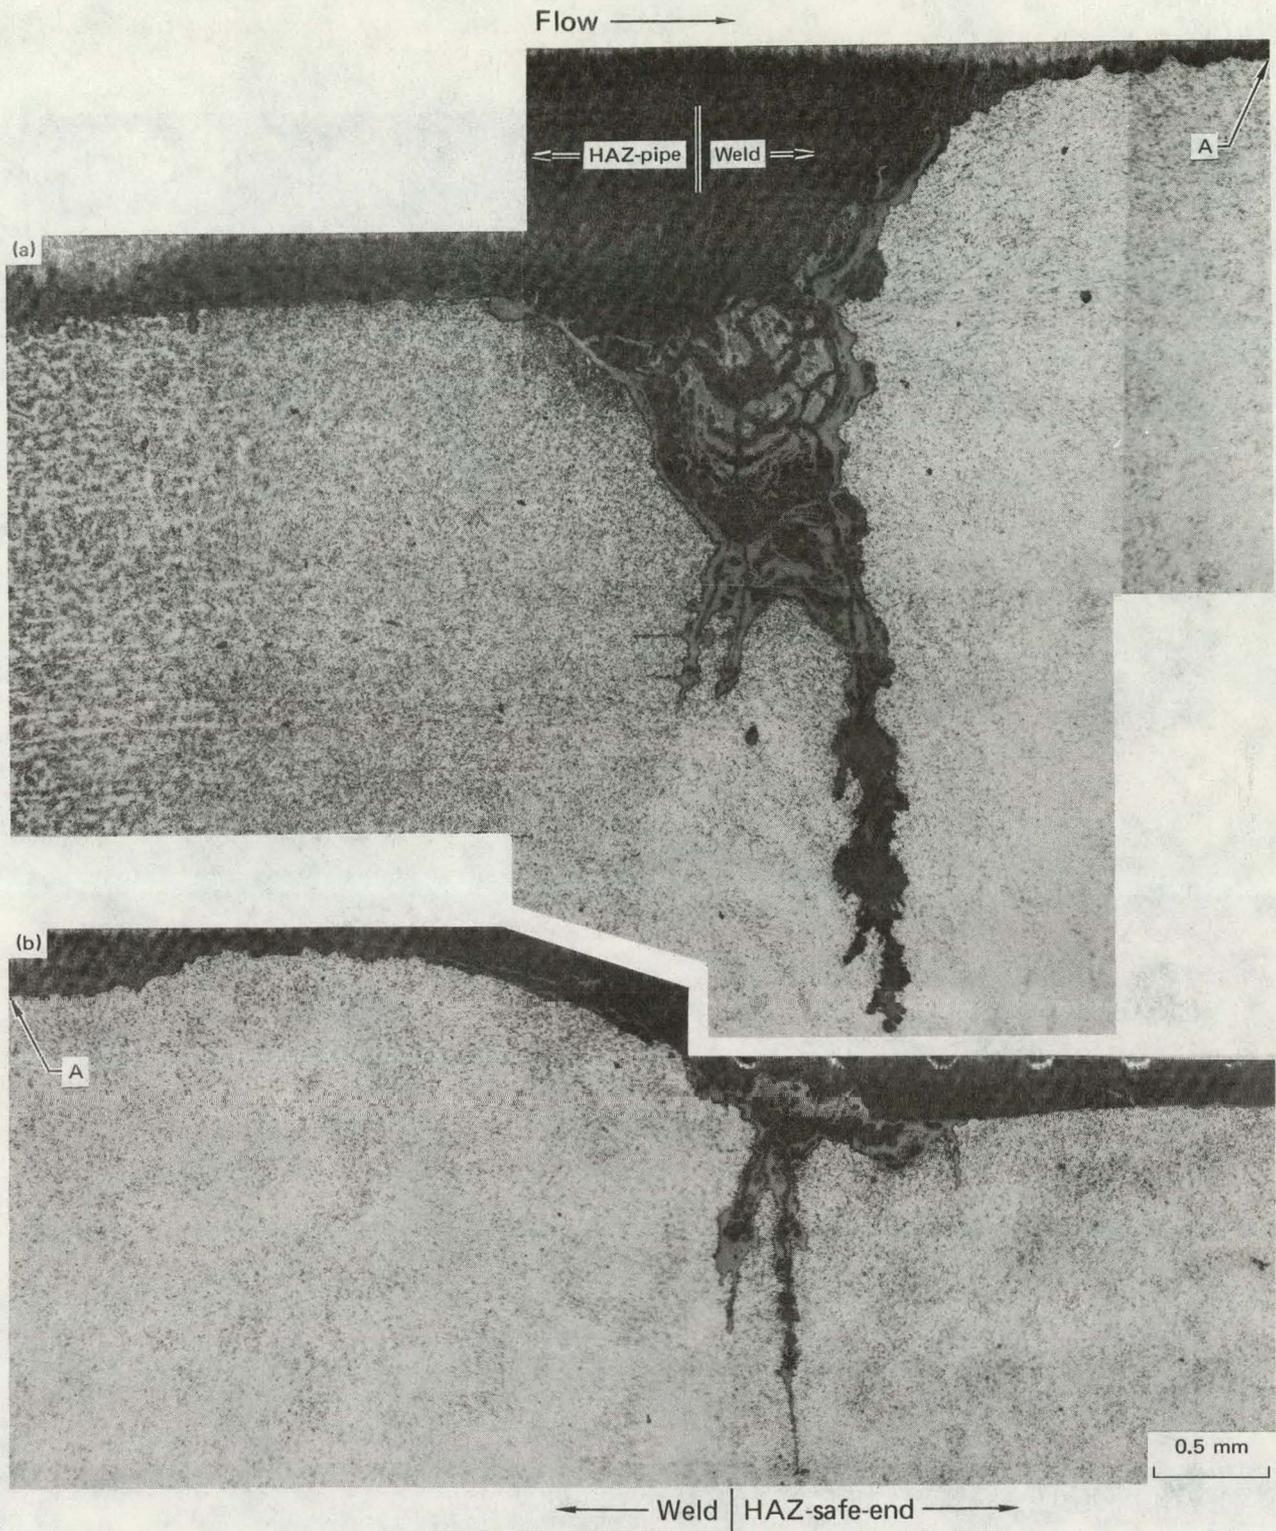
FIG. D.4. Photomicrographs showing cracks initiating at weld-HAZ interfaces corresponding to points of discontinuous changes in a Palisades section. Note that views (a) and (b) match up at A.

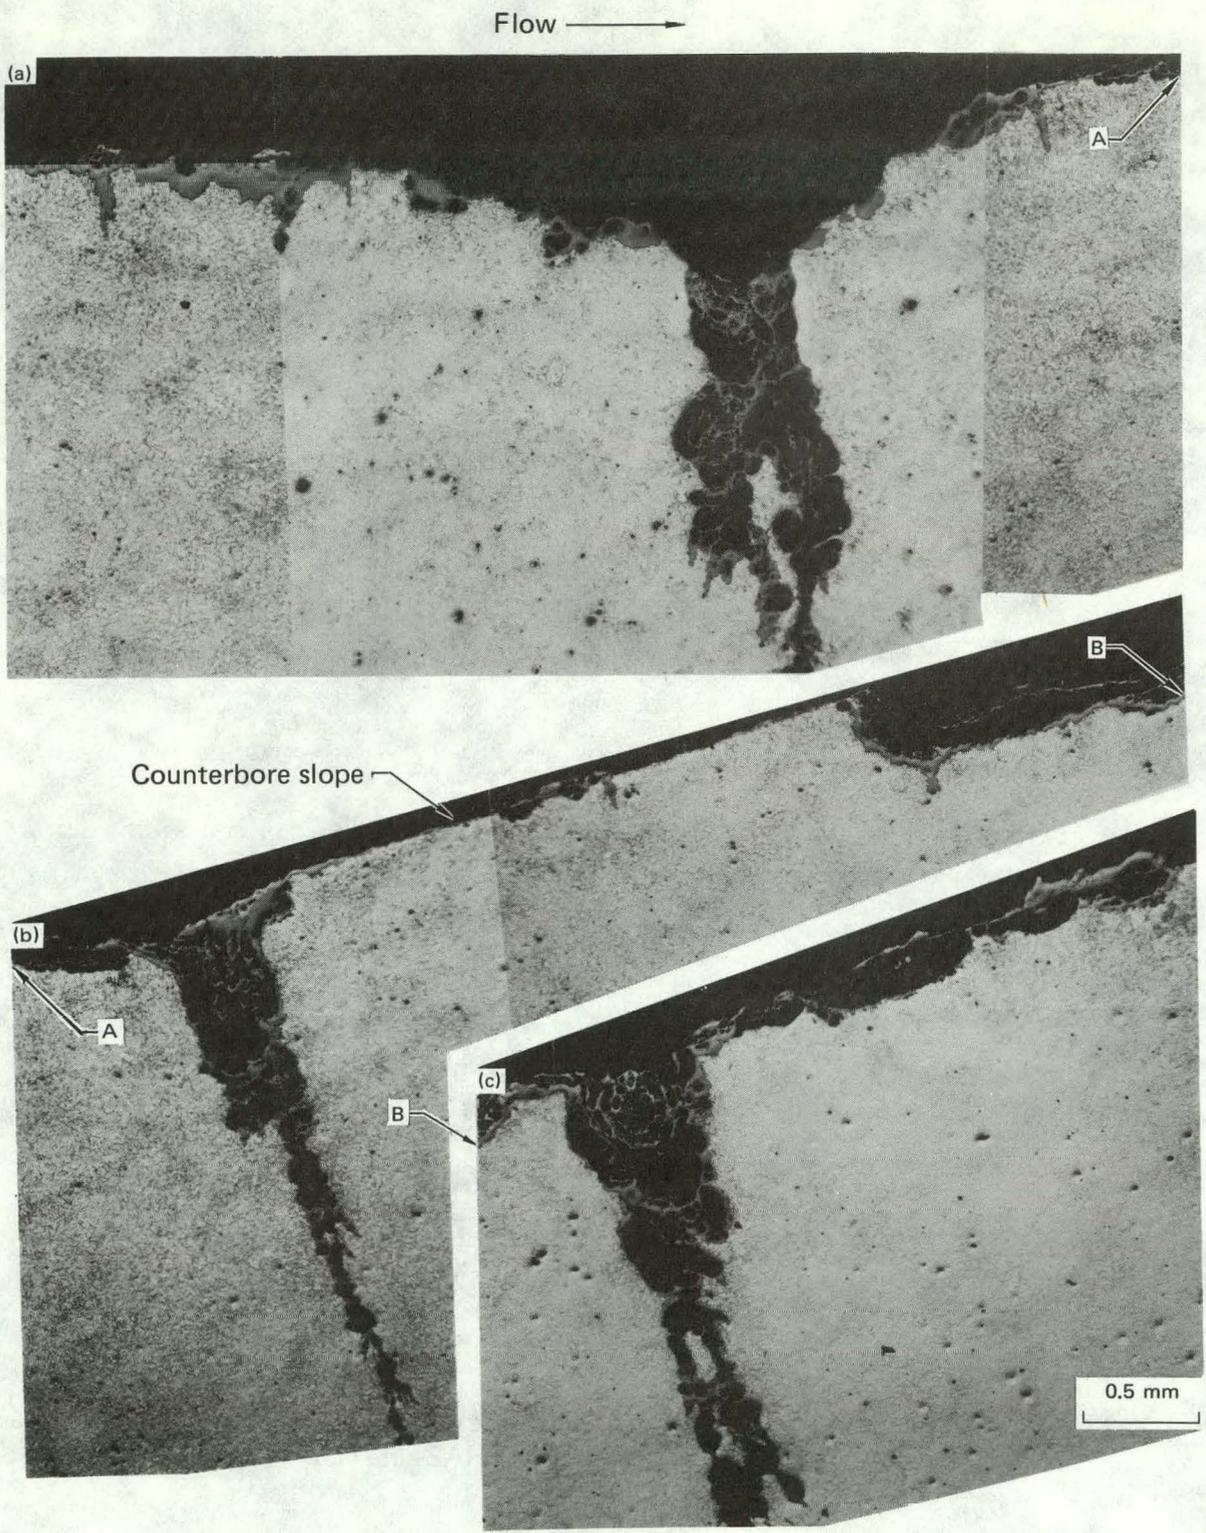
FIG. D.5. Photomicrographs of a Palisades section showing corrosion, pits, and cracks along the counterbore of the safe-end. In views (b) and (c), note the orientation of cracks along counterbore slope. Note that views (a) and (b) match up at A and views (b) and (c) at B.
