NUREG/CR-1603
UCRL-53000

Evaluation of Cracking in Feedwater Piping Adjacent to the Steam Generators in Nine Pressurized Water Reactor Plants

Alfred Goldberg, Ronald D. Streit, and Robert G. Scott

Lawrence Livermore Laboratory
7000 East Avenue
Livermore, CA 94550

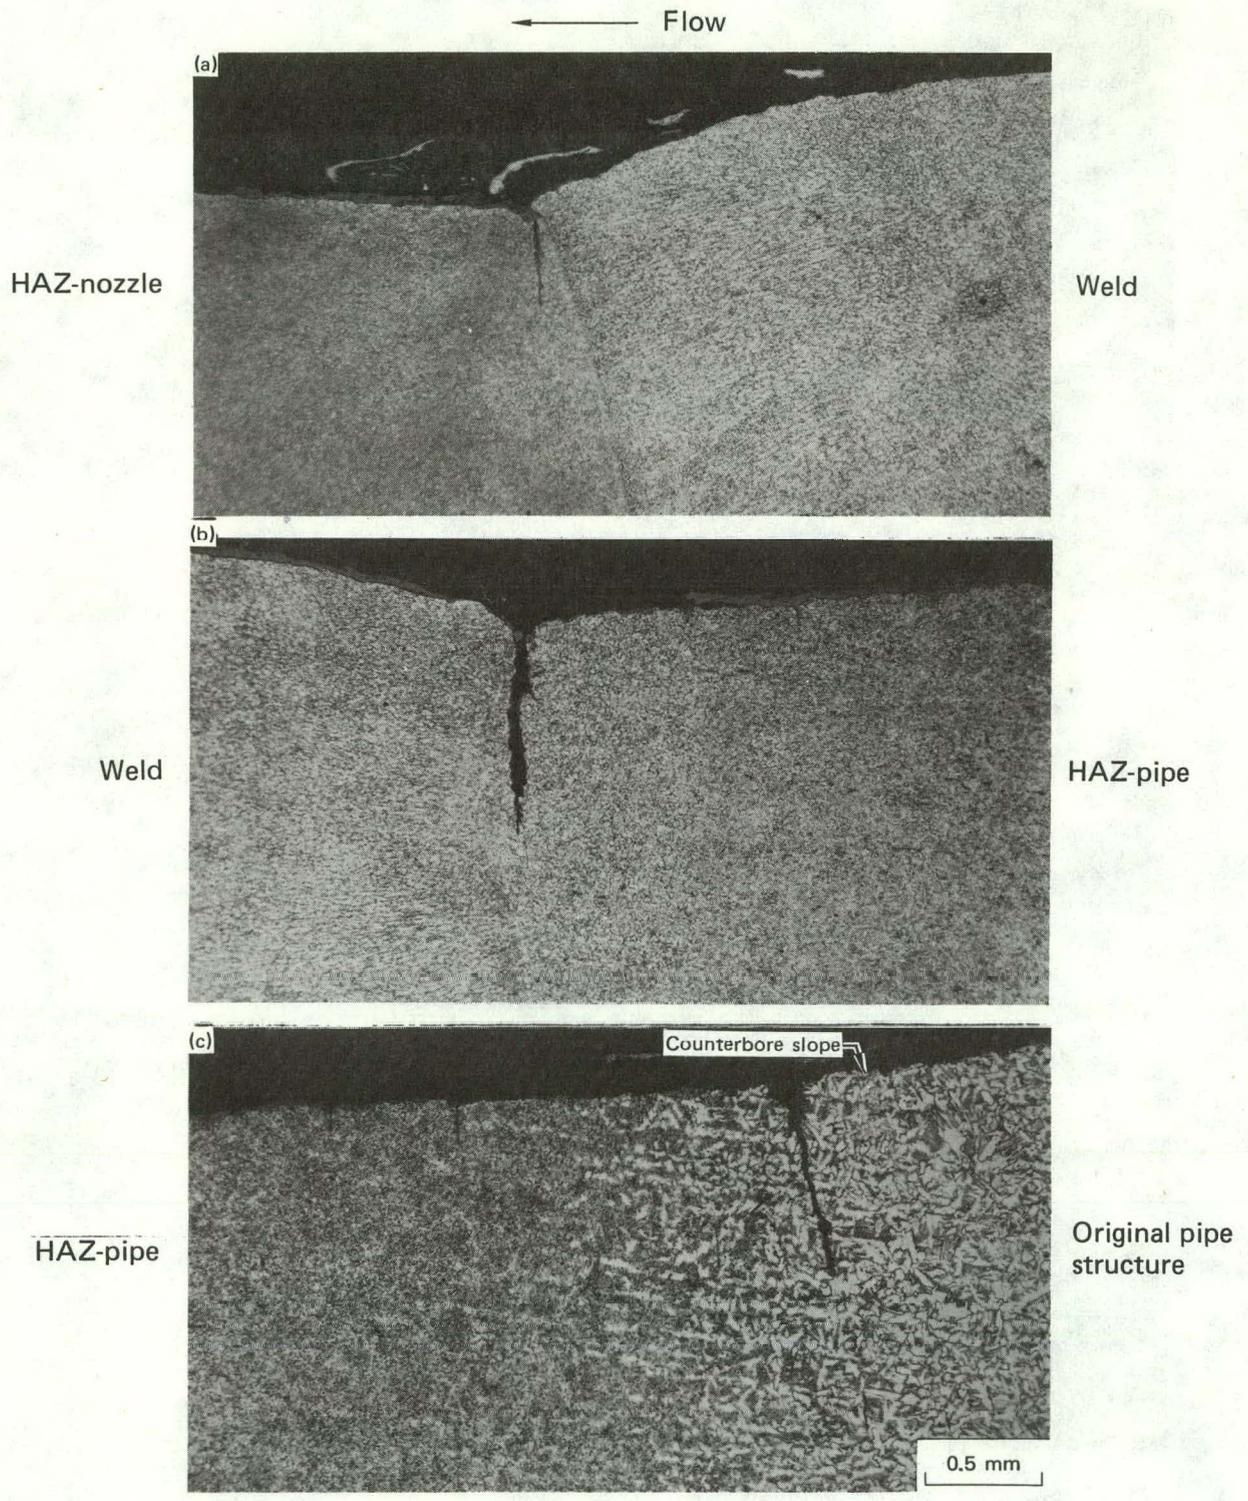
FIG. D.7. Photomicrographs showing cracks at discontinuous changes in a Kewaunee section. Views (a) and (b) show the weld-HAZ interfaces. View (c) shows the bottom of the counterbore slope.
