**INSPECTION OF ALUMINUM COMPONENTS
FROM FREEZE DESALTING FACILITY
AT WRIGHTSVILLE BEACH, NC**

D. G. Melton and T. S. Lee

ANL/OTEC-BCM-007

February 1980

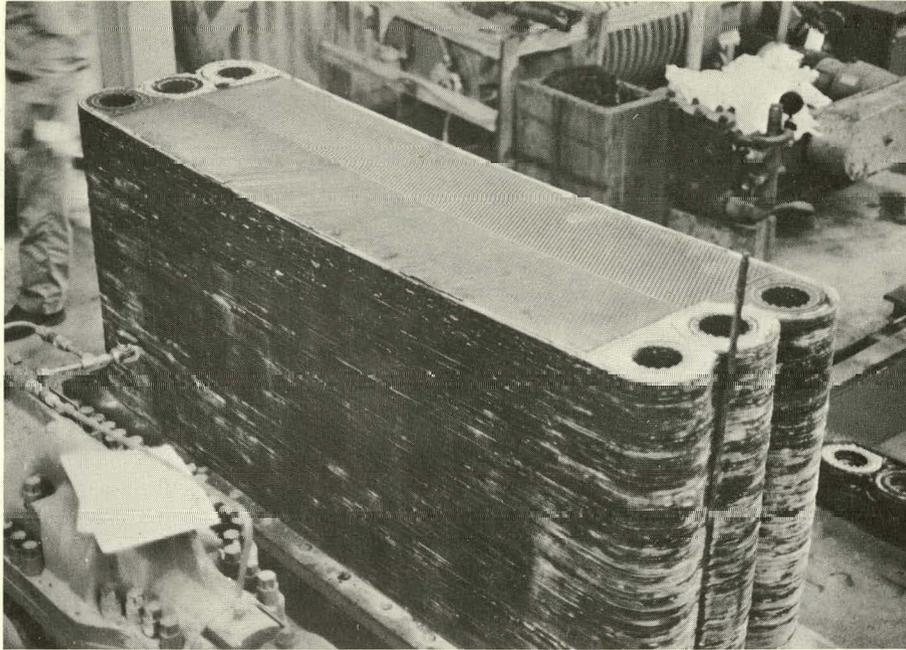
The materials of construction include aluminum alloy 6061-T4 cover plates, carbon steel tie rods, and Alclad 3003/7072 heat-exchanger plates.¹ During disassembly of the heat exchanger, however, the producer markings on the top heat-exchanger plate indicated the material to be aluminum alloy 3003-0. Subsequent metallographic examination confirmed the absence of an Alclad layer of 7072 on the plates. An overview of the partially disassembled unit is shown in Figure 3.

Figure 3. Appearance of Plate-type Heat Exchanger after Removal of Cover Plate and Tie Rods

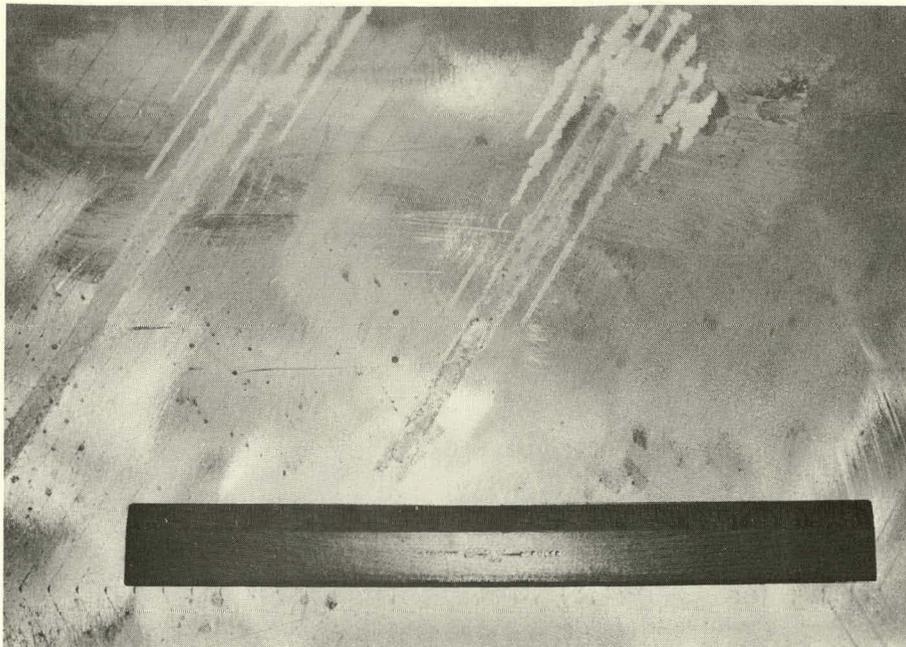
As this heat exchanger was disassembled, corrosion attack to a depth of approximately 0.03 mm was measured on the cover sheet in contact with the top plate. Although this area was not a part of the flow pattern, moisture was evidently trapped during assembly. This cover sheet is shown in Figure 4. Figure 5 shows what appeared to be corrosion on the inlet end of the seawater plates, but later cleaning proved this to be a build up of salts from leakage.

Figure 4. Appearance of Cover Sheet on Top of First Plate of Plate-type Heat Exchanger. Maximum depth of corrosion measured at 0.03 mm.

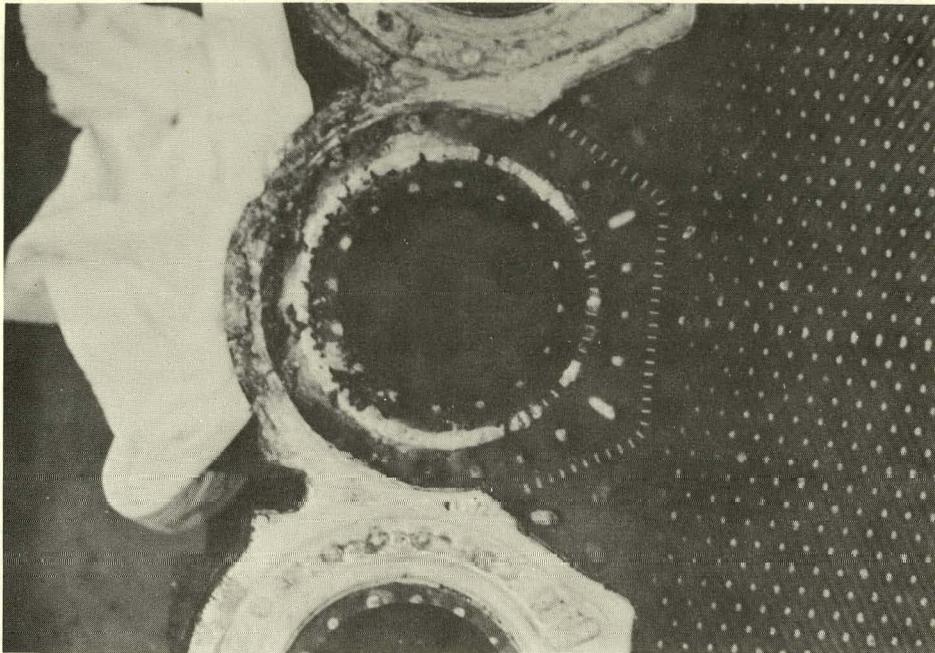
Figure 5. Close-up View of Inlet End of Raw Seawater Side of Plate Showing Build-up of Salts. Cleaning revealed minimal attack to underlying aluminum.

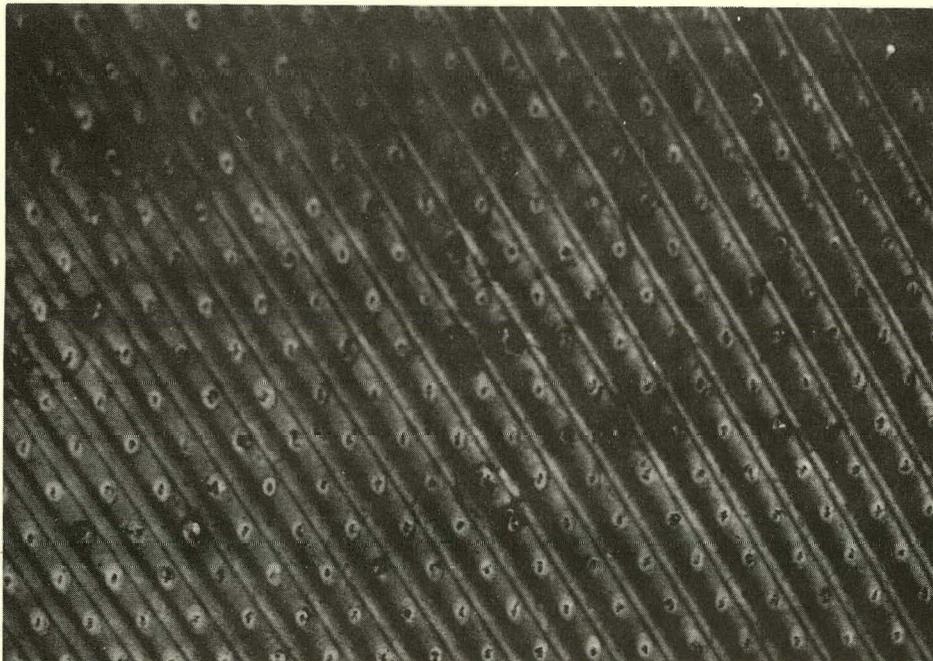
When the individual plates were inspected, a regular pattern of crevice sites was noted, with corrosion products at each of these sites. The general appearance of one of these plates is shown in Figure 6. This regular pattern was created by the contact points between plates. Further inspection of these sites has shown crevice-corrosion attack to varying extents, and, in at least two of the six plates inspected, the corrosion had perforated the 1 mm thickness.

Figure 6. Appearance of Plate Showing Crevice Attack at Contact Points between Individual Plates

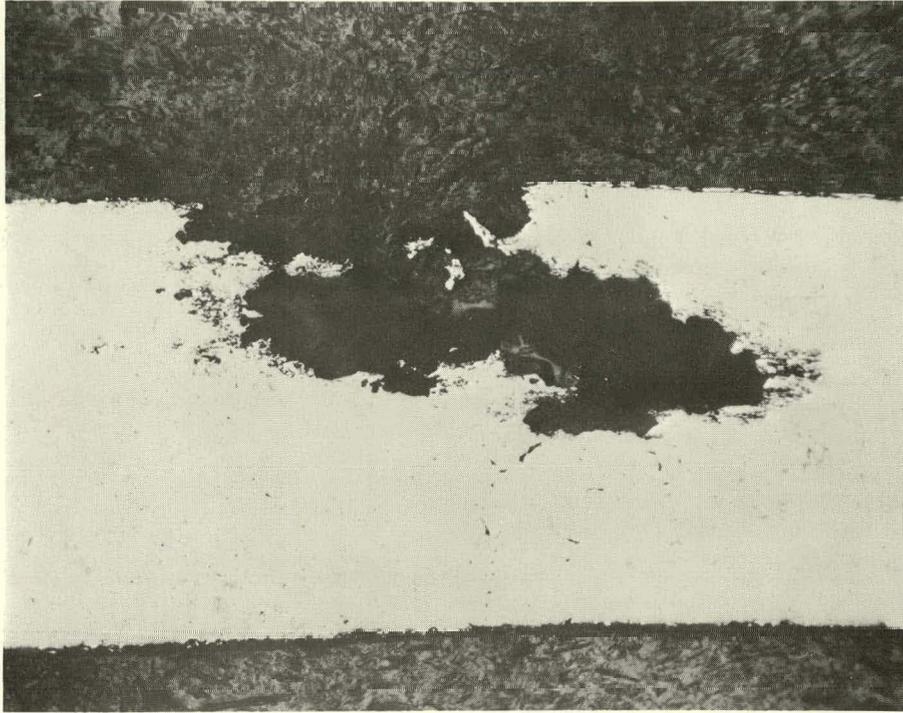
Samples of the deposits surrounding these contact points have been analyzed and found to be calcium carbonate. The cause of the black appearance of these deposits is presently unknown. The cross section of one of these contact points is shown in Figure 7.

Figure 7. Photomicrograph of Cross Section through Plate at Location of Contact Point. Magnification 55X.

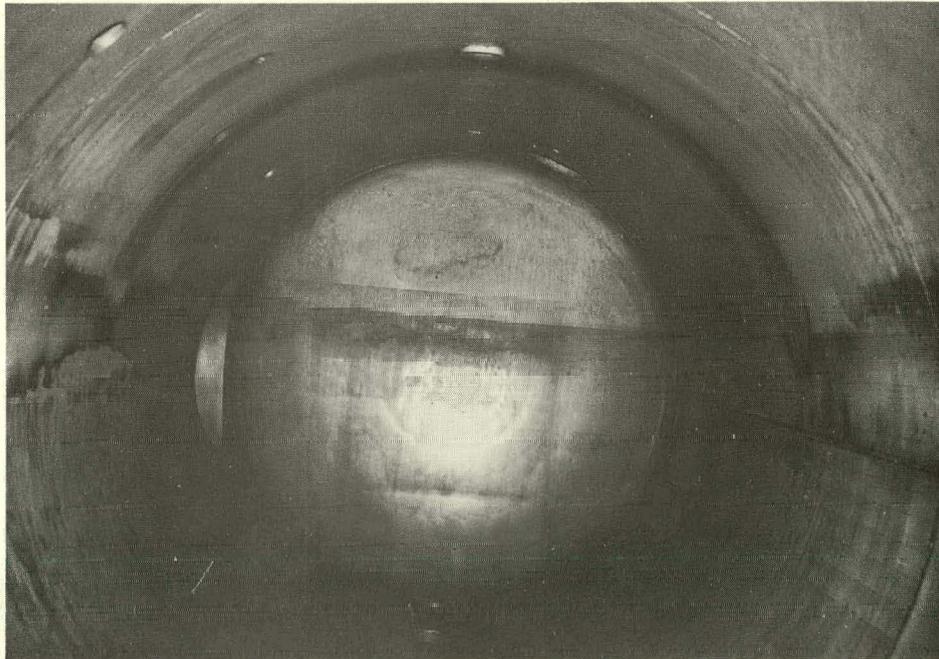
Figure 8. View of Inside of Freezer. Note waterline approximately 80 cm above bottom.

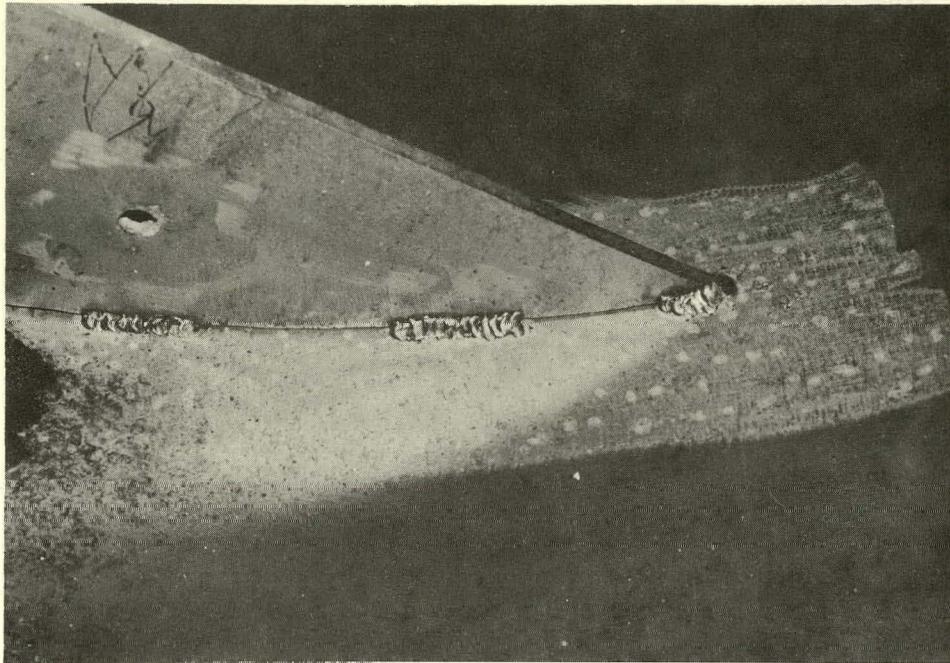
Minimal corrosion was found during the inspection. Figure 9 is a close-up view of a welded baffle in the bottom of the freezer showing the excellent condition of the aluminum alloy 5083. Some shallow pitting was observed, as evidenced by Figure 10; however, this pitting appeared to be limited to the material exposed in the vapor or upper half of the freezer.

Figure 9. Close-up View of Welded Baffle Plate
in Bottom of Freezer

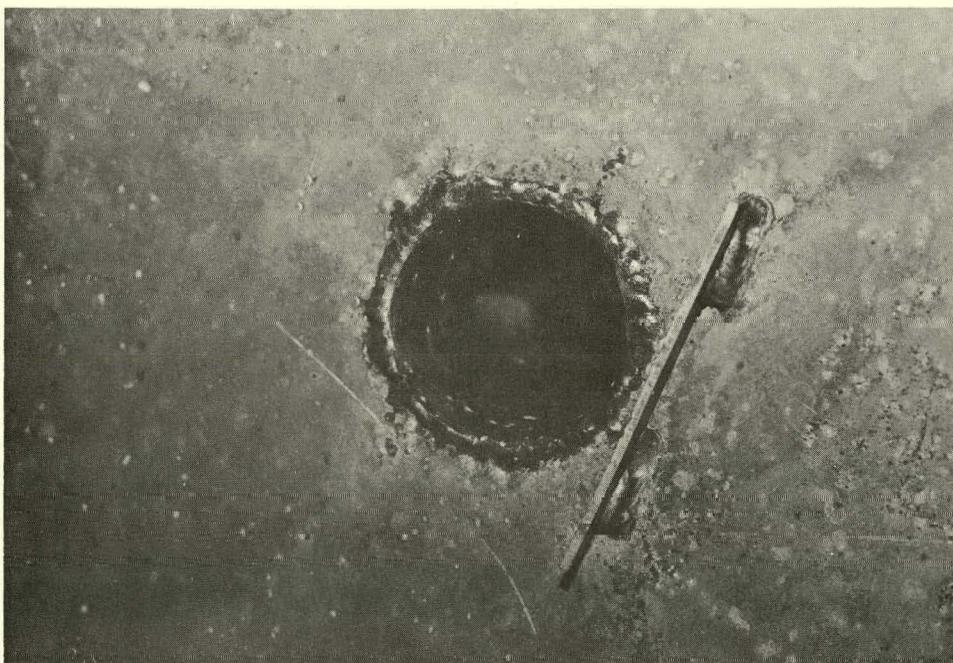
Figure 10. Close up of Welded Nipple and Baffle in Top
of Freezer. Note shallow pitting due to
refrigerant and chloride vapor environment.

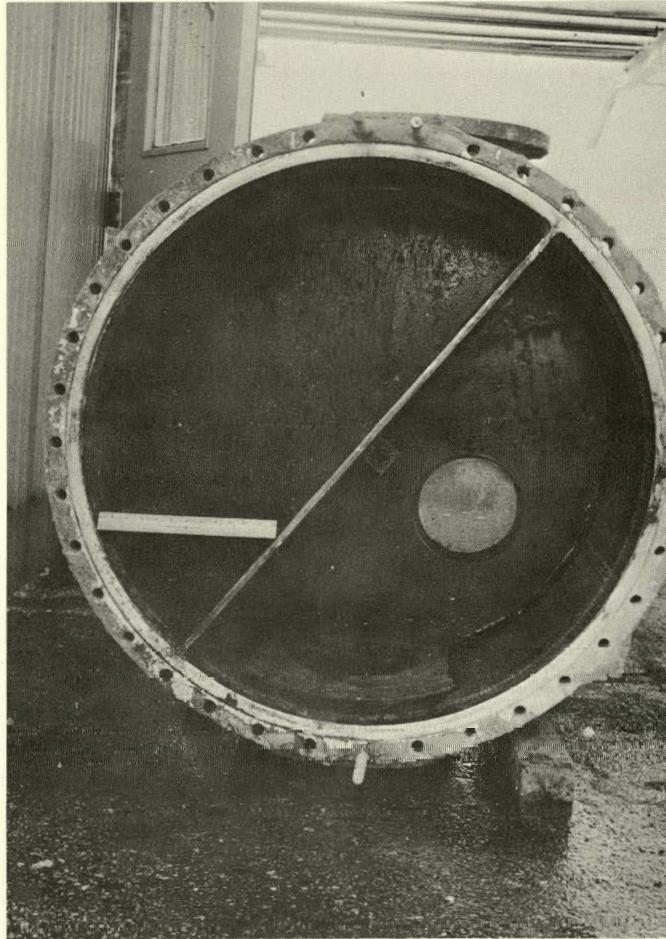
Figure 12. Internal View of Melter-Condenser Water Box with Inlet on Bottom. Note debris from failed coating system and corrosion products from steel pipe lines in system.

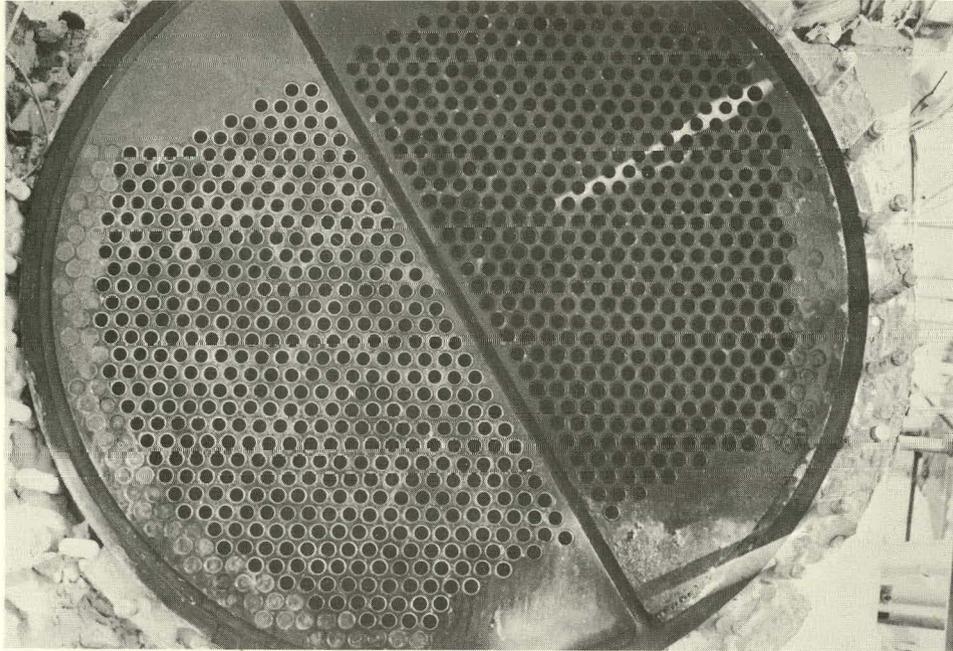
Figure 13. Appearance of Tube Sheet and Tubes on Melter-Condenser. Note tube sheet plugs to allow for installation of floating head on opposite end of condenser.

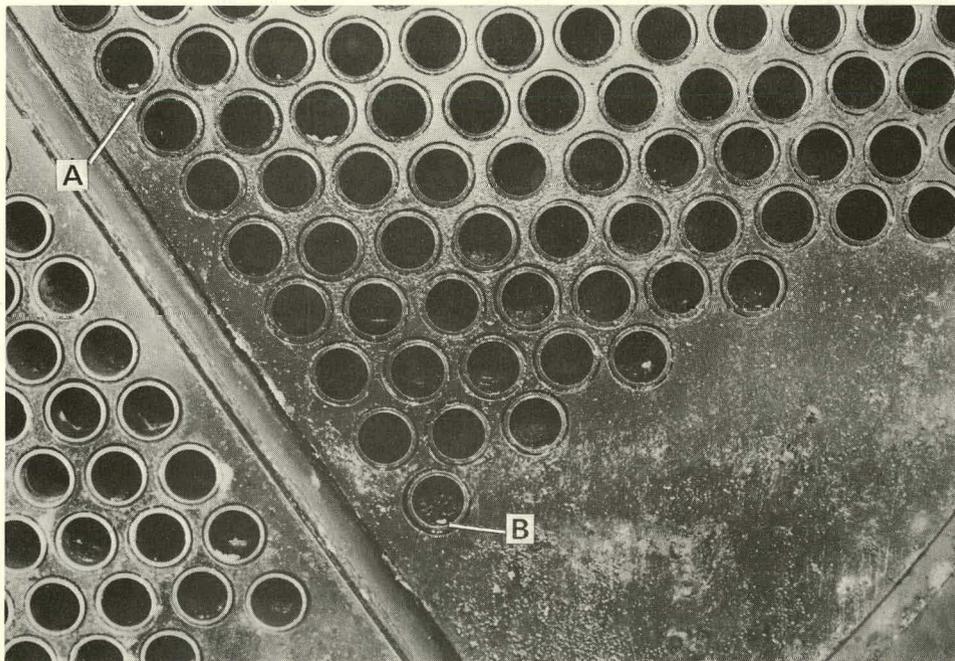
Some minor corrosion was found at the interface between the tubes and tube sheet, as evidenced by the corrosion product shown in Figure 14; however, no corrosion was visible on the inlet ends of the tubes. Depth of attack on the tube sheet was approximately 0.3 mm. Figure 14 also shows some debris that was found in the tubes. There was a large amount of this debris in the discharge side of the water box that was apparently the remains of attempts to coat the pipelines⁴ and of iron corrosion products. Figure 15 shows the inlet flange of the melter-condenser water box with minimal corrosion. In Figure 16, the discharge side of the water box exhibited accelerated general and pitting corrosion. The accelerated attack on the discharge flange could be due to galvanic attack resulting from a direct connection to a steel flange and pipe.

Figure 14. Close-up View of Melter-Condenser Showing (A) Corrosion Product between Tube and Tube Sheet and (B) Debris in Tubes.

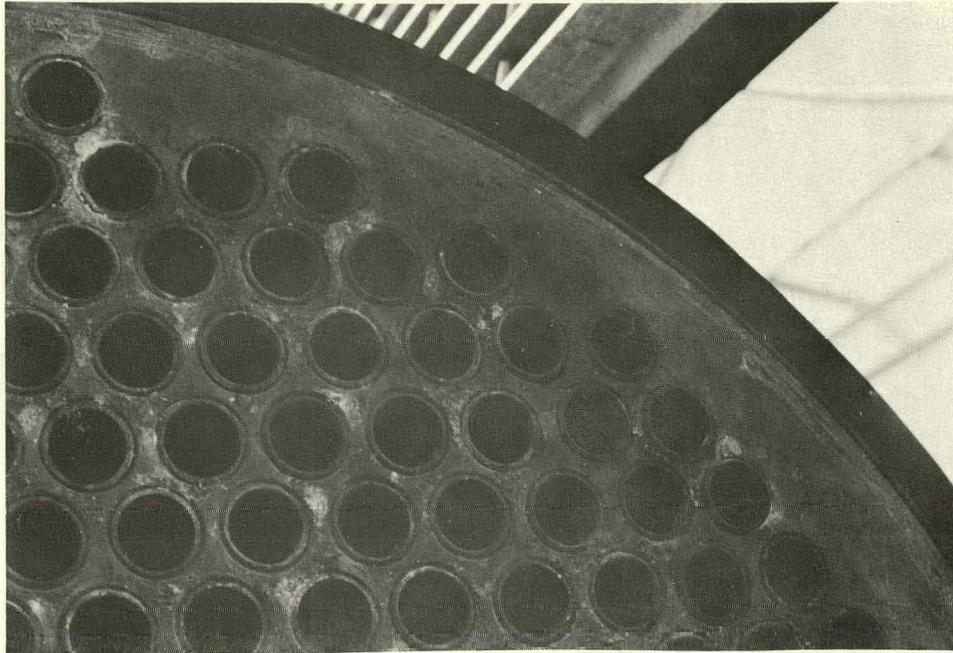
The heat-removal condenser displayed severe pitting on the tube sheet (approximately 6-mm depth), as shown in Figure 19; however, the tubes in this unit showed no visible corrosion on the inlet ends. Severe pitting also was found on the water-box inlet flange and pipe, as shown in Figures 20 and 21. This pitting corrosion could be attributed to the steel pipe section that was attached directly to the inlet flange (Figure 22). However, as shown by Figure 23, the discharge flange and pipe were free of any signs of pitting corrosion.

Figure 19. Close-up View of Heat-removal Condenser Tube Sheet Showing Pitting Corrosion. Maximum depth of attack approximately 6 mm.

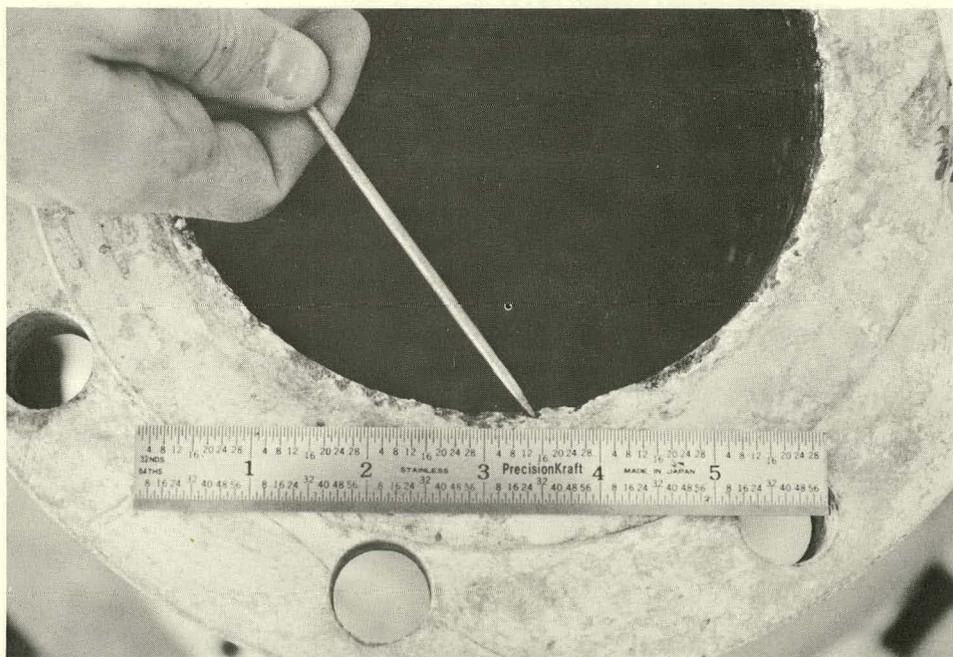
Figure 20. Close-up Appearance of Inlet Flange on Heat-removal Condenser Water Box. Depth of attack approximately 6 mm.

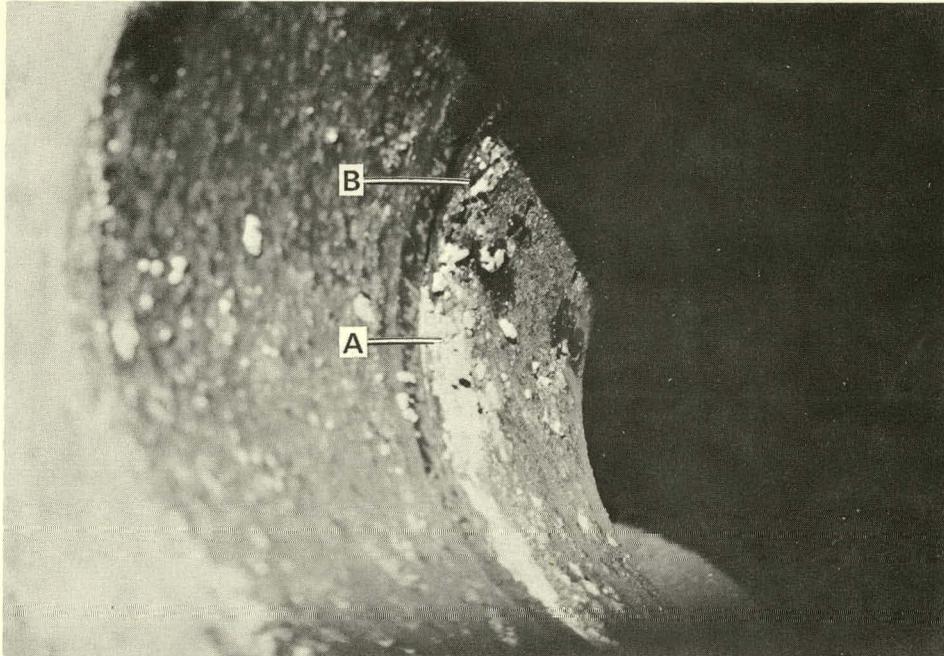
Figure 21. Close-up Appearance of Inlet Pipe on Heat-removal Condenser Water Box Showing (A) Corrosion Products and (B) Pitting

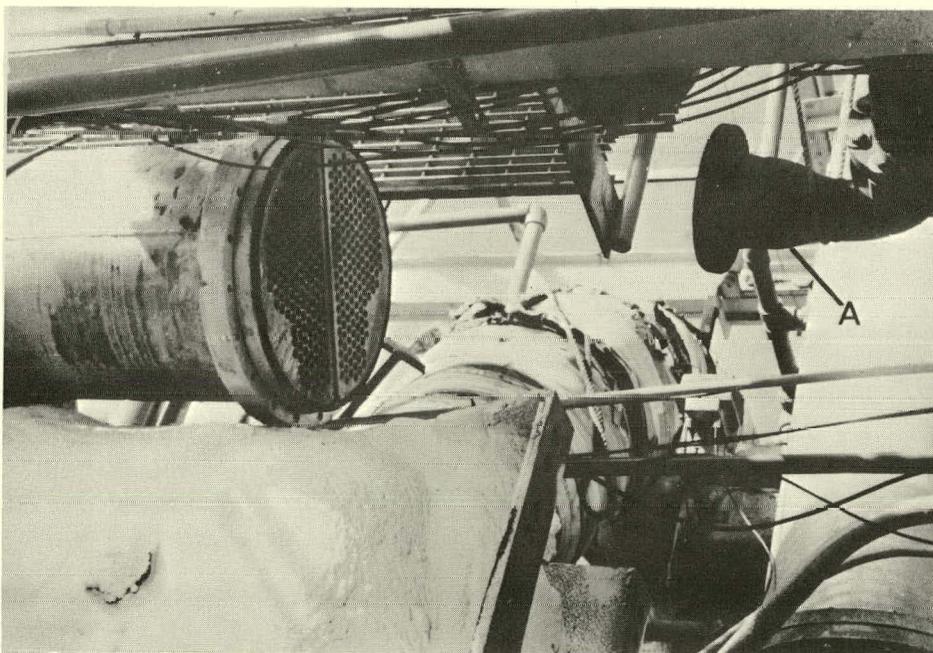
Figure 22. Overview of Inlet-discharge End of Heat-removal Condenser with Water Box Removed. Steel pipe section that supplied seawater to heat exchanger is designated by the symbol A.

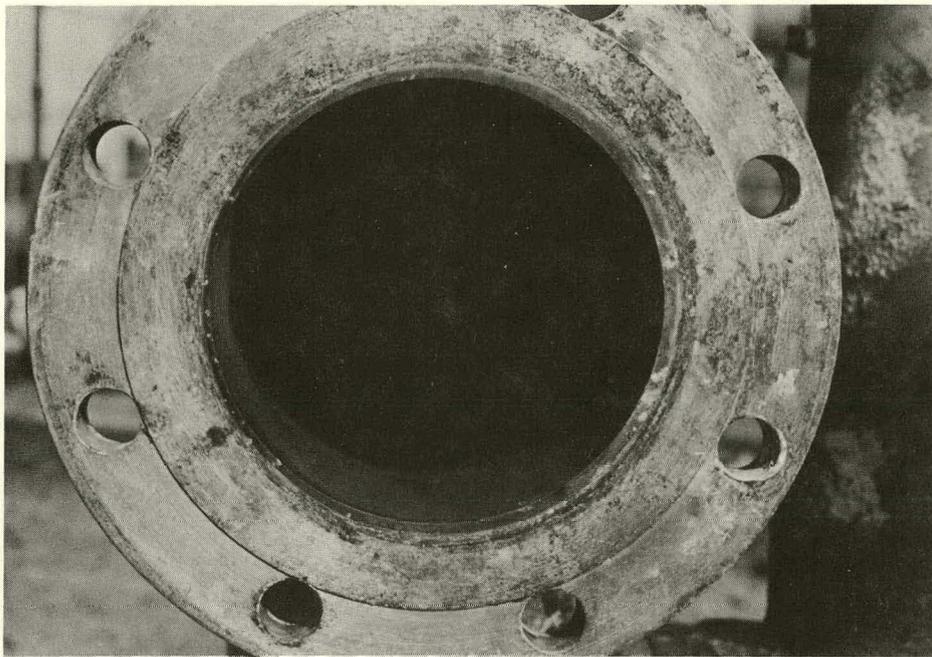
Figure 23. Close-up View of Discharge Flange on Heat-removal
Condenser Water Box Showing Minimal Corrosion Attack
