324 AND 325 BUILDING
HOT CELL CLEANOUT PROGRAM

AIR LOCK COVER BLOCK REFURBISHMENT

May 1989

Pacific Northwest Laboratory
Richland, Washington 99352

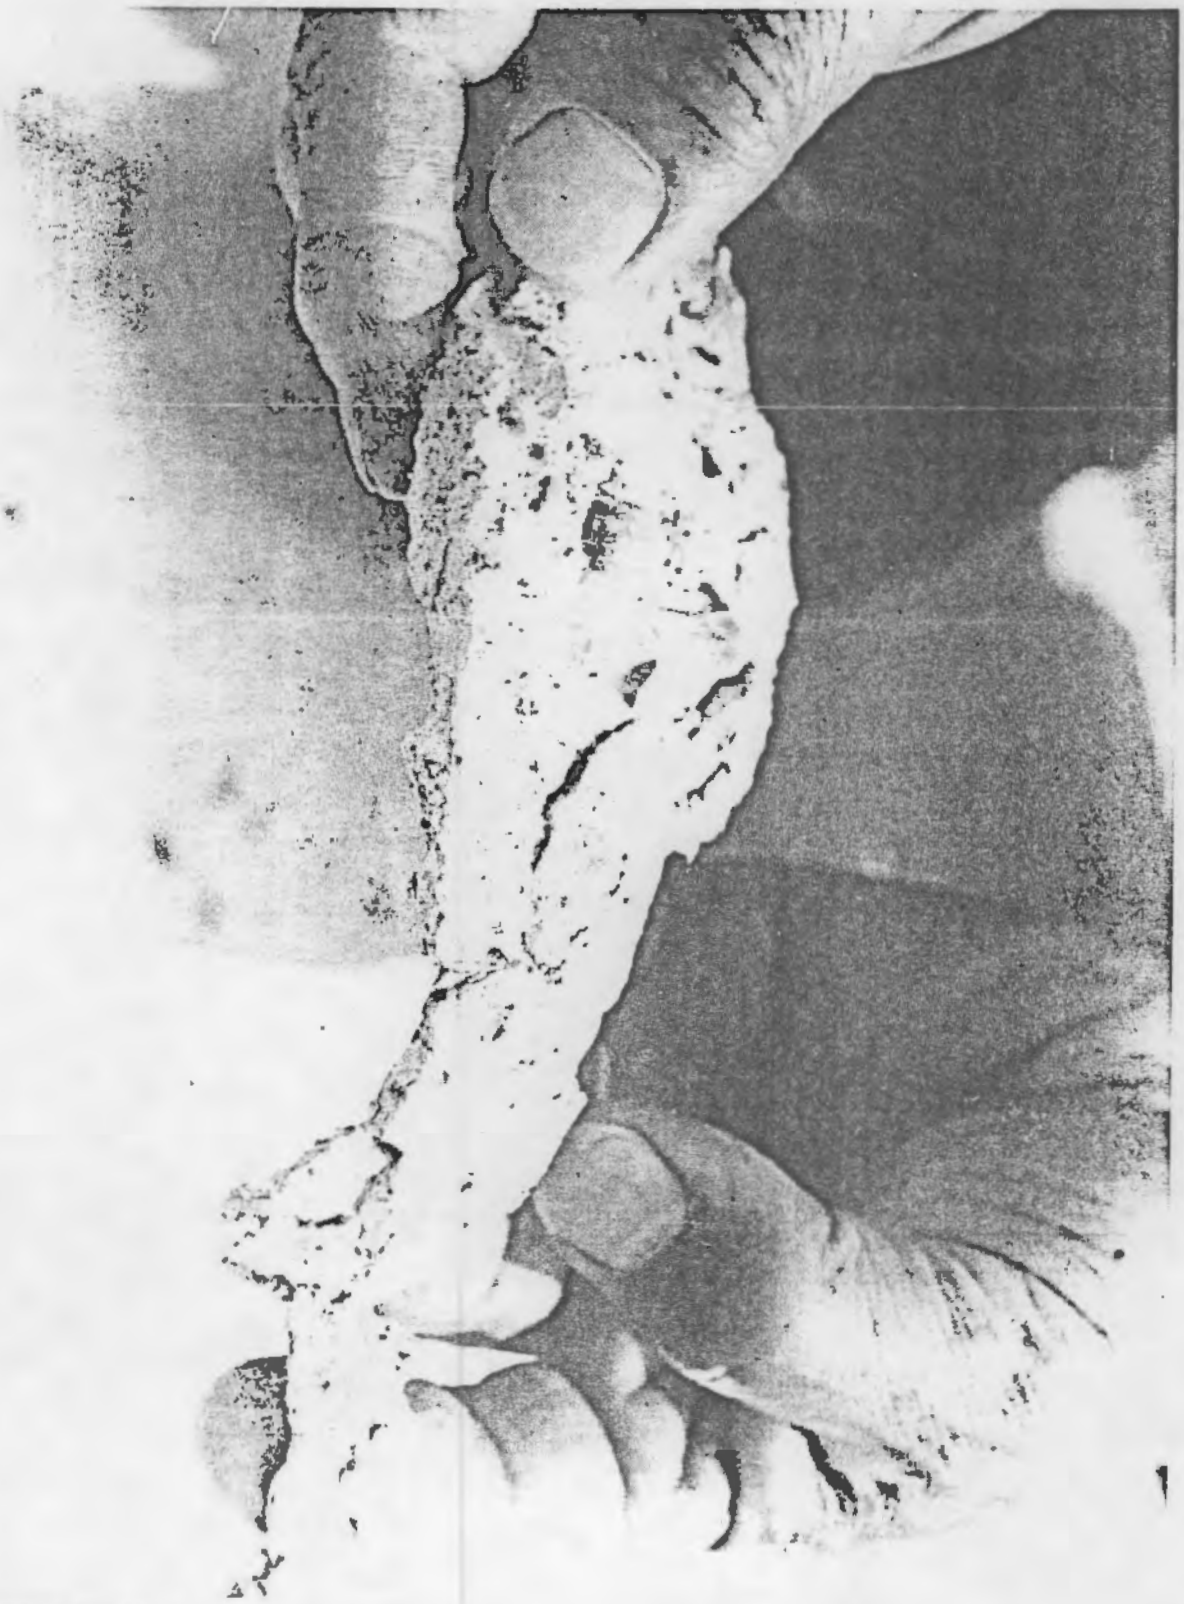
FIGURE 6. Spalled Aggregate Fragments Held Together
by Paint Film in Cold Pretesting

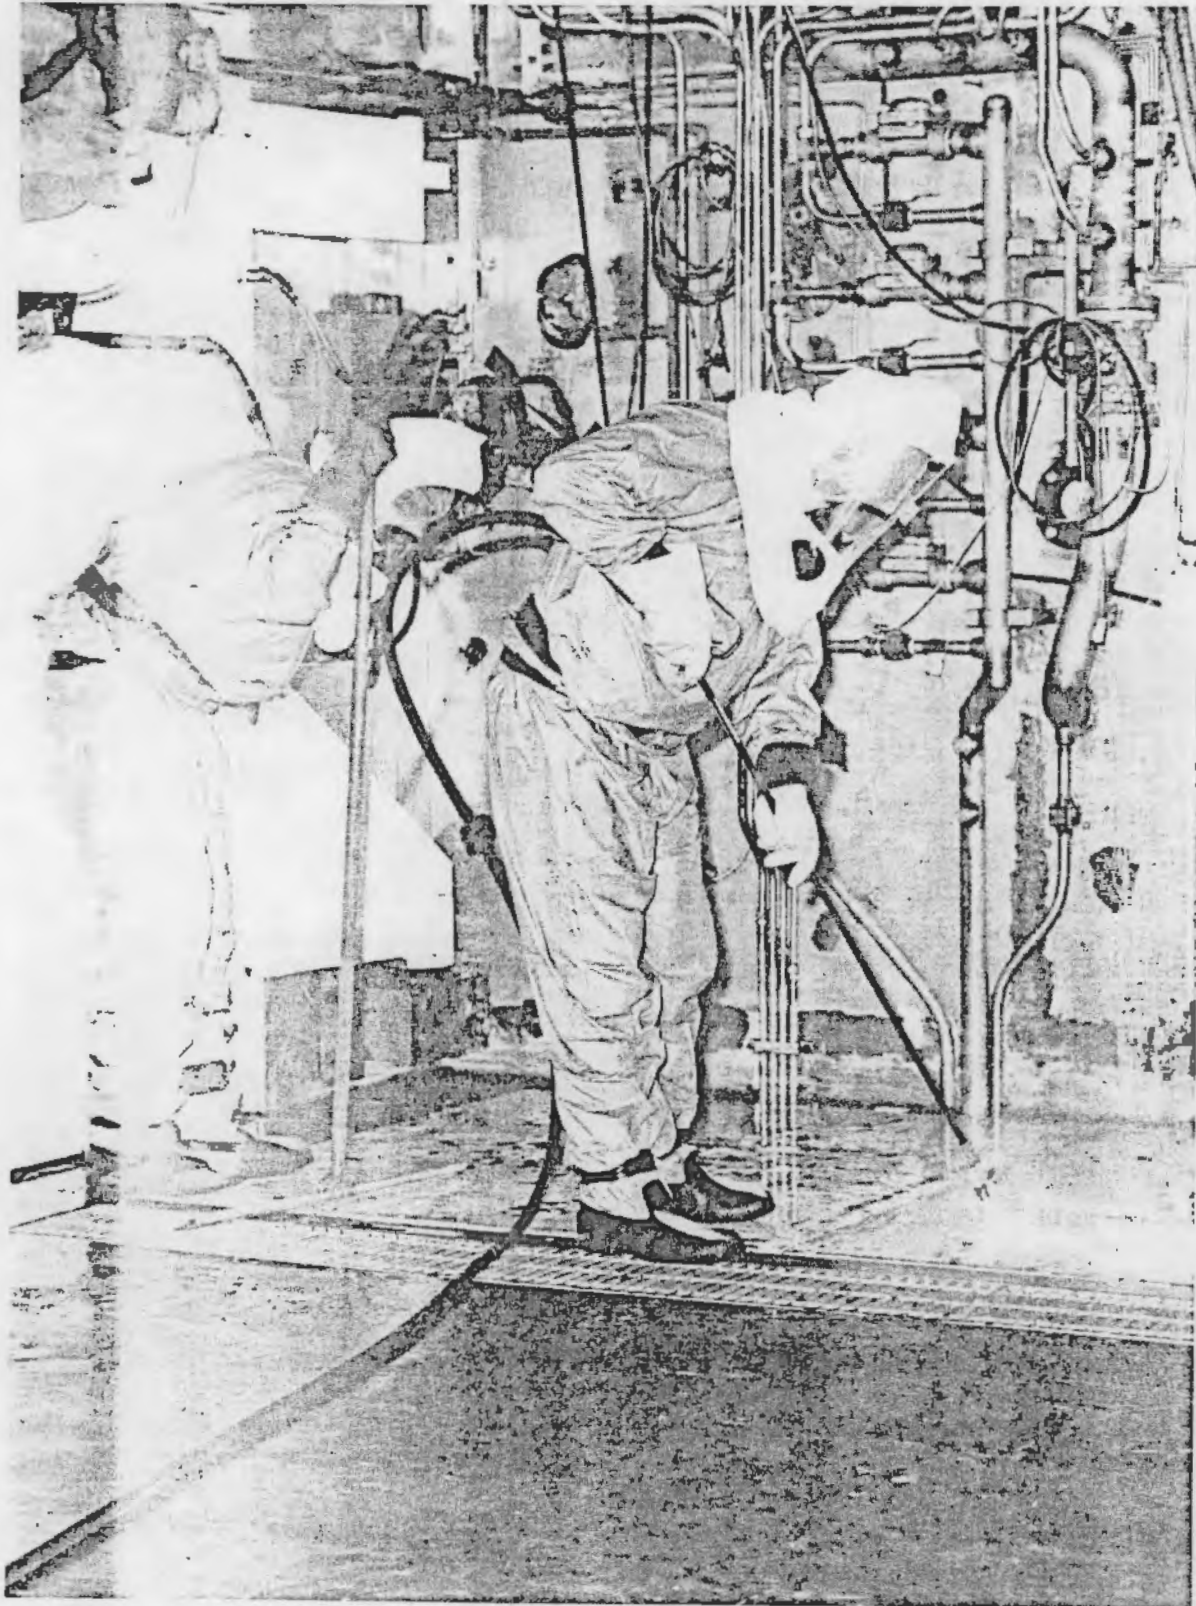
FIGURE 7. Washing Cover Blocks Prior to Painting

The cover blocks were washed to remove loose radioactivity. A pressurized (4,000 psi) water spray was used to wash the air lock as well as the cover block surfaces (see Figure 7). Radiation exposure rates were measured with a black widow CP at preselected areas on the cover blocks using a template. Figure 8 is a plan view sketch of the cover blocks showing initial exposure rates measured with the template and recorded as millirads per hour for window open/window closed measurements. The template was used periodically during refurbishment to measure exposure rates and verify that the background radiation level above the cover blocks was decreasing as expected. The periodic measurements of exposure rates are provided in the Appendix and are discussed in the Post-Refurbishment Analyses section of this report.

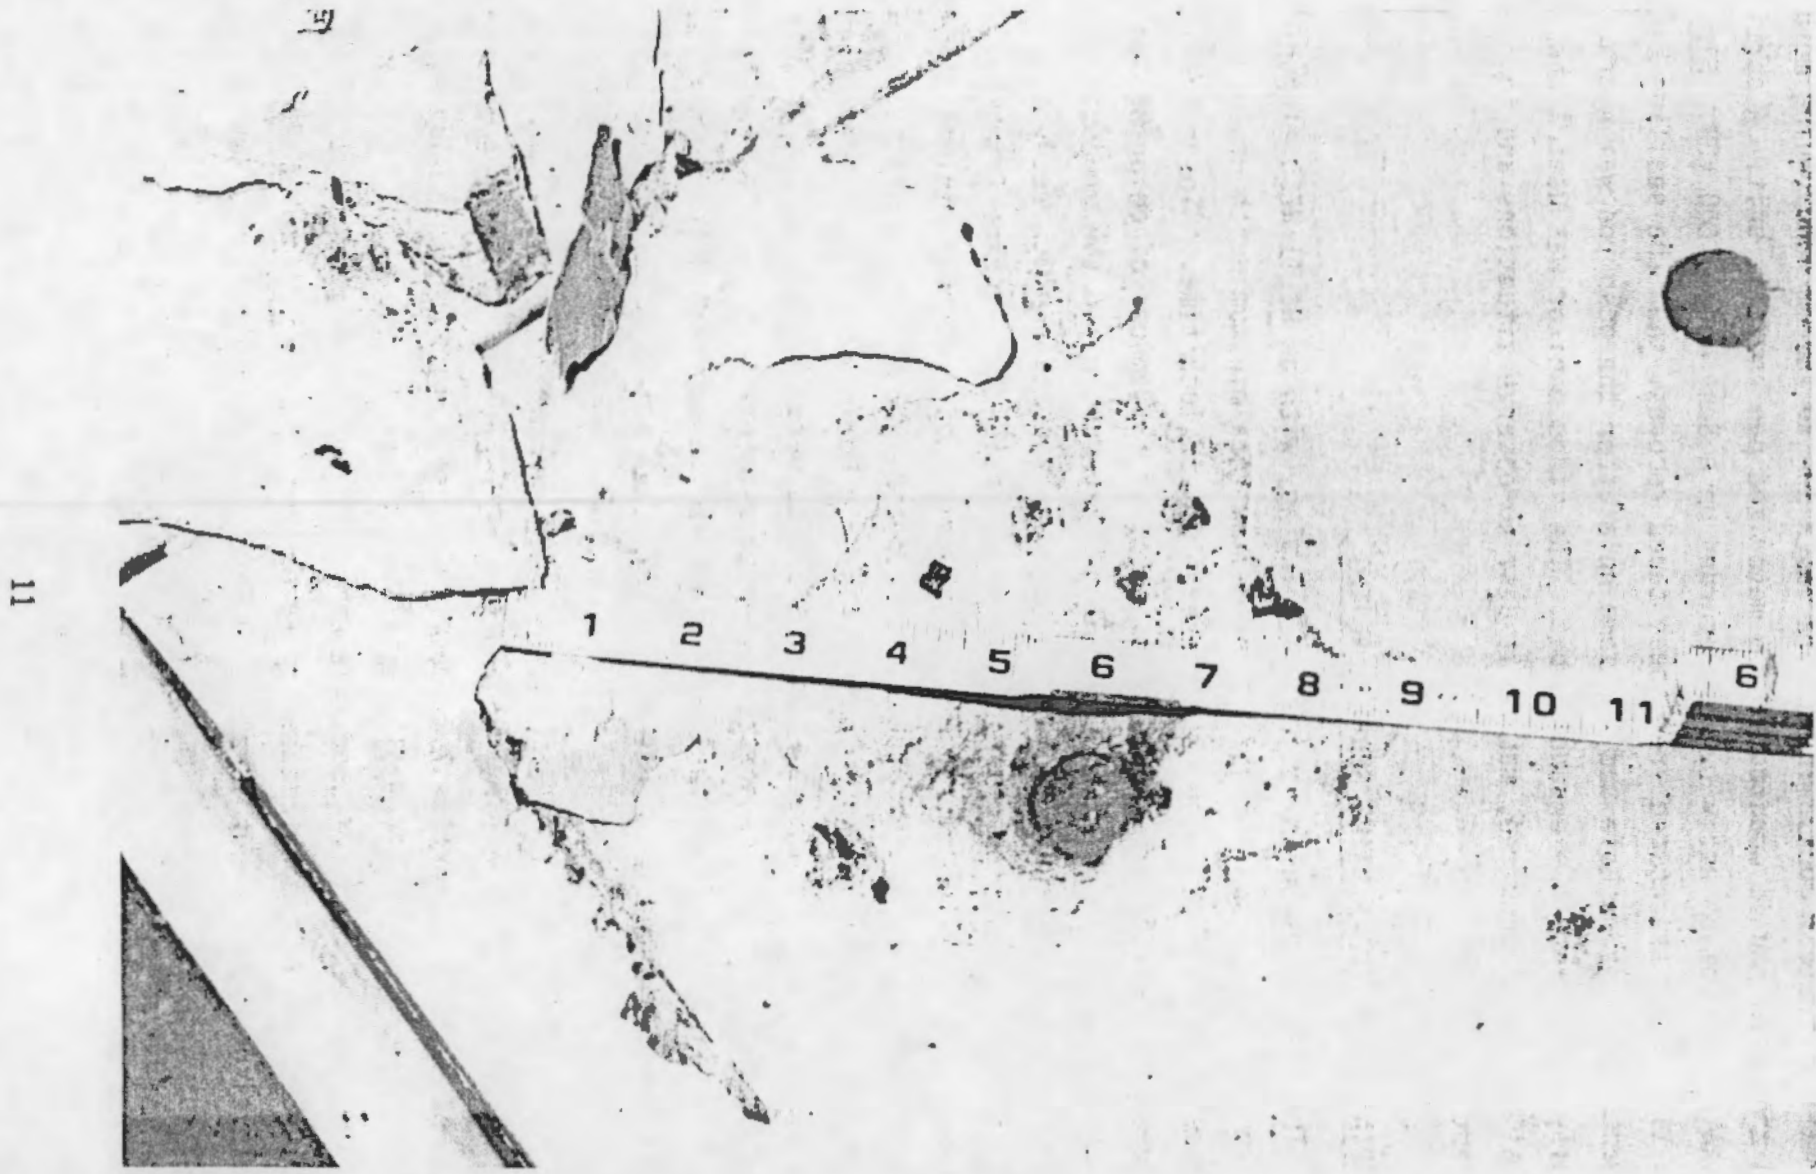
FIGURE 10. First Spalled Hole on Cover Block #1

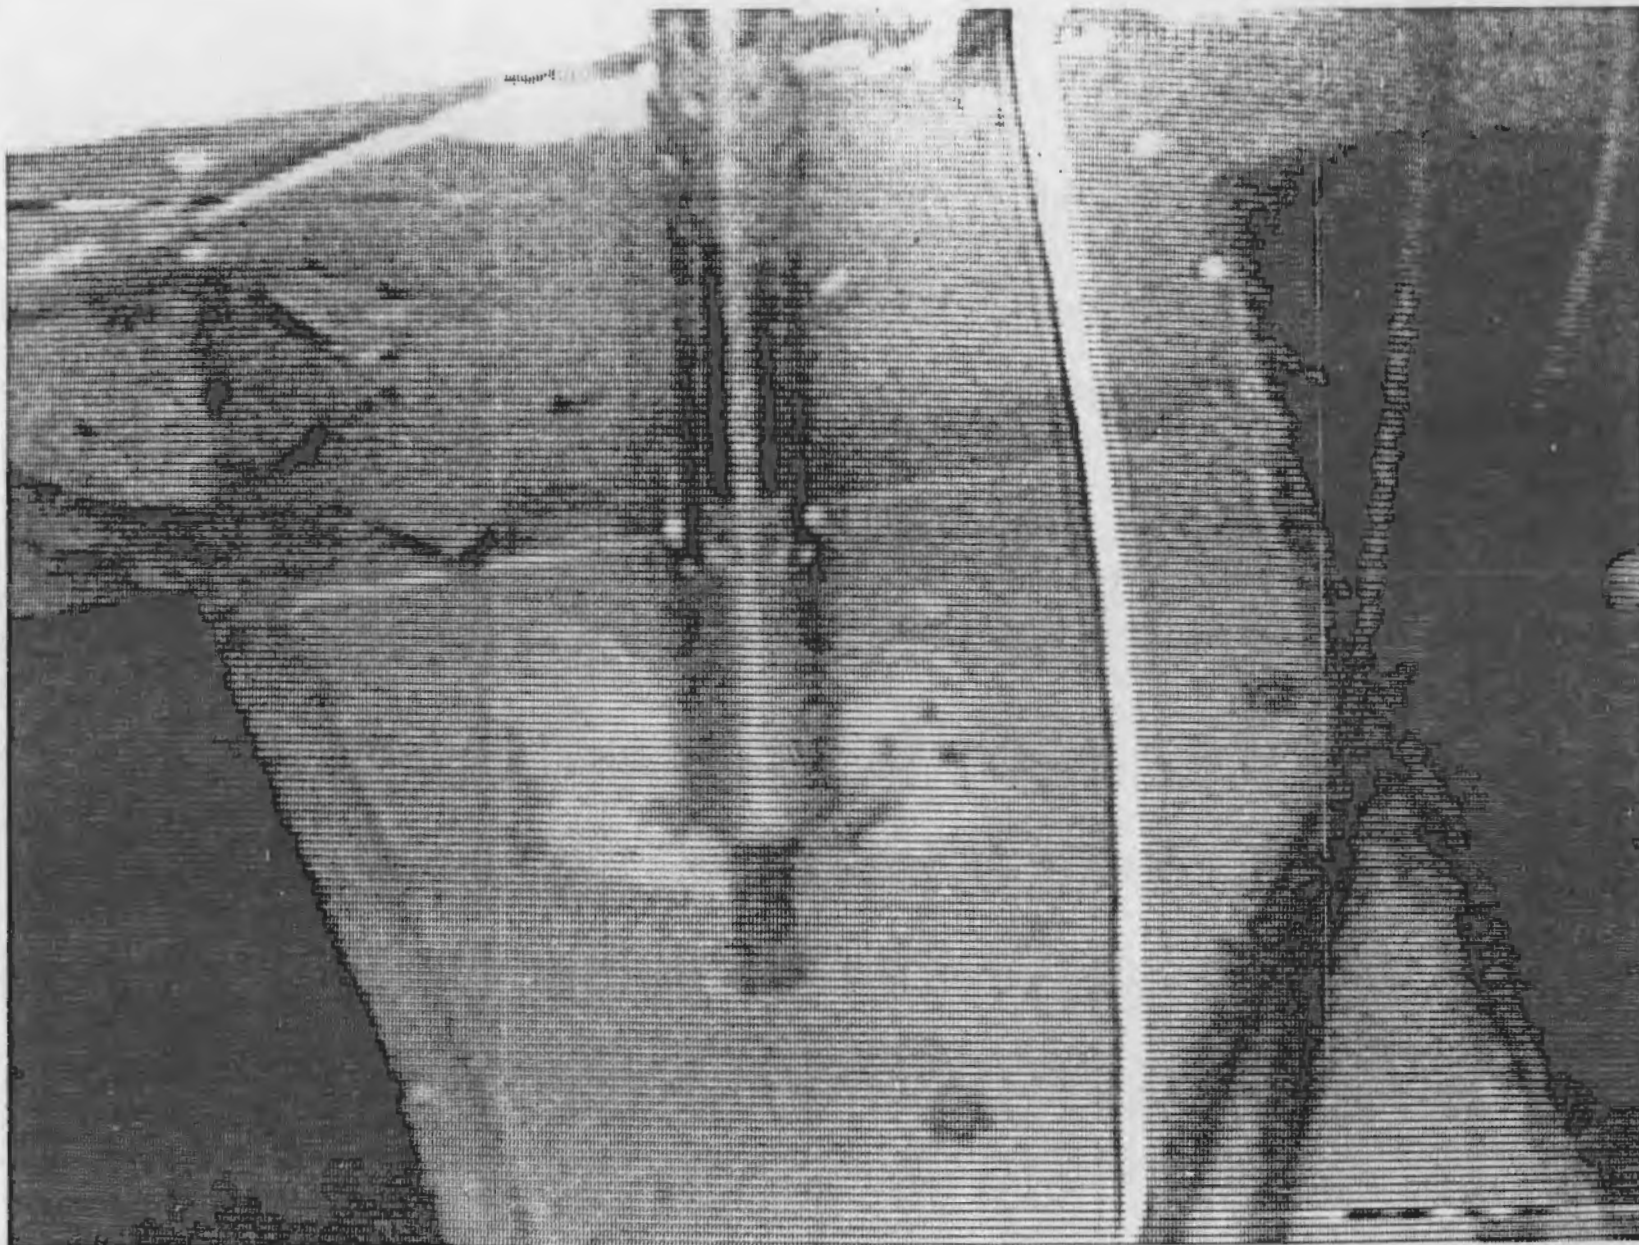
FIGURE 11. VCR Photo of Spaller Bit Placed into Drilled Hole

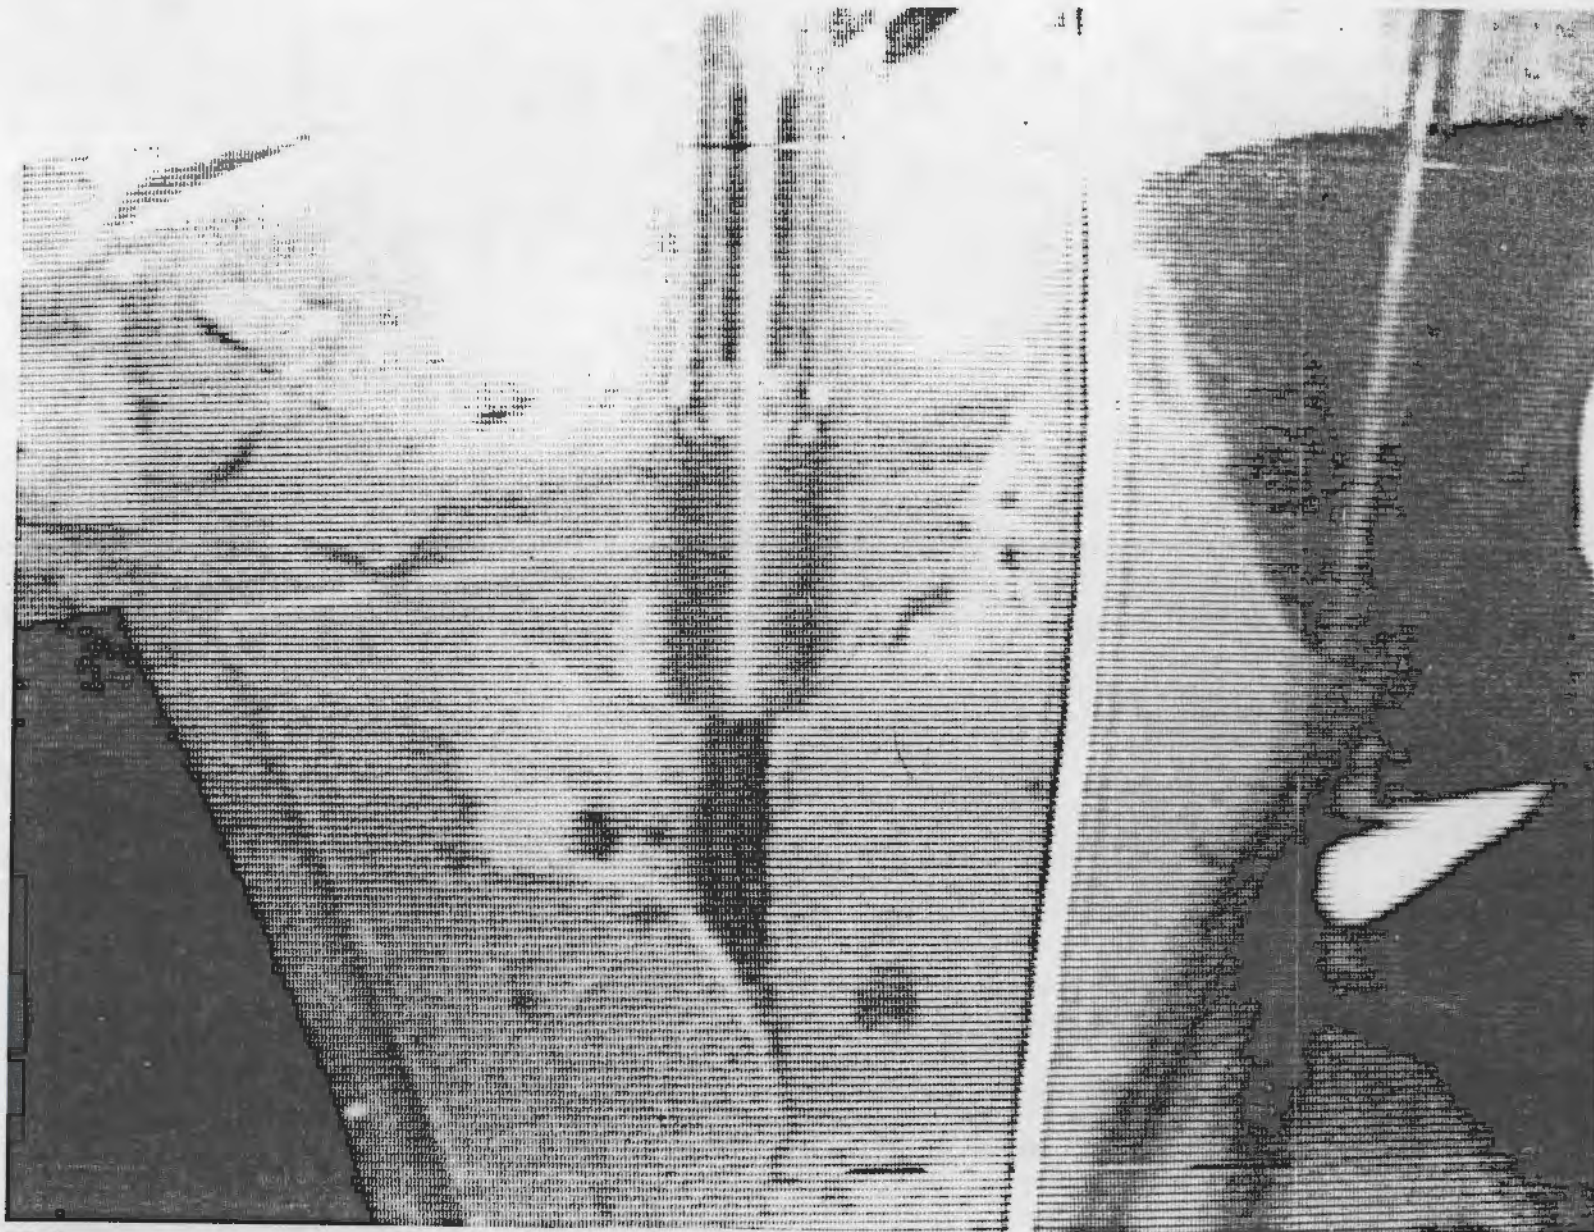
FIGURE 12. VCR Photo of Hole in Figure 11 After Spalling

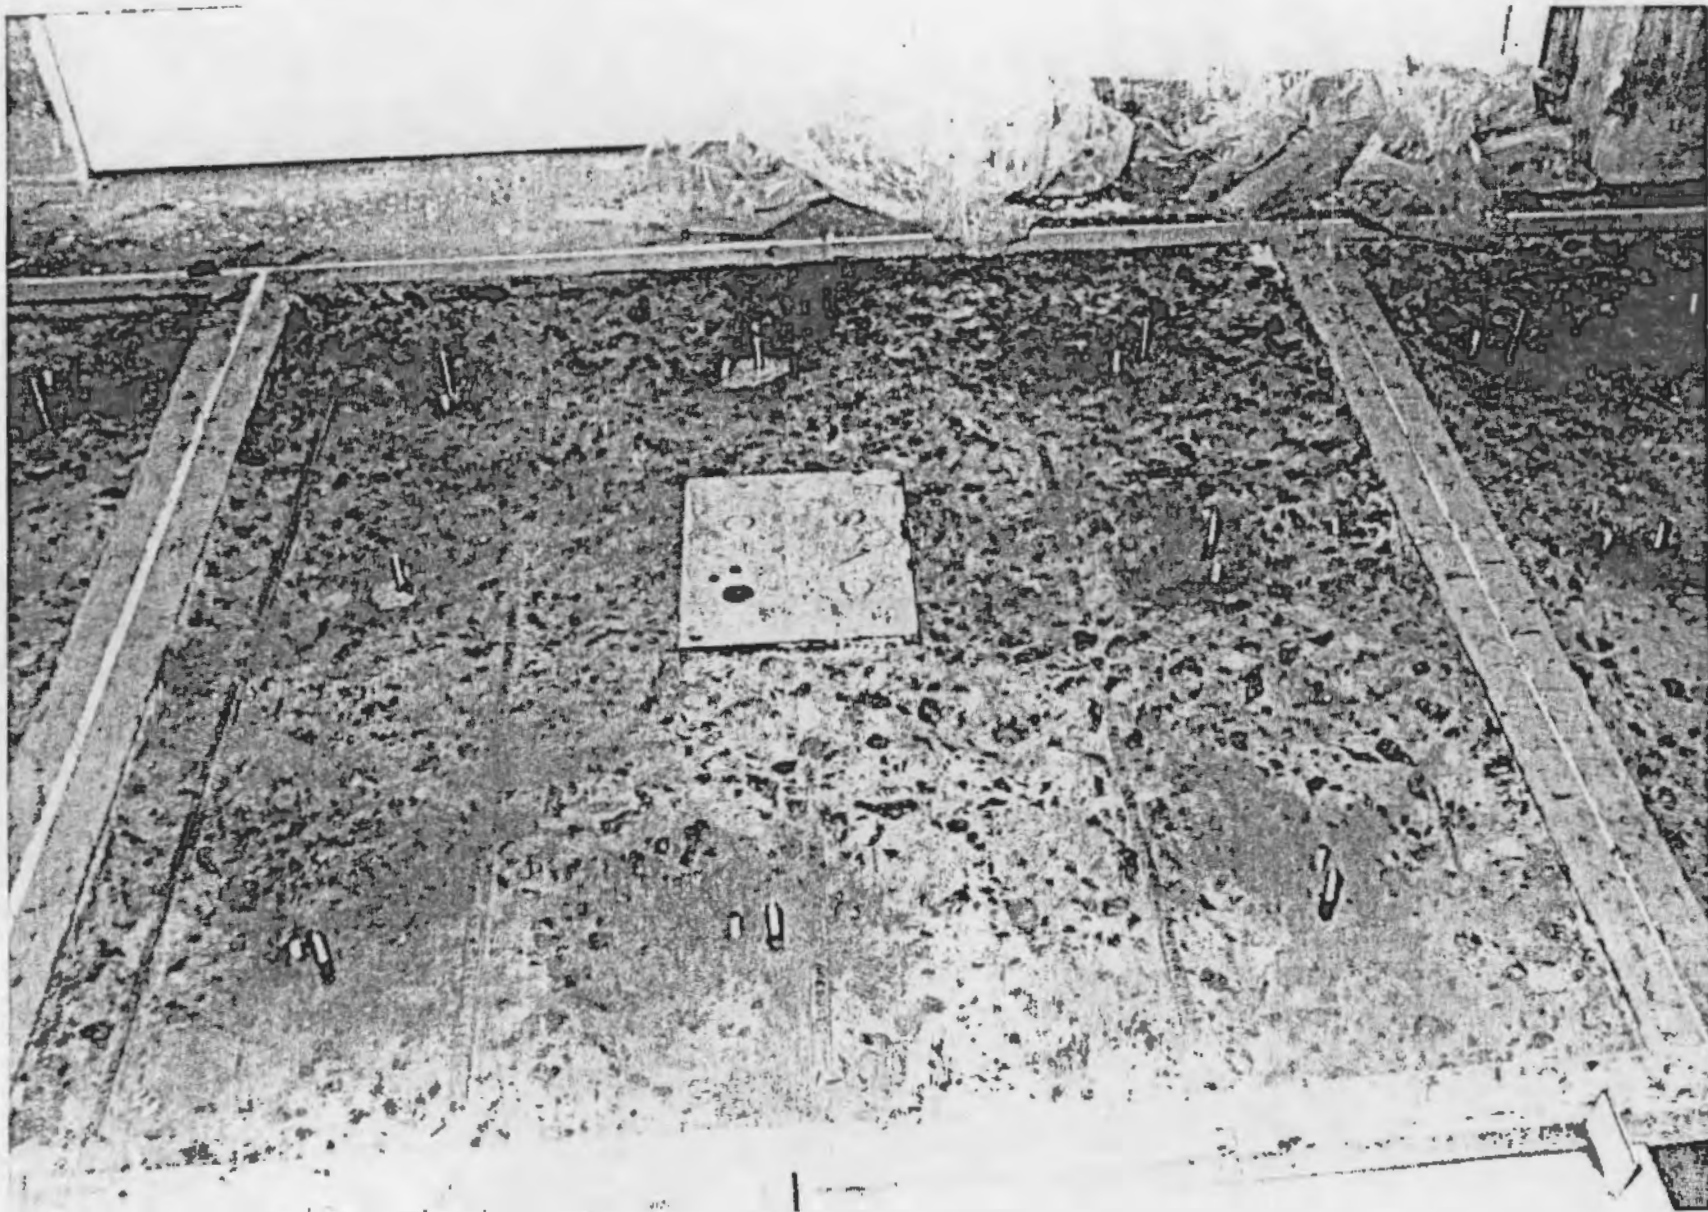
FIGURE 13. Cover Block Ready for Grouting

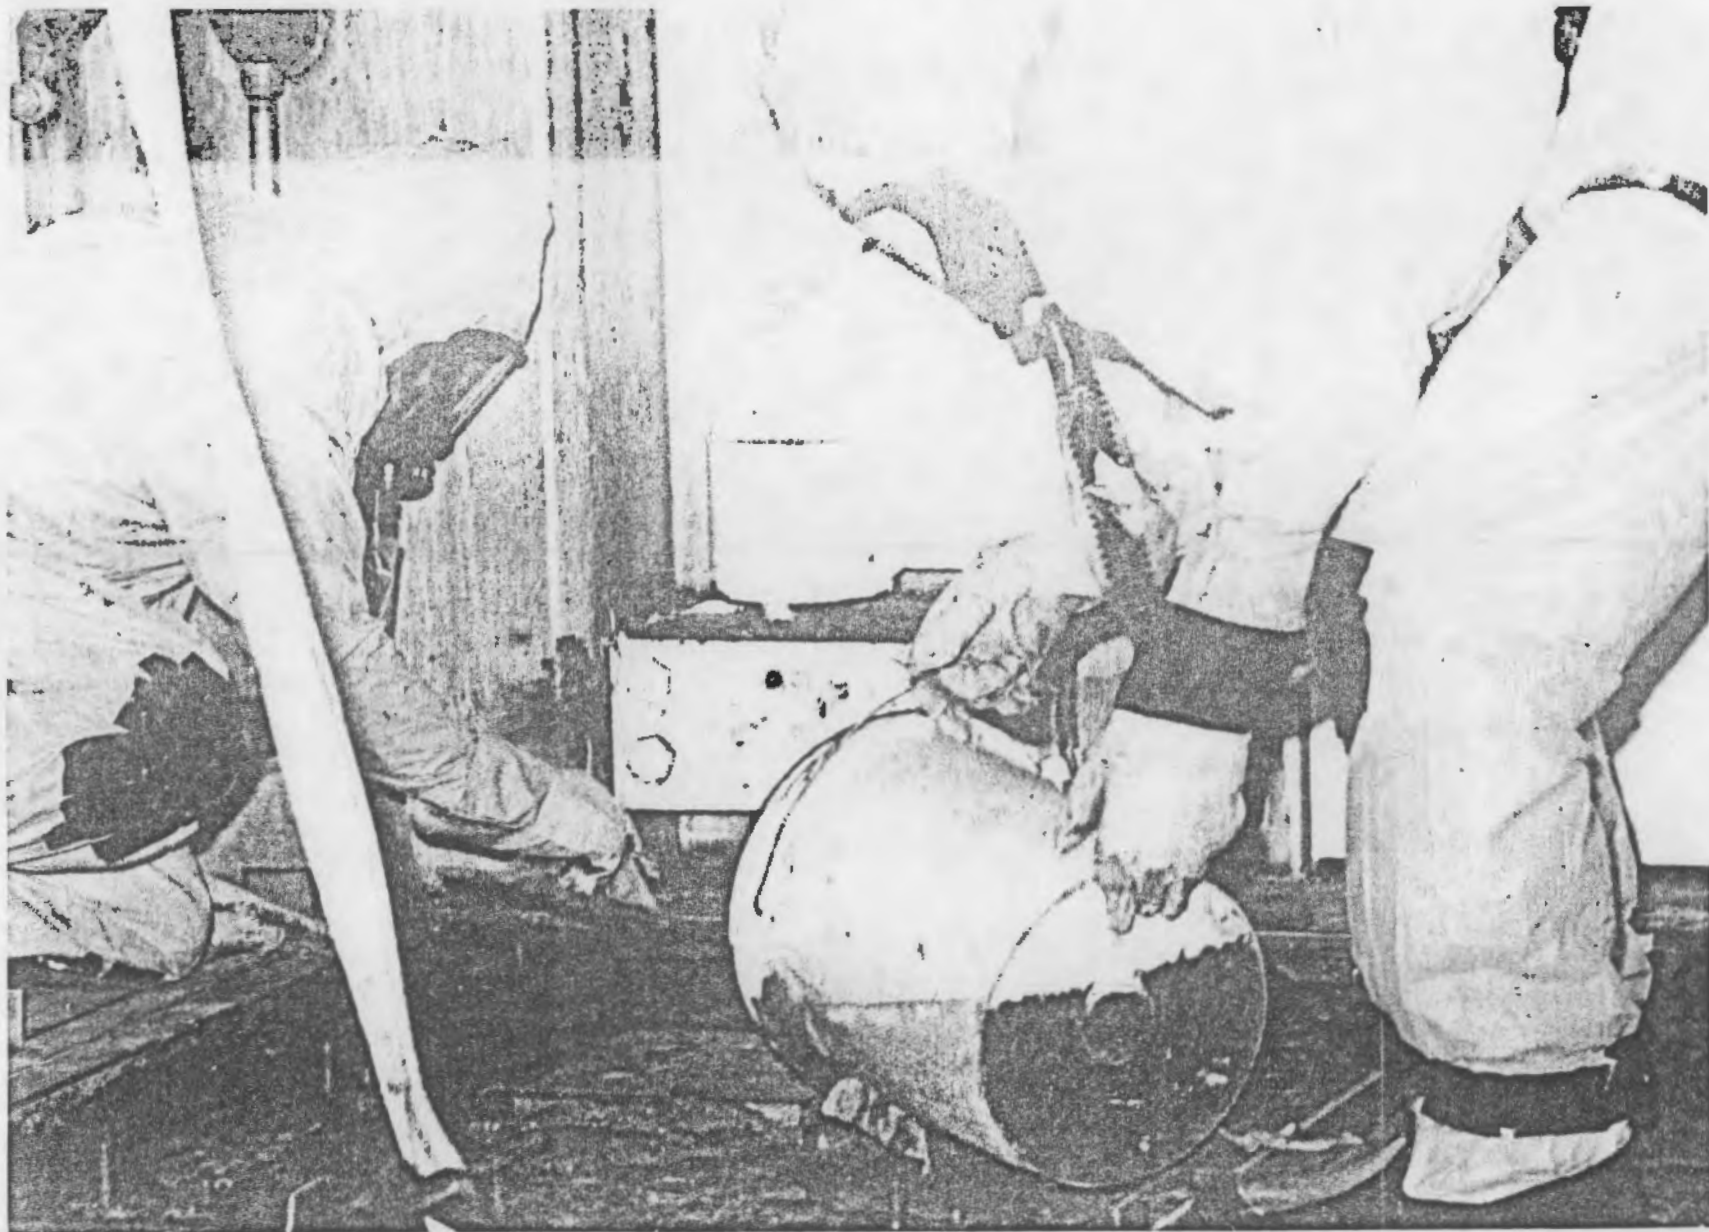
FIGURE 14. Pouring and Leveling of Grout

with the standard frit/water ratio it was not easily workable in the small, oddly shaped areas interdispersed with anchoring studs. Therefore it was made more fluid after the first cover block was grouted and was then observed to flow out from under the stainless steel surface plates as they were being anchored into place. The stainless steel surface plate leveling supports were used to aid in determining the grout fill height during leveling.

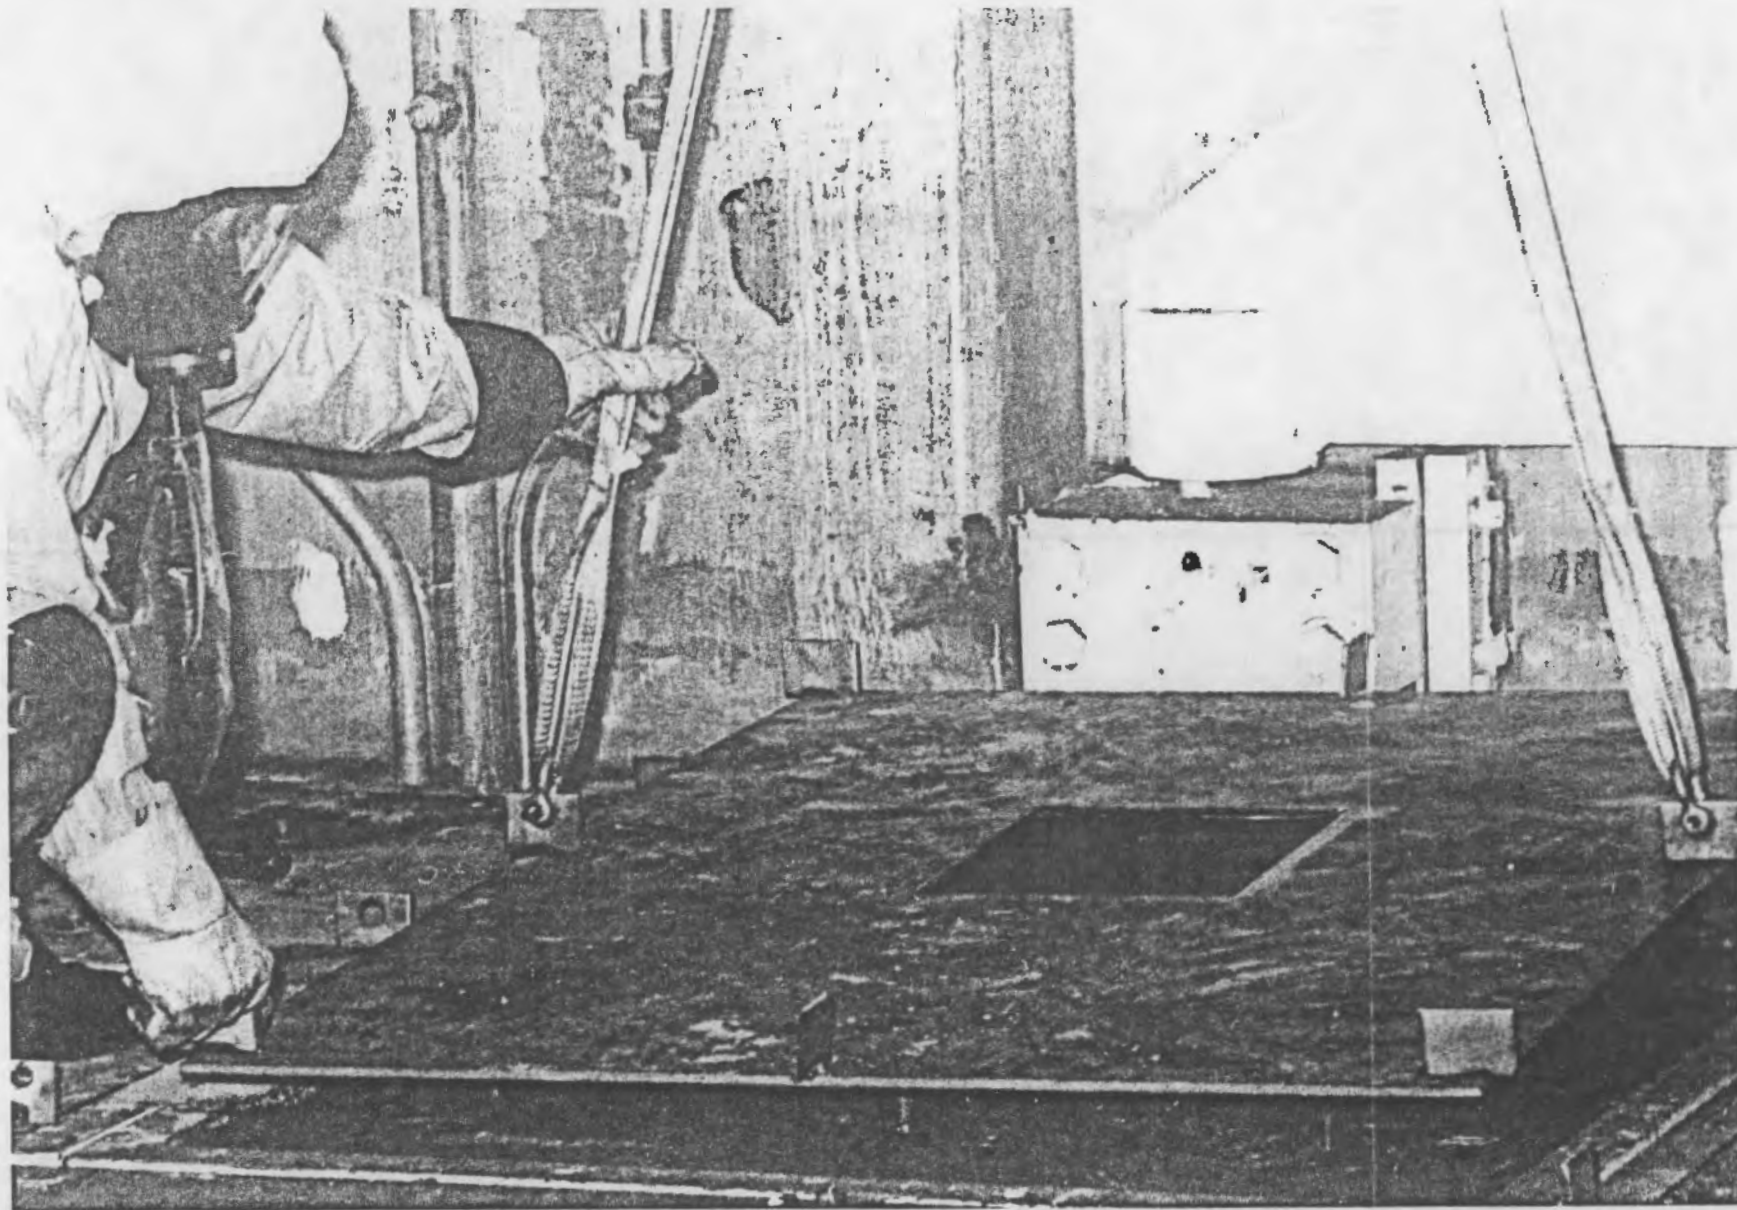
FIGURE 15. Stainless Steel Surface Plate Being Lowered onto Fresh Grout

The stainless steel surface plate was placed over the grouted cover block (Figure 15) and the plate bolted down to contact the leveling supports with a "U" shaped spacer-washer under the nut. A tack weld was made in the "U" opening of the washer before the nut and washer were removed (Figure 16). The anchor studs were completely welded, as shown in Figure 17, and all protrusions above the surface plate were ground away.

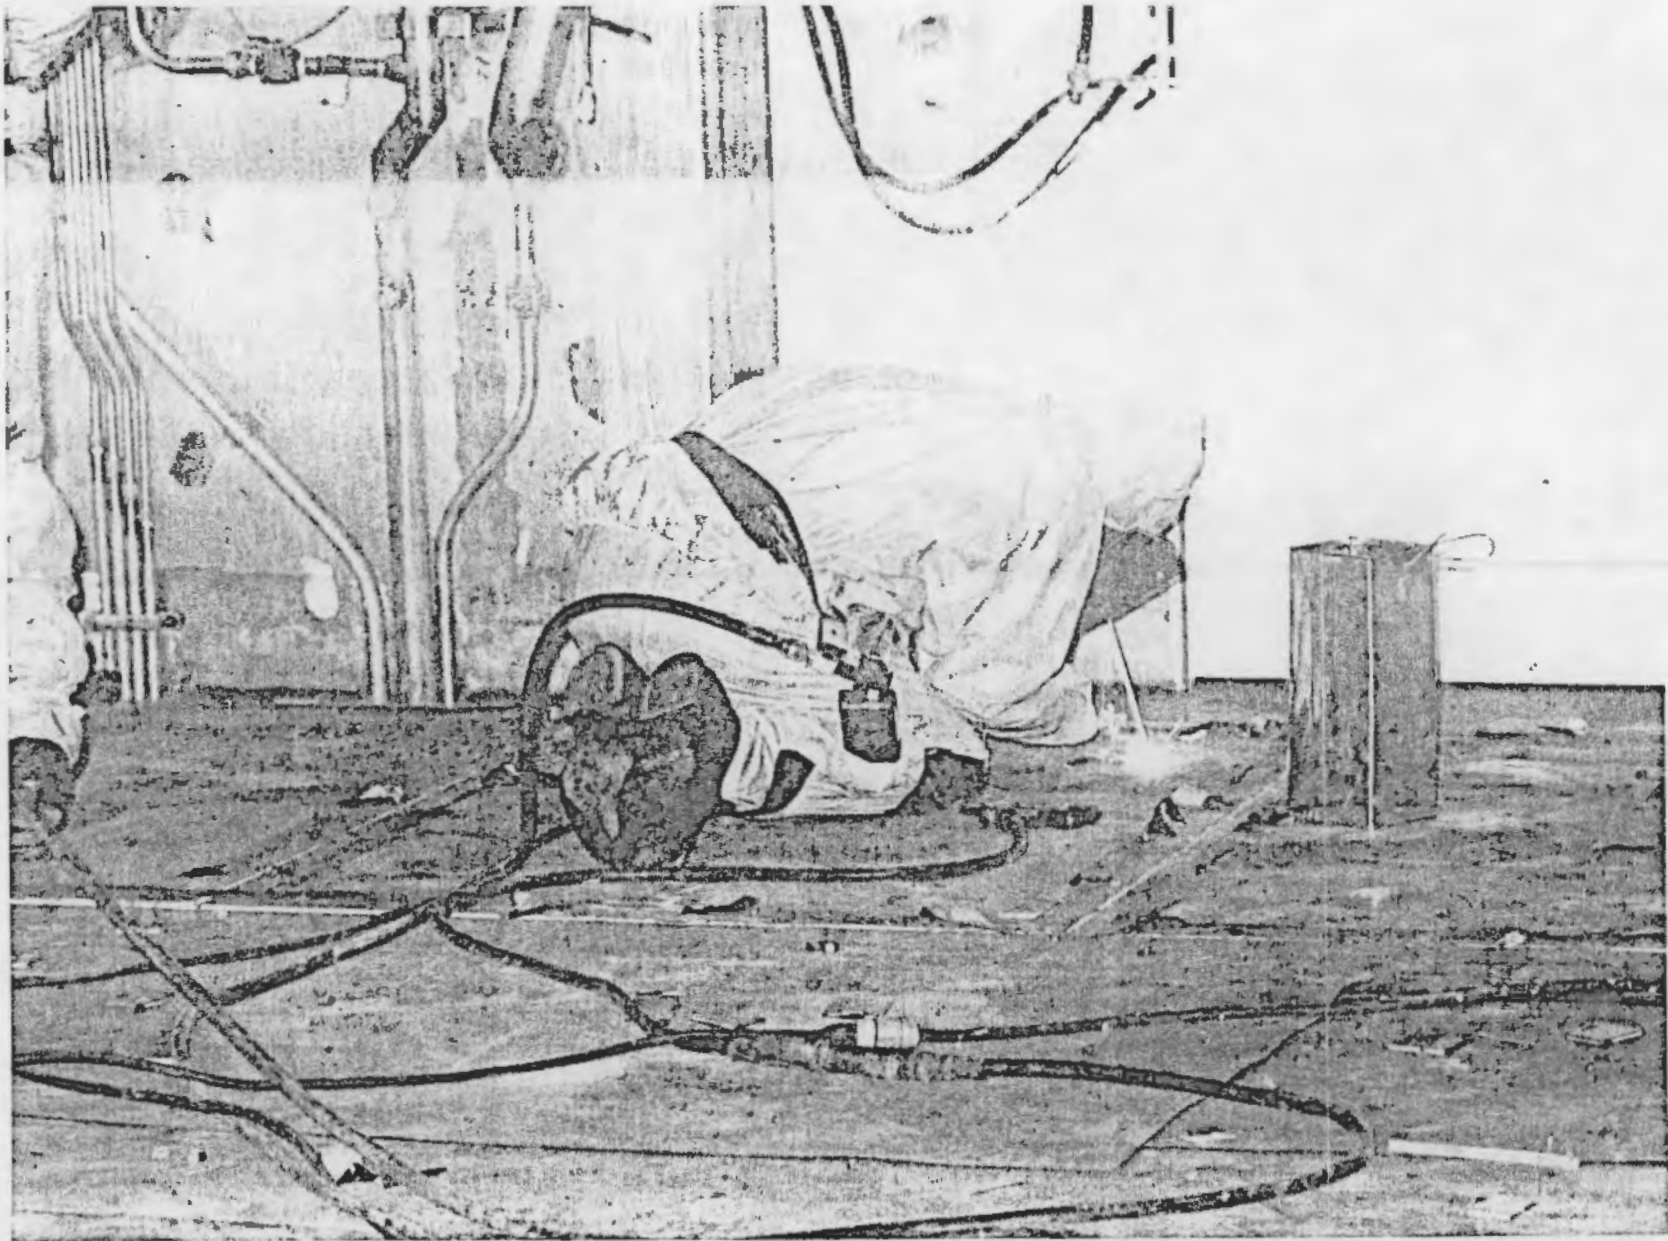
FIGURE 17. Anchor Studs Being Seal-Welded to Surface Plate

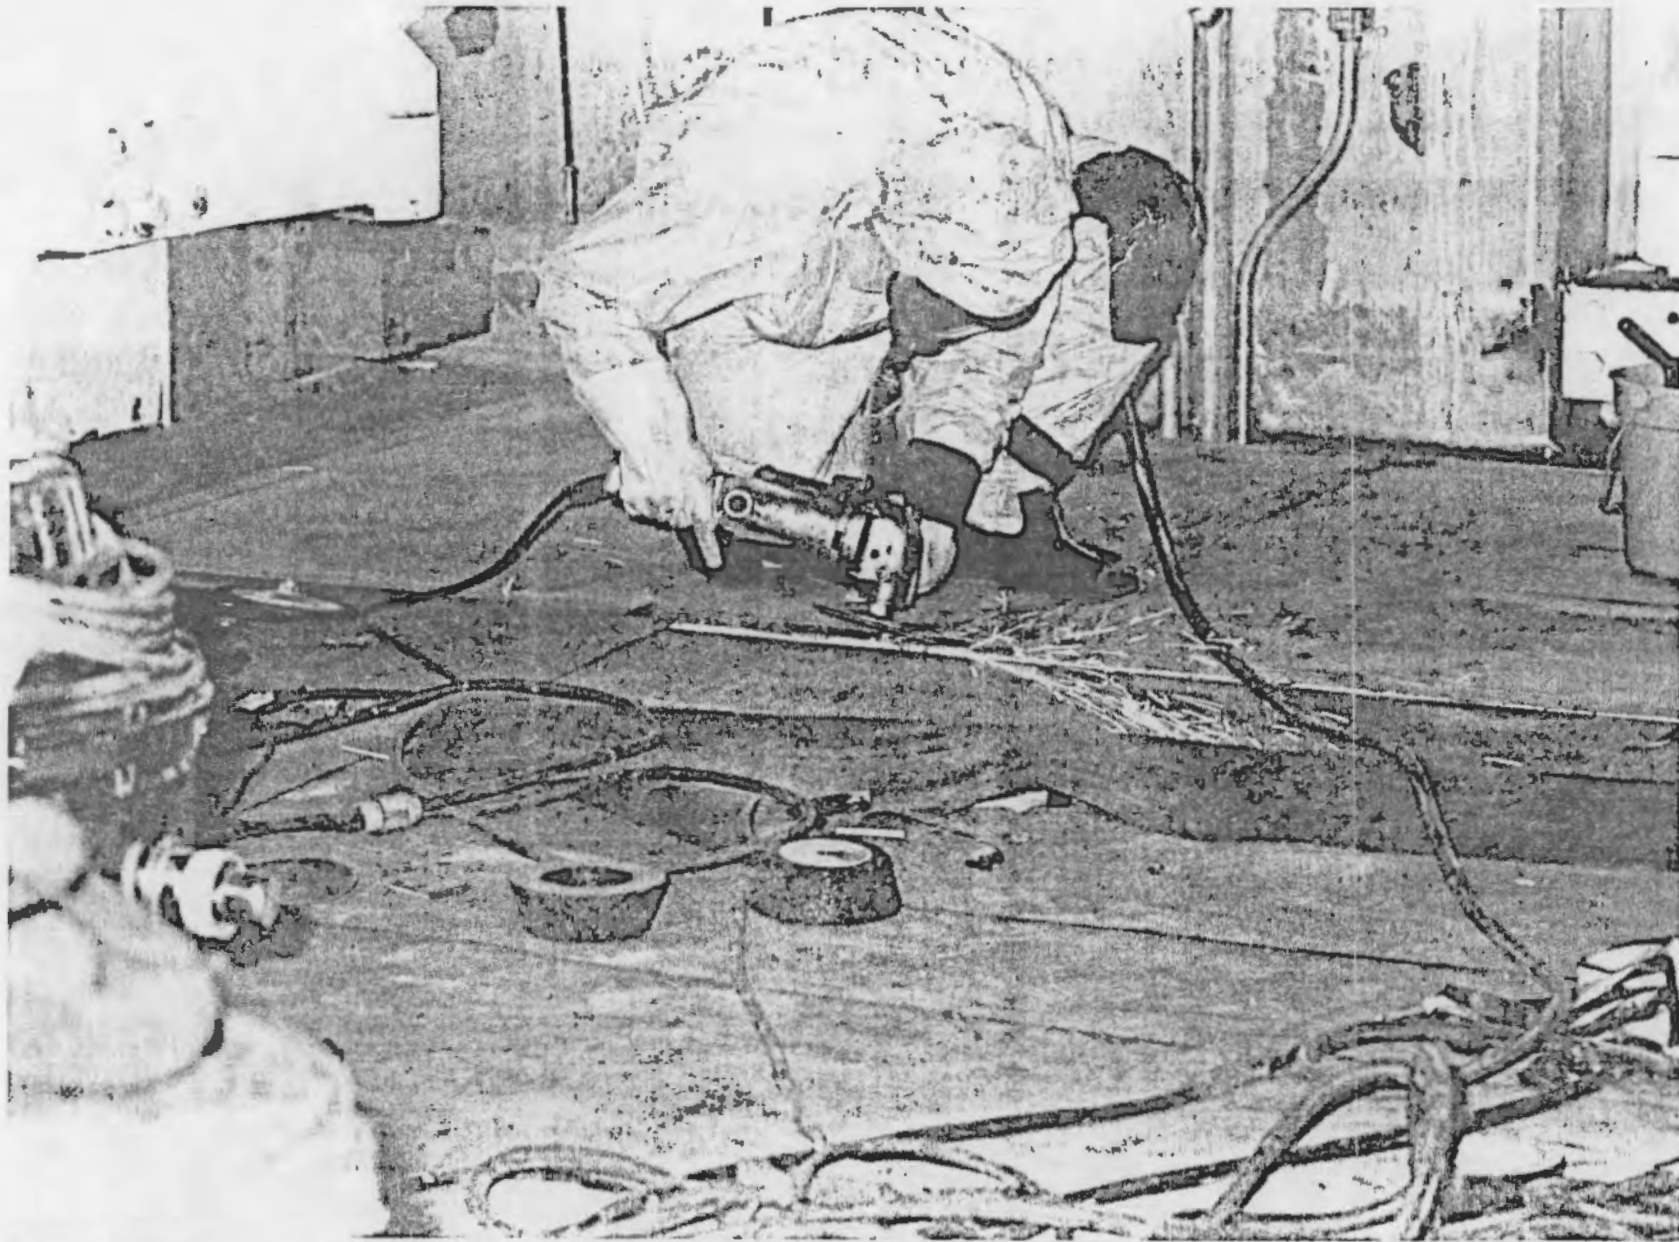
FIGURE 18. Grinding Contamination from Steel Angle-Iron Framework

The next refurbishing step was to decontaminate the mild steel portions on the original surface of the cover blocks. These areas were the angle-iron framework and the cover block lifting plates anchored at the balanced point of the blocks. Dry sand was poured into the gap between the newly installed stainless steel surface plates and these paint-covered contaminated metal surfaces before grinding away the contaminated layer of metal as shown in Figure 18. The sand was then vacuumed out, and the gap was filled with GE RTV 102 silicone rubber sealant (Figure 19) rather than with a metal weldment. Although the stainless steel plates were tack-welded to the mild steel angle-iron framework, they were not seal-welded to it in order to preclude warpage and subsequent interference with the opening and closing of the cell doors. The freshly ground steel portions of the cover blocks were painted with Amercoat Red primer followed by a coat of Amercoat Grey paint, Figure 20.

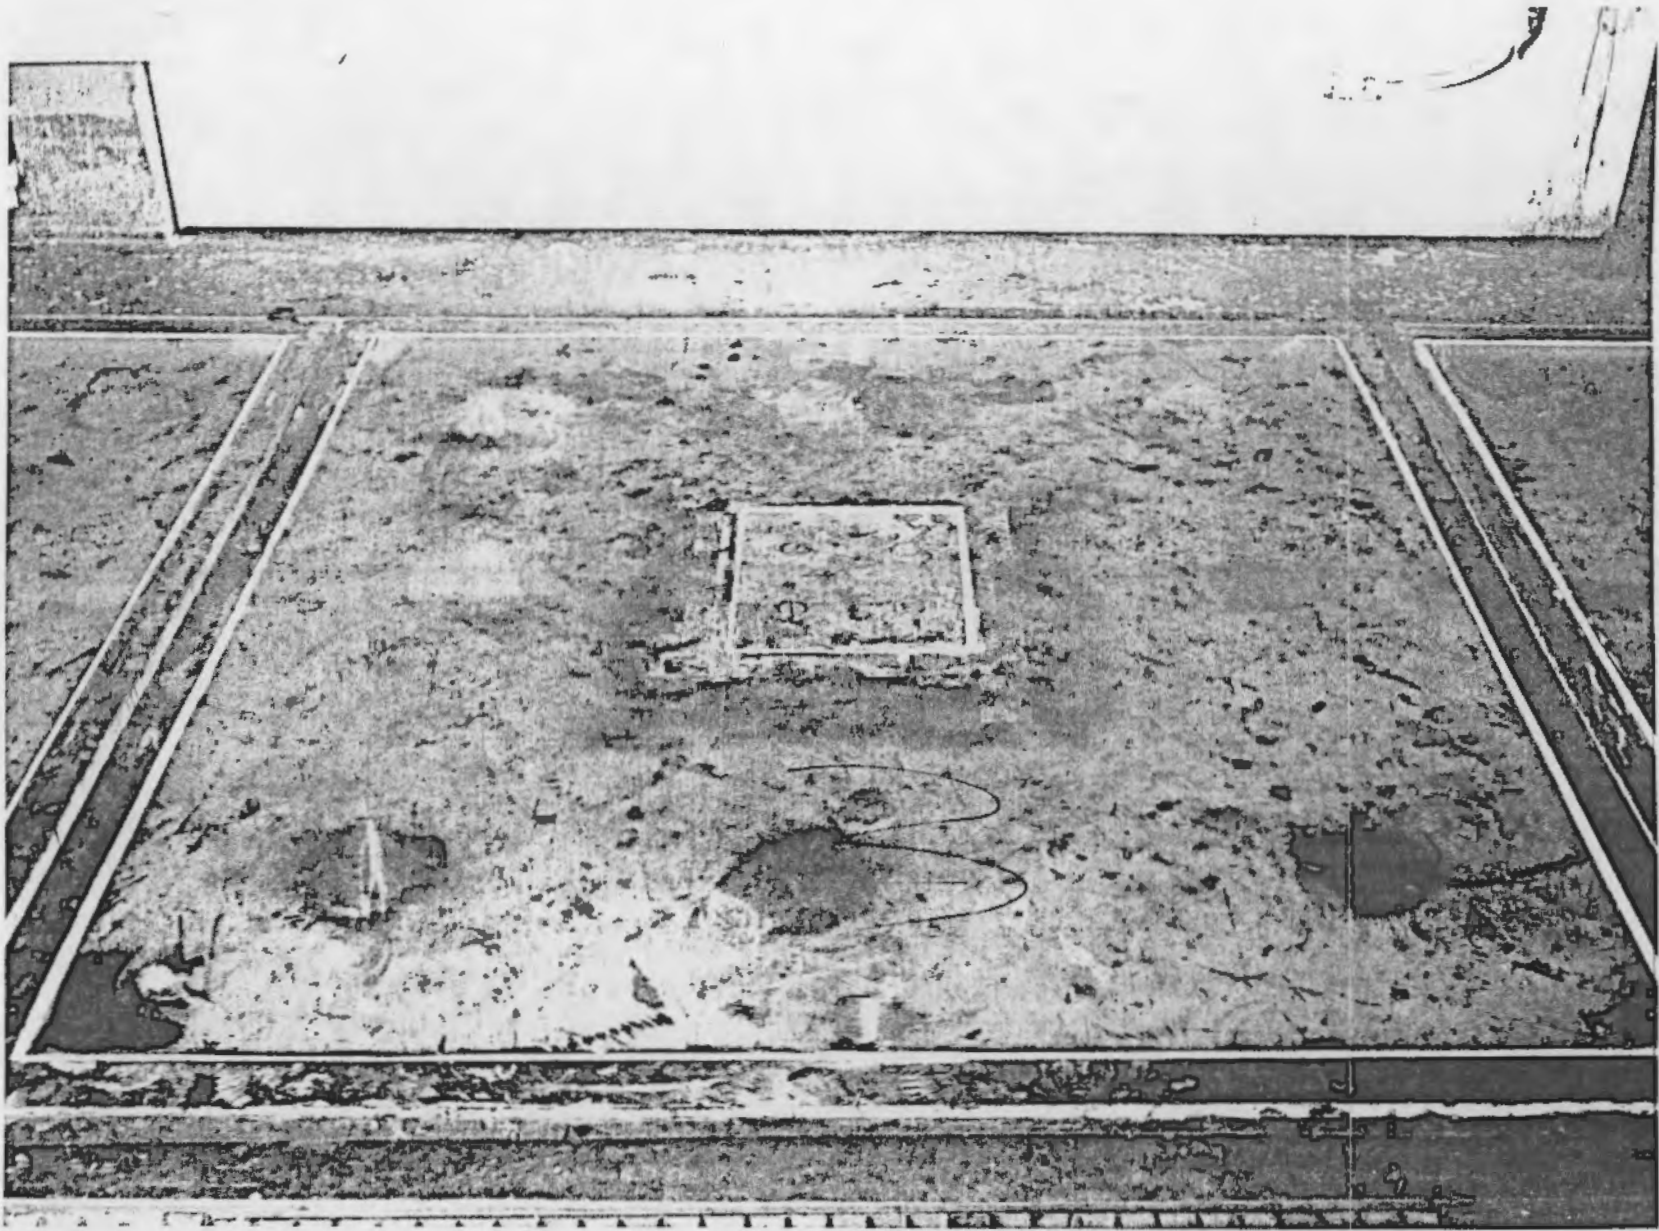
FIGURE 19. Silicone Rubber Sealant Placed Between Metal Joints
