324 AND 325 BUILDING
HOT CELL CLEANOUT PROGRAM

AIR LOCK COVER BLOCK REFURBISHMENT

May 1989

Pacific Northwest Laboratory
Richland, Washington 99352

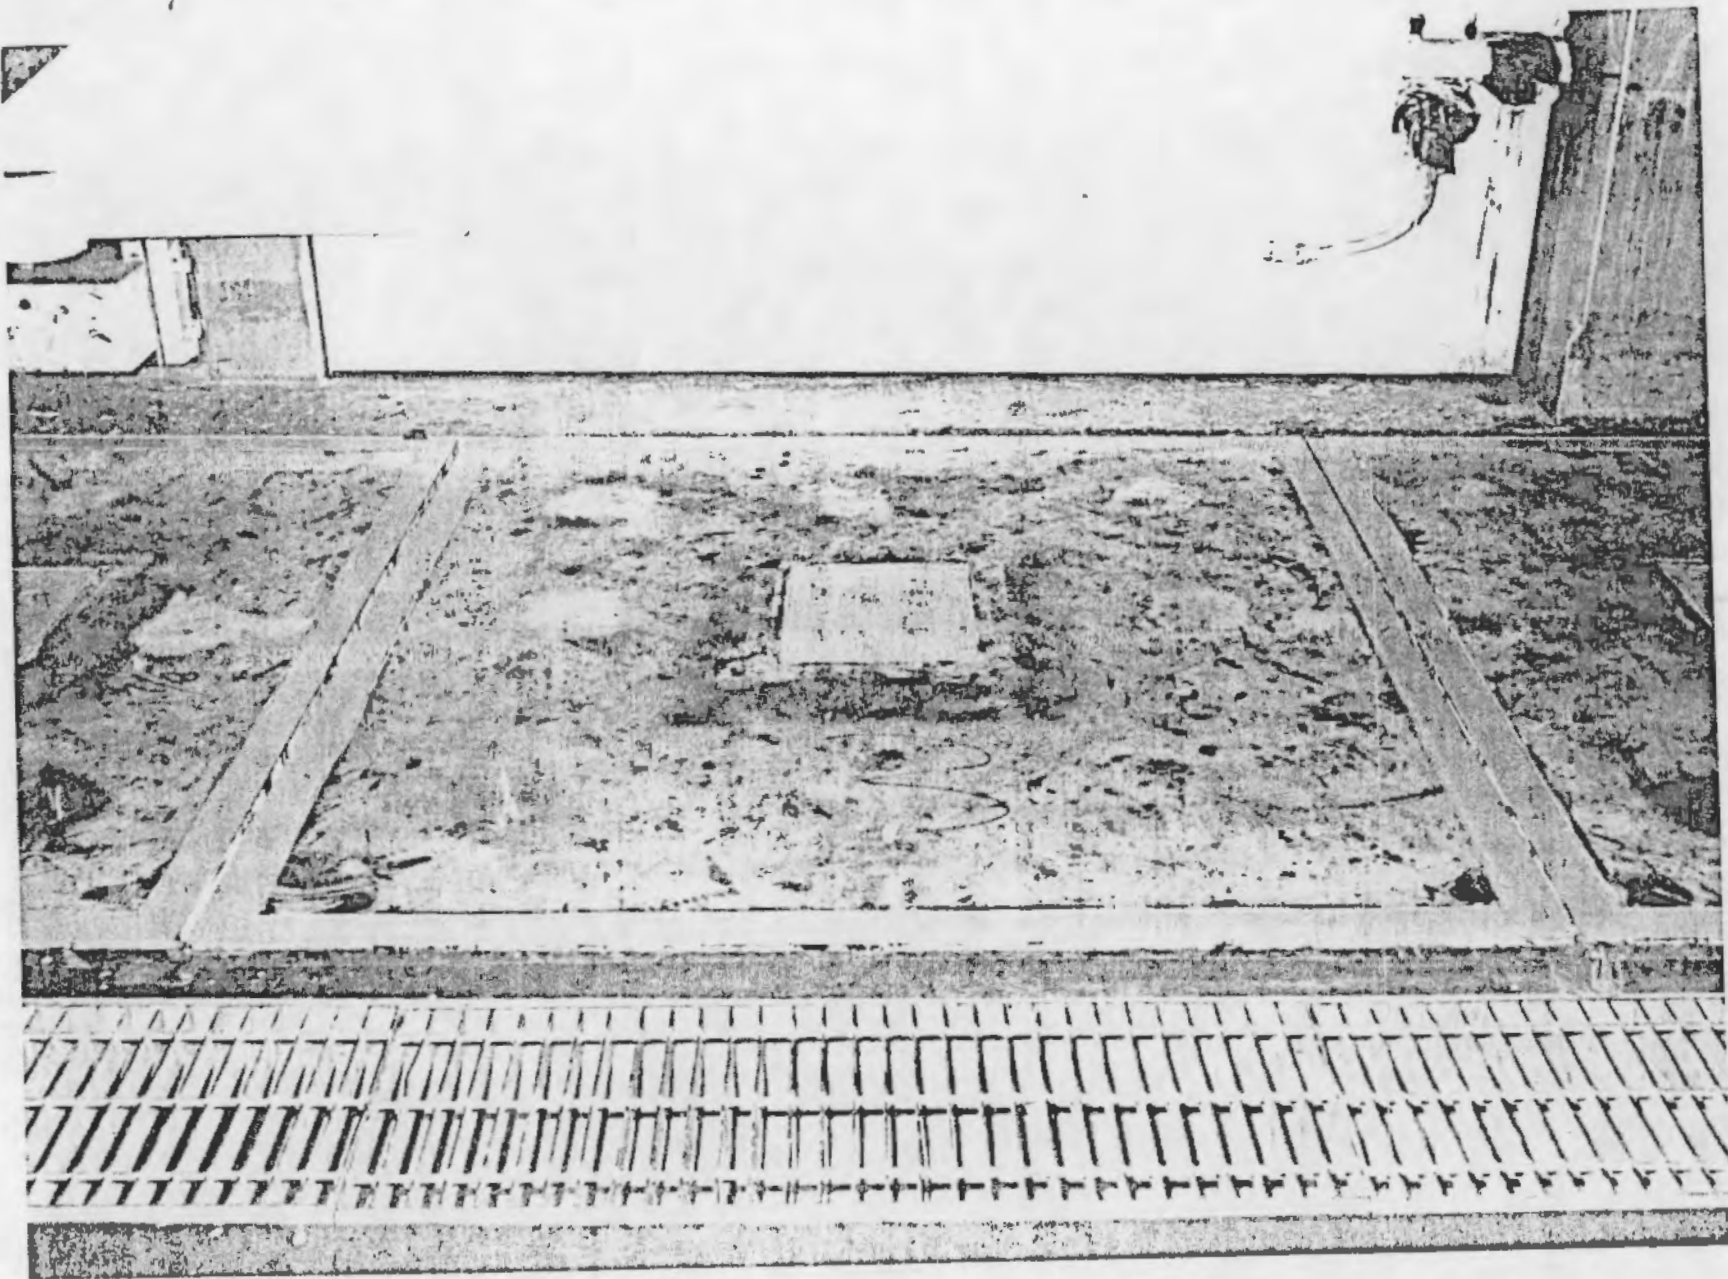
FIGURE 20. Refurbished Cover Blocks with Steel Surfaces Painted

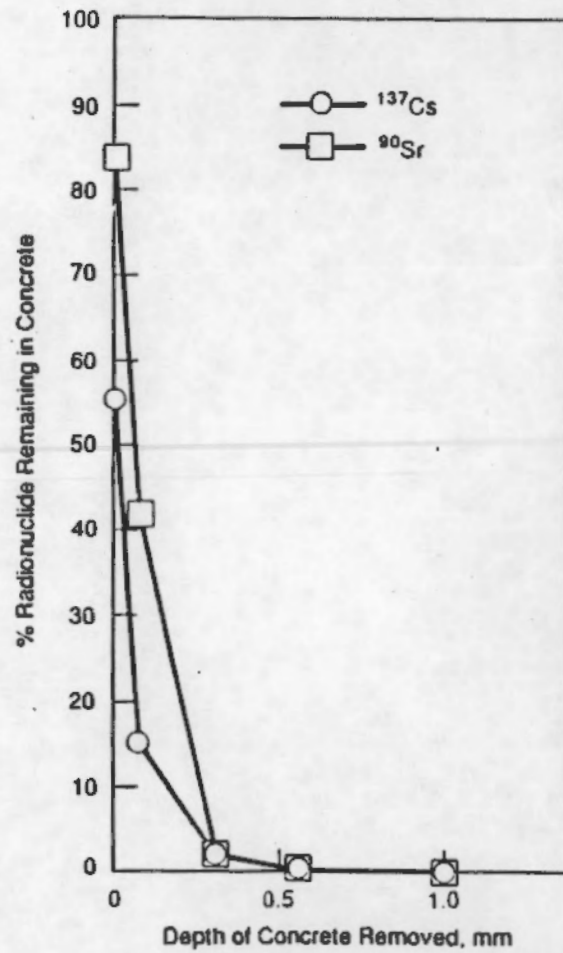
Figures 21 and 22 show the percent of the radionuclide species ^{137}Cs and ^{90}Sr remaining in the concrete as a function of the depth of high-density concrete removed. Differences in penetration depths may reflect error in accurately removing each layer of concrete rather than show different porosities between the two samples. At zero depth, the percentage decrease from 100% reflects the radioactivity that was removed with the surface paint. About 50% of the ^{137}Cs inventory and 30% of the ^{90}Sr inventory in the samples were found in the painted layer. Strontium appears to migrate more readily than cesium into the concrete.

FIGURE 21. Radionuclide Penetration into Concrete Sample 52186-48-1

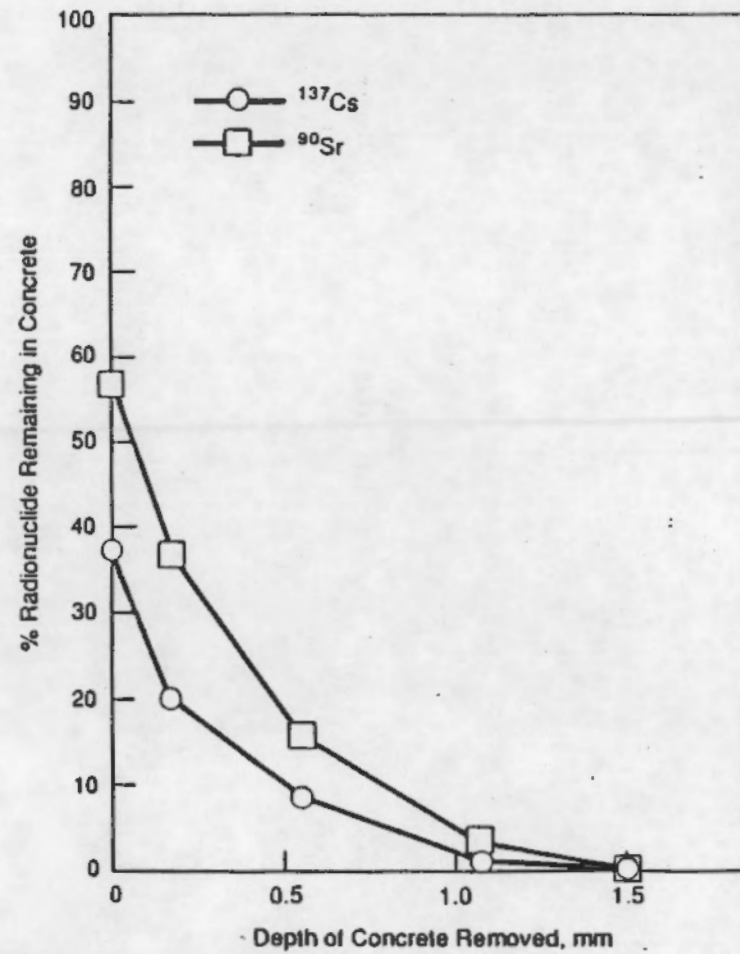
FIGURE 22. Radionuclide Penetration into Concrete Sample 52186-48-2
