UCID- 18886

**SAFETY ANALYSIS (SA)  
OF THE  
DECONTAMINATION FACILITY  
BUILDING 419  
At THE LAWRENCE LIVERMORE NATIONAL LABORATORY**

**BYRON N. ODELL**

JUNE 17, 1980

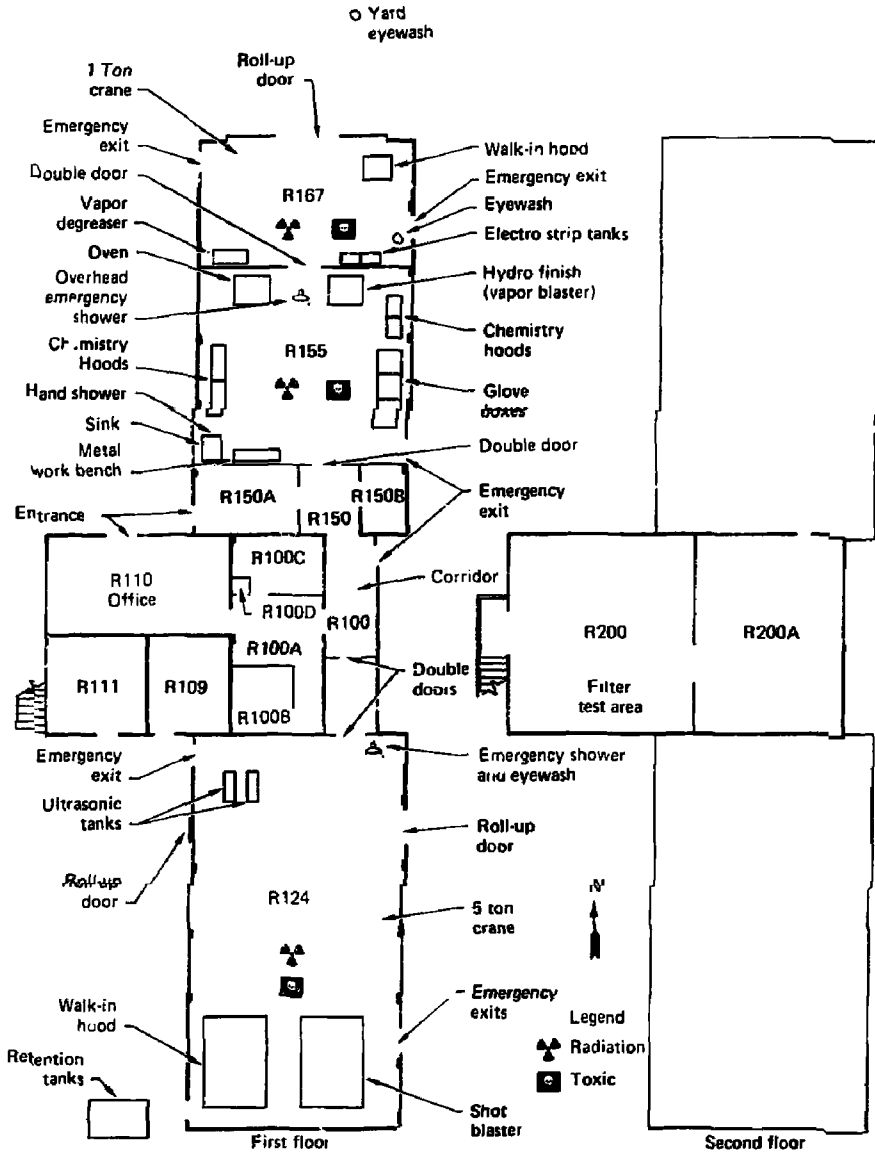
Fig. 2-1. Building 419 Floor Plan

Eye Wash and Emergency Showers -- Adequate eye wash and emergency showers are provided in areas where chemicals are located. These locations are shown in Fig. 2-1.
