GEAP-4360
AEC RESEARCH AND
DEVELOPMENT REPORT
SEPTEMBER 16, 1963

FUEL FAILURE EXAMINATIONS AND ANALYSES IN THE HIGH POWER DENSITY PROGRAM

By
W.H. ARLT
S.R. VANDENBERG

VALLECITOS ATOMIC LABORATORY

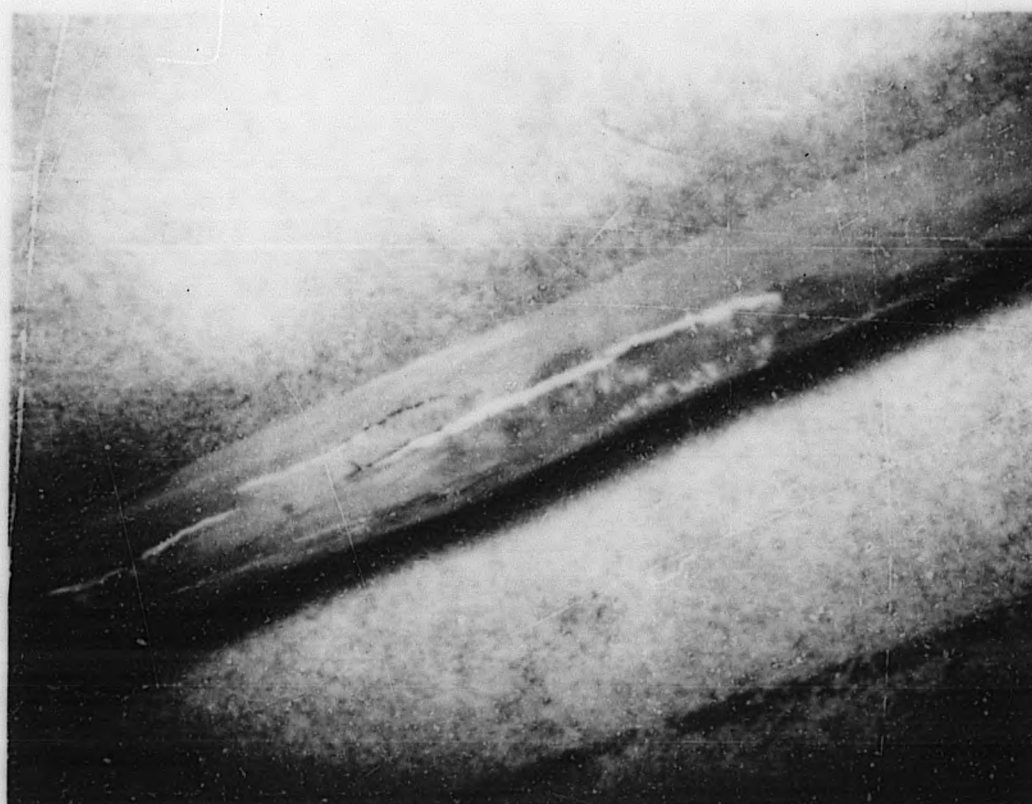
Figure 4. HPD 1D - Rod E Service Failure

Longitudinal cracking observed in failed rod.

No detailed examination performed.

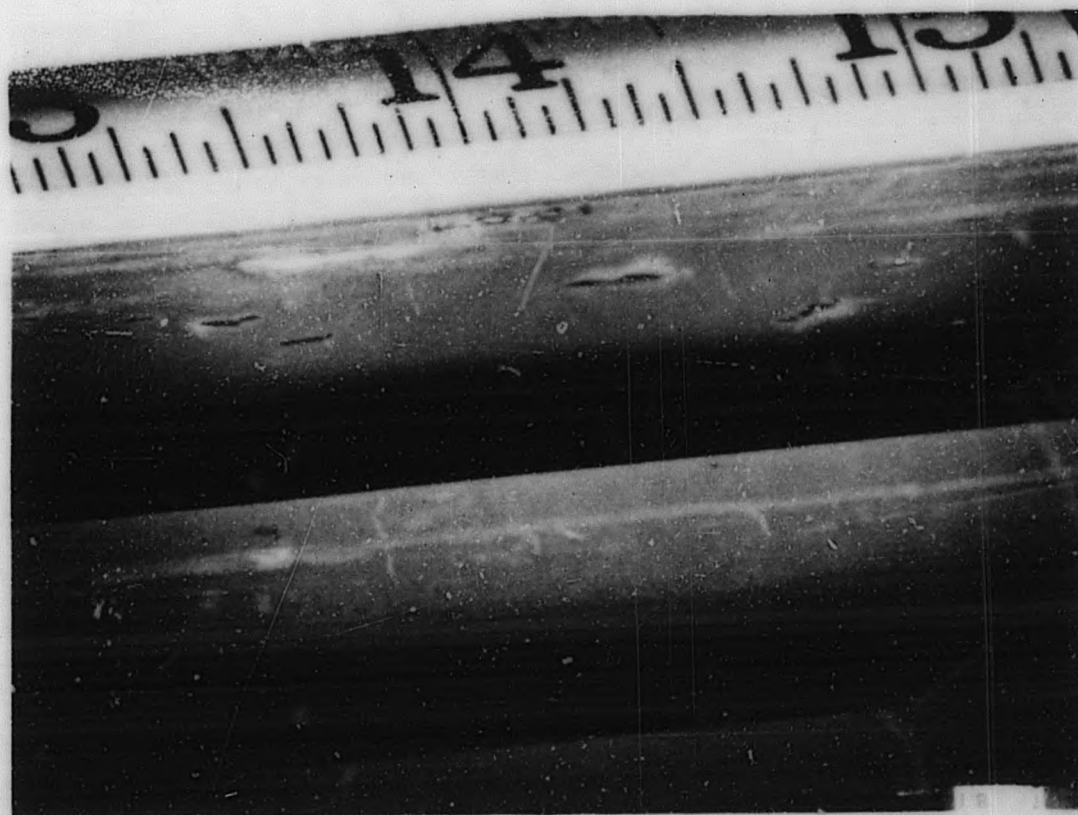
Figure 5. HPD 2D - Rod A Service Failure

Short longitudinal cracks in fuel clad

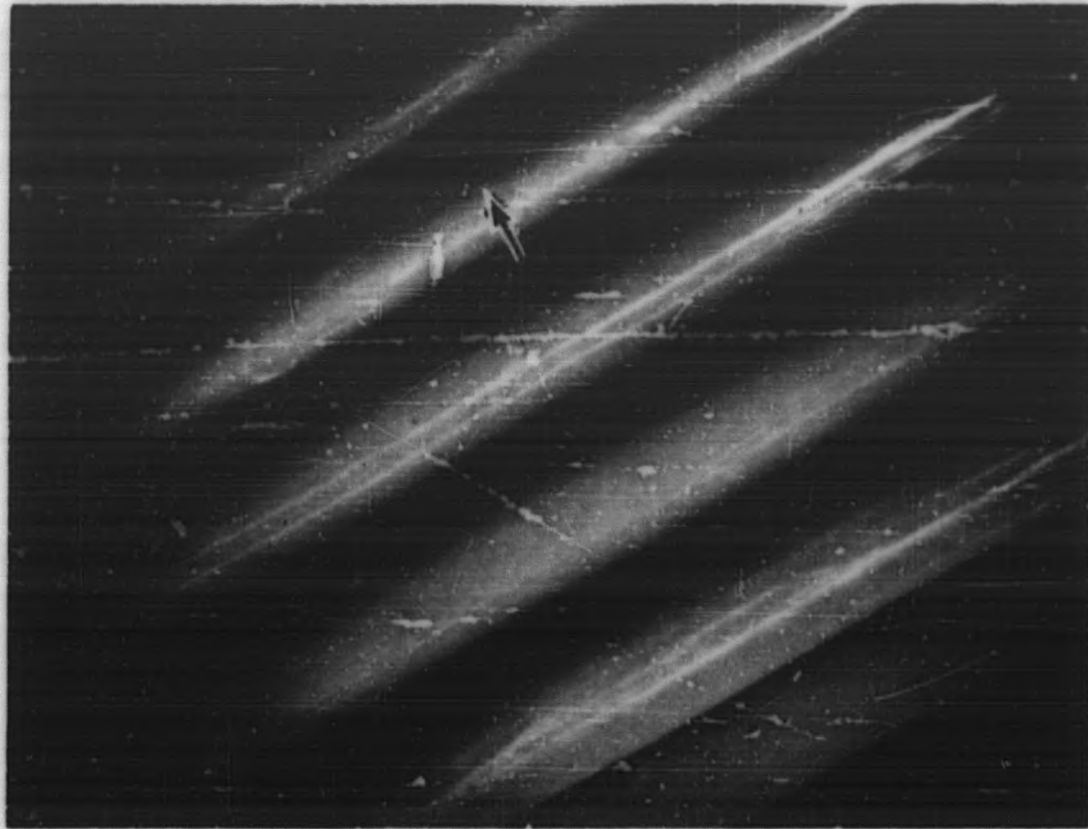
Figure 6. HPD 3D - Rod V Service Failure

Failure occurred 8 $\frac{1}{2}$ to 9 $\frac{1}{2}$ inches from bottom end.

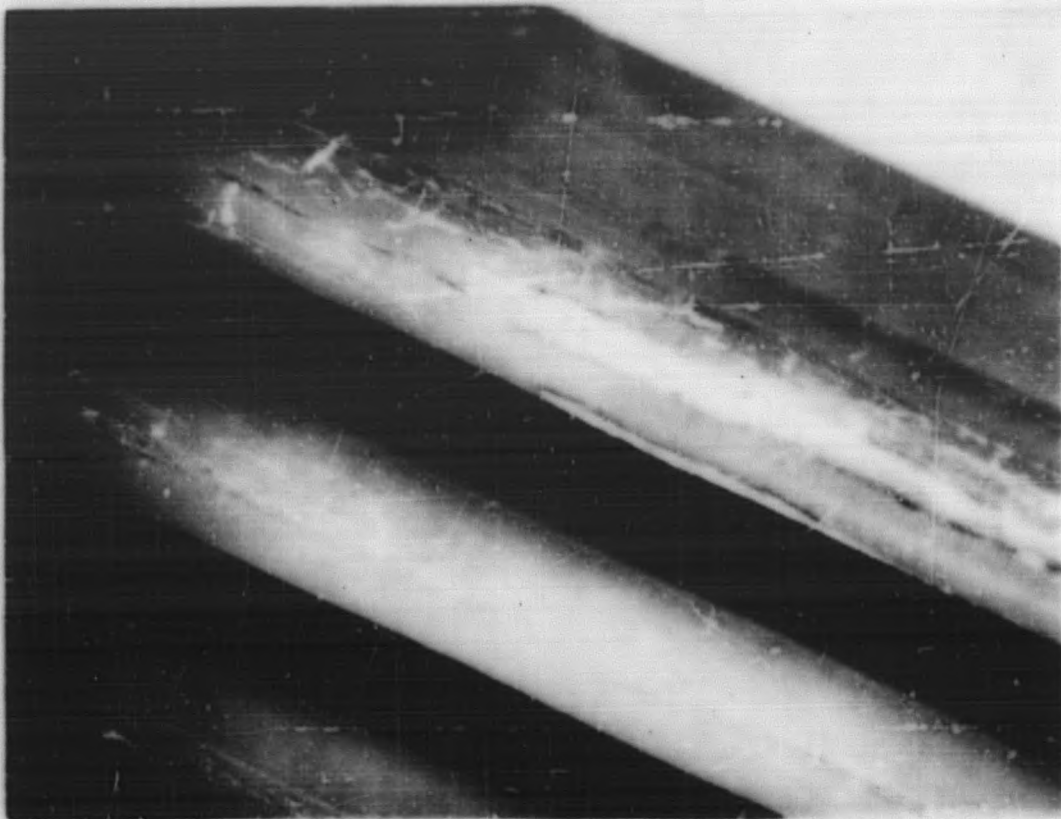
Figure 7. HPD 1E - Rod E Service Failure

Failure occurred 9¹ to 10¹ inches from bottom.

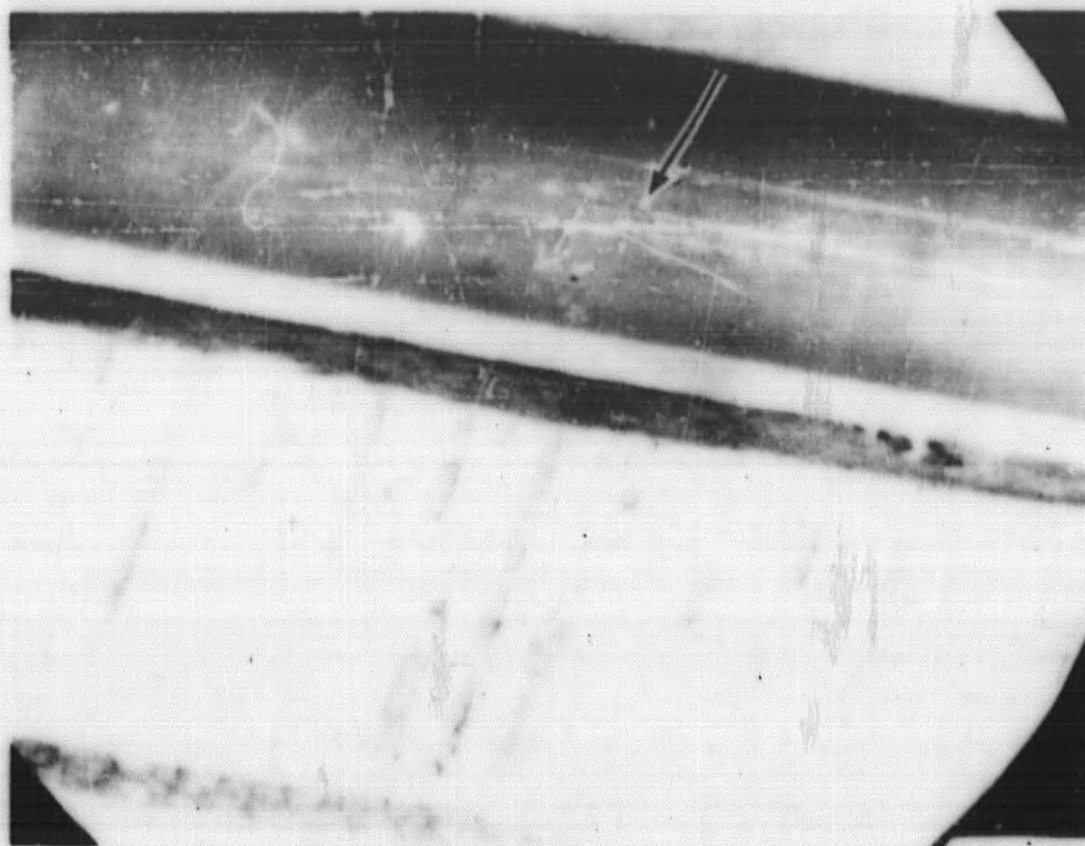
Figure 8. HPD 2E - Rod O Service Failure

Longitudinal crack 11 inches from bottom.

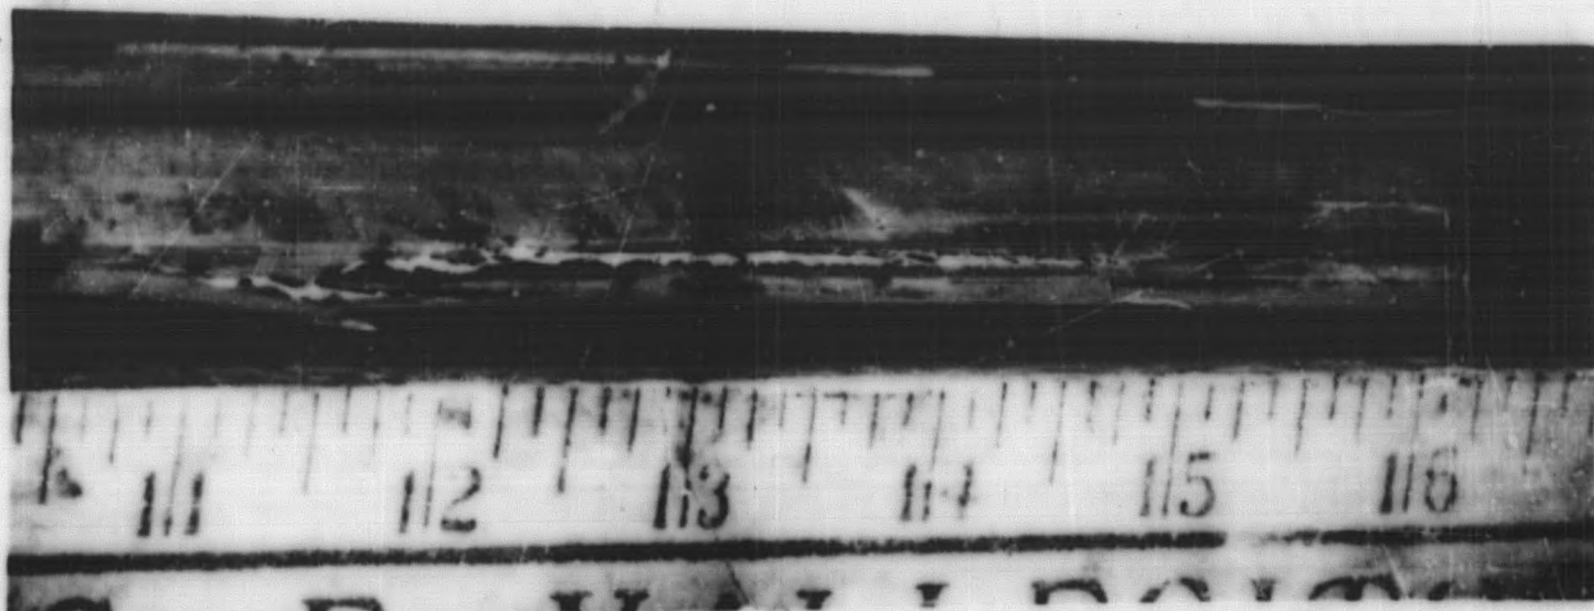
Figure 9. HPD 3E - Rod X Service Failure

Gross failure 10¹ to 16 inches from bottom.

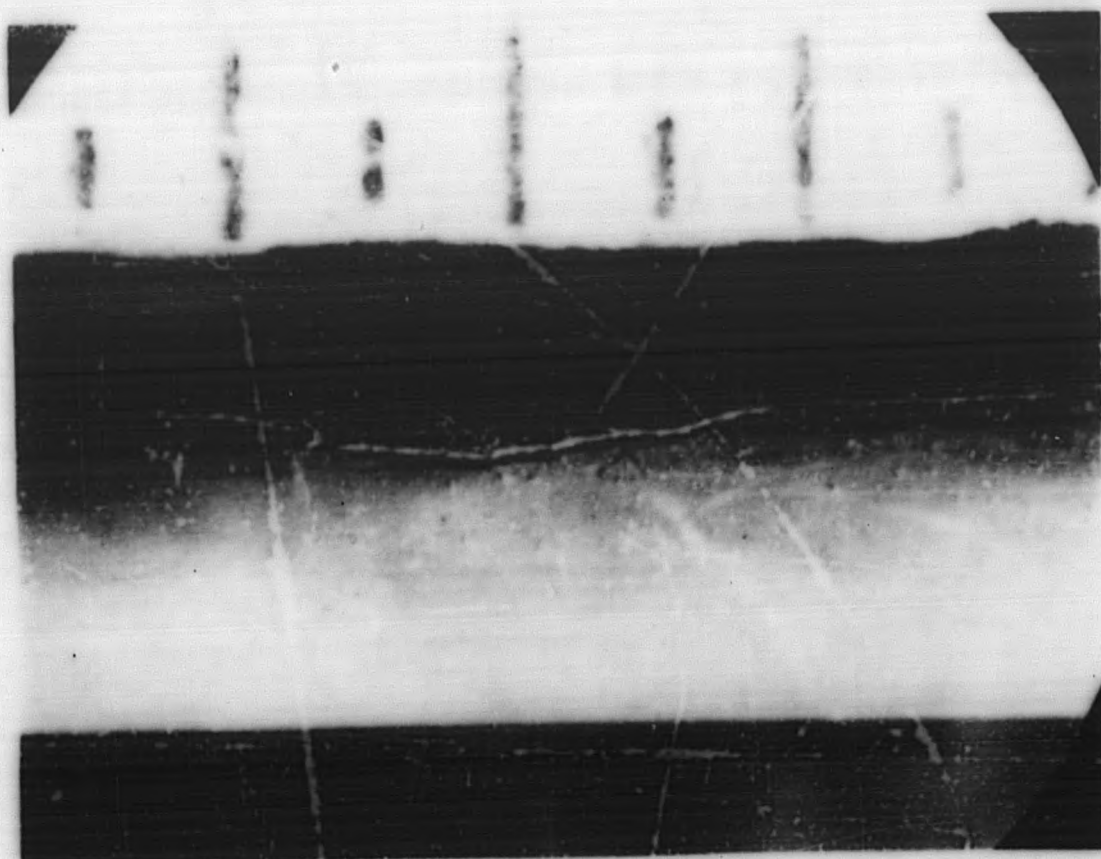
Figure 11. HPD 6E - Rod A Service Failure

0.363 in. x 0.014 in. 304 SS clad UO_2
0.005 inch nominal gap
Initial clad condition: Cold worked 90,000 psi Y. S.
Failure location: Peak heat flux region
Exposure at failure location: 12,200 MWD/t
Heat flux at failure location: 470,000 Btu/hr-ft²

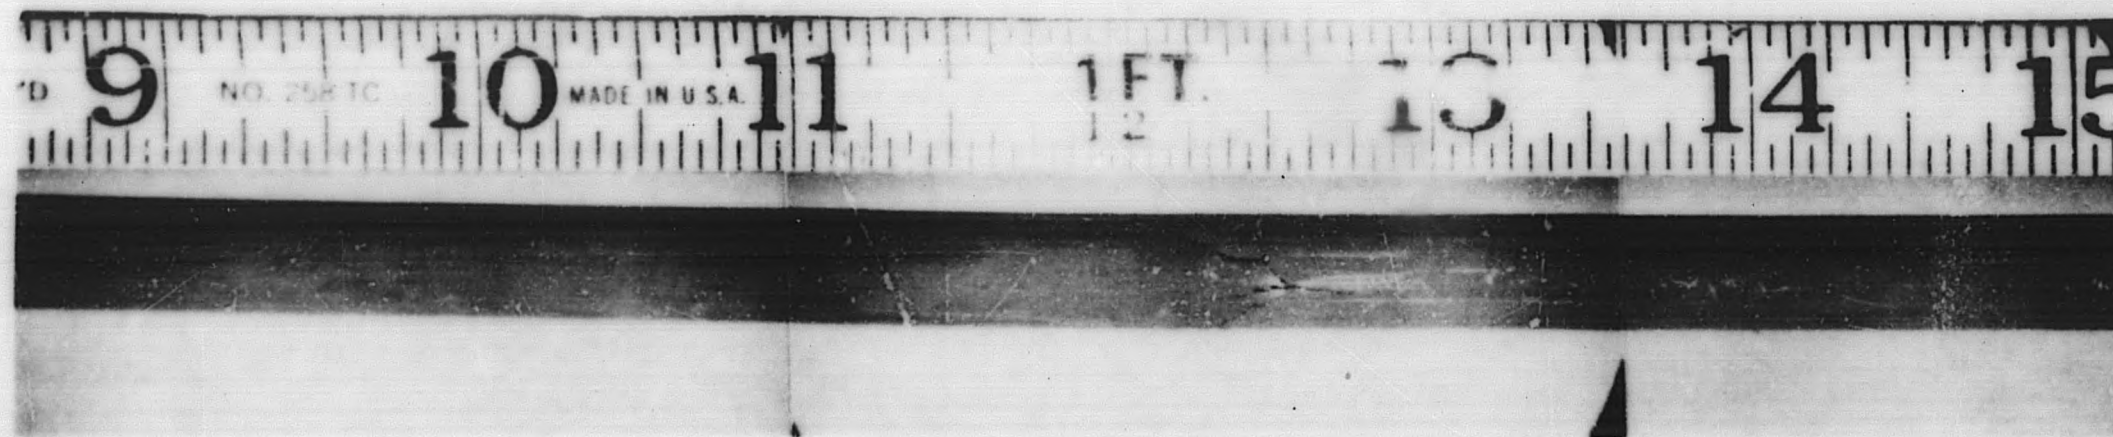
Figure 12. HPD 1G - Rod R Service Failure

Longitudinal Cracking

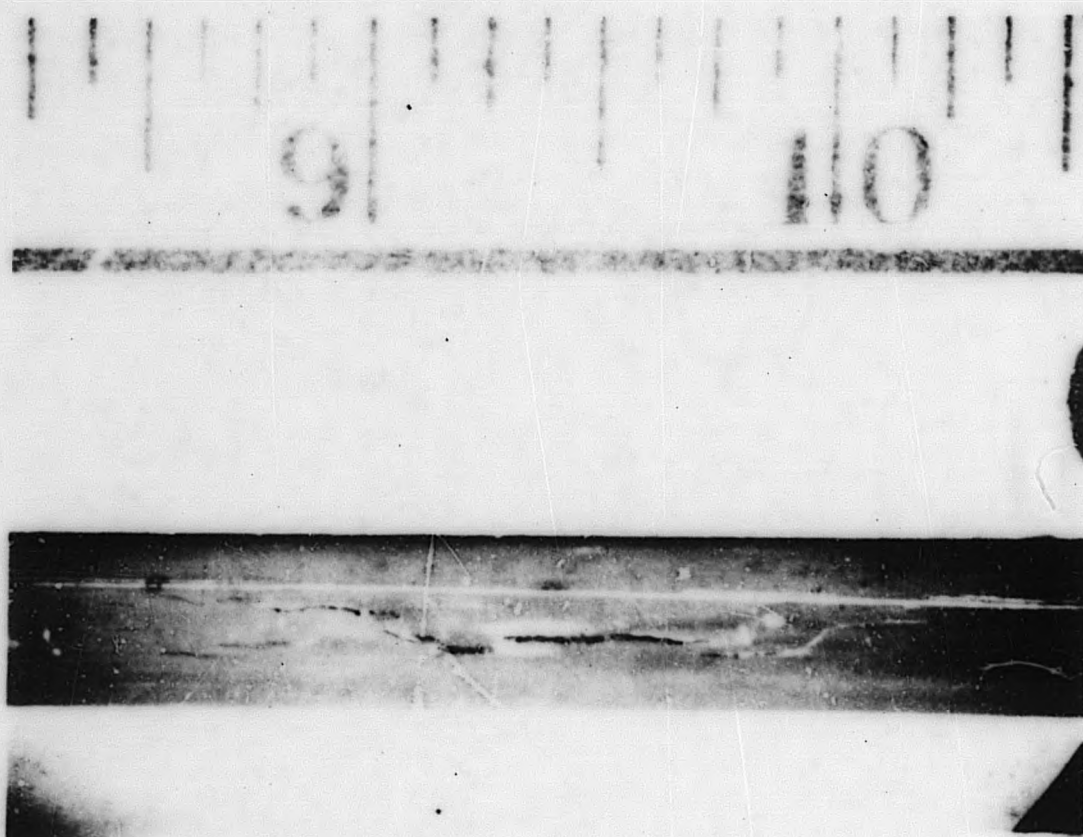
Figure 13. HPD 2G - Red G Service Failure

Irregular longitudinal crack in peak flux region.

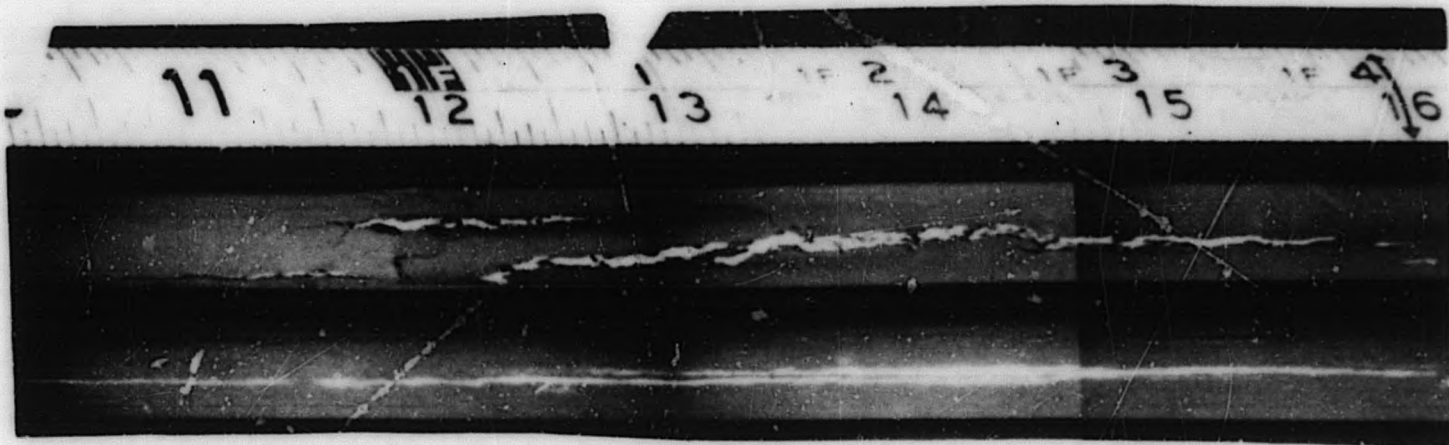
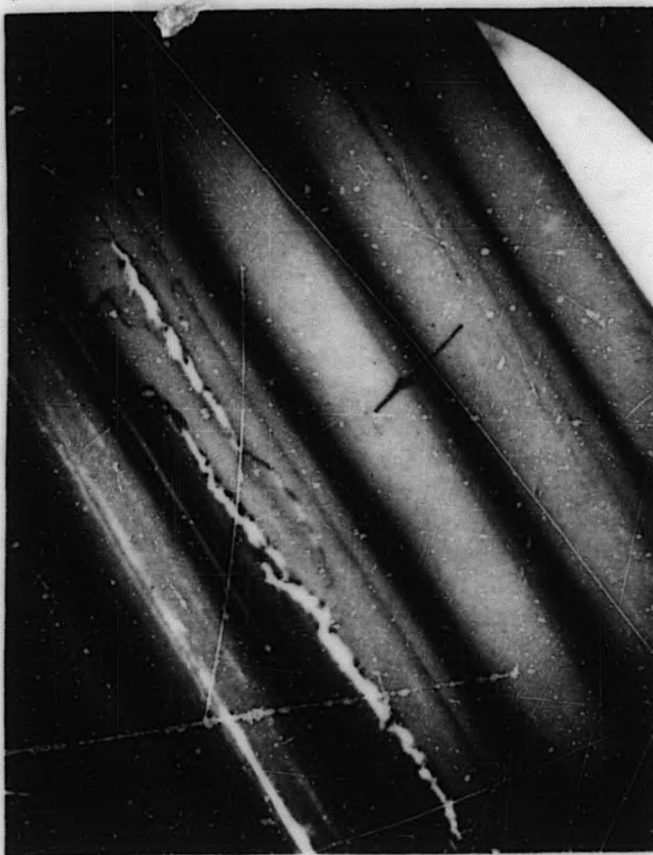
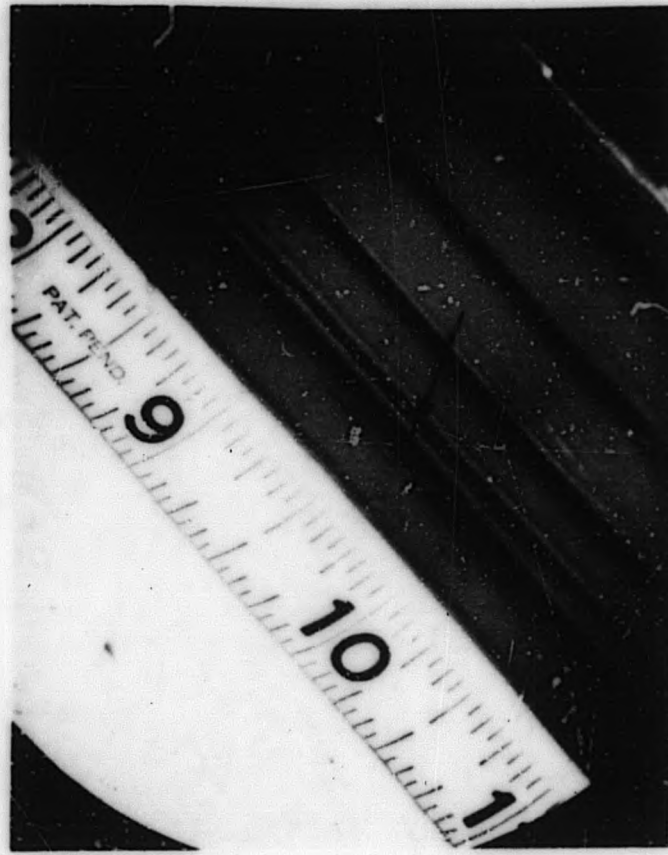
Figure 14. HPD 3G - Rods B, C and E Service Failure

0.360 in. \times 0.014 304 SS cladding
 0.002 nominal gap
 Initial clad condition: Cold worked, 90,000 psi Y. S.
 Failure Location: Peak Flux Region
 Exposure at failure location: 11,600 MWD/t
 Heat flux at failure locations: 500,000 Btu/hr-ft²
 No detailed examination performed.

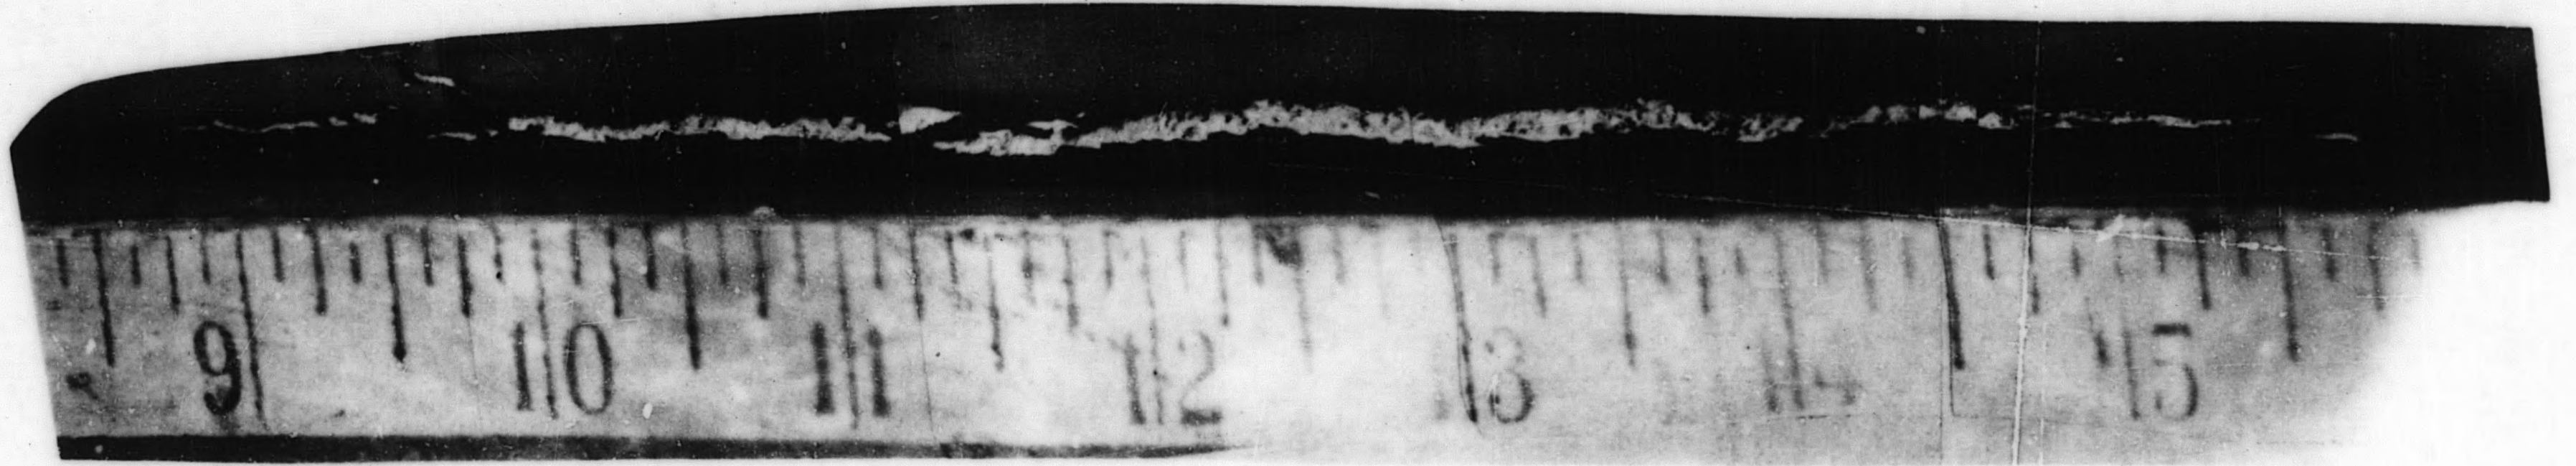
Figure 15. HPD 2S - Rod I Service Failure

Longitudinal split in Rod Number 437, Rod I Assembly HPD-2S. The cladding is Type 304 stainless steel, 0.011 inch thick. The fuel is fused uranium dioxide swaged to a density of 93 ± 1 percent of theoretical. Only a small amount of fuel was lost to the reactor coolant.

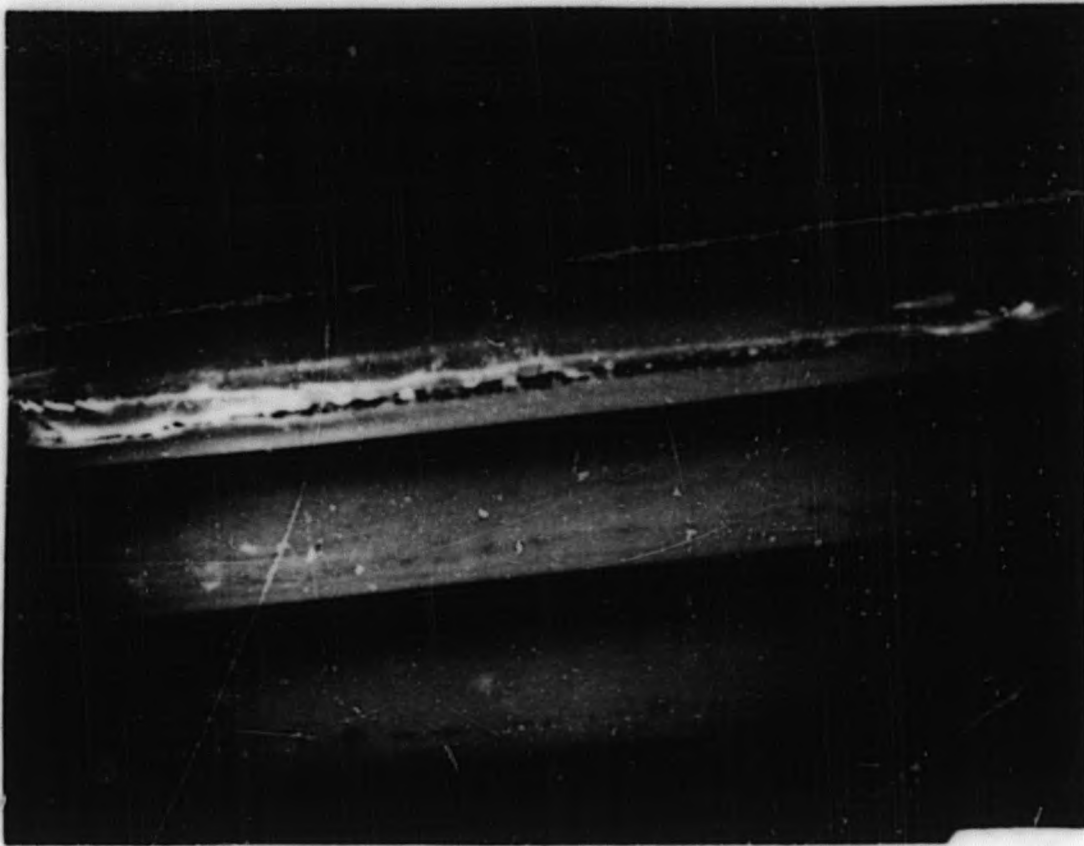
Figure 17. HPD 3S - Rod A Service Failure

Longitudinal Cracking

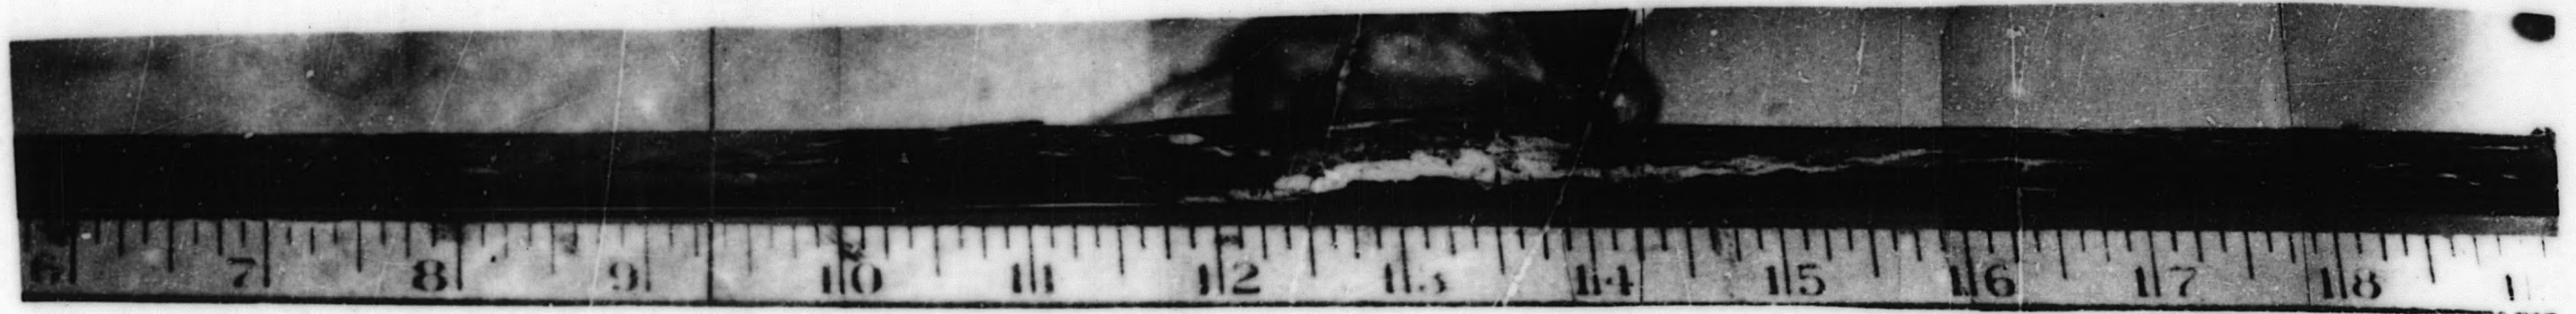
Figure 18. HPD 3S - Rod U Service Failure

Longitudinal Cracking

0.400 in. x 0.012 in. 304 SS clad UO_2
 0.002 nominal gap
 Initial clad condition: Cold worked, 80,000 psi Y.S.
 Failure location: Peak heat flux region
 Exposure at failure location: 7200 MWD/t
 Heat flux at failure location: 380,000 Btu/hr-ft²

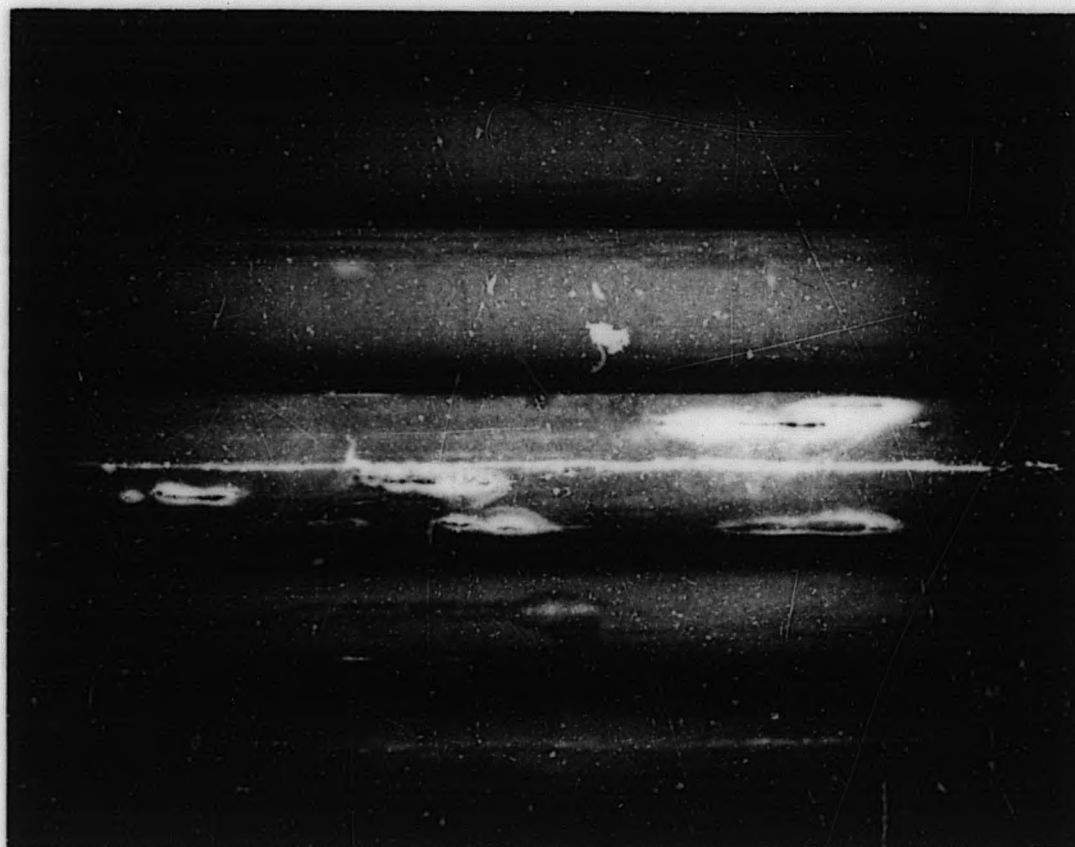
Figure 19. HPD 3S - Rod Y Service Failure

Longitudinal Cracking

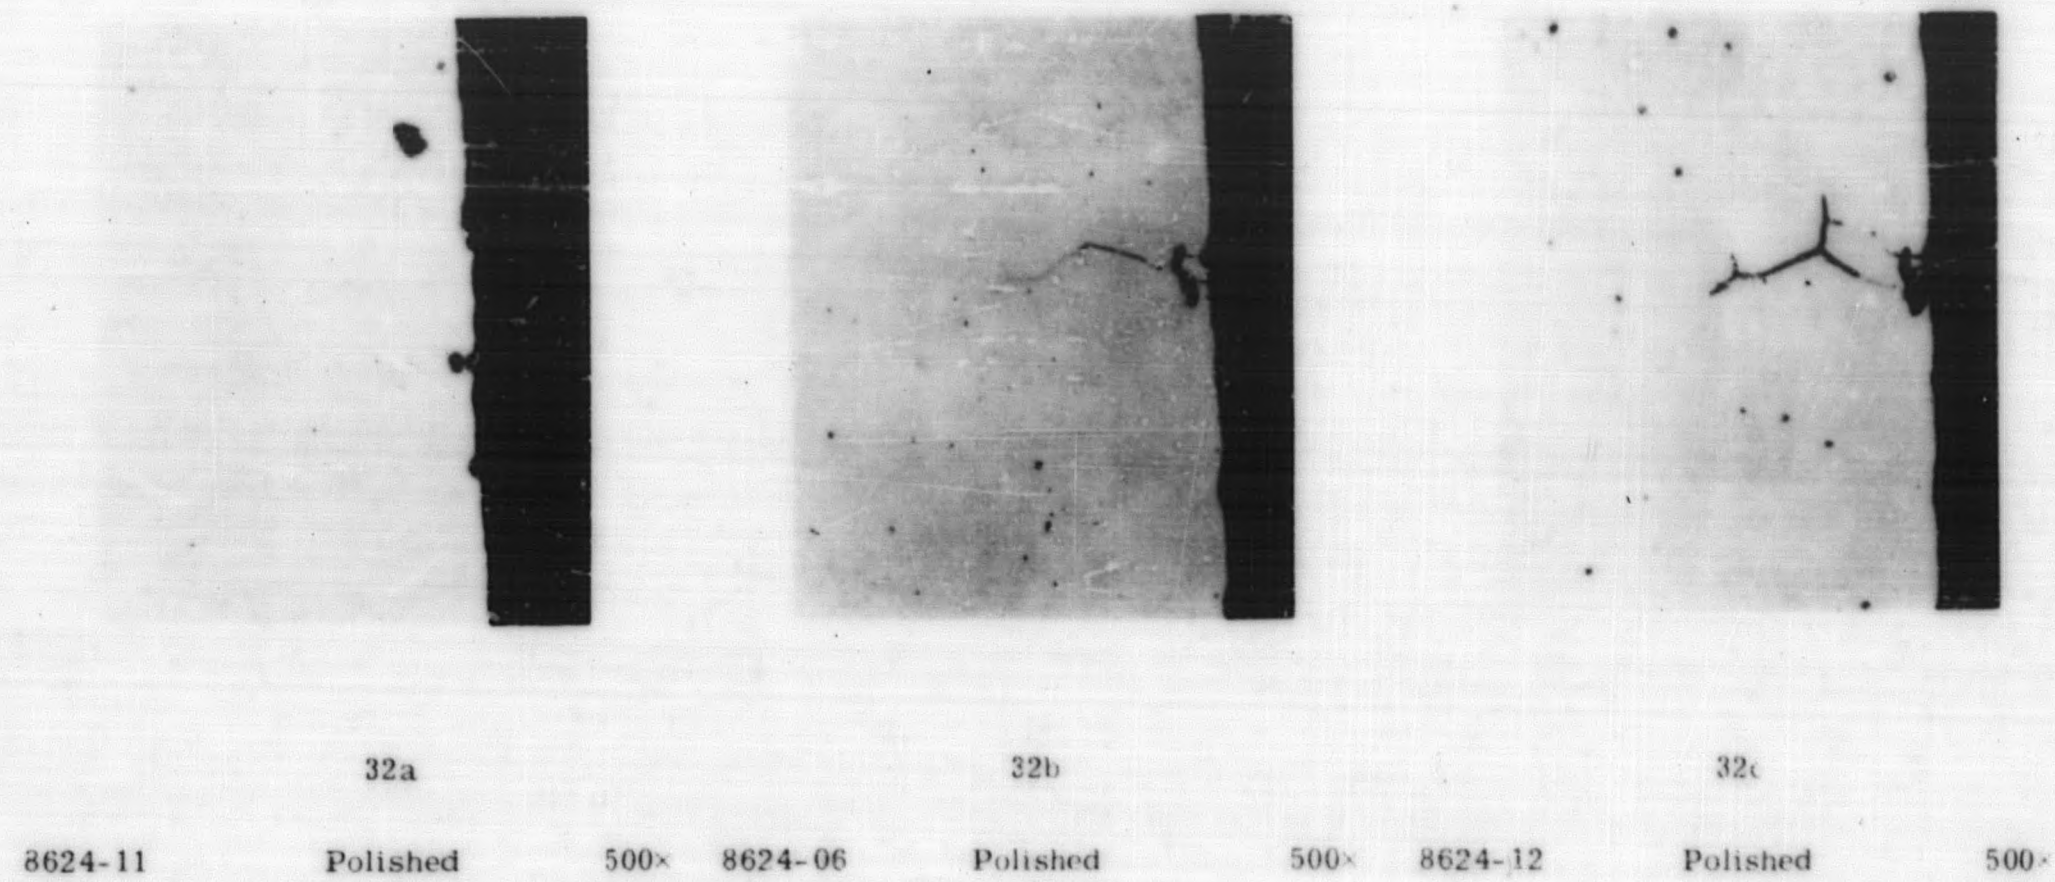
Figure 32. Assumed Mode of Crack Propagation from Outside Surface Toward Inside Surface of Clad. Photomicrographs Are of Different Sections of Same Polished Specimen. Assembly 1G. Rod Q.

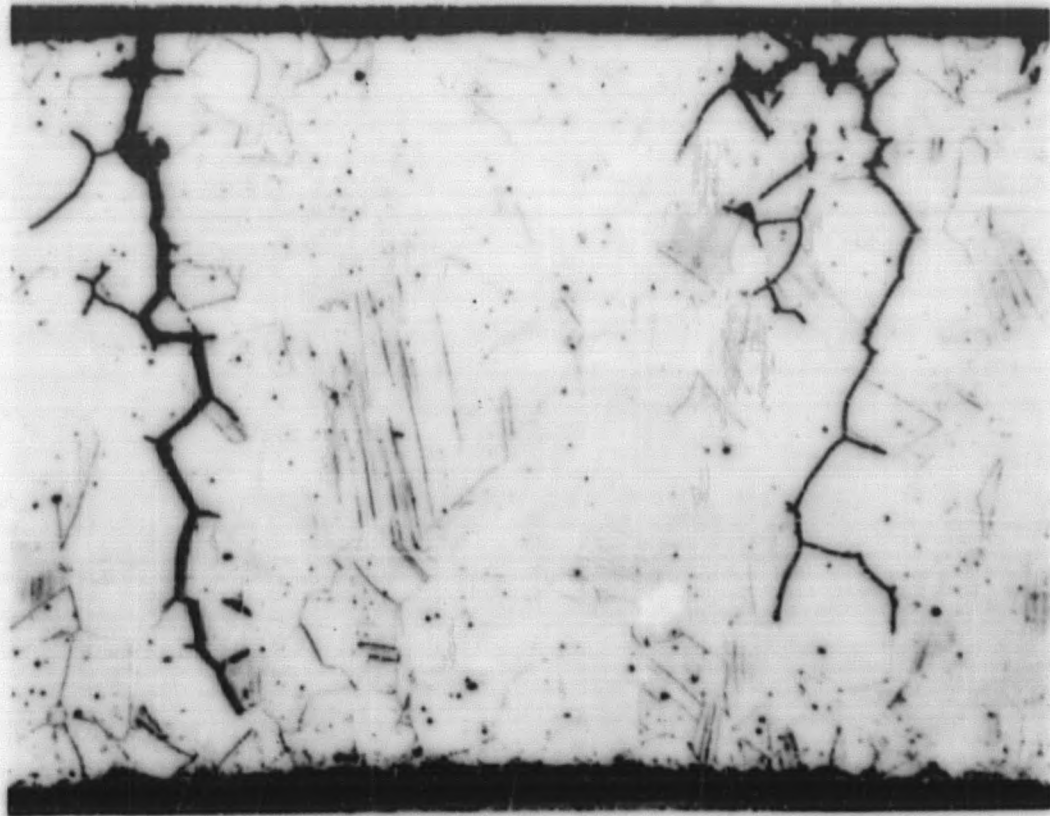
Figure 33. Cracks in Clad of Rod Q, HPD 1G

Cold-worked structure and intergranular attack.

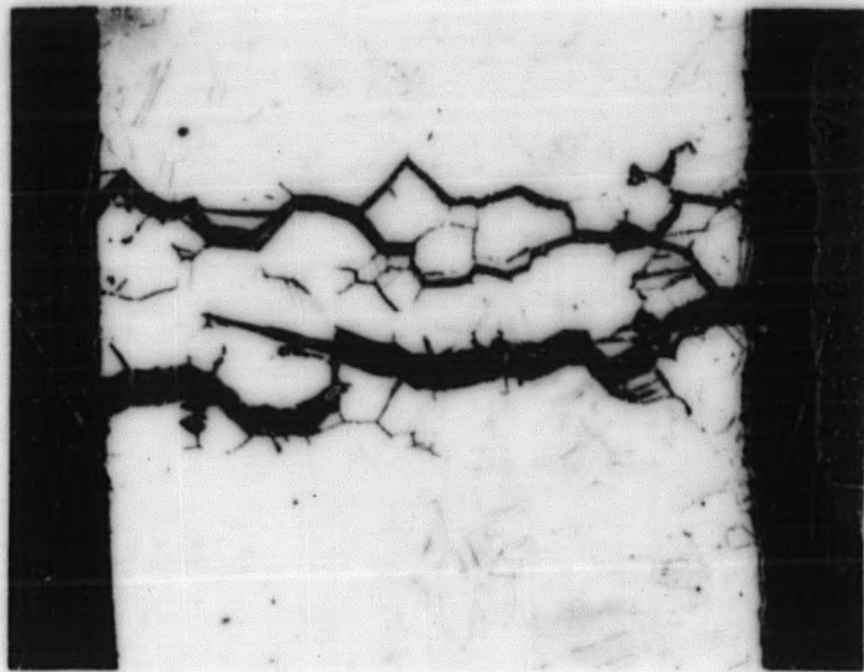
Figure 35. Intergranular Cracks in Initially Cold Worked Cladding From Rod R, Assembly 1G. (Peak Flux Location. 250x)

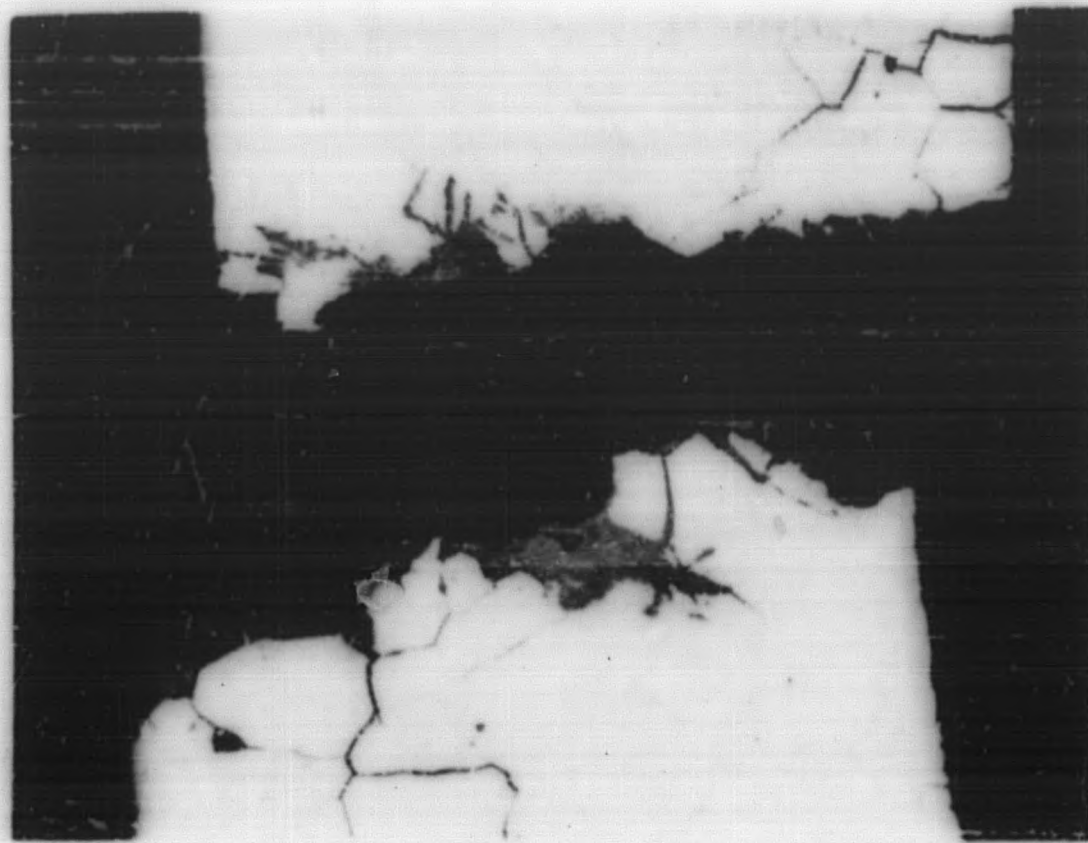
Inspection of Figure 36 reveals a sizeable "nugget" of what is assumed to be an oxide corrosion product. Figure 37 shows a similar appearing oxide along the crack interface. Analysis will be attempted of the nugget material. These observations of oxide have not always been

Figure 36. Section of Rod R, HPD 1G, Showing "Nugget" of Corrosion Product Near Mid-Thickness of Cladding

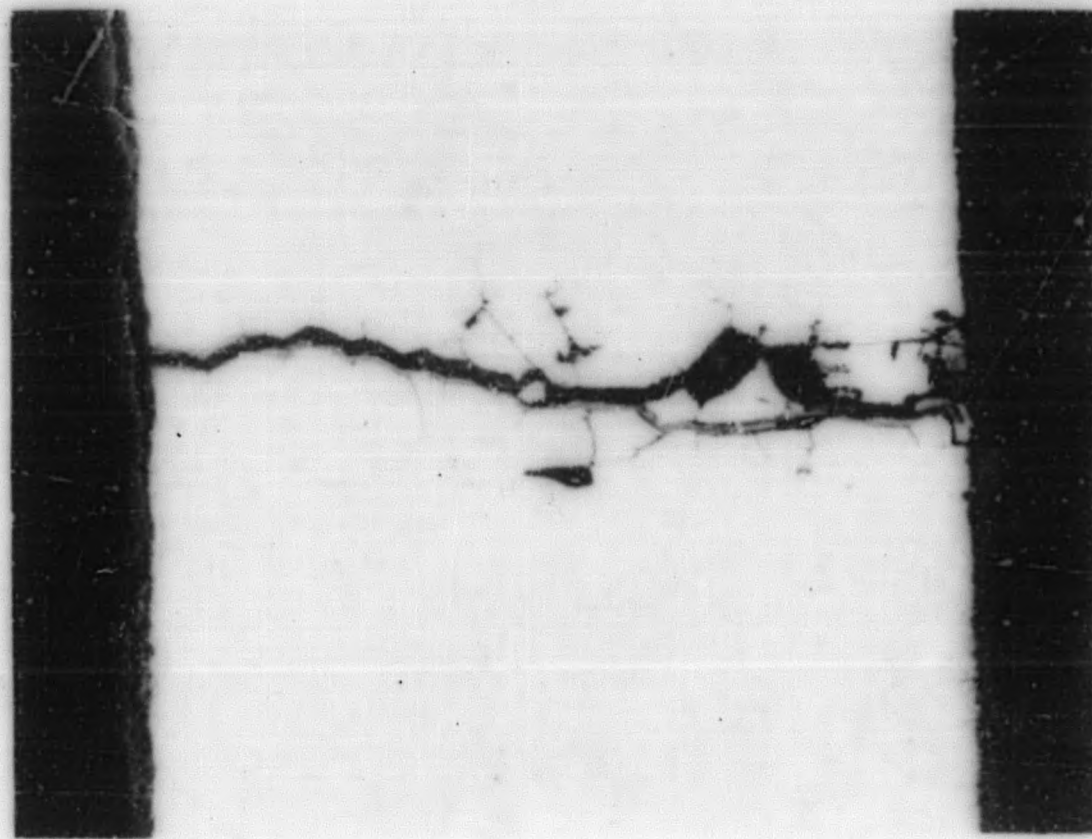
Figure 37. Section of Rod R, HPD 1G, Reveals Uniform Layer of Corrosion Product in Fracture

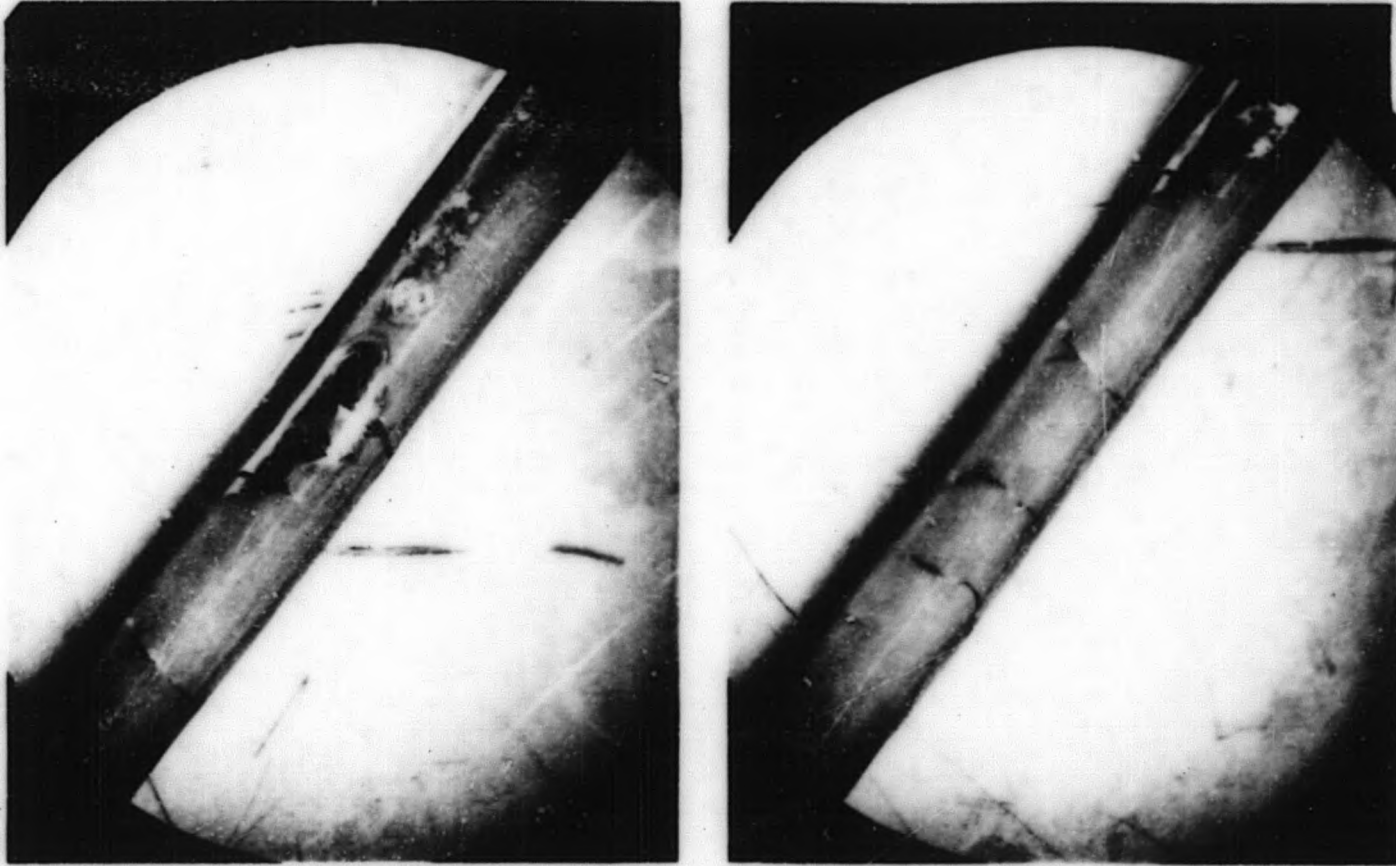
Figure 51. Circumferential Cracks in Rod C, HPD 4E

Circumferential cracks appear to be at or near pellet interfaces. This suggests that axial stress concentrations may have been present at these locations.

A metallographic section revealed that the cracks are intergranular. See Figures 52, 53, 54, 55 and 56.

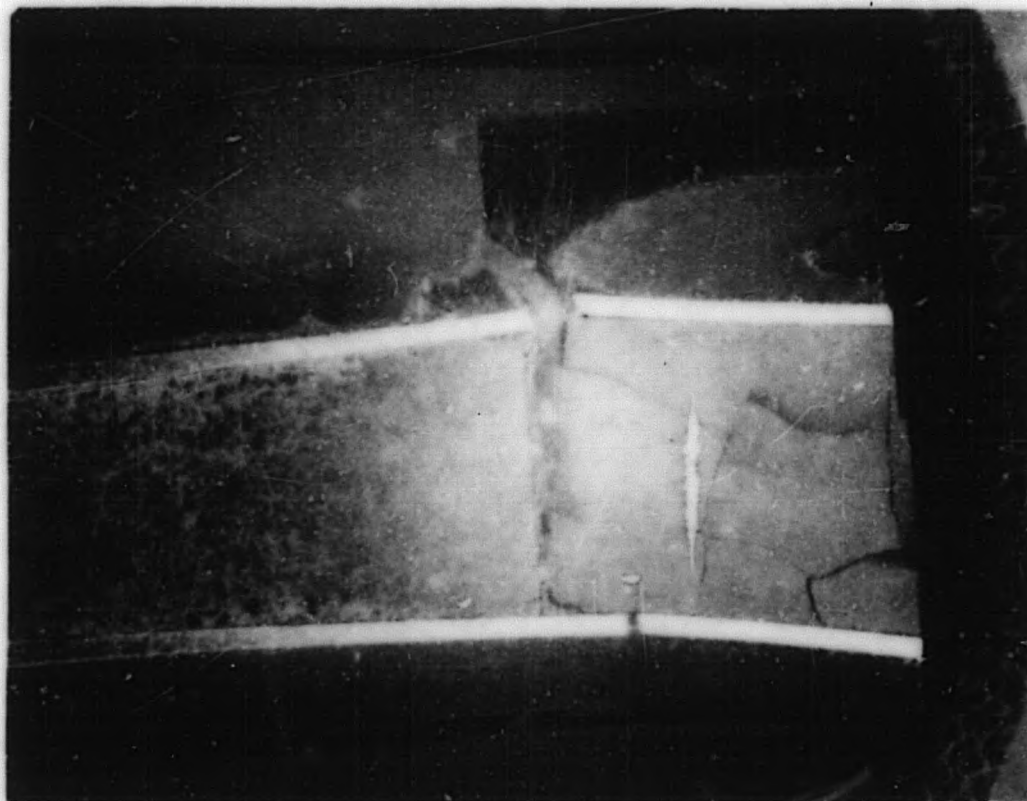
Figure 52. Circumferential Cracks in Rod C, HPD 4E

0.036 in. × 0.014 in. SS clad UO_2 pellets
0.005 nominal gap
Initial clad condition: Annealed 40,000 psi Y. S.
Failure location: Peak heat flux region
Exposure in failure location: 13,500 MWD/t
Heat flux in failure location: 460,000 Btu/hr-ft²
