GEAP-4360
AEC RESEARCH AND
DEVELOPMENT REPORT
SEPTEMBER 16, 1963

FUEL FAILURE EXAMINATIONS AND ANALYSES IN THE HIGH POWER DENSITY PROGRAM

By
W.H. ARLT
S.R. VANDENBERG

VALLECITOS ATOMIC LABORATORY

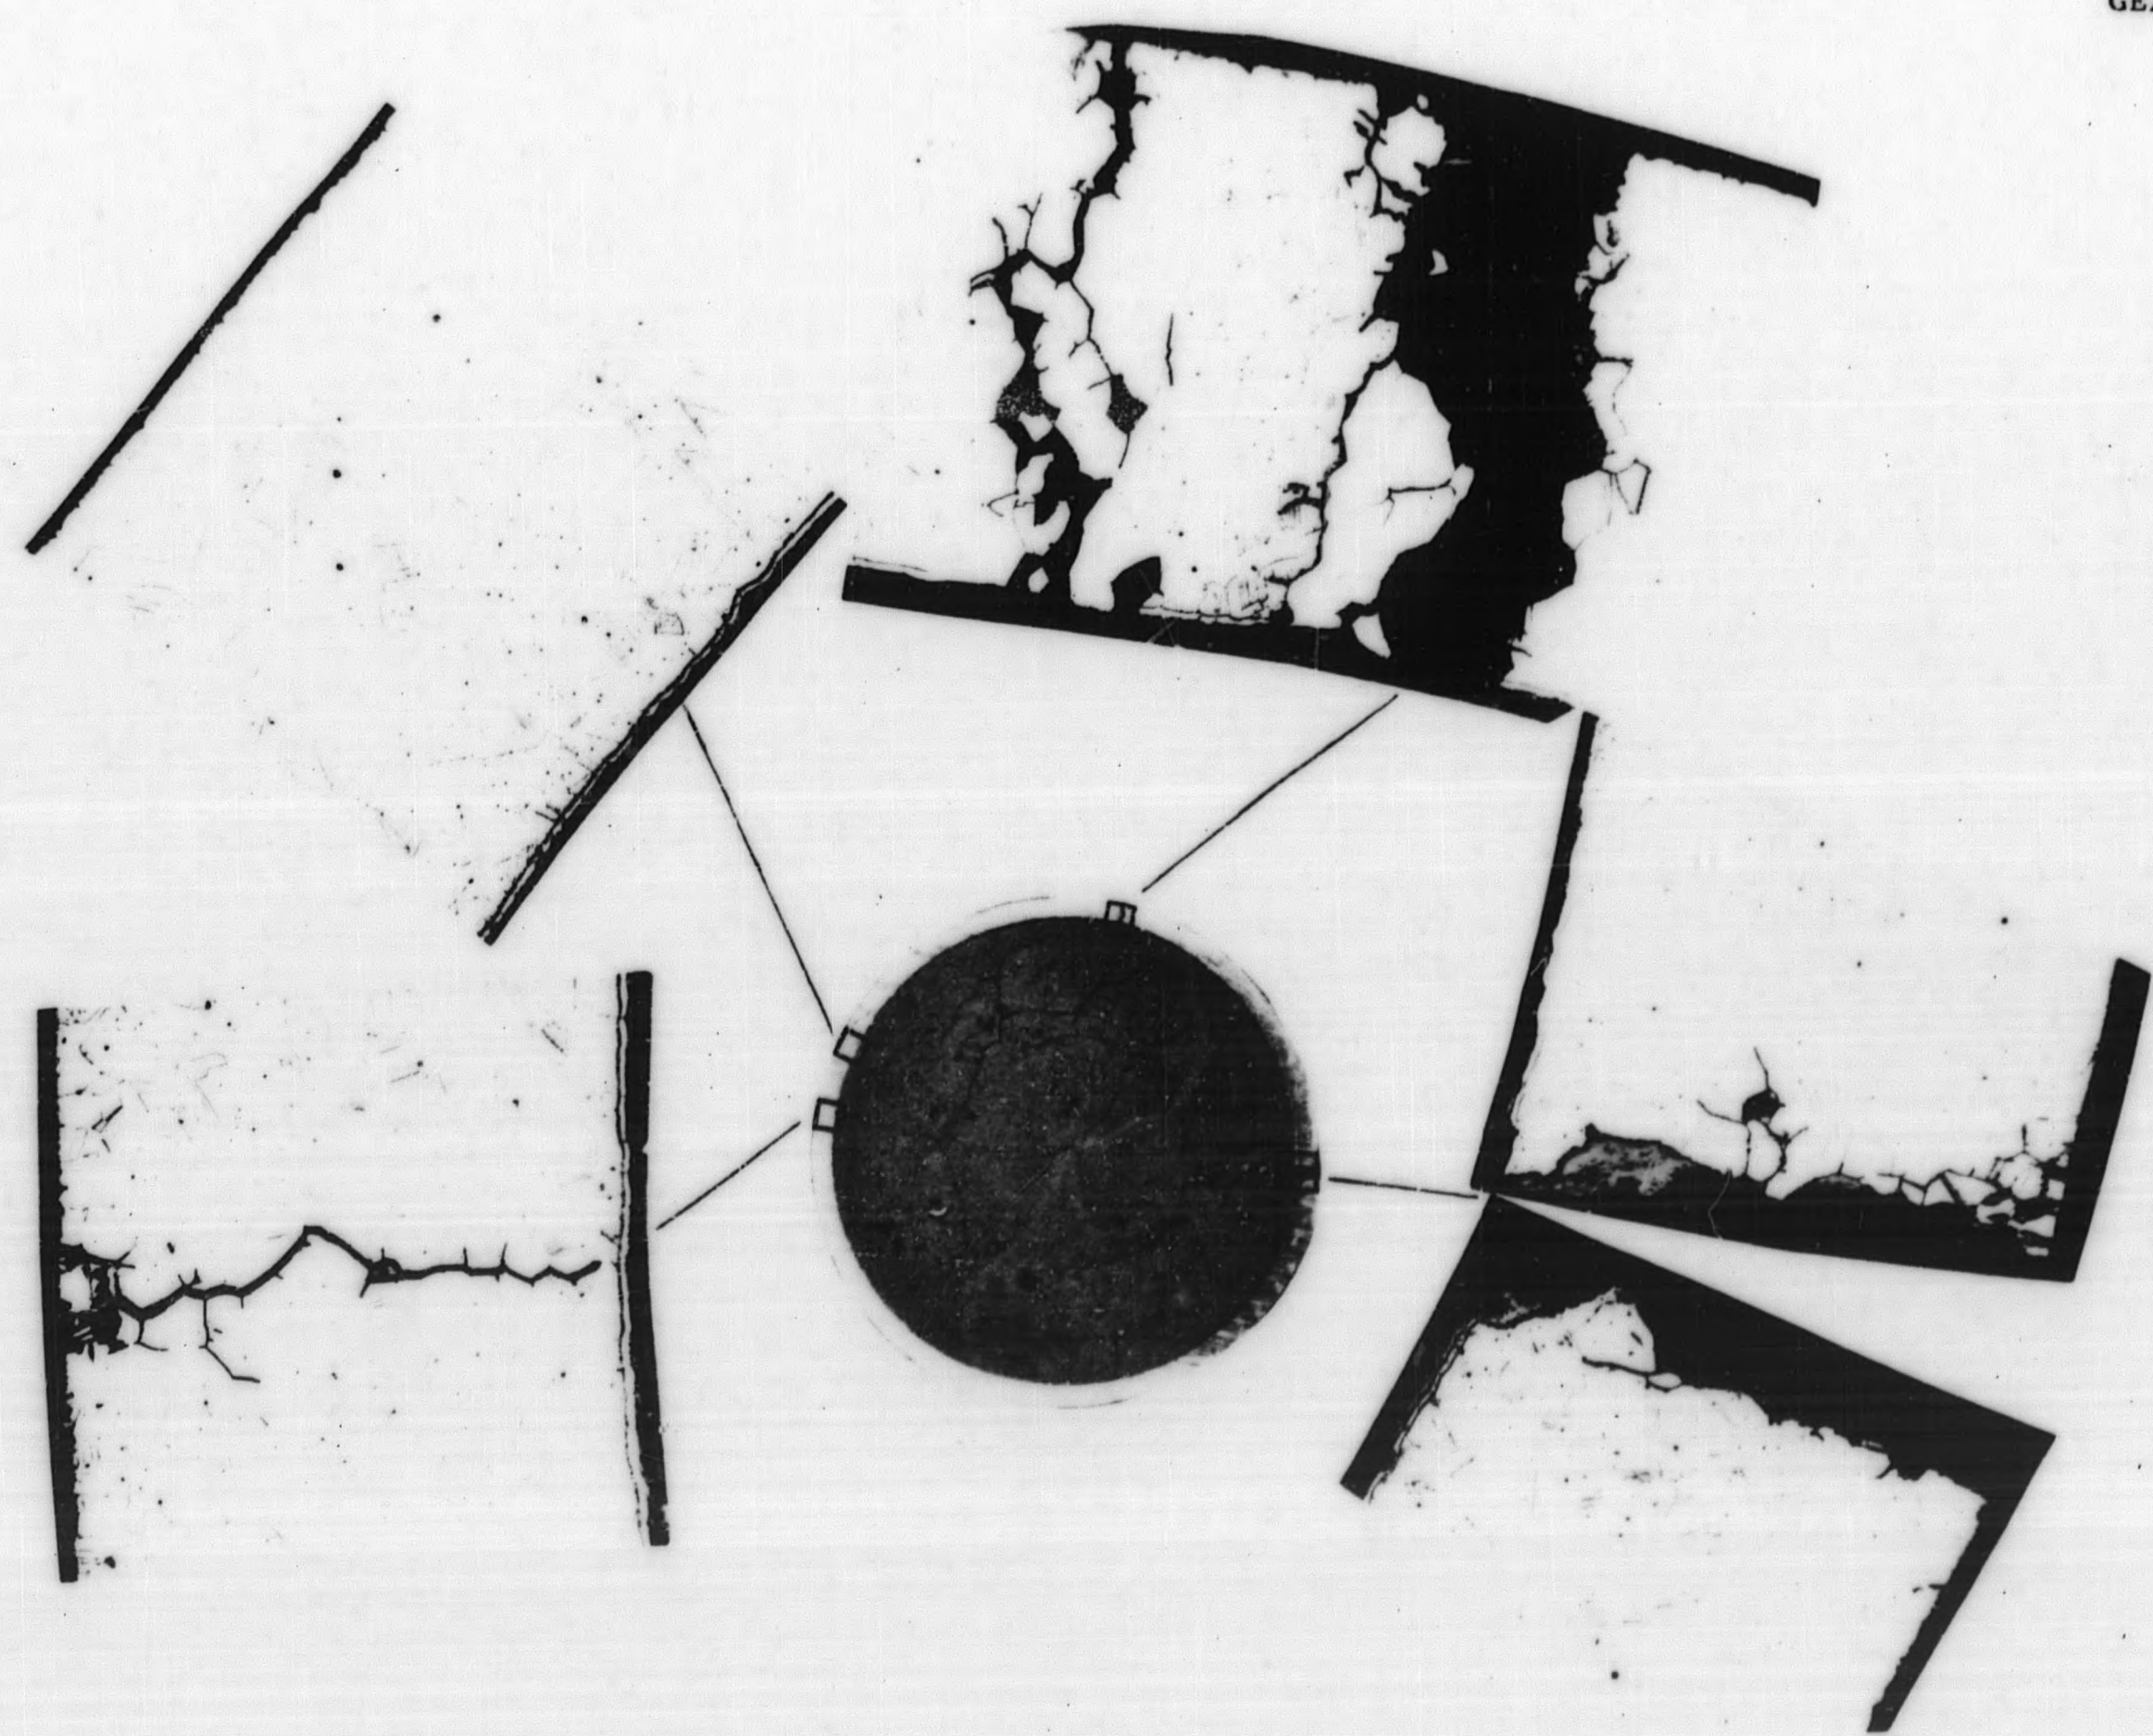
Figure 57. Cladding Defects in HPD 1E - Rod E

The appearance of intergranular cracking is shown. Notice the appearance of the large oxide "nugget" in photo on lower right. The appearance of this nugget is very similar to the one shown in Figure 35.
