NUREG/CR-1715
EGG-2061

Fuel Rod Behavior During Tests PCM 8-1 RS, CHF Scoping, and PCM 8-1 RF

November 1980

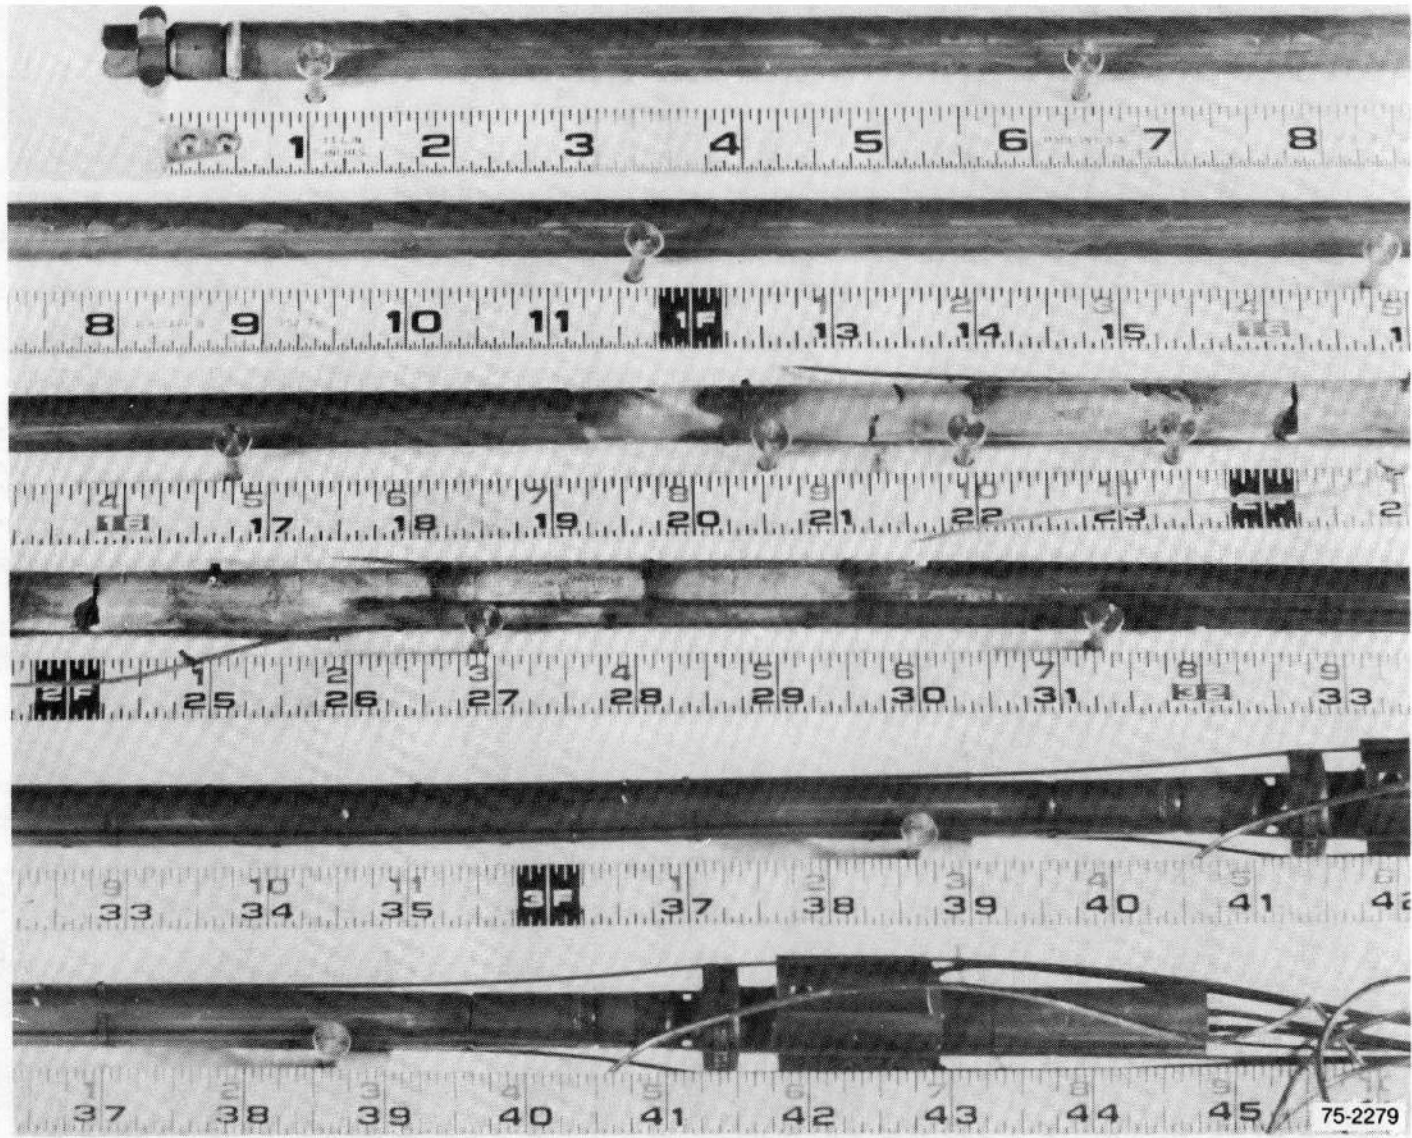
Figure 11. Posttest photograph of Test 8-1 RS fuel rod.

During removal of the fuel rod from the flow shroud, it was discovered that the rod was in two pieces, with the separation at about 0.59 m from the bottom of the fuel stack. This break was believed to have occurred during the removal process. As the lower portion of the rod was lowered onto a table, the broken end of the rod touched the table first and broke from the weight of the rod at a location about 0.51 m from the bottom of the fuel stack. Both fractures occurred through the main portion of a fuel pellet, rather than at a pellet-to-pellet interface. The fractures appeared to be brittle, with no evidence of ductile tearing. Because of the brittleness of the rod, great care was taken in preparing the rod for metallurgical examination.

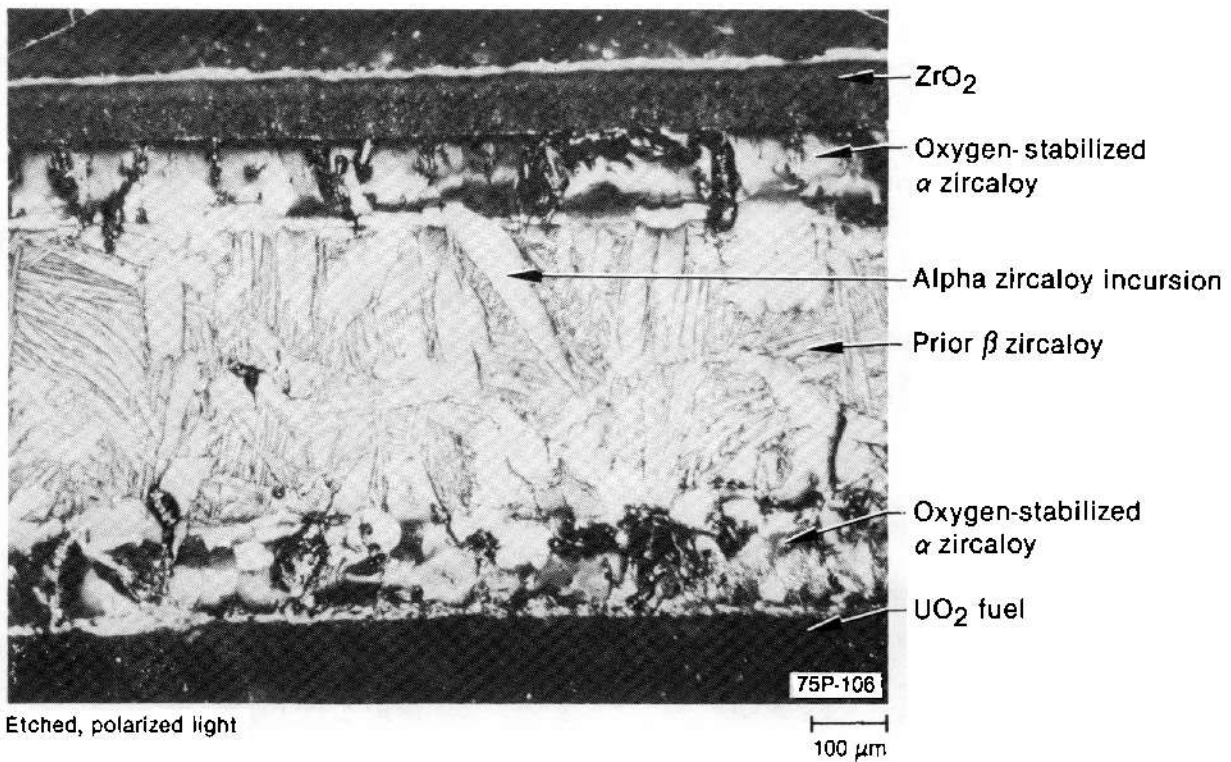
Figure 13. Longitudinal section of fuel rod at 0.556 m from bottom of fuel stack showing cladding microstructure (Test 8-1 RS).

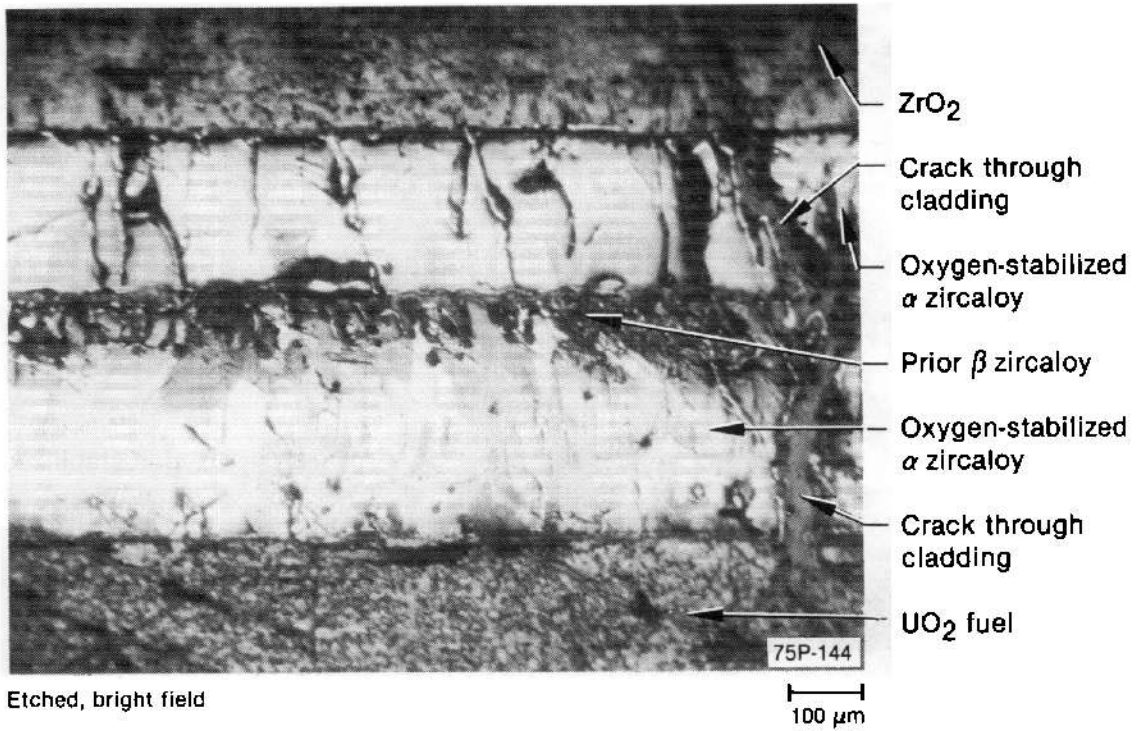
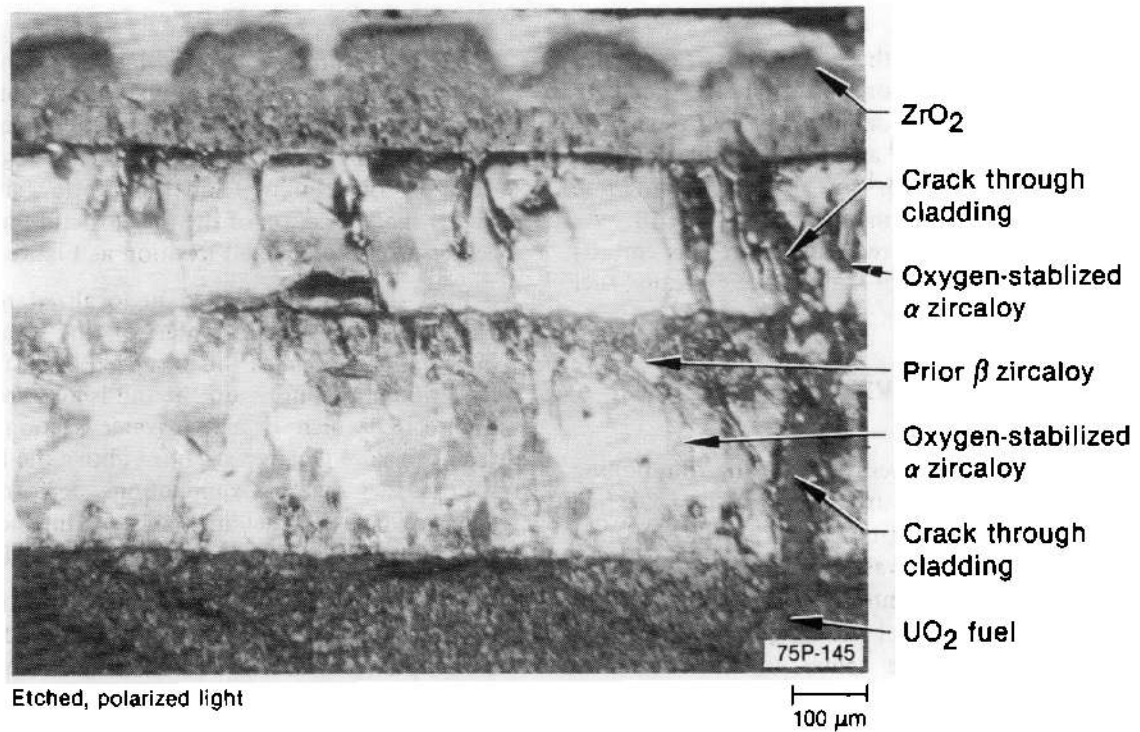
Figure 14. Longitudinal section of fuel rod at 0.581 m from bottom of fuel stack showing cladding microstructure (Test 8-1 RS).

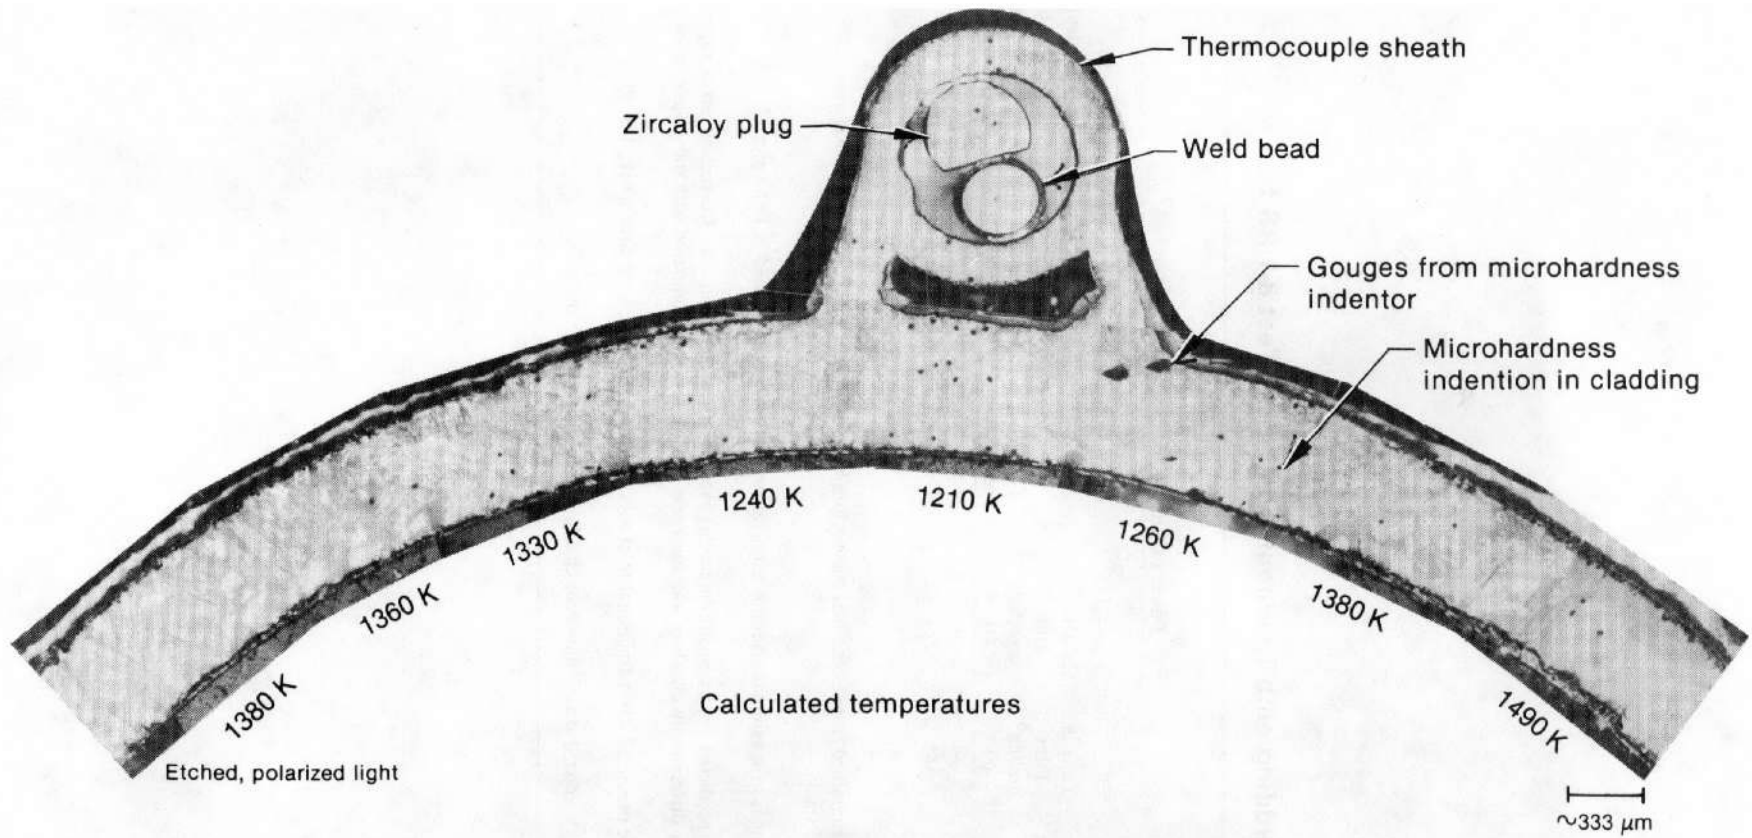
Figure 15. Composite transverse section of fuel rod showing microstructure in cladding near 0.635-m thermocouple (0.622-m location) (Test 8-1 RS).

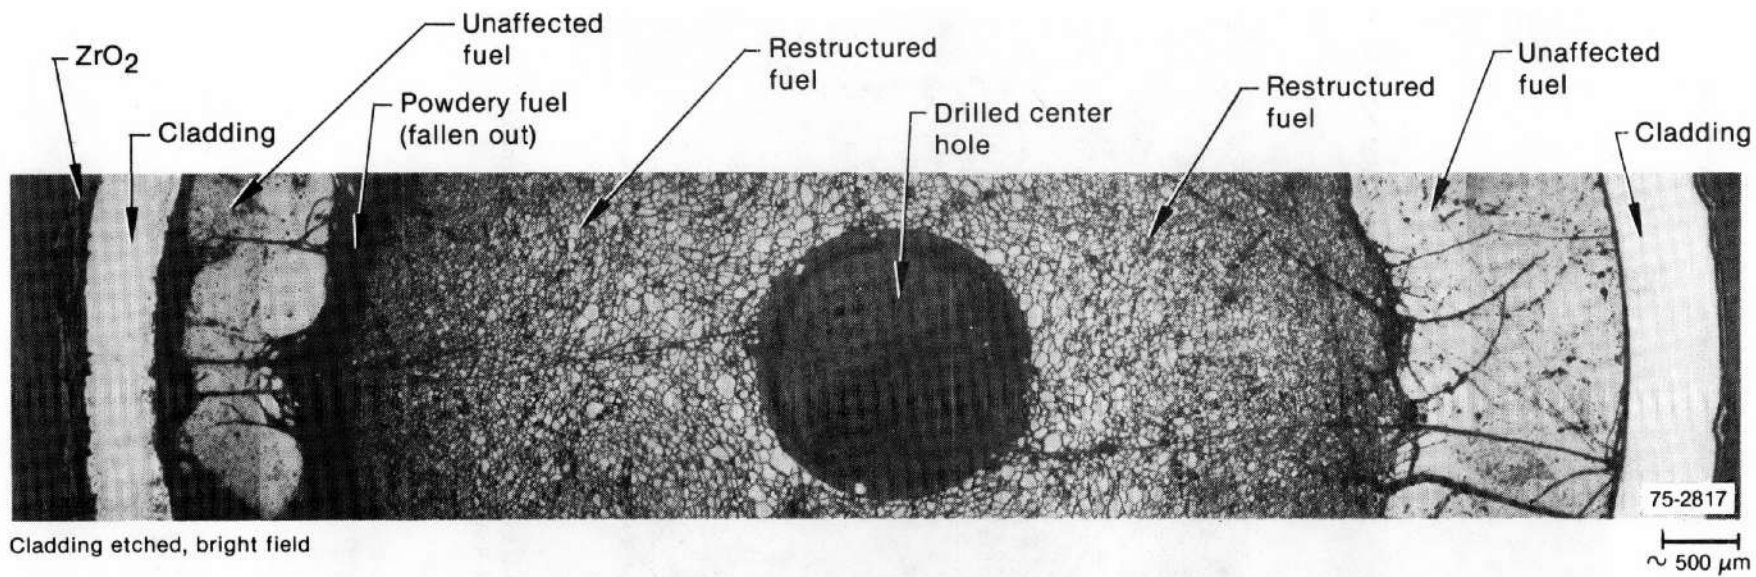
Figure 16. Composite photomicrograph across fuel rod at about 0.622 m from bottom of fuel stack showing fuel restructuring and cladding oxidation (Test 8-1 RS).

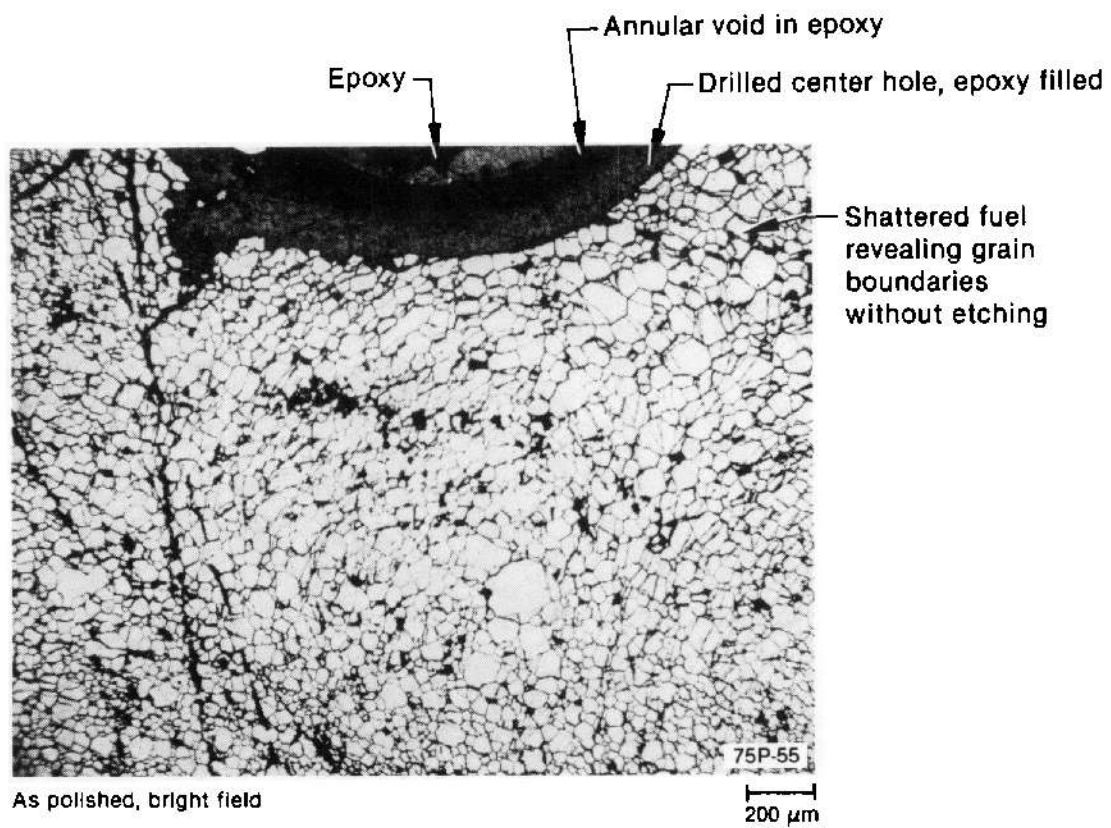
Figure 17. Transverse section of fuel rod showing fuel structure near center hole of fuel pellet, 0.622 m from bottom of fuel stack (Test 8-1 RS).

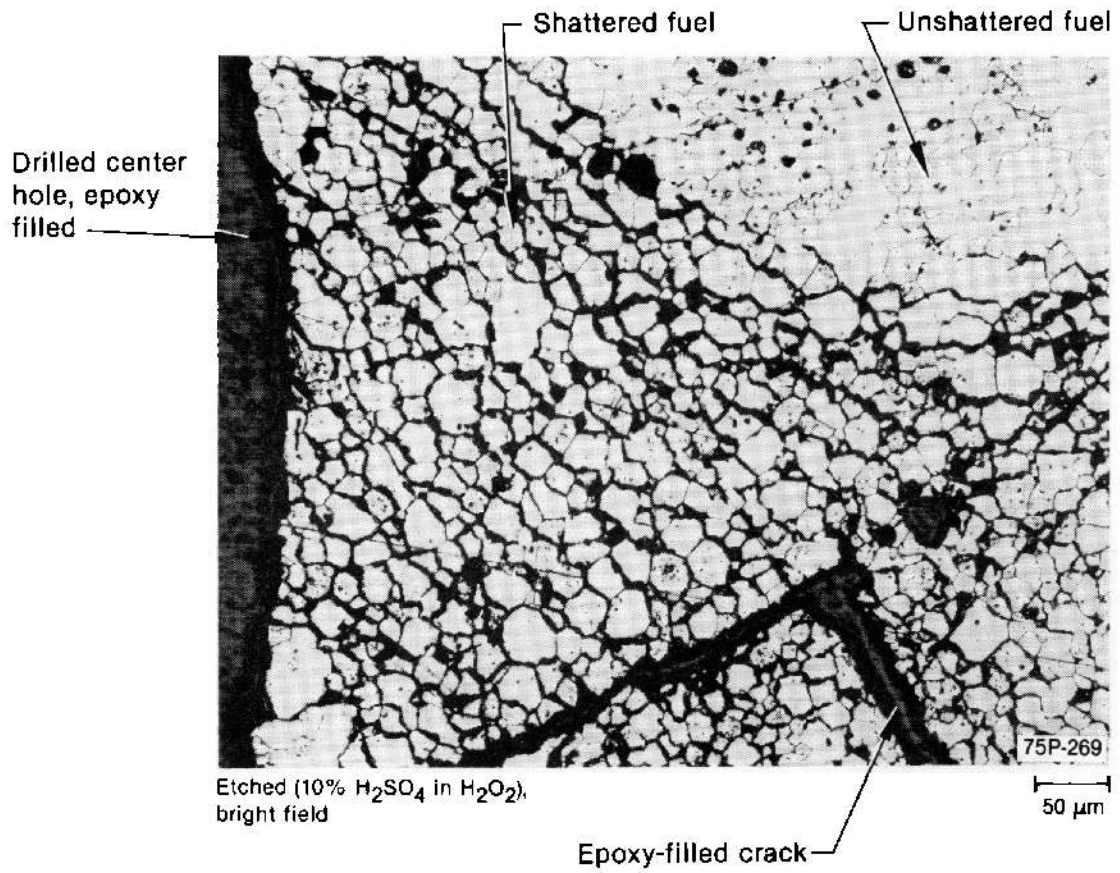
Figure 18. Transverse section of fuel rod showing fuel structure near center hole of fuel pellet, 0.721 m from bottom of fuel stack (Test 8-1 RS).

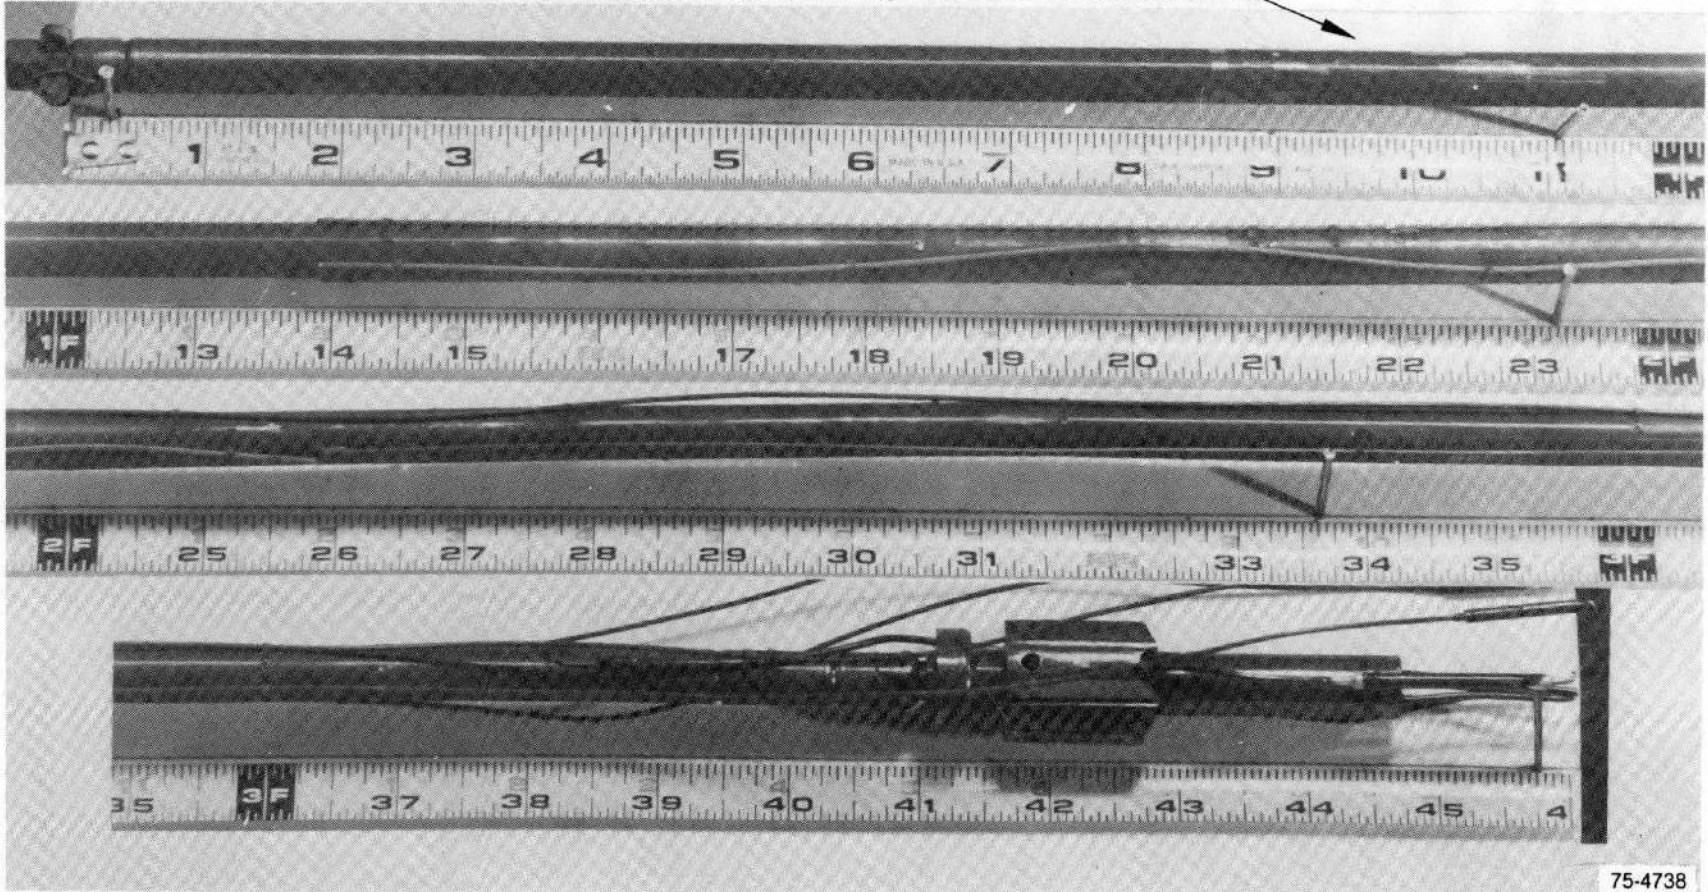
View of rod at higher magnification showing details of rod condition

Figure 33. Posttest photograph of Test CHF Scoping fuel rod (90-degree orientation).

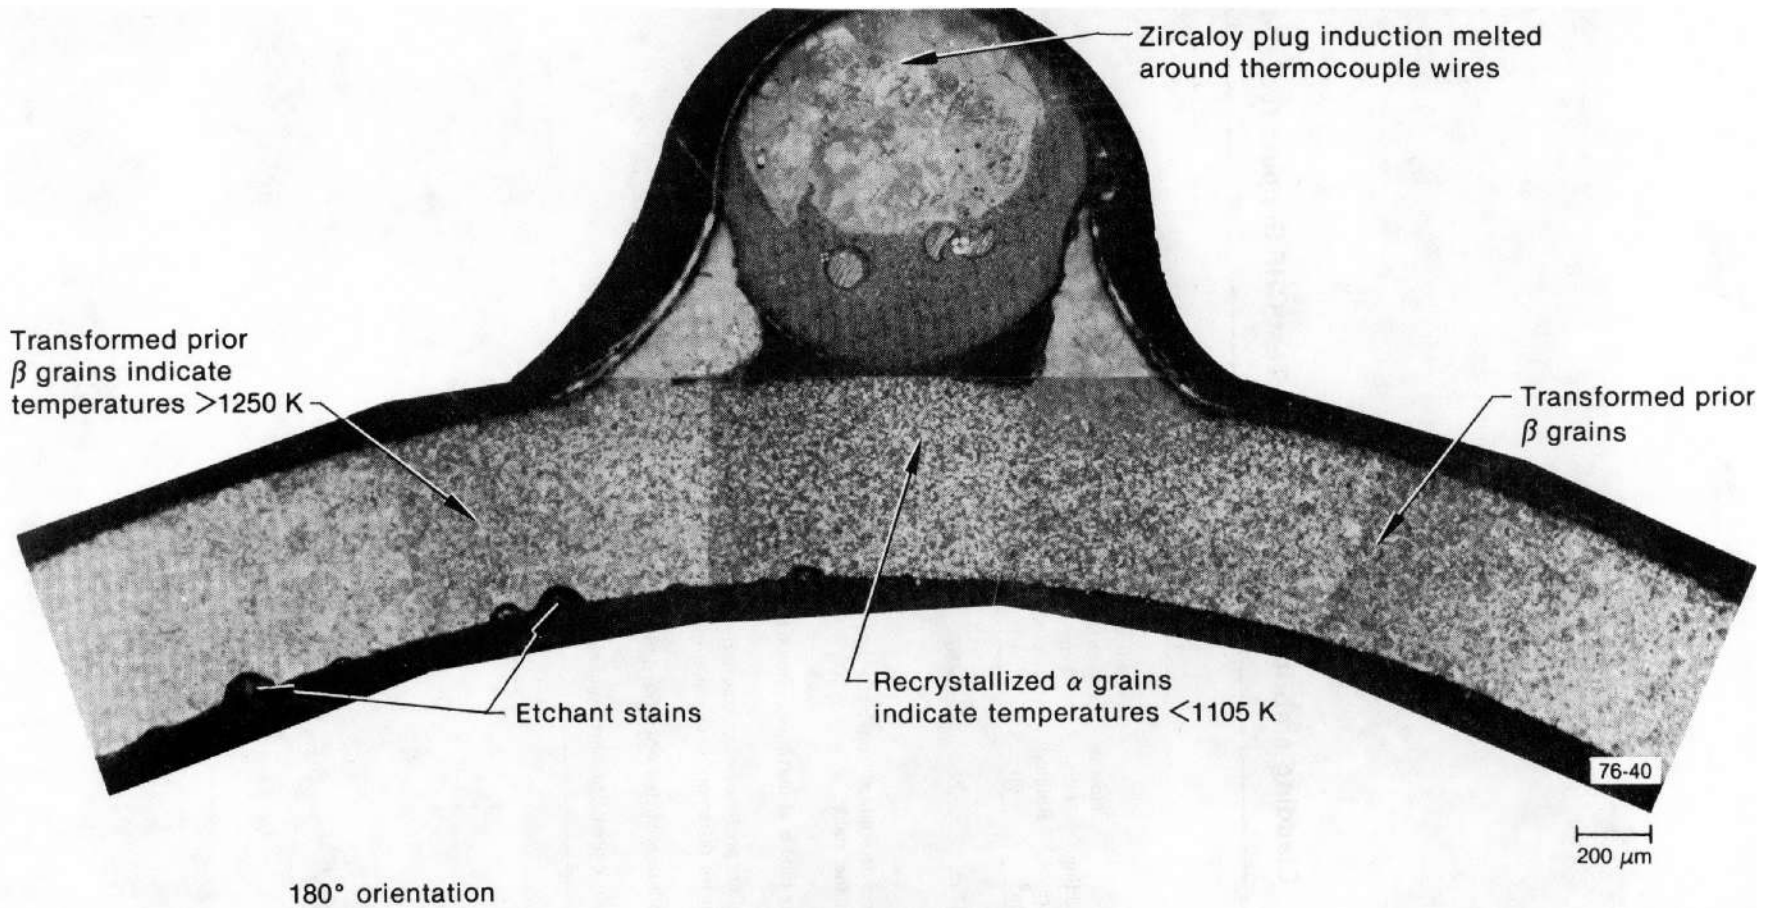
Figure 36. Transverse section of Test CHF Scoping fuel rod showing the microstructure near the 180-degree thermocouple on a plane located 0.525 m from the bottom of the fuel stack.

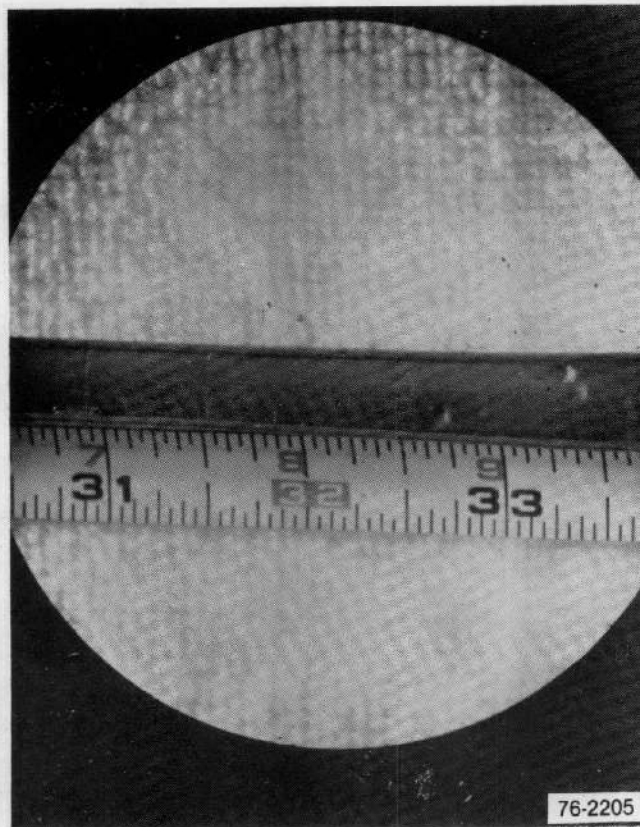
Figure 44. Cladding collapsed into interfaces and chipped regions at ends of Test 8-1 RF fuel pellets. The scale represents the distance from the bottom of the Test 8-1 RF fuel rod.

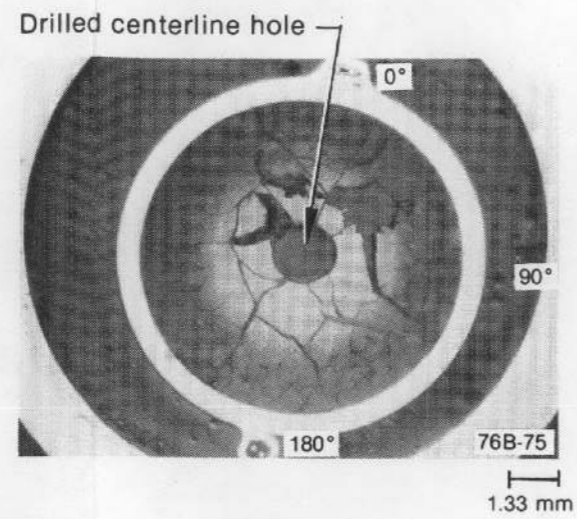
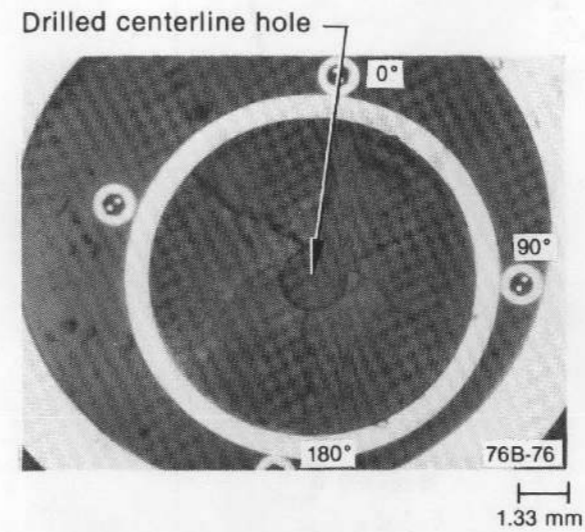
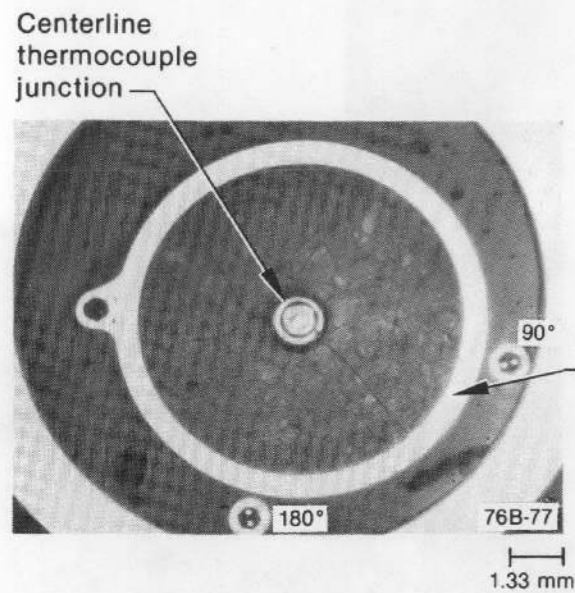
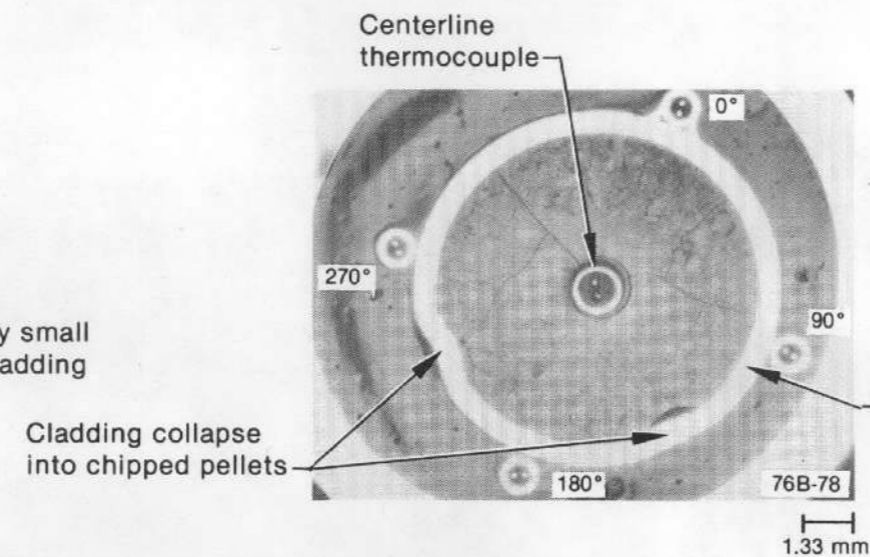
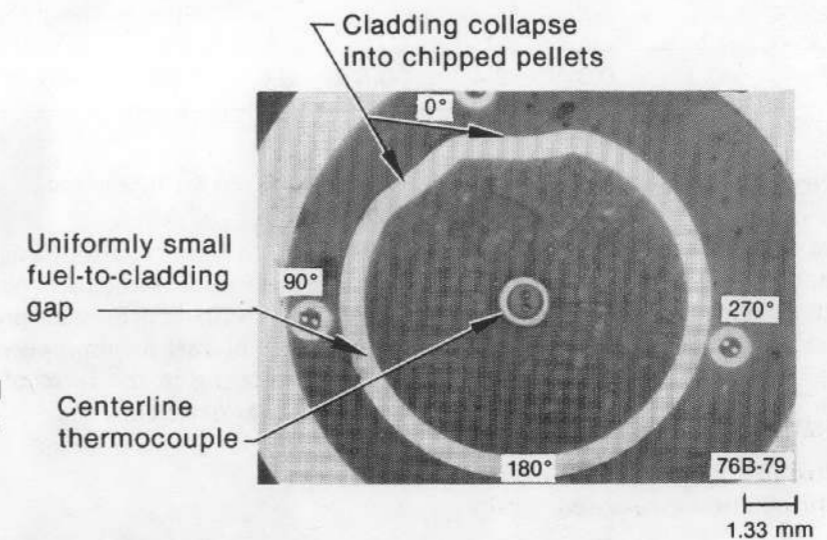
Figure 46. Transverse sections of Test 8-1 RF fuel rod located (a) 0.634, (b) 0.733, (c) 0.779, and (d) 0.823 m above bottom of fuel stack.

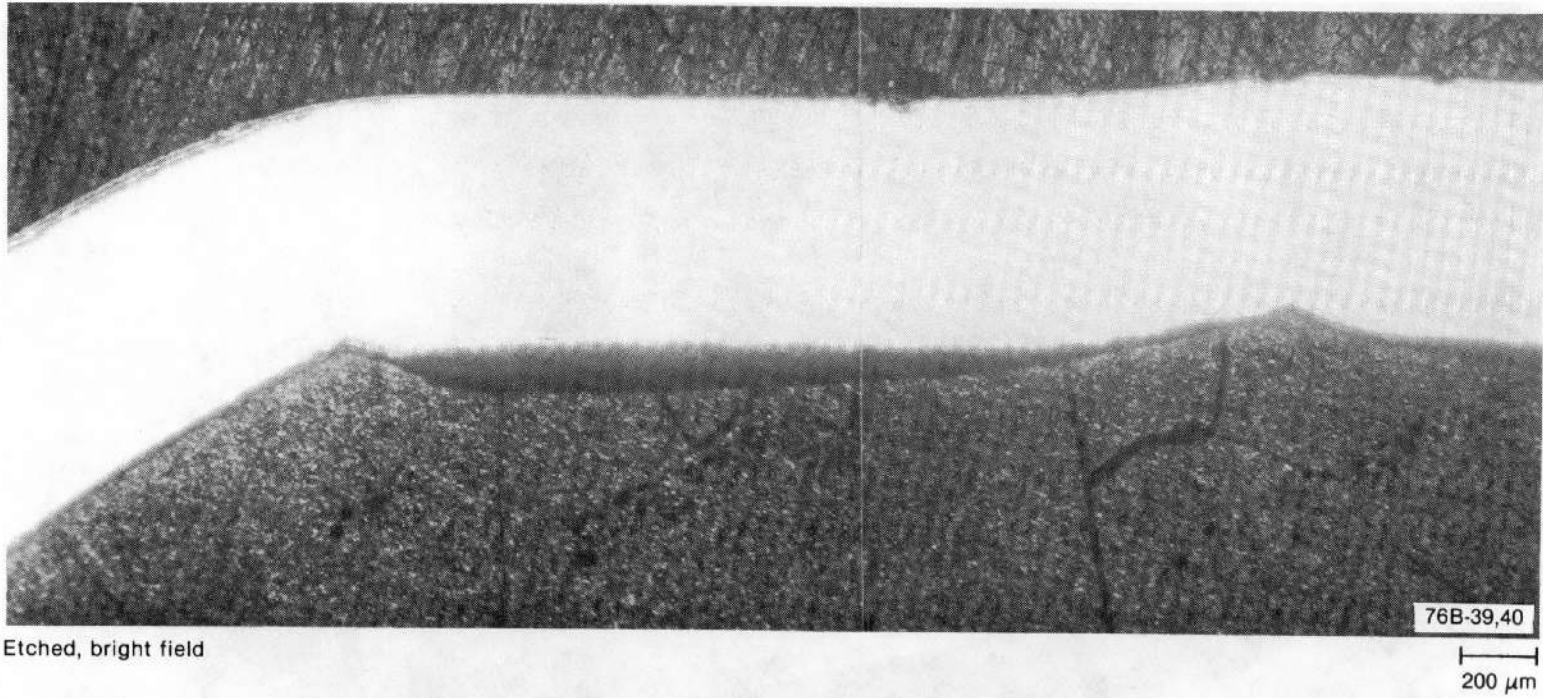
Figure 47. Transverse section of Test 8-1 RF fuel rod showing cladding collapsed into voids of a chipped fuel pellet located 0.779 m above the bottom of the fuel stack [see Figure 46(c)].

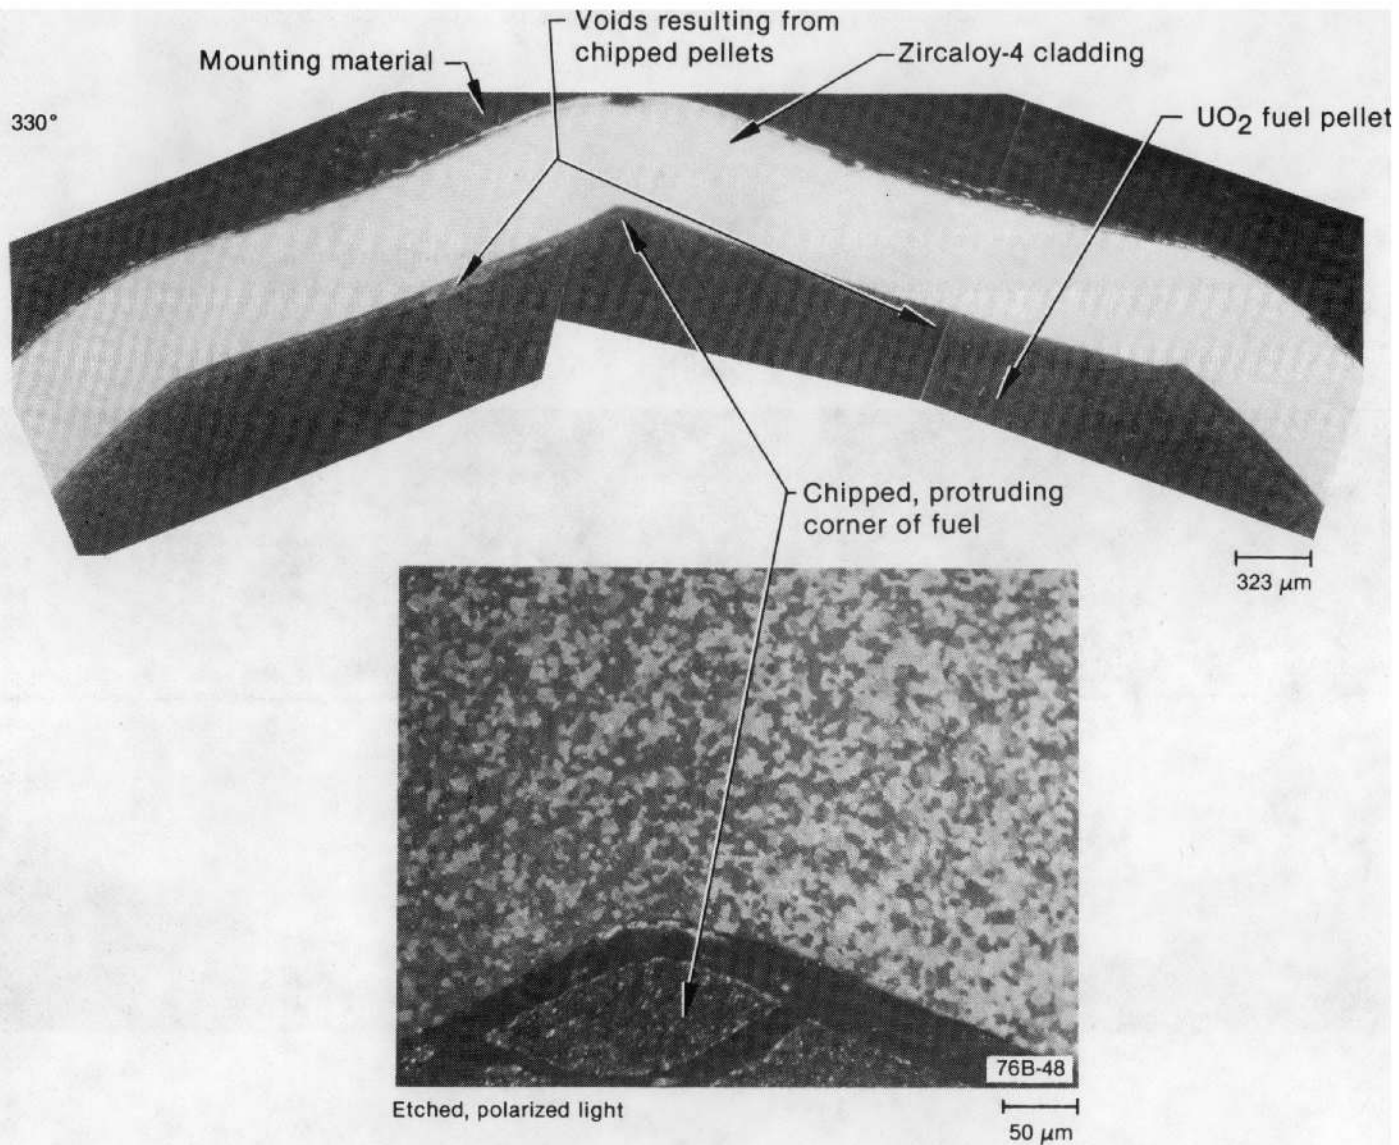
Figure 48. Transverse section of Test 8-1 RF fuel rod showing cladding collapsed into voids of a chipped pellet located 0.823 m above the bottom of the fuel stack [see Figure 46(d)].

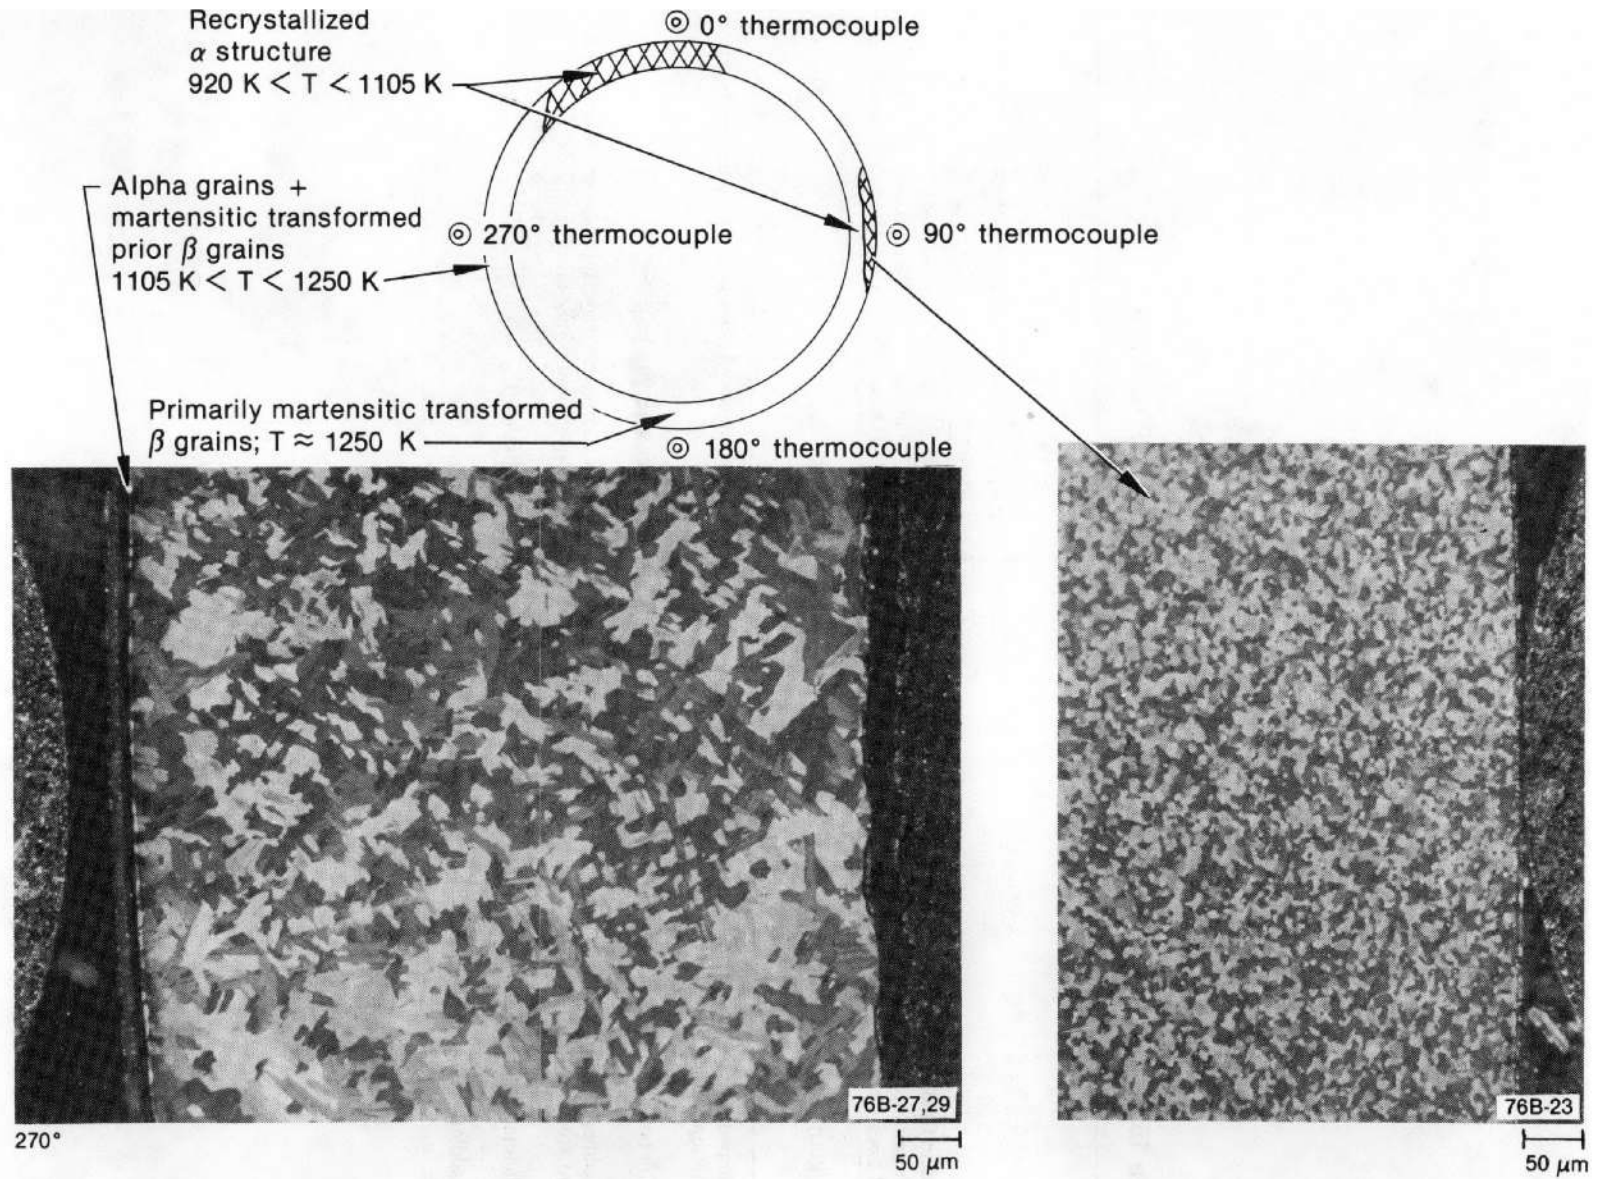
Figure 49. Transverse section of Test 8-1 RF fuel rod showing cladding microstructures observed 0.779 m above the bottom of the fuel stack.
