MLM-MU--90-72-0001

Corrosion of Copper in Mound's Single-Pass Potable Water Systems

Patrick M. Schleitweiler and Pameia S. Miller

Issued: December 7, 1990

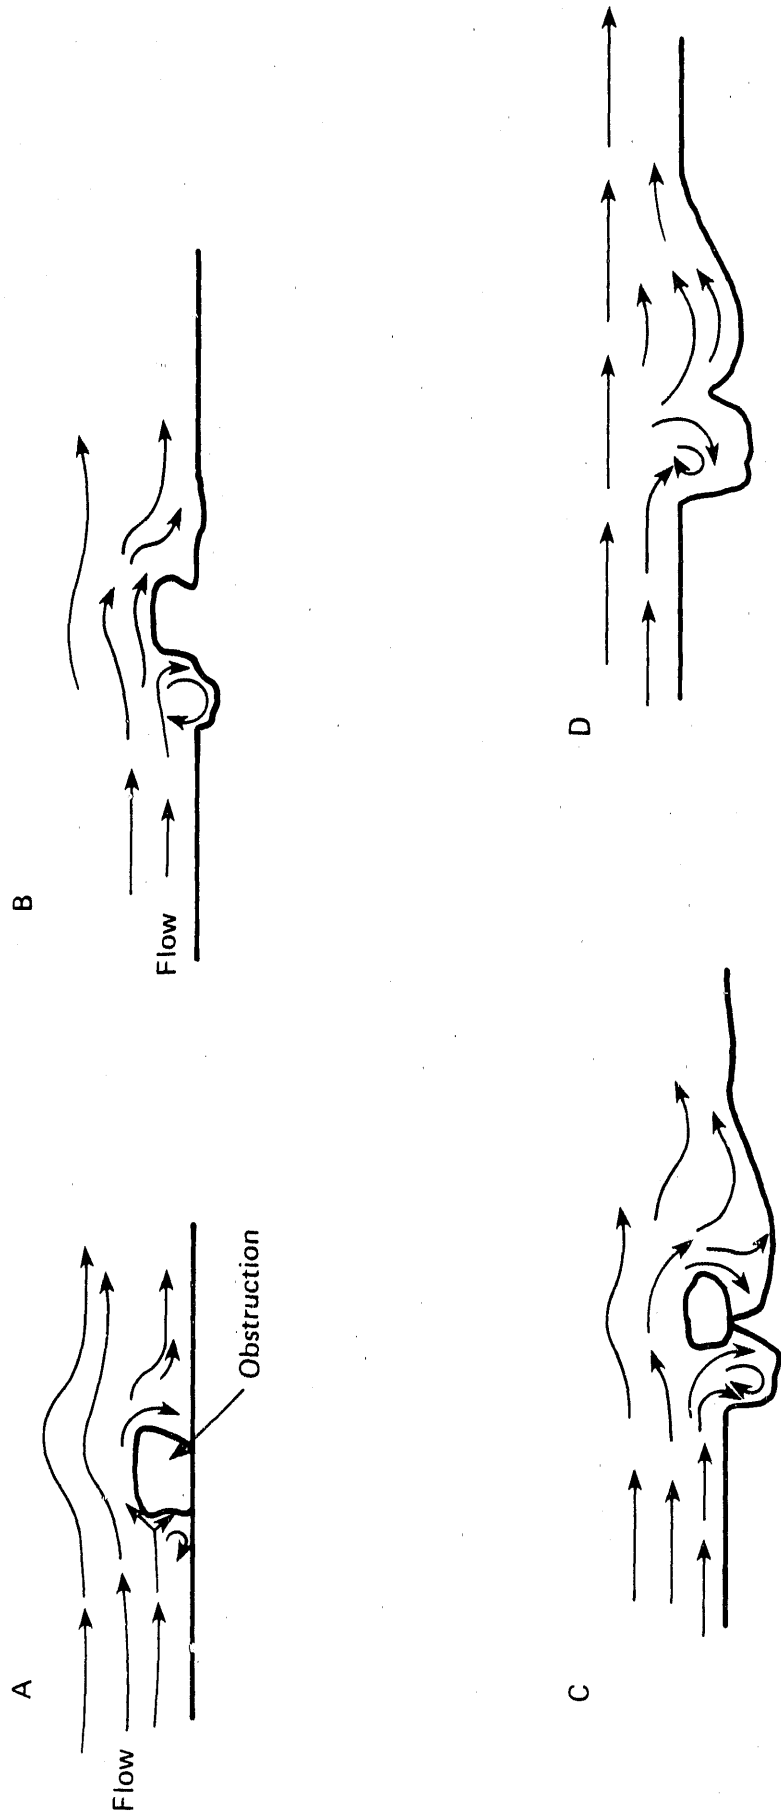
The first straight pipes that were examined exhibited signs of classical erosion corrosion, with horseshoe-shaped grooves and undercut pits characterizing the failures. The development of an erosion pit within a pipe is schematically depicted in Figure 1. In the early stages, an obstruction alters the flow of water against the wall (A). The turbulence on the upstream side of the obstruction erodes away the pipe wall (B). As the erosion progresses, a "golf tee" is formed (C). The stem of the tee is finally worn away, and a horseshoe-shaped pit results (D).

The deepest part of the pit is on the upstream side of the obstruction. This obstruction can come from a variety of sources (for example, a mineral deposit or any surface discontinuity). The resulting localized turbulence and increased flow rates continue accelerating the erosion process. When particles or entrained gas bubbles are part of the flow, the abrasive action of the liquid media is increased.

Figure 1 - Schematic of a cross section of straight pipe showing the effects of an obstruction on the surface of the pipe with high flow.

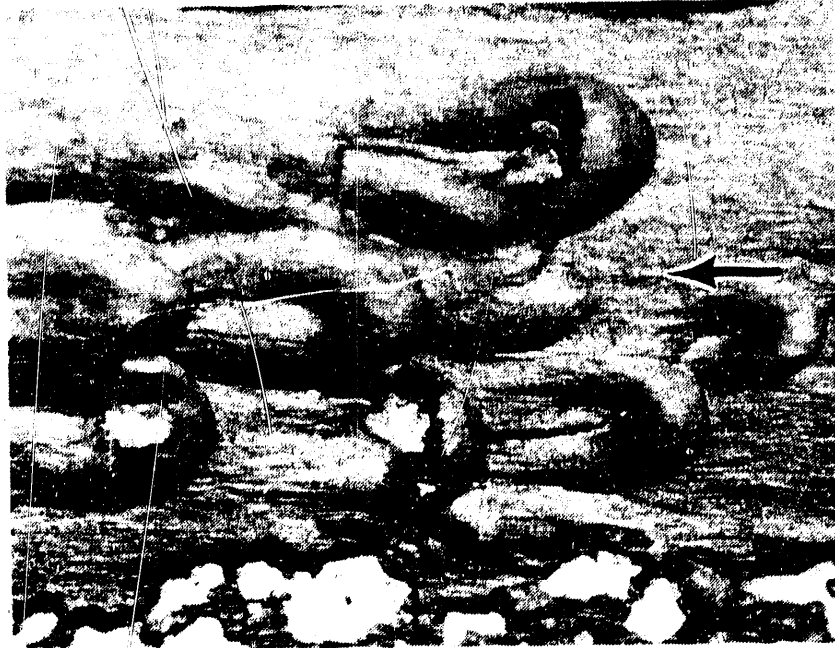
Figure 2 shows a section of straight pipe with the telltale signs of erosion. The flow direction of the water is indicated with the arrow. The open end of the crescent horseshoe-shaped erosion groove is downstream of the obstruction. The shape of the grooves was consistent with the direction of the water flow in these pipes.

Figure 2 - Erosion corrosion found in a failed straight section of pipe. The arrow indicates direction of flow.

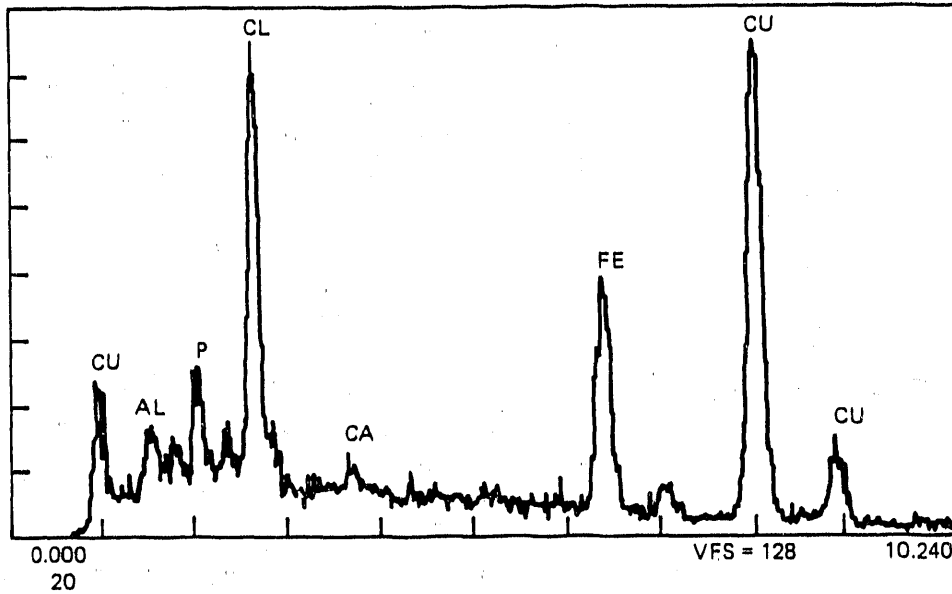
The blue-green scale visible in Figures 2 and 3 was analyzed using energy dispersive spectroscopy (EDS). Typical spectra are shown in Figures 4 and 5. Iron, chlorine, phosphorus, and some calcium accompany copper in the spectra. These elements are present in the water both naturally and through water treatment.

Figure 4 - Energy Dispersive Spectrum (EDS) of blue-green scale on failed parts. Note the strong Iron (Fe) and Phosphorous (P) peaks.

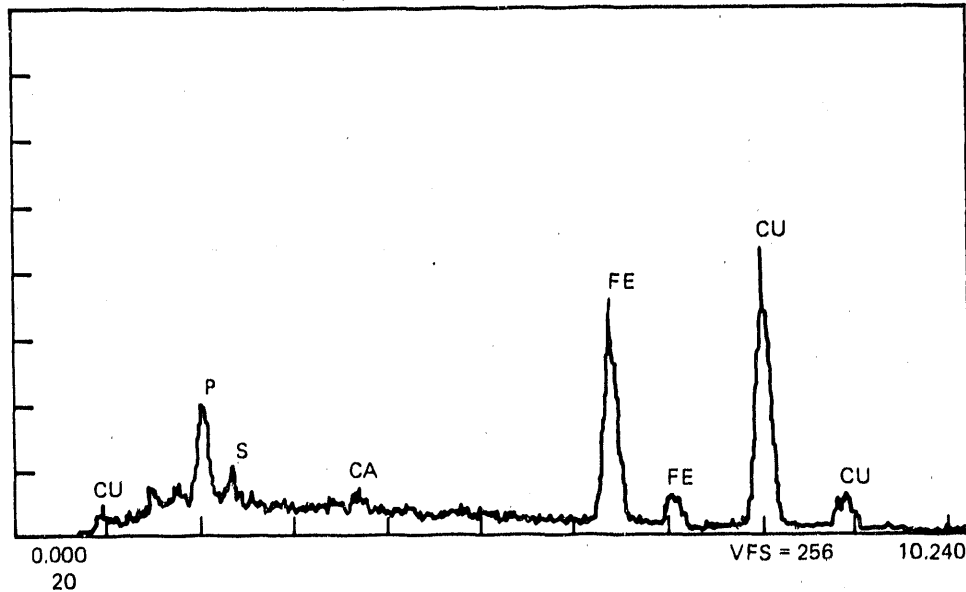
Figure 5 - Energy Dispersive Spectrum (EDS) of blue-green scale on failed components. Note strong Chlorine (Cl) and Iron (Fe) peaks.

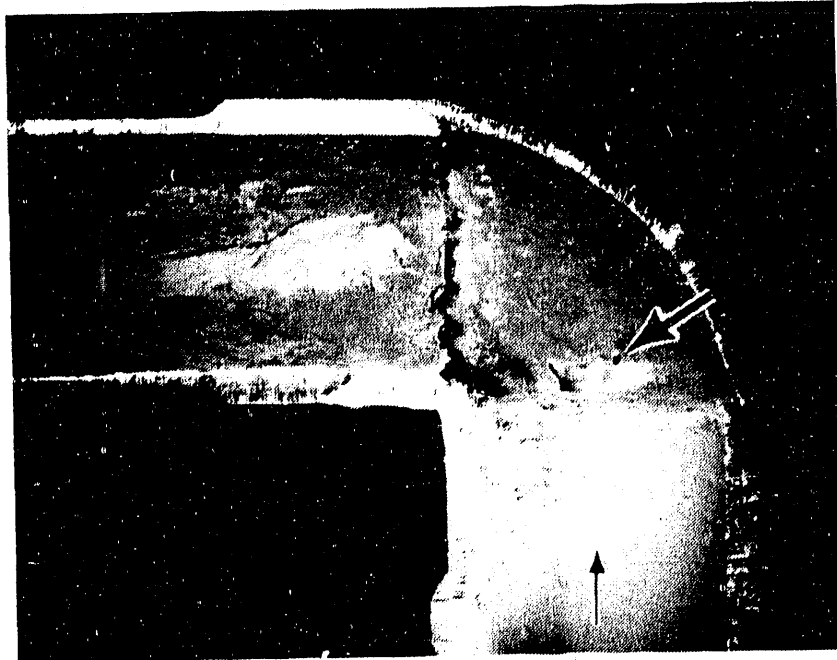
The largest number of plumbing failures have occurred in copper elbows. Figures 6 and 7 are cross-sections of failed elbows that were cut from the plumbing. Close examination of all the elbows revealed the same type of deterioration. Each exhibited deep grooving where the inlet and outlet pipes terminated in the elbow. In nearly all cases, the localized thinning of the elbow led to a perforation on the upstream side of the connection. The small arrows in the figures indicate the direction of flow; the large arrows highlight the perforation.

Heavy scale buildup is visible in Figure 6. It is apparent that the scale is broken and discontinuous. Again, as in the straight pipe, EDS analysis indicated that the scale is composed of iron, calcium, phosphorous, and chlorine. Pipe cutting burrs were observed in nearly all of the elbows examined. The burrs normally result when tube cutters are used to cut the copper pipes to length. Figure 8 clearly shows the lip from the cut pipe. Good workmanship practices include a reaming operation to eliminate burrs after the pipe is cut, thereby eliminating flow obstruction [7].

Figure 6 - Cross section of a 1/2-in. diameter copper elbow. Small arrow indicates flow direction. Large arrow shows perforation.

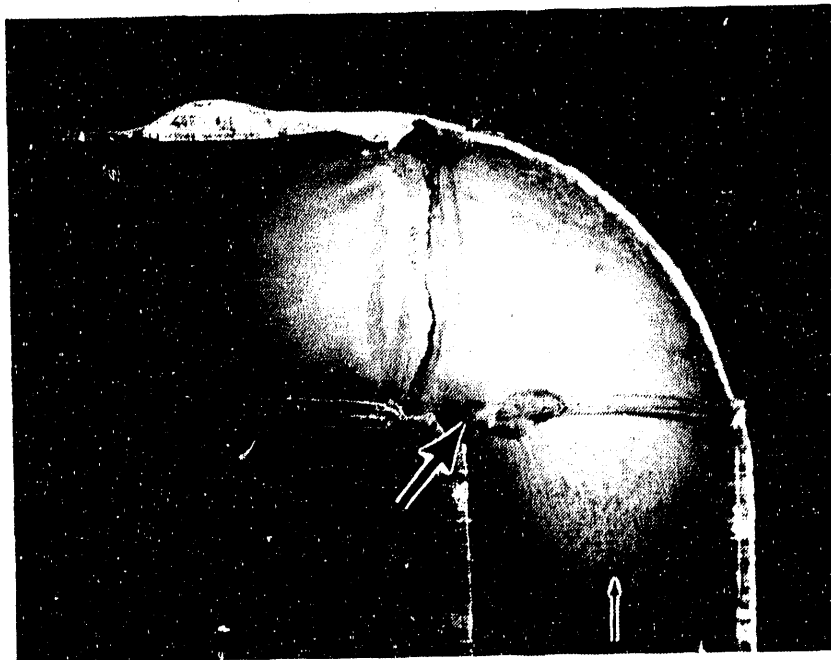
Figure 7 - Cross section of a 3/4-in. diameter copper elbow. Small arrow indicates flow direction. Large arrow shows perforation.
