Atomics International North American Rockwell		SUPPORTING DOCUMENT		NUMBER TR-097-330-007	REV LTR/CHG NO. SEE SUMMARY OF CHG																																																								
PROGRAM TITLE Fast Reactors (Central Station)				DOCUMENT TYPE Test Report																																																									
DOCUMENT TITLE MSG Test Report - Removal of Residual Sodium				KEY NOUNS MSG, Cleaning																																																									
PREPARED BY/DATE R. B. Harty <i>R. B. Harty</i>				ORIGINAL ISSUE DATE																																																									
DEPT		MAIL ADDR		GO NO. 41001	S/A NO. 33000																																																								
IR&D PROGRAM? YES <input checked="" type="checkbox"/> NO <input type="checkbox"/> IF YES, ENTER TPA NO. _____				PAGE 1 OF TOTAL PAGES 53																																																									
APPROVALS				REL. DATE <i>3-8-74 sm</i>																																																									
E. B. Baumeister <i>EBS</i>		DATE 3/8/74		SECURITY CLASSIFICATION																																																									
J. S. McDonald <i>JSM</i>		DATE 3/8/74		(CHECK ONE BOX ONLY)

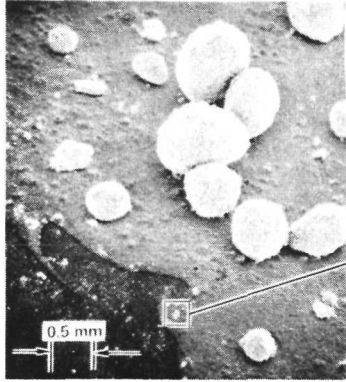
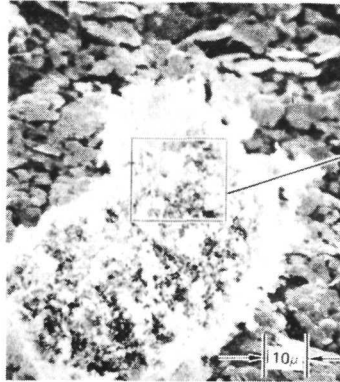
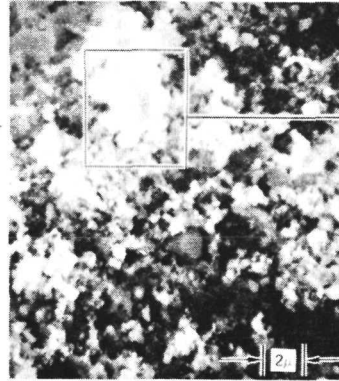
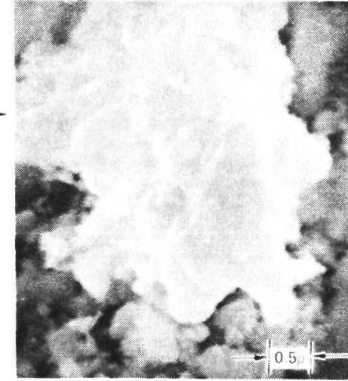
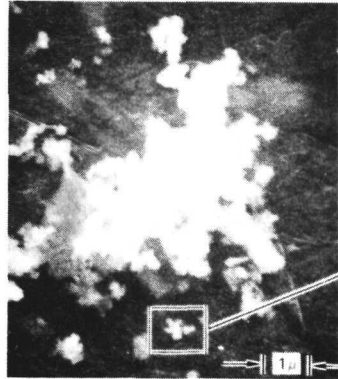
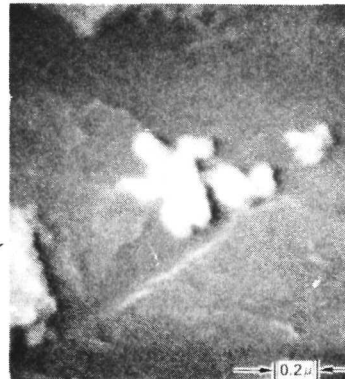
SCANNING ELECTRON MICROGRAPHS
OF MODULAR STEAM GENERATOR
DEPOSITS

Analyses of the black powder were performed on the material taken from the filter. An x-ray fluorescence scan of the sample showed the presence of Fe(major), Cr(first minor), Ni(second minor), and Mo(third minor). X-ray diffraction of the deposit showed it to be alpha Fe which is isostructural with Croloy. From the x-ray fluorescence, the estimate of the composition of the residue is as follows:

Fe	-	60-80%
Cr	-	4-5%
Ni	-	1-2%
Mo	-	~1 %

The above observations and supporting analysis indicates the observed deposits are nearly identical with the base metal (2-1/4 Cr - 1 Mo). Some of the internals are fabricated from Incoloy 800 (wastage baffles) and 304 stainless steel (thermal liner), accounting for the nickel. The formation of the residue is believed to be caused by the formation of an oxide scale on the internals during fabrication and post-weld heat treatment. During sodium service, the oxides are chemically reduced leaving a residue of the observed composition. The results observed by the SEM examination are consistent with this theory. Similar observations of a black residue were noted in Ref. 6 after alcohol cleaning of a steam generator. Conclusions as to formation and composition were similar to those presented here.

mass of residue formed would be about 1.9 lbs. This amount represents a uniform corrosion of the internal surface of only 0.02 mils.

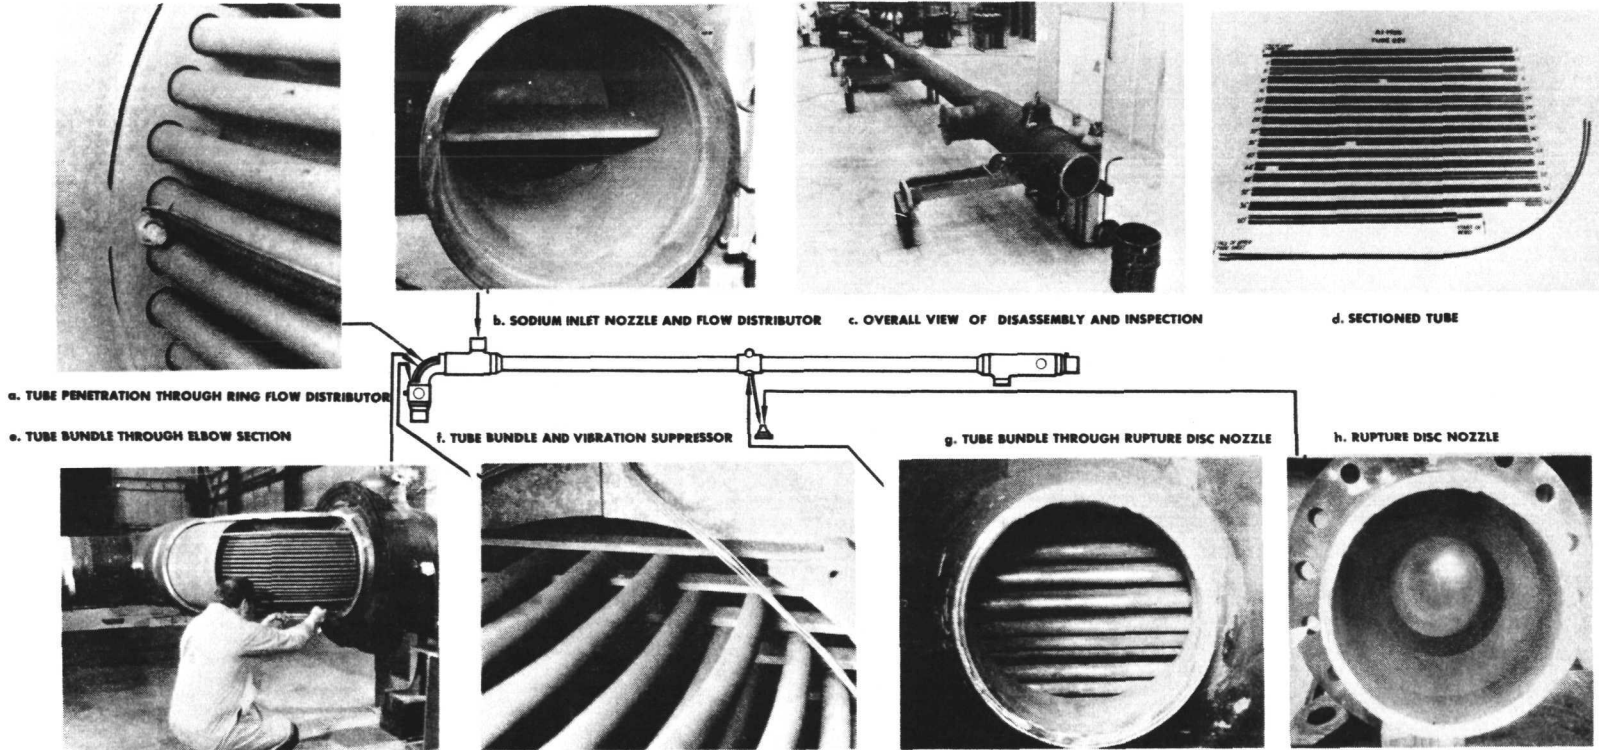
MSG SODIUM SIDE INSPECTION

Inspection of internal surfaces showed a general coating of a black residue. In areas where the solvent flow was nearly stagnant and not accessible to sparge gas flow, the residue was much thicker. These thicker regions were in the form of a cake with thicknesses up to about 1/8-in. The black deposits were analyzed and found to be the same composition as that obtained from the filter during cleaning. Wet chemistry analysis showed that the sodium content of the residue was between 1 and 2%. X-ray defraction analyses indicated the crystalline structure to be that of sodium ethoxide and sodium hydroxide. The sodium ethoxide, the reaction product of the sodium-ethanol reaction, remains as a surface contamination after drying. The sodium hydroxide was apparently formed from the reaction of sodium-ethoxide and moist air after the MSG was exposed to the atmosphere. In areas where the cake residue occurred, a reddish-black deposit was also noted. These deposits were shown to contain, in addition to alpha-ion as observed in all other residue samples, the compound Fe_3O_4 (magnetite). Only small amounts of this compound were noted on the MSG internals,

Figure VI-10 shows various photographs of the MSG internals. Figure VI-10c shows an overall view of the MSG during disassembly and inspection. At the time of this photo, the feedwater and steam heads and rupture disc nozzle had been removed. Work is proceeding on the removal of elbow section and sodium inlet nozzle cap.

Photo VI-10g shows a view looking into the tube bundle at the rupture disc. The thin black residue film, described above, can be noted on the surfaces. Several sections were wiped with acetone exposing the shiny base metal. A borescope examination of two adjacent tube spacers (not shown) was made. No signs of unreacted sodium were observed, even in the 0.006 in radial gap between the tubes and tube spacer holes. The tubes could be moved in this radial gap giving a noticeable metal to metal contact sound. A view looking into the sodium side of the rupture disc nozzle is shown in Photo VI-10h. Again, the thin black residue film is visible, but no signs of unreacted sodium were observed. The shiny surface on the rupture disc is an area wiped with acetone exposing the base metal. The cross marks noted are the back side of the grooves on the disc for providing the proper rupture pressure. The disc was removed from the nozzle by grinding the lip formed when the disc was welded to the nozzle. A rather deep crevice was exposed showing no signs of unreacted sodium.

Photo VI-10b shows a view looking into the sodium inlet nozzle after the weld cap was removed. The flow baffle plate and the outside surface of the upper flow distributor can be seen. The thicker residue cake (1/16 to 1/8 inch) can be observed on the lower surface (right side of photo) of the nozzle. The thicker layer on the lower surface is postulated to have occurred, as discussed above, as a result of the solvent flow characteristics in the nozzle region during cleaning. There was no solvent flow through the sodium nozzle during cleaning, which results in essentially stagnant flow conditions between the flow distributor and nozzle. Also sparge gas flow could not agitate the solvent in this region. Because of these stagnant conditions, the black residue picked up by the solvent would tend to settle out on the lower surface of the nozzle. During cutting of the nozzle to remove the weld cap, sparks were observed, indicating the possibility of unreacted sodium. Inspection of the internals revealed no signs of unreacted sodium. The sparks that were observed are postulated to have occurred from residual ethanol which condensed on the cold uninsulated sodium nozzle.

Photo IV-10e shows a view of the tube bundle after the elbow section was removed. The thermal liner assembly can be seen, which was later removed. A portion of the vibration suppressor is visible as well as some of the internal thermocouples. The photo shows residue samples being taken for chemical analysis. Photo IV-10f shows a closeup of the vibration suppressor. The metallic particles noted on top of the suppressor are cutting chips from the elbow removal operation. A bolt hole can also be noted which was completely free of sodium. Photo IV-10a shows a closeup of the tubes as they pass through the ring flow restrictor after the thermal liner was removed. A portion of a tube spacer is visible behind the flow restrictor. Also shown is one of the eight tie rod hex nuts and a thermocouple. One of the thermocouple bands, that hold the TC's to the tubes, was removed and inspected for unreacted sodium. No trace of sodium was found under the band as well as any of the areas accessible for inspection in the upper bend region.

The final photo (VI-10d) shows the external surface of a full length tube which had been split and sectioned into about four-foot lengths. The black residue was noted only on certain portions of the tube length. These portions corresponded to the lower region, rupture disc nozzle region, and up bend region. These regions in turn correspond to areas that were subjected to post-weld heat treatment after the tubes were installed. This observation substantiates the theory that the residue originated from an oxide layer formed during post-weld heat treatment, and then chemically reduced during sodium service. Since the residue is magnetic, it tends to adhere to the metal surface. Close inspection of the tube surface revealed no signs of unreacted sodium. Location of areas where the tube passed through the tube spacer proved to be very difficult, because of clean appearance of the tube surface.

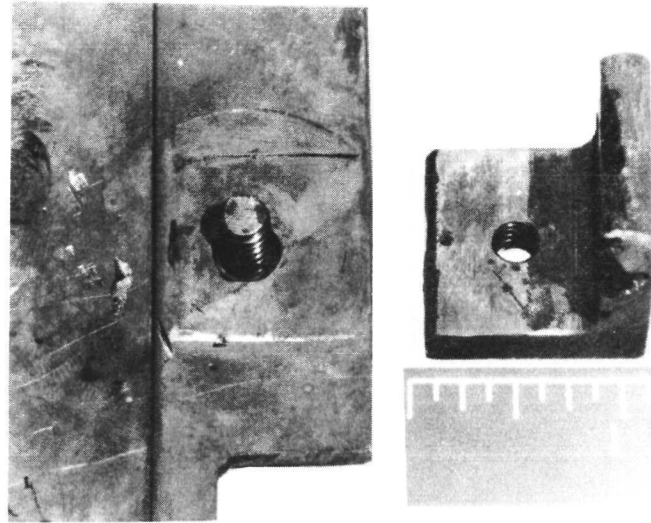
B. EXPOSED BOLT THREAD

shows the exposed bolt threads with the bracket removed. The underside of the bolt head (not shown) was completely (360°) seal welded to the liner. No unreacted sodium was found either in the opening between the bolt and hole in the liner or on any of the threads.
