APAE Memo 106

CONTROL ROD DRIVE DEVELOPMENT

Issued Aug. 15, 1957

Alco Products, Incorporated
Mechanical Laboratory Report No. 3036

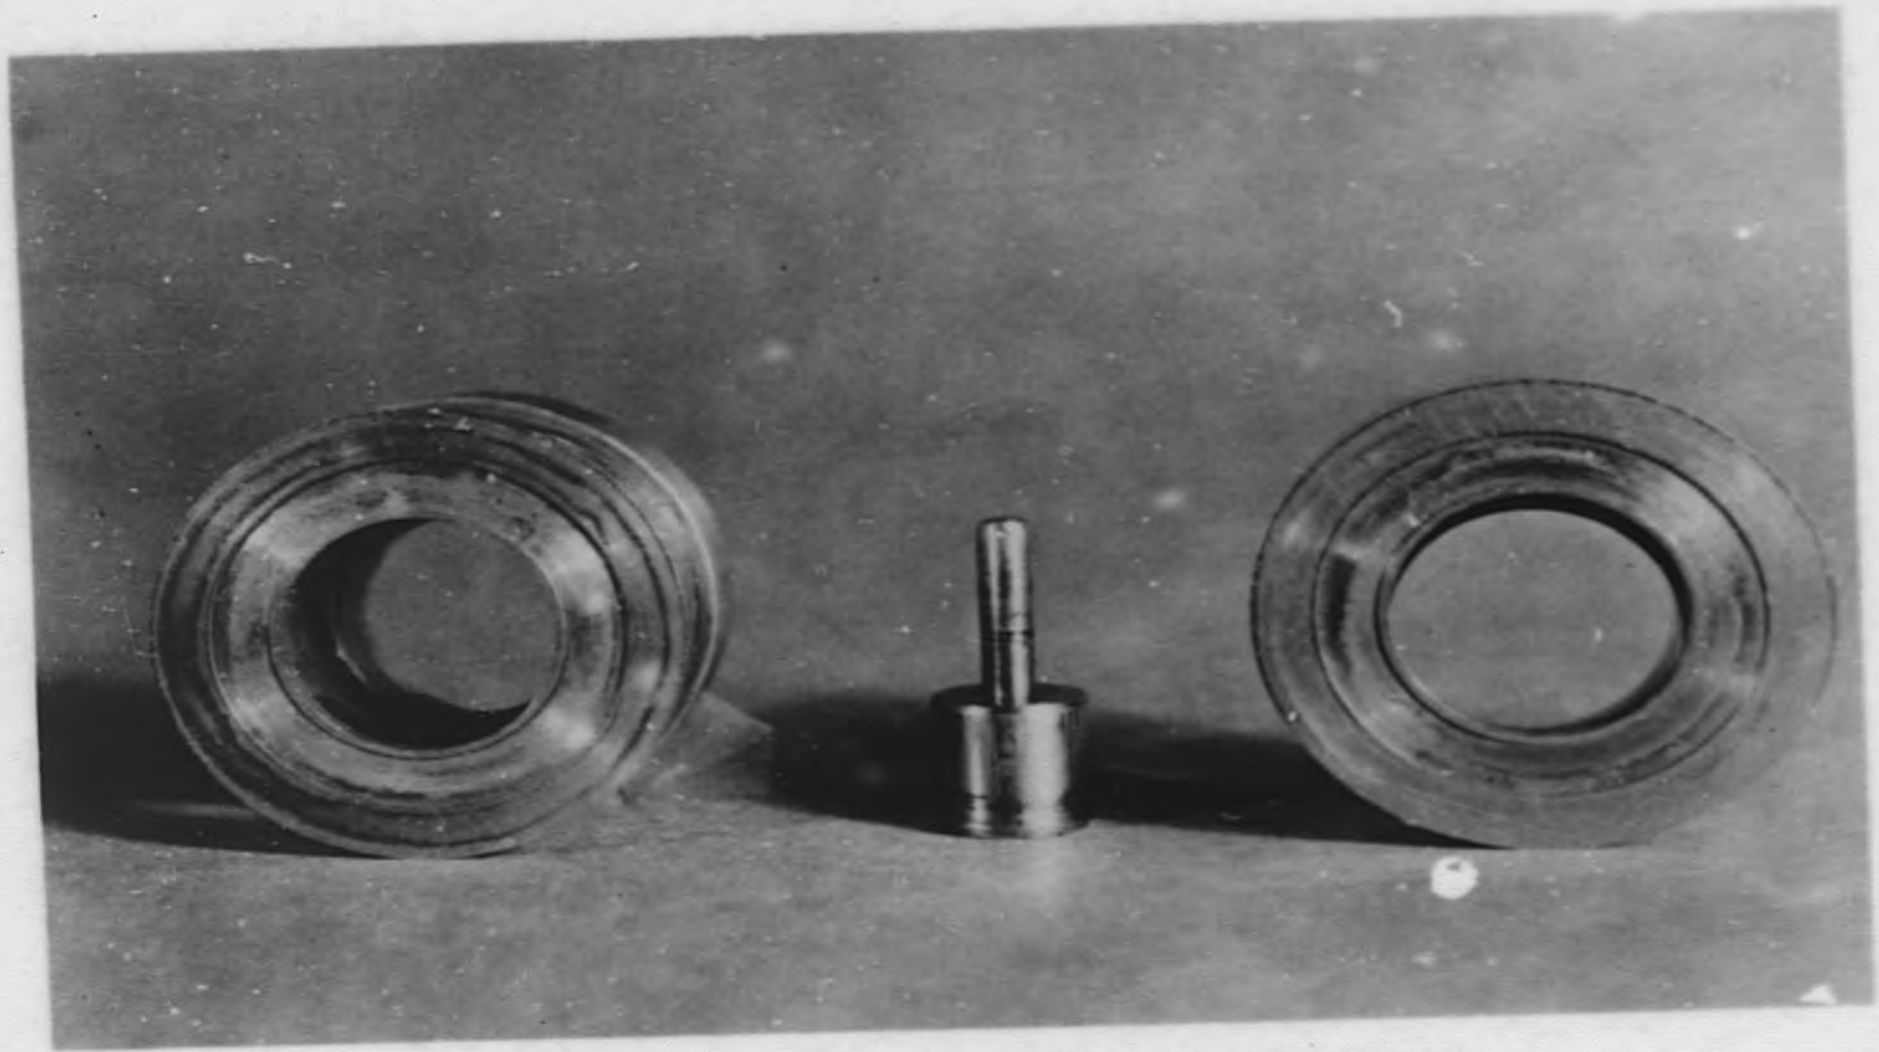
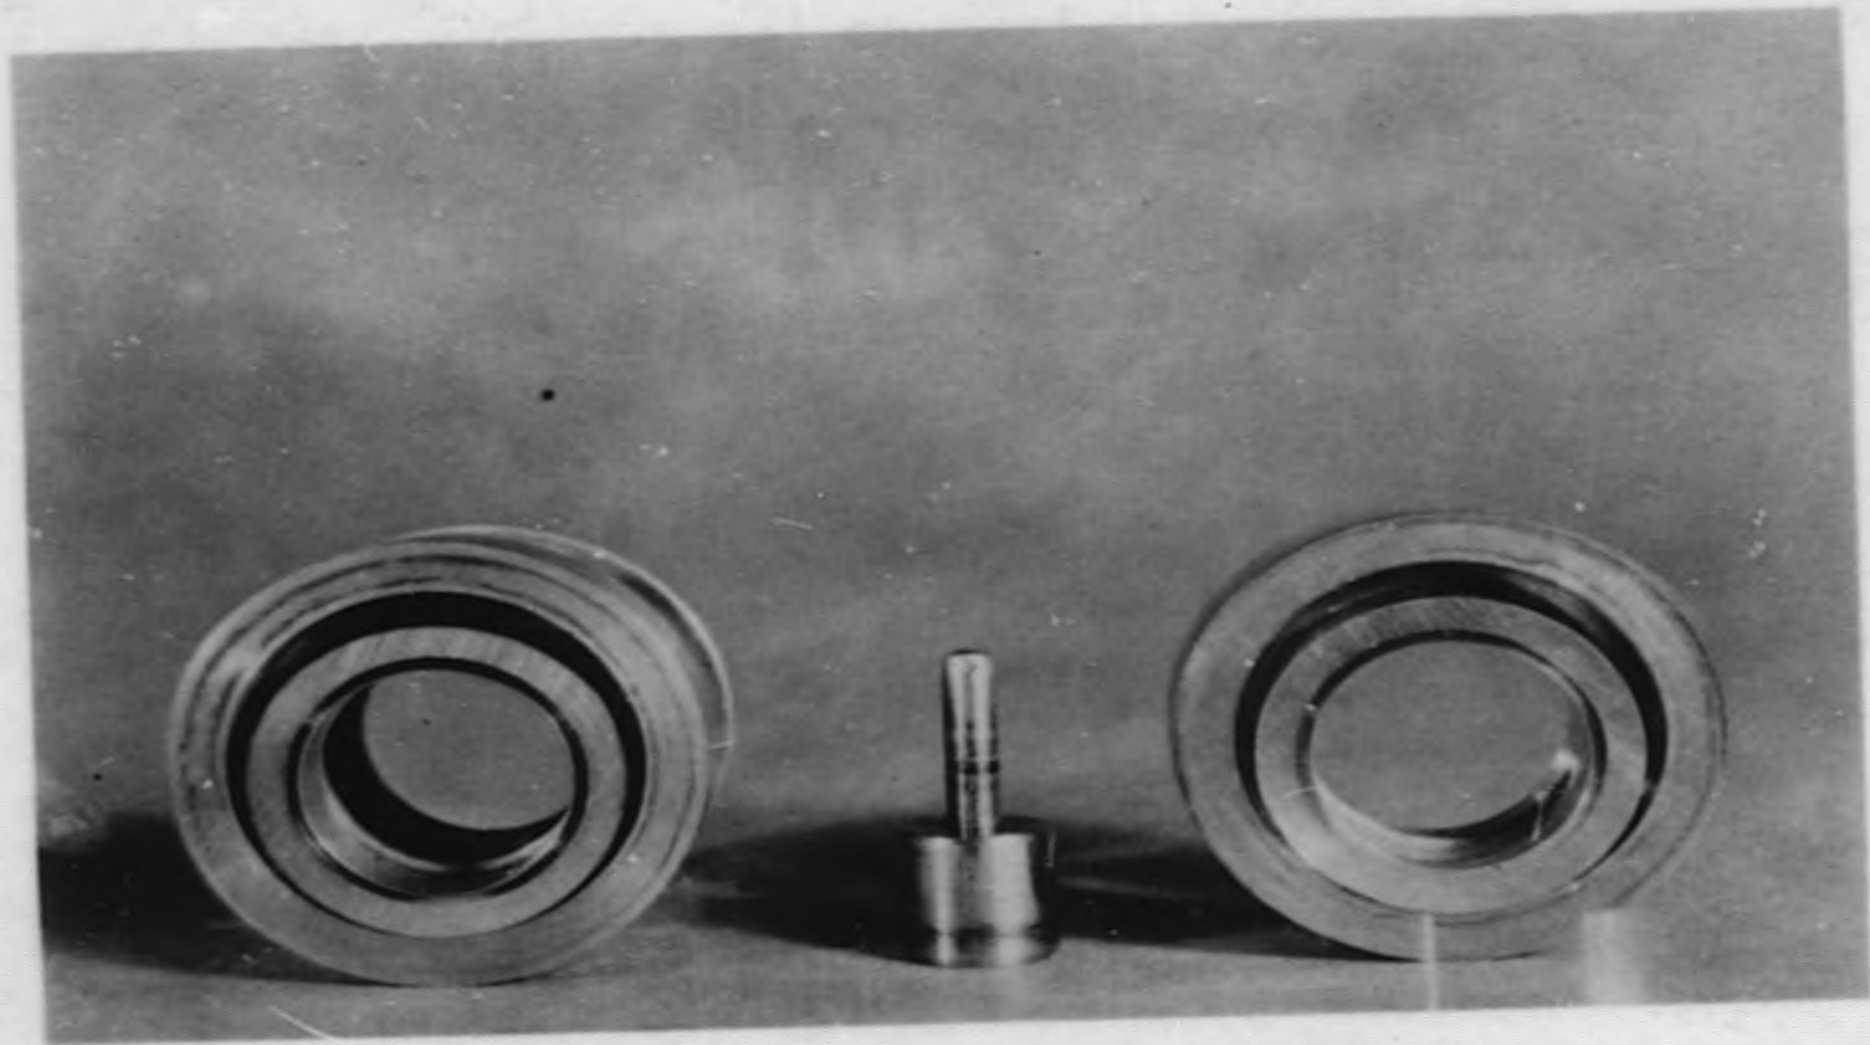
The test rig was dismantled completely and all components inspected. The attached photographs, #4725 thru 4728, indicate the condition of the water seal rings, control rod guide rollers and the control rod snubber, and are representative of the conditions found throughout the test rig.

Seal Rings & Control Rod Roller as Received in ORNL Test Rig
Photo 4725

Seal Rings & Control Rod Roller as Received In ORNL Test Rig
Photo 4726

Before reassembly of the rig the individual components were reworked as necessary, such as, lapping the water seal rings, polishing off score marks on the control rod, adjusting guide rollers, etc. A dimensional check was made of critical components.

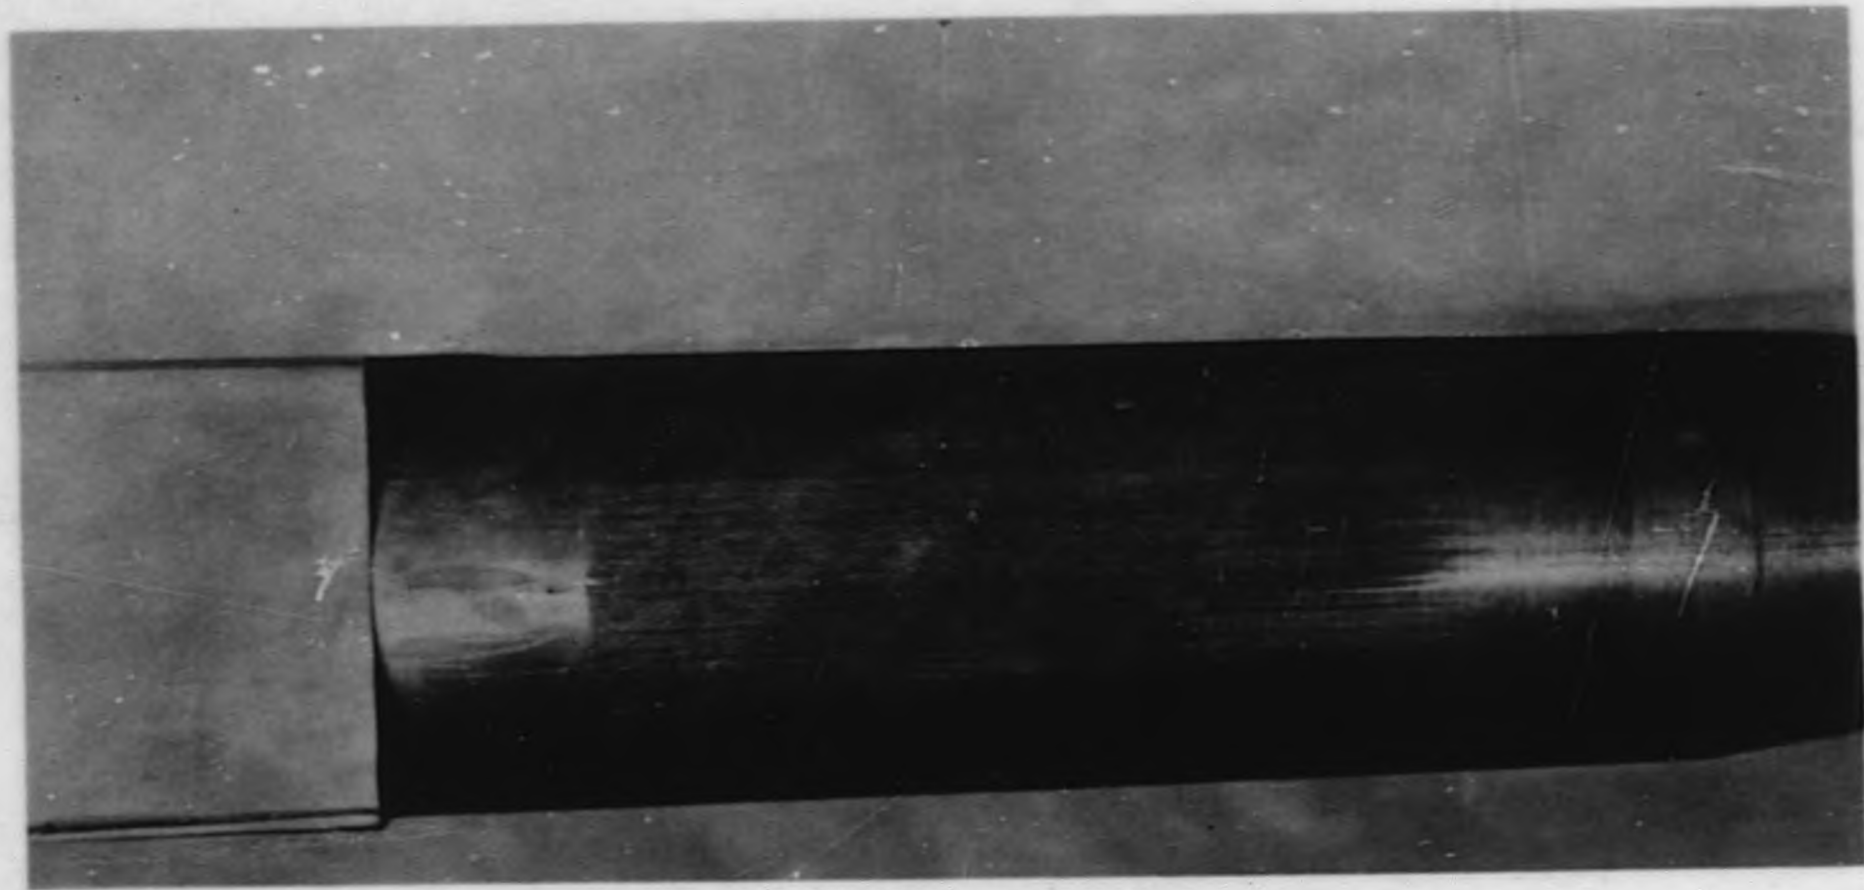
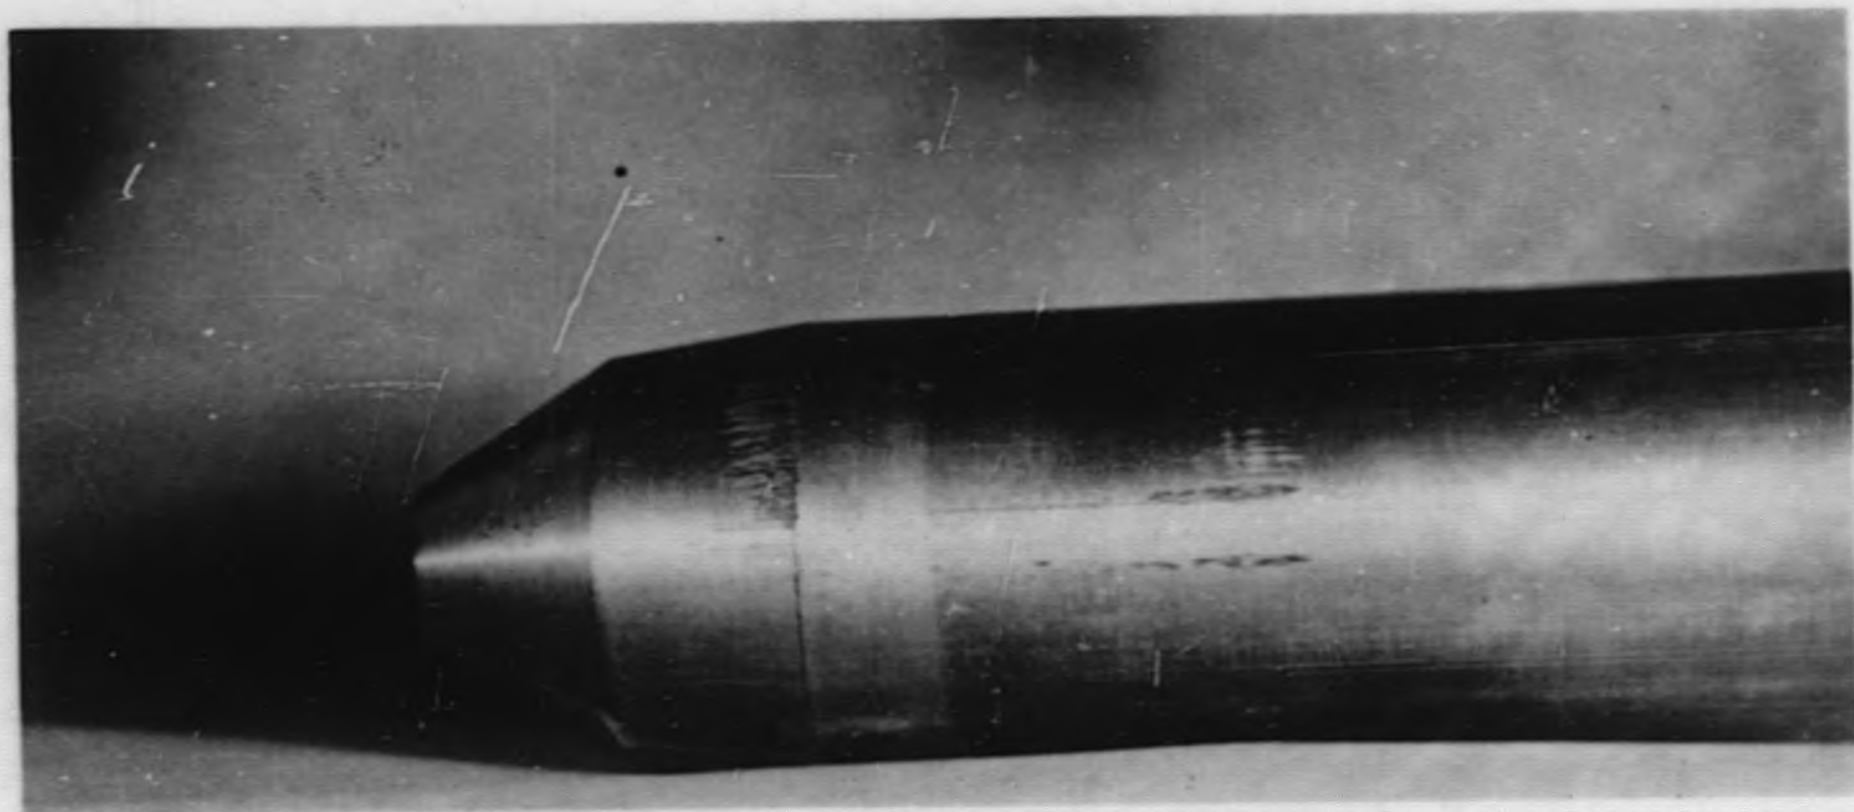
Photo 4727

Control Rod Snubber as Received in ORNL Test Rig

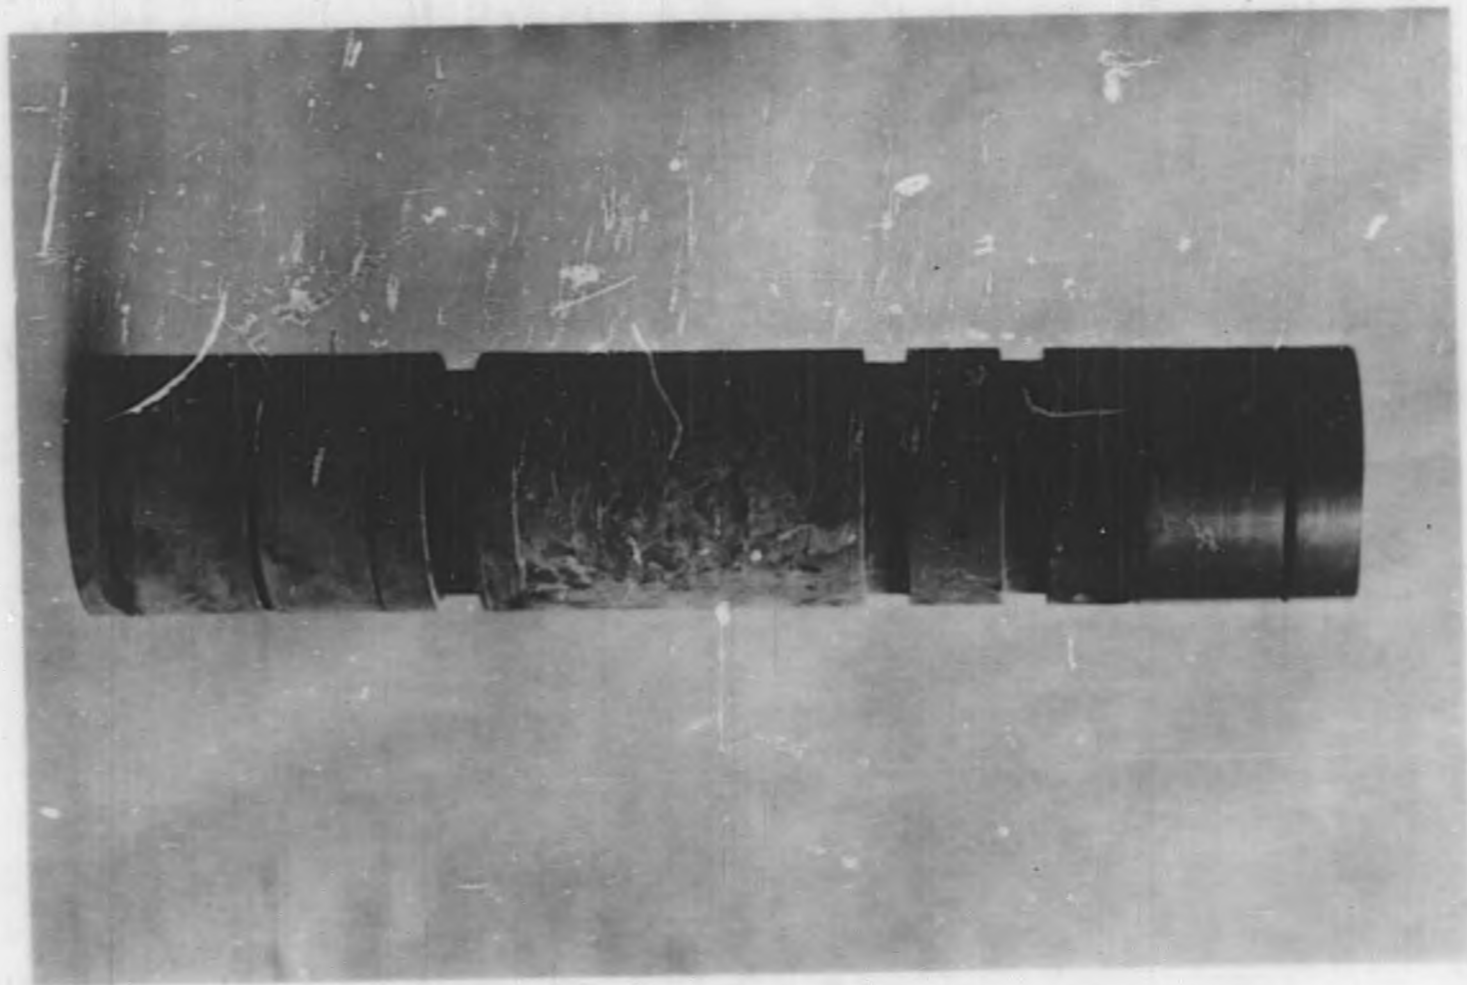
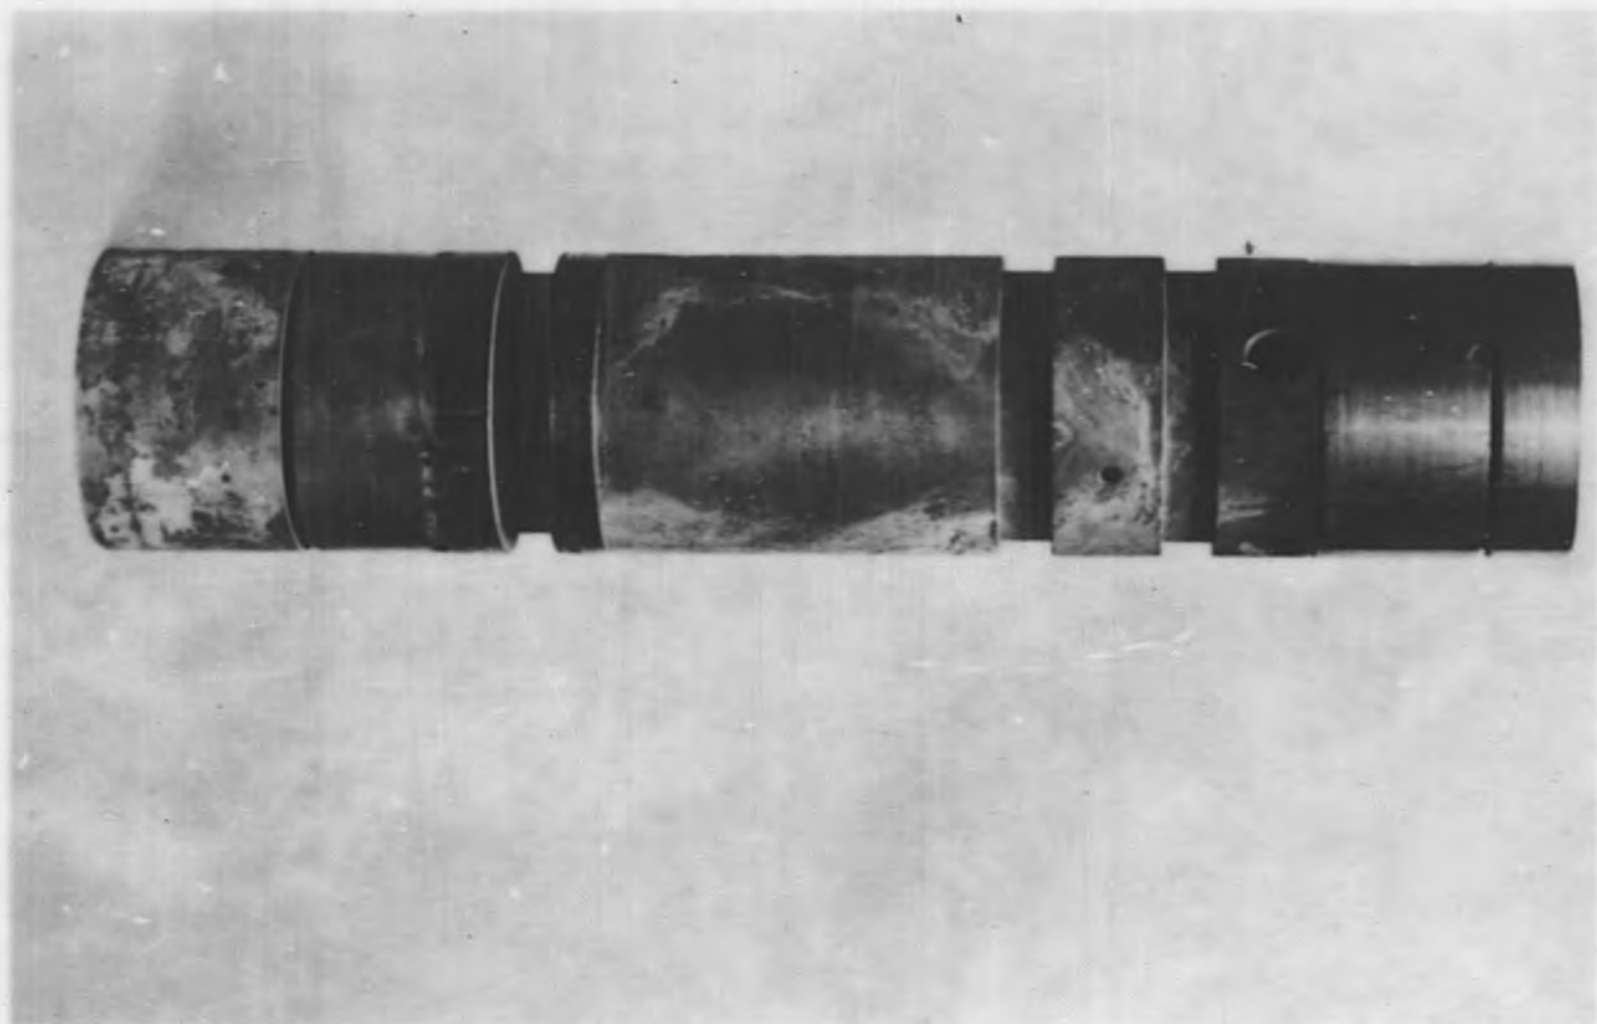
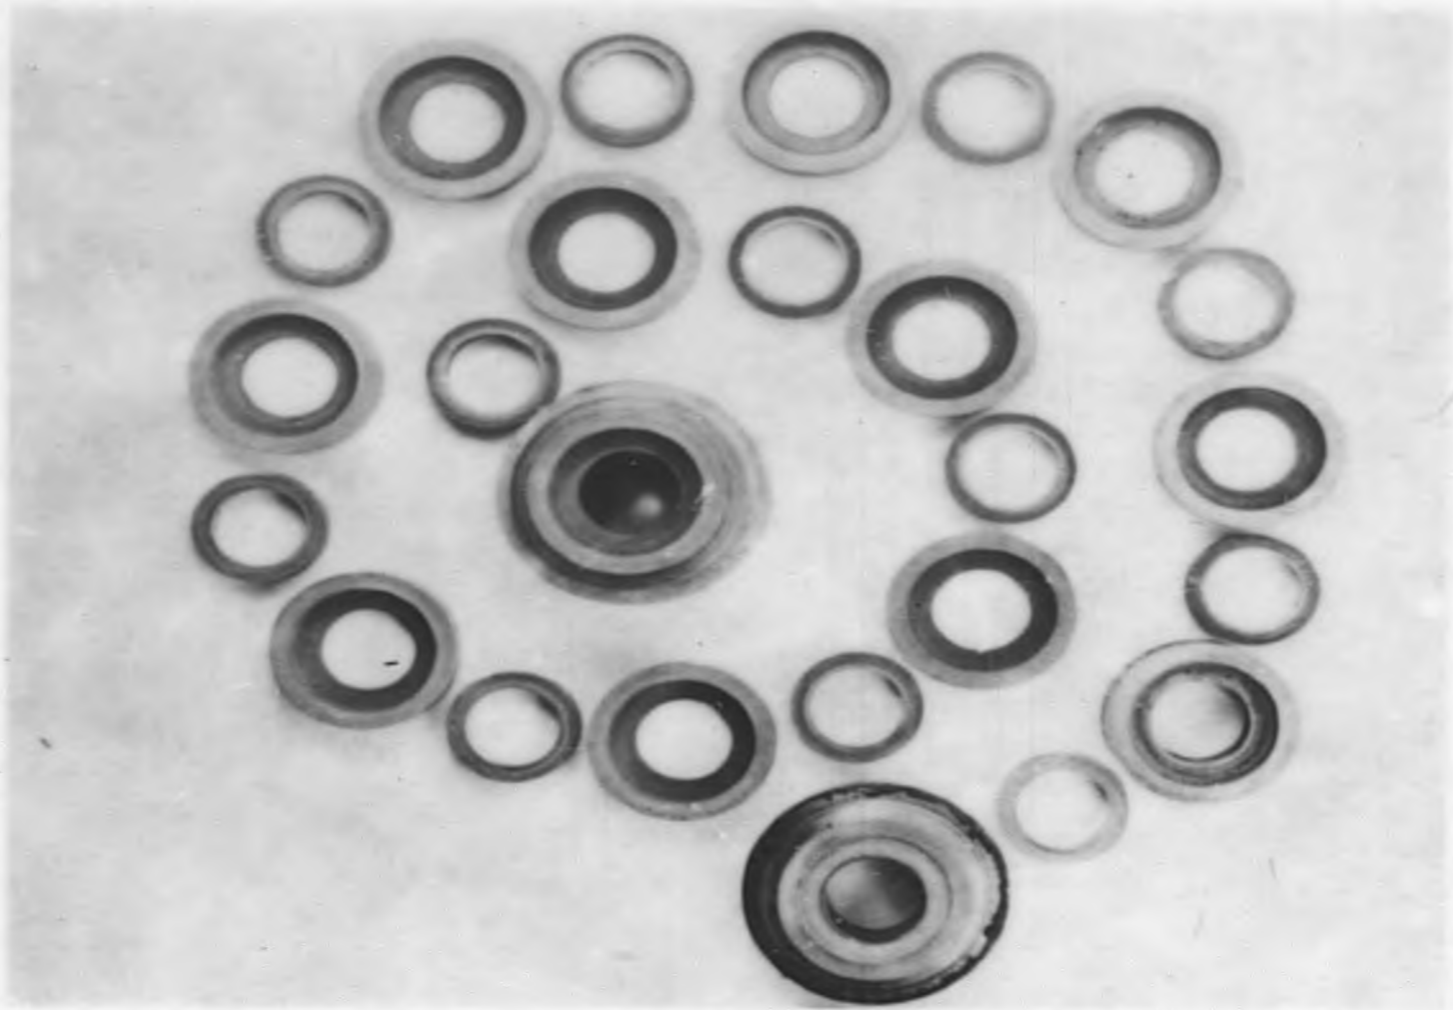
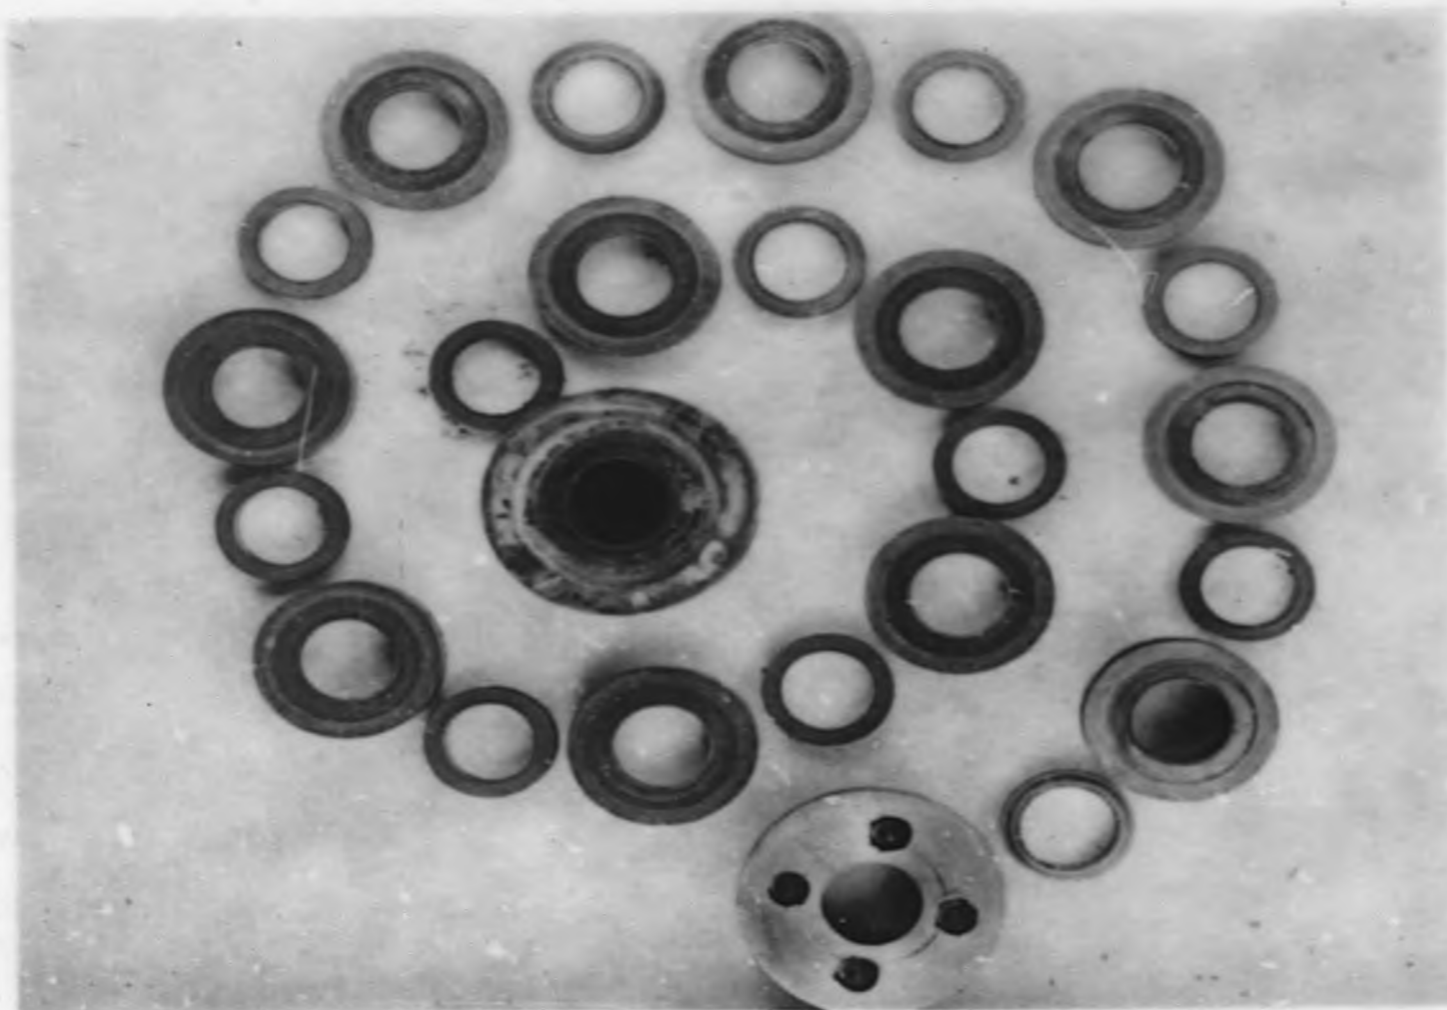
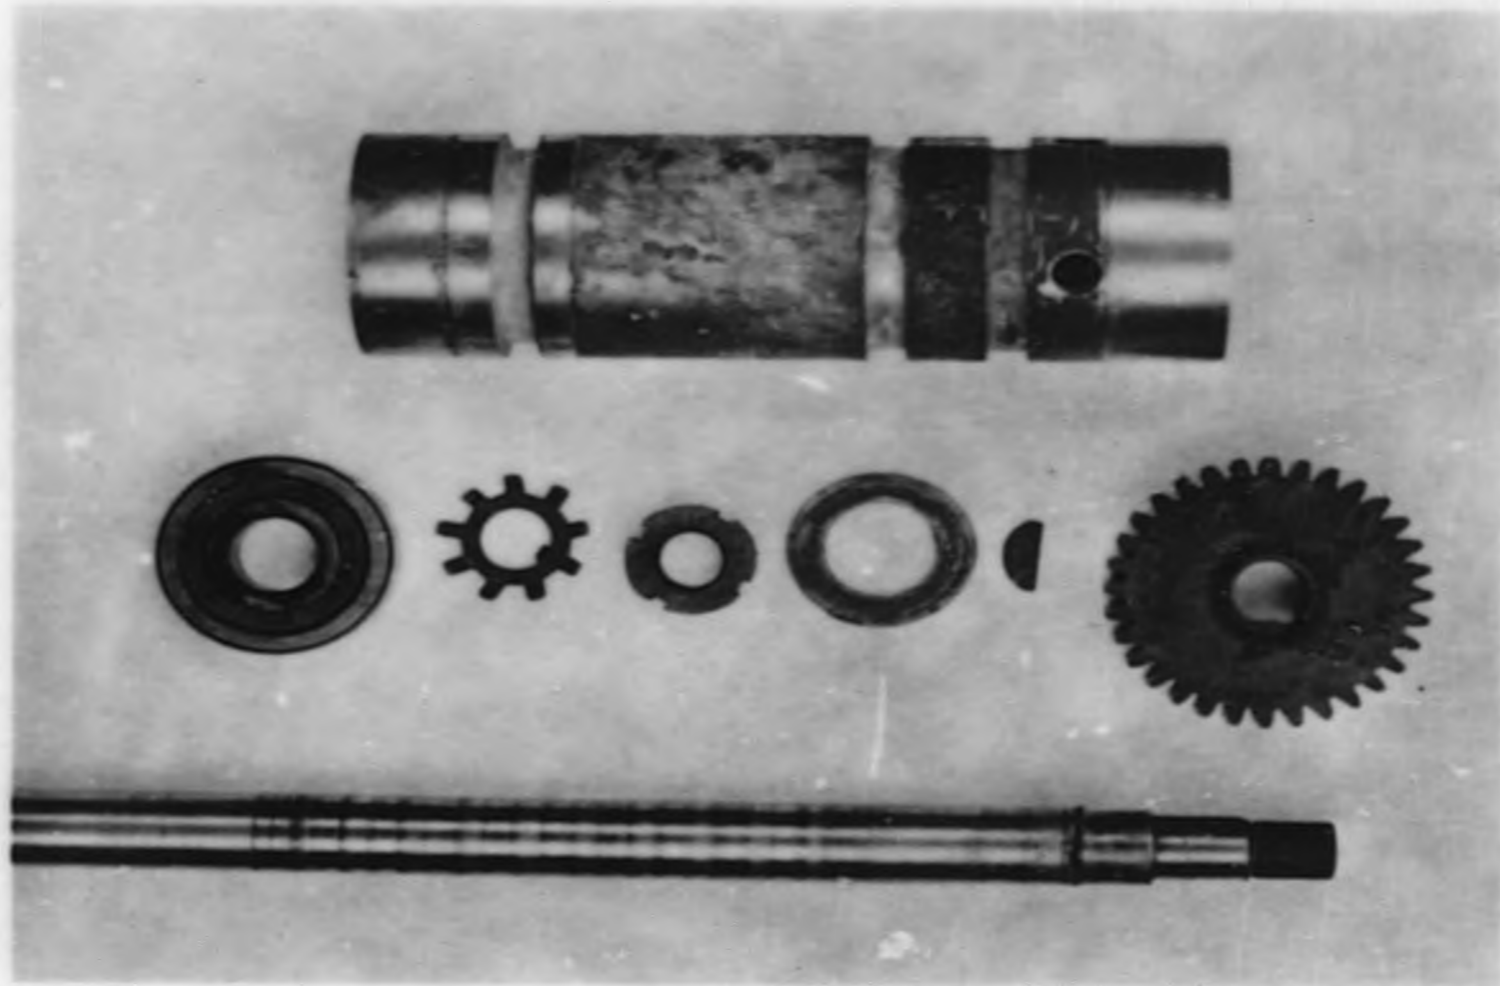
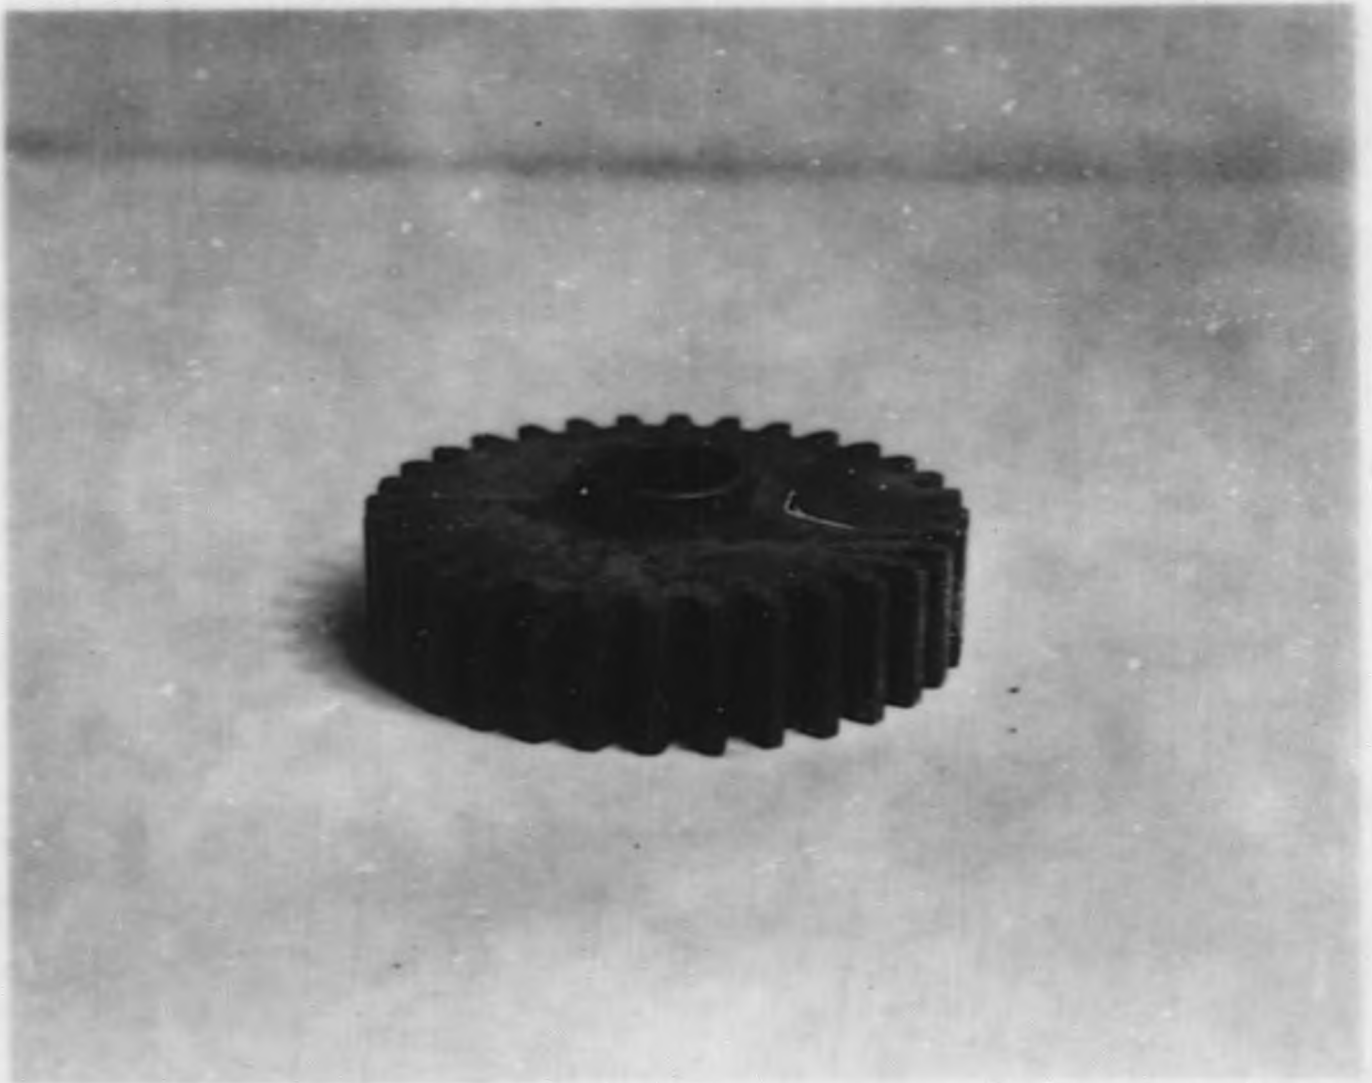
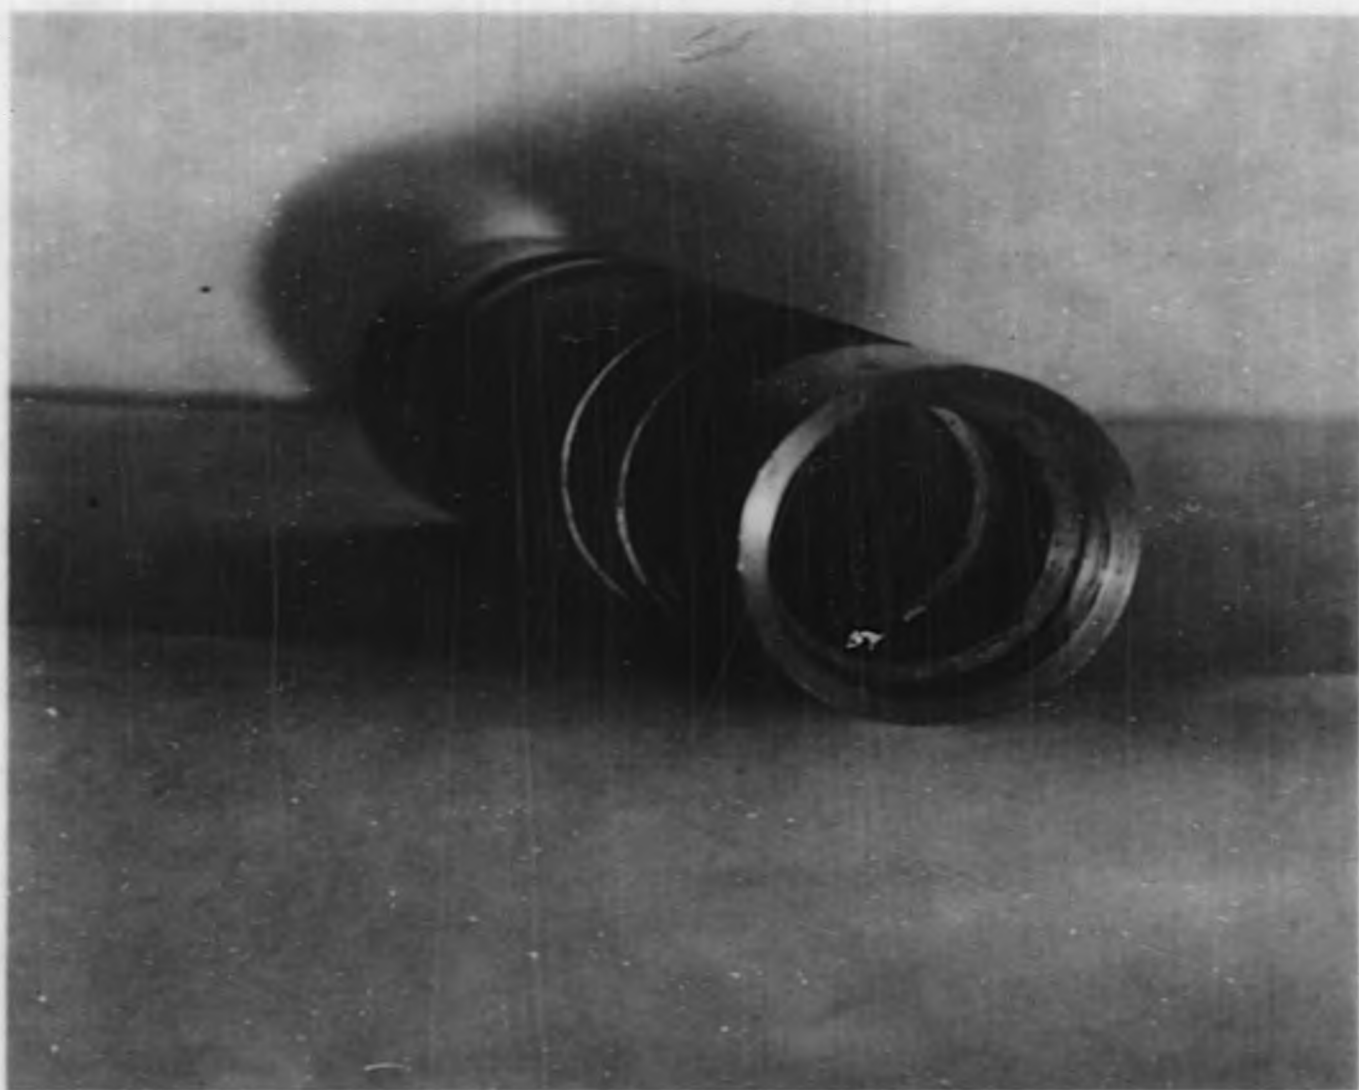
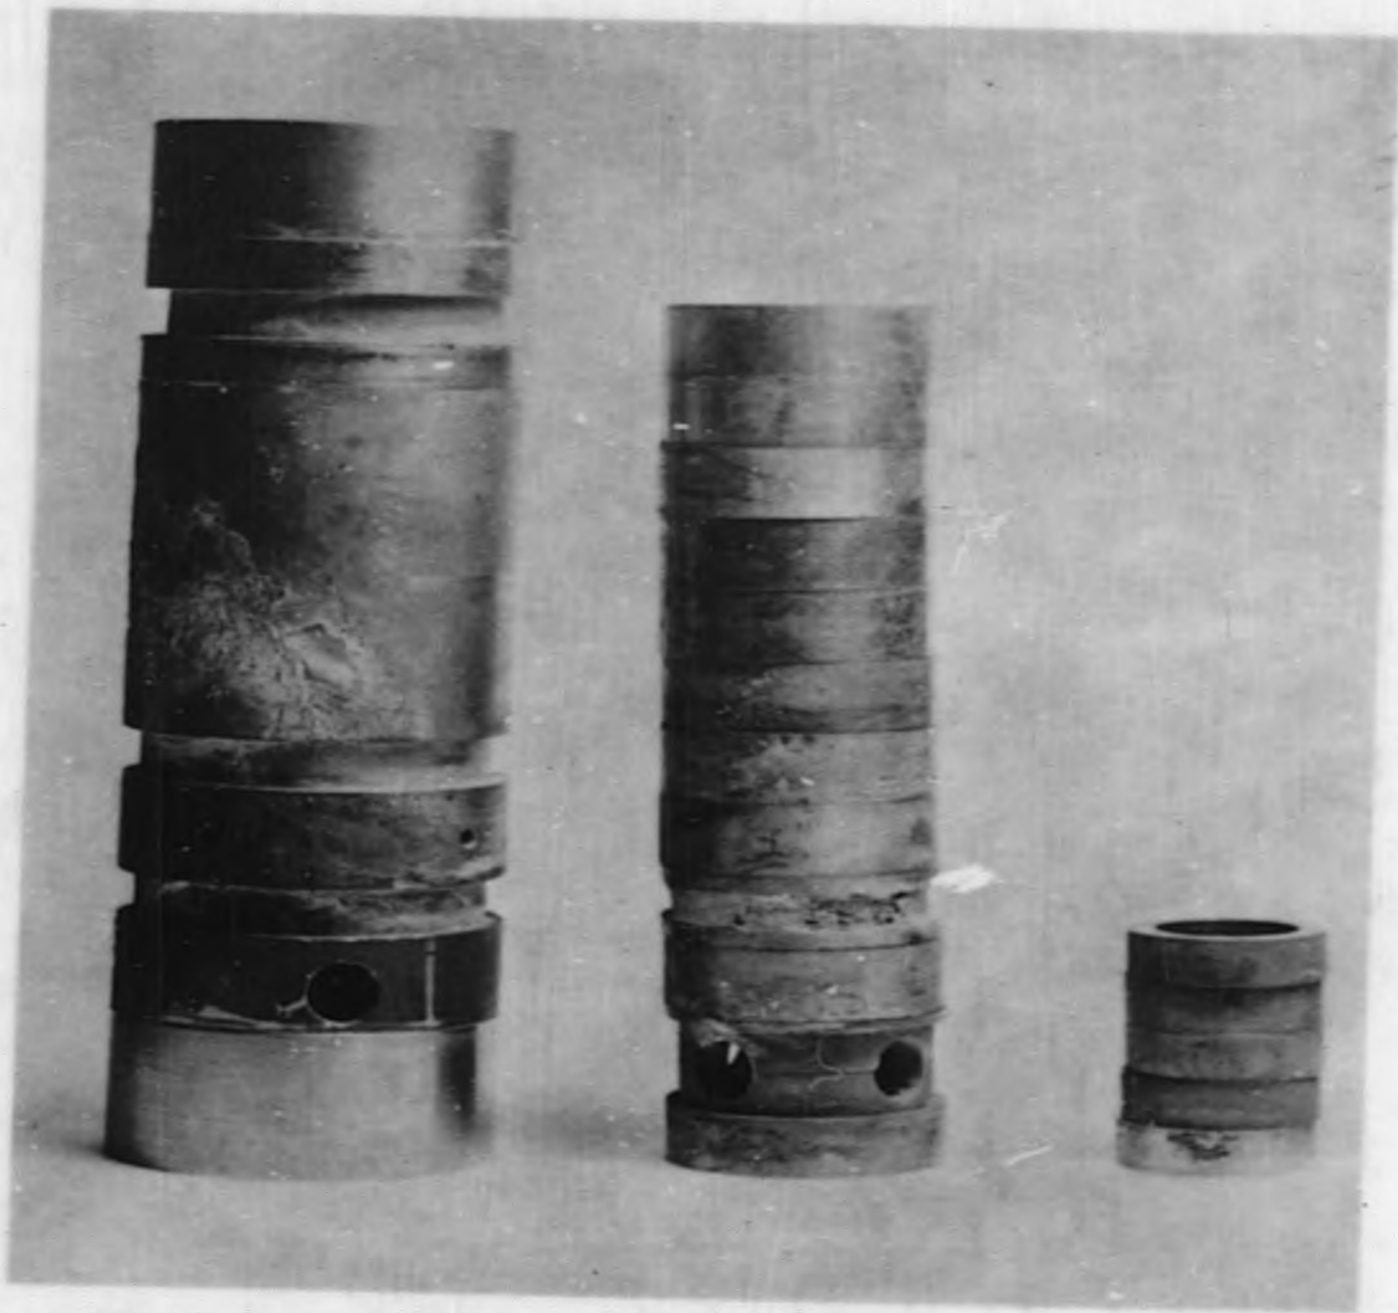
mately 36 #/hr with the rod in operation and 18 #/hr with the rod stationary. The seal ring retainer was tightened on numerous occasions but this only improved the leakage rate for short periods. Because of the inaccessibility of the seal, tightening of this retainer required an extensive dismantling of the drive components.

After 1600 hours of operation on the rig (530 hours with the rod running or 2120 cycles), the seal was disassembled for inspection. Considerable deposits of rust and scale were found on all components in contact with the primary water. The water seal components were stuck in the housing due to scale formation and corrosion. The pinion bearing was very badly worn and had to be replaced. Photographs #4872 to 4879 show the conditions of various parts of the seal and drive after 5 months of operation (1600 hours). The seal was cleaned up and reassembled, but no improvement in the seal leakage rate was apparent.

ORNL High Pressure Water Seal From Control Rod Drive After
5 Months in Use

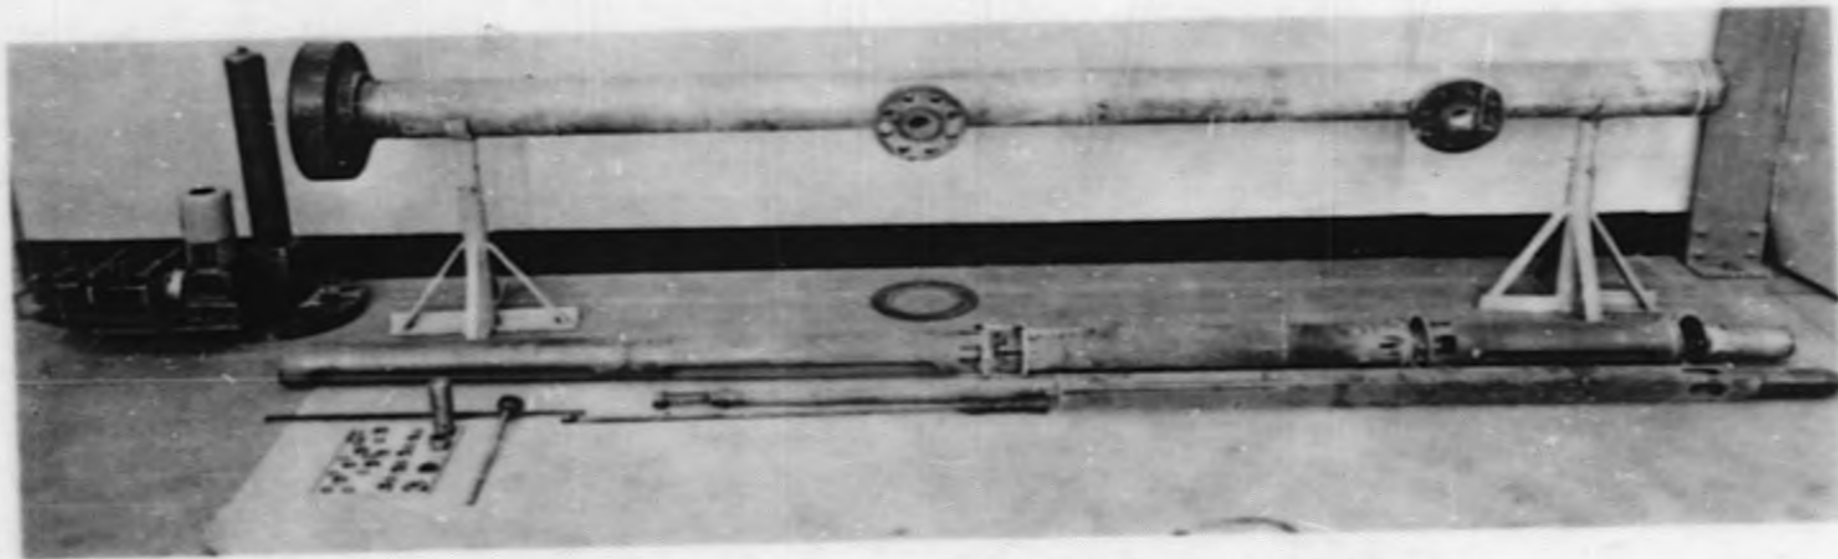
Photo 4928

After a total of 1767 hours of operation (567 with the rod running), the system was shut down and dismantled. At this time, under standard operating conditions, the leakage rate was approximately 24 lbs/hr. Photograph #4928 shows the disassembled control rod, drive, seal and test tank.

Inspection of the various parts after disassembly showed the control rod guide rollers to be practically useless. The adjustable spring mounted roller supports did not maintain their proper position. This lack of accurate guiding on the control rod caused heavy scoring of the dashpot piston and cylinder. A number of the rollers had stuck on their mounting pins resulting in flat spots due to their inability to rotate.

ORNL Control Rod Drive Seal & Test Tank Disassembly

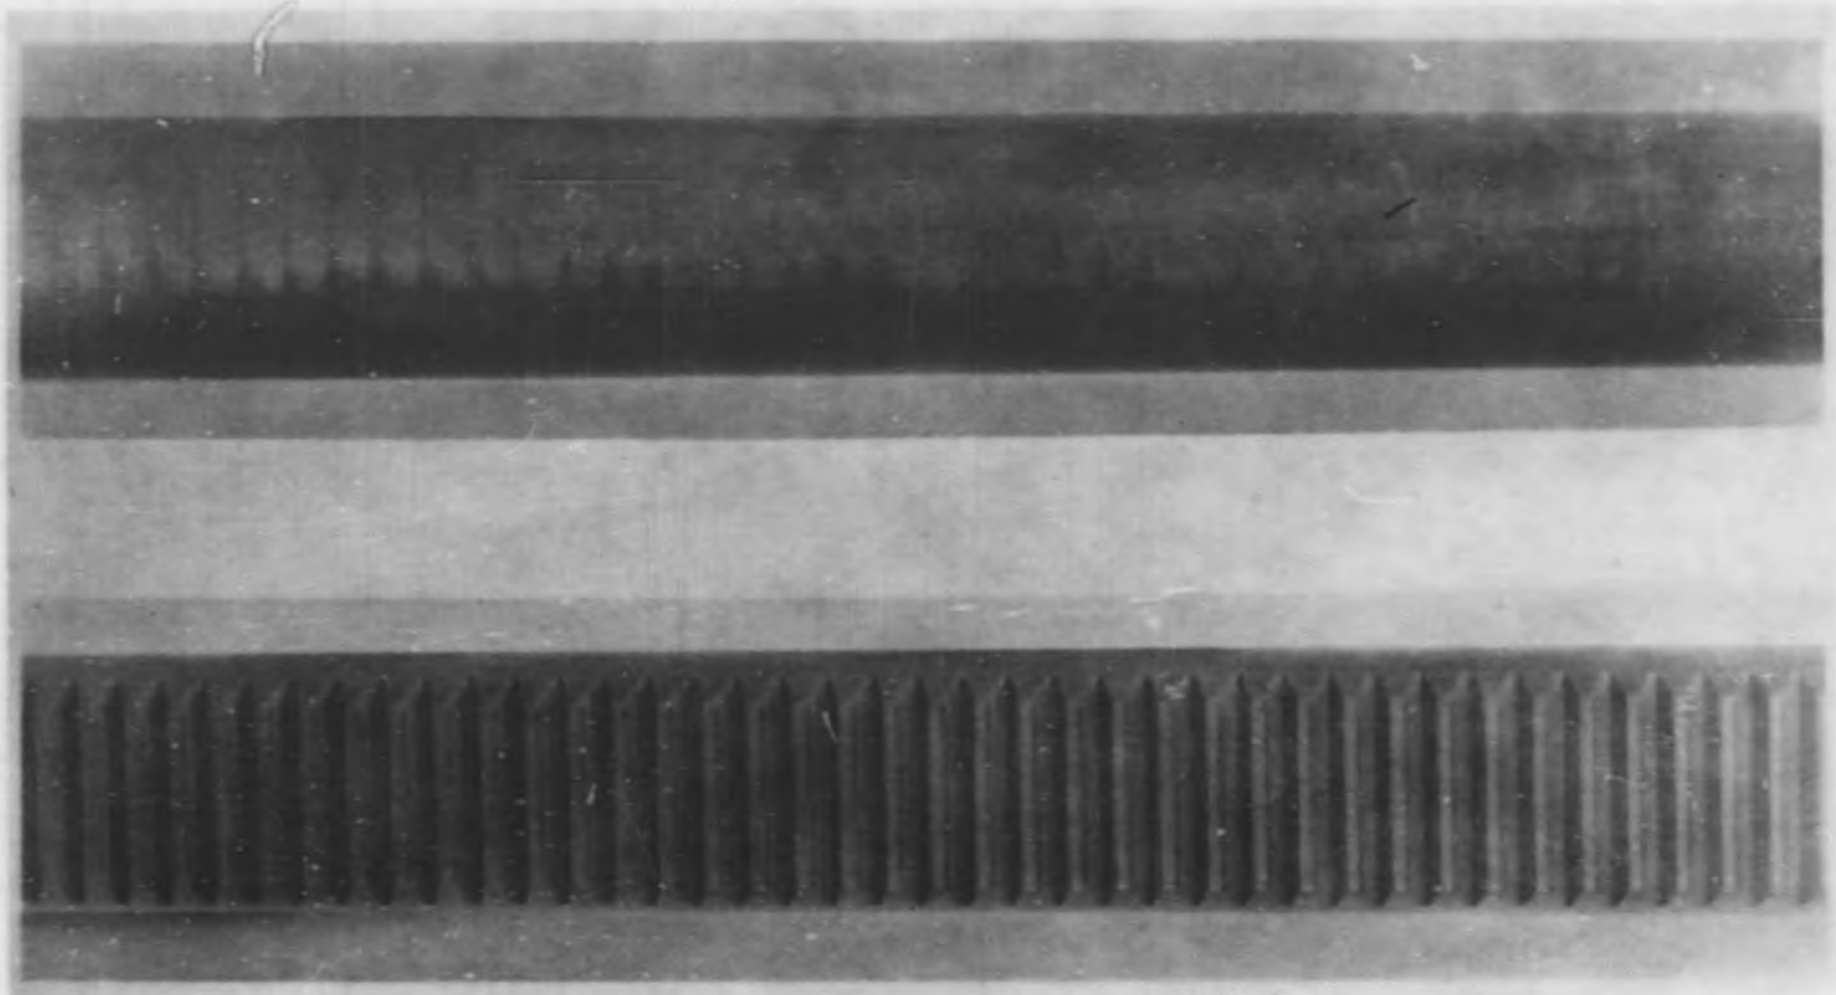
Photo 5126

Single Rig Control Rod Rack Showing Condition of Teeth & Back - Hours of Operation 1035

balls and races of red oxide which was prevalent on all the surfaces in contact with water. The back of the rack showed indication of sliding on the roller. All pinion and rack teeth were in excellent condition.
