APAE Memo 106

CONTROL ROD DRIVE DEVELOPMENT

Issued Aug. 15, 1957

Alco Products, Incorporated
Mechanical Laboratory Report No. 3036

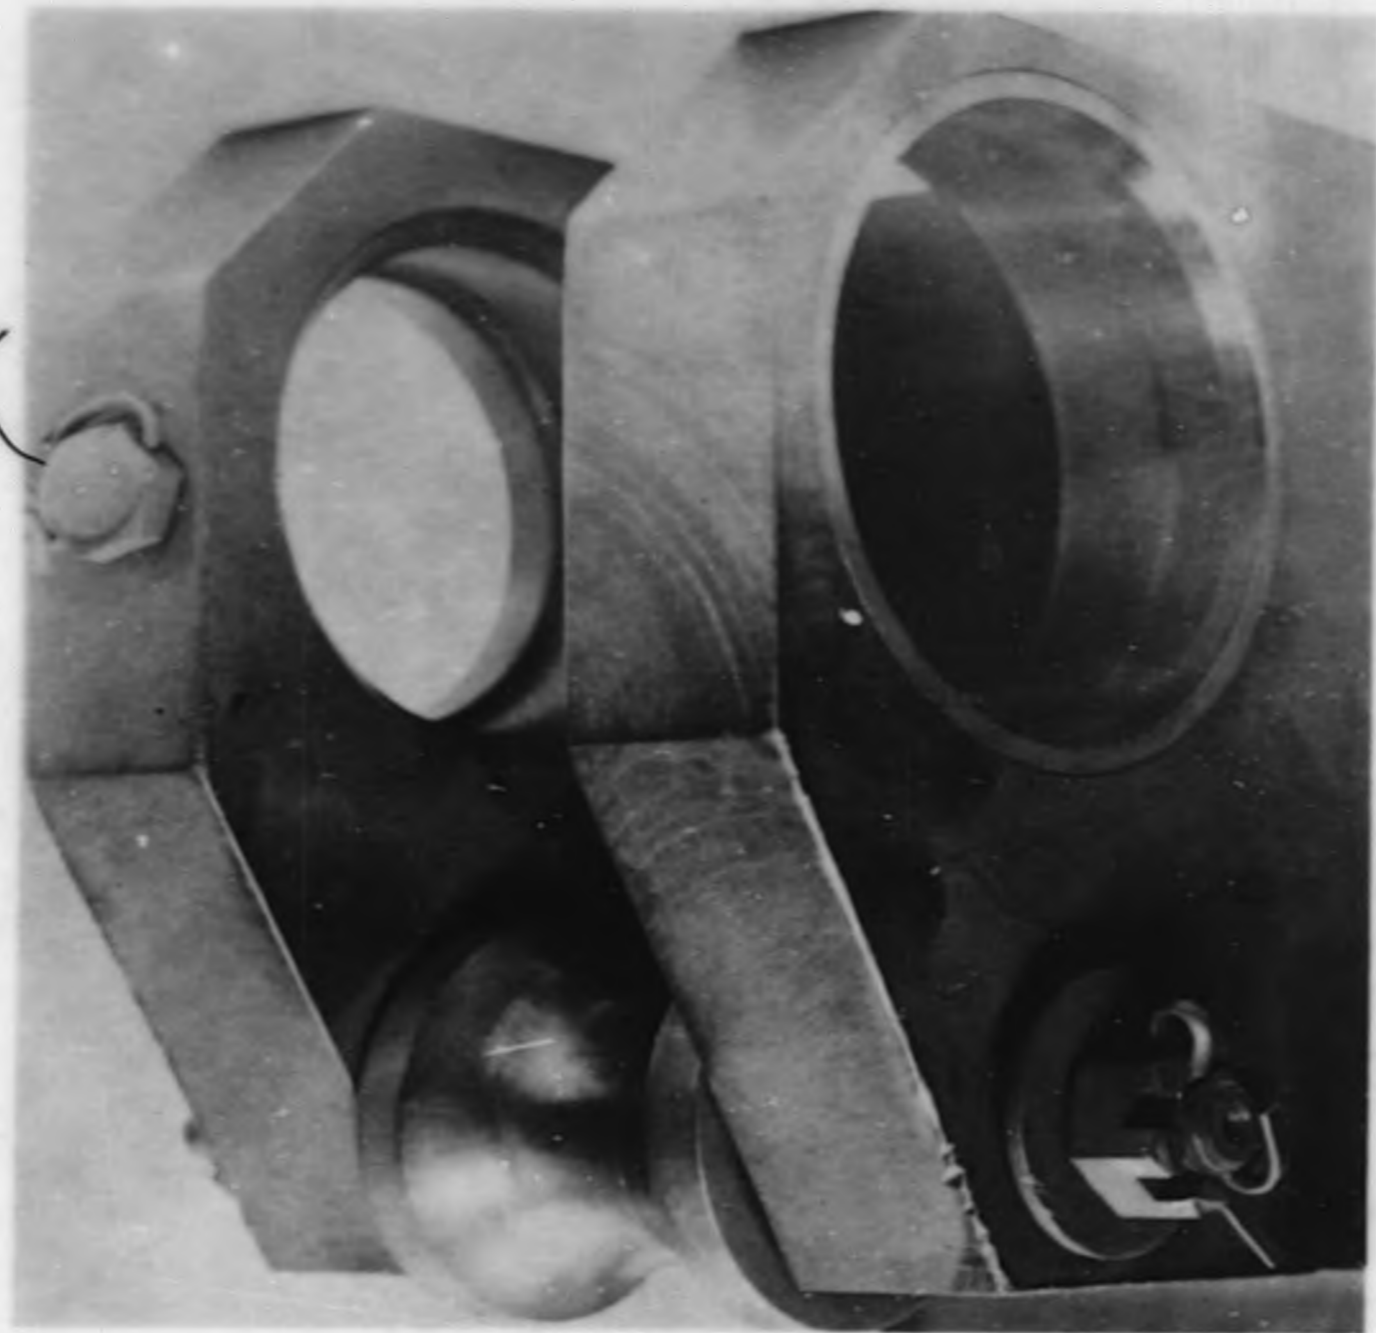
Photo 5129

Single Rig Rack Roller - Hours of Operation 1140

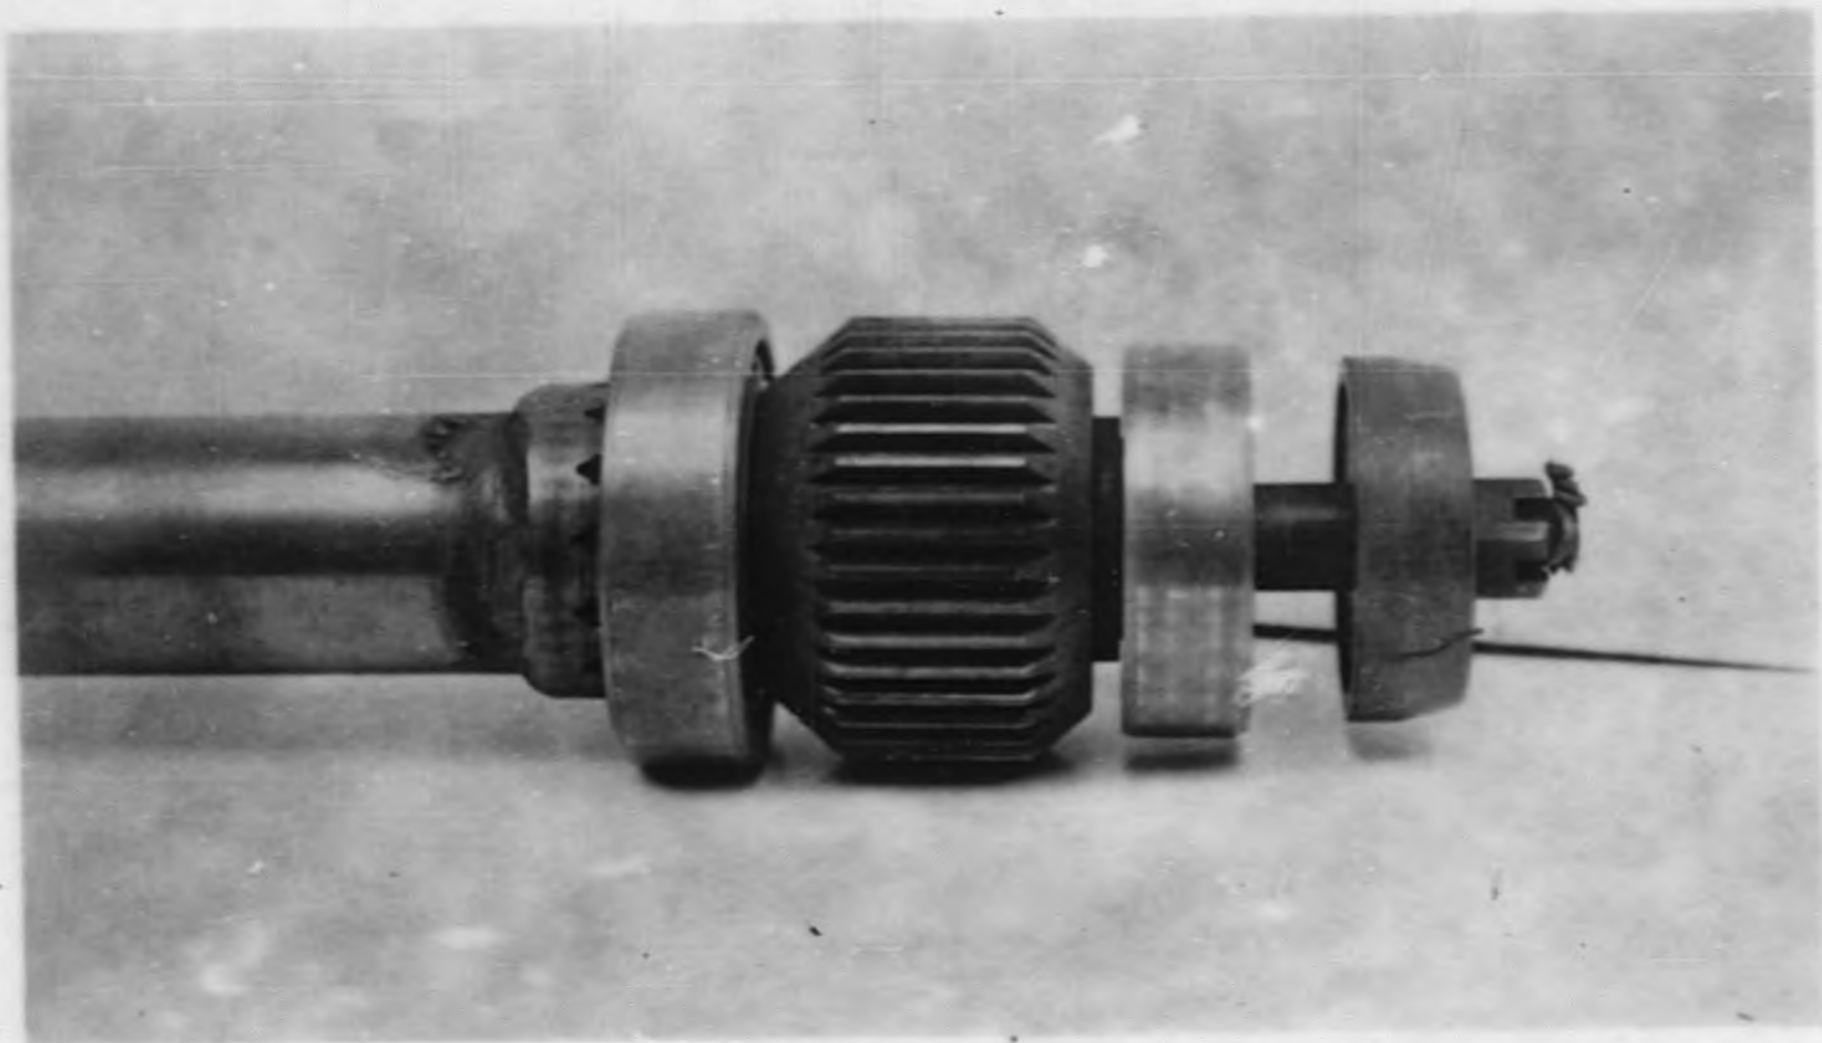
Photo 5132

Single Rig Drive Shaft Showing Condition of Rack Pinion - Hours of Operation 1140

balls and races of red oxide which was prevalent on all the surfaces in contact with water. The back of the rack showed indication of sliding on the roller. All pinion and rack teeth were in excellent condition.

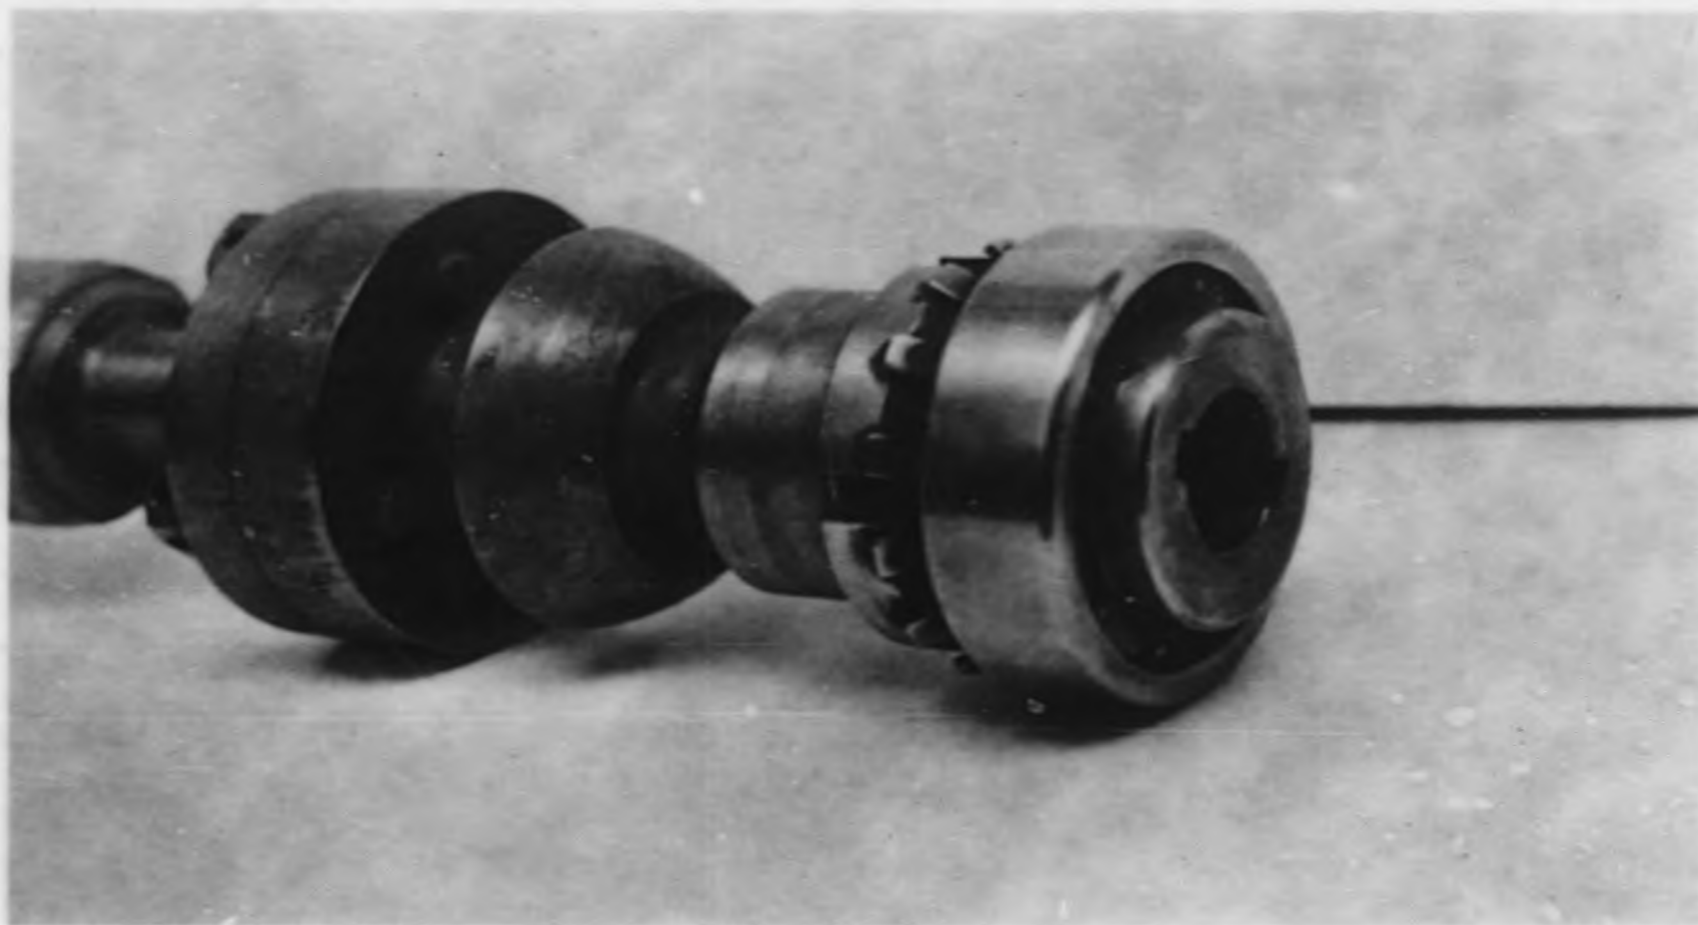
Photo 5133

Single Rig Drive Shaft Showing Condition of Valve - Hours of Operation 1140

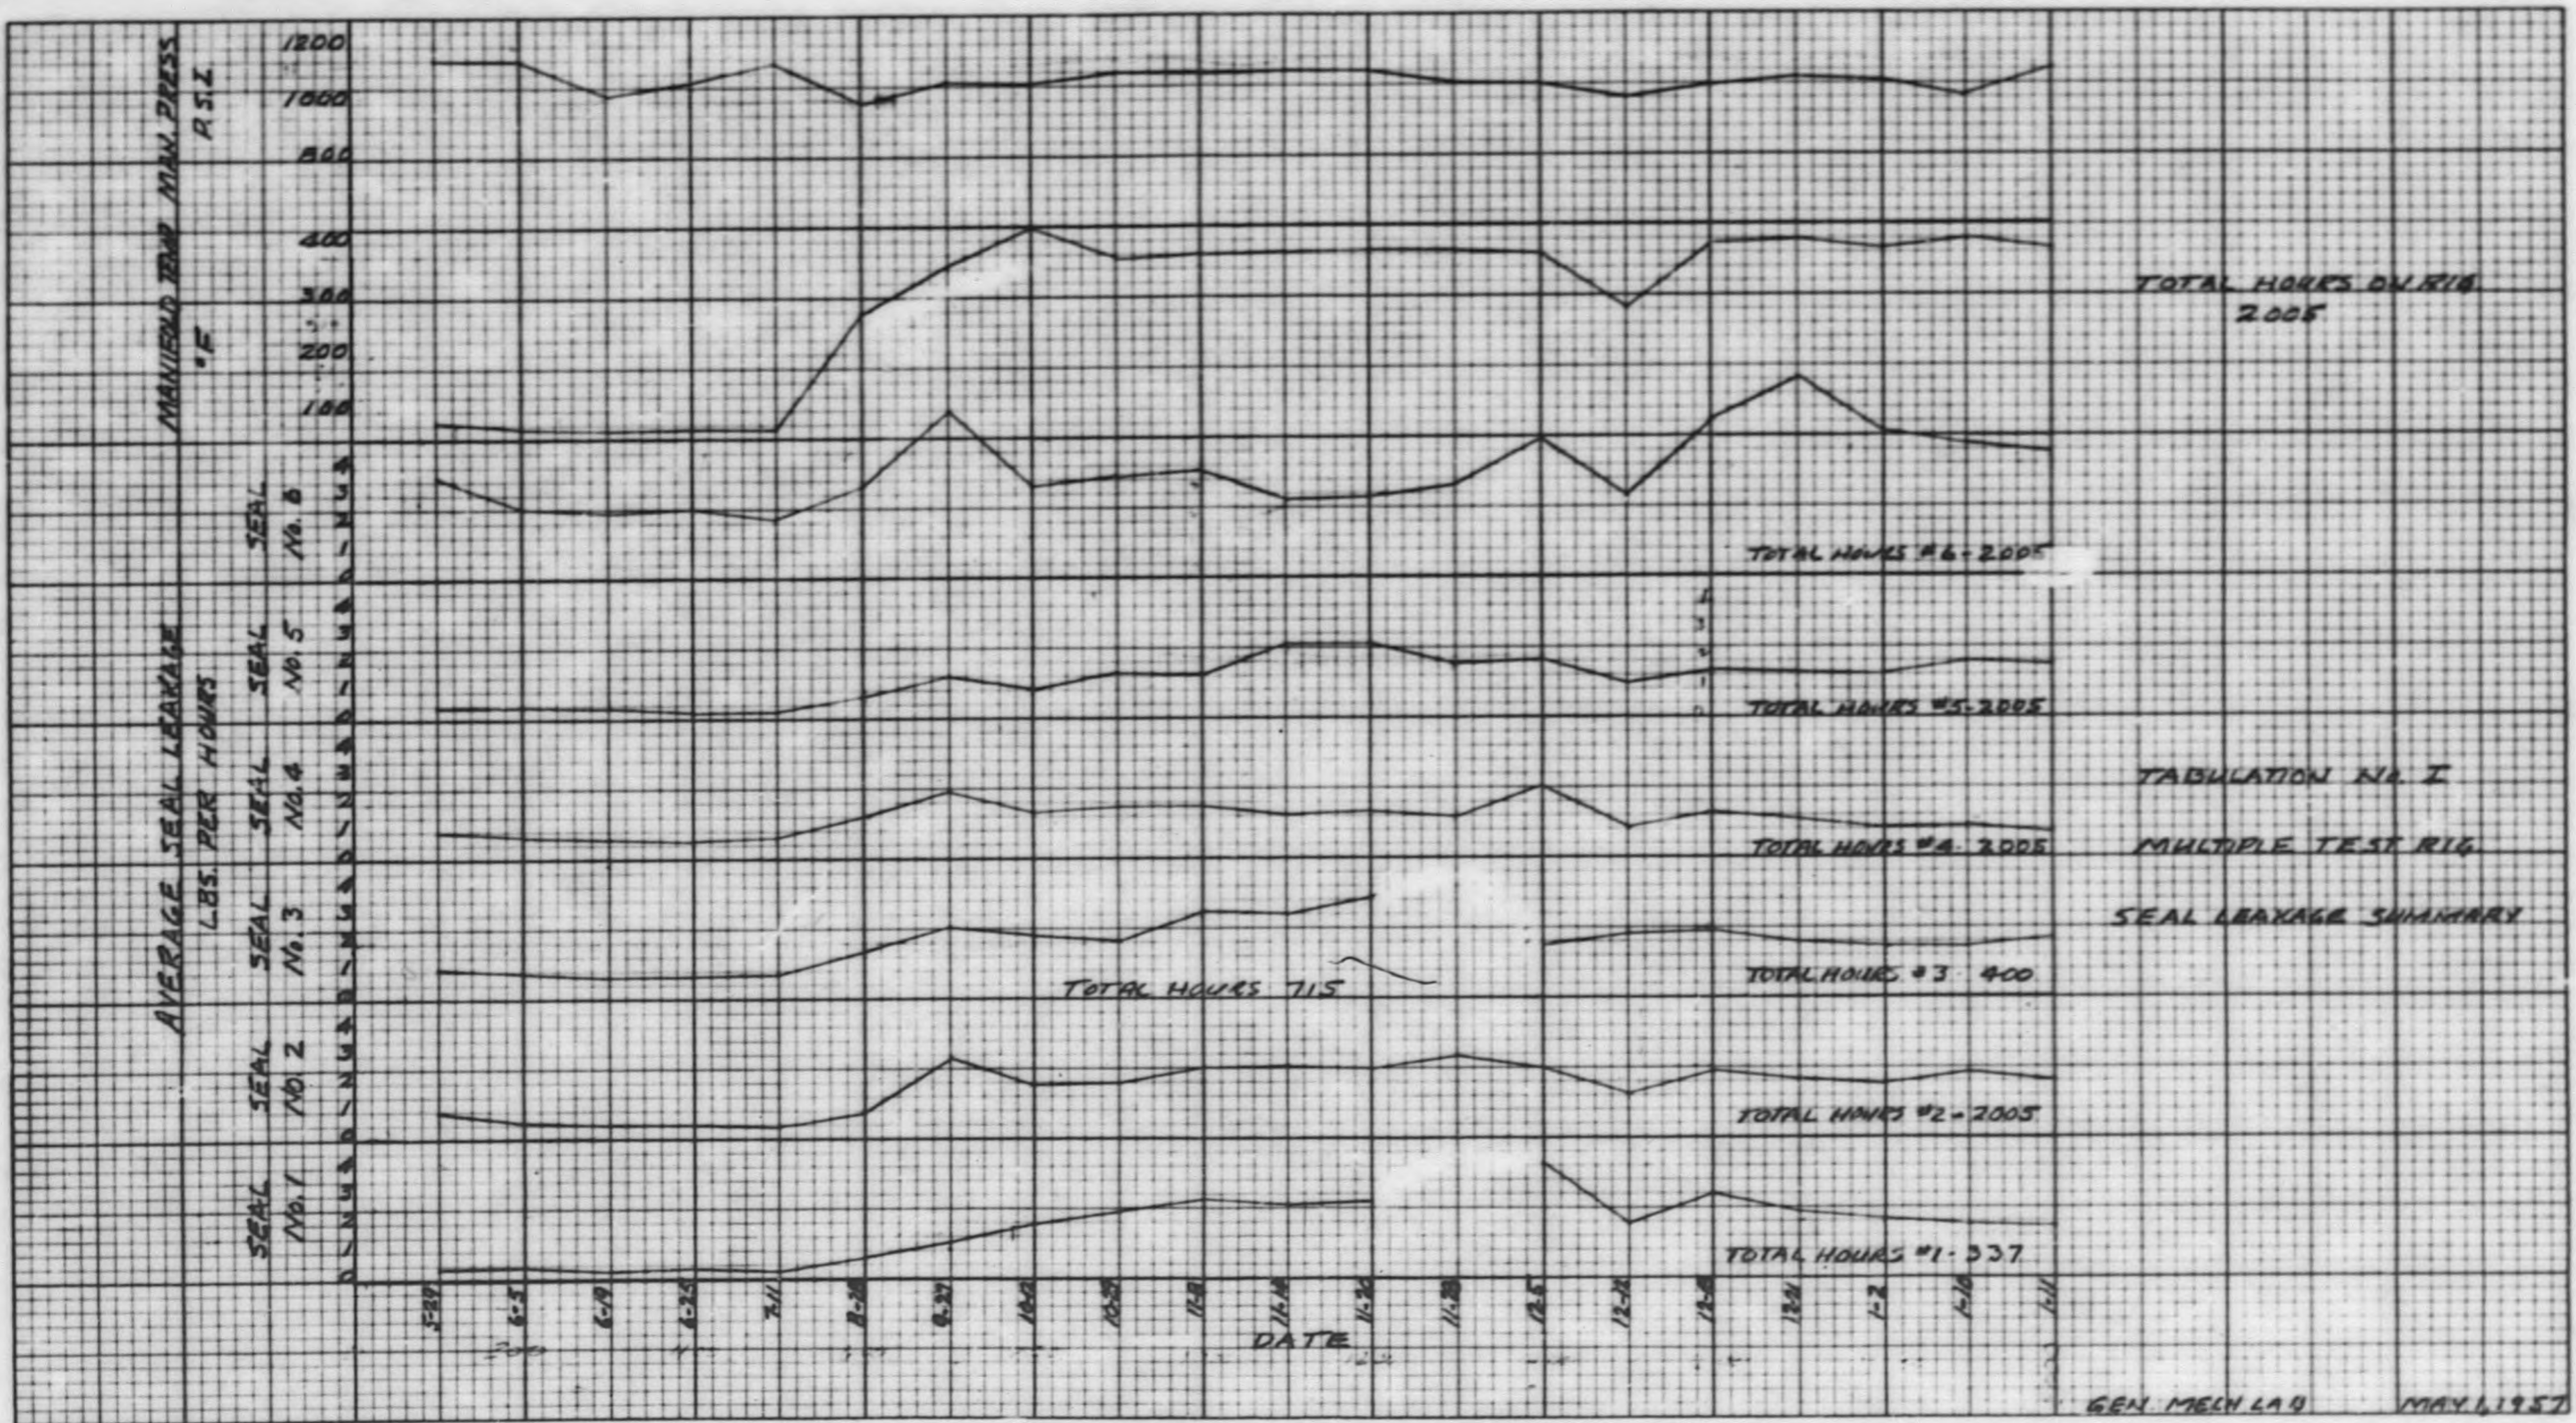
Fig. 3

The number 6 seal was dismantled to check for misassembly, but none could be found. The comparatively high leakage rate was attributed to the ring and shaft clearance being on the upper limits. The seal was cleaned and reassembled and the high leakage rate remained constant. The graph (Fig. 3) shows the seal leakage over a long period.

Graph of Seal Leakage

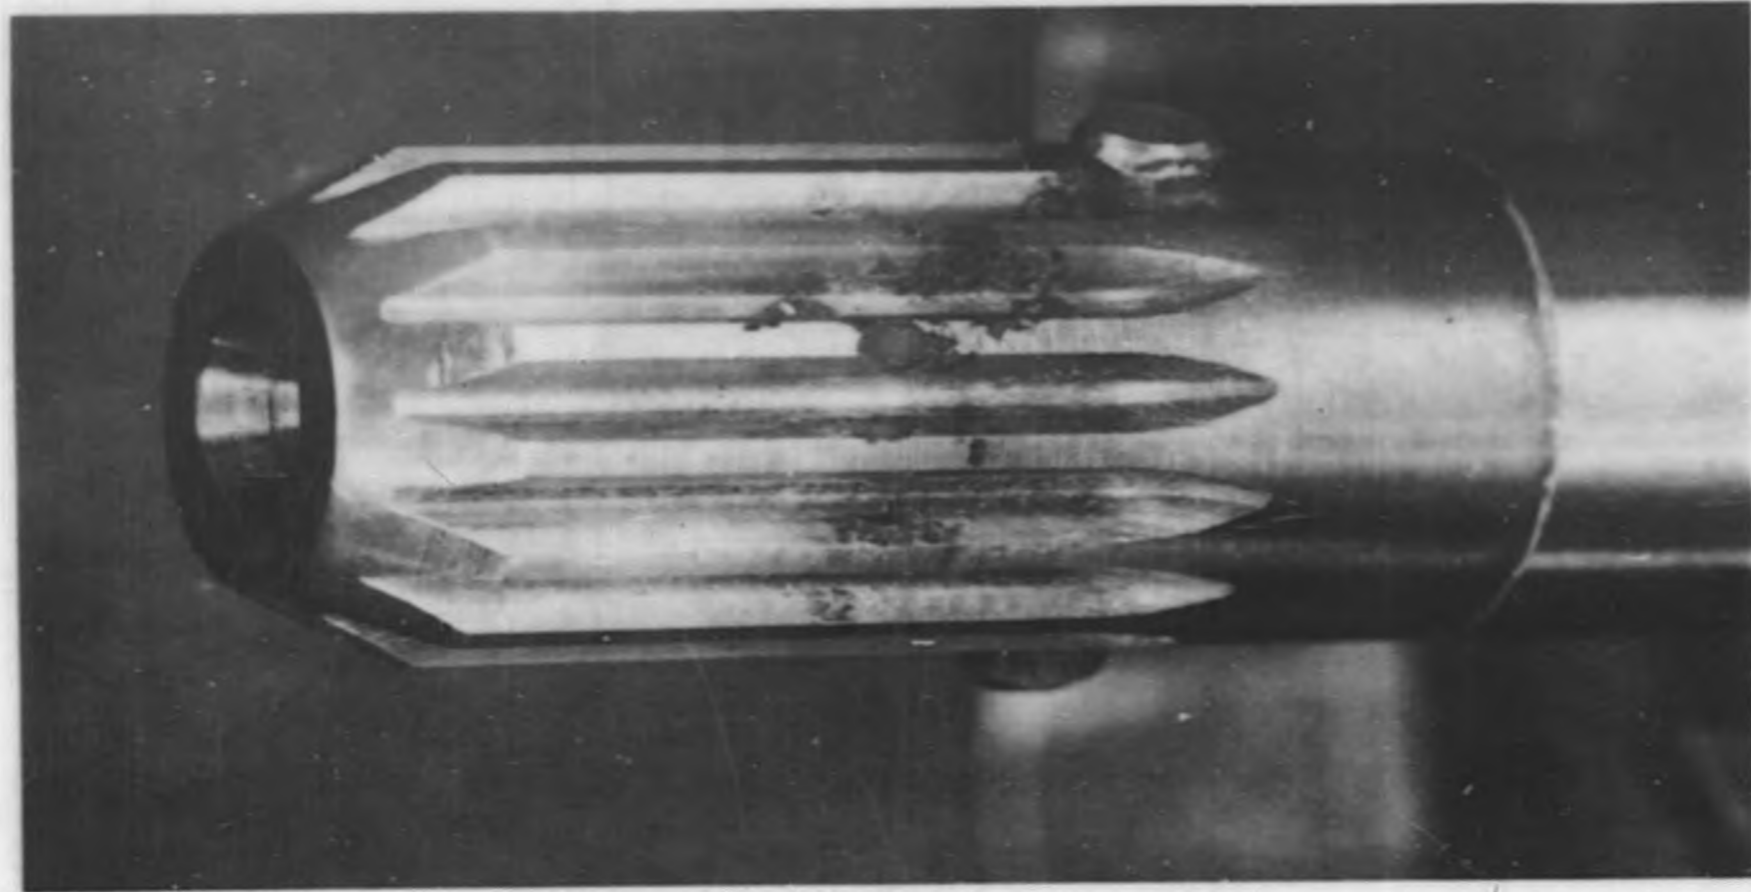
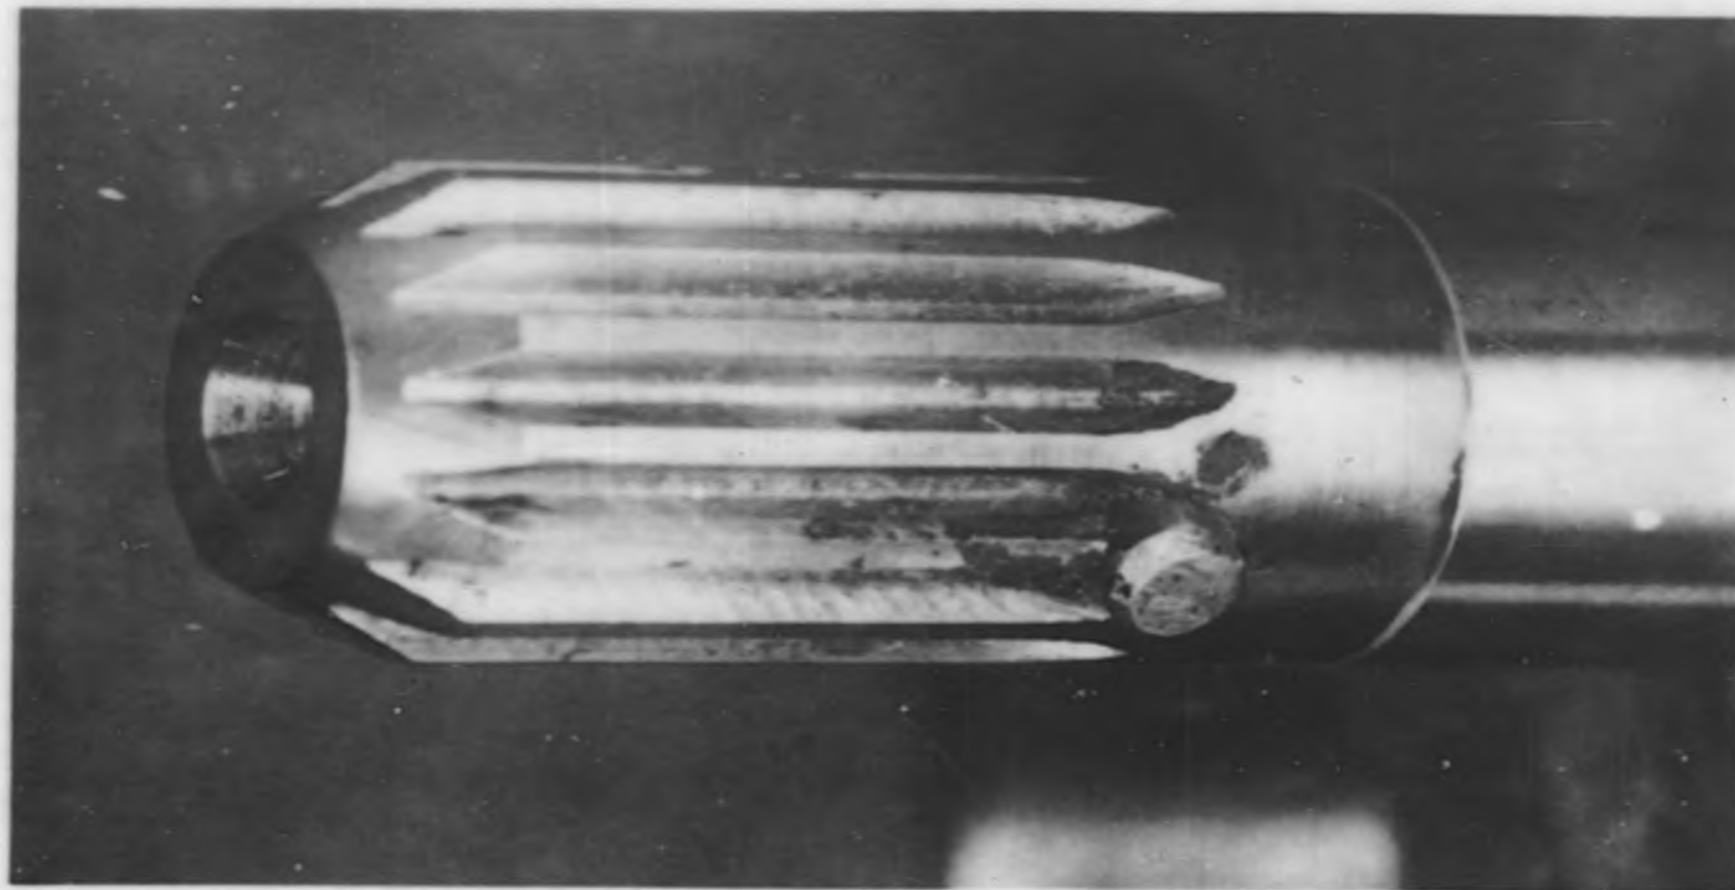
The APPR-1 drives were removed from the criticality facility and installed on the multiple rig for leakage tests, before being shipped to Fort Belvoir. The spline end of the seal shafts were badly pitted. Photos 5153 and 5154 show this condition. Because of the presence of this corrosion it was decided to replace all APPR-1 seal shafts with 17-4 PH Stainless Steel. The corroded shafts were made of 440C annealed stainless steel. 17-4 PH has superior corrosion resistance as well as better physical properties.

Corroosion of Spline End of Water Seal Shaft

Corrosion of Spline End of Water Seal Shaft
