**SLOPE AND BANK
EROSIONAL STABILITY OF THE
CANONSBURG, PENNSYLVANIA,
UMTRA DISPOSAL SITE**

December 1994

Prepared for
U.S. Department of Energy
UMTRA Project Office
Albuquerque, New Mexico

Prepared by
Jacobs Engineering Group Inc.
Albuquerque, New Mexico

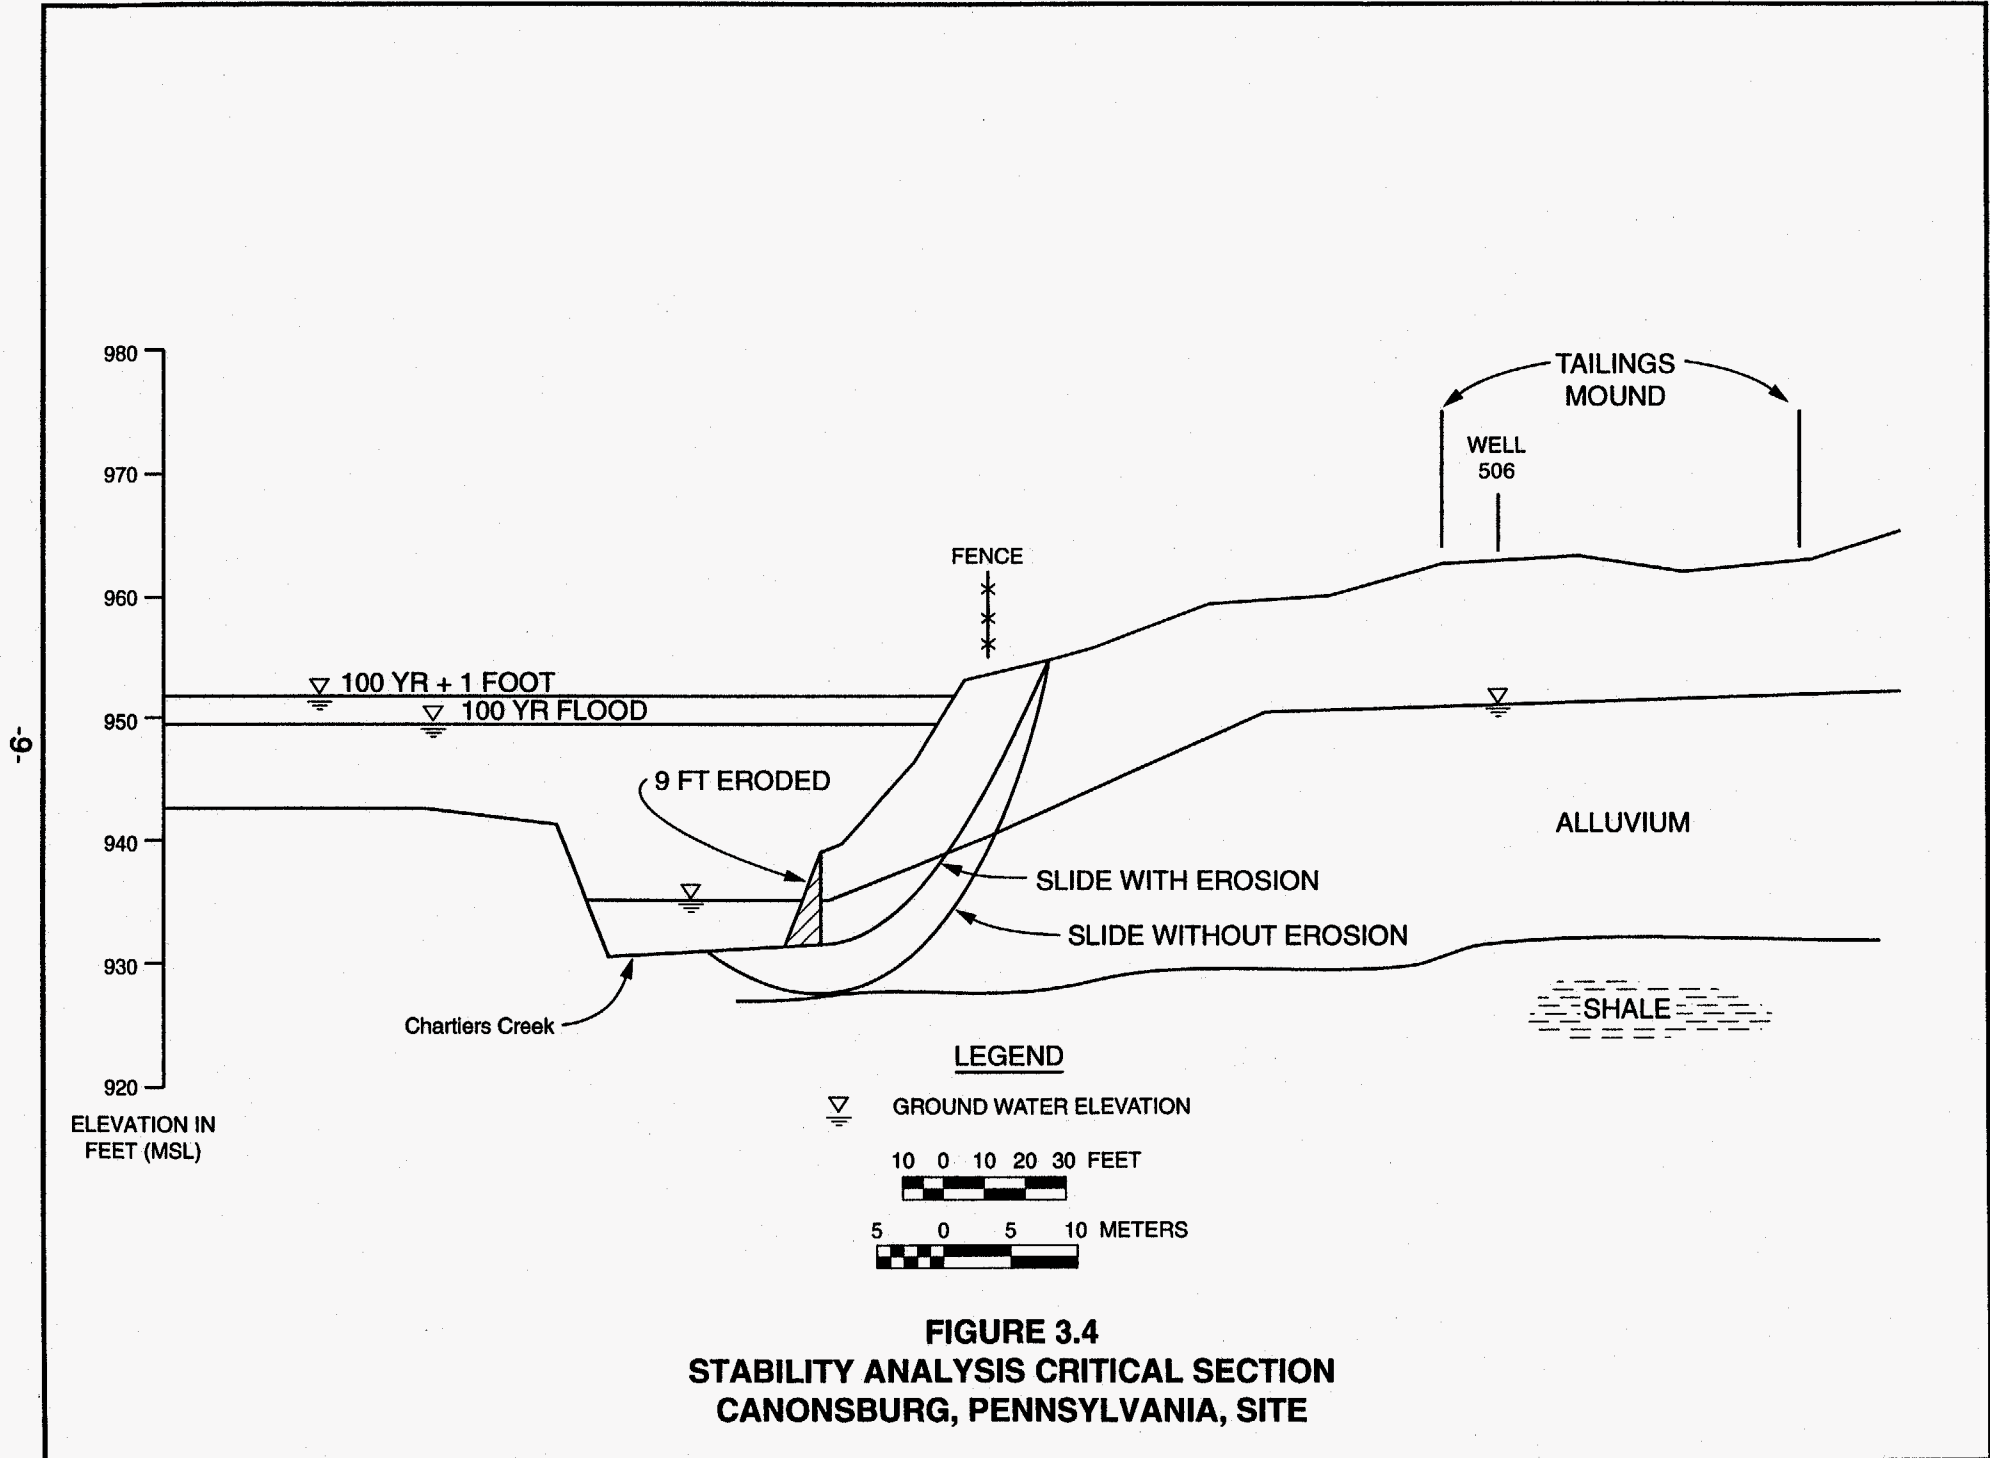
The FEMA 100-year-flood level and the statutory level of 100 years plus 1.0 ft is plotted on the critical section included in Figure 3.4. As can be seen from this section, both the 100-year-flood elevation of 949.6 ft and the statutory level of 950.6 ft do not exceed the banks of the existing Chartiers Creek channel, and would not even reach the perimeter fence along the west side of the Canonsburg UMTRA site. Review of the Canonsburg as-built site grading plan (MK-Ferguson Company, 1986b) indicates that no RRM is affected by 100-year flooding in areas A, B, the residential area, or the industrial area (i.e., all of the site west of Strabane Avenue). Review of as-built grading in area C (east of Strabane Avenue) indicates most of this area would be under water during a 100-year flood, but area C does not contain RRM that is vulnerable to removal by surface erosion.

Using the actual field geometry along critical section A (surveyed by Mounts Engineering Company in July 1994) and assuming that a wedge of soil 9 ft wide at its base is eroded from the bank, the STABL5 program (Carpenter, 1986) was used to determine the location of likely failure surfaces that would be generated. The minimum factor of safety surface is plotted in Figure 3.4.

The upper end of the slide mass is 82 ft from the centerline of Chartiers Creek and is approximately 100 ft from the toe of the VP mound (Figure 3.4). The fence would be damaged by the slide movement, and should be easily spotted by prelicensing inspection personnel.

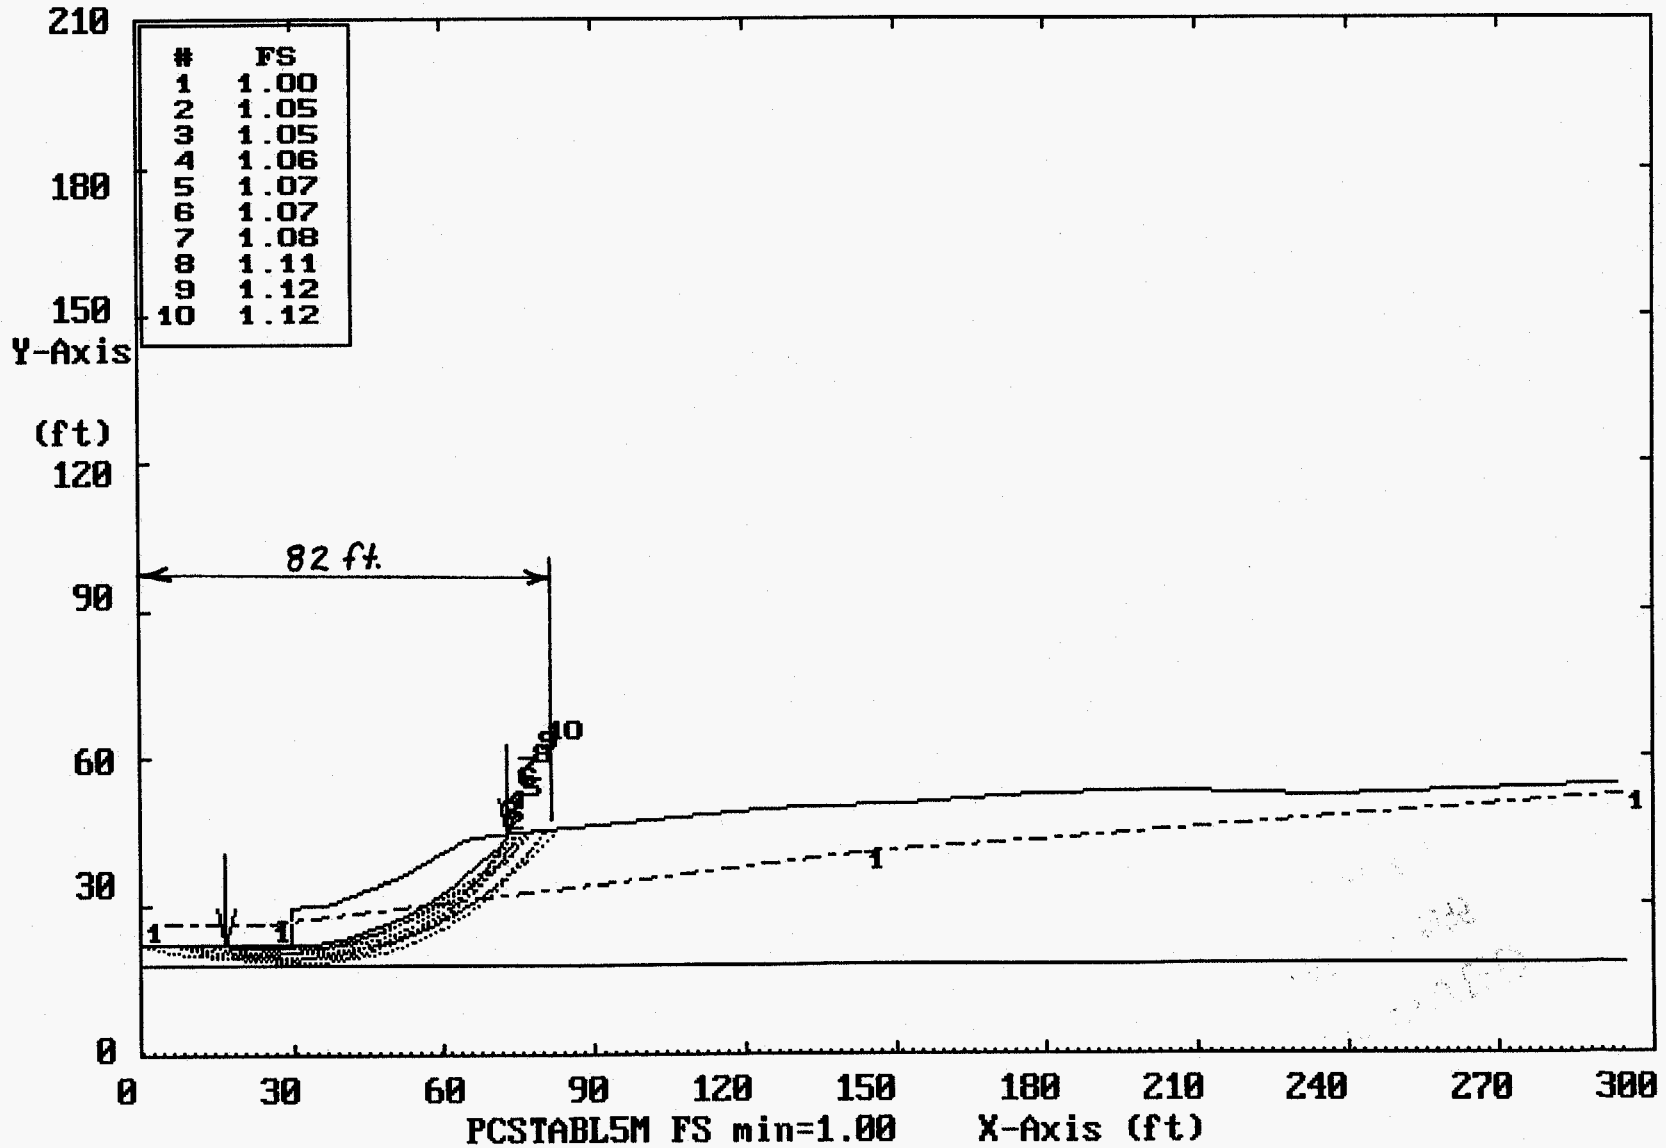
Canonsburg, Mounts, Section A w/erosion Soil 26.0 deg & 120 pcf, EQ = 0.0g
 Ten Most Critical. A:CANON.PLT By: John Lommler 12-09-94 8:37am

Circle Center At X = 25.9 ; Y = 80.7 and Radius, 59.3

*** 1.000 ***
