ANL/ESD/TM-60

Initial Building Investigations at Aberdeen Proving Ground, Maryland: Building E5190

by K.L. Brubaker, J.M. Dougherty, and C. Tome

October 1993

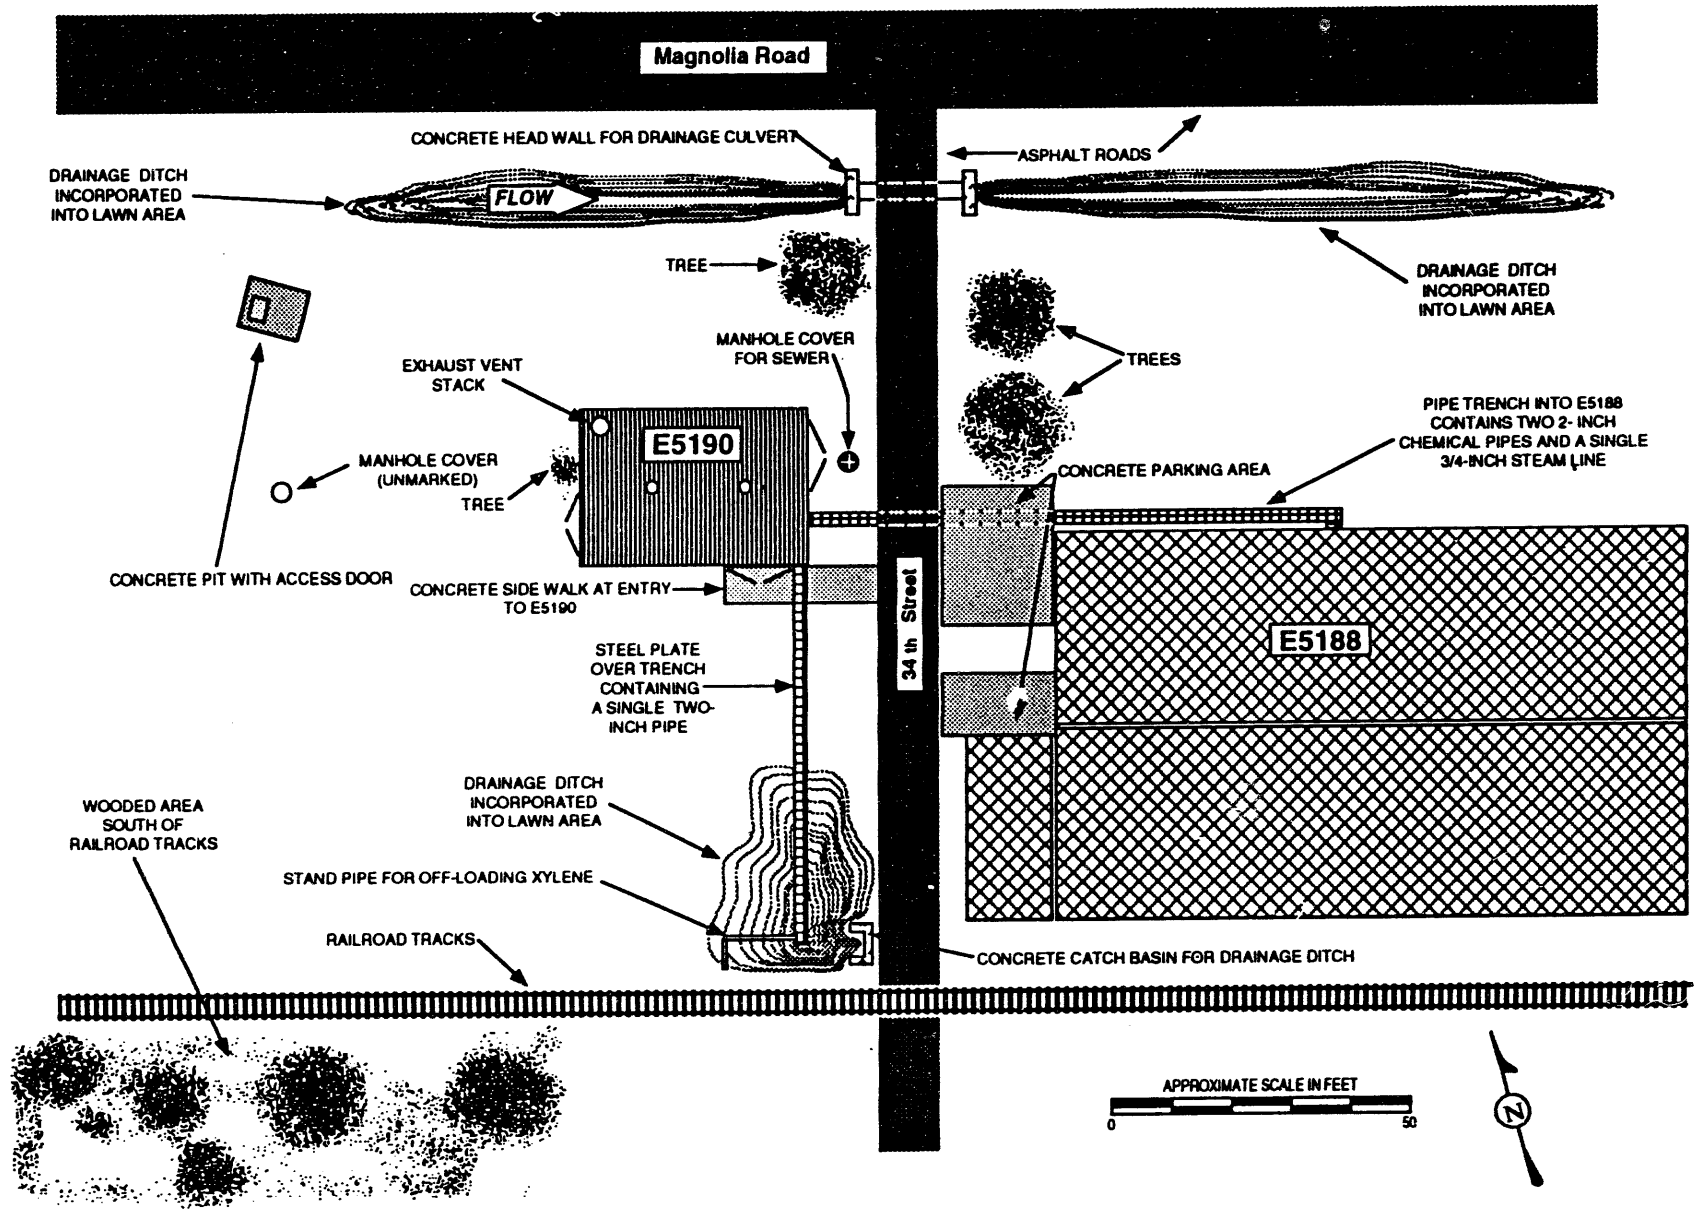
FIGURE 4 Building E5190 Site Plan

A pipe trench connects Building E5190 with the railroad siding directly to the south of the building (see Figure 4). Another pipe trench connects the building with the adjacent, main PWP production building (Building E5188). These trenches contain pipes that were used for pumping xylene from tank cars at the siding into Building E5190 and from Building E5190 to Building E5188.

Building E5190 is connected to the PWP production Building E5188 by an underground, open-top, concrete, pipe trench (Figure 4). This trench extends from the east side of Building E5190 for approximately 80 ft before reaching Building E5188. It runs parallel to the north side of E5188 for an unmeasured distance before turning and entering Building E5188 from the north. The trench still houses three pipes, two 2-in. pipes that were used to transport xylene into and possibly out of E5188 and a single 1-1/2-in. insulated steam line to deliver steam to the heating unit in Building E5190. This steam line may also have ensured that the trench did not become frozen or icebound in the winter months. Building E5190 is also connected to a railroad siding approximately 100 ft south of the building by a similar pipe trench (Figure 4). This trench contains a single, 2-in. pipe used for off-loading xylene from railroad tank cars. The pipe trenches are constructed of approximately 3-in.-thick cast-in-place concrete. The interior dimensions of these trenches are as follows: east-west trench 16 in. wide \times 18 in. deep and north-south trench 12 in. wide \times 18 in. deep. In low areas within the trenches, a thick layer of silt covers the bottom, and in some of the level areas, the trenches contained standing water. The pipe trenches are covered with removable 1/4-in. diamond-plate steel panels, each about 4 ft long.

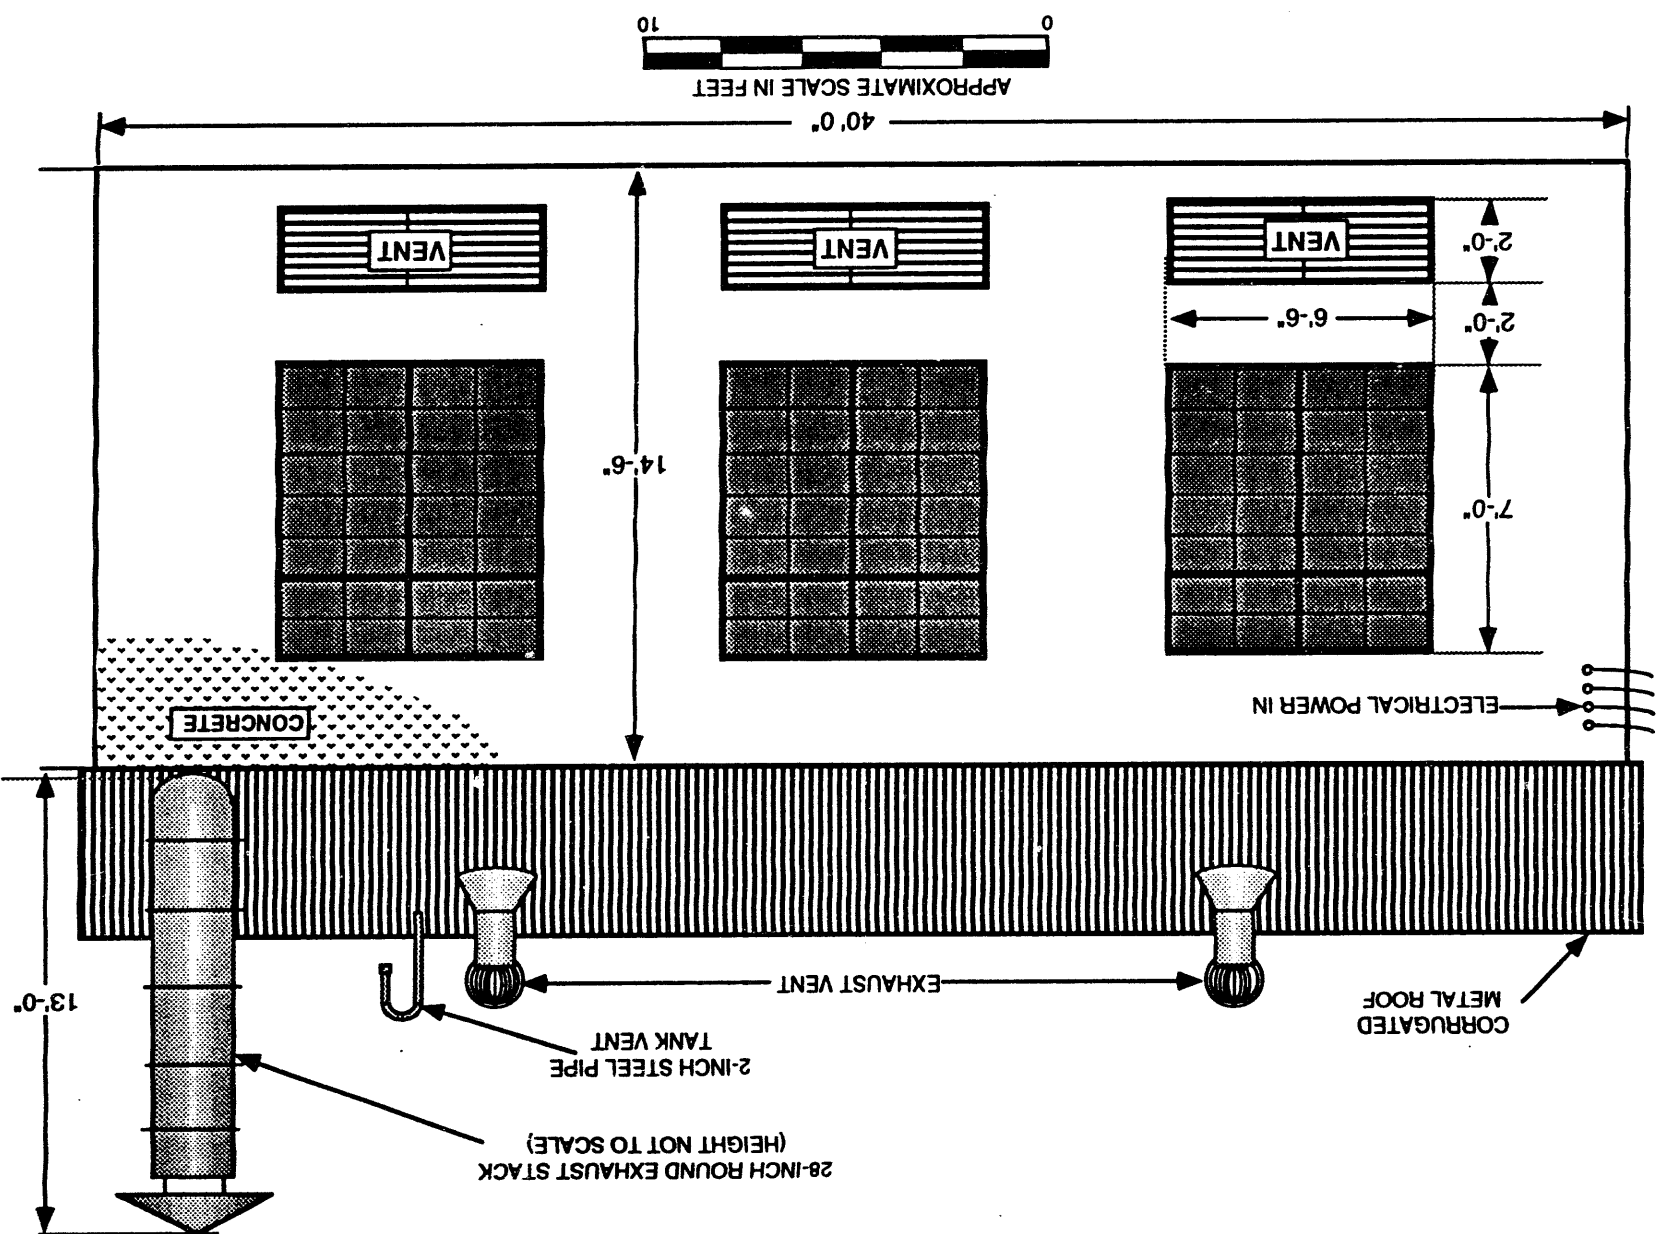
FIGURE 5 Building ES190 North Exterior Elevation

No doors are present in this elevation. Three window/vent combinations are on the north elevation of E5190. Windows in E5190 are typical in design, measuring 78 in. wide × 84 in. high. They are constructed of a metal framework with multiple panes of glass. Each window has an accompanying 24-in.-tall × 78-in.-wide vent mounted directly below it. The north elevation E5190 contains three of these window/vent combinations (Figure 5).

The overall condition of this elevation of the building is good. All of the components that make up this elevation remained in place at the time of this investigation.

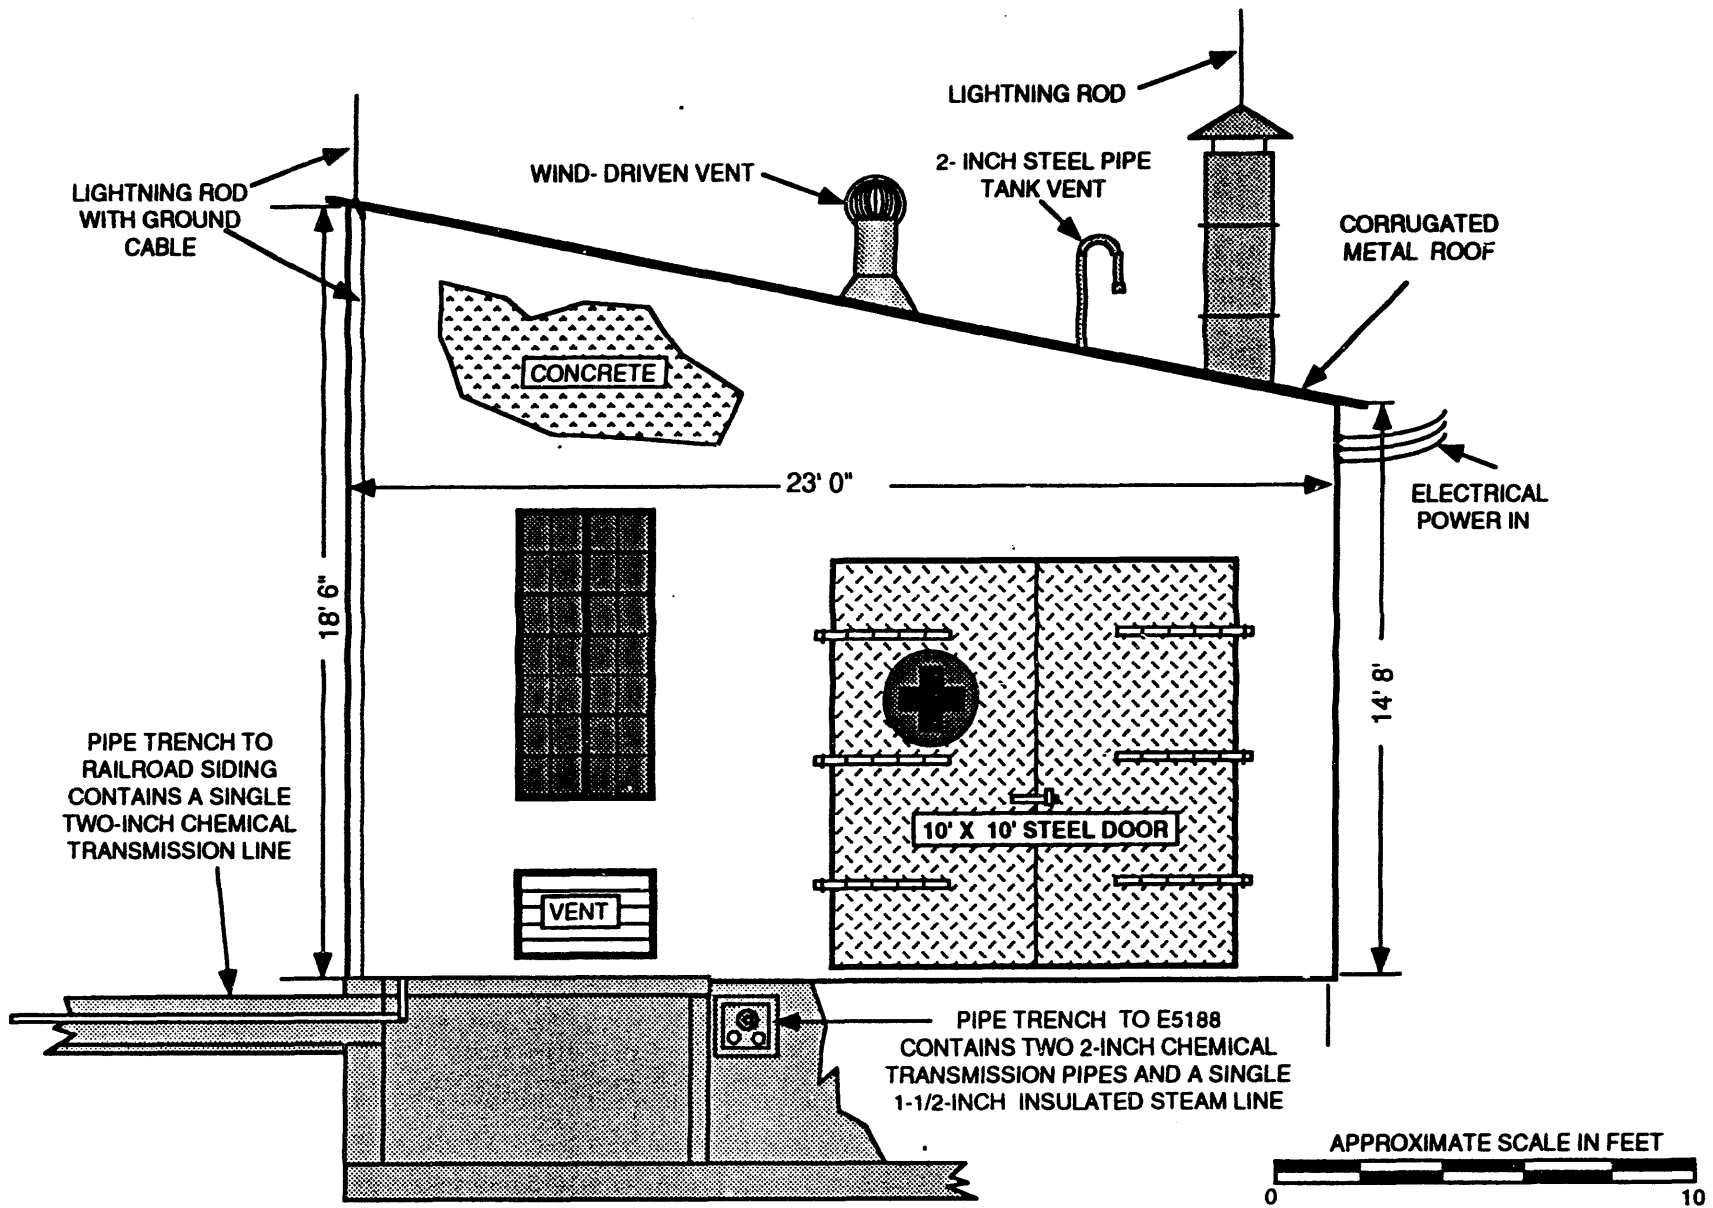
FIGURE 6 Building E5190 East Exterior Elevation

The east elevation of Building E5190 contains one set of double doors measuring 10 ft × 10 ft. These doors appear to be constructed of wood cores and wrapped with a metal covering (Figure 6).

There is a single window/vent combination in the east elevation of E5190. The only window in Building E5190 that differs in size from all other windows in the building, this window opening measures 84 in. tall × 40 in. wide. There is an accompanying wall vent directly below the window that measures 40 in. in width and 24 in. in height (Figure 6).

The overall condition of this elevation of the building is good. All of the components that make up this elevation remained in place at the time of this investigation.

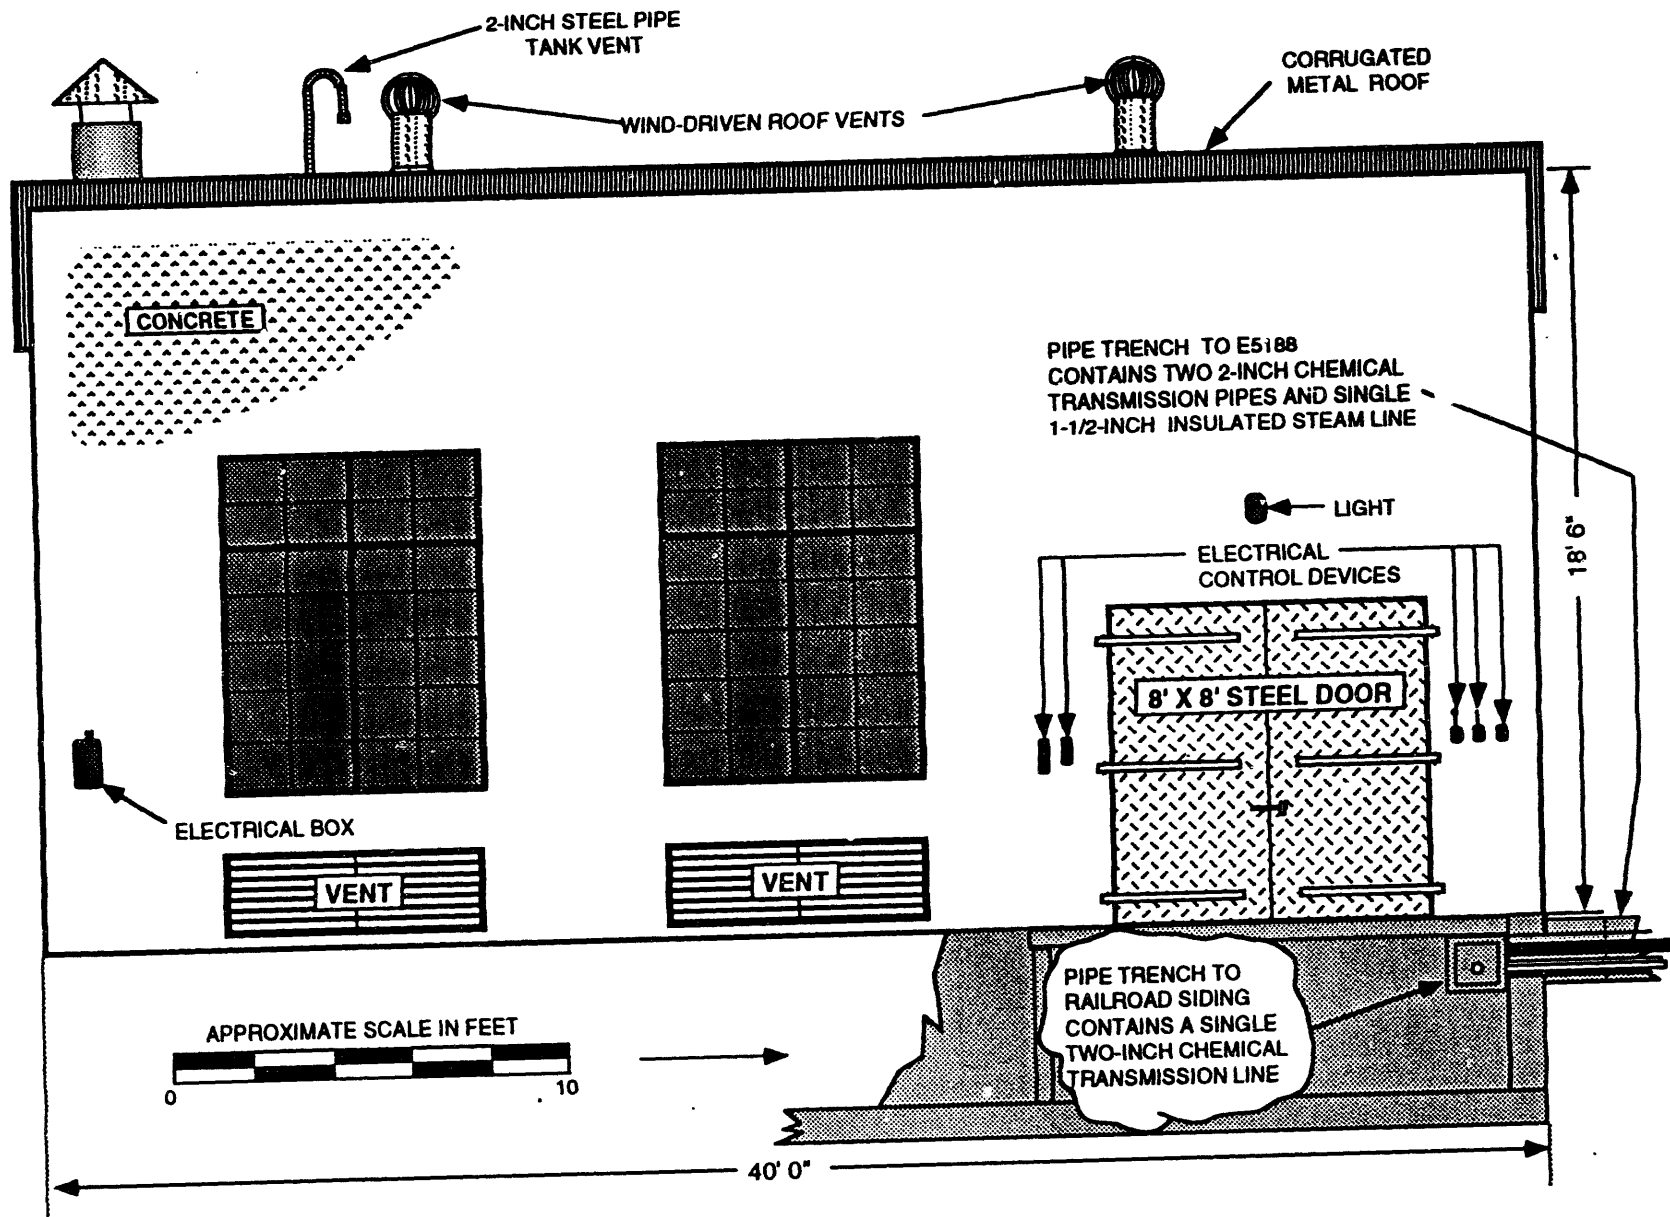
FIGURE 7 Building E5190 South Exterior Elevation

The south elevation of Building E5190 contains one set of double doors measuring 8 ft \times 8 ft. These doors appear to be constructed of wood cores covered with metal (Figure 7). There are two window/vent combinations in the south elevation of E5190 (Figure 7).

The pipe trench that connected Building E5190 with the railroad siding to the south of the building (Figures 4 and 7) exits the building (underground) at the southeast corner.

The overall condition of this elevation of the building is good. All of the components that make up this elevation remain in place at the time of this investigation.

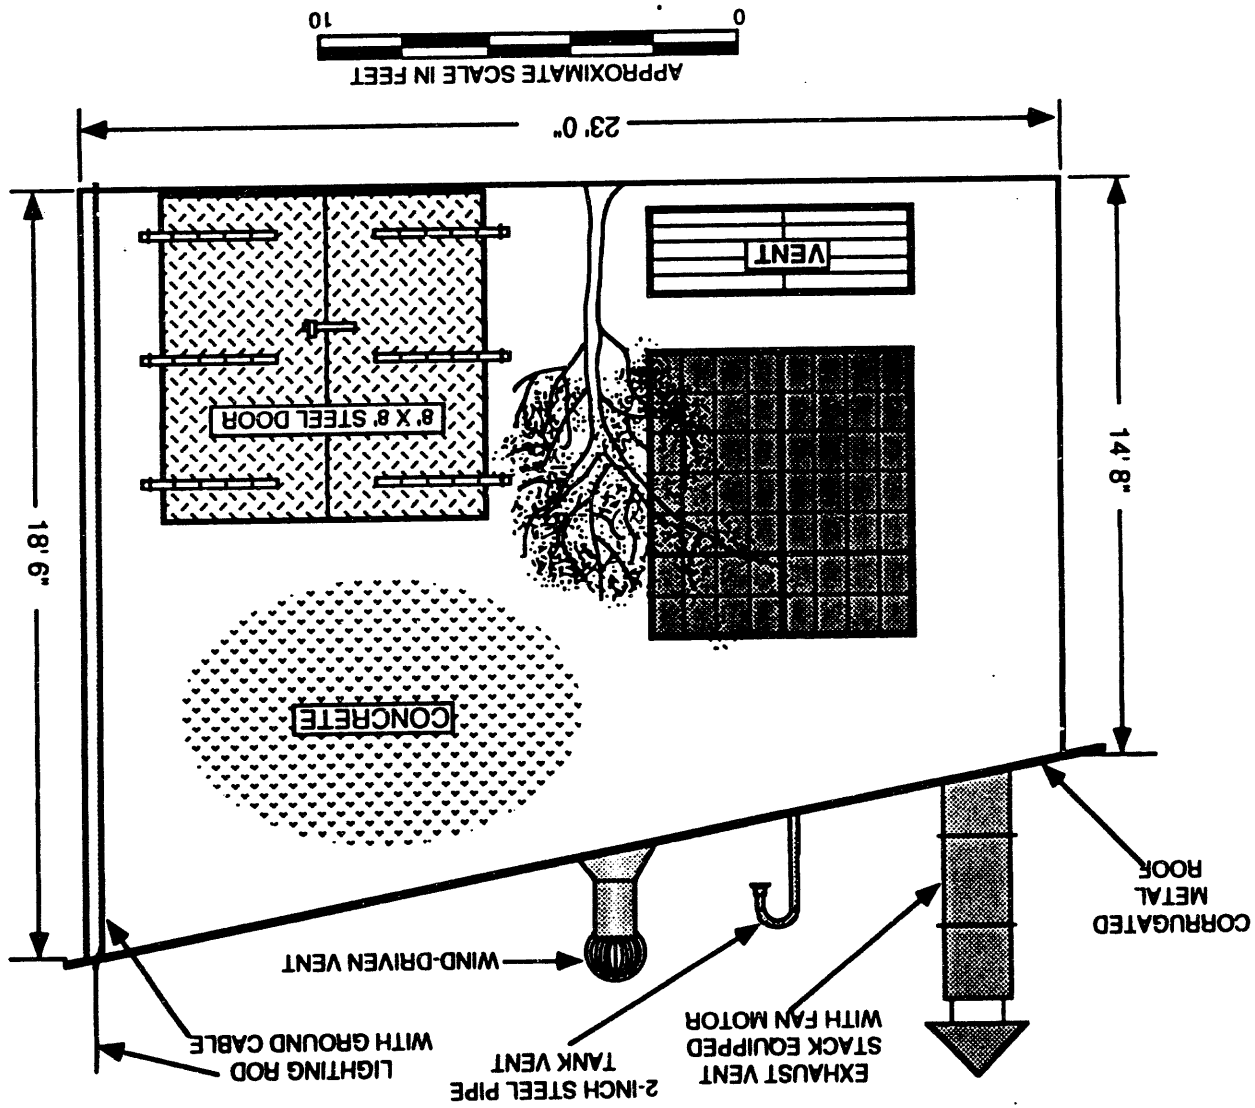
FIGURE 8 Building 8 Building ES190 West Exterior Elevation

The west elevation of Building E5190 measures 18 ft 6 in. at the south end of the roof to 14 ft 6 in. at the north end; the overall width of the building along this elevation is 25 ft (Figure 8).

The overall condition of this elevation of the building is good. All of the components that make up this elevation remain in place at the time of this investigation.

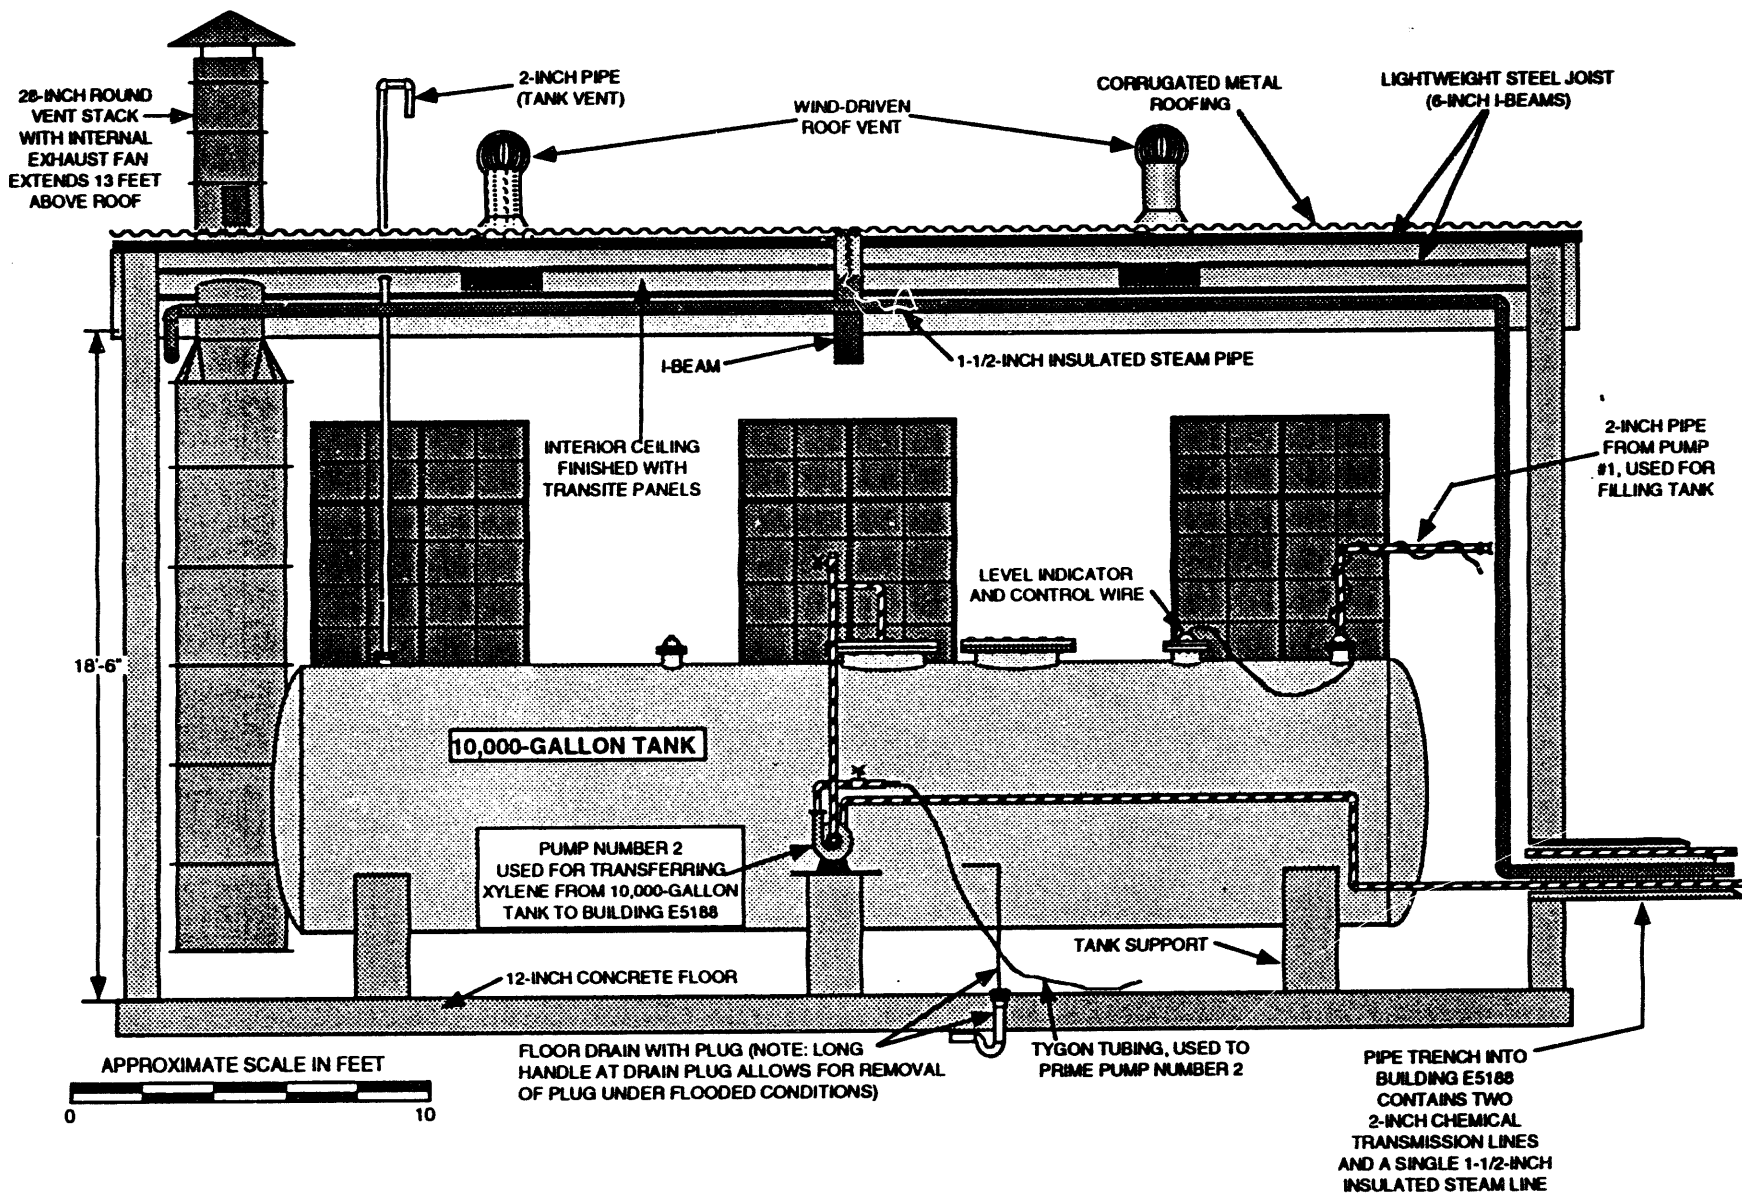
FIGURE 10 Building E5190 North Interior Elevation

The ceiling of Building E5190 is finished with Transite panels and appears to be in fair condition (Figure 10).

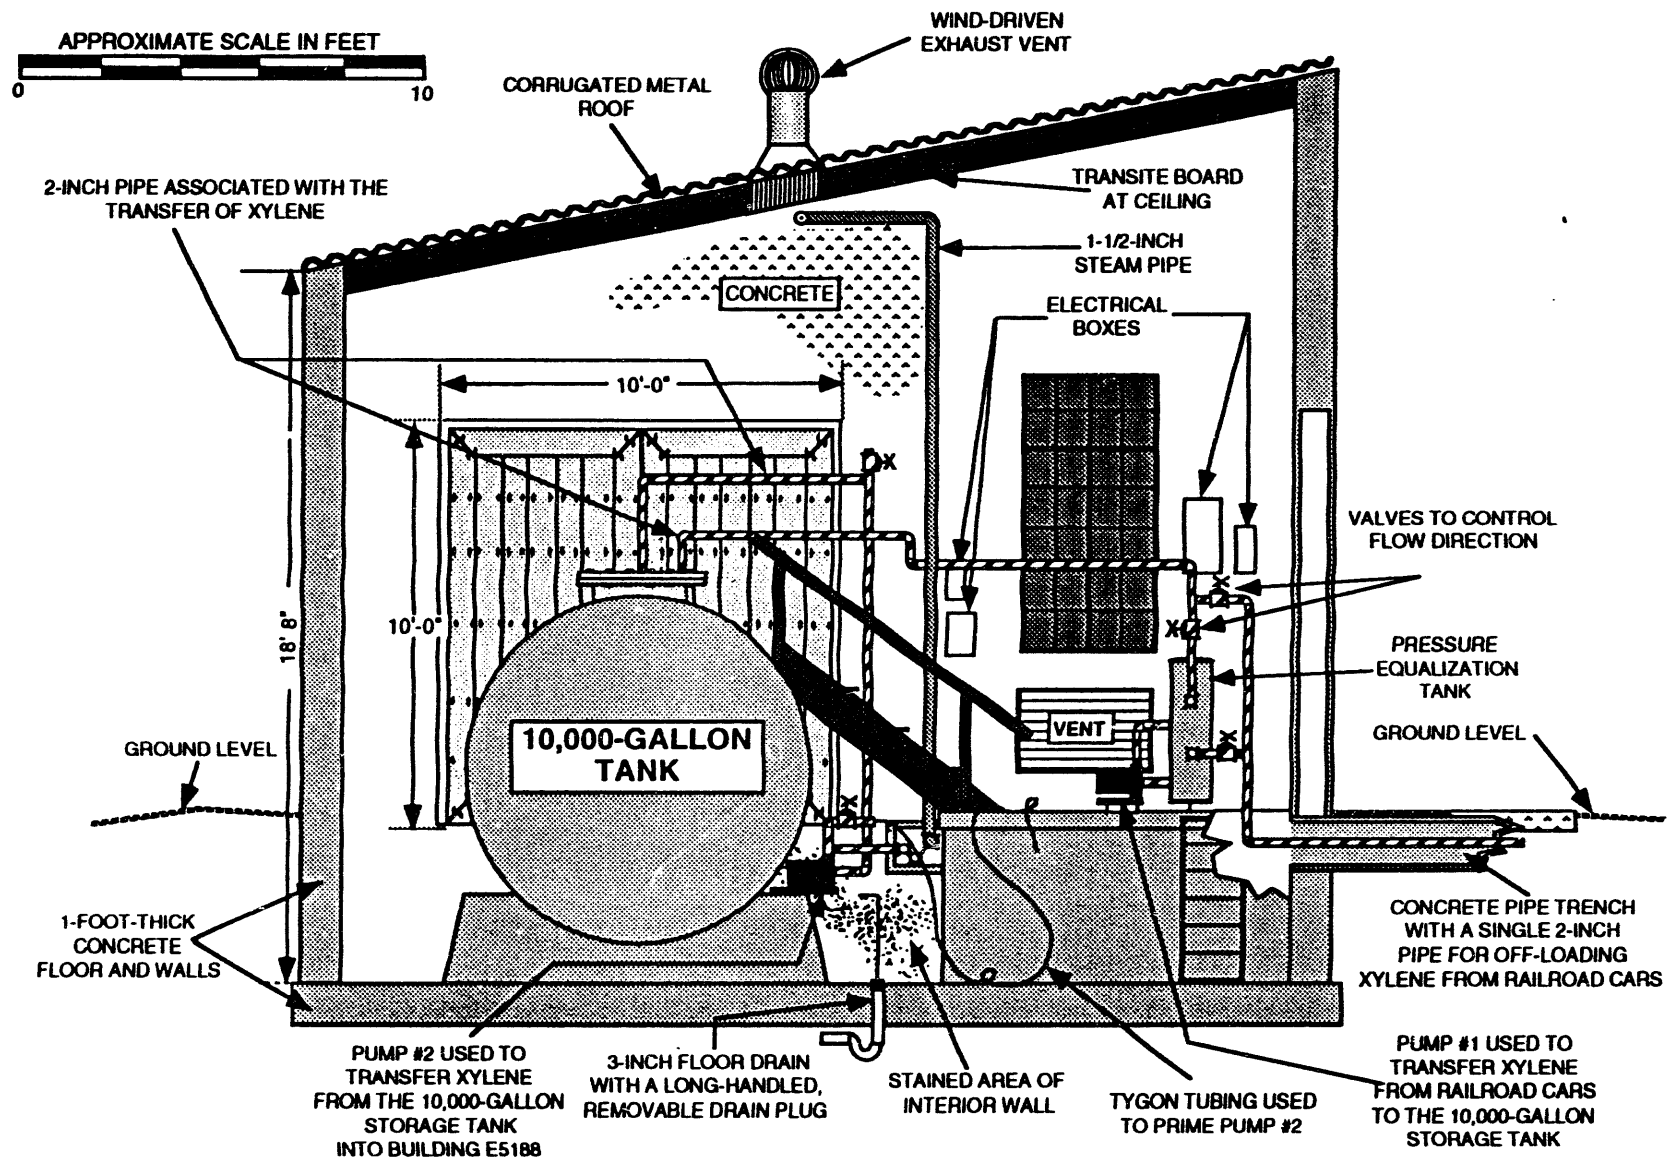
FIGURE 11 Building E5190 East Interior Elevation

The interior walls of Building E5190 are raw, uncoated concrete. Around and near the area of the east wall (where the opening of the pipe trench appears) is an area of staining or discoloration that appears to have originated from the pipe trench. The stained area is orange, probably as a result of rust from the metal pipes and covers associated with the trench. The concrete in the area near the opening of the pipe trench is pitted and flaking.
