FINAL REPORT

ACCIDENTAL NUCLEAR EXCURSION

RECUPLEX OPERATION

234-5 FACILITY

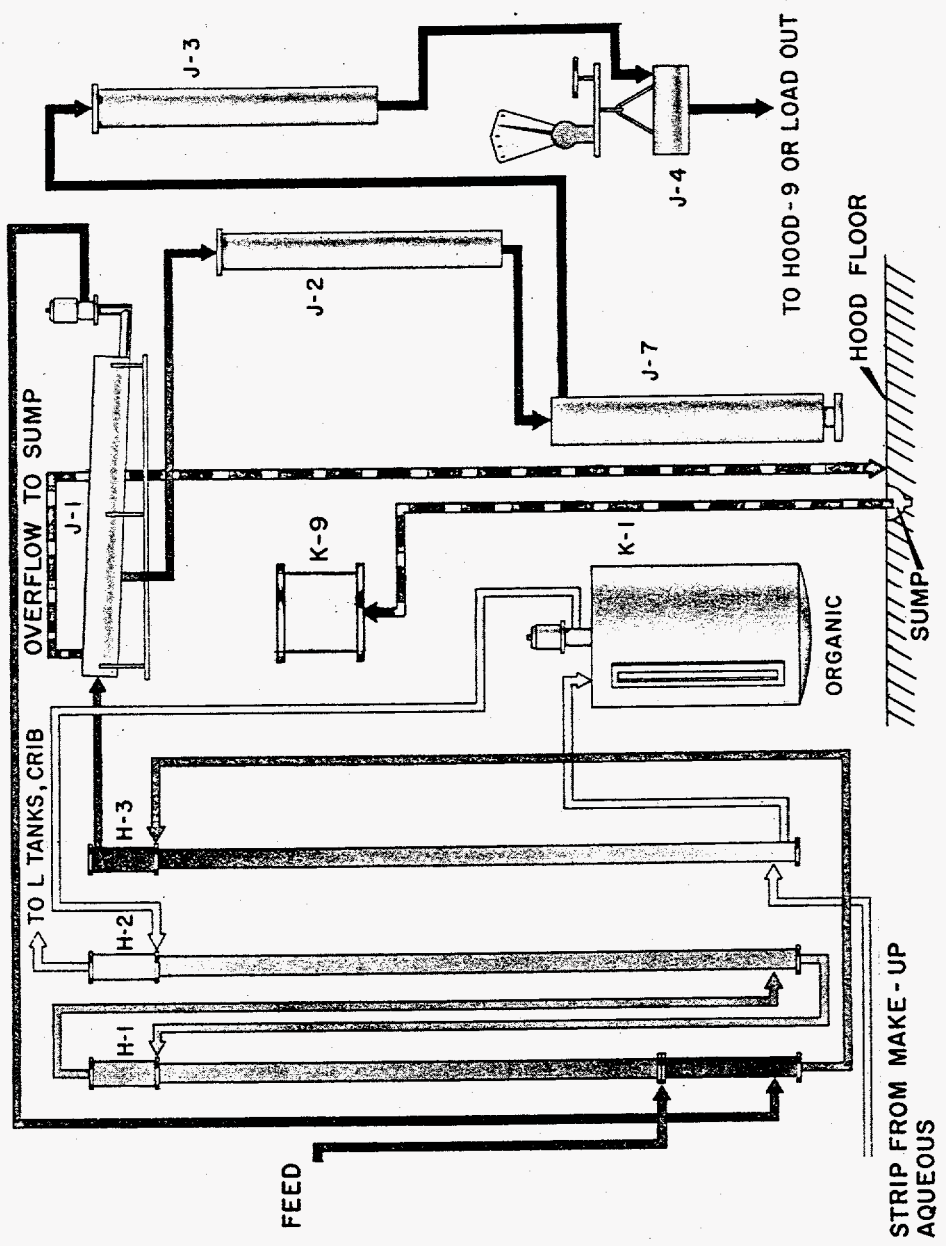
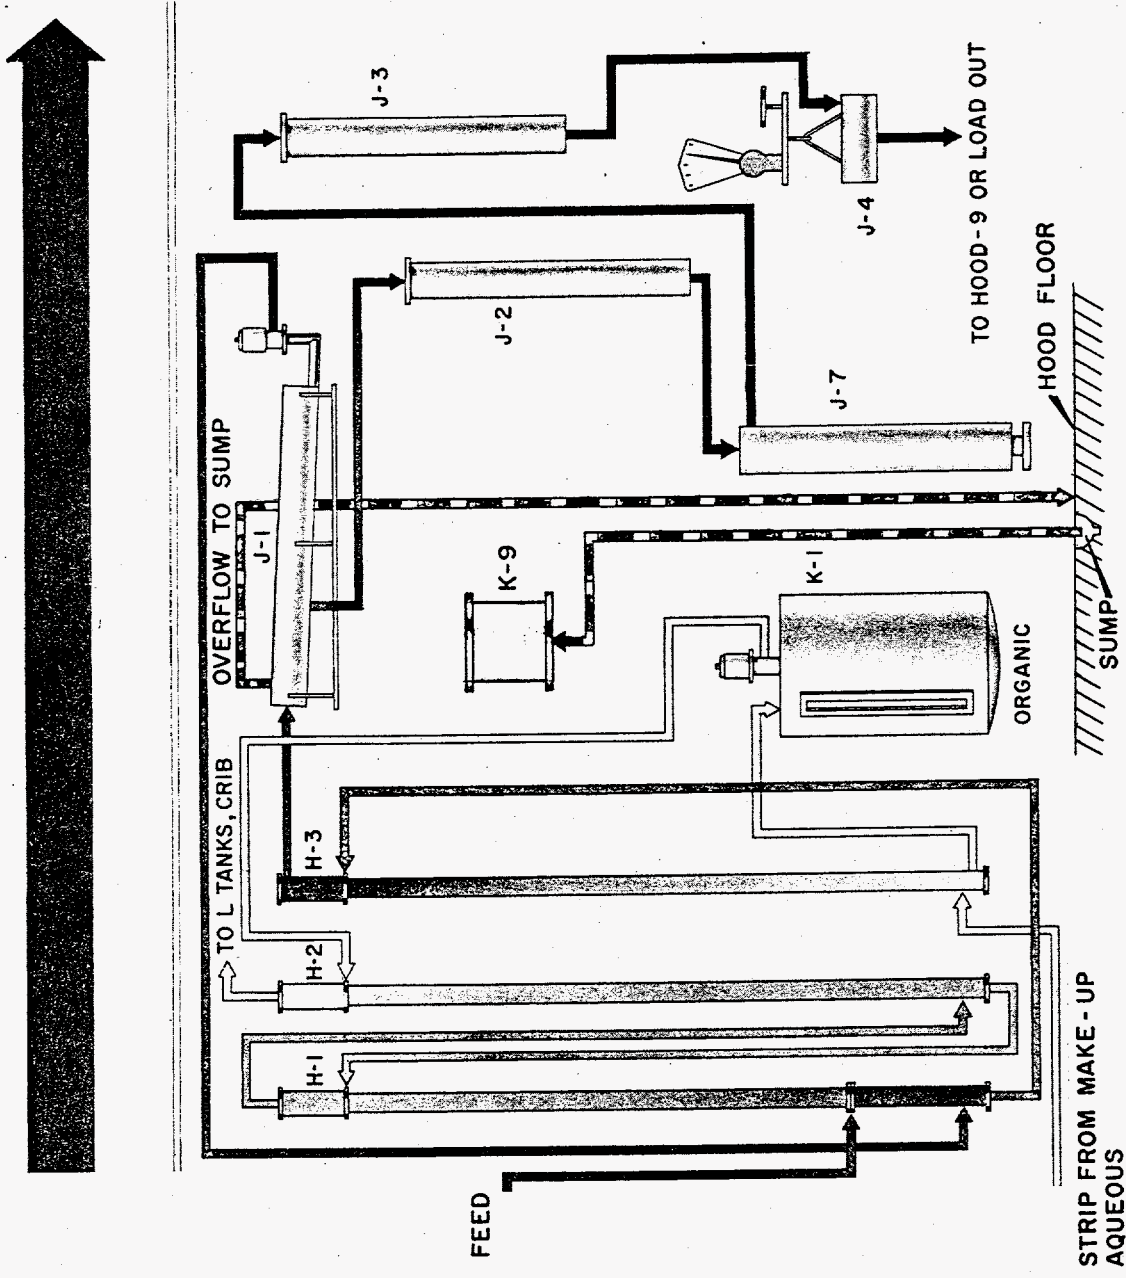
FIGURE IV - 5
Pictorial Flow Diagram of SE Process

Fig. IV-5 is a pictorial flow diagram of the SE process. This figure concerns itself mainly with the route by which product solution entered the K-9 tank, viz., from the J-1 tank via the J-1 overflow to the sump, and from the sump via the 1" temporary plastic line to the K-9 tank.

1. During the latter part of the 12-8 shift on April 7, product solution flowed intermittently from the top of column H-3 (solvent extraction stripping column - see Fig. IV-5 for flow diagram) to vessel J-1 (a product receiver tank) and was intermittently removed from J-1 during this period. However, during part of the period, input sufficiently exceeded output to cause J-1 to fill and then to overflow. The overflow went via a line provided for the purpose to the floor of the SE hood.

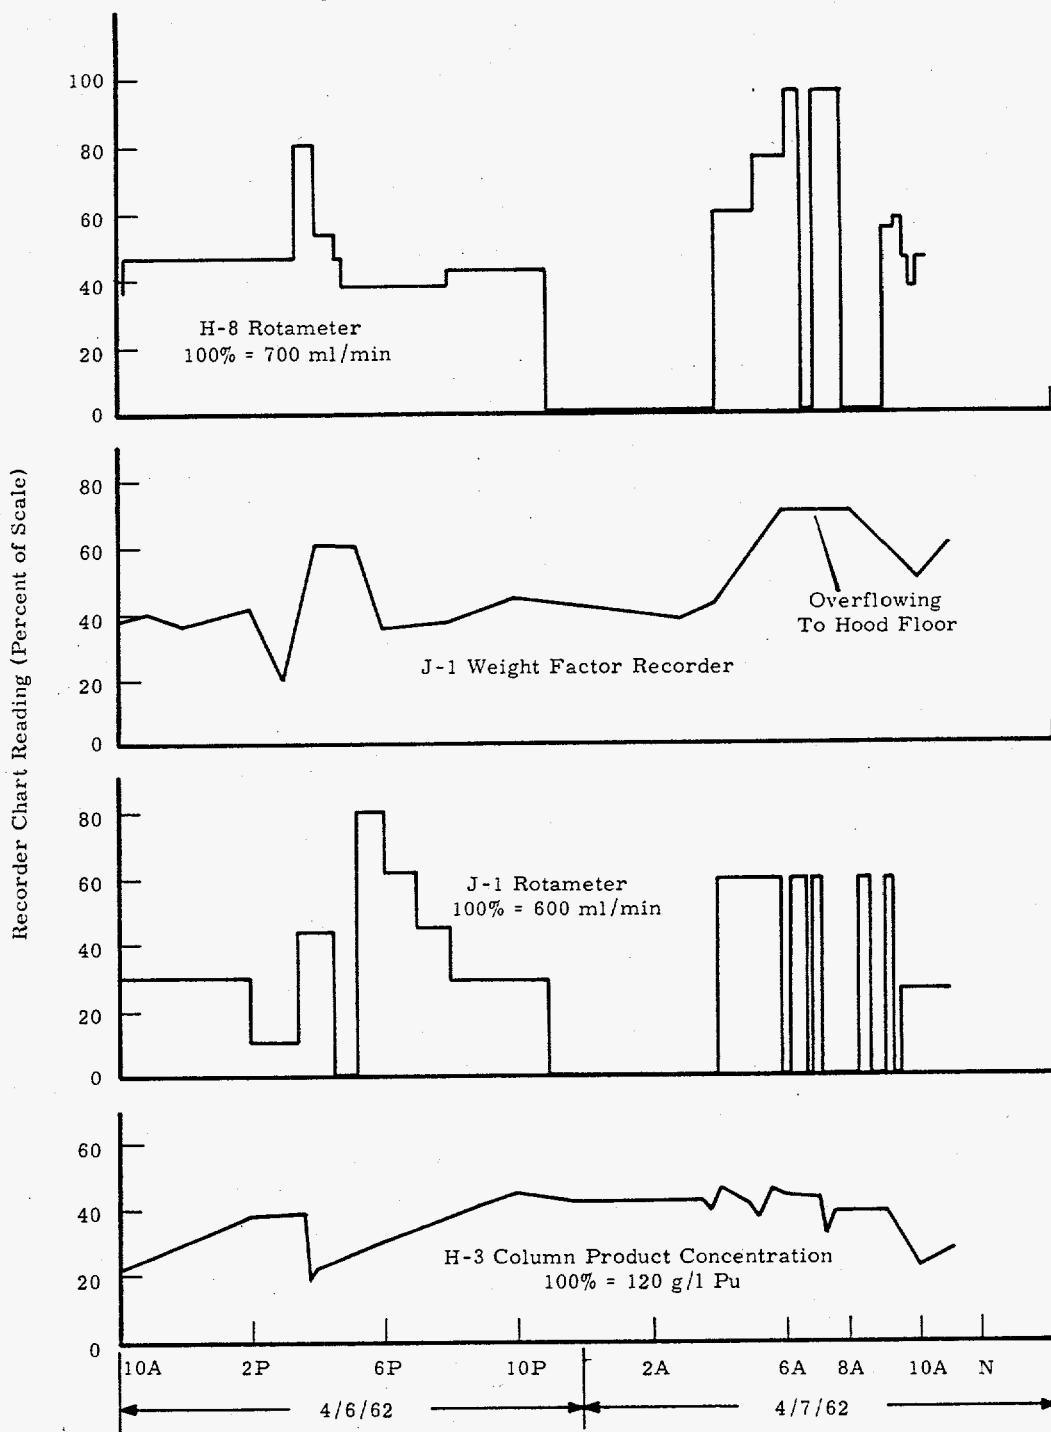
FIGURE VIII-1

The evidence for this statement is summarized on Fig. VIII-1, which is a record of inflow to J-1, outflow from J-1, and weight factor (i.e., depth x density) in J-1. This figure is drawn from charts taken from recorders after the accident. The traces on the original charts were not as sharp as these drawings might imply, because of instrument noise and sticking of the tracing stylus in places. However, the uncertainties thus introduced are not enough to invalidate the conclusion above-stated. It will be observed that for considerable periods between 0600 and 0800, the weight factor indicated J-1 to be full while input was occurring at rates greater than output. During these periods, J-1 must have been overflowing.

of 0.66 liters/minute for 90 minutes (≈ 59 liters total) in the 0600-0800 interval. The rate of outflow from J-1 was 0.36 liter/minute for 30 minutes (≈ 11 liters total). The weight factor indicator showed J-1 full throughout the entire two-hour interval, so all of the difference ($59 - 11 = 48$ liters) must have overflowed onto the floor.) The Pu concentration found in the J-1 tank after the accident was 34.4 grams/liter, but the Pu concentration in the J-1 liquid during the interval 0600-0800 is estimated from Fig. VIII-2 (H-3 column product concentration) to have been about 45 grams/liter average. Hence, the Pu overflowing onto the floor was about $48 \times 45 = 2160$ grams.

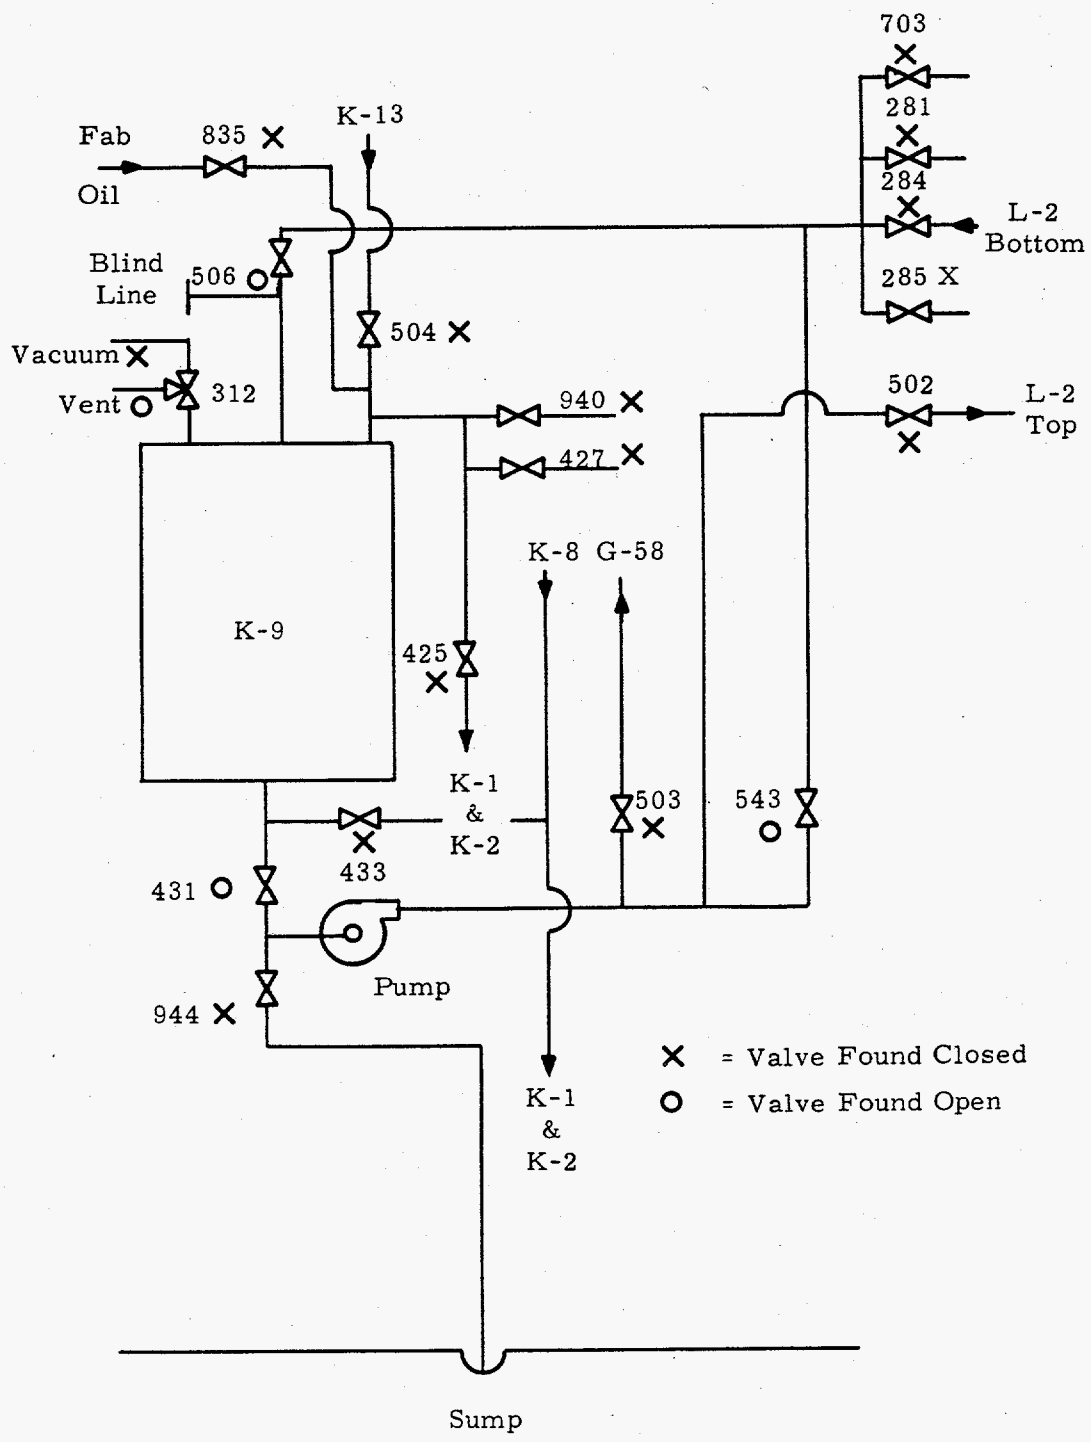
FIGURE VIII-2

The product solution flowed across the floor of the solvent extraction (SE) hood, and was from there later partly sucked up into K-9 through a temporary line used in previous hood clean-up operations. In order for the solution to have entered K-9 via this temporary line, a valve (#944) in that line had to be opened and subsequently closed by human agency. The valve (#944) was found closed upon examination after the accident.

4. The process vacuum (line vacuum possibly as high as 26" mercury) was apparently on the K-9 tank at the time of the incident.
5. The temporary plastic line from the bottom of K-9 tank was in place with one end lying in the bottom of the sump. The temporary ball valve installed in this line was found to be in the closed position and the permanent valve (431) in the line to the bottom of K-9 tank, to which this line is attached, was found open.

6. The valve (433) between K-9 and the chemical addition line from K-8 to K-2 was found closed.
7. The material which went critical in K-9 vessel was analyzed subsequent to the incident and found to have the following analysis:

K-9 Piping and Post-Accident Valve Status

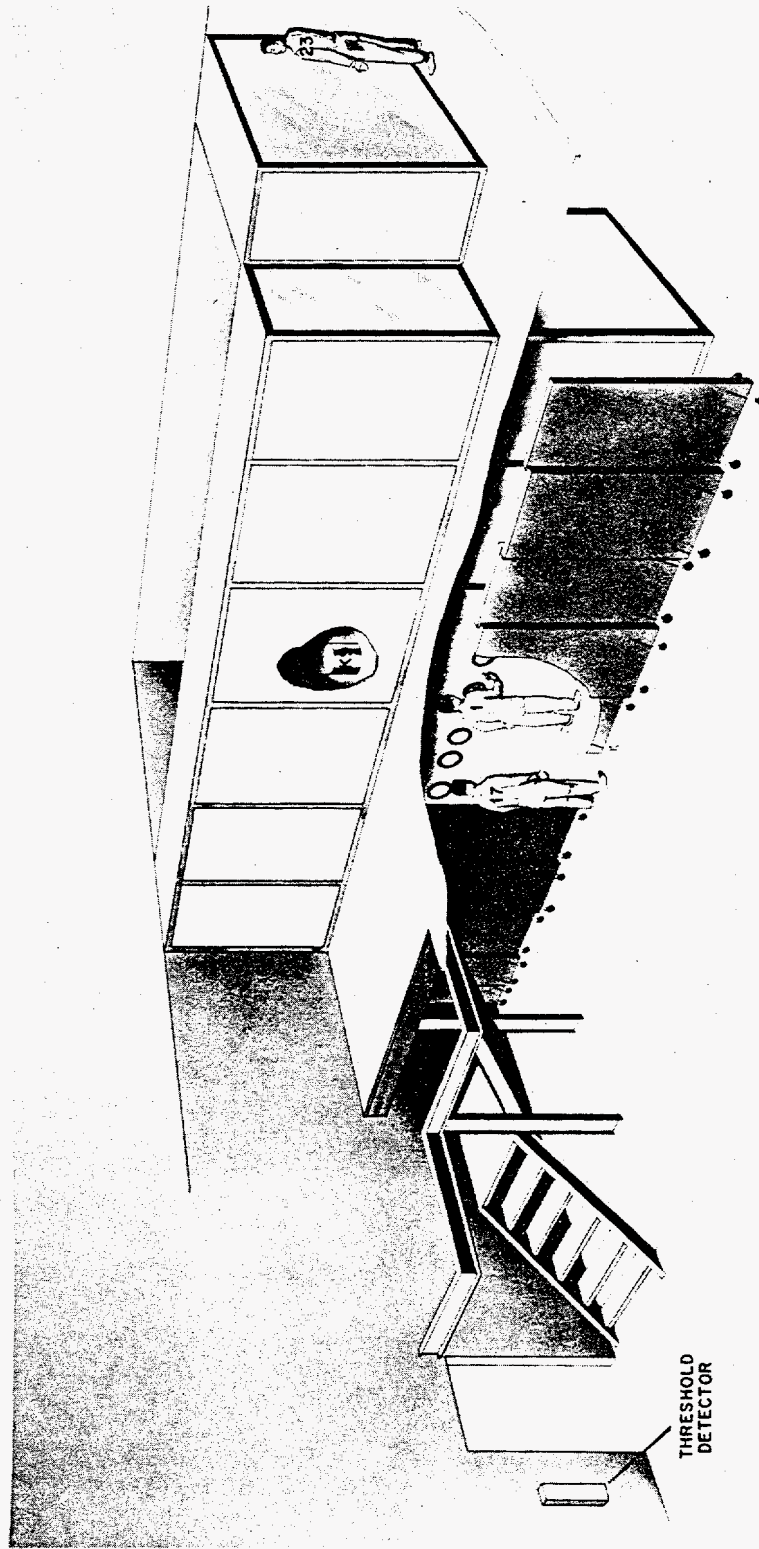
FIGURE 3

Information for the three most highly exposed persons was made as detailed as their recollections would allow. Figure 3 shows where these people were standing at the time they saw the Cerenkov radiation flash. Employee #1 was standing immediately below the critical vessel, the K-9 Tank, manipulating a valve at the face of the hood containing the tank. His body was very close to the hood wall. His eyes were about 5 feet from the center of the K-9 Tank; the parts of the trunk of his body were between 6 and 8 feet away. Employee #17 was standing about 2 feet to the side and about 5 feet behind Employee #1. There was a movable lead shield behind #1, but #17 was in full view of #1 and of the K-9 Tank. #17's eyes were about 10 feet from the center of K-9 and the trunk of his body was 10 to 11 feet away. The K-9 Tank is cylindrical with a capacity of 69 liters; it contained about 45 liters when the excursion occurred. The tank has a Pyrex wall about $3/8$ inch thick and a steel bottom plate about one inch thick. #1 and #17 were exposed to radiations coming through both the wall and the bottom. The only other materials between them and the tank were the half inch thick lucite hood walls and some plumbing inside the hood. Employee #23 was standing in front of another hood about 26 feet from the center of K-9. Most of the radiation reaching him probably came through the sides of the tank. The only materials between him and K-9 were the lucite walls of

Positions of Employees in the Recuplex Area at the Time of the Accident. The Position of the Threshold Dosimeter is Also Shown.

A threshold detector²⁾ was located about 26 feet from the critical vessel. Its position is shown in Figure 3. At least one of the steel beams of the stairway shown in the figure was on the line-of-sight between the

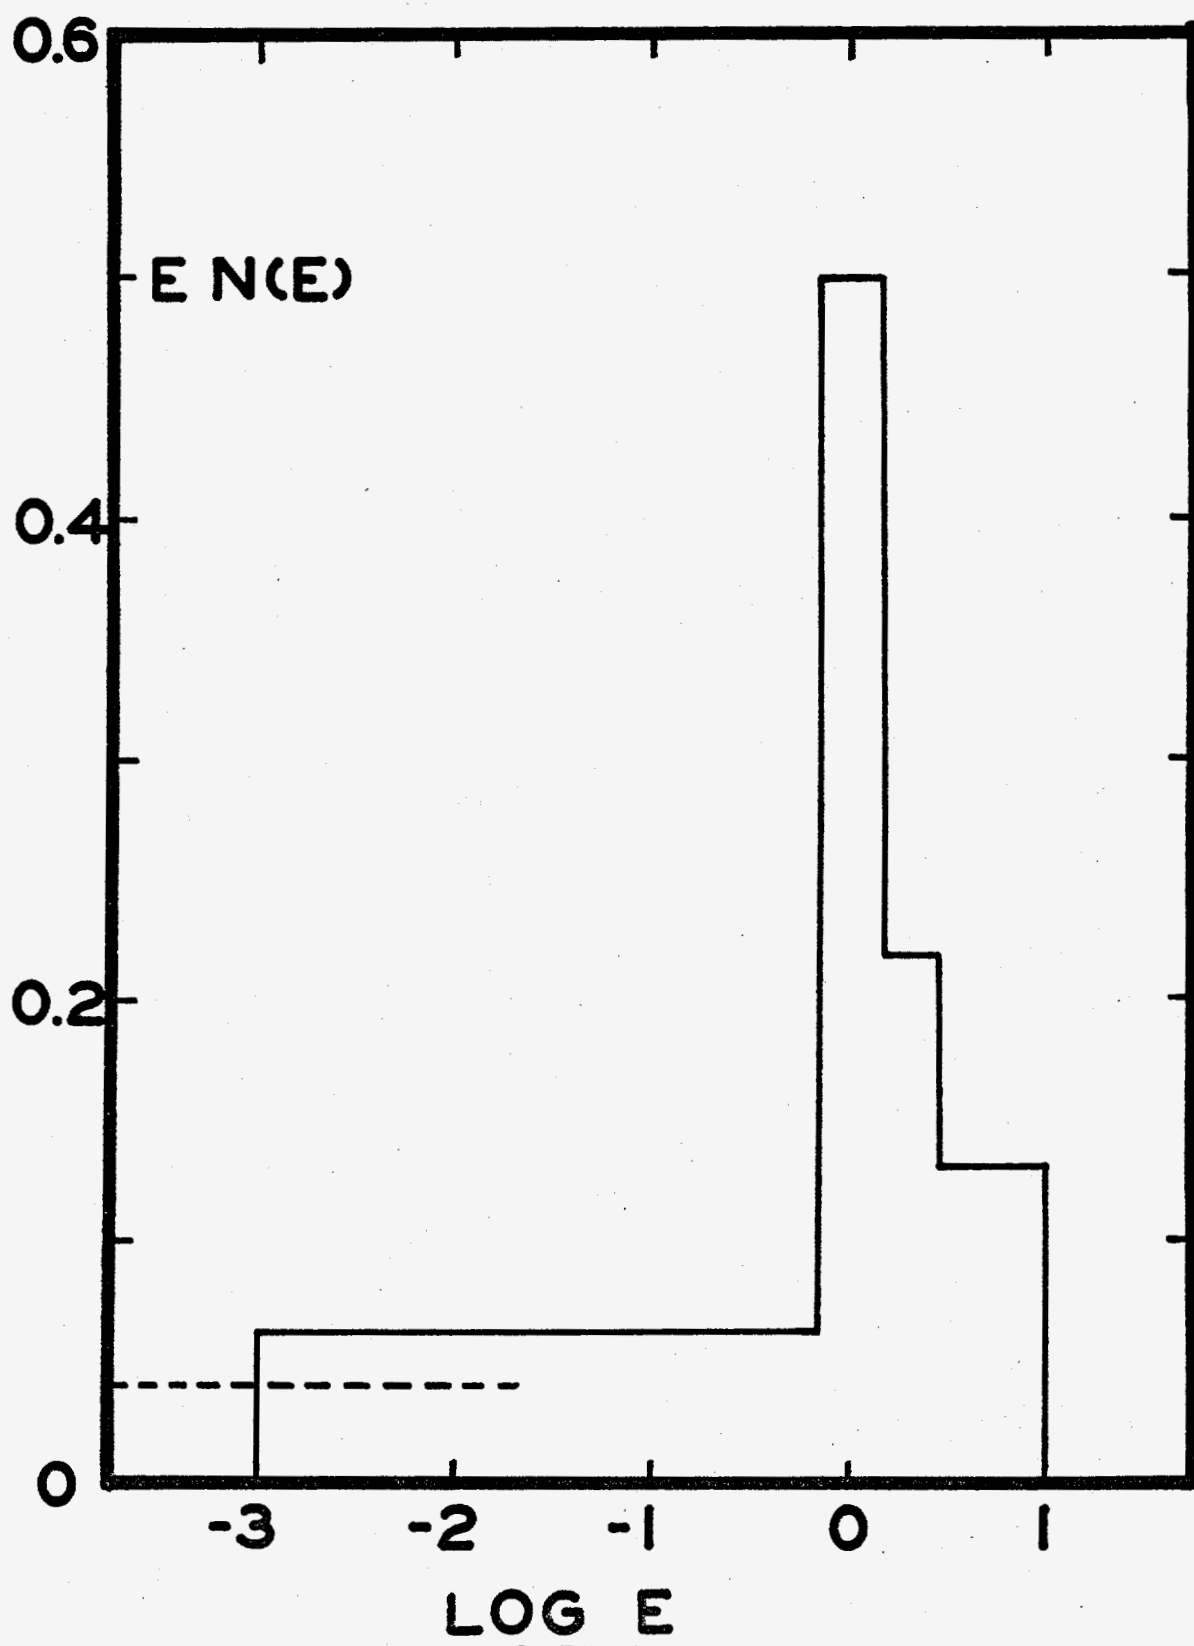
LOG E
 FIGURE 5

The number spectrum is presented in Figure 5. For comparison several other spectra obtained with threshold detectors³⁾⁴⁾⁵⁾ and normalized in the same way are shown in Figure 6. Figure 7 shows histograms prepared from calculated spectra⁶⁾; since information is lost in going from the calculated spectra to

Spectrum Measured with Threshold Detector During Recuplex Accident.

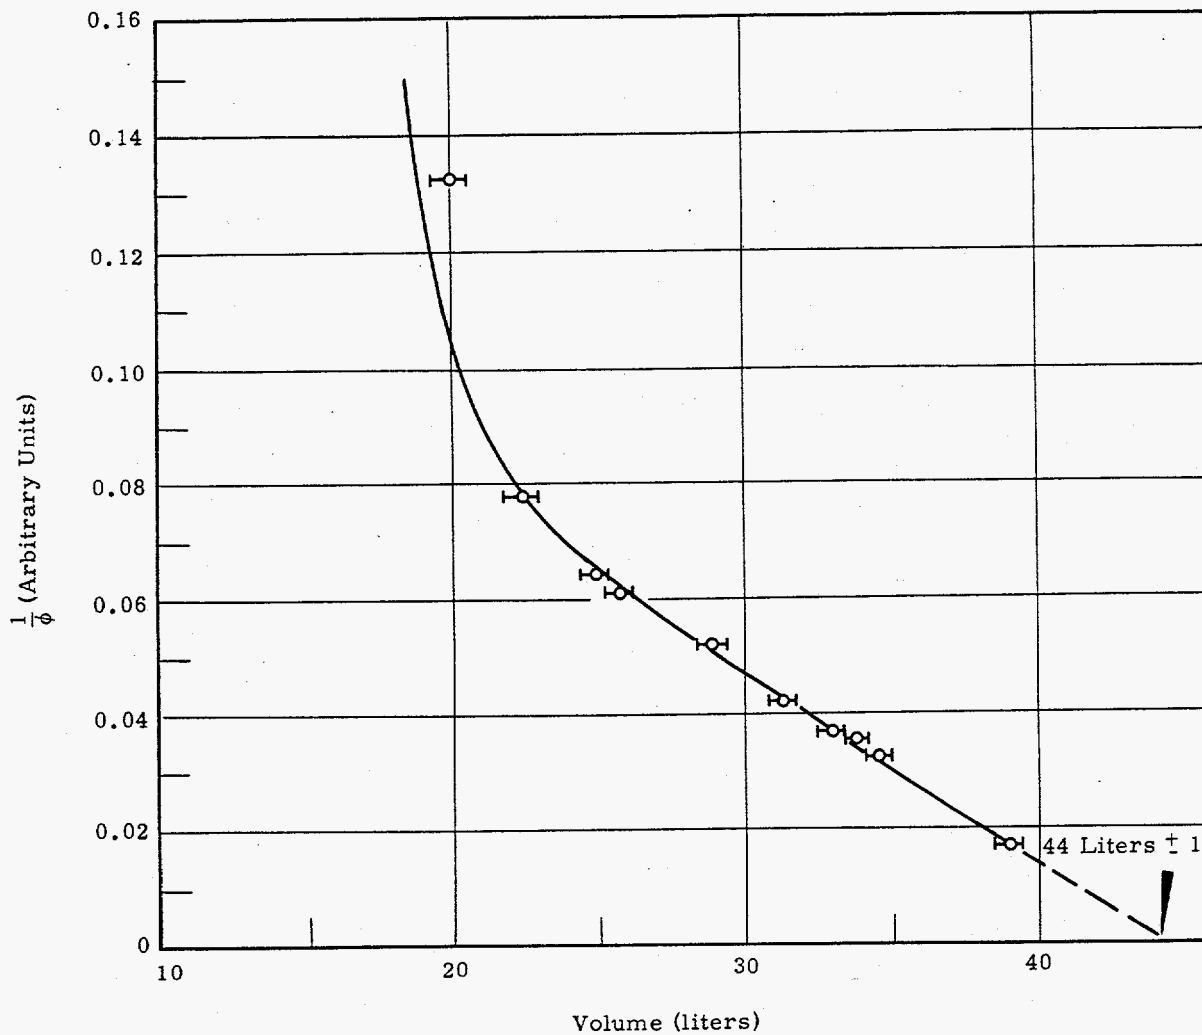
Exhibit 8-D

Estimate of Criticality in Vessel K-9
(35 grams Pu/liter, 120 grams NO₃/liter)

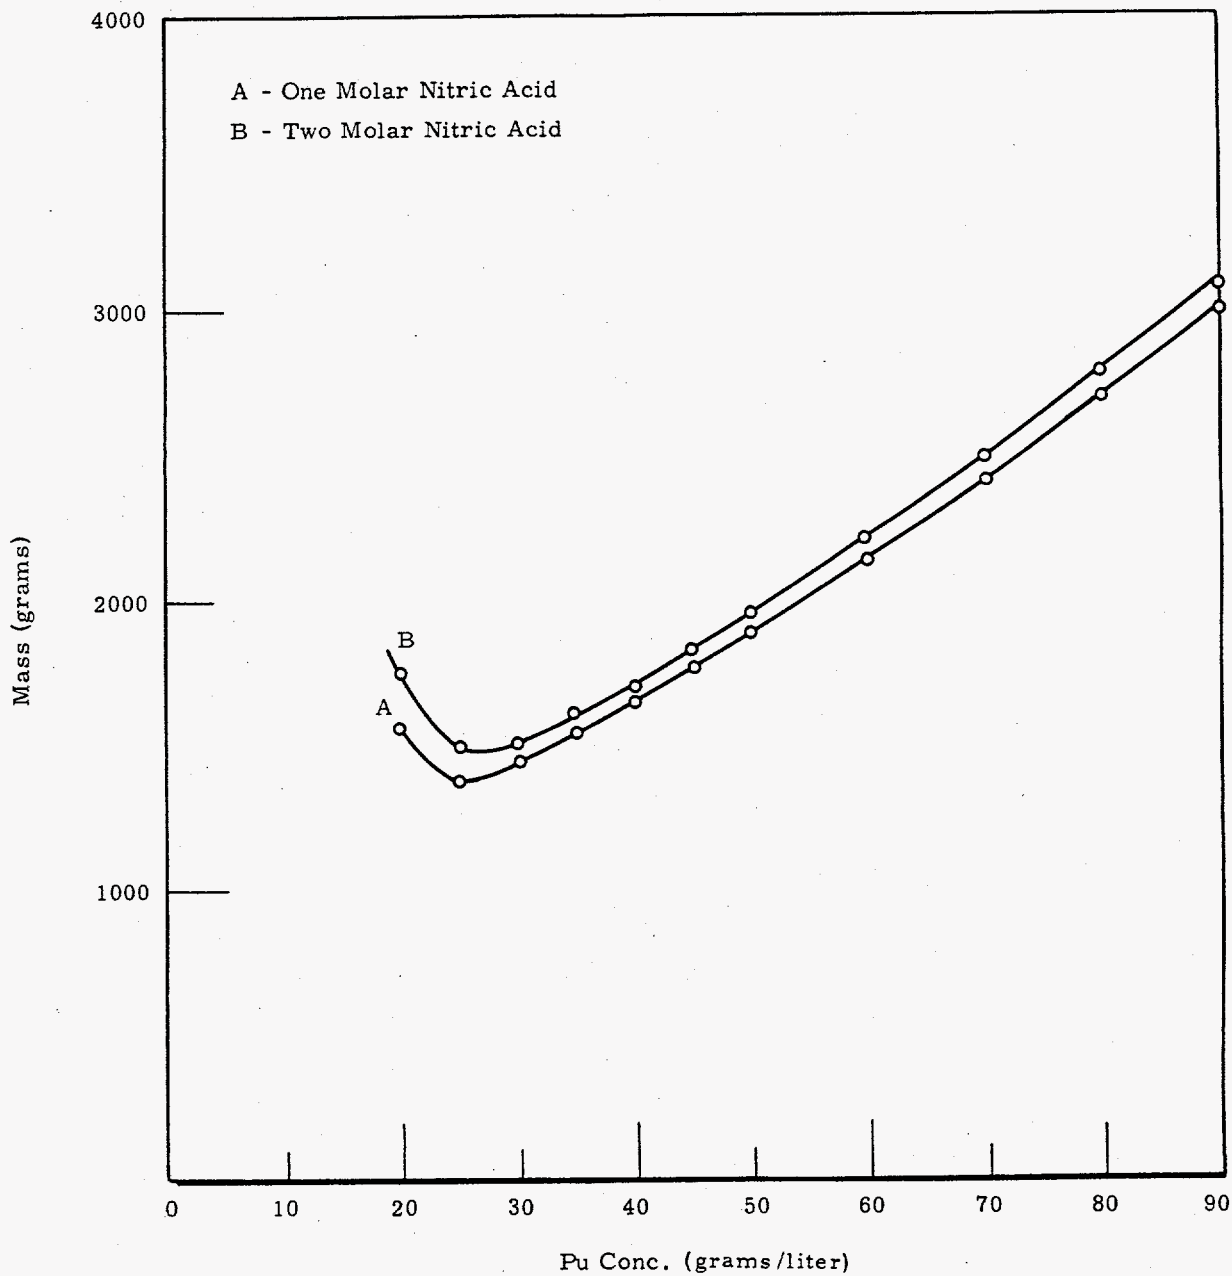
FIGURE 8-E-(1)

Calculated Critical Mass vs. Pu Concentration in Vessel K-9
