HW-65989

July 18, 1960

REACTOR EFFLUENT OUTFALL STRUCTURES - STATUS AND POTENTIAL PROBLEMS

J. P. Corley

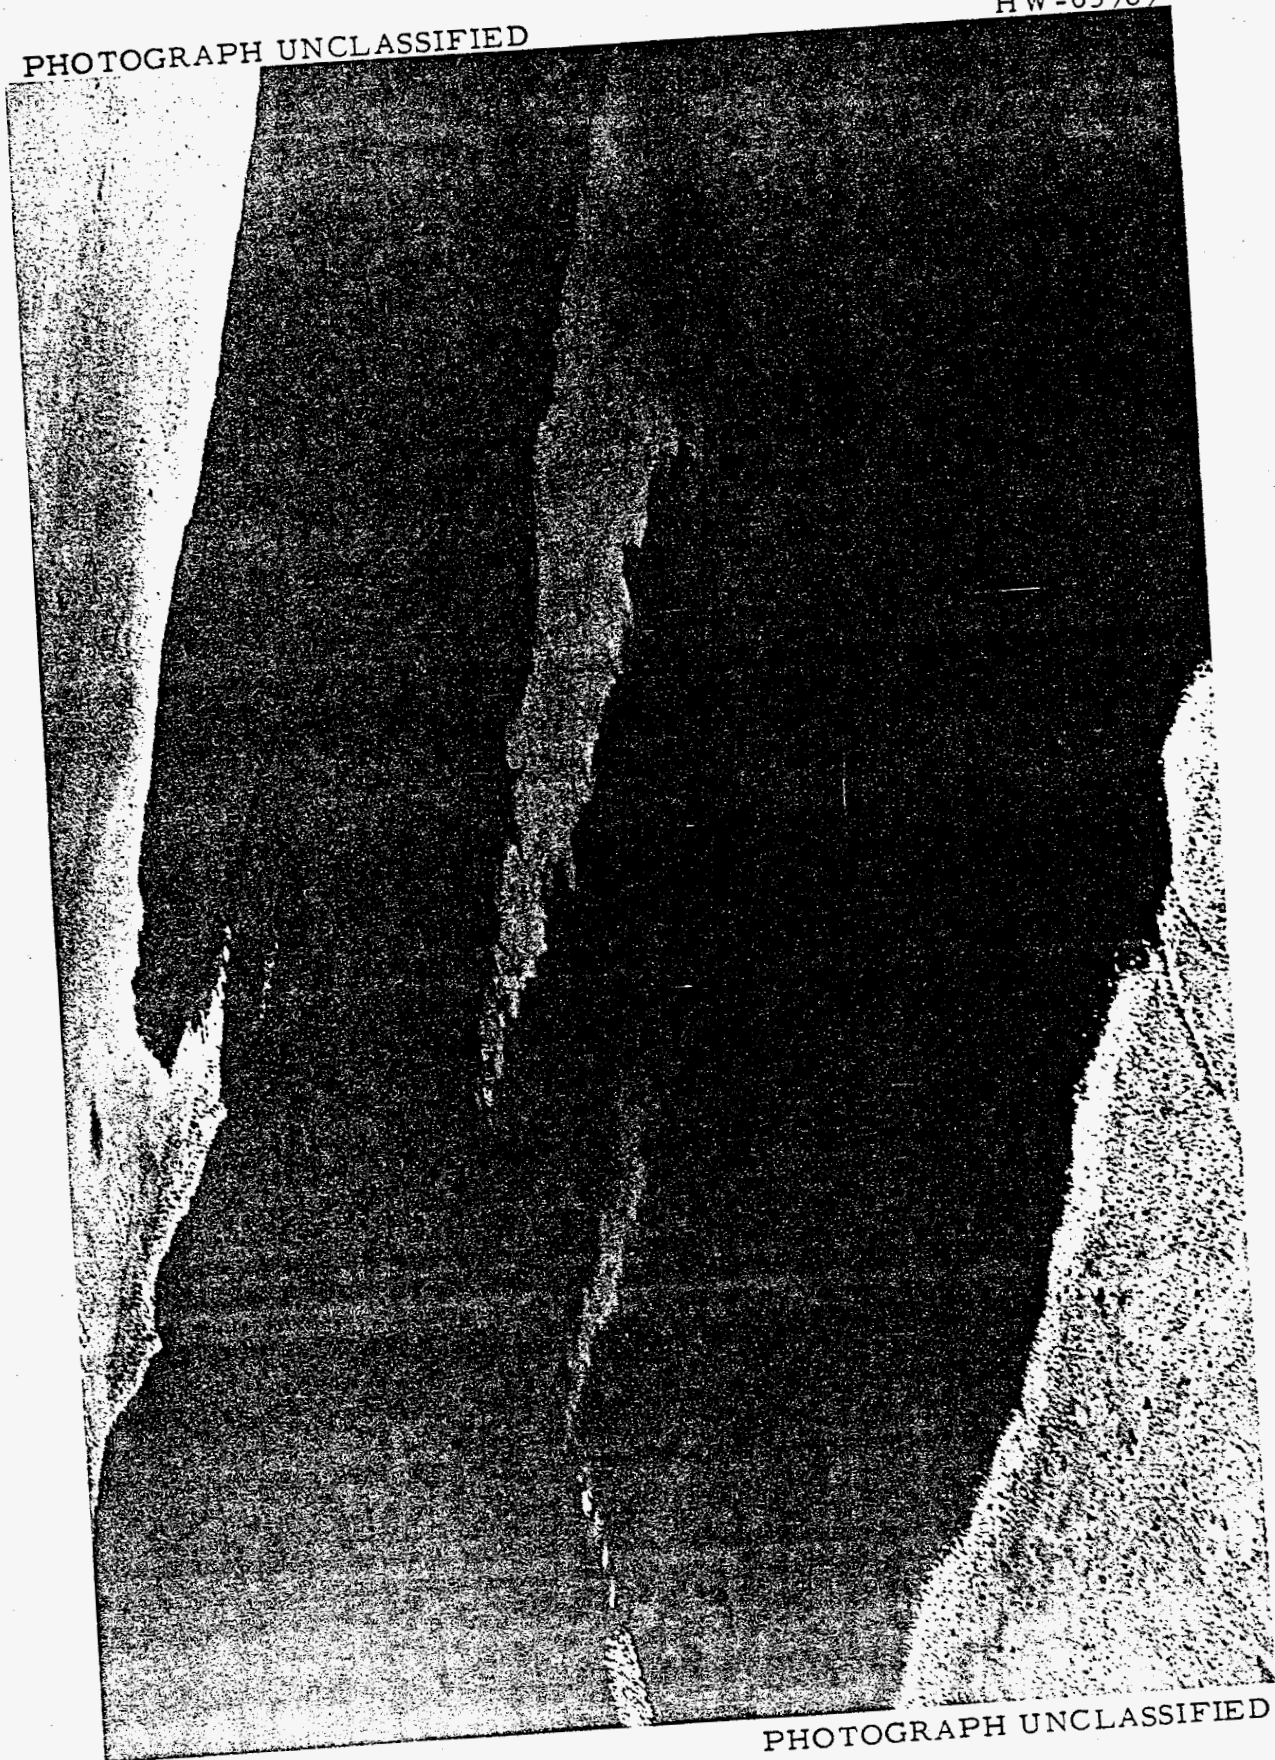
In the meantime, dye tests and other studies were made to determine the effect of the leakage from the existing breaks and to evaluate the potential severity of that rupture. The dye tests indicated leakage, mostly from the KW line, of about 17,000 gpm (10 per cent of one K Reactor effluent flow rate) at a river flow of about 65,000 cfs; the effect of this leakage on D Area was felt to be slight. Subsequent calculations show an average increase in D Area raw water temperature of about 0.1°C from a leak of this size, which by the usual methods of calculation would cause production losses at D and DR Reactors valued at \$20,000 to \$30,000 per year. A separate study ⁽¹⁾ by HLO, including detailed sampling and measurement, showed a potential for much more severe effects in the event of total failure. These results are discussed below under POTENTIAL SEVERITY OF FAILURE. Figure 1 shows the present leak ratio and distribution of effluent; Figure 2 shows the probable distribution pattern from a line break at the end of the K jetty.
