SAND93-1380 • UC-261

## The Application of Non-Destructive Techniques to the Testing of a Wind Turbine Blade

Herbert Sutherland, Alan Beattie, Bruce Hansche, Walt Musial, Jack Allread,  
Jim Johnson, Mike Summers

NonDestructive Testing (NDT), also called NonDestructive Evaluation (NDE), is commonly used to monitor structures before, during, and after testing. This paper reports on the use of two NDT techniques to monitor the behavior of a typical wind turbine blade during a quasi-static test-to-failure. The two NDT techniques used were acoustic emission and coherent optical. The former monitors the acoustic energy produced by the blade as it is loaded. The latter uses electronic shearography to measure the differences in surface displacements between two load states. Typical results are presented to demonstrate the ability of these two techniques to locate and monitor both high damage regions and flaws in the blade structure. Furthermore, this experiment highlights the limitations in the techniques that must be addressed before one or both can be transferred, with a high probability of success, to the inspection and monitoring of turbine blades during the manufacturing process a

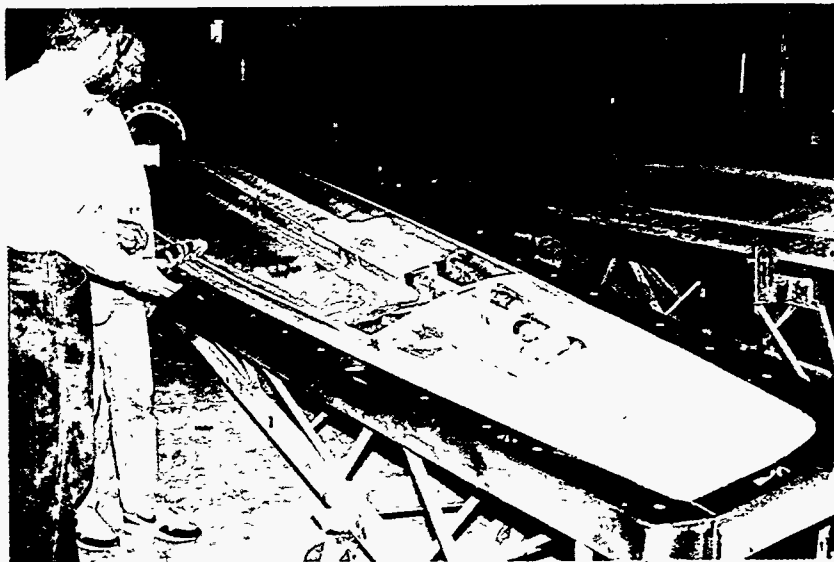
Figure 15. Internal structure of the NREL 7.9 meter blade.

Visual examination of the primary (Phase 1) failure at station 240 showed that the steel pitch shaft of the tip spoiler mechanism (see Figure 15) was bent inboard of the cam mechanism. The skin was also buckled on the low pressure side of the blade in the same radial location as the failure of the steel tip mechanism itself; see Figure 16. This failure location also coincides with the termination of the internal shear webs; see Figure 15.

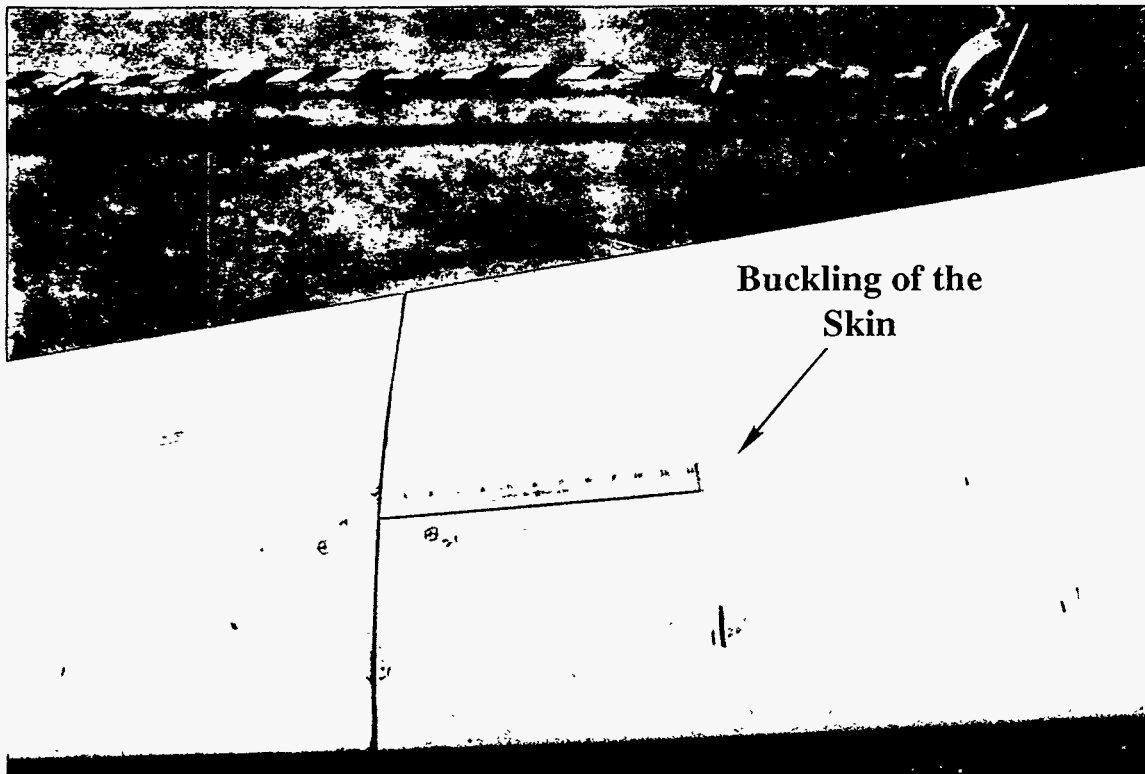
The Phase 1 test resulted in a failure of the blade at approximately station 240. This station is located approximately 12 in. (30.5 cm) inboard from the split line of the pitchable tip at station and approximately 6 in. (15.2 cm) inboard from the middle saddle used to load the blade. The failure occurred near the point where the internal spar (shear web) was terminated and the pitch shaft transitions to a smaller diameter shaft. The peak load recorded at failure was 3925 lb (17.5 kN) on the load cell; see Figure 6a. This load results in a root failure load of 72,528 ft-lb (97.9 kN-m). The bending moment at the failure location due to the force on the outer two saddles was 3596 ft-lb (4.8 kN-m). The failure appeared as a cordwise crease in the skin on compression surface.

**Figure 16. Blade failure for Phase 1 loading, buckled skin at station 240.**

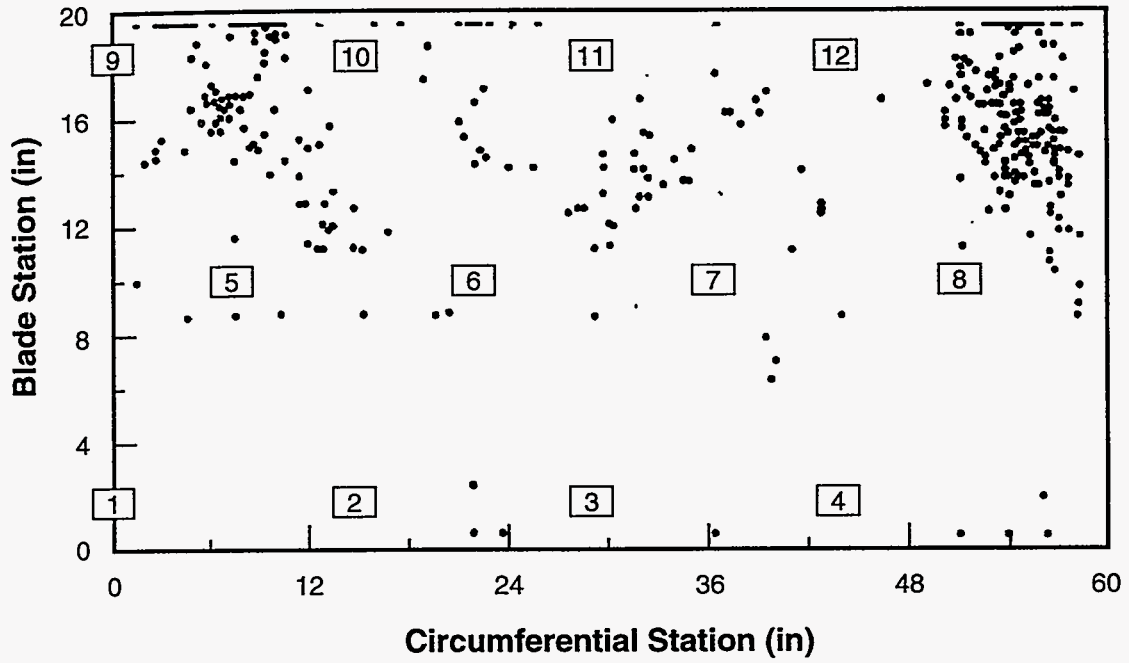
Figure 20a. Root region.

Figure 20a is the "location plot" for the AE events in the root of the blade during Phase 1 loading of the blade. As can be seen in these plots, most of the emissions came from the compression side (top) of the blade, between transducers 9 and 12. As seen in this plot, the events were located primarily between blade stations 12 to 20. Figure 20b shows a similar plot along the length of the blade. There was a small cluster of events between stations 40 and 55, near sensor 14. Most of the events were from a region near station 240 (between sensors 20 and 21).

Figure 21a shows the AE events in the root of the blade plotted as a function of the load on the blade. In this plot, the number of AE events for transducers 1 through 12 is summed together to get the total number of events emanating from the root of the blade. The large number of events noted in this figure implies that significant damage may be accumulating in the root of the blade. However, the location graph, Figure 20a, illustrates that the damage is

For Phase 1 and 2a loadings (see Figures 20a and 23a), there was, more or less, a random scattering of located events in the root region. Most of the events were in the band that lies between blade stations 12 and 20. In this band, there was some concentration of AE events on the top of the blade and toward the leading edge. Sensor 9 (see Figure 19a) recorded the most AE events, but all of the sensors in the root region detected emissions. The total number of hits in the Phase 1 and 2a loadings ranged from 287 on sensor 3 to 2,625 on sensor 9. Figures 27a and 27b are plots of the total "energy" for the emissions detected by sensor 9 during Phase 1 and 2a loadings, respectively. In these plots, all events whose rise time was greater than one half the signal duration were ignored. These were mainly low amplitude emissions with signal characteristics that resemble noise more than acoustic emission. In these figures, the energy increases after a load step for all loads above 2900 lb (12.9 kN). If acoustic emissions do not cease almost immediately after a step in the load, then either a flaw is growing or, in this case, the stress level in the blade structure has exceeded the strength of the fiberglass. The location graphs (Figures 20 and 23) show that the damage is spread over a wide area in, more or less, a random fashion.

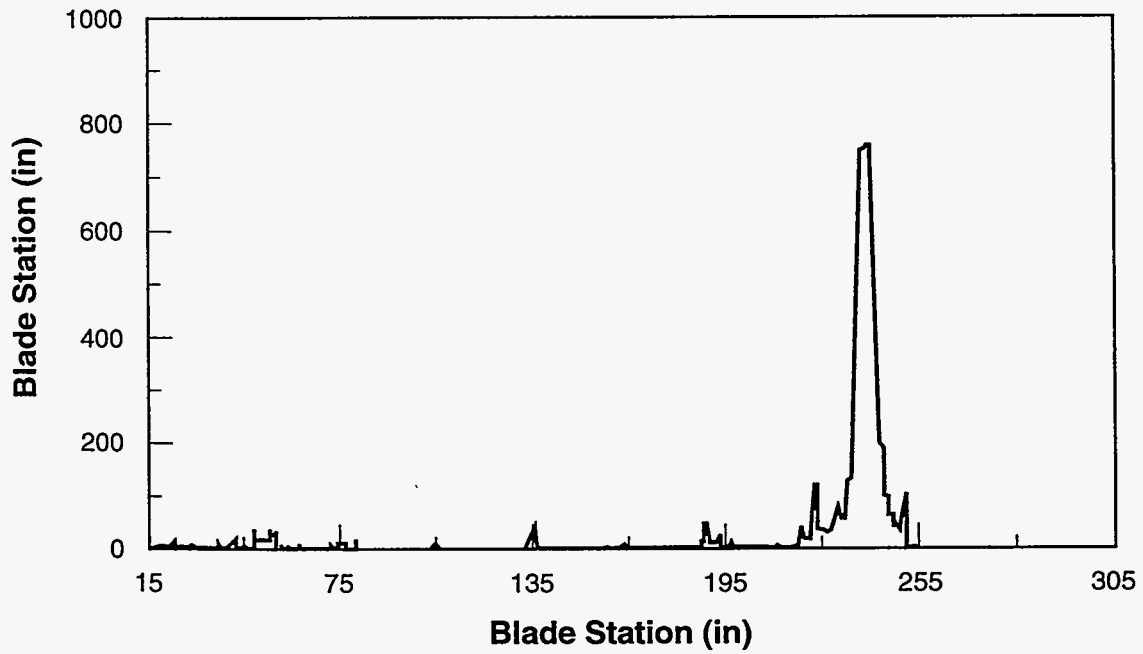
Figure 20b. Blade region.

Phase 1 loading produced a failure in the blade near the tip. The location plot for blade during this load cycle (Figure 20b) shows two regions with a clustering of event locations. One is between stations 40 and 56 and the second is between stations 234 and 242. Expanded location plots for these two regions are shown in Figures 29a and 29b. The events shown in Figure 29a started very early in the loading and continued at a moderate level for all three loadings. Figure 30 shows the acoustic "energy" detected at sensor 14 (station 48) versus the load for the three different loadings. For Phase 1 loading, there is more "energy" emitted during the increasing load than during load holds. However on each load hold over 4800 lb (21.4 kN), there is more "energy" emitted during the hold than during the loading, although the amount of emitted "energy" decreases after the hold at 7100 lb (31.6 kN). The emitting structure between stations 40 and 56 appeared to be reaching a point where all the material which could break, had broken and the rest was still capable of bearing the load at 8996 lb (40.0 kN). Upon sectioning of the blade in this region, it was found that one side of the box spar, which started at about station 37 and then ran most of the rest of the length of the blade, was debonded from the top skin in the region from station 37 to about station 50. Also found was a section of the skin on the top of the blade, about 5 in. (127 cm) wide and running from about station 37 to station 54, which was only

about one half the thickness of the rest of the skin in this area. The emissions observed in Figures 20b, 23b and 26b most probably come from the progressive debonding of the spar from the top skin. However it is possible that the thinned skin underwent some buckling and produced some of these emissions. A further examination of Figure 30 reveals that almost half of the energy emitted from this region occurred during the Phase 1 loads above 2400 lb. Relatively few of the emissions occurred at loads above 7200 lb.

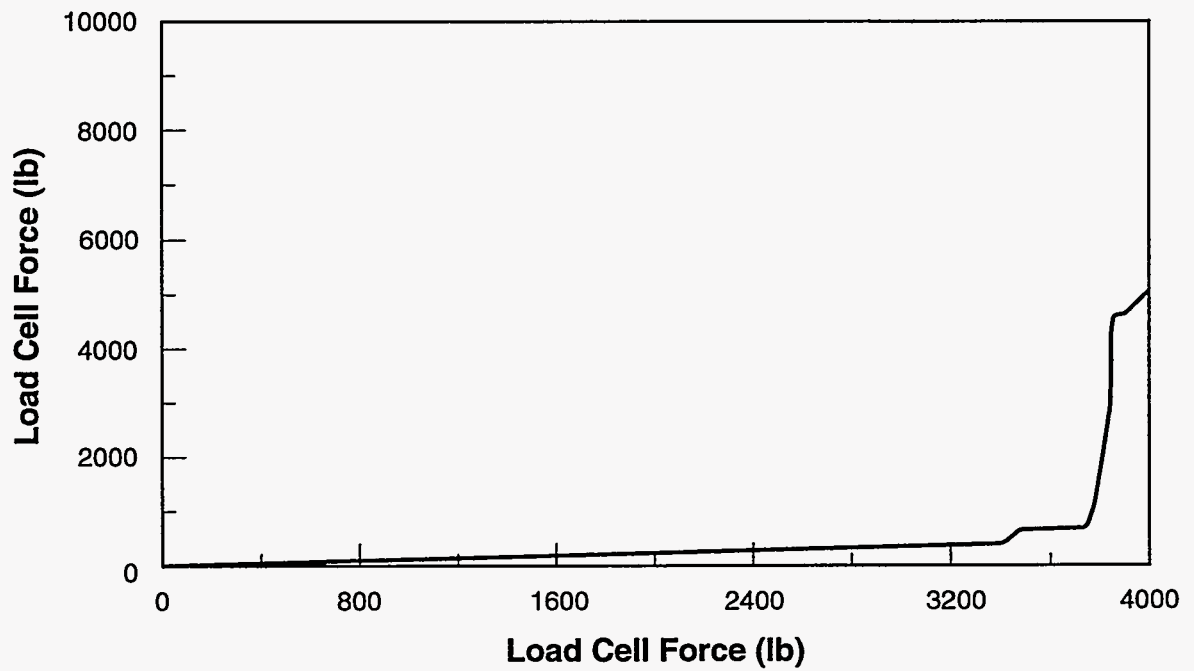
**Figure 21b. Blade region.**

widespread and not concentrated into a few serious flaws. Figure 21b shows the events versus load curve along the span of the blade; i.e., the AE events from transducers 13 through 23 are summed together. This plot indicates that the onset of failure started at about 2900 lb (12.9 kN) load; i.e., most of the AE events occur during the load step. As shown in Figure 20b, most of these AE events were clustered at or near the blade failure zone between stations 240 and 250.

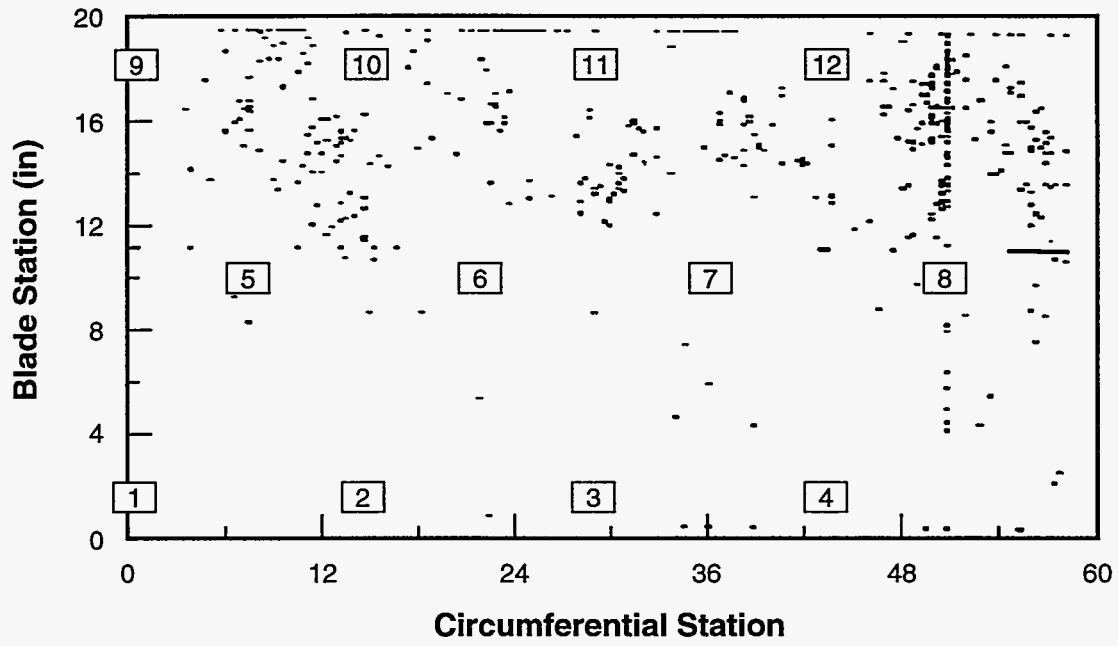
Figure 23a. Root region.

The root location plot is shown in Figure 23a. This figure is similar in appearance to Figure 20a, which shows the locations for this region during the Phase 1 loading. This figure shows continuing widespread damage and it indicates that flaws are coalescing into cracks and growing. The main difference between the two figures is the appearance of lines of located events near sensors 8 and 12. Both the vertical and horizontal lines shown in Figure 23a are artifacts of the location algorithm.\*

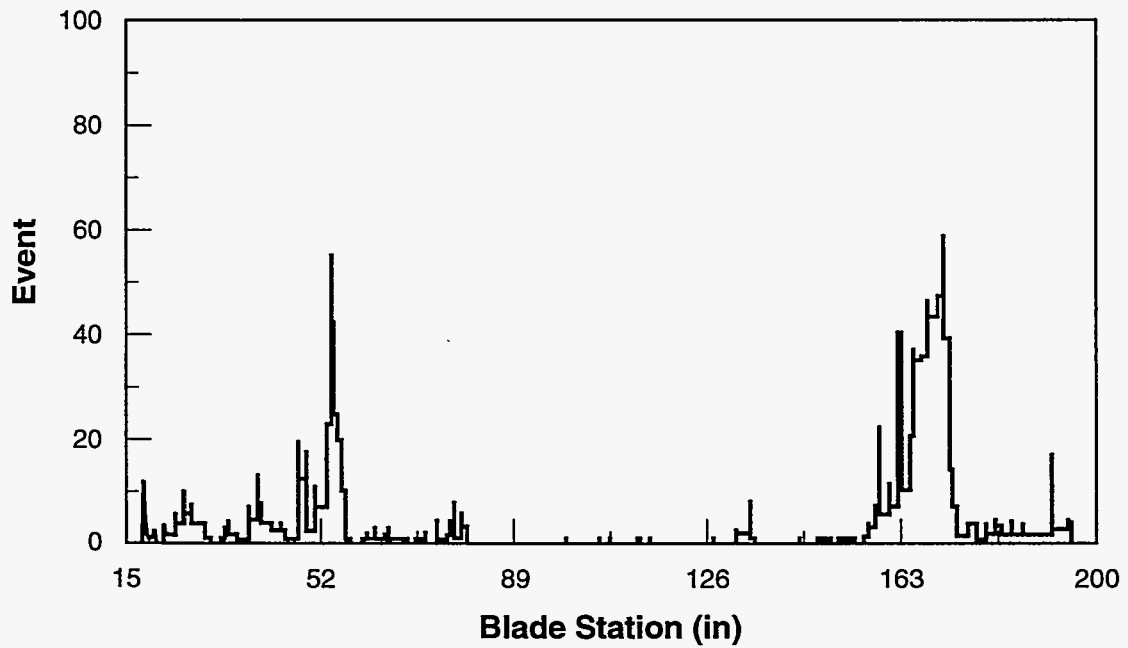
Figure 23b. Blade region.

Figure 23b shows the location graph for the blade region for Phase 2a loading. The emission near blade station 15, sensor 13, is an extension of damage seen in the root region. The events near station 50, sensor 14, are a continuation of the damage seen in Figures 20b. Note that the number of emissions from this area in the two figures is approximately the same. The emissions just beyond station 165, sensor 18, are emanating from the load fixture (saddle). As this fixture is being used to supply the entire load on the blade (one saddle instead of three), the bottom of the blade was beginning to crush.

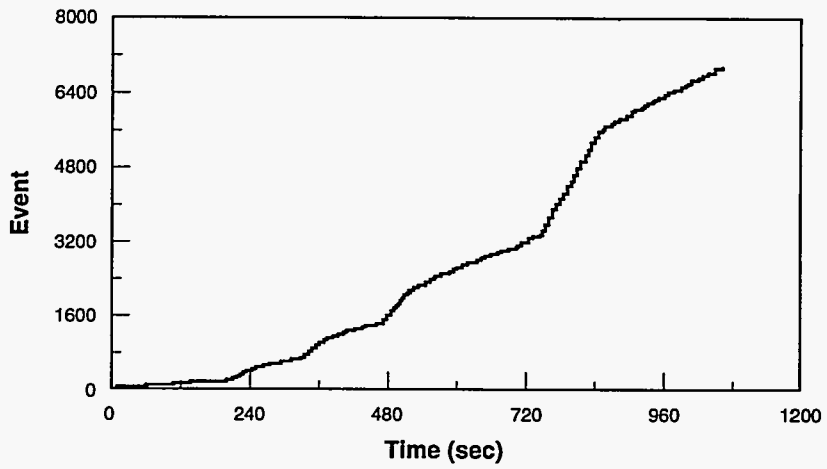
**Figure 25b. Root region.**

Figure 25b shows the events as a function of time for the root region of the blade. Notice that while there is some increase in the event rate during the loading, there are even more emissions for the loads above 7300 lb (32.5 kN), at approximately 480 seconds, right after a step in the load. This observation is indicative of a rapid increase of blade damage. The accumulation of damage slows as the stress is redistributed and the load drops. This figure also shows that there was steady damage growth between all load steps. Thus, blade failure probably would have occurred in this region for all loads above 6000 lb (26.7 kN), if the loads were held long enough.

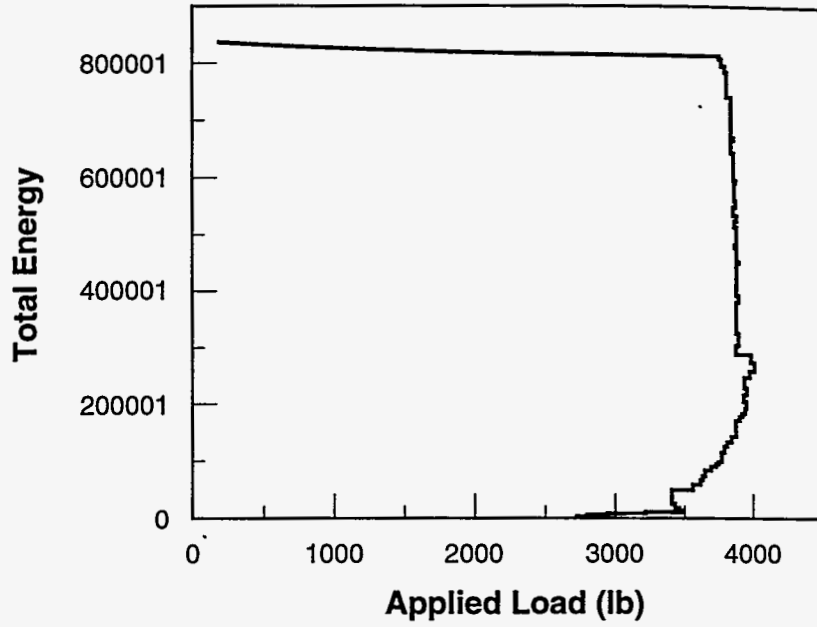
Figure 31. Total "energy" observed by sensor 21 during Phase 1 loading.

Figure 31 is the “energy” versus load curve for sensor 21 (station 250) during Phase 1 loading. This data is basically the “energy” for the events shown Figure 21b. Here the first emission is observed at 2800 lb (12.5 kN). Appreciable emissions begin during the load hold at 3500 lb (15.6 kN). Failure starts at approximately 3400 lb (15.1 kN) and continues to 3925 lb (17.5 kN). At this point there is a load drop, indicating structural failure, followed by large amounts of emissions, which was probably produced by tearing of the upper skin. Examining the sectioned blade, debonding of the strengthening web from the top skin was found from about station 230 to its end at station 239. There was also buckling and tearing of the top skin between stations 236 and 242. This is exactly the region of failure located in Figure 21b. Also shown in this figure is that almost no emissions emanated from this region for loads below 2800 lb (12.5 kN). During the Phase 2 loading, considerable emissions were detected in the region from station 155 to station 175; see Figure 32. The emissions from stations 163 to 175 are primarily caused by the bottom surface breaking up under the loading fixture. However this does not account for the events observed between stations 157 and 161.

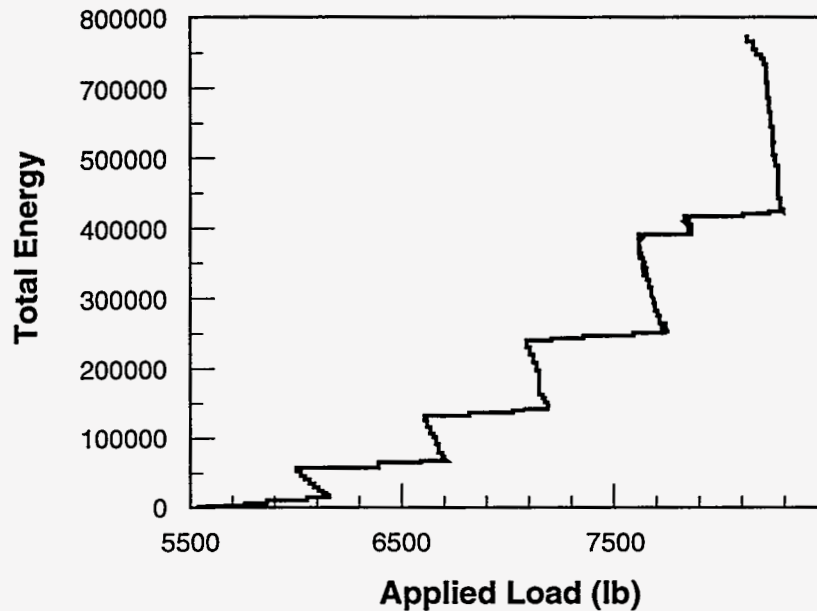
Figure 33. Total "energy" observed by sensor 18 during Phase 2b loading.

Figure 33 shows the detected acoustic “energy” from sensor 18 versus the load for phase 2 loading. Most of this energy comes from the breakup of the skin caused by the loading fixture. The blade was not sectioned in this region, but a piece from stations 132 to 138 shows debonding of the box spar from both the top and bottom skins. It is probable that such debonding was present along much of the blade during this loading. While this loading broke the blade with appreciable violence, the acoustic emission pulse associated with this failure has not been identified. The failure appeared to start near the trailing edge of the blade and the foam inserts could have damped the wave to the point where it was indistinguishable from other emissions. There was also bond failure between the top and bottom skins at the leading edge.

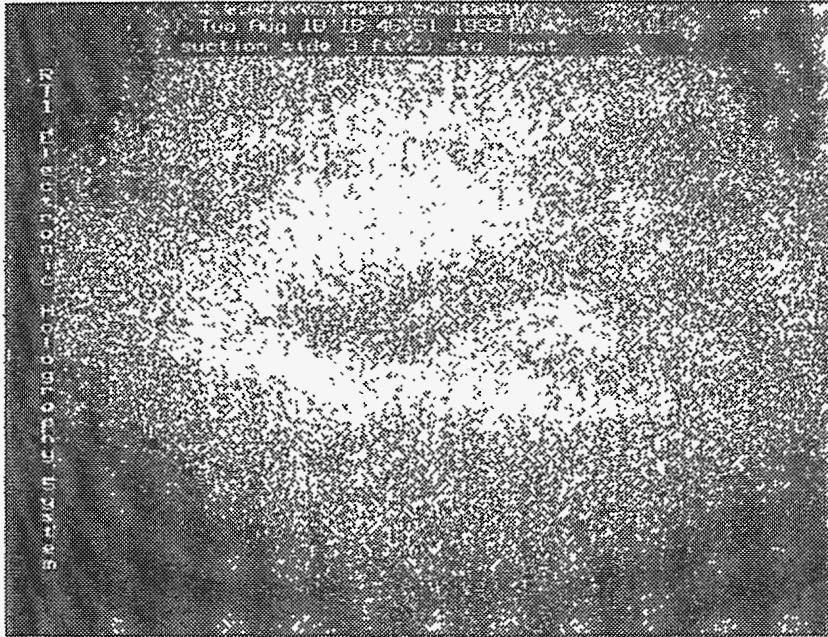
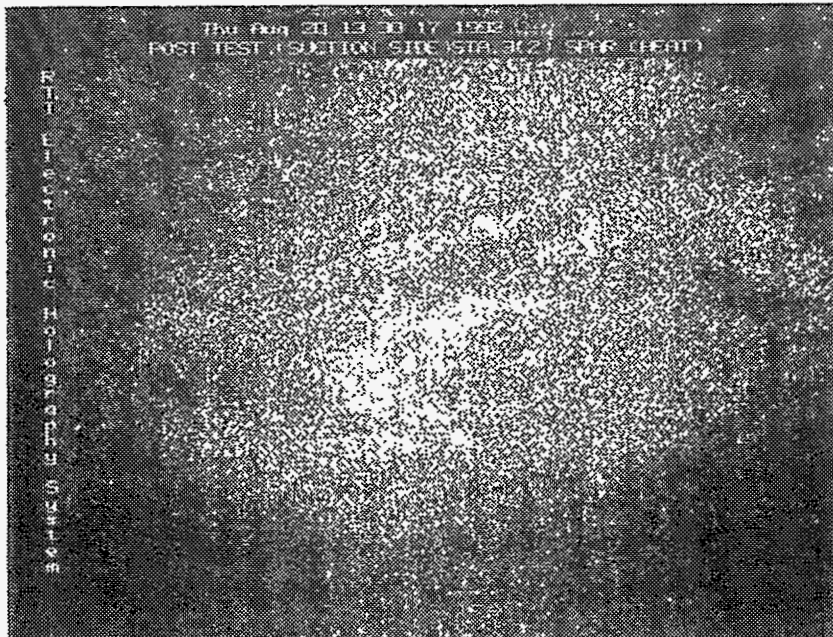
**Figure 38. Shearograms using thermal stress, station 36 to 48.**

The area between stations 36 to 48 was inspected after the test, again using thermal stress. Figure 38 shows shearograms of this area, before and after the blade test. It appeared that the anomaly grew during the test. The post-mortem of this area showed a debonding of the spar and the skin (also discussed above). The original indication of a suspected "problem" in this area can be attributed to a thinning of blade skin. Shearography indicated that the deformation of this section was significantly different from its surroundings. The post-mortem was required to determine that the difference was attributable to a thin skin.

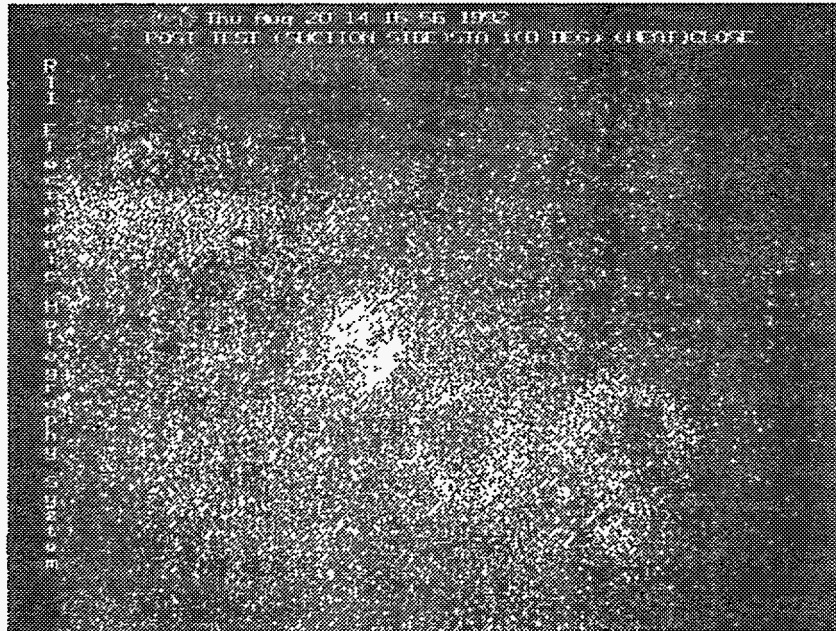
Several small flaws were noted and marked on the blade skin during the pre-test examination. Two flaws, near the transition from the circular root to an airfoil blade section, had significant AE activity during the blade loading. Post-test shearographic inspection of this area using thermal stress revealed that the two flaws had grown in size. Both flaws appeared to be small [approximately 1.4 in. (3.5 cm) in diameter], near-surface delaminations, and probably were not structurally significant. A shearogram of one of these flaws is shown in Figure 39. A post-mortem examination of one of the flaws showed that it was a region of high porosity (a manufacturing "bubble") near the surface of the blade. Under microscopic examination, the flaw showed evidence that it had grown (approximately doubling in size) during the course of the experiment.

**Figure 39. Shearogram of the flaw at station 24. The two circles with dark centers are where acoustic emission sensors 13 and 9 were located—the remaining adhesive caused these indentions. The bright circle above and left of the transducer locations is the flaw.**

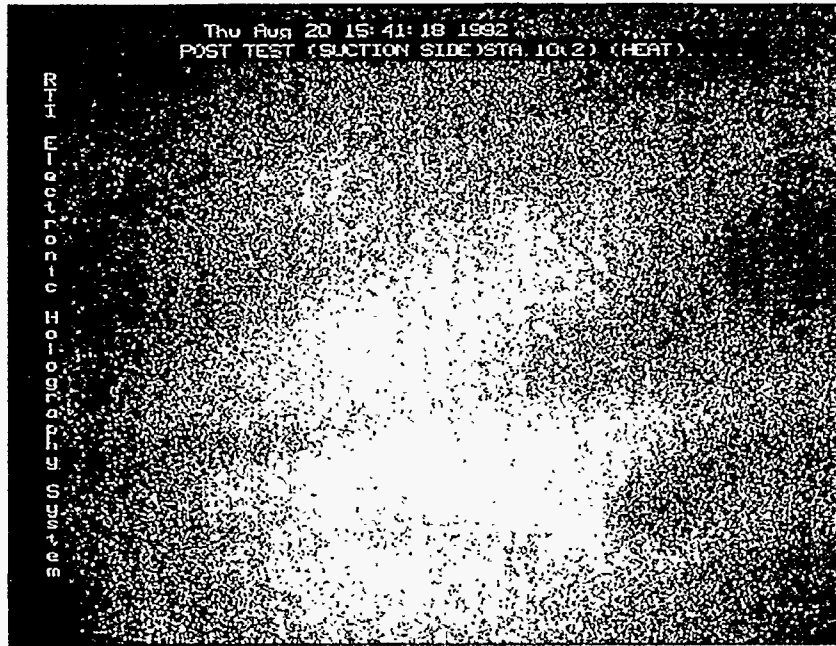
After the blade failed, there was clearly a delamination between the spar and the skin in the area of failure. This area was examined with shearography, again using thermal stress, to determine how well shearography could locate the end of the debonded area. The shearographic image indicated a discontinuity starting at about station 224.

**Figure 40. Post-test shearogram of the spar/skin bond failure, station 120 to 132. The dark areas at Station 124 are the end of the bonded area.**
