ANL-79-56

ARGONNE NATIONAL LABORATORY
9700 South Cass Avenue
Argonne, Illinois 60439

MATERIALS TECHNOLOGY FOR
COAL-CONVERSION PROCESSES
Seventeenth Quarterly Report
January—March 1979

W. A. Ellingson
Program Manager
Materials Science Division

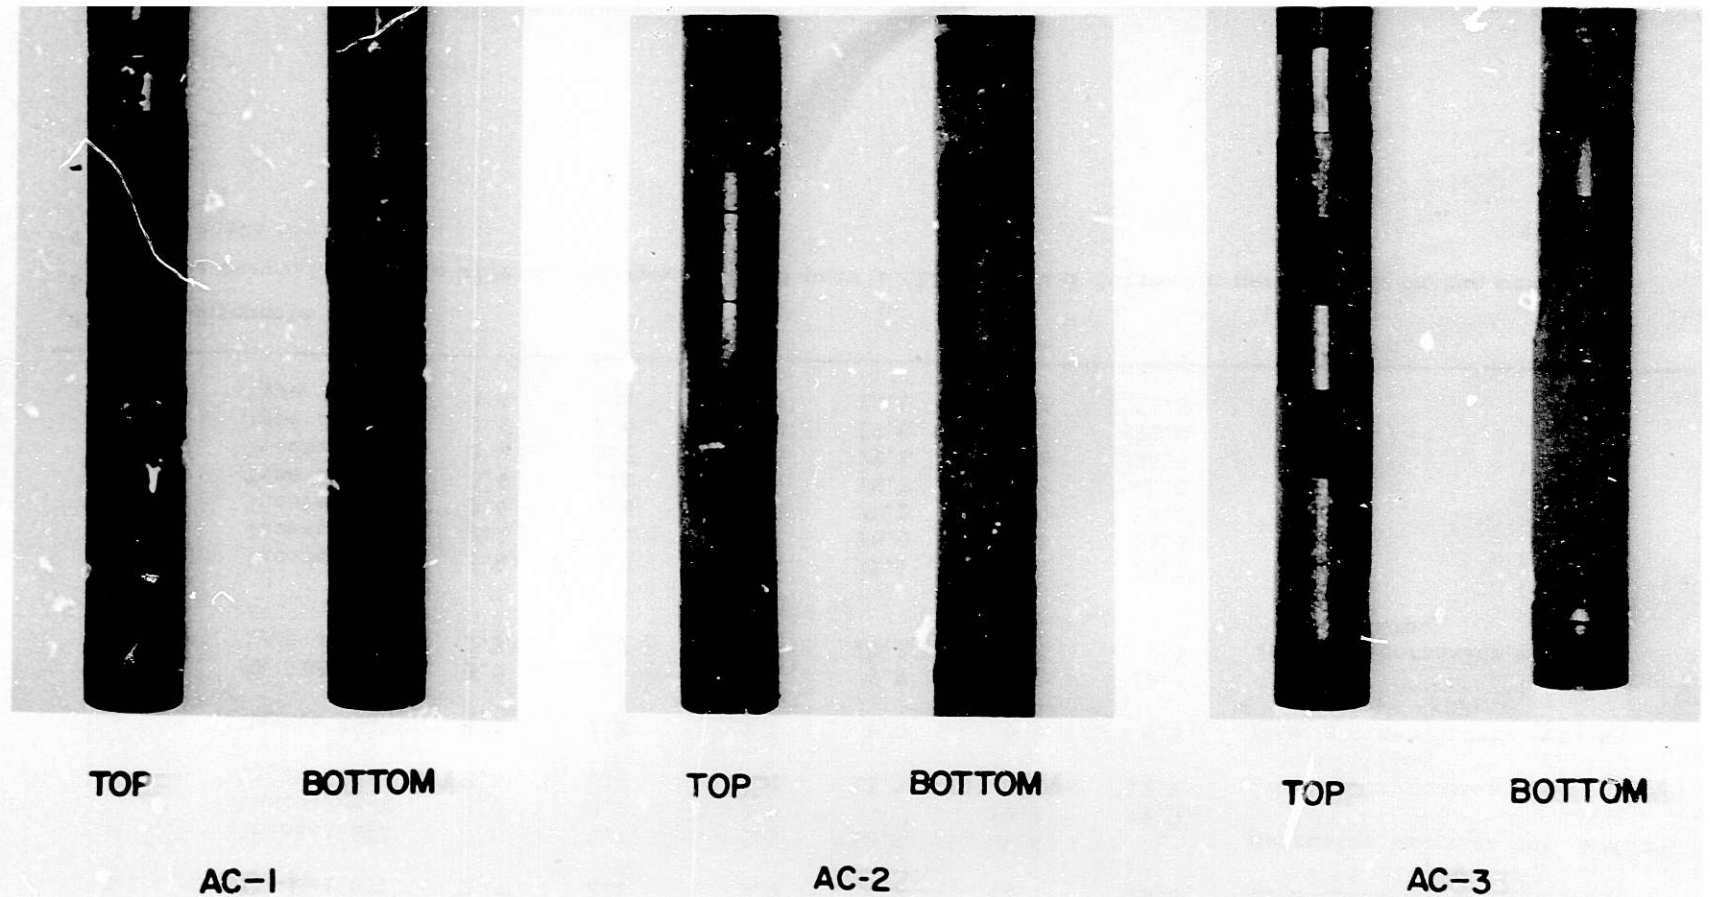
Fig. 39. Top and Bottom Views of Air-cooled Probes from Corrosion Test Run CT-4. Specimens stacked from top to bottom according to the sequence given in Table XI. ANL Neg. No. 306-79-386.

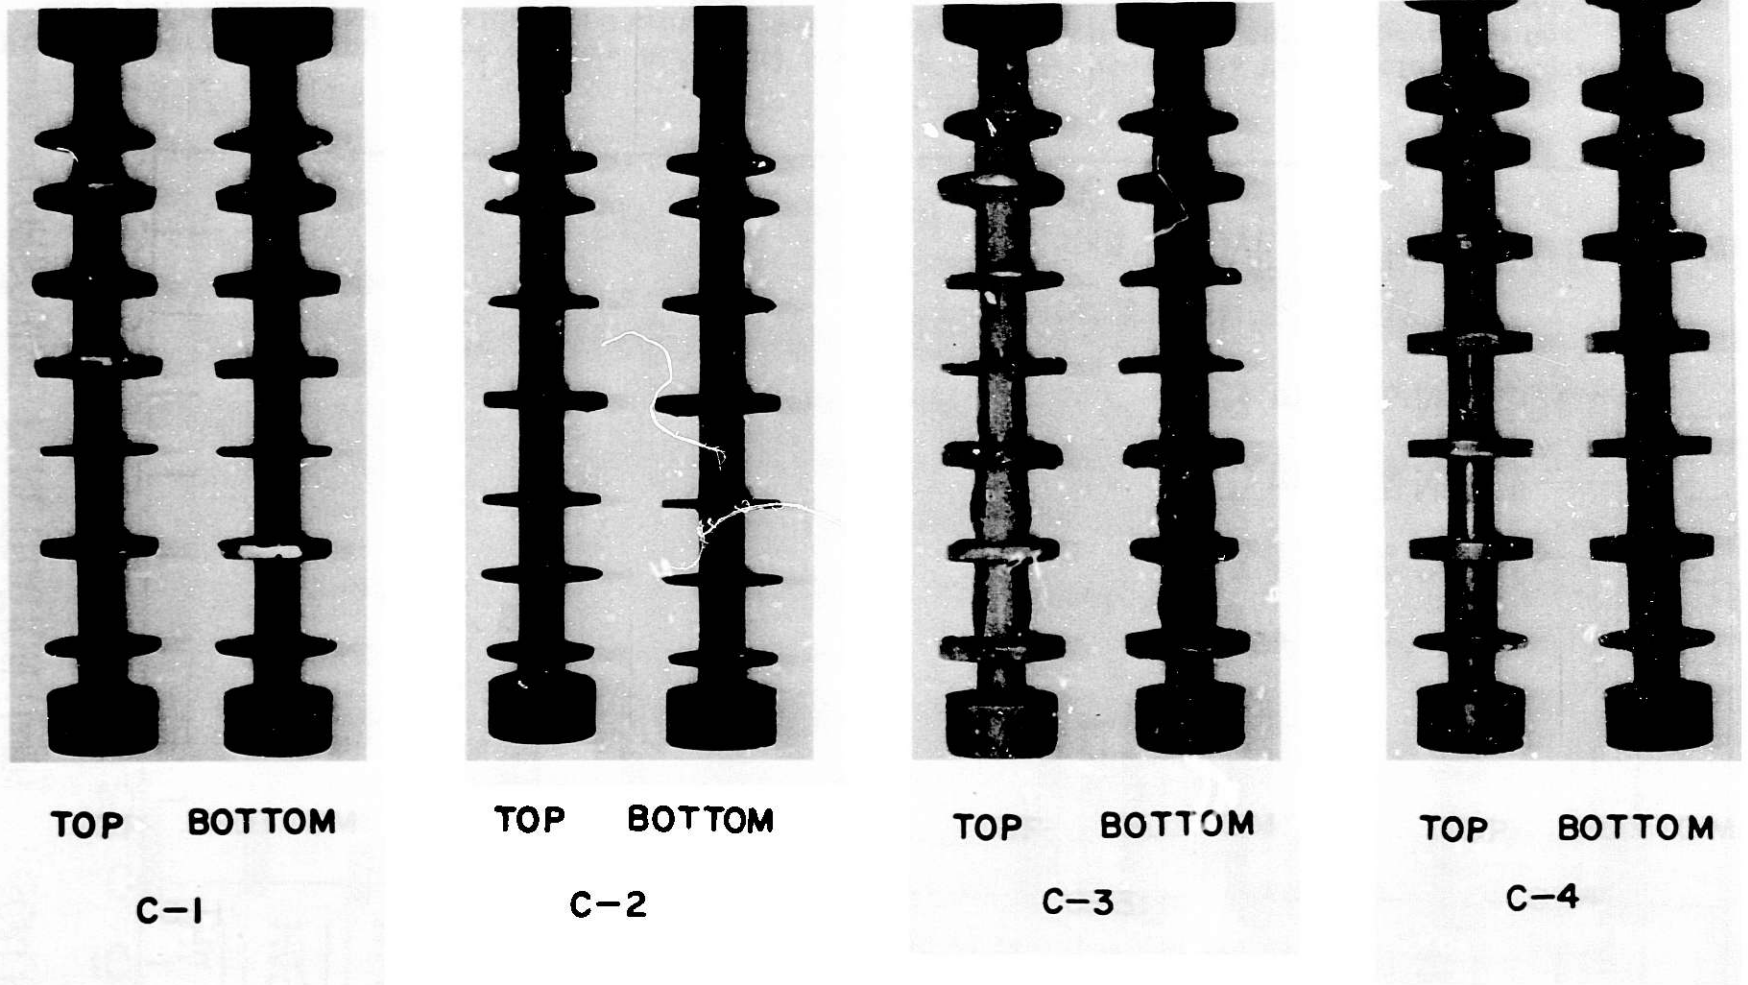
Fig. 40. Top and Bottom Views of Coupon Holders from Corrosion Test Run CT-4. Specimens stacked from top to bottom according to the sequences given in Table XI. ANL Neg. No. 306-79-385.

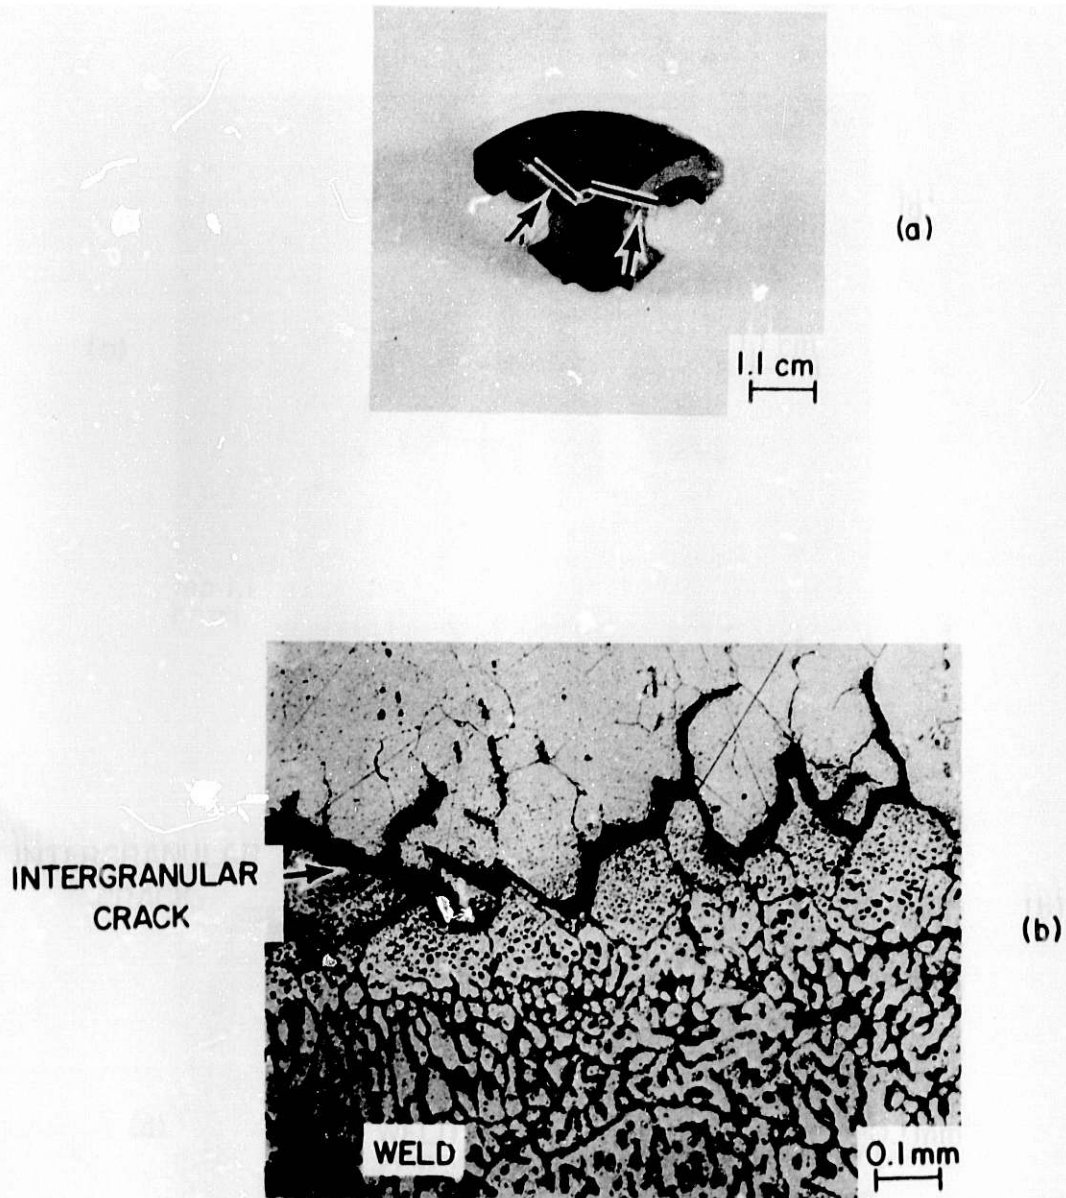
Fig. 50. (a) Optical Photograph of the South Tuyere Tip; (b) Micrograph of Polished and Etched Cross Section through the Region Indicated in (a). Intergranular cracks can be seen at the weld-base metal interface. ANL Neg. No. 306-79-550.

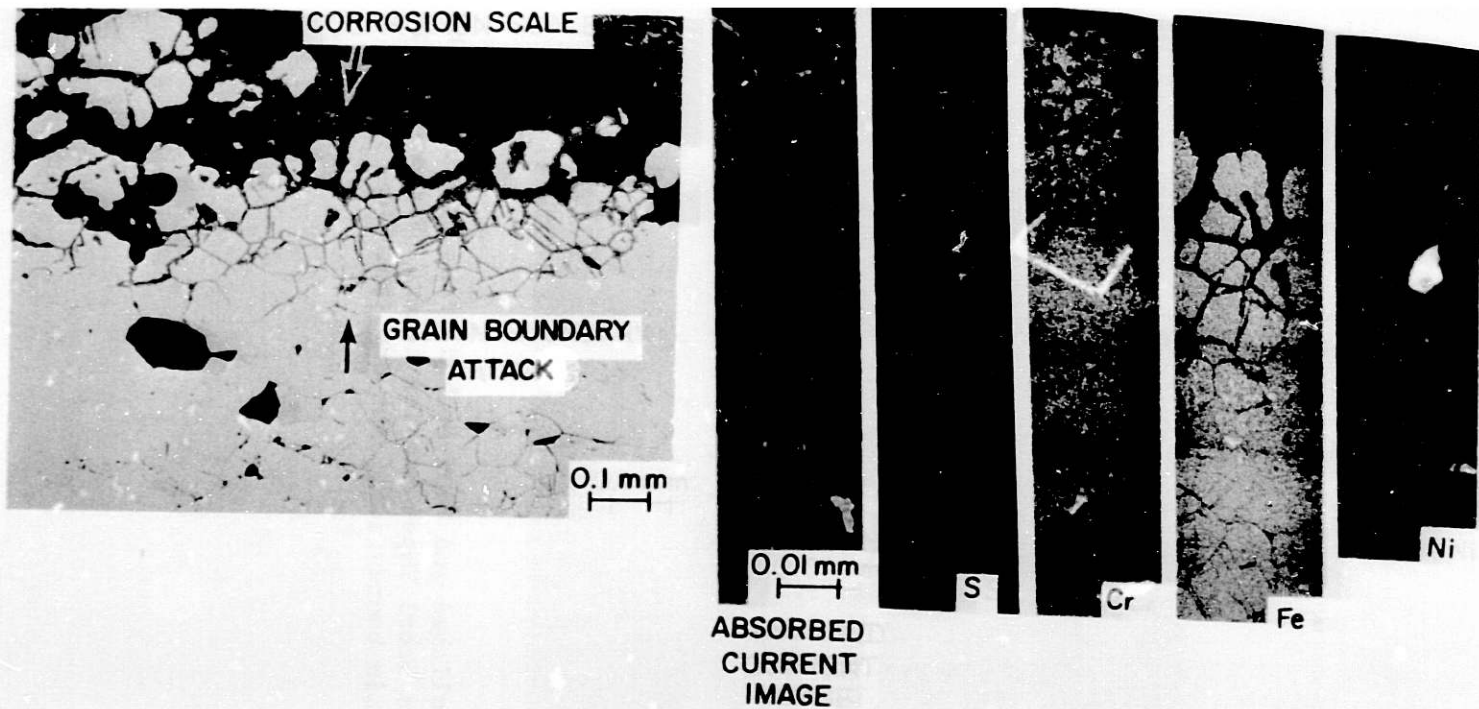
Fig. 51. (a) Micrograph of a Cross Section of the Type 310 Stainless Steel Vapor-barrier Liner; (b) Electron Microprobe Results Showing the Absorbed-current Image and the Sulfur, Chromium, Iron and Nickel Distributions in the Corrosion Scale. ANL Neg. No. 306-79-546.

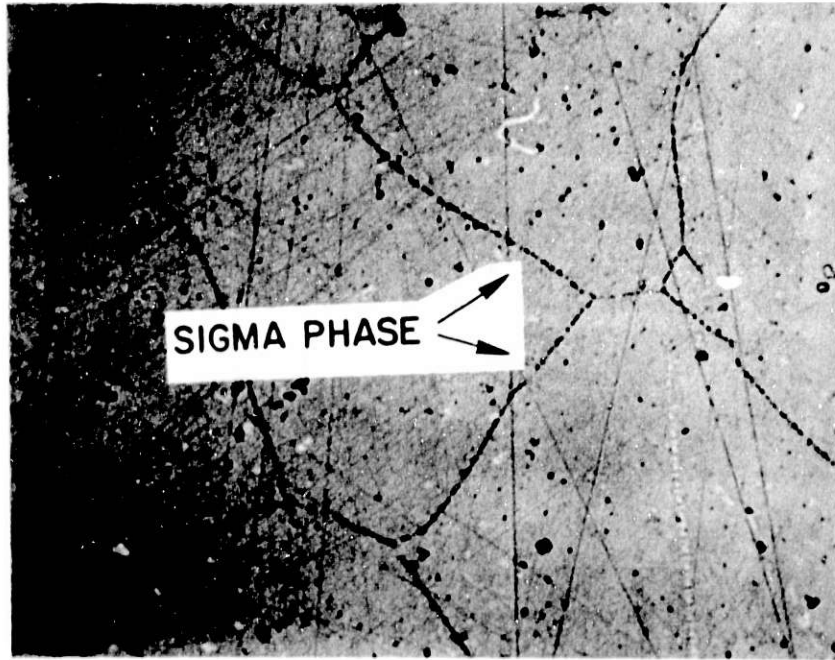
Fig. 52. Micrograph of a Polished and NaOH-etched Cross Section of the Type 310 Stainless Steel Vapor-barrier Liner. Sigma phase is evident at the grain boundaries. ANL Neg. No. 306-79-551.

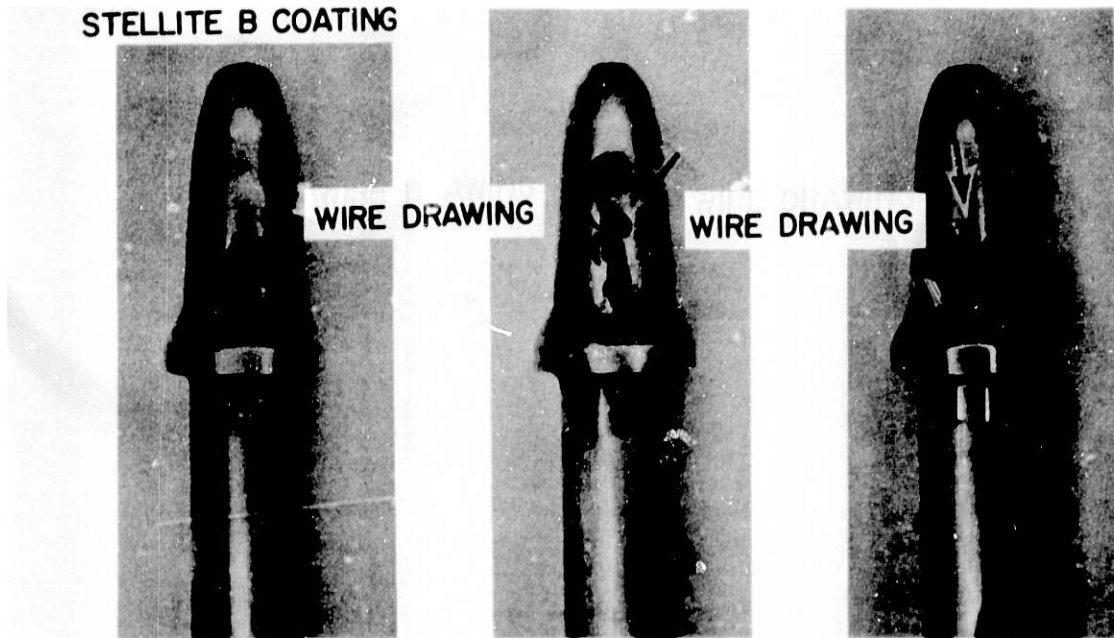
Fig. 54. Photographs of the Stems from the Failed Flow-control Valves. All are of Type 316 stainless steel. The stem at the left is coated with Stellite B. ANL Neg. No. 306-79-544.

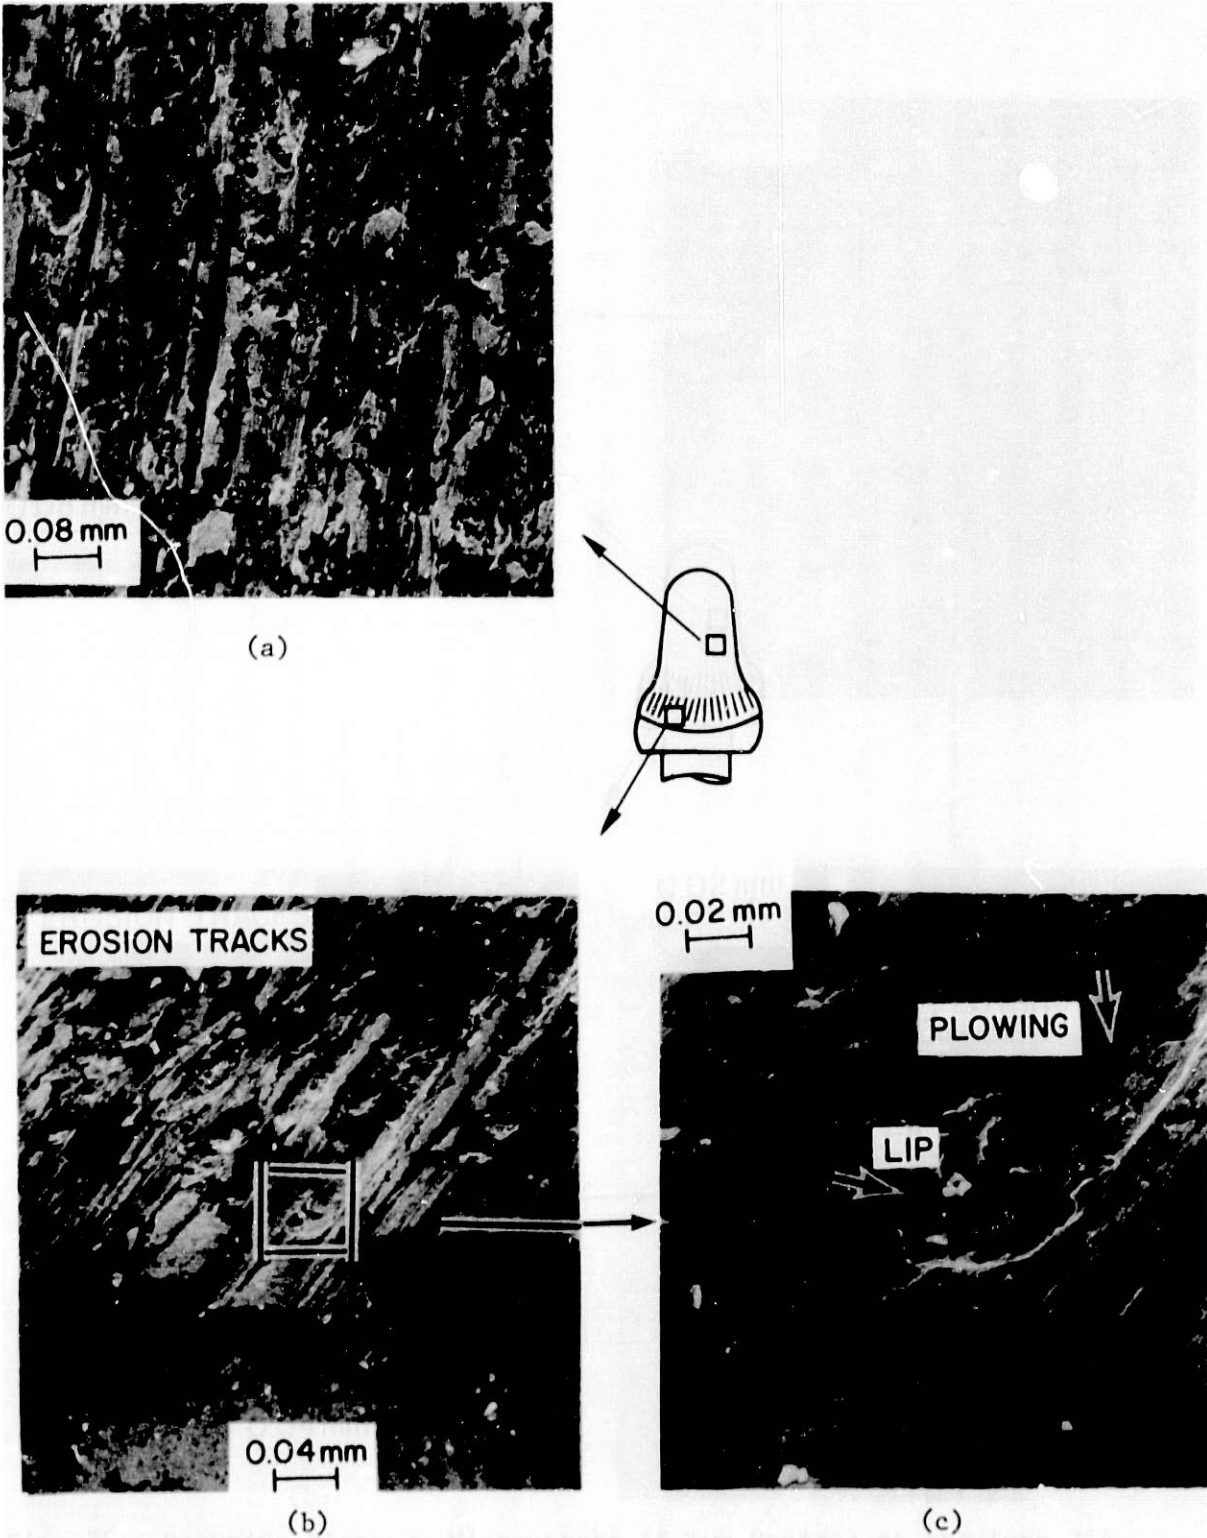
Fig. 55. Scanning Electron Micrographs of Two Regions of the Type 316 Stainless Steel Valve Stem Shown at the Center of Fig. 54. Both regions show metal smearing due to solid-particle impact. Plowing is the dominant erosion mechanism, as evidenced by the material buildup and lip formation visible in (c). ANL Neg. No. 306-79-545.

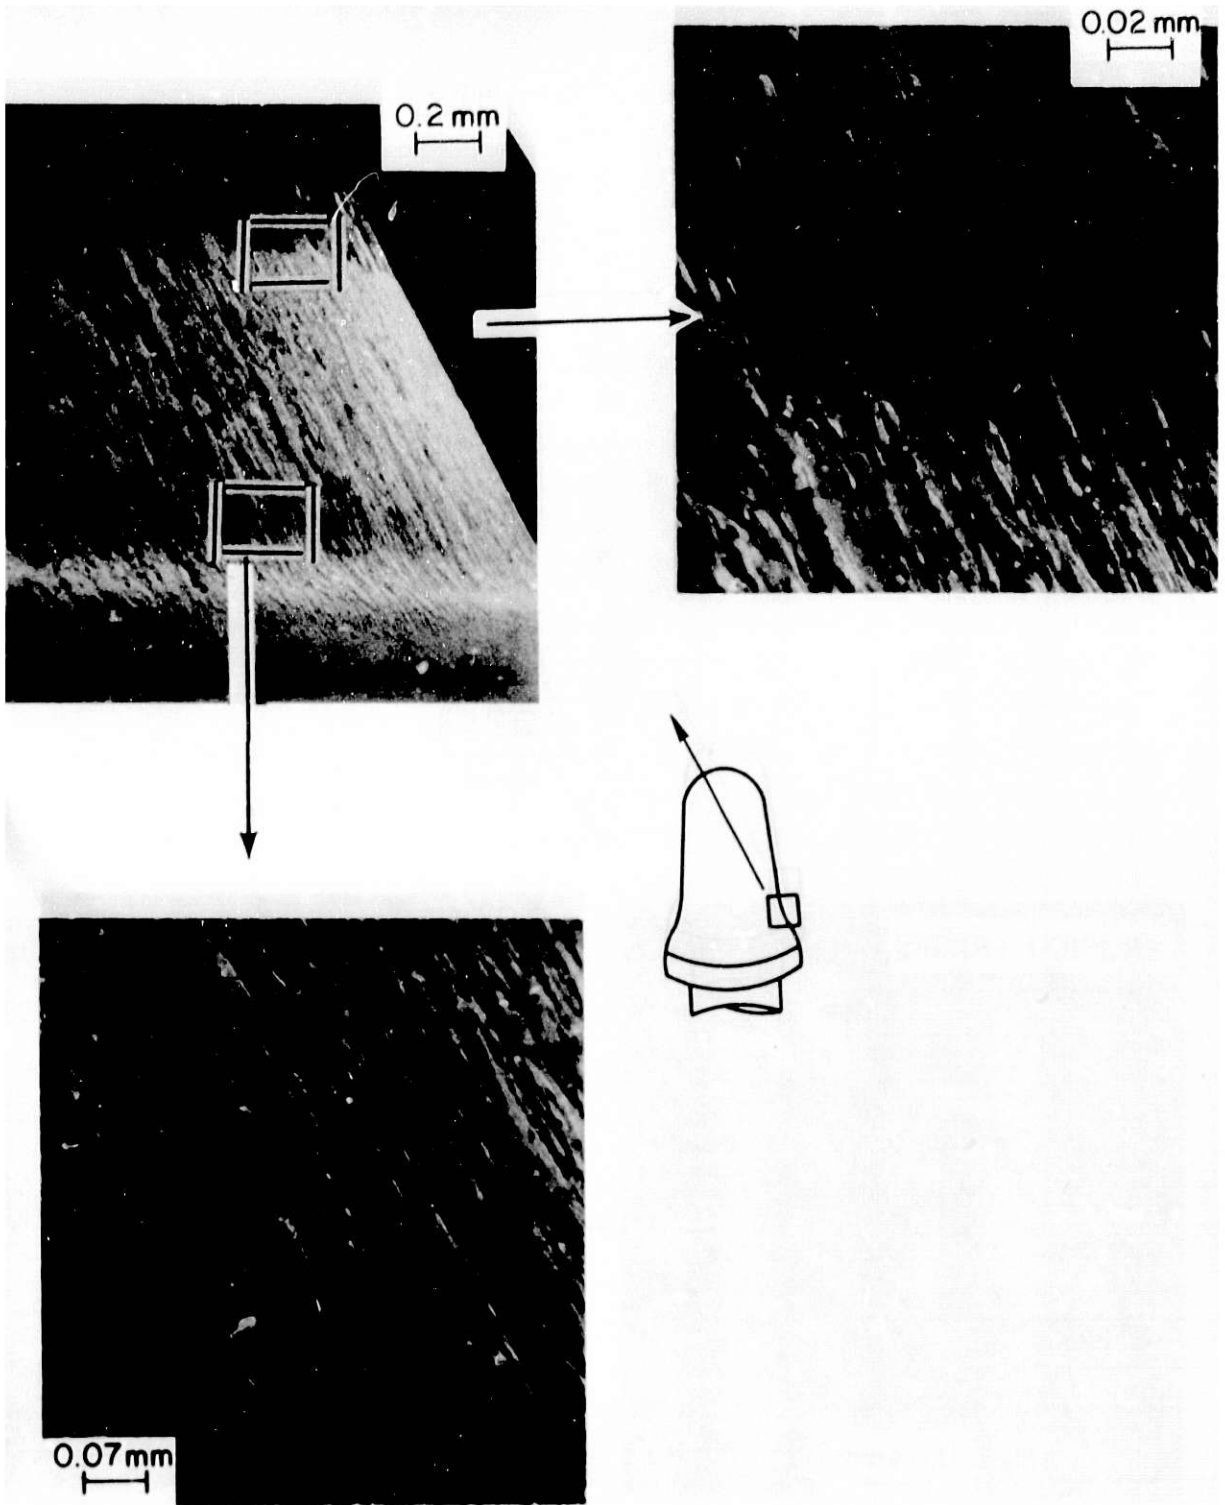
Fig. 56. Scanning Electron Micrographs of Two Regions of the Type 316 Stainless Steel Valve Stem Coated with Stellite B. The micrographs show the solid-particle erosion that occurred in regions subject to low (top) and high impact angles. ANL Neg. No. 306-79-542.
