**MATERIALS TECHNOLOGY FOR
COAL-CONVERSION PROCESSES**

**Progress Report for
July—September 1980**

ARGONNE NATIONAL LABORATORY, ARGONNE, ILLINOIS

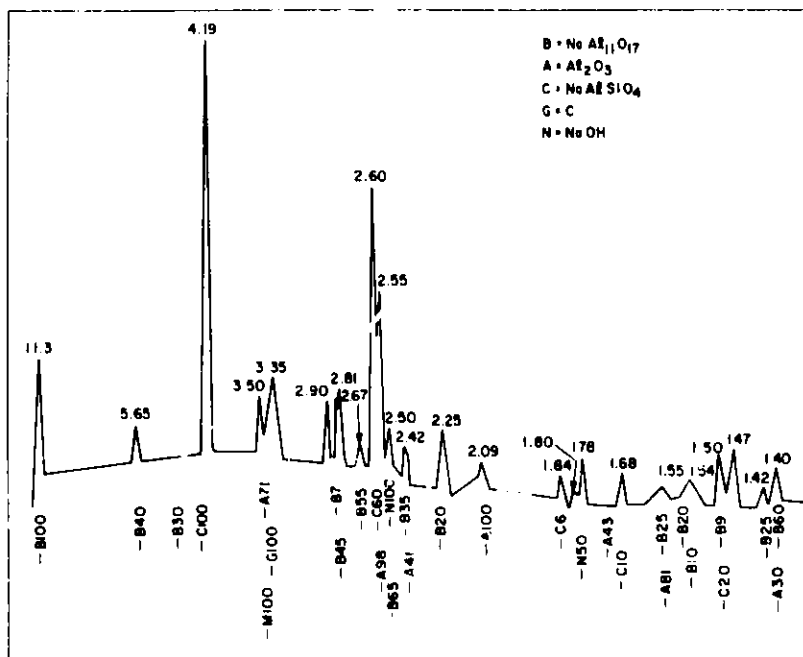
X-ray analysis of the exposed specimen (Fig. 3) indicated that the mullite had been almost completely converted into carnegieite (NaAlSiO_4) and beta-alumina ($\text{NaAl}_{11}\text{O}_{17}$). Minor amounts of mullite, alumina, carbon, and NaOH were detected. The x-ray pattern of high carnegieite, although not a perfect fit, was closer to the observed pattern than was low carnegieite. The presence of nepheline could be definitely ruled out. Since the high form of carnegieite is stable only above 1250°C , it is possible that the gasifier was operated, at least for a short time, above the reported temperature of $1000 \pm 150^\circ\text{C}$. SEM-EDX confirms the existence of a major phase containing Na-Al-Si and a secondary Na-Al phase (Fig. 4).

Fig. 3. X-ray Diffraction Pattern Showing Intensity Versus "d" Spacing for the Exposed Mullite Sample. The position and intensity of the peaks or the beta-alumina (B), alumina (a), carnegieite (C), carbon (G), and sodium hydroxide (N) diffraction patterns are shown at the bottom of the pattern.

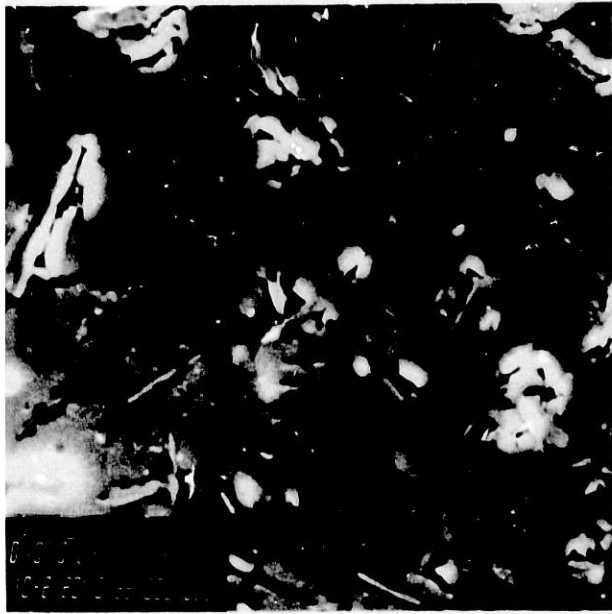
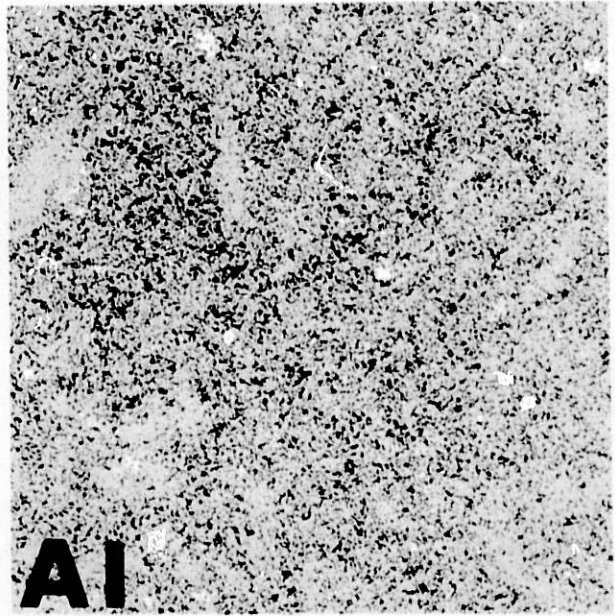
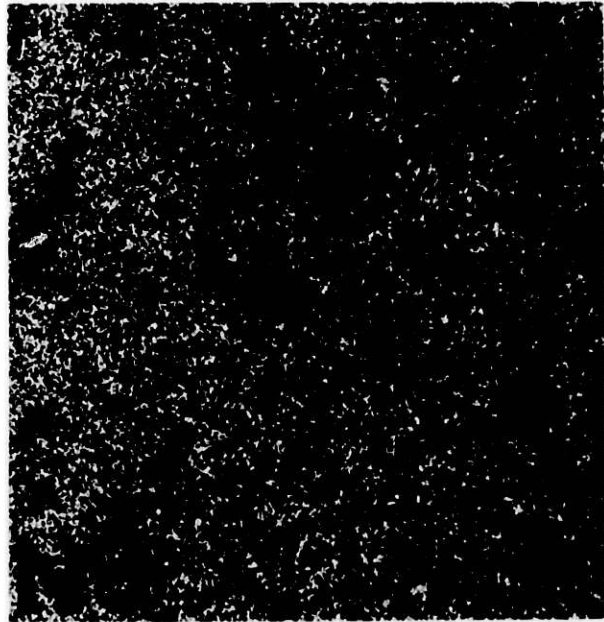
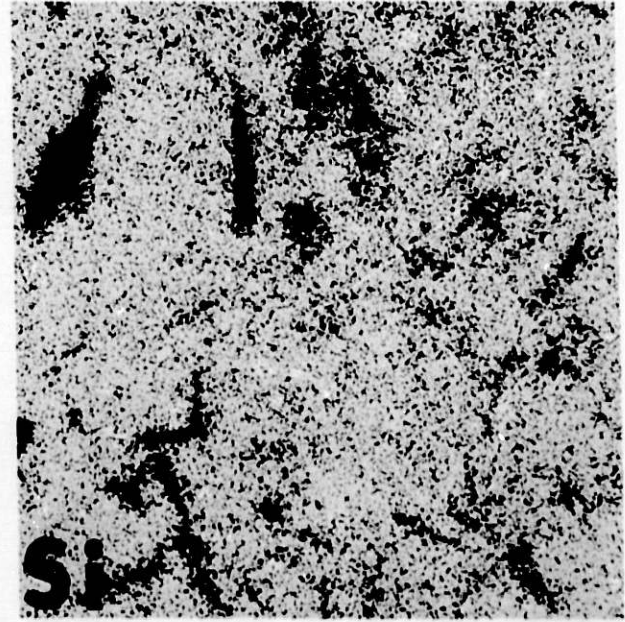
GFETC EXPOSED

Fig. 4. SEM Micrograph and Elemental Scans of the Exposed Refractory Sample.

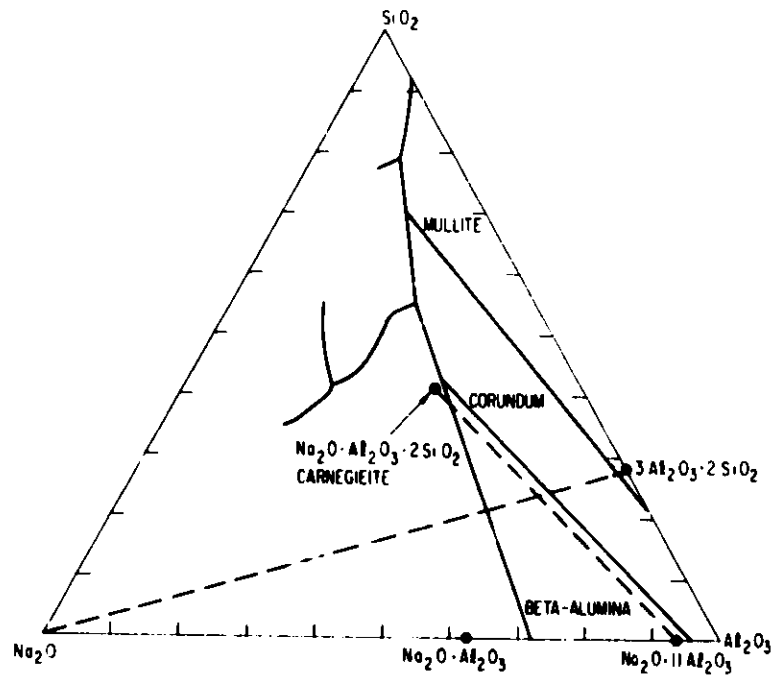
This reaction can be depicted graphically on the $\text{Na}_2\text{O}-\text{SiO}_2-\text{Al}_2\text{O}_3$ phase diagram (Fig. 5) if Na_2O is substituted for 2NaOH . According to the lever rule, a reaction between a Na compound and mullite should produce ~ 40 wt% β -alumina and 60 wt% carnegieite. If the volume of the Na species is ignored, this reaction has $\sim 30\%$ volume expansion associated with it, easily explaining the observed failure.

Fig. 5. Equilibrium Phase Diagram of the Na₂O-SiO₂-Al₂O₃ System. Dotted lines indicate the reaction according to the "center of gravity" principle.

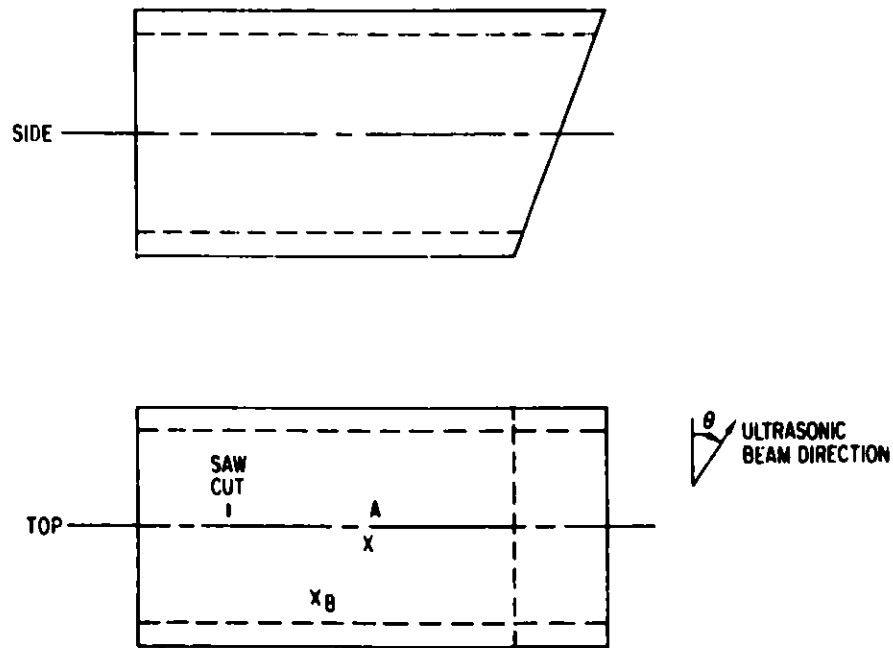
In October 1979, ultrasonic echoes were observed during an in-service ultrasonic shear-wave inspection of a bend in a 4-in. Type 347 stainless steel pipe at the SRC II plant in Ft. Lewis, WA (pipe identification #4-in.-SL-16-A6). The echoes were thought to be from ~ 0.1 -mm (0.004-in.)-deep cracks on the pipe inner surface. Argonne National Laboratory was asked to help identify the source of these ultrasonic echoes. A general examination of the elbow section received from SRC indicated a hard scale of varying thickness [generally of the order of 0.13-0.5 mm (5-20 mils)] on the inner surface, but no obvious cracking. An ultrasonic examination of the pipe was carried out at ANL using 45° and 60° angle-beam shear waves operating at frequencies of 2.25 and 10 MHz. Indeed, several echoes were observed, suggesting cracks at the inner surface. However, no cracks were found upon close examination of the specific region where they were expected. This examination included sectioning and grinding of a piece of the piping in an area where a reflector was indicated.

Fig. 9. Schematic of Type 347 Stainless Steel Pipe Section, Showing Locations of 0.13-mm (5-mil)-deep Saw Cut and Two Flaw Indications (A and B).

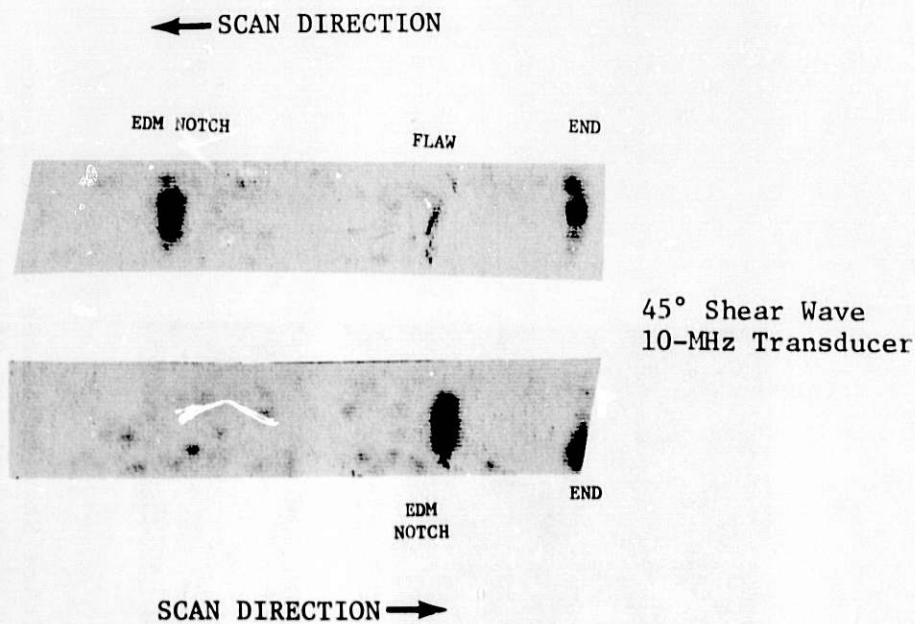
Fig. 11. Gray-scale C-scan Recordings of Specimen Shown in Fig. 10. Two scan directions are indicated. A 10-MHz, 1/2-in.-dia Aerotech immersion transducer was used to generate 45° shear waves.

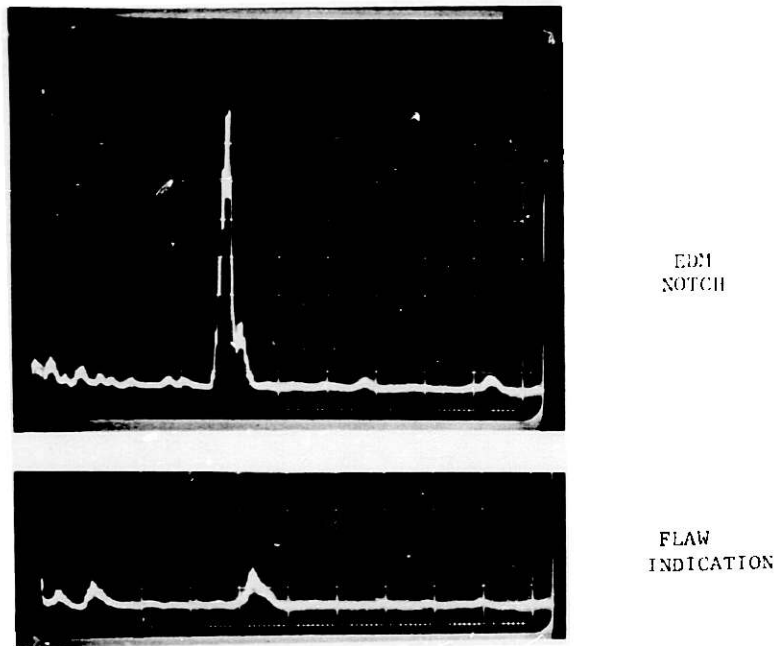
Fig. 12. A-scan Trace Showing Echoes from Reference Notch and Flawed Region of Pipe Section Shown in Fig. 10. A 2.25-MHz, 1/4-in.-dia Aerotech miniature 45° shear-wave transducer was employed. Beam direction (along the pipe axis) and equipment settings are the same for both traces.

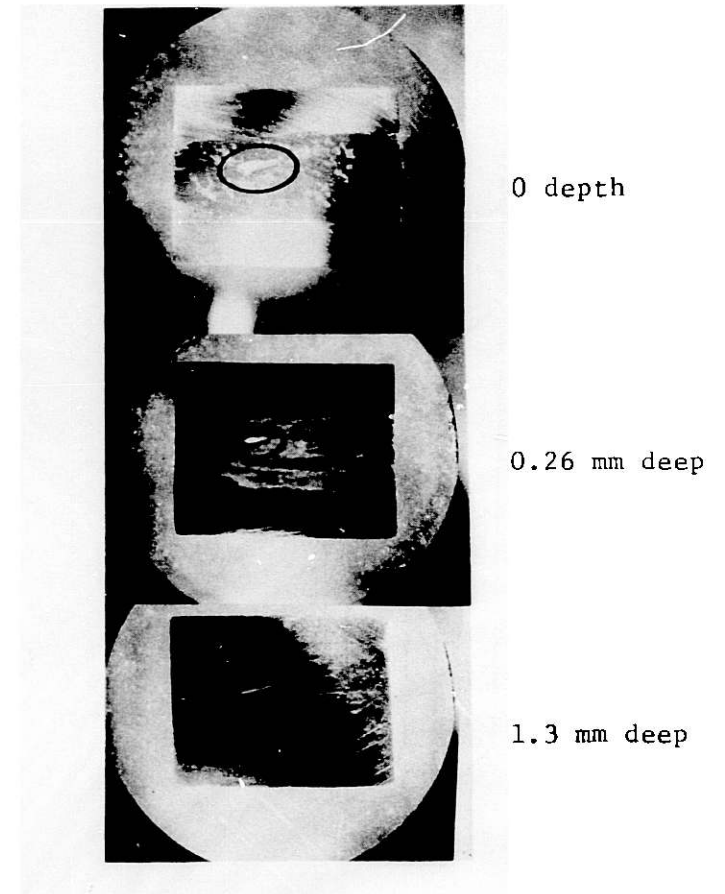
1. The main conclusion is that ultrasonic shear-wave reflections near the inner wall of a pipe cannot be considered a priori evidence of cracks. In at least one case, ultrasonic echoes detected in a Type 347 stainless steel pipe were reflections from a deep subsurface blister containing a cluster of nonmetallic particles. The cluster may have been present in the steel as a result of processing (e.g., trapped slag). Once in the steel, it may have served as a preferred scale-buildup site and caused the large blister to form; alternatively, the cluster may have formed as a result of scale buildup, and may represent accelerated localized oxidation.

Fig. 13. Cross Section of Blister at Various Depths of Grinding. The circular field of view is 25 mm in diameter.

2. The use of both 45° and 60° angle-beam probes during shear-wave ultrasonic testing is recommended to help increase the probability of identifying the cause of reflections. Crack-like flaws at the inner surface will probably cause detectable ultrasonic echoes with both 45 and 60° probes (as do EDM notches); however, other types of flaws, such as those found in the present examination, may not be detected or may generate much weaker signals with the 60° probe than with the 45° probe.

3. Normal-incidence longitudinal waves (up to 15 MHz) should also be used to interrogate a suspect pipe region. With normal-incidence longitudinal waves, the presence of echoes not identified as inner-wall reflections would indicate laminar-type defects, voids, or blisters. However, depending on the equipment used, such defects could also be present without generating discernible longitudinal-wave echoes, as in the example reported here.

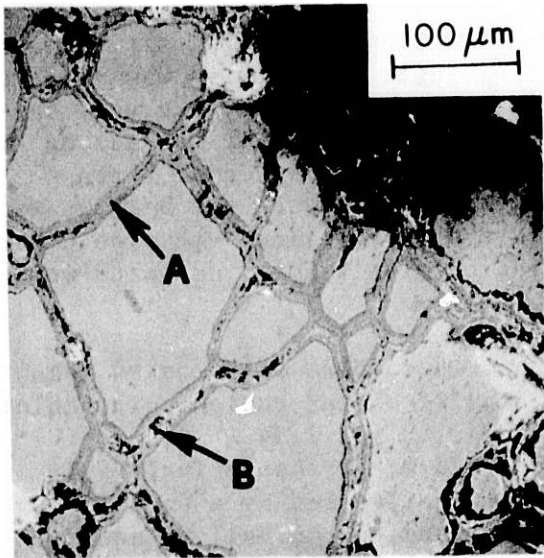
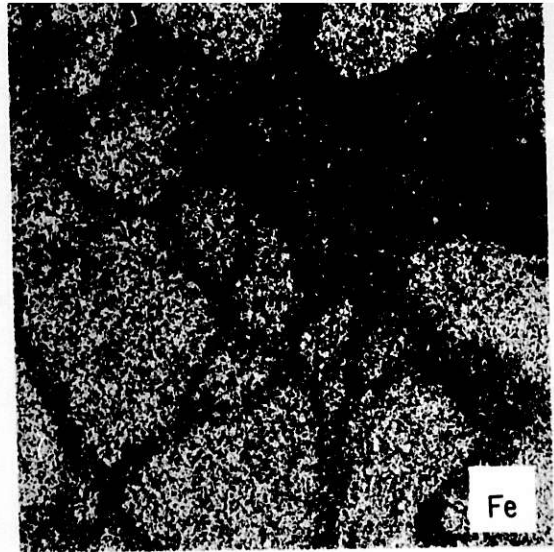
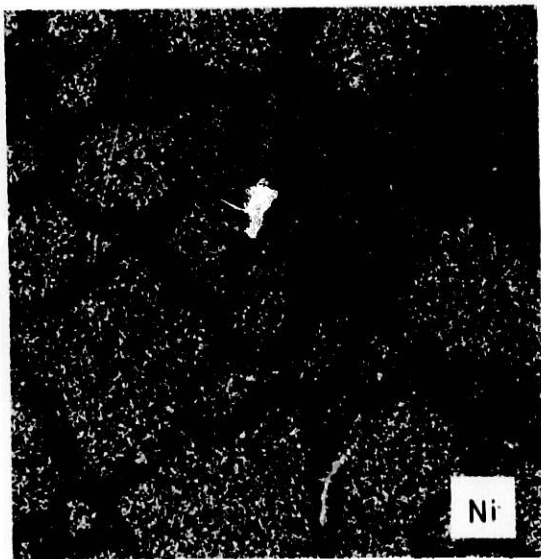
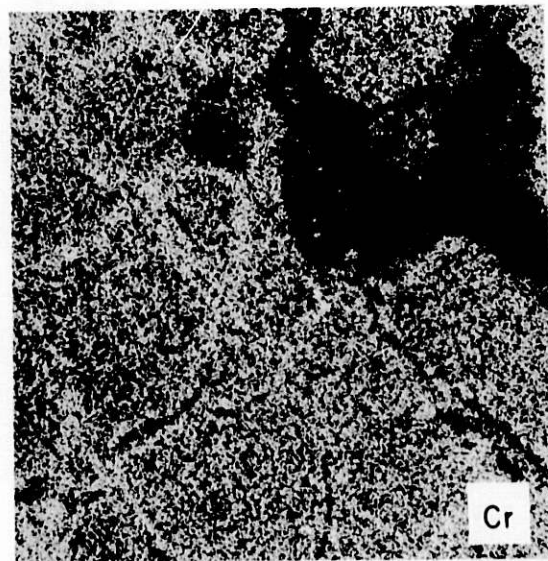
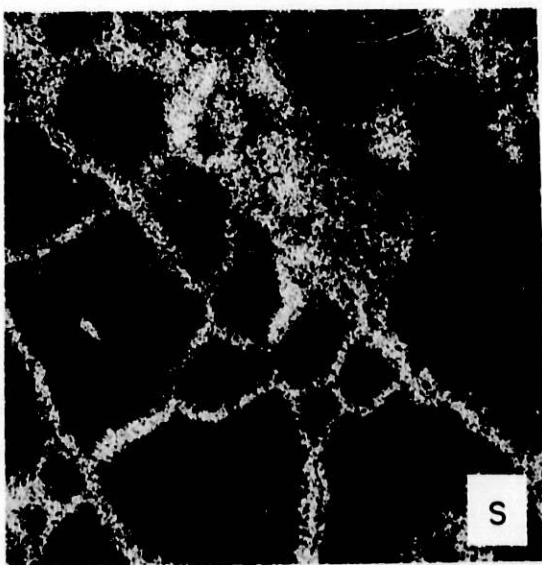
Fig. 33. SEM Micrograph and Elemental Scans of a Region of the Attacked Coupling near the Inner Surface.

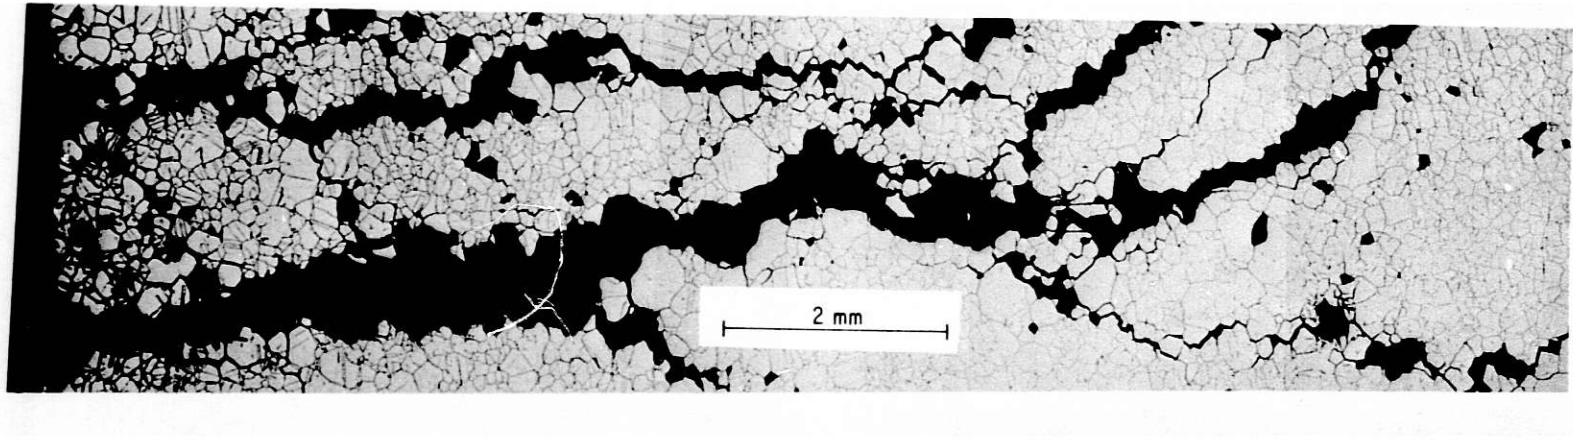
Fig. 34. Cracking Present near Inner Surface of Bi-Gas Product Gas Line.

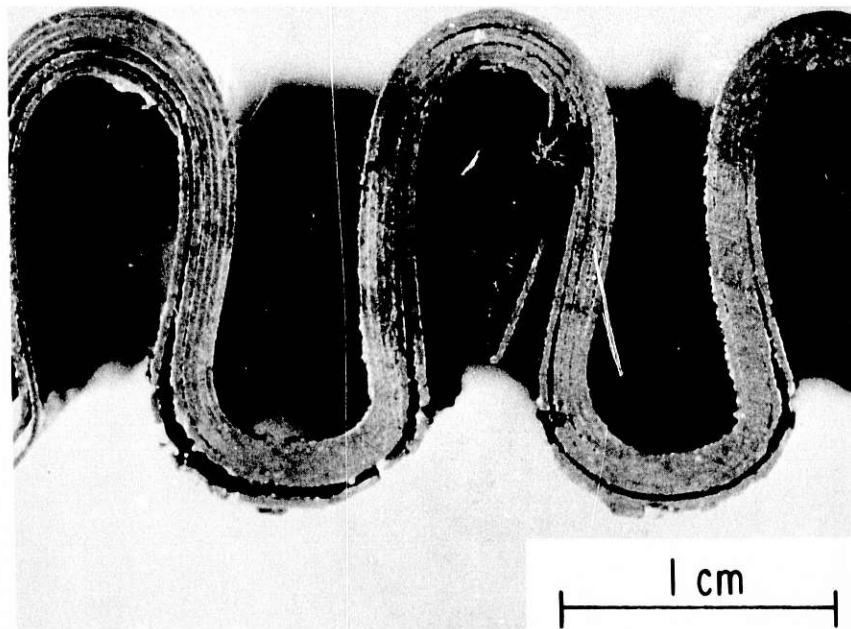
Fig. 35. Cross Section Through Failed Bellows from Product Gas Line Expansion Joint in U-Gas Pilot Plant. The inner surface of the bellows faces downward in the picture.

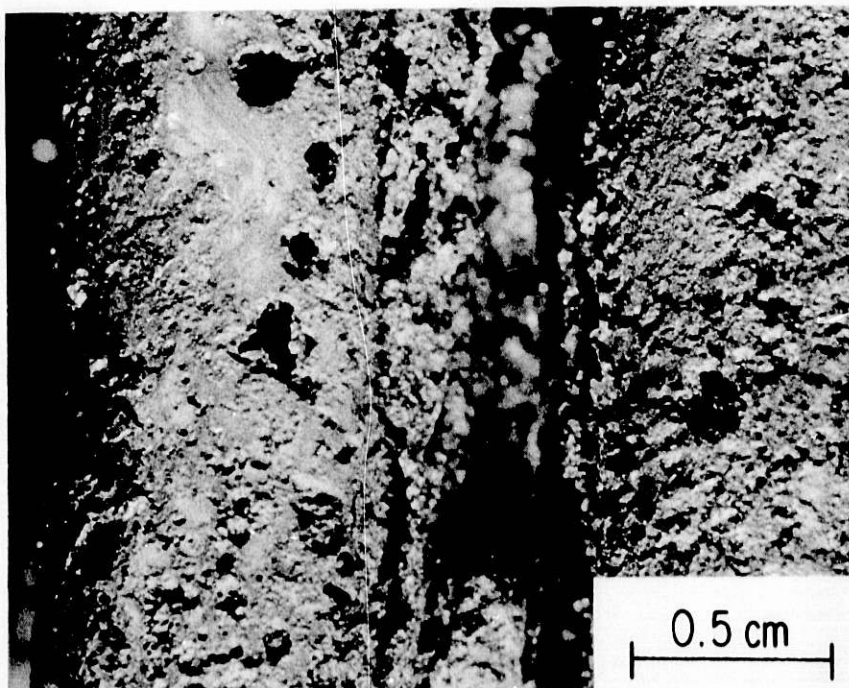
Fig. 36. Photograph of Inner Surface of Failed U-Gas Expansion Joint Bellows, Showing Corrosive Attack and Pitting.
