**MATERIALS TECHNOLOGY FOR
COAL-CONVERSION PROCESSES**

**Progress Report for
October—December 1980**

ARGONNE NATIONAL LABORATORY, ARGONNE, ILLINOIS

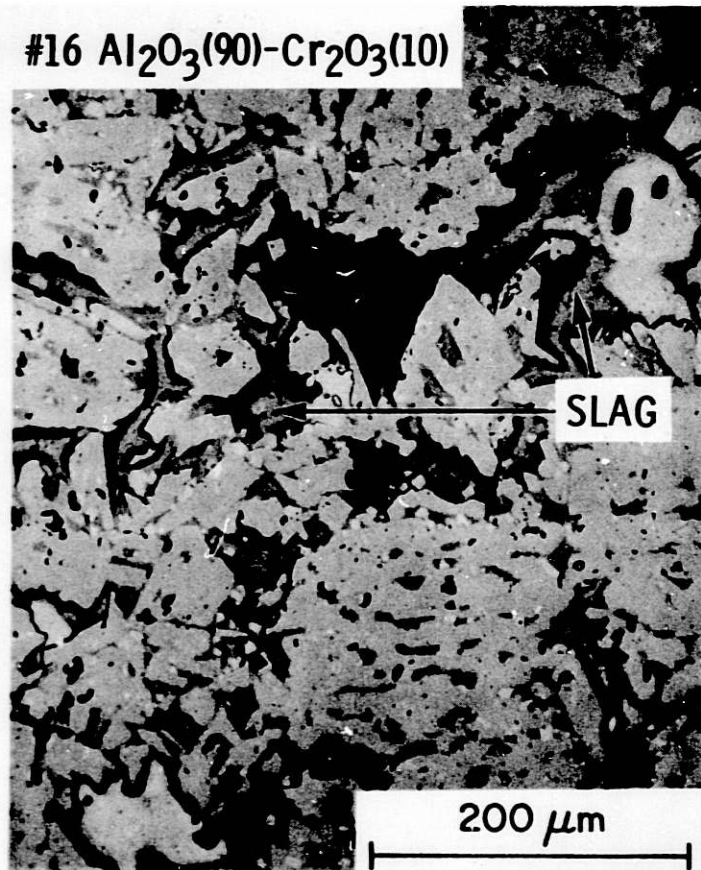
Fig. 5. Reflected-light Image ~ 1 mm from the Slag-Refractory Interface of Number 16, Showing Intergranular Attack.

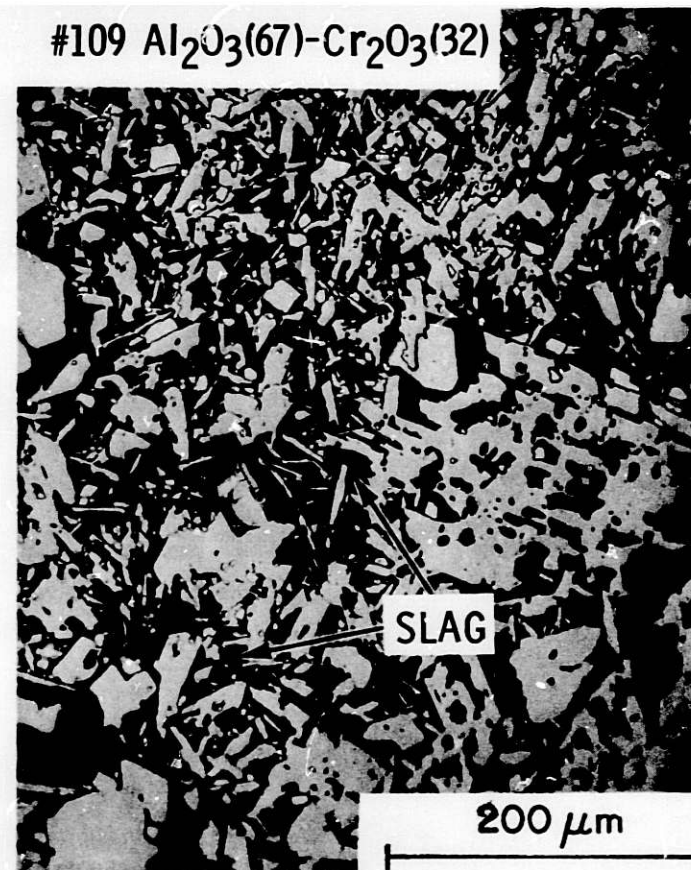
Fig. 6. Reflected-light Image ~ 1 mm from the Slag-Refractory Interface of Number 109, Showing Extensive Nature of the Intergranular Attack.

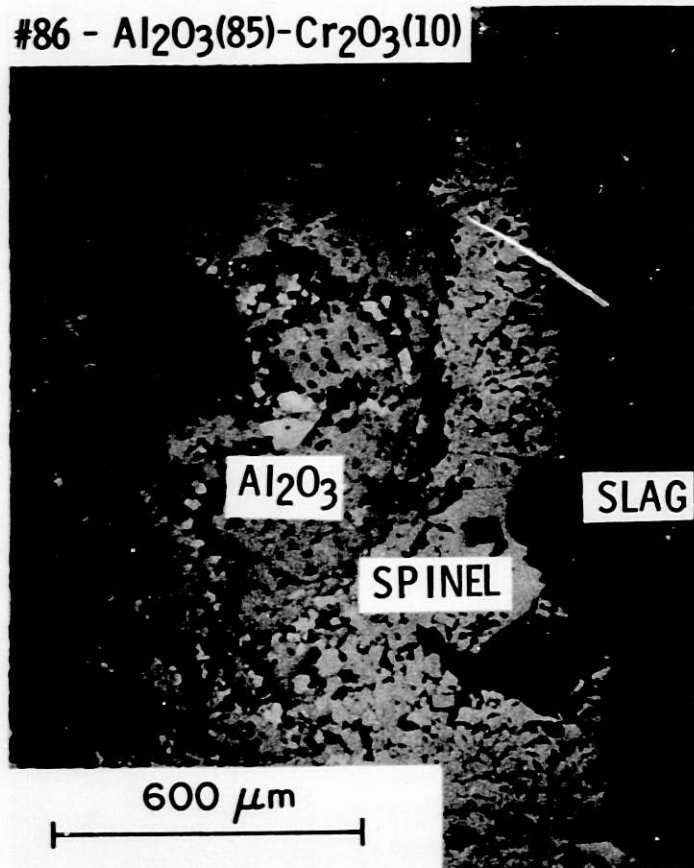
#86 - Al₂O₃(85)-Cr₂O₃(10)

In contrast, examination of the chemically bonded 85 wt% alumina-10 wt% chromia refractory (Number 86), which suffered the most corrosion in test run 12, revealed the formation of a loose network of spinel reaction product 200-300 μm thick (Fig. 12), accompanied by very extensive intergranular attack. SEM-EDX results (not shown) indicated that the spinel was of the $(\text{Fe,Mg})\text{Al}_2\text{O}_4$ type.

Fig. 12. Reflected-light Image of the Slag-Refractory Interface of the Chemically Bonded 85 wt% Al₂O₃-10 wt% Cr₂O₃ Refractory (Number 86) After Exposure.

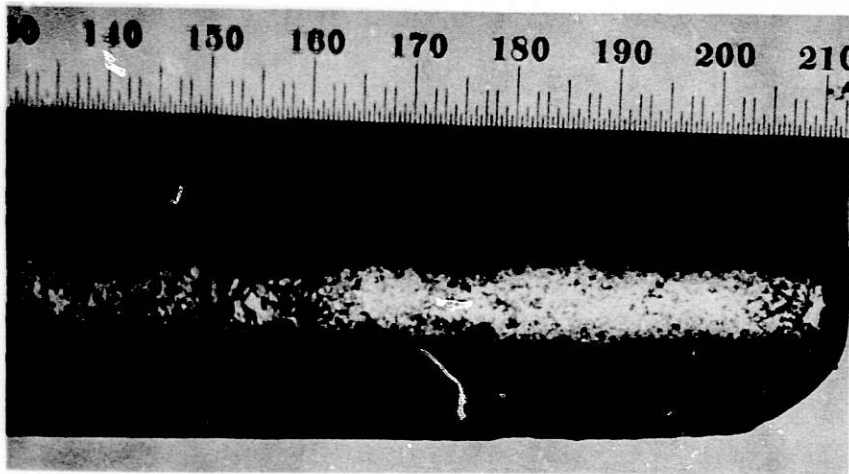
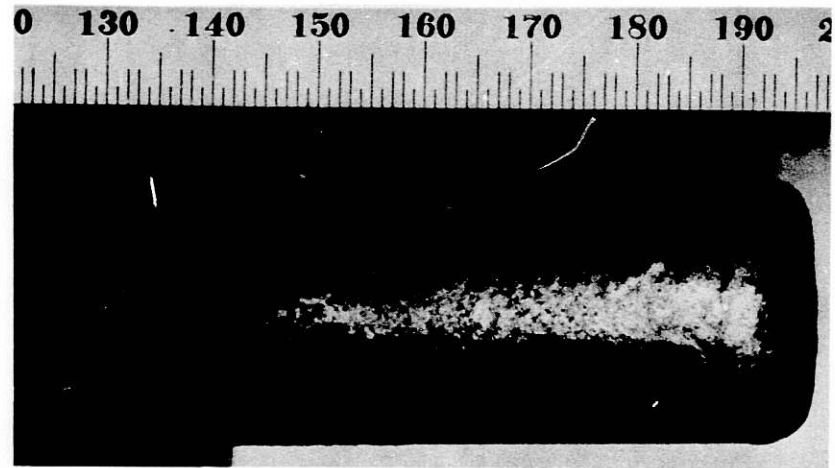
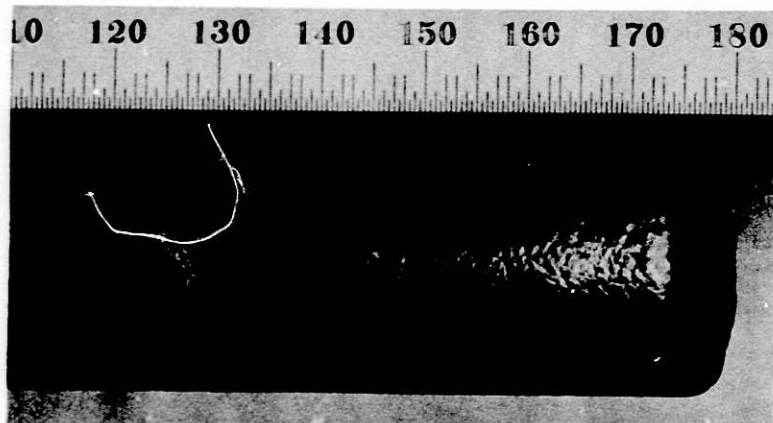
The macroscopic appearance of thermowells 1, 2, 3, and 7 after removal from the U-Gas Pilot Plant is shown in Fig. 25. Only the last ~6 to 8 cm of each thermowell projected into the gasifier beyond the inner surface of the refractory lining, and the damage was almost entirely confined to this region. Both thermowells 1 and 7 suffered significant loss of material at the tip, and in both cases this damaged region faced downward toward the fluidized bed during the exposure. The remaining portions of these two thermowells exhibited much less damage, with only slight surface roughening or local spallation of the coating noted. Thermowells 2 and 3 did not experience any severe attack at the tip, and the overall surface roughening was comparable to that seen in thermowells 1 and 7 away from the tip.

Fig. 25. Macroscopic Appearance of Four Experimental Thermowells after Exposure to Six Runs in U-Gas Pilot Plant Gasifier. (a) Thermowell 1, (b) thermowell 2, (c) thermowell 3, and (d) thermowell 7.

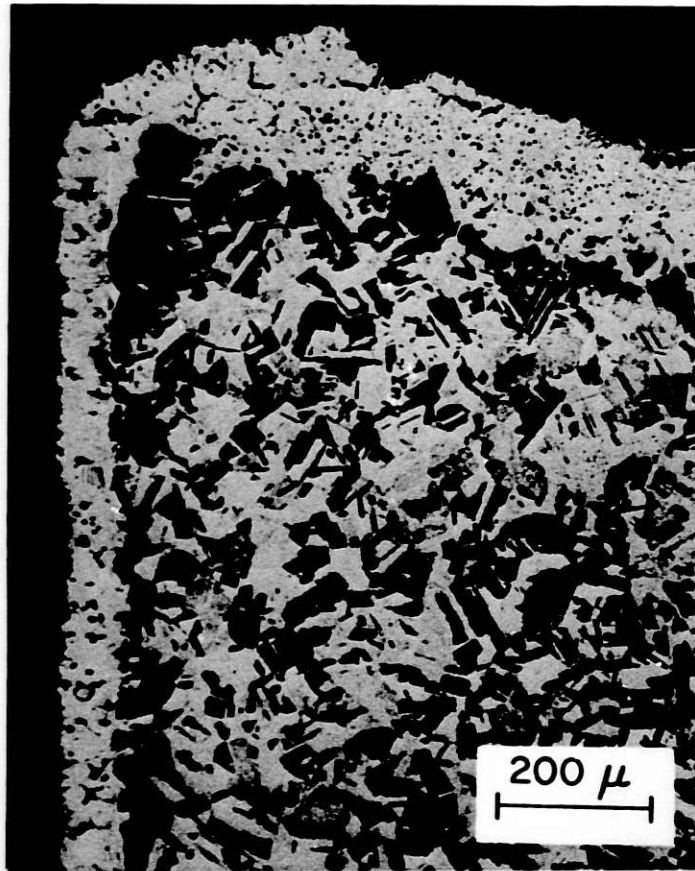
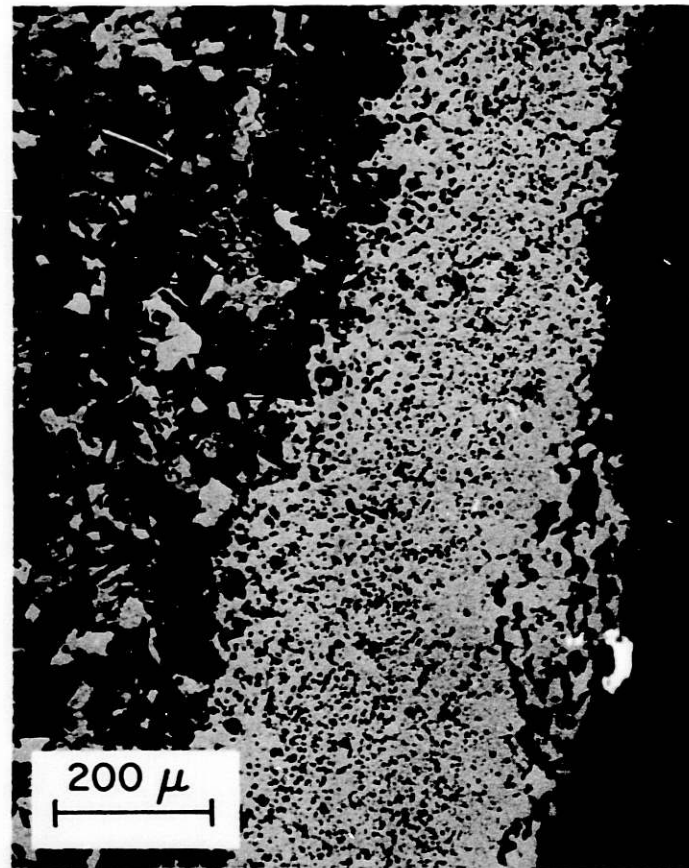
Fig. 26. Microstructures at Two Locations in Axial Section Through Heavily Eroded Region in End Plug of Thermowell 1. (Etchant - 100 ml HCl, 15 ml HF, 30 ml H₂O₂).

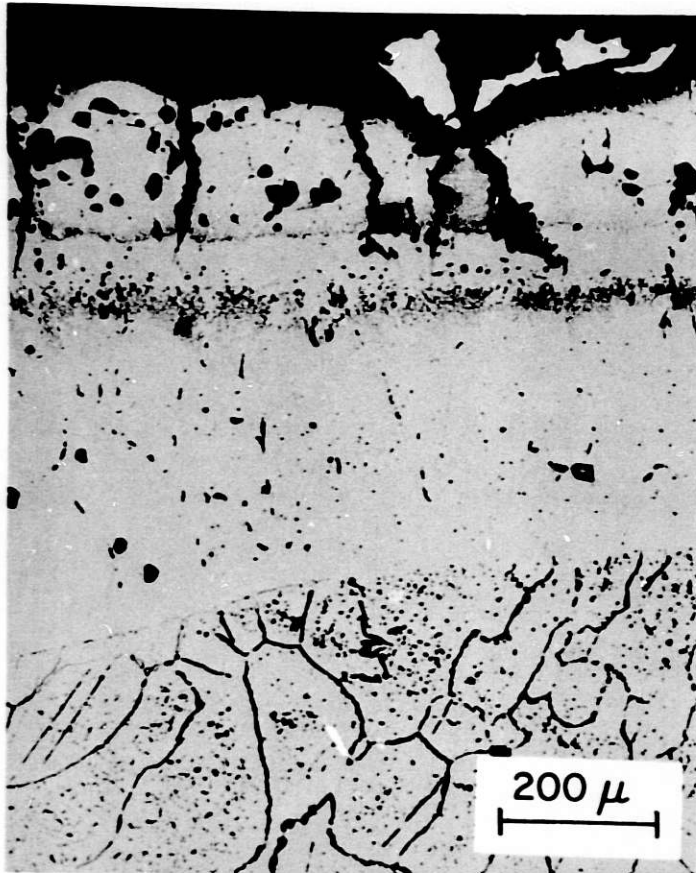
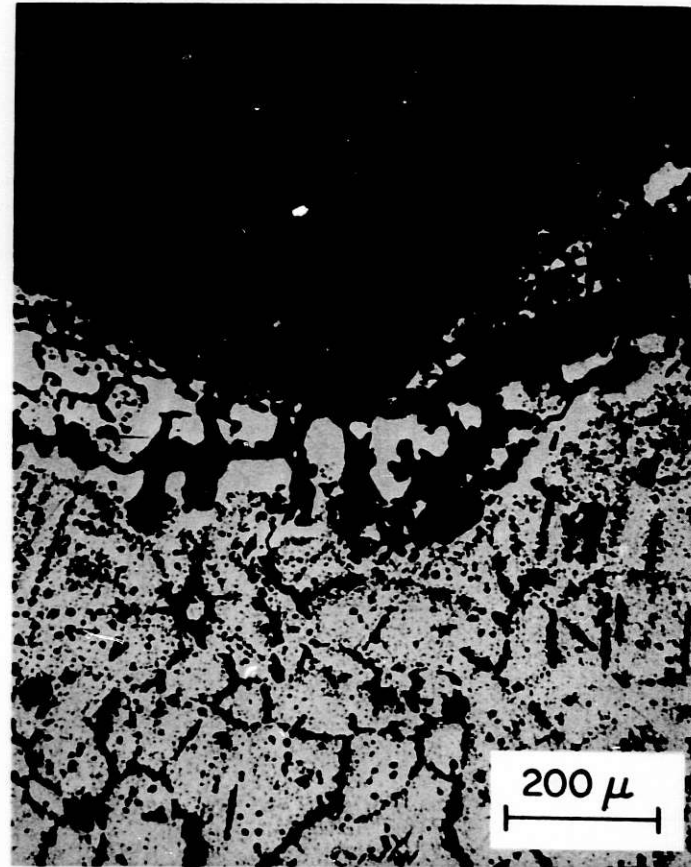
The other failed thermowell that was examined here was thermowell 7, which was made of aluminized Type 310 stainless steel. Figure 27a shows the microstructure present at the outer surface of the tubular sidewall away from the region of heavy erosive wear at the tip. The Type 310 stainless steel base metal is visible near the bottom of the micrograph, and the multilayered aluminized coating is seen above it. Several cracks extend into the coating from the outer surface, and these cracks appear to be filled with a corrosion product, probably an oxide. However, the general adherence of the coating to the substrate is good, and the coating appears to be providing reasonable protection against erosive wear and corrosive attack at this location.

Figure 27b shows the microstructure at the outer surface of the end plug in the highly eroded region at the tip of thermowell 7. The aluminized coating has been entirely lost here, and the Type 310 stainless steel base metal is experiencing extensive intergranular and intragranular corrosive attack as well as erosive wear.

Fig. 27. Microstructures at Two Locations in Axial Section Through Thermowell 7. (a) Intact location in sidewall, and (b) heavily attacked region in end plug. (Etchant - 10% oxalic acid in water electroetch).

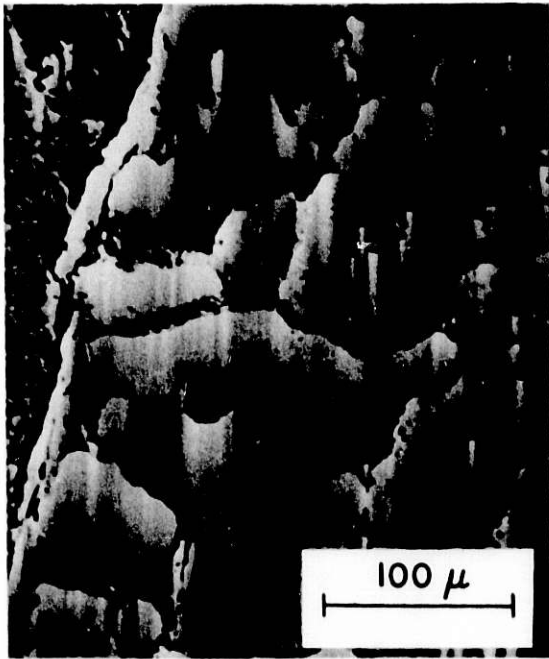
Because corrosive attack appears to have played an important role in the failures of thermowells 1 and 7, samples from these two thermowells were examined by SEM and electron microprobe in order to identify the corrosion product phases present. Selected microprobe results for thermowell 1 are shown in Figs. 28a through d. The region shown in the backscattered electron image of Fig. 28a is at the outer surface of the end plug, somewhat away from the region of most severe erosive attack. Both intergranular and intragranular precipitates are clearly visible. The accompanying x-ray images of Figs. 28b through d identify the grain-boundary phase as chromium oxide near the surface and a mixture of chromium oxide and sulfide farther in. The fine intragranular precipitates appear to be sulfides, probably again in combination with chromium. The distribution of iron, nickel, and cobalt (not shown here) showed no unusual features except that iron tended to be somewhat concentrated intragranularly near the surface, and all three elements were depleted in the grain-boundary regions near the surface.

Fig. 28. SEM and Electron Microprobe Analysis of Surface Region Away from Heavily Attacked Area in End Plug from Thermowell 1. The back-scattered electron image is shown in (a), and the x-ray maps for selected elements are shown in (b) through (d).

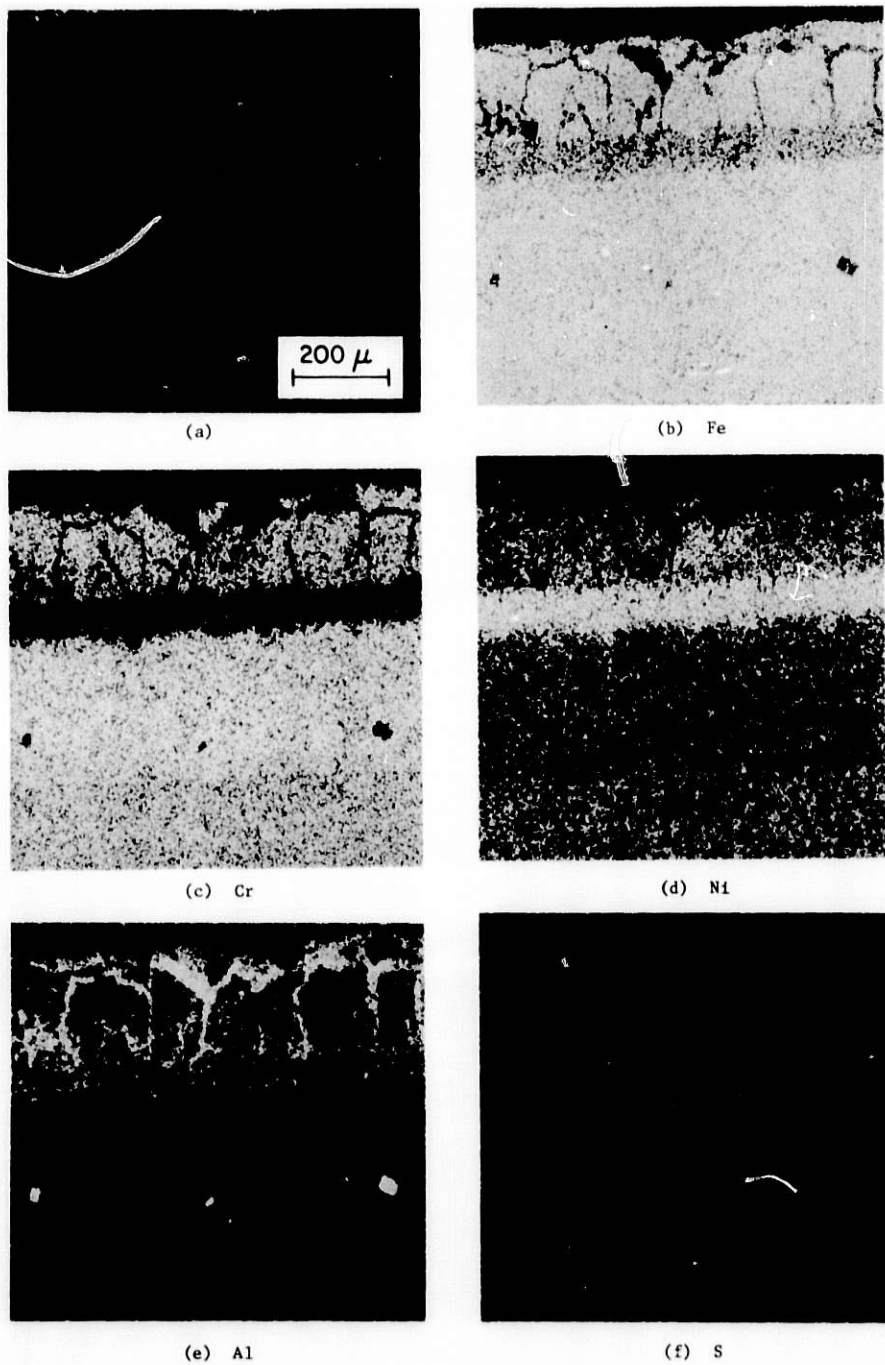
Thermowell 7 was examined in regions where the aluminized coating was still intact as well as in areas of severe attack. A series of photographs from an intact region is shown in Fig. 29. The aluminized coating in the top two-thirds of the photographs is seen to consist of three layers, namely (1) an outer layer high in Al, Fe, and Cr and low in Ni, (2) a thin, intermediate layer high in Ni and Al and depleted in Cr and Fe, and (3) a thicker third layer somewhat higher in Al and Cr and lower in Ni than the underlying Type 310 stainless steel substrate. The outer layer of the aluminized coating contains numerous cracks which appear to stop at the interface with the second layer. These cracks are seen here to contain high aluminum concentrations, and a separate analysis (not shown here) on an instrument more sensitized to low atomic number elements also showed them to contain high oxygen levels. The phase in the cracks is thus identified as Al_2O_3 . The sulfur scan of Fig. 29 indicates that no significant sulfidation occurred in this region.

Fig. 29. SEM and Electron Microprobe Analysis of Surface Region Away from Heavily Attacked Region in End Plug from Thermowell 7. The back-scattered electron image is shown in (a), and the x-ray maps for selected elements are shown in (b) through (f).
