**MATERIALS TECHNOLOGY FOR
COAL-CONVERSION PROCESSES**

**Thirteenth Quarterly Report,
January—March 1978**

ANL-78-54

W. A. Ellingson
Project Leader

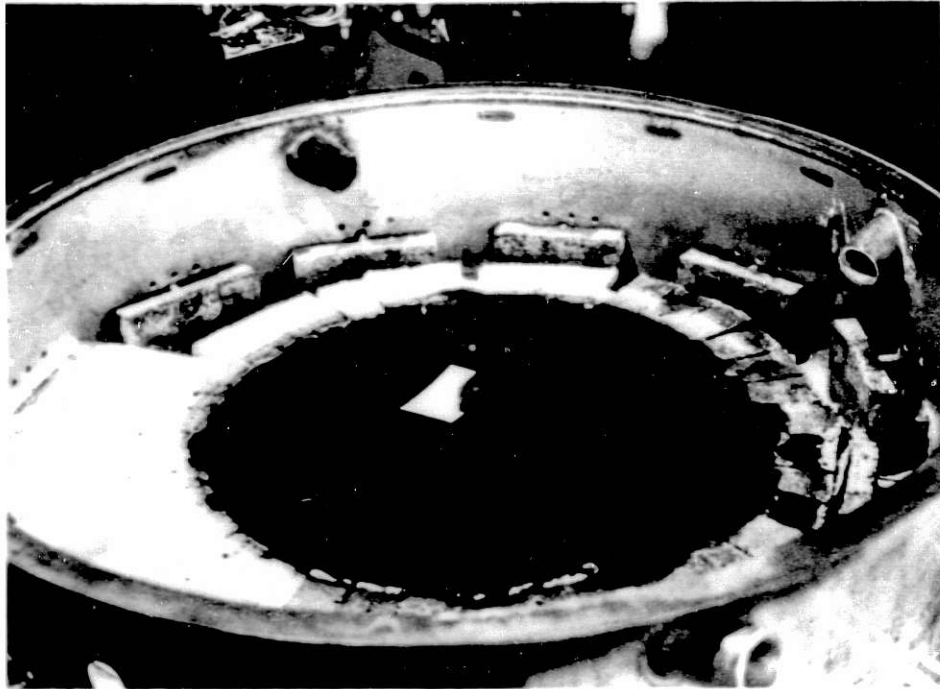
Fig. 4. Posttest Photograph Showing the Placement of the Standard Specimen of Refractory Number 2. Note that the furnace has been partially disassembled, the insulating upper wall has been removed, and the cooling cans for the 1/2-size bricks have been detached. A 76-mm x 127-mm (3-in. x 5-in.) file card has been placed next to the specimen to illustrate the depth of corrosion.

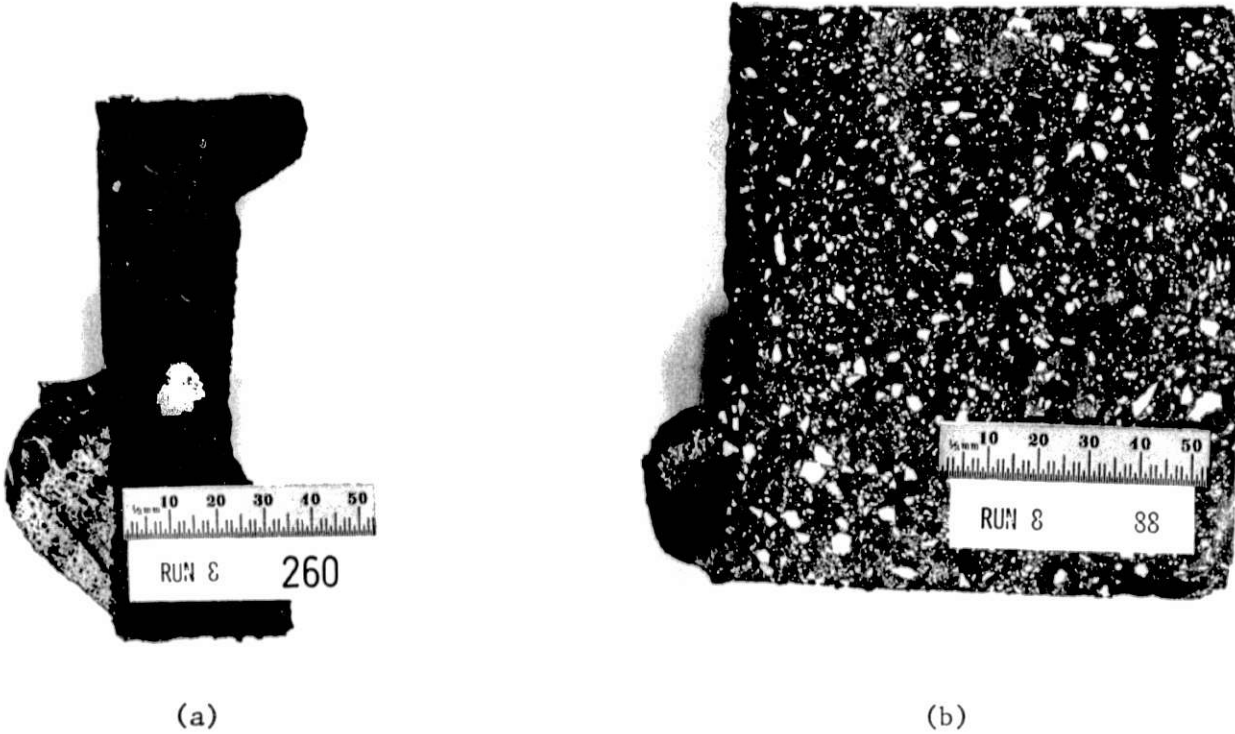
Fig. 9. Cut Sections of Refractories Exposed to Slag Attack in Test Run 8. (a) Number 260 and (b) Number 88. The left-hand vertical face was exposed. Note that number 260 fractured ~ 20 mm from the hot face (the cooler section of the brick is not shown).

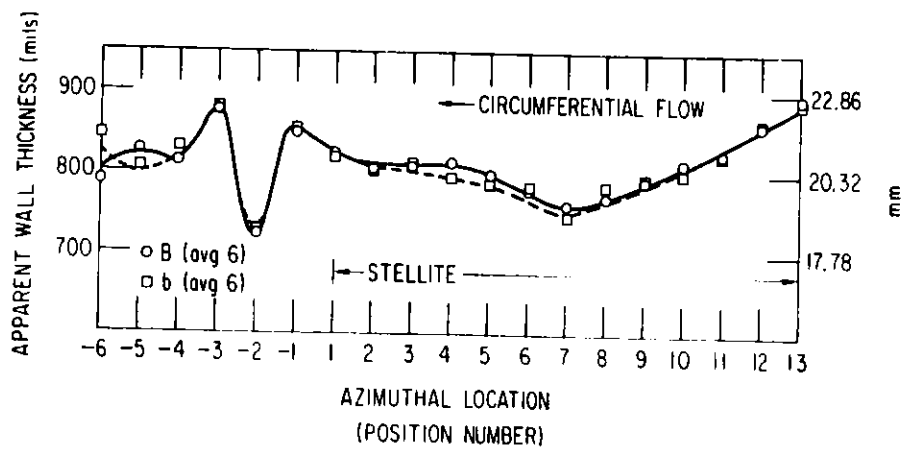
The HYGAS external cyclone separator was again ultrasonically inspected after an additional 1092 hours of operation (total exposure now 3142 h). The erosive wear was shown to be significant and will be more frequently inspected for optimizing replacement time. Additional results from ANL Instrumented Elbow II in the main coal feed line of the Synthane pilot plant after transfer of 133000 kg of coal indicated small amounts of erosive wear comparable to the error band of the field measurements (~ 0.13 mm/measurement). Data from the Bi-Gas plant transfer lines have been refined by further measurements and analysis, and the amount of erosion appears to have been very small: techniques have been introduced to improve the measuring accuracy in order to detect the wall-thickness changes. In-service tests of the operation of the erosive-wear monitoring system are planned. Improved methods of attachment of ultrasonic wave-guides to specimen piping are being tested. Experiments and analysis to develop methods for characterization of eroded metallic surfaces by examination of reflected ultrasonic pulse echos are in progress.

Fig. 12. HYGAS Cyclone Separator after 3142 Operating Hours. Wall thickness at matrix rows B and b versus azimuthal location, 3/78. Neg. No. MSD 65256

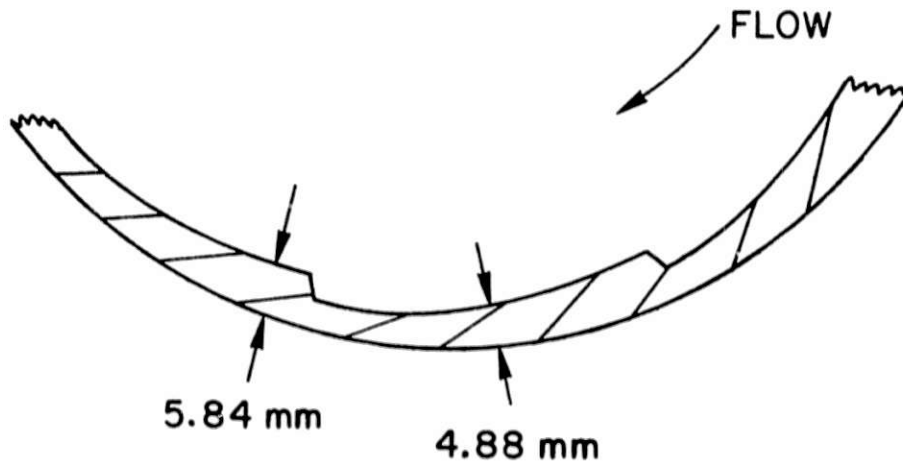
Fig. 15. Schematic of End View of Long Cone Within Body of HYGAS Cyclone Separator, Showing Sawtooth Erosion Pattern and Dimensions at Sites 0.5 m from Solids Outlet Flange. Original thickness of the cone was 6.35 mm. Neg. No. ANL-306-78-537

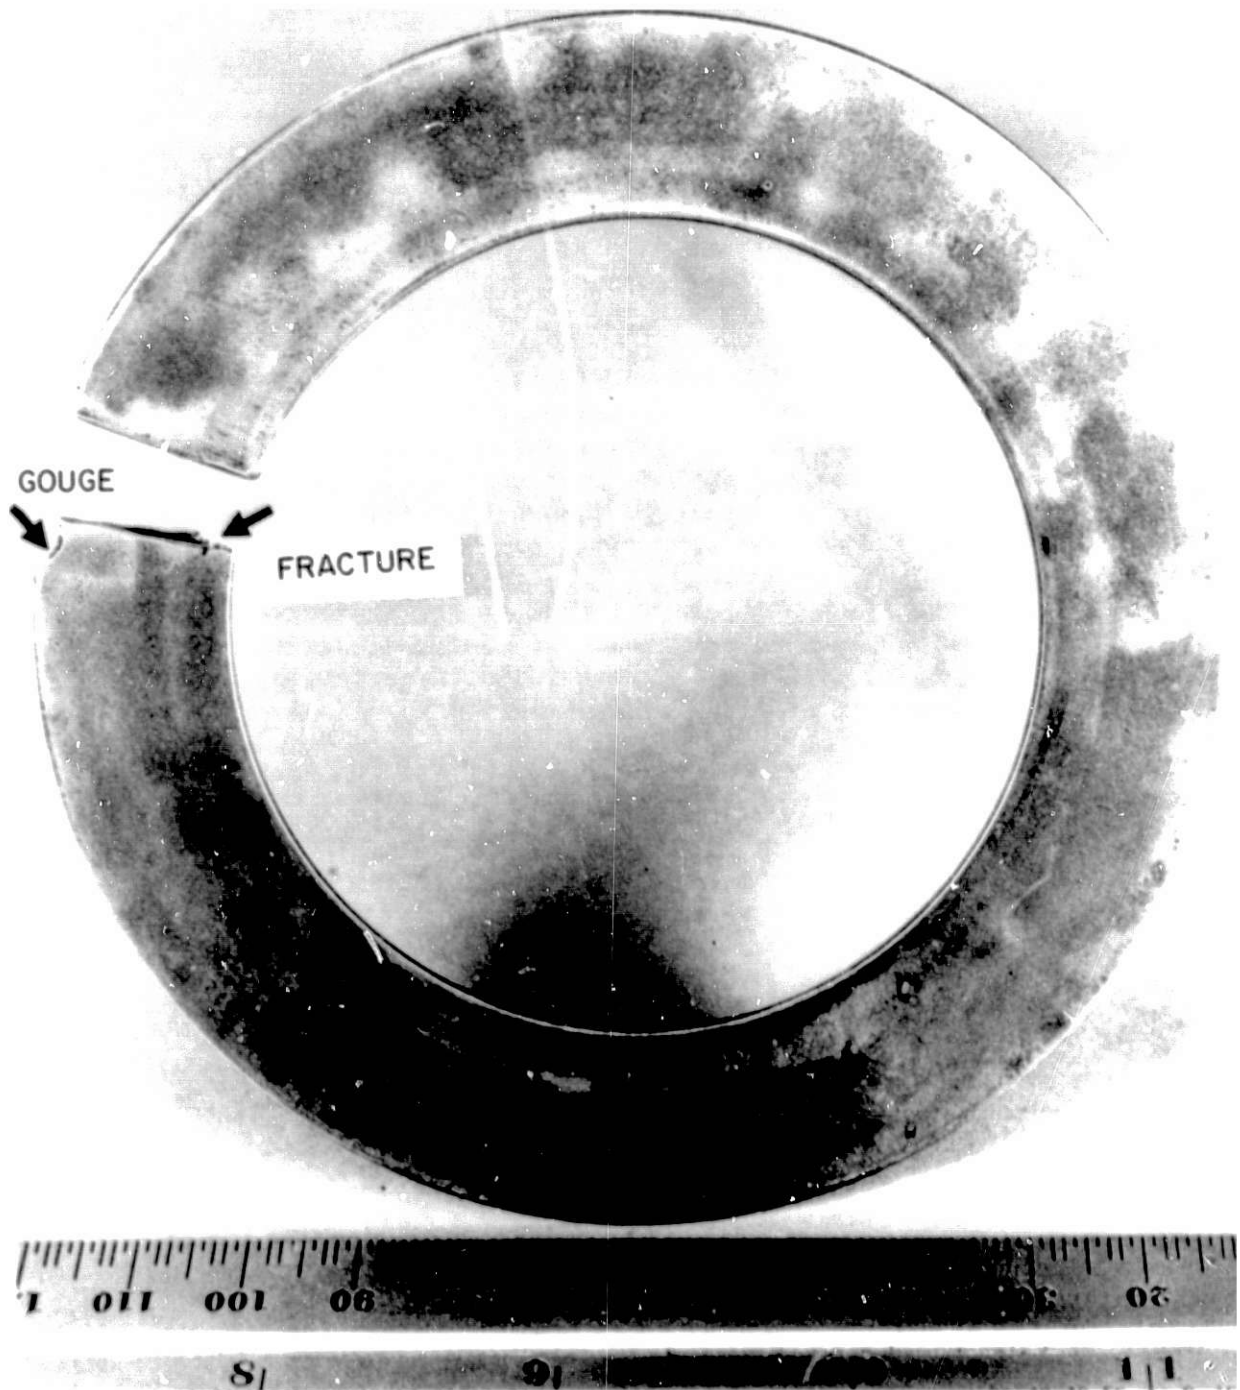
Fig. 50. HYGAS Valve Assembly Leaf Spring. The spring is helical and the fracture surface and gouge are readily visible. ANL Neg. No. 306-77-546

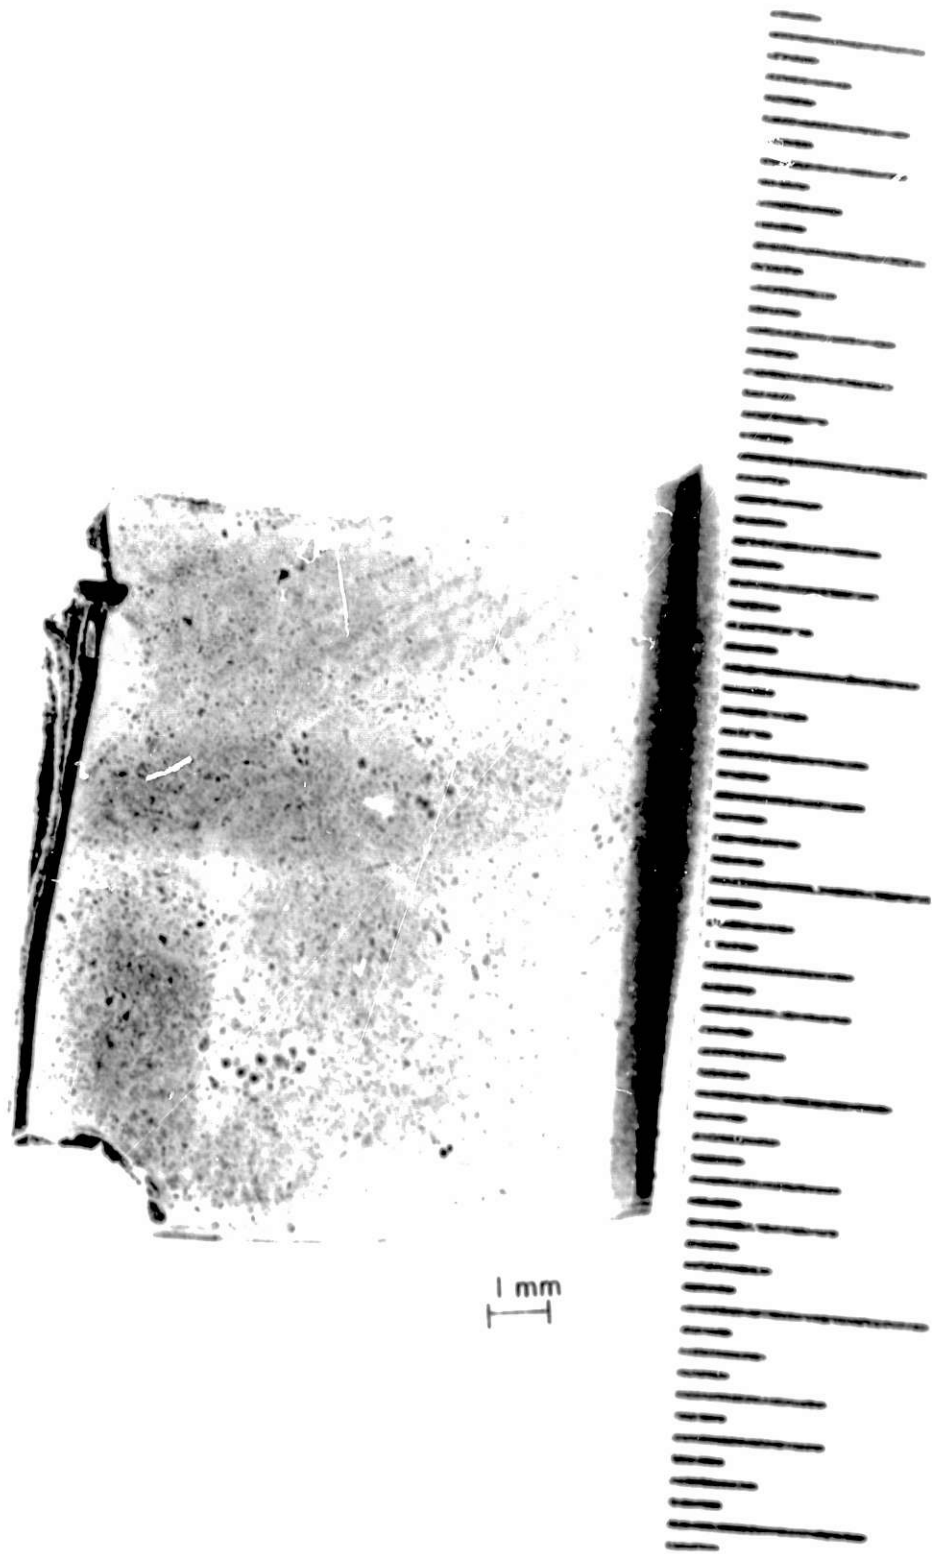
Fig. 51. Enlarged View of Fracture Surface and Gouged Area of HYGAS Valve Assembly Leaf Spring. ANL Neg. No. 306-77-547

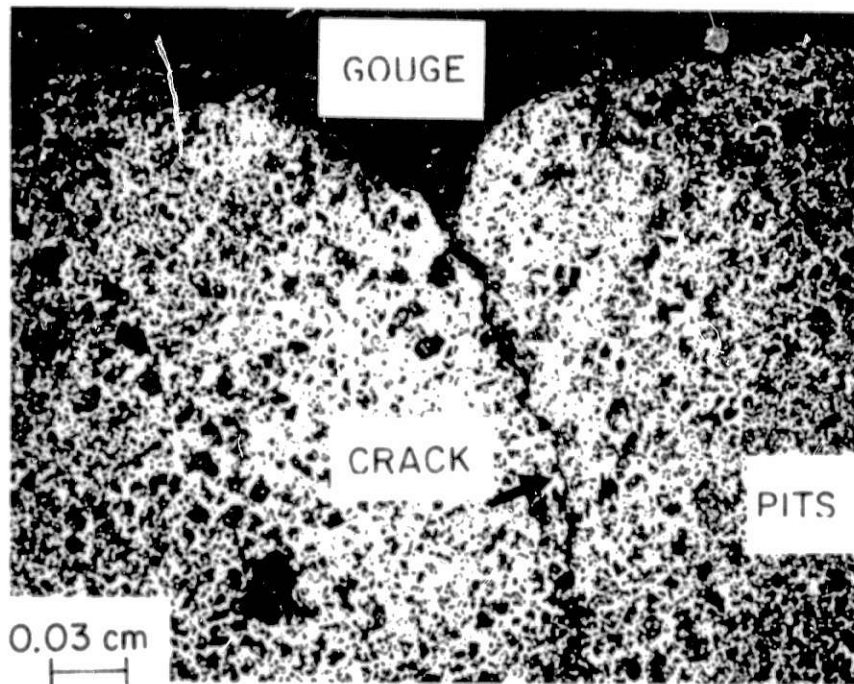
Fig. 52. Top Surface of HYGAS Valve Assembly Leaf Spring, in the As-received Condition. A crack is emanating from a gouge. Neg. No. ANL-306-78-580

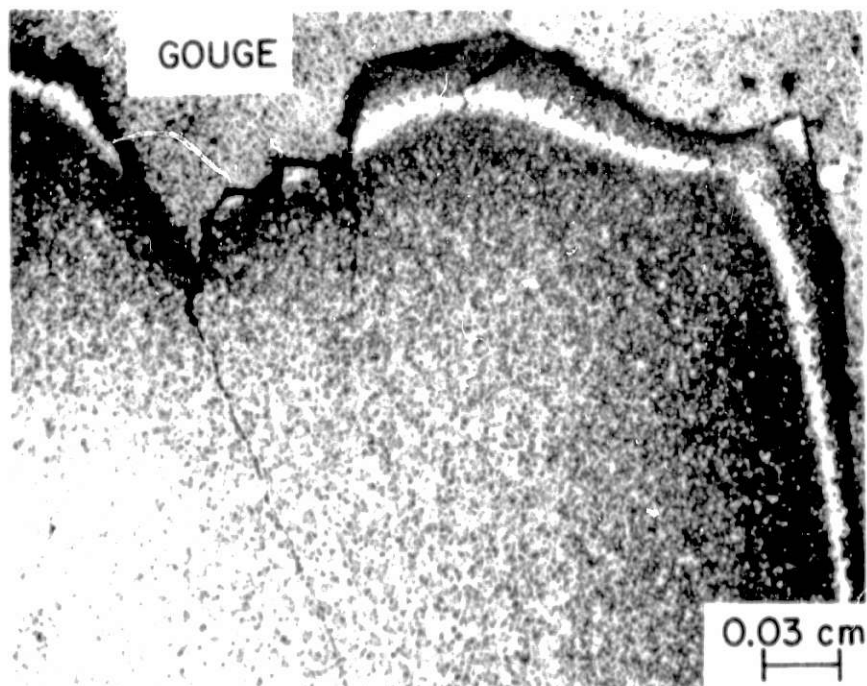
Fig. 53. Polished and Etched Surface of HYGAS Valve Assembly Leaf Spring, Showing Cracks Originating in a Gouged Region. Neg. No. ANL-306-78-574

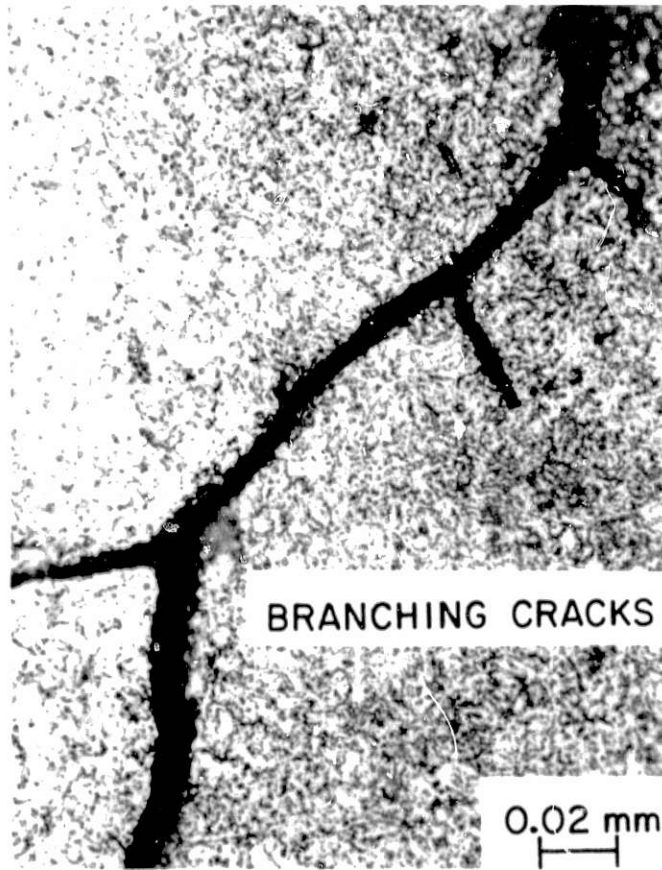
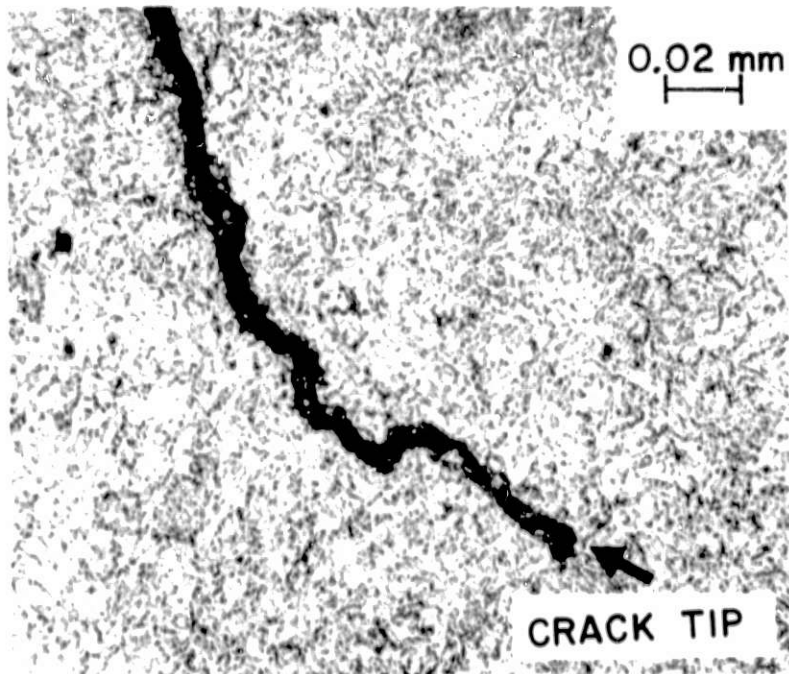
Fig. 54. HYGAS Valve Assembly Leaf Spring Cracks. Branched cracks are shown in (a) and the crack tip is shown in (b). The microstructure is tempered martensite. Neg. No. ANL-306-78-583

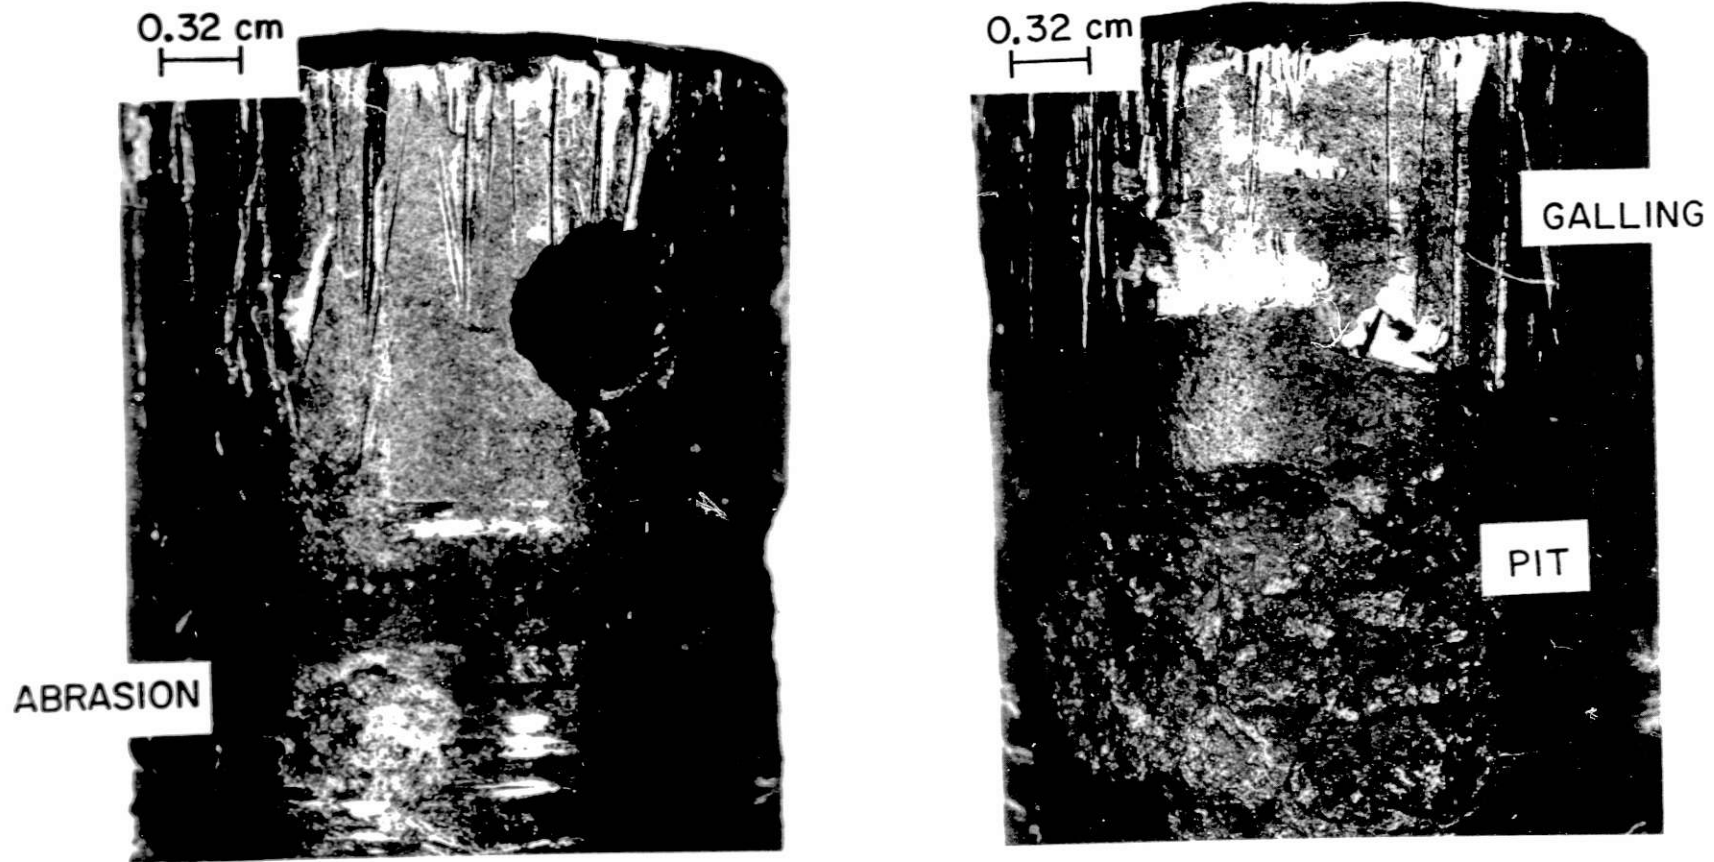
Fig. 56. Photographs of the HYGAS Hinge Pin. Pitting corrosion, galling, and abrasion are visible. The abraded region is shiny.
Neg. No. ANL-306-78-568

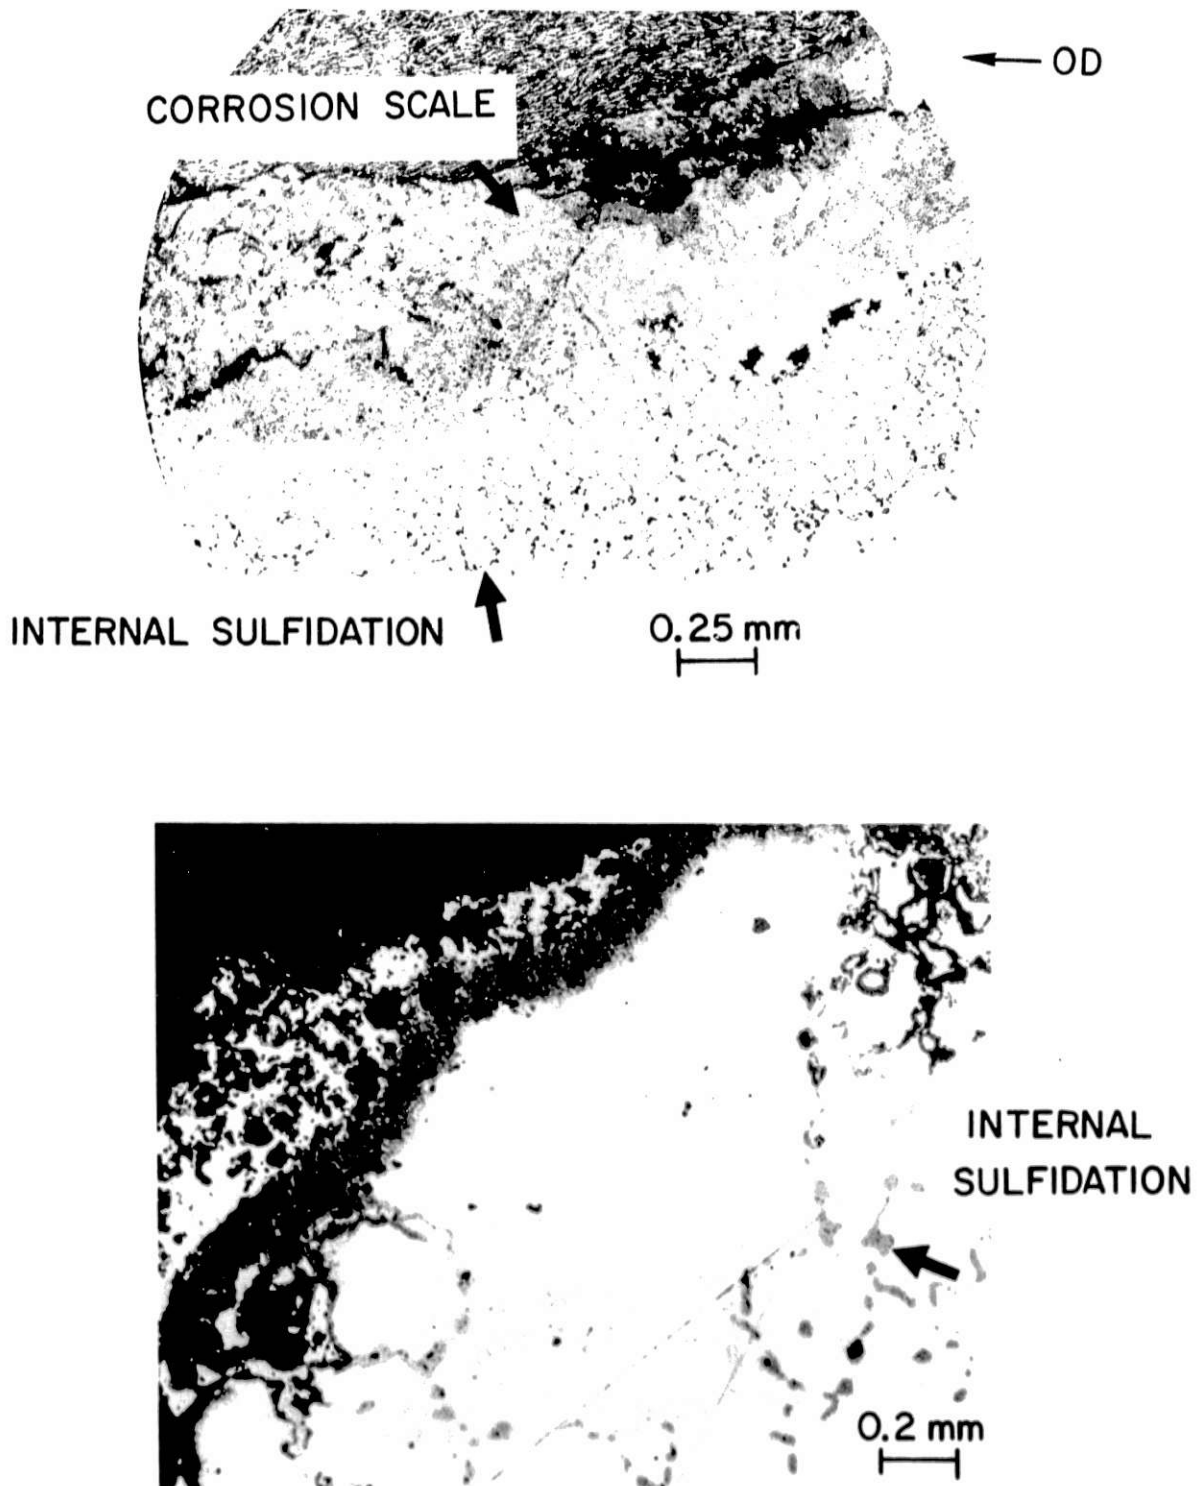
Fig. 58. Micrographs of Corroded Regions of the HYGAS Hinge Pin. The OD is severely corroded and grain boundaries and twins are outlined with corrosion product, most probably a sulfide phase. Neg. No. ANL-306-78-569

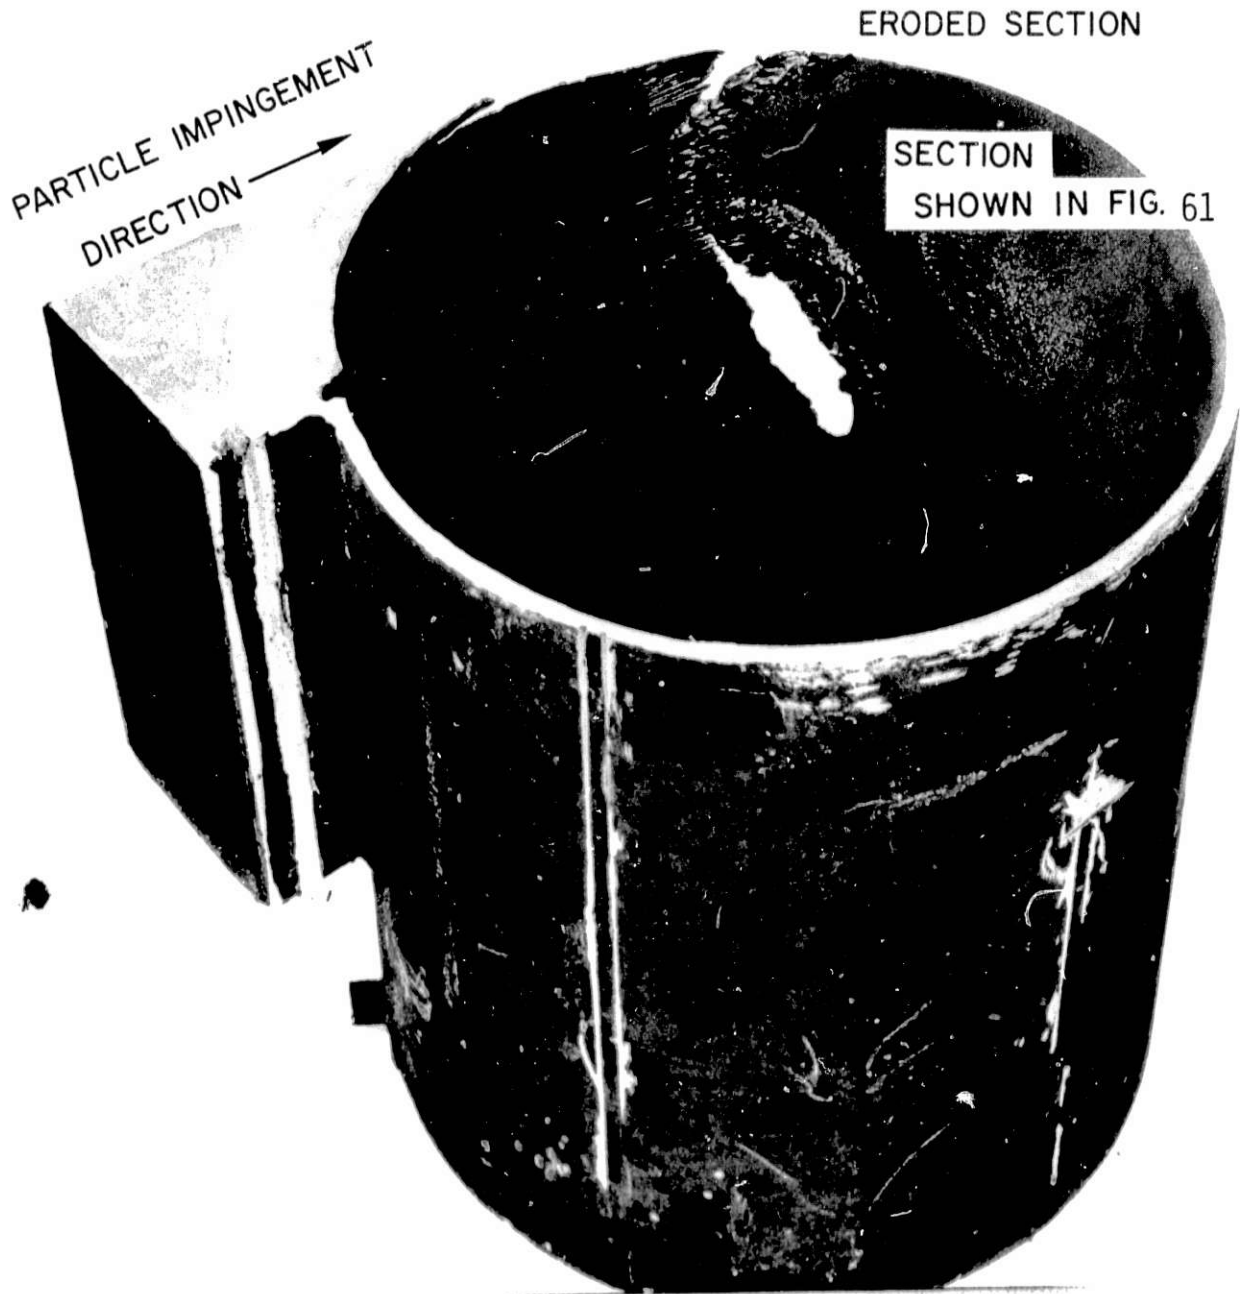
Fig. 59. Photograph of the Type 310 Stainless Steel Internal Cyclone. The particle impingement direction and the eroded section are indicated. ANL Neg. No. 306-77-543

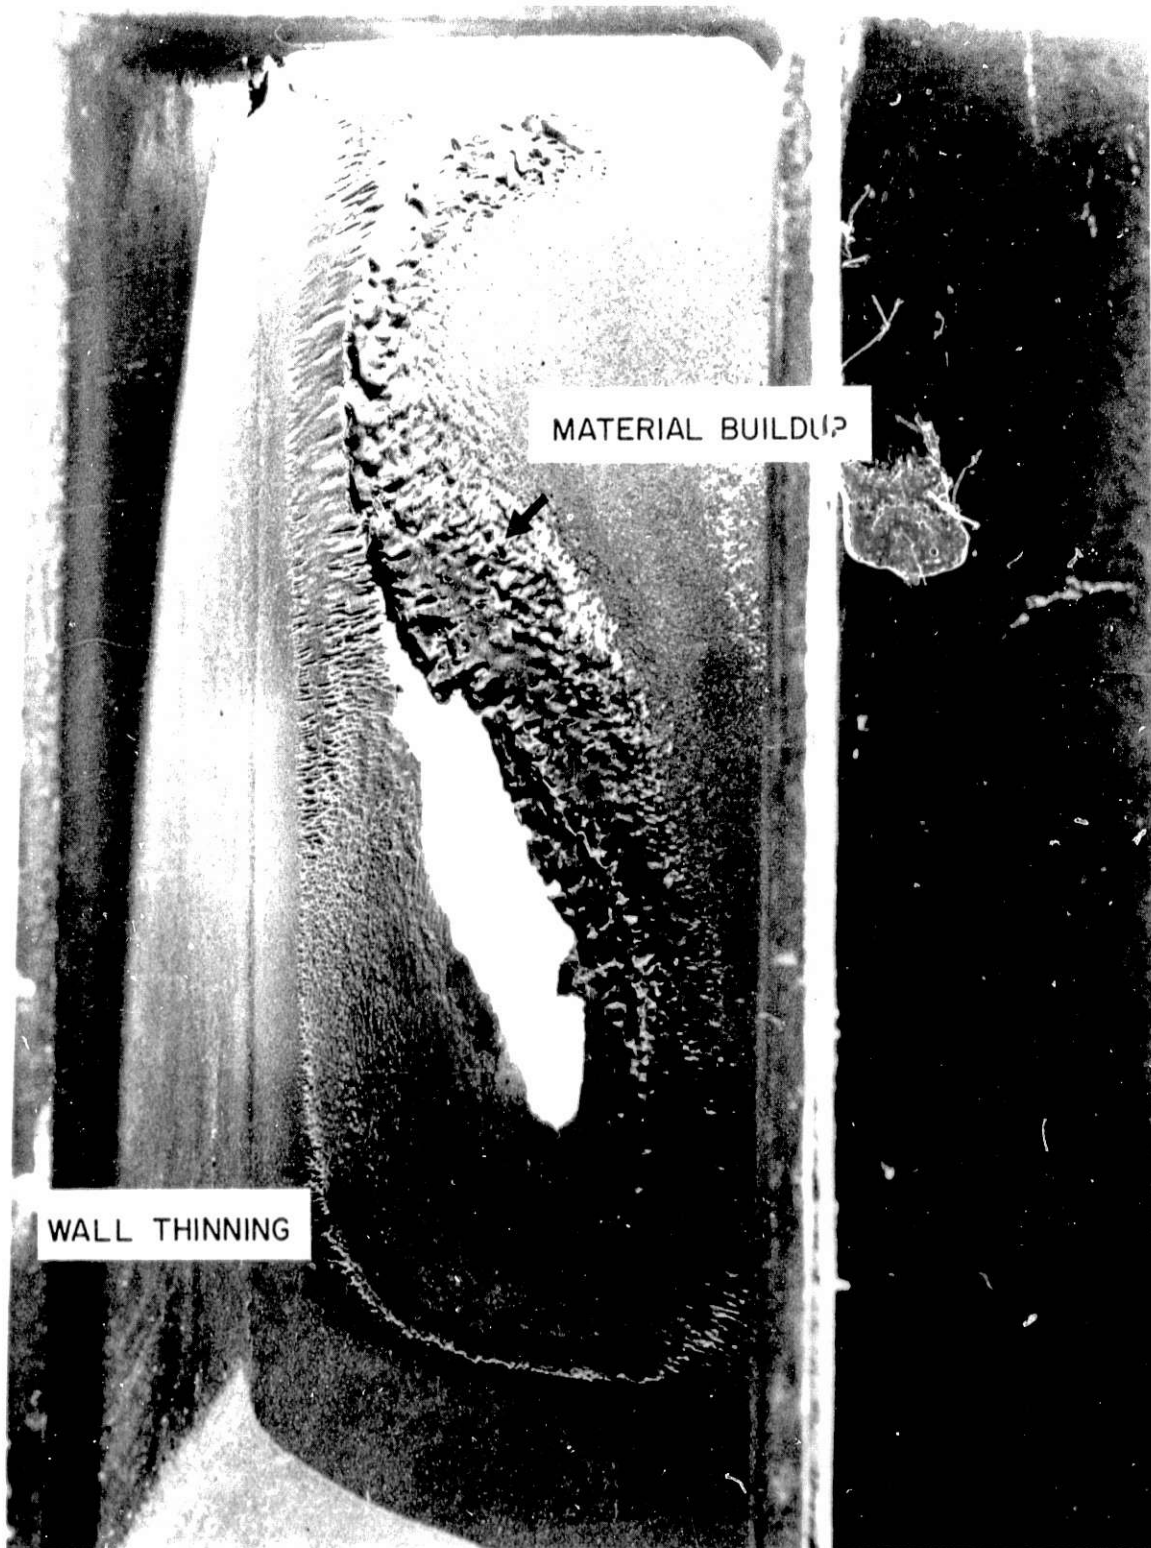
Fig. 60. Photograph of the Eroded Region of the Internal Cyclone. The view is through the particle inlet section. Wall thinning is seen at the near section and material buildup is seen at the far section of the perforation. ANL Neg. No. 306-77-541

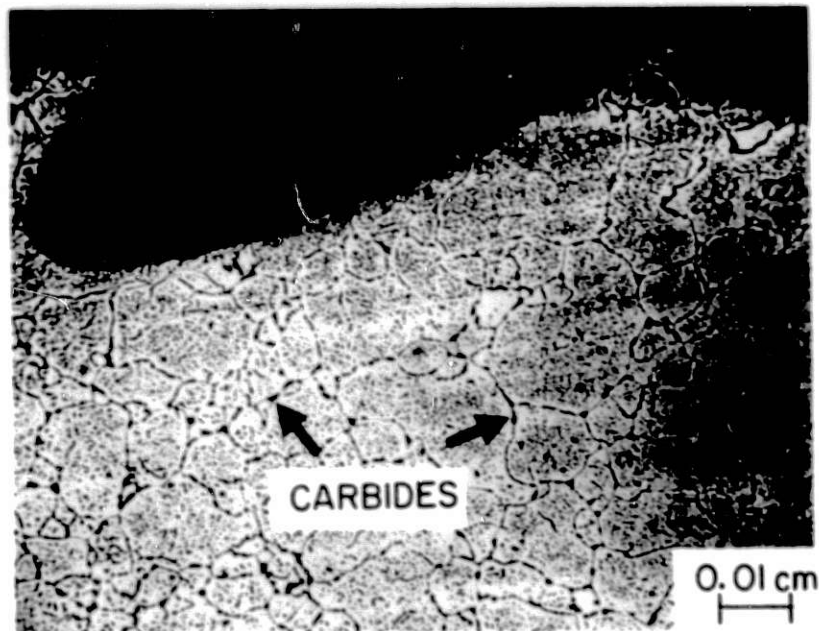
Fig. 62. Photographs of the Internal Surface (a) and a Cross Section (b) of the Cyclone. The ridges in (a) were formed by the impinging particles. The hollow region in (b) was caused by particle bombardment. Sensitization of the steel (carbide precipitation at the grain boundaries) is also visible in (b). ANL Neg. No. 306-78-581

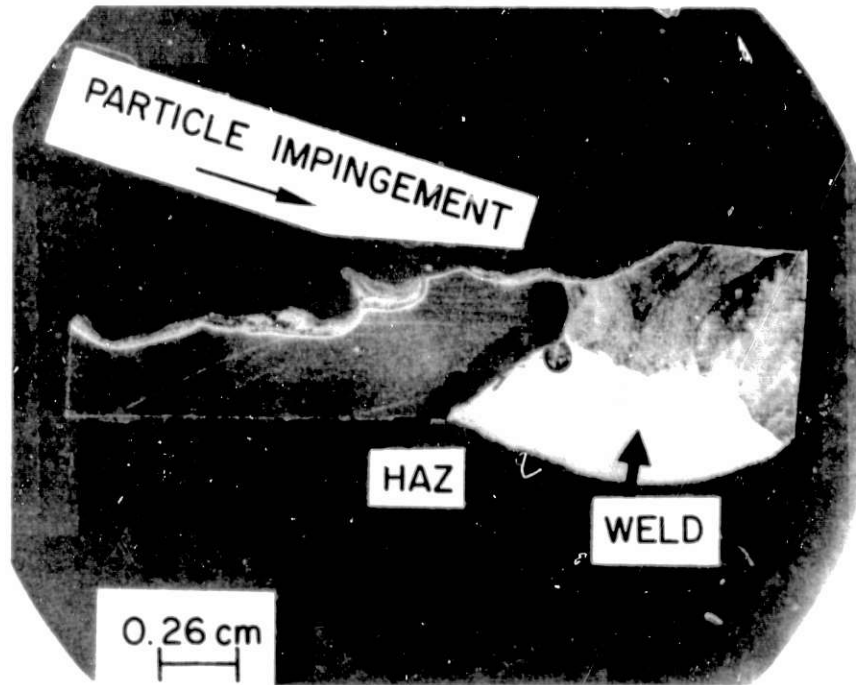
Fig. 65. Cross-sectional View of the Eroded Stainless Steel Insert in the Polished and Etched Condition. The heat-affected zone (HAZ) and the weld are readily seen. The surface topography reflects the incoming particle trajectories. Neg. No. ANL-306-78-570

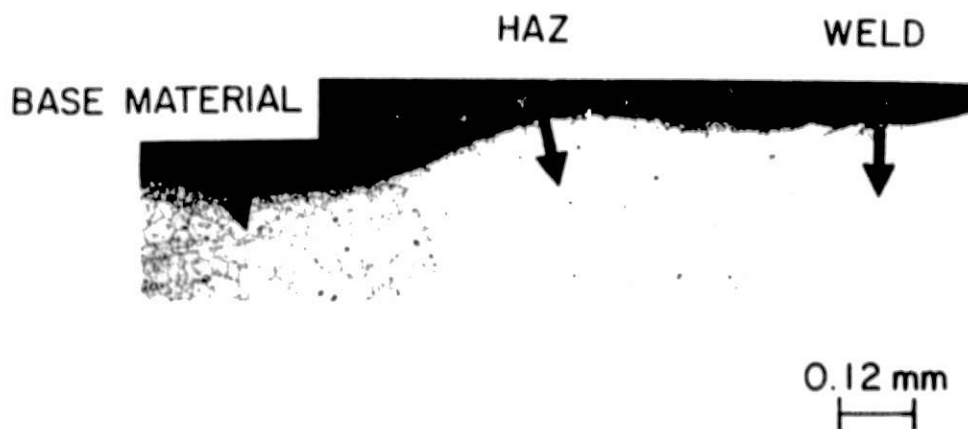
Fig. 66. The HAZ and Stainless Steel Insert at the ID. The HAZ has not eroded to the same extent as the insert material. Neg. No. ANL-306-78-591

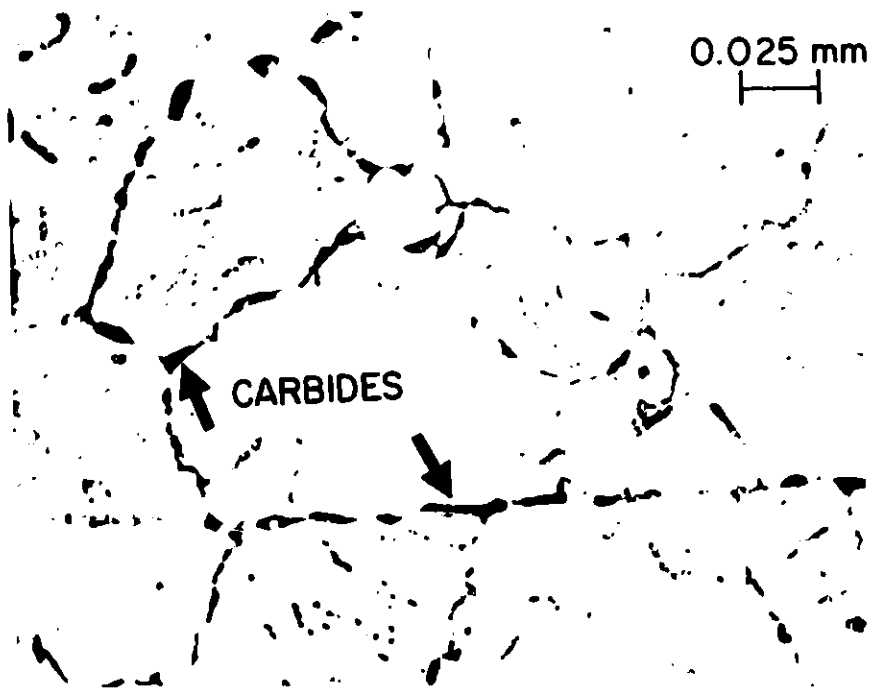
Fig. 67. Microstructure of the Stainless Steel Insert Material. Grain boundaries are decorated with carbides as a result of sensitization.
Neg. No. ANI-306-78-590

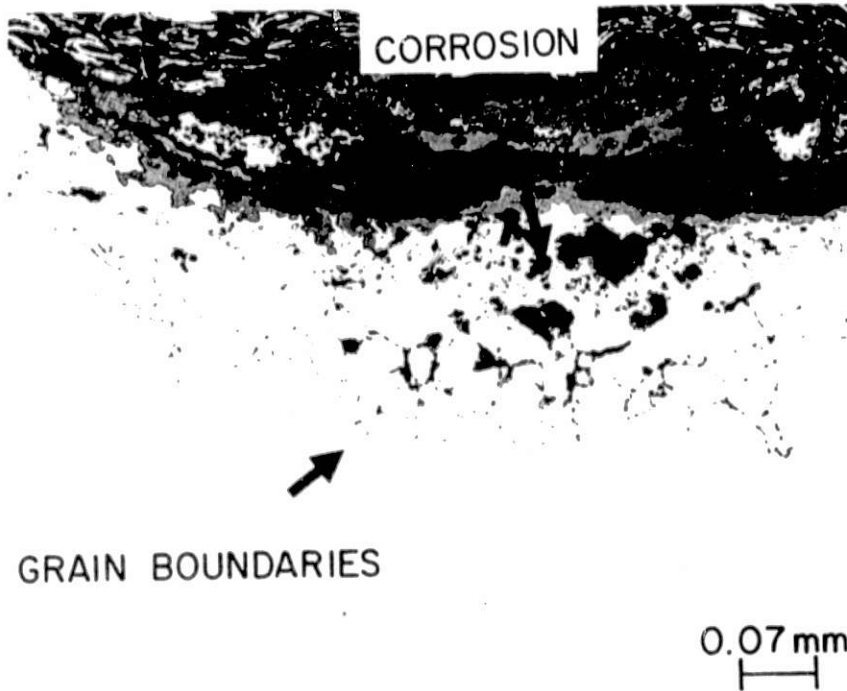
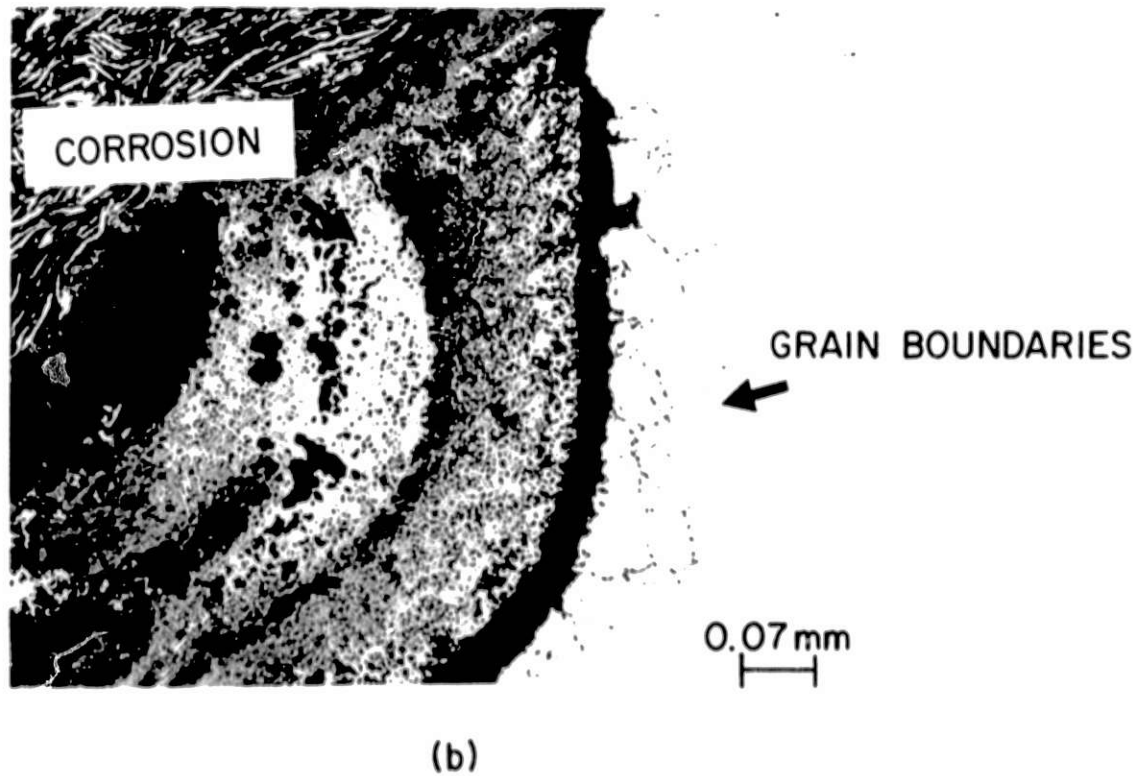
Fig. 68. Corrosion at the ID of the Stainless Steel Insert. The grain boundaries are embrittled, probably by sulfides. Neg. No. ANL-306-78-589

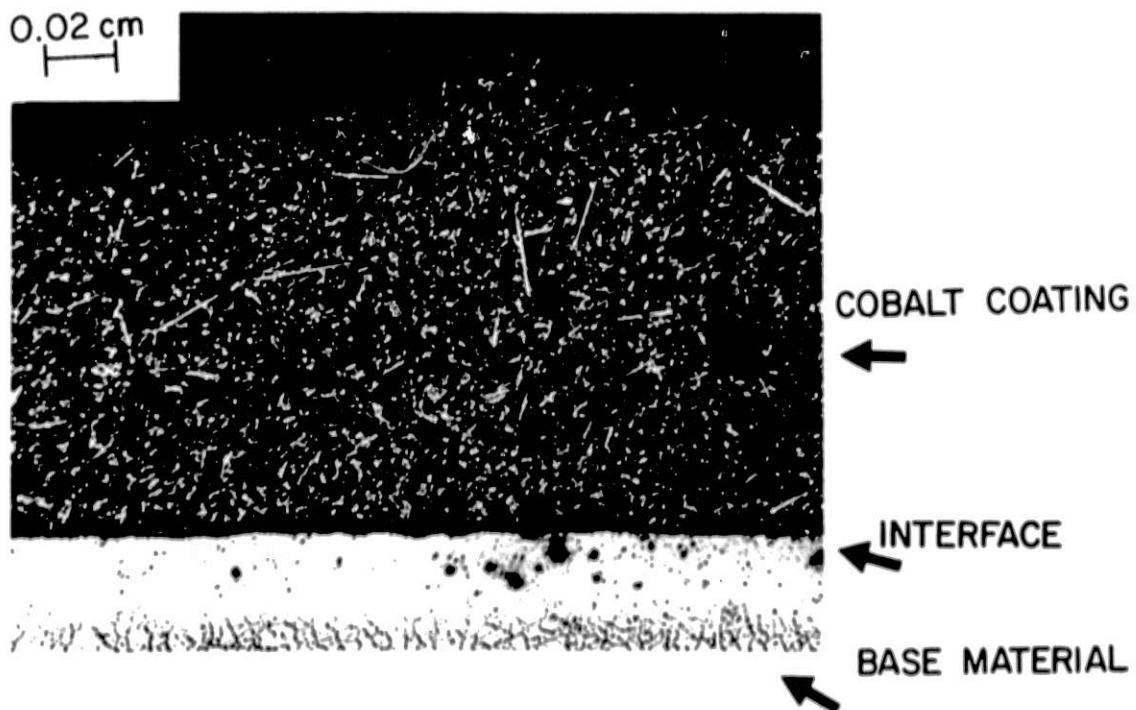
Fig. 71. Micrograph of a Cross Section of the Cobalt Hardfacing. The microstructure in the coating appears similar to ferrite and pearlite that are formed in iron-based alloys. Neg. No. ANL-306-78-586

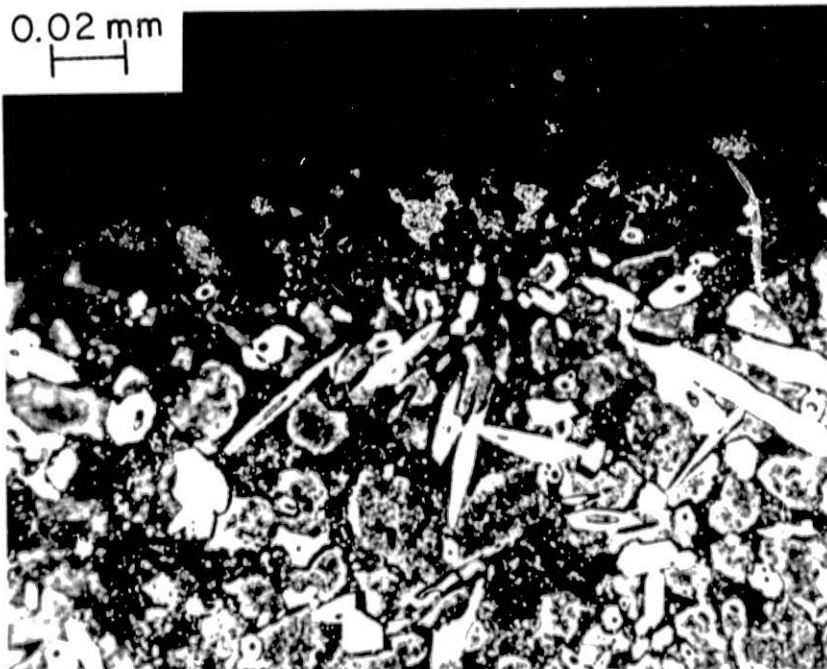
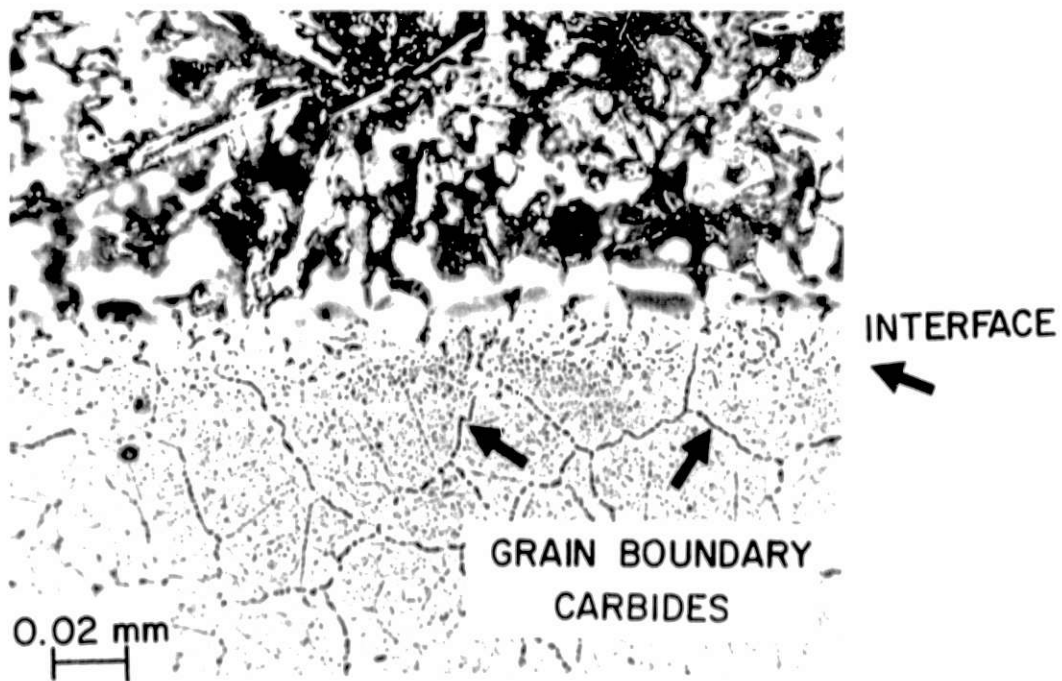
Fig. 72. Microstructure of the Cobalt Hardfacing and the Interface Between the Coating and Substrate. The microstructure in the coating appears similar to ferrite and pearlite that are formed in iron-based alloys. ANL Neg. No. 306-78-584

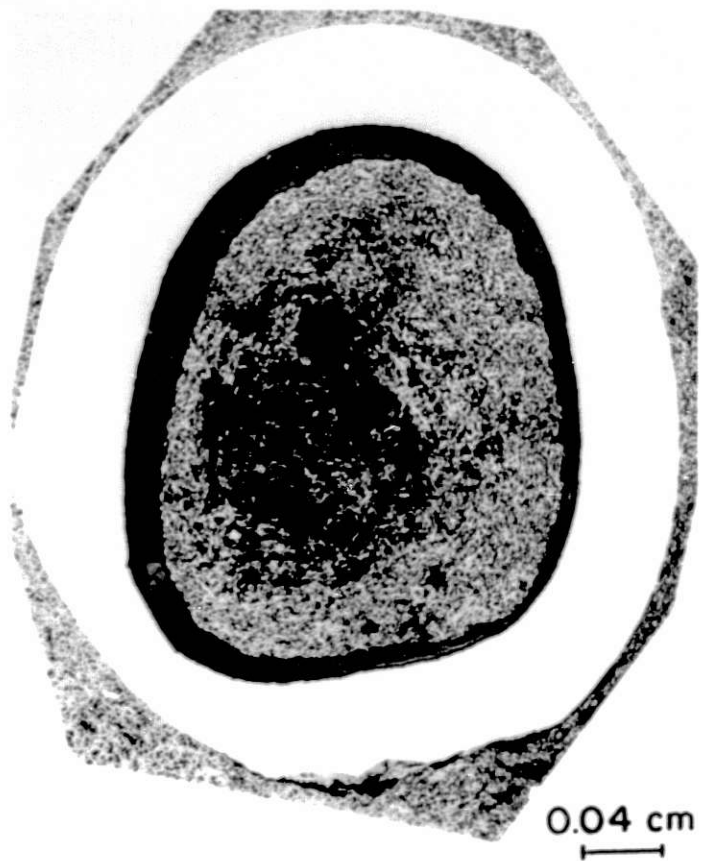
Fig. 77. Optical Photograph of a Cross Section of the Taphole Cooling Coil. A corrosion scale is seen at the ID, and localized corrosion is visible at the OD. Neg. No. ANL-306-78-575

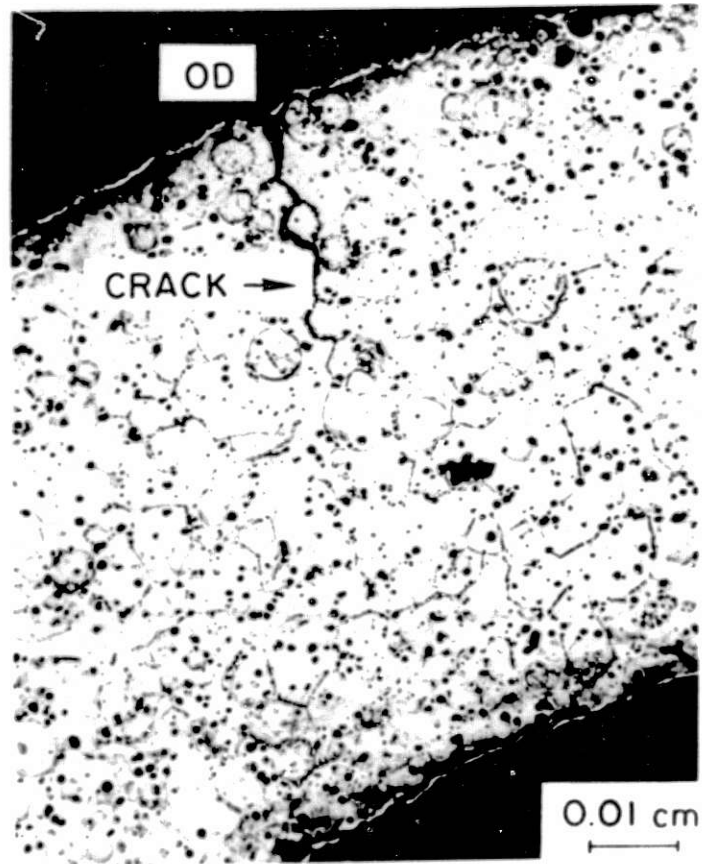
The failure of the Hastelloy G tube is attributed to IGSCC. From discussions with Cabot Corporation personnel, it was concluded that the alloy Hastelloy C-276 would be more resistant to IGSCC, especially since the tube is cold worked and exposed to a sulfur environment.

Fig. 78. Polished and Etched Micrograph of a Crack in the Hastelloy G Taphole Cooling Coil. The crack propagates from the OD toward the ID and is intergranular. Higher-magnification micrographs of this crack are shown in Fig. 79. Neg. No. ANL-306-78-577
