**MATERIALS TECHNOLOGY FOR
COAL-CONVERSION PROCESSES**

**Thirteenth Quarterly Report,
January—March 1978**

ANL-78-54

W. A. Ellingson
Project Leader

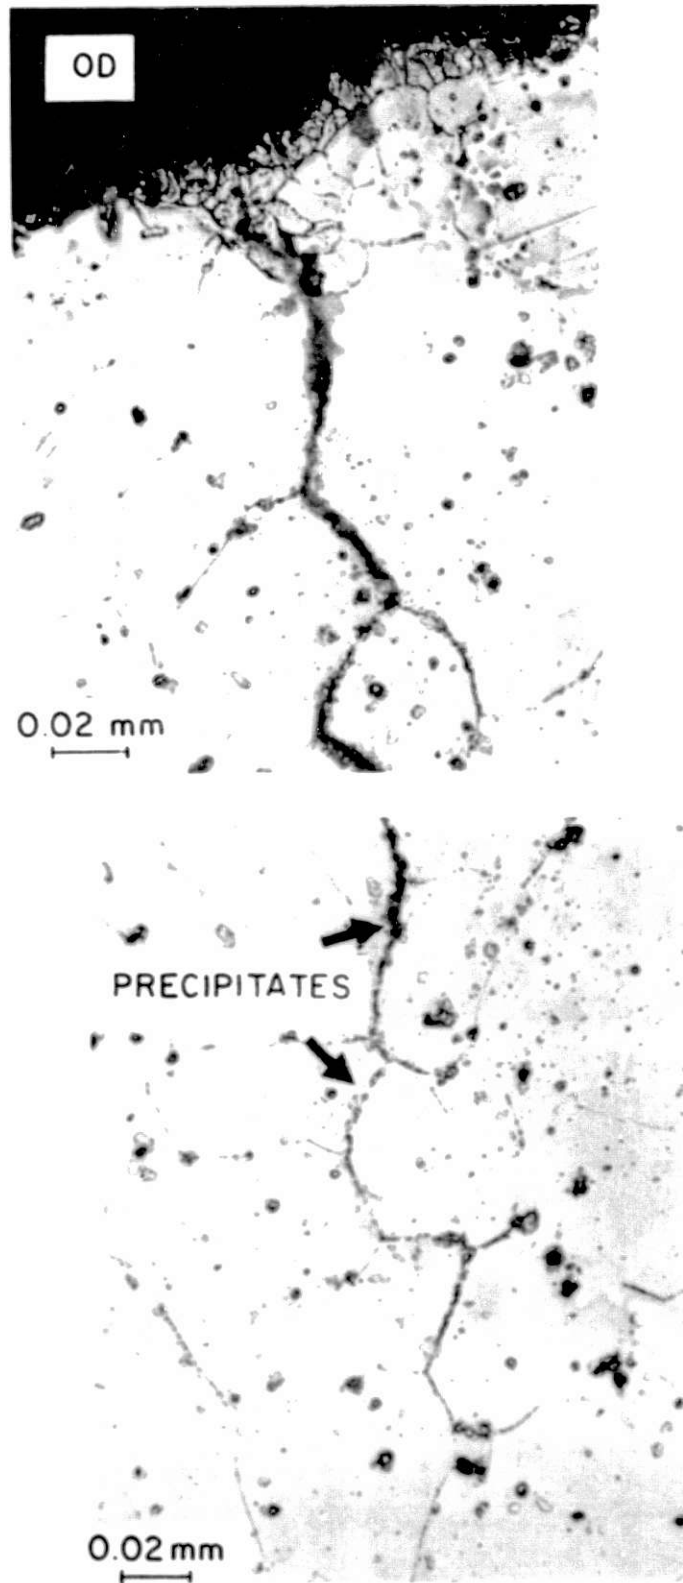
Fig. 79. Enlarged Micrographs of the Intergranular Crack Shown in Fig. 78. Recrystallization is visible at the OD where the crack initiated, and precipitates are observed at the grain boundaries. ANL Neg. No. 306-78-576
