MISCELLANEOUS PAPER S-73-22

CONDITION SURVEY, MALMSTROM AIR FORCE BASE, MONTANA

R. D. Jackson

April 1973

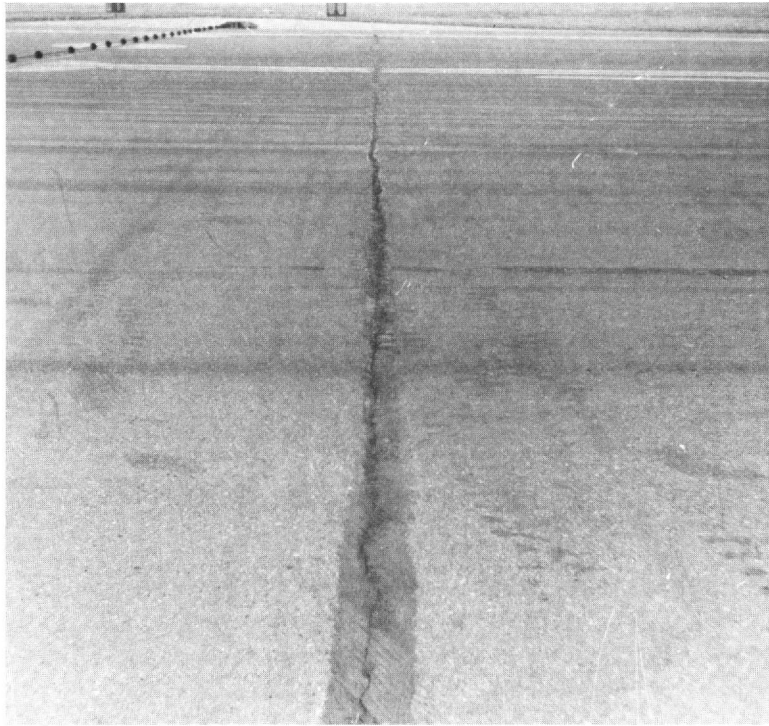
was in very good condition. The first 1000 ft of the NE (20) end (features R1A and R2B), which is also 16-in. PCC, was in excellent structural condition, and no major defects were noted. The joint sealing materials on both 1000-ft runway ends were in very poor condition and had completely deteriorated between several slabs at the southwest end. The asphaltic-concrete (AC) portion of the runway was in good condition, even though there were numerous longitudinal and transverse cracks that appeared to be reflection cracks (photos 1 and 2).

Photo 1. Transverse crack in runway near NE end

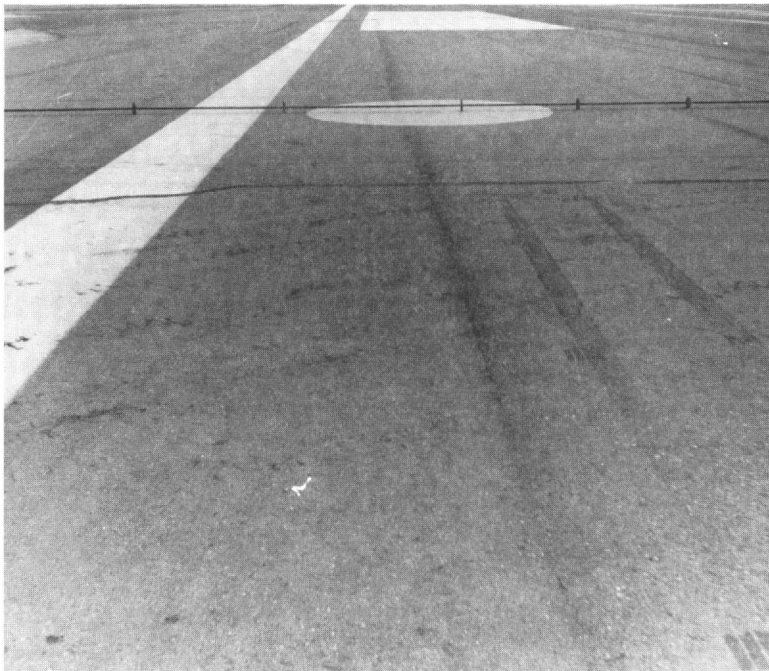
Photo 2. Longitudinal and transverse cracks
near NE end of runway

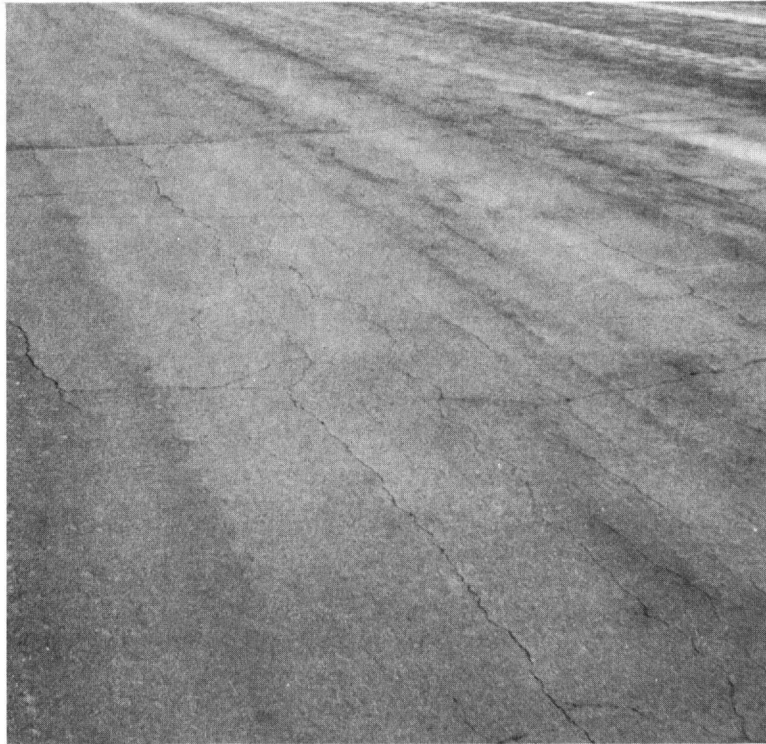
16. The primary taxiway system consists of taxiway T, the apron taxiway, and taxiway O. The southwest end of taxiway T (feature T1A) was in good condition. The AC portion of taxiway T was in poor condition (photo 3). The surface of this taxiway was uneven and contained numerous cracks and scales in the slurry seals placed in 1959 and 1965. The apron taxiway (features T3A and T7A) was in very good to excellent condition, even though there were a considerable number of minor defects. Taxiway O was in excellent condition.

Photo 3. View of AC portion of taxiway T

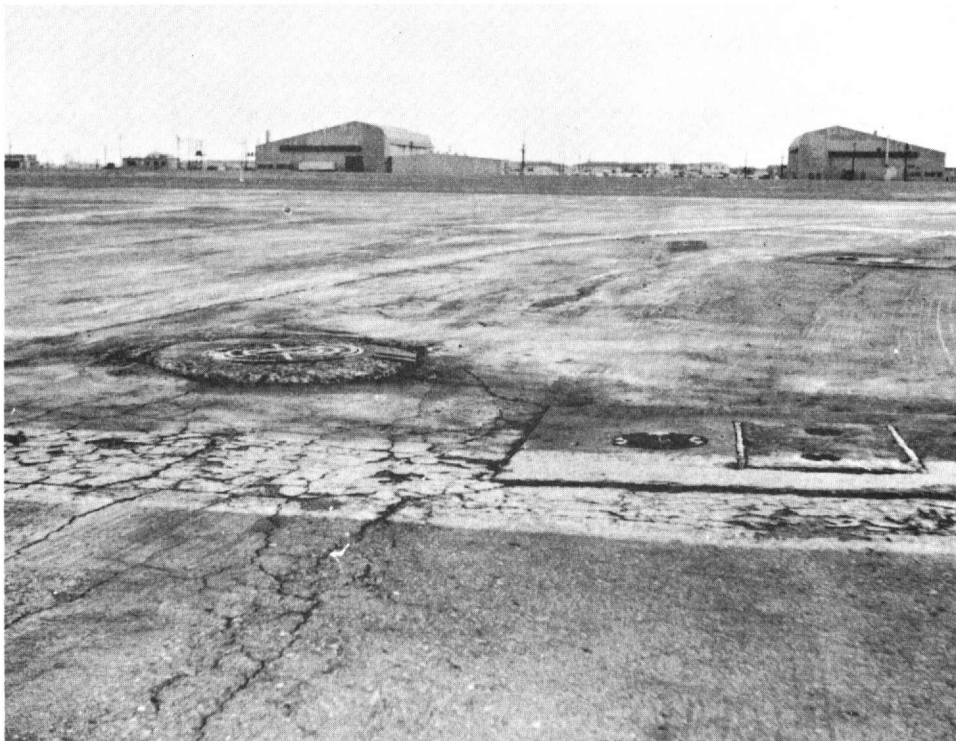
24. The most noticeable frost heaves were those affecting the concrete bases for taxiway lights and manholes inserted in the shoulder pavements. Several light bases along taxiway T were heaved for about 1 in. above the adjacent pavement, while 2 manhole covers in taxiways R and A were about 3 in. higher than the adjacent pavement. These differences in pavement elevations constituted a problem for snow removal equipment.

Photo 4. Taxiway R shoulder pavement. Note
heaving adjacent to manhole on left

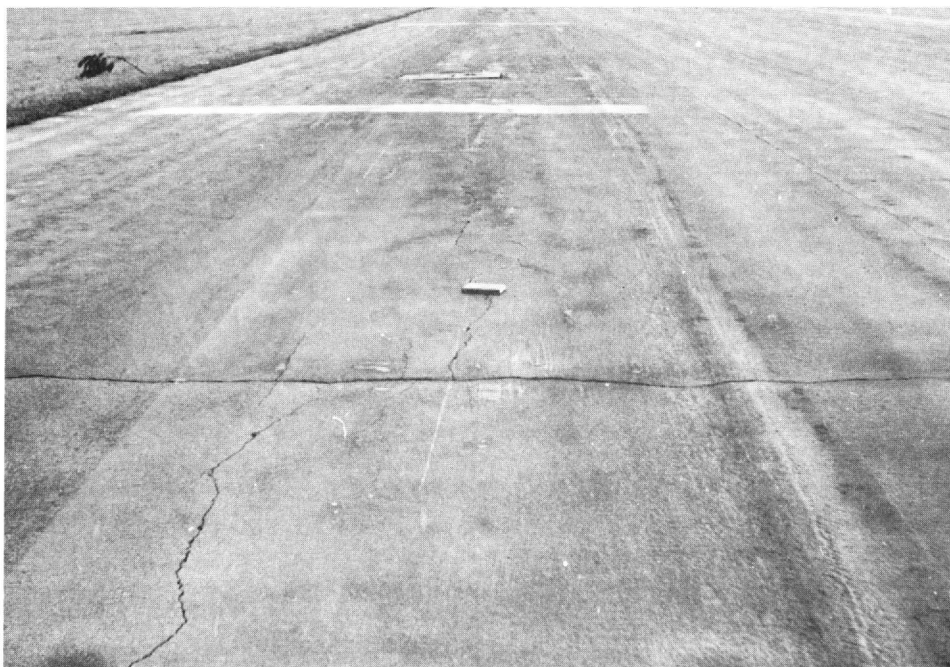
23. The runway overruns were smooth and showed no evidence of frost heaving. (The combined thickness of the overrun pavement is 65 in., while that of the adjacent rigid pavement is only 36 in.) The taxiway and apron shoulders showed considerable unevenness in many areas, with some longitudinal and transverse cracks, particularly in taxiways T, S, R, and Q and in the southwest warm-up apron (see photos 4 and 5). The roughness was probably the result of frost heaving, while much of the cracking was probably the result of vehicular traffic.

Photo 5. Taxiway T shoulder pavement
