# CONDITION SURVEY, MINOT AIR FORCE BASE, NORTH DAKOTA

P. J. Vedros

April 1973

Conducted by U. S. Army Engineer Waterways Experiment Station  
Soils and Pavements Laboratory  
Vicksburg, Mississippi

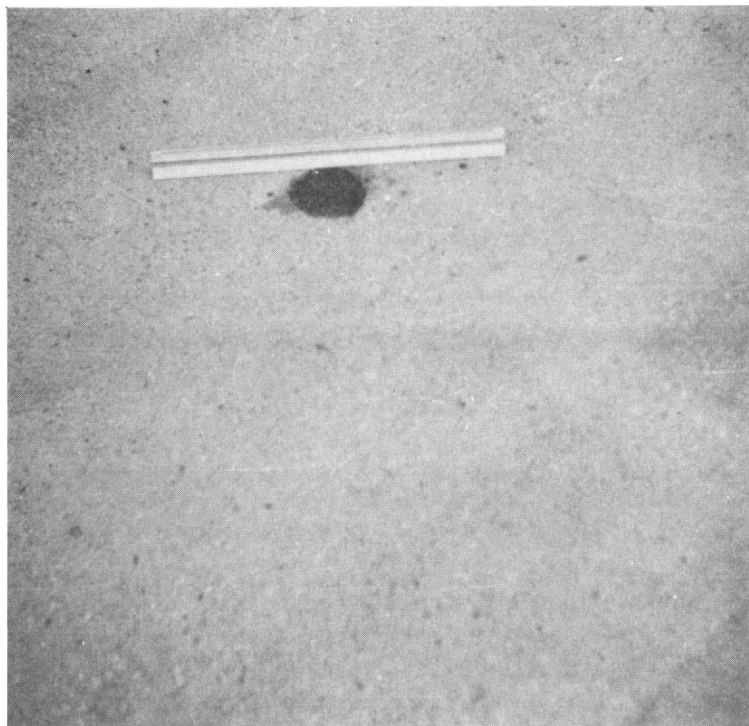
15. There were some aggregate pop-outs observed in the runway pavements, with the majority occurring in the interior section. The maximum size of the voids resulting from the pop-outs was about 3 in. in diameter (photo 1). These areas are kept free of debris by sweeping.

26. Pop-outs are occurring in some areas of the airfield, but they have not been considered a maintenance problem. The pop-outs are small in size (3-in.-diam, maximum), and patching is not required. Sweeping keeps any loose particles resulting from pop-outs off of the pavement surfaces.

Photo 1. Pop-out in runway interior  
(approximately maximum size observed)

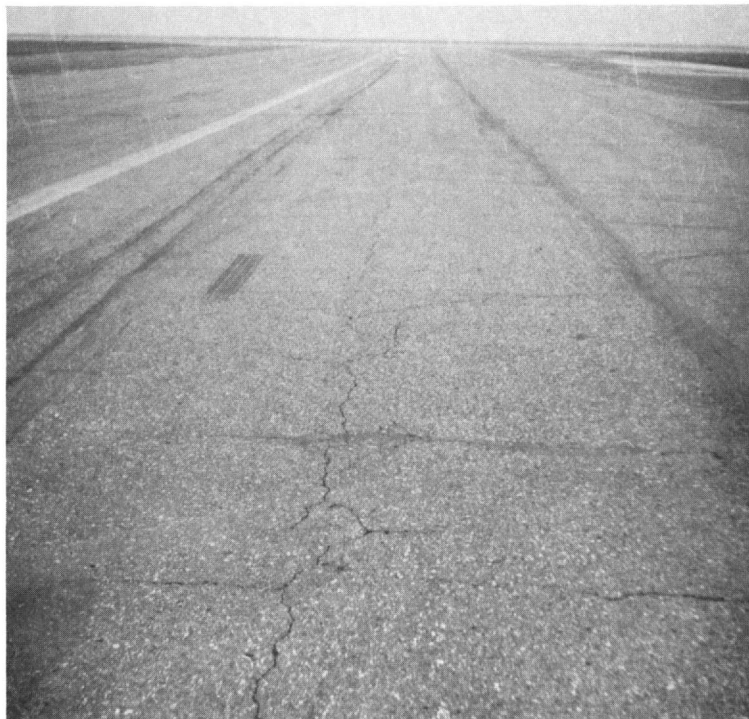
24. Both of these taxiways connecting the runway to the primary taxiway are of flexible pavement construction. The pavements were in fair condition, with random cracking in the surface (photo 2). Some longitudinal cracking occurred in taxiway C as a result of operations of aircraft during practice alerts. The taxiway was also used to park alert aircraft; and, because of the surface condition, Base Civil Engineering

Photo 2. Random cracking in taxiway C

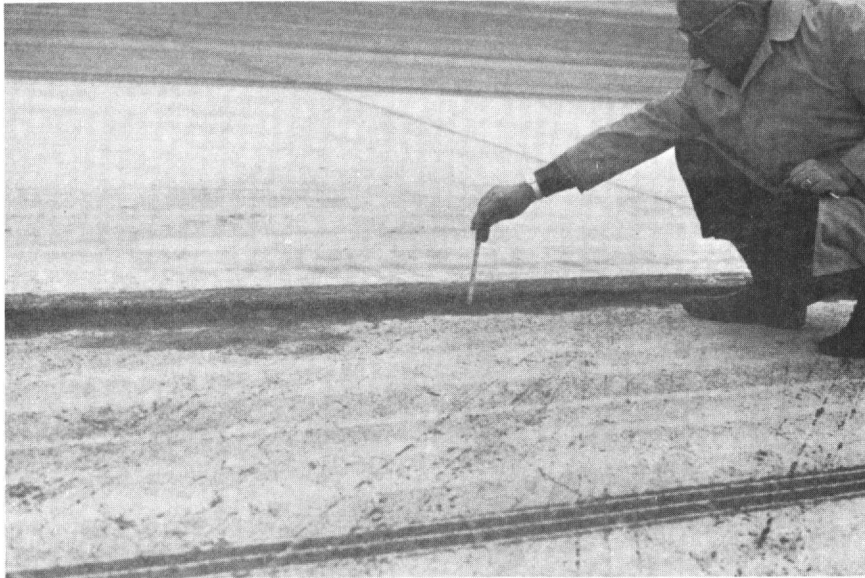
Photo 3. PCC runway keel heaved 2 in. above  
AC runway edge pavement near intersection of  
runway with taxiway C

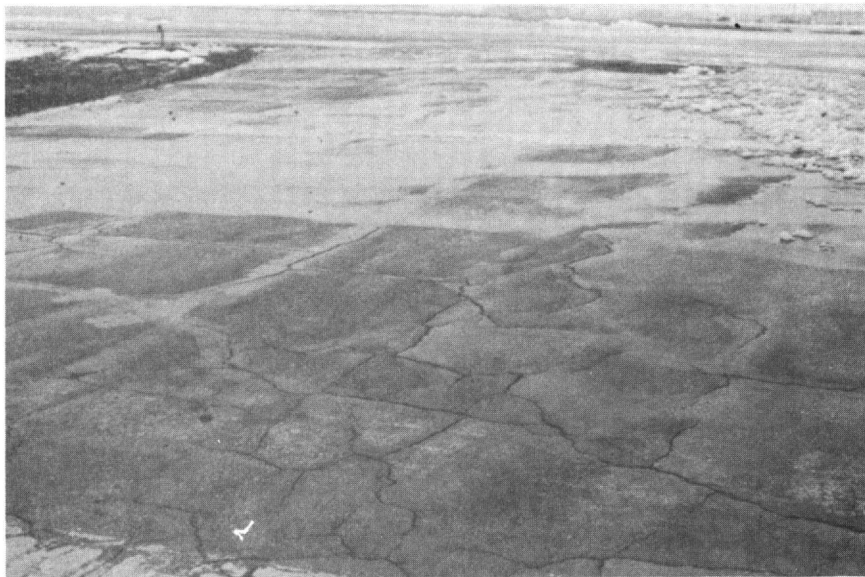
Photo 4. Random cracking of shoulder pavement at  
taxiway B caused by nonuniform frost heave

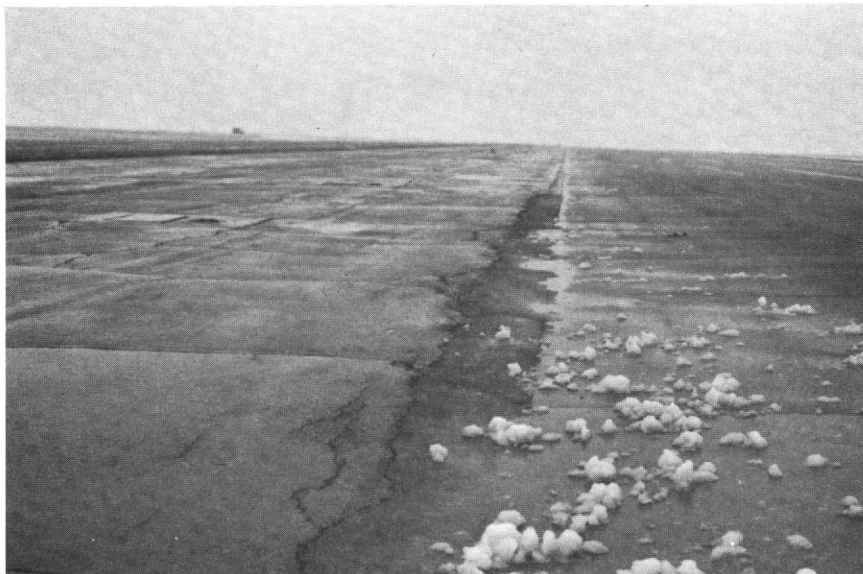
Photo 5. Shoulder pavement of parallel taxiway  
heaved 1-1/2 in. above edge of feature T11A

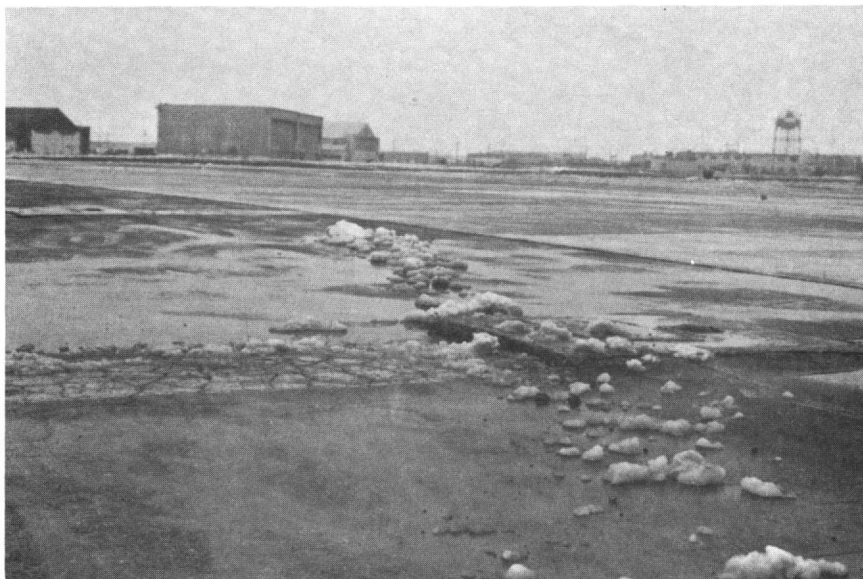
Photo 6. Differential frost heave at concrete  
insert in shoulder of taxiway B

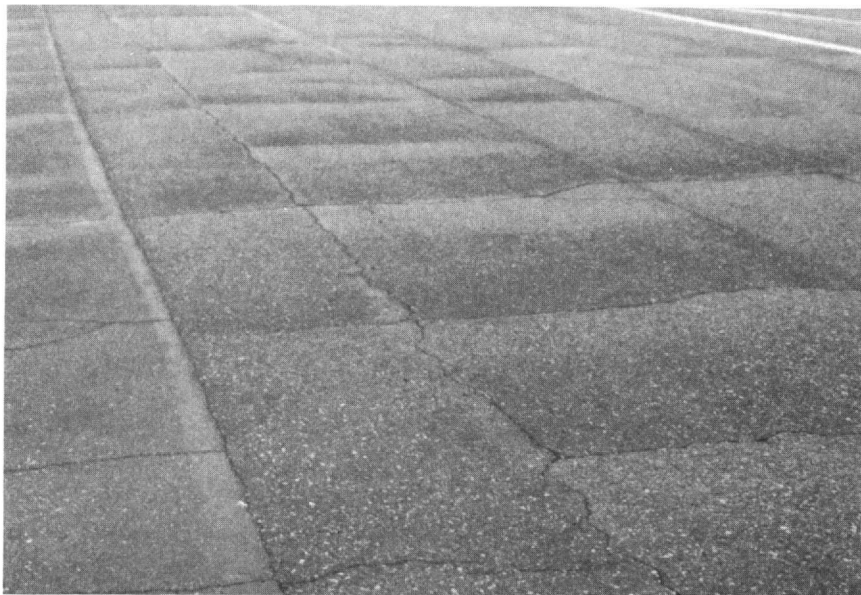
Photo 7. Transverse and longitudinal low-temperature contraction cracks at spacing of 10 to 15 ft in edge of primary taxiway (feature T11A)
