MISCELLANEOUS PAPER S-73-33

# CONDITION SURVEY, GLASGOW AIR FORCE BASE, MONTANA

R. D. Jackson

May 1973

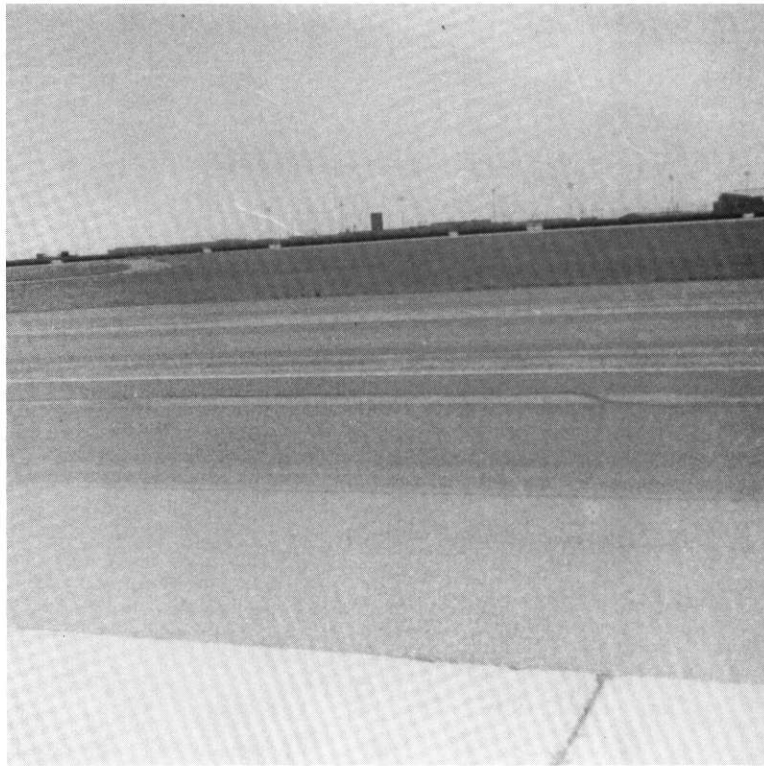
14. The portland cement concrete (PCC) pavement of the runway was in very good condition (except for two areas), even though the number of defects had increased considerably since the 1960 survey. The 17-in.-thick pavement from sta 78+75 to 88+75 was rated as being in poor condition, because the number of major defects had more than doubled since the 1960 survey. The 14-in.-thick edges of the runway ends (features R5D and R6D) were considered to be in poor condition. The flexible pavement edges of the runway interior (feature R8D), however, were considered to be in good condition (see photo 1).

Photo 1. General view of AC pavement of outer edge of runway interior (feature R8D) near  
sta 45+00

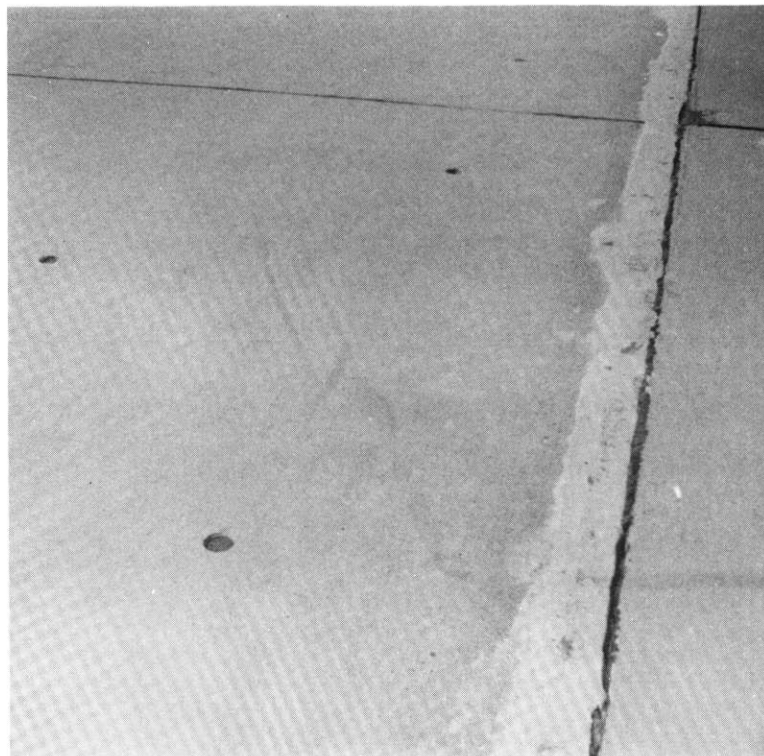
15. There was evidence of settlement of several slabs in the runway interior between sta 65+00 and 70+00 (feature R7C). It was reported that unsuccessful mud jacking had been performed in this area in 1966 and 1967. An epoxy surface patch approximately 115 ft long and 6 to 8 in. wide was installed to smooth out the transition area onto the settled slabs. There was no evidence that movement of these slabs had occurred since the installation of the patch. Photo 2 shows the condition of the patch. Numerous grouted drill holes (photo 2) were noted in runway features R3C and R4C, indicating that mud jacking had been performed at some previous time. Some settlement of slabs was noted near sta 45+00 (photo 3).

Photo 2. Epoxy patch and grouted drill holes

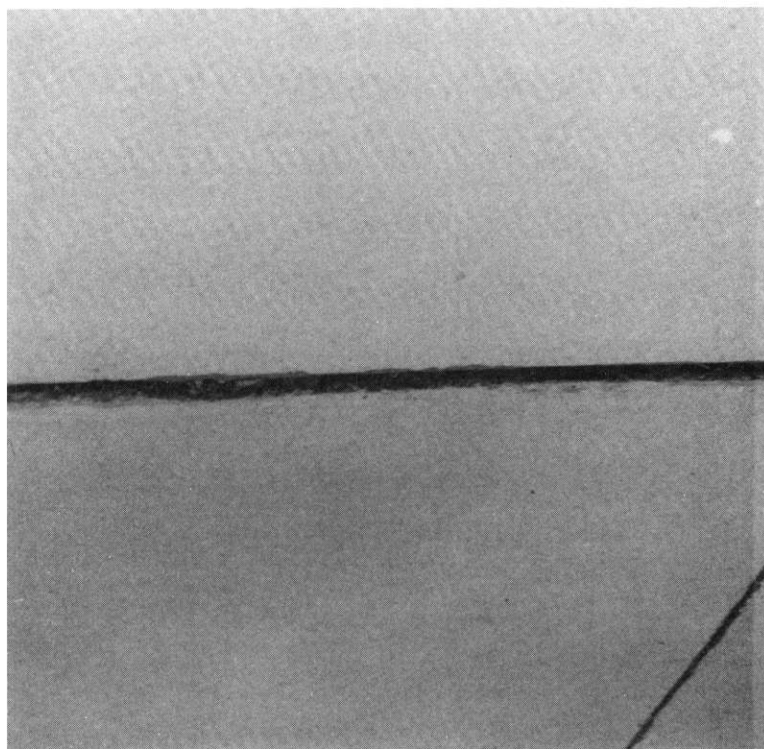
Photo 3. Settlement of slab near  
sta 45+00 of runway
