MISCELLANEOUS PAPER S-73-34

CONDITION SURVEY, PEASE AIR FORCE BASE, NEW HAMPSHIRE

May 1973

Conducted by U. S. Army Engineer Waterways Experiment Station
Soils and Pavements Laboratory
Vicksburg, Mississippi

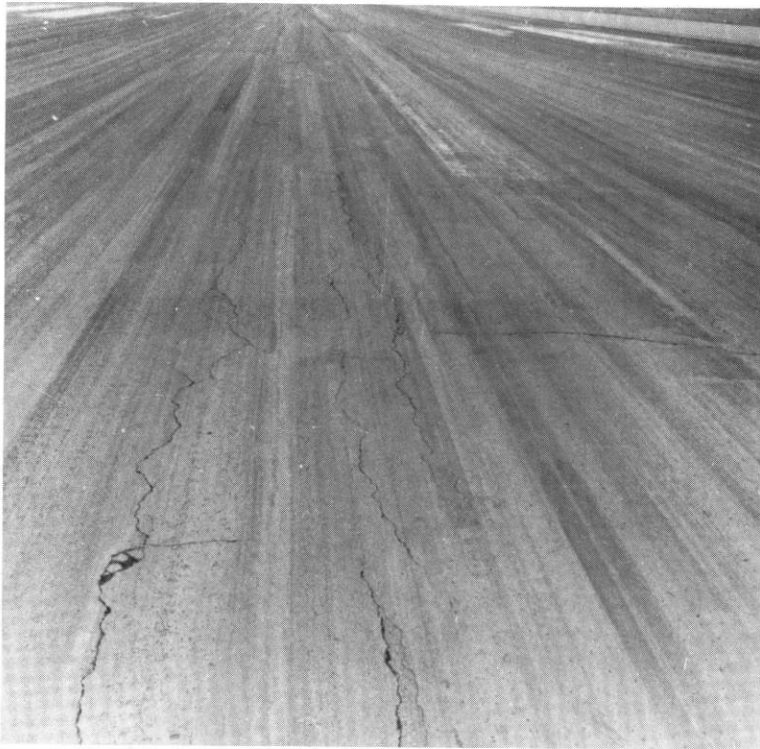
Photo 1. General view of cracking on runway approximately
2500 ft from NW end

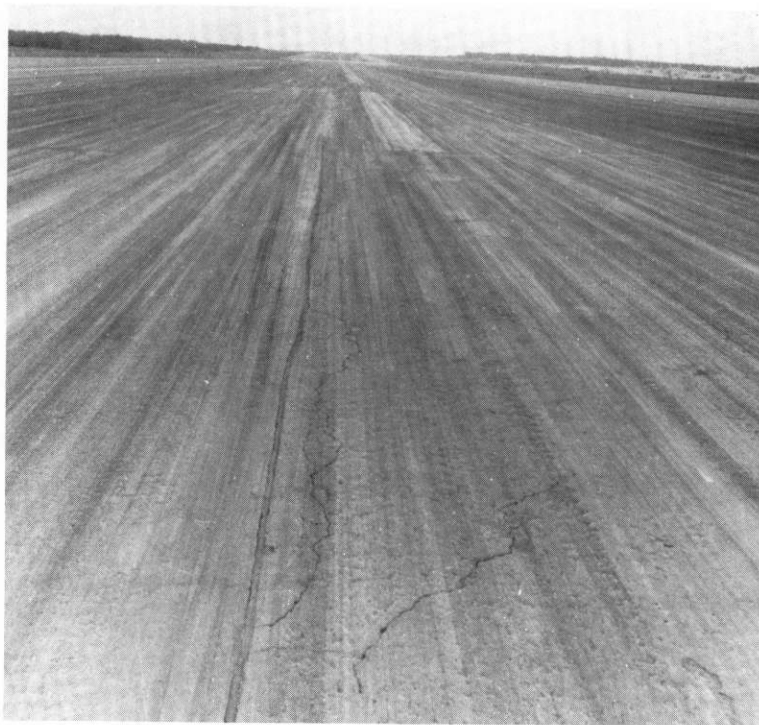
Photo 2. General view of runway near SE end
of AC pavement

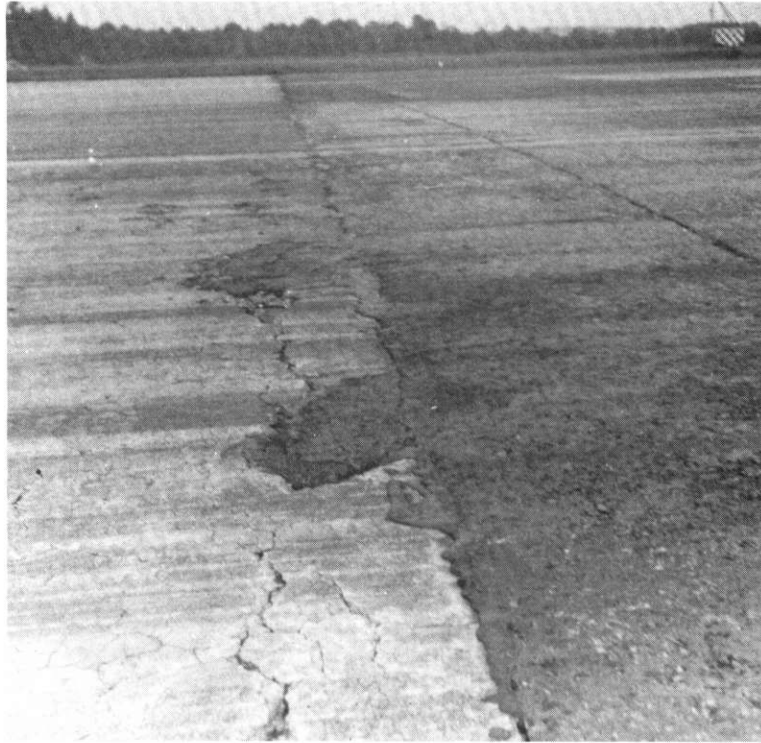
Photo 3. Pavement condition at junction of
PCC and AC at SE end of runway

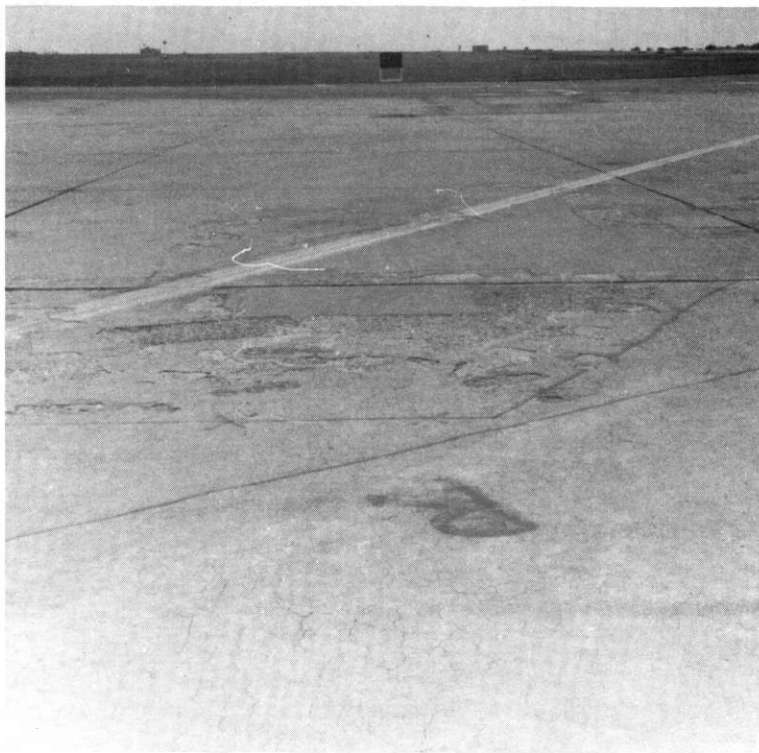
14. The north warm-up apron (feature A1B) was in very good condition based on the percentage of slabs containing no major defects. Jet blast had caused scaling on approximately 10 percent of the slabs. Photo 6 shows some of the scaling in feature A1B. The south warm-up apron (feature A2B) was in fair condition. There were 110 major defects in this feature, of which 100 were longitudinal cracks. Most of the longitudinal cracks were of the type shown in photo 7. They appeared to be caused by the manner in which the pavement had been placed rather than by overloading. Scaling was also prevalent in this feature, with approximately 20 percent of the slabs containing this defect (photo 8). Parking aprons A and B (features A3B and A4B) were in very good condition based on the percentages of slabs containing no major defects. Approximately 10 percent of the slabs in these features contained longitudinal cracks, which were the predominant defect. A large percentage of these longitudinal cracks were of the type shown in photo 9, and they did not appear to be load related. Considerable expansion of these aprons has resulted in upheaval of the shoulder pavements (photo 10) and the removal of the PCC pavement around embedded features, such as the fueling hydrants and drainage structures (photo 11).

Photo 6. Scaling of slabs in north warm-up apron

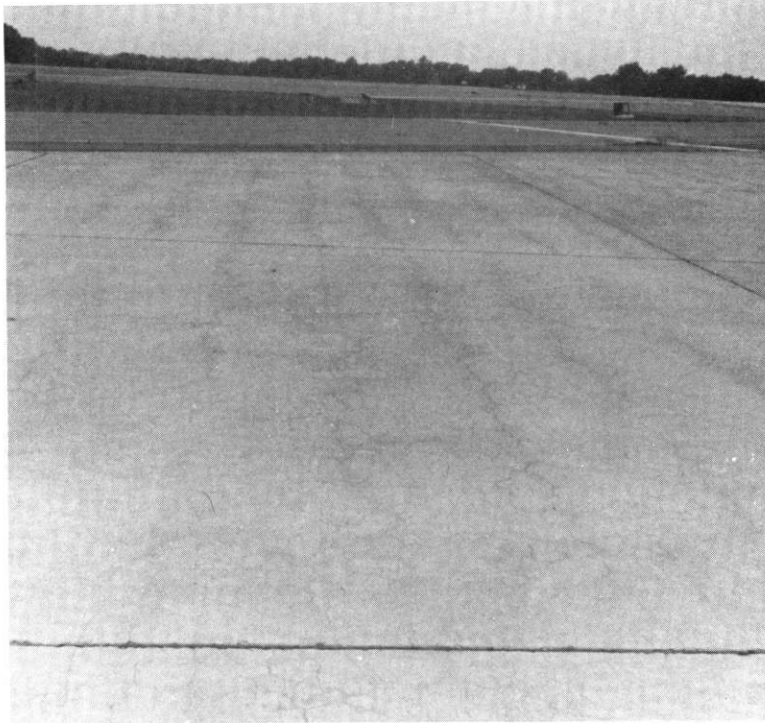
Photo 7. Longitudinal cracks in south warm-up apron

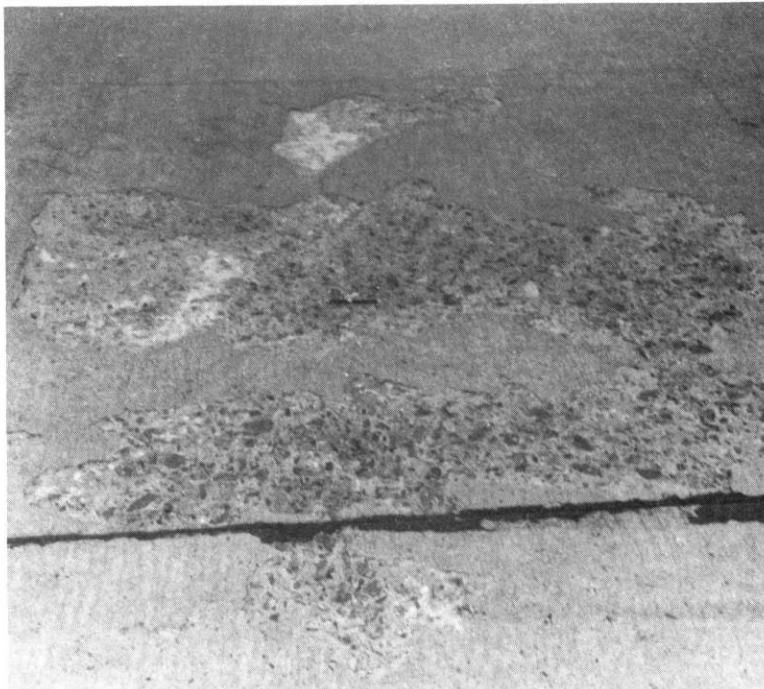
Photo 8. Scaling of slabs in south warm-up apron

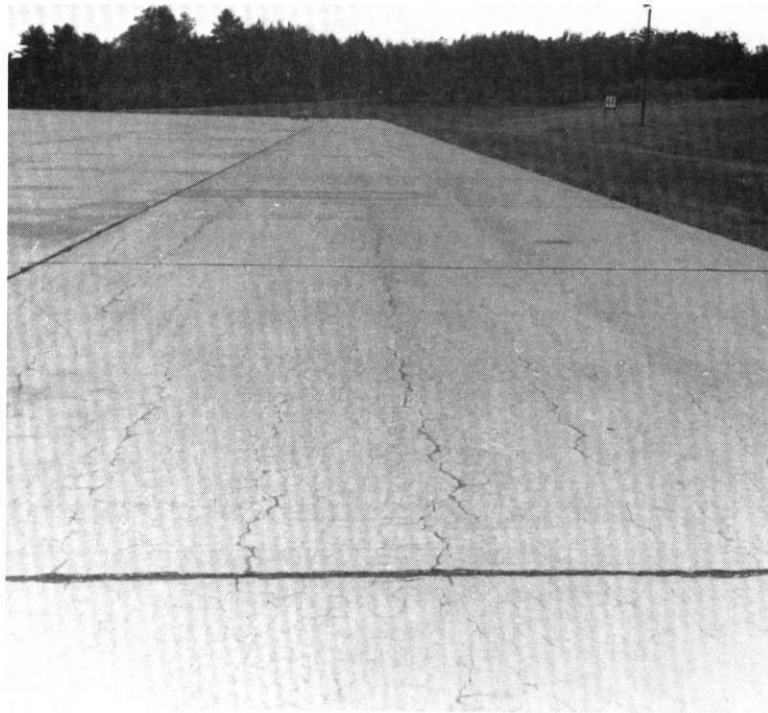
Photo 9. Typical longitudinal cracking
(as in parking aprons A and B)

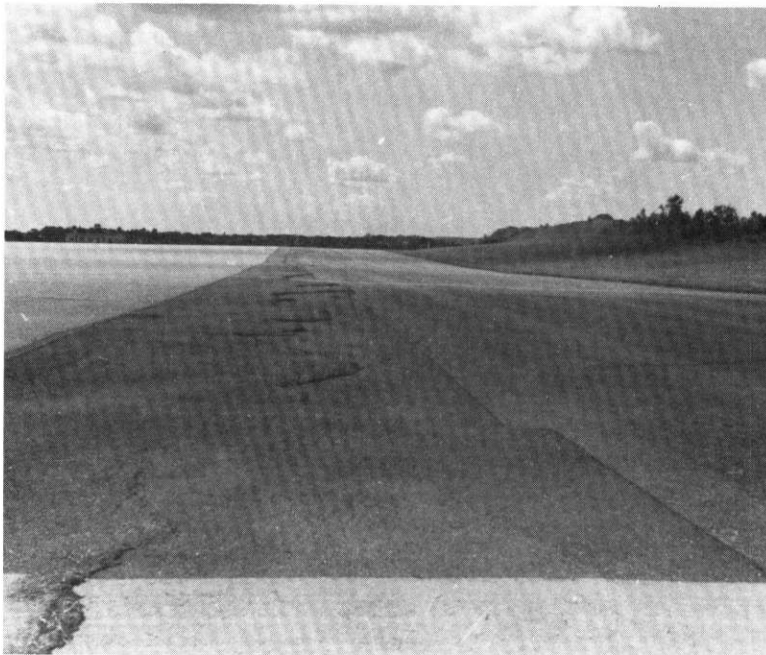
Photo 10. Upheaval of shoulder pavement at
north end of parking apron A

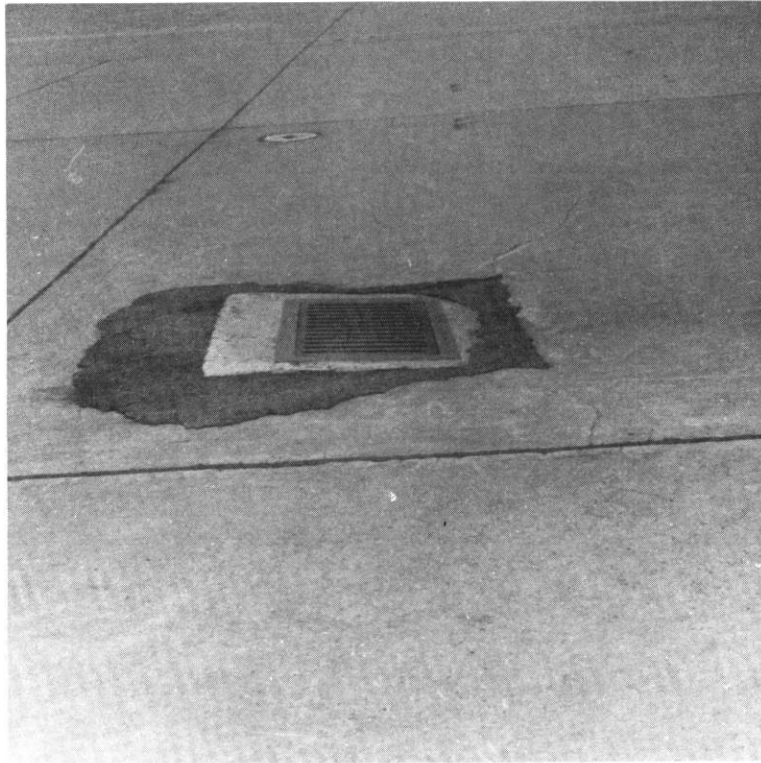
Photo 11. AC replacement of PCC pavement
at drainage structure
