MISCELLANEOUS PAPER S-73-42

# CONDITION SURVEY, GRAND FORKS AIR FORCE BASE, NORTH DAKOTA

June 1973

Conducted by U. S. Army Engineer Waterways Experiment Station  
Soils and Pavements Laboratory  
Vicksburg, Mississippi

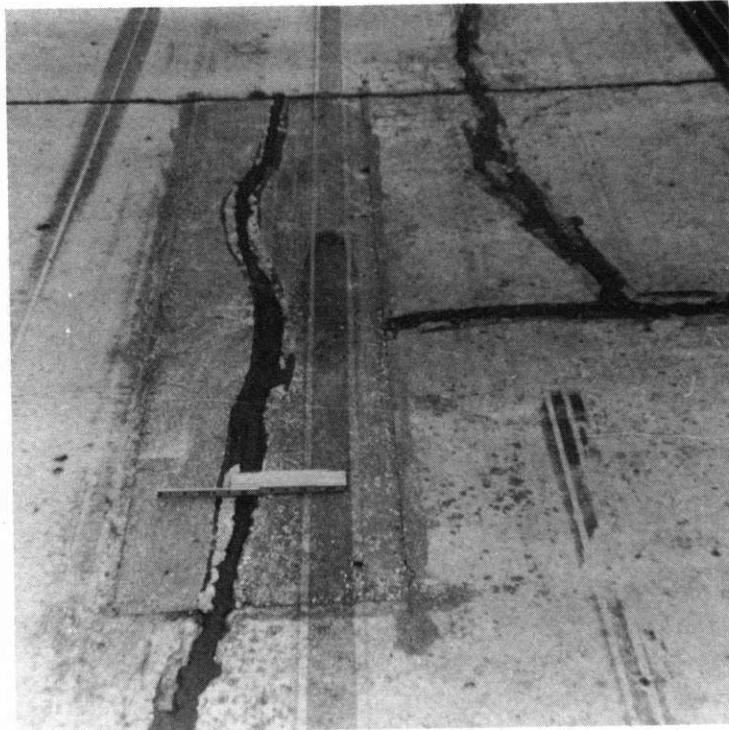
12. The greatest amount of cracking was occurring in the runway extension (4000-ft extension to the north (17) end of runway) between sta 75+00 and 98+00. It was concluded from the crack surveys in 1959 that the uncontrolled cracking was caused by nonuniform frost heave and subsidence of undisturbed soils.

Photo 1. Longitudinal cracks in slabs in interior of runway (typical of area from sta 75+00 to 100+00)

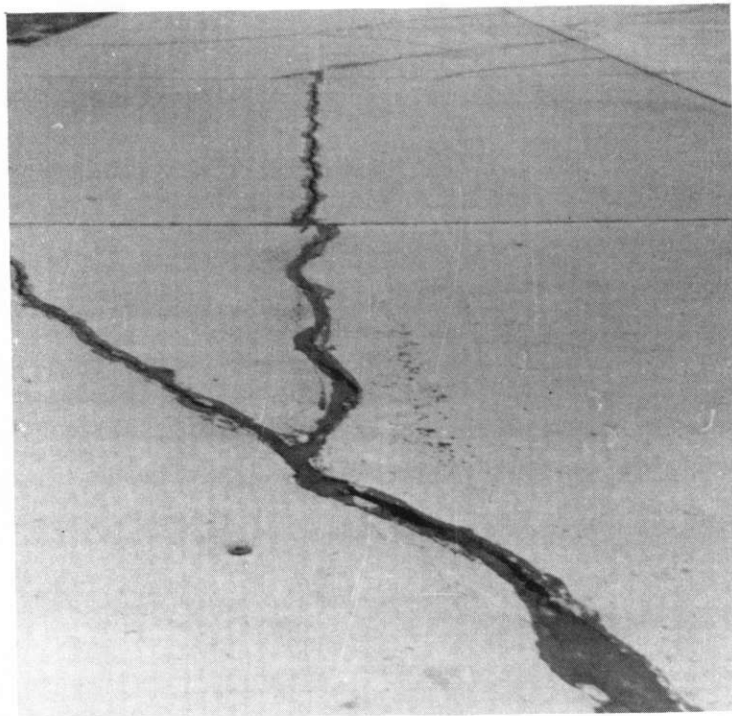
Photo 2. Cracking in outside lane of runway

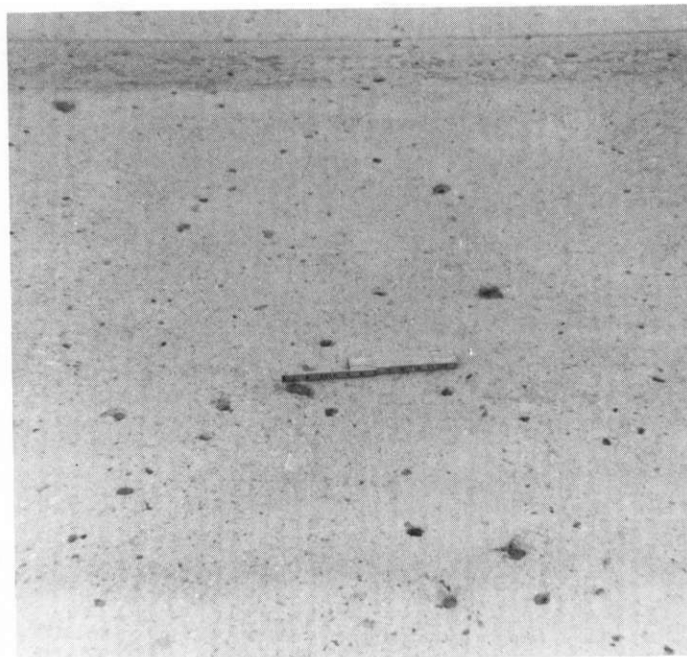
21 percent of the slabs in this feature contained major defects. Most of these defects were in the two east lanes of this three-lane taxiway. Pop-outs were observed in all taxiways (photo 4) except taxiway G. This taxiway was constructed in 1964 by the Air Force using a crushed granite aggregate in the concrete. Some transverse spalls on taxiway G had been patched with epoxy and were performing satisfactorily (photo 5).

Photo 4. Pop-out condition on north end of taxiway C

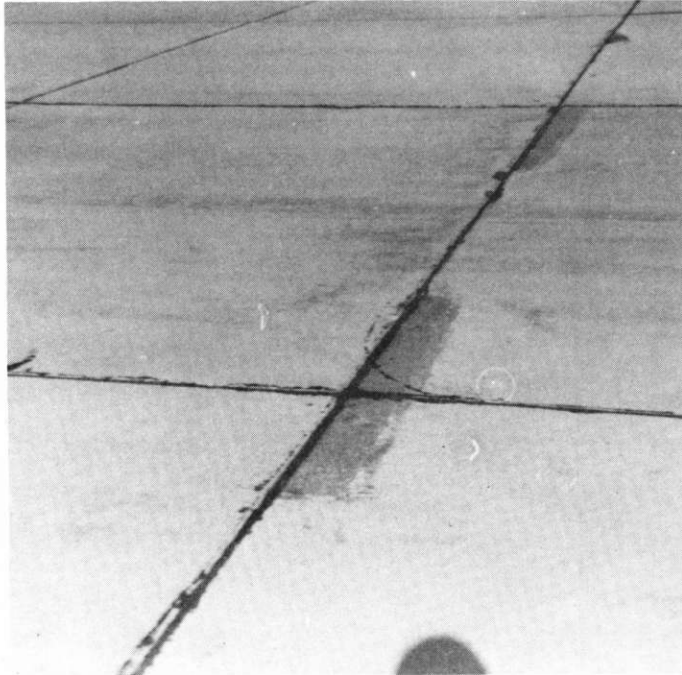
Photo 5. Transverse spalls on taxiway G patched with epoxy.  
Note absence of pop-outs

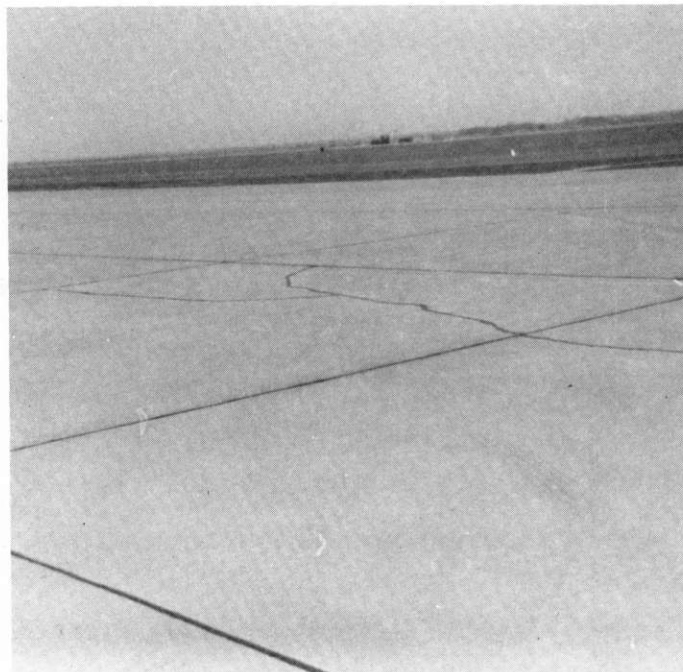
20. The warm-up apron (feature A1B) was in excellent condition, with only one transverse crack observed. The missile loading ramp (feature A15B) was in excellent condition, with only about 5 percent of the slabs containing major defects. Some slabs at the entrance to the loading ramp contained longitudinal cracks (photo 6).

Photo 6. Cracking in slabs of taxiway C at  
entrance to missile loading ramp
